AEROSPACE REPORT NO.
TR-93(3904)-1

Honeycomb Sandwich Structures: Vented Versus Unvented Designs for Space Systems

October 1993

GEORGE EPSTEIN and SUSAN RUTH
Manufacturing Engineering Department
Design Engineering Subdivision
Engineering and Technology Group

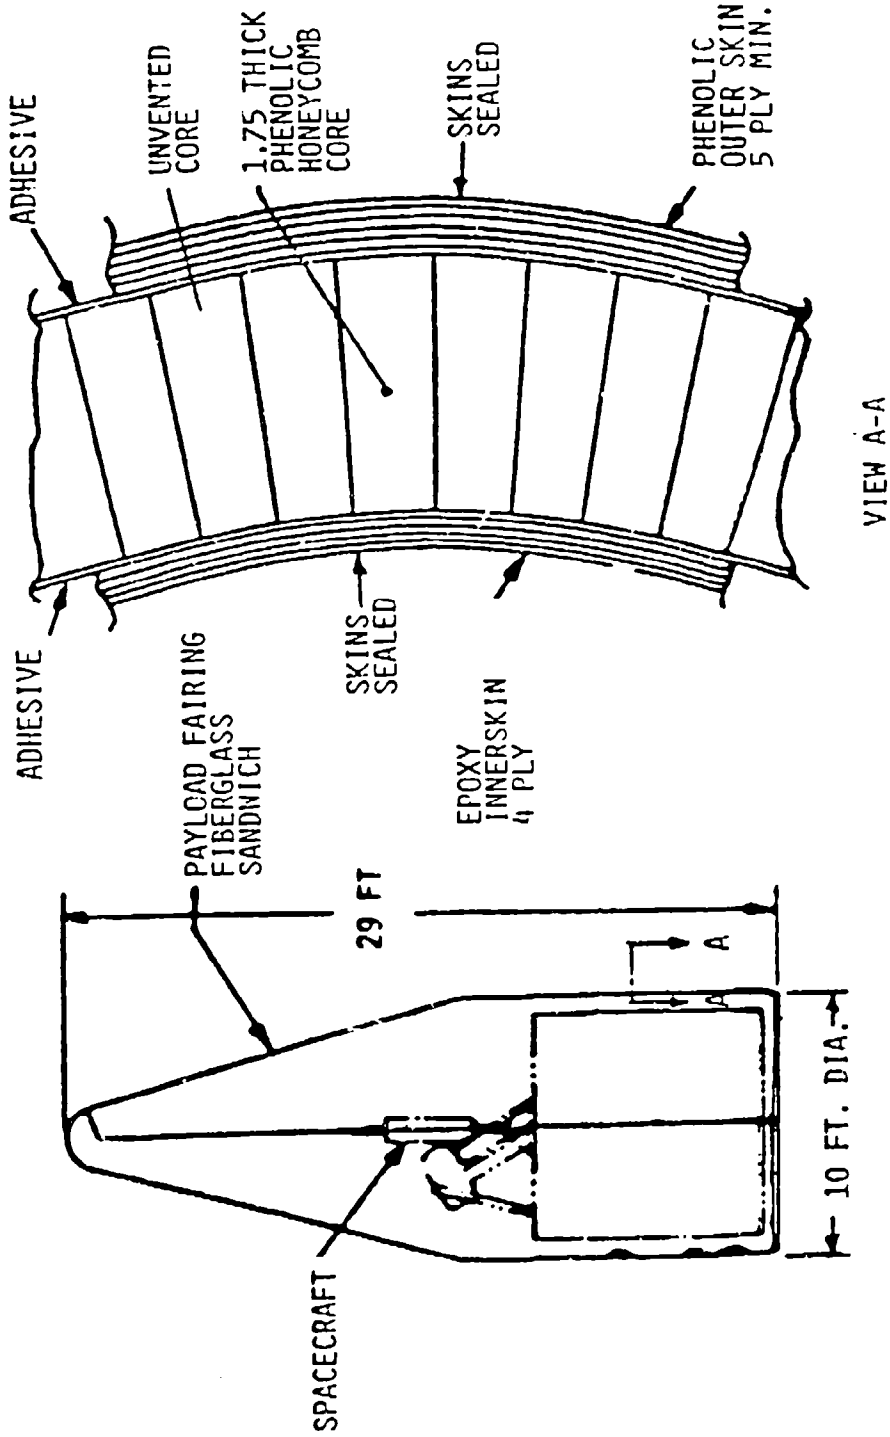
Figure 2. Fiberglass Payload Fairing

Figure 2 (from Ref. 2) shows the construction, consisting of a four-ply glass/epoxy inner skin and a five-ply glass/phenolic outer skin, bonded with HT-424 film (tape) adhesive to 1.75-in. thick HRP (glass/phenolic) honeycomb core of 3/8 in. cell size.

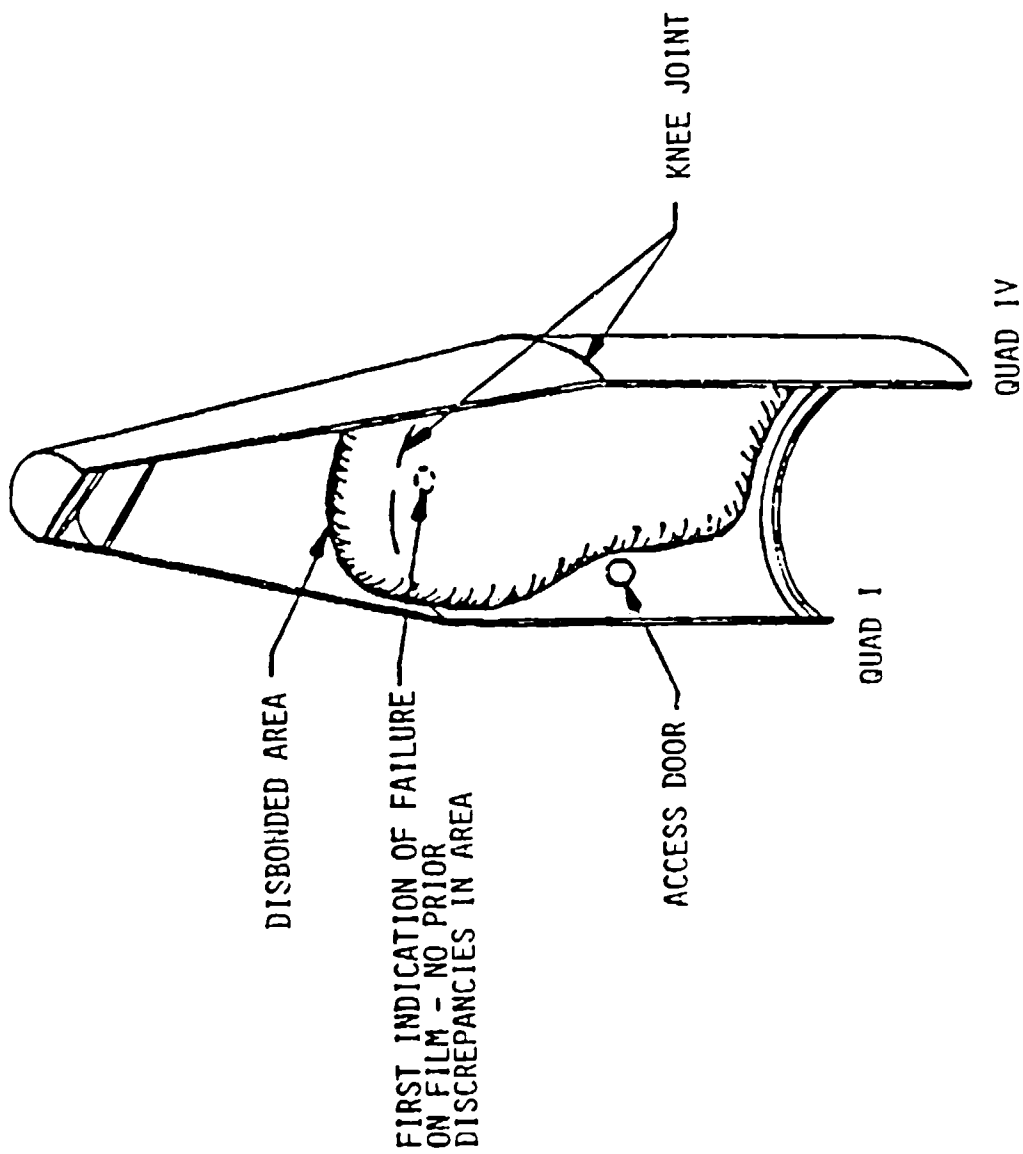
Figure 3. Spare Payload Fairing Uncapped Half Inner Skin Debond

During the proof test of the AC-58 payload fairing, it exploded. High-speed motion pictures recorded the event. There was a small blisterlike separation observable in one frame, followed by rapid growth of an apparent disbond and explosive separation of the inner skin-to-core bond, accompanied by extensive fracture of the inner skin (see Figure 3; from Ref. 2).

Investigation indicated that the failure initiated in an area in which there had been a weak bond, i.e., there was no imprint from the core on the adhesive film. However, no discrepancies had been noted (i.e., no voids observed) in this particular area, based on numerous sonic ("tap") tests. (Many *other* areas had been found defective and were repaired by injecting a liquid epoxy resin to fill the discrepant/debonded areas.) Various possible causes were postulated for the "weak-bond" area:

- a. Contamination of core or adhesive film surfaces
- b. Inadequate flow of adhesive during cure
- c. Cure pressure and/or temperature too low (affects adhesive flow and contact between core cell walls and skins)
- d. Poor contact between mating surfaces
 1. Poor fit
 2. Cure pressure too low

Particularly noteworthy, the "tap" inspection had failed to detect the discrepancies in both AC-58 and AC-59 fairing failures; and both fairings had similar designs processing, including nonvented honeycomb construction.

In the recovery effort, it was decided to apply additional cork insulation on the exterior to reduce the glue-line temperature and to conduct an overpressure proof test of the AC-68 payload fairing intended for flight. It was noted also that there had been improvements in the materials and processes for fairings produced after AC-59, i.e., for AC-60 and beyond. A thicker adhesive film was introduced, and more attention was paid to processing details and controls. Also the inner skin was increased from three to four plies.

The augmented overpressure, ambient-temperature, proof test was implemented successfully for the AC-68 payload fairing. The maximum expected pressure during flight was calculated to be 16.1 psi, allowing for pressure rise due to heating to 155°F at the bondline. Allowance also was made for bond strength reduction (8%) at elevated temperature (155°F), 1.3 psi; water partial pressure saturated at 155°F, 0.8 psi; and instrumentation error (5%), 0.9 psi. Accordingly, the overpressure proof test was conducted at ambient room temperature by pressurizing internally to 19.1 + 0.5/-0.0 psi using GN₂. (Subsequently the AC-68 payload fairing, with additional cork insulation on the exterior, was used successfully to help launch the FLTSATCOM F-8 satellite into orbit.)

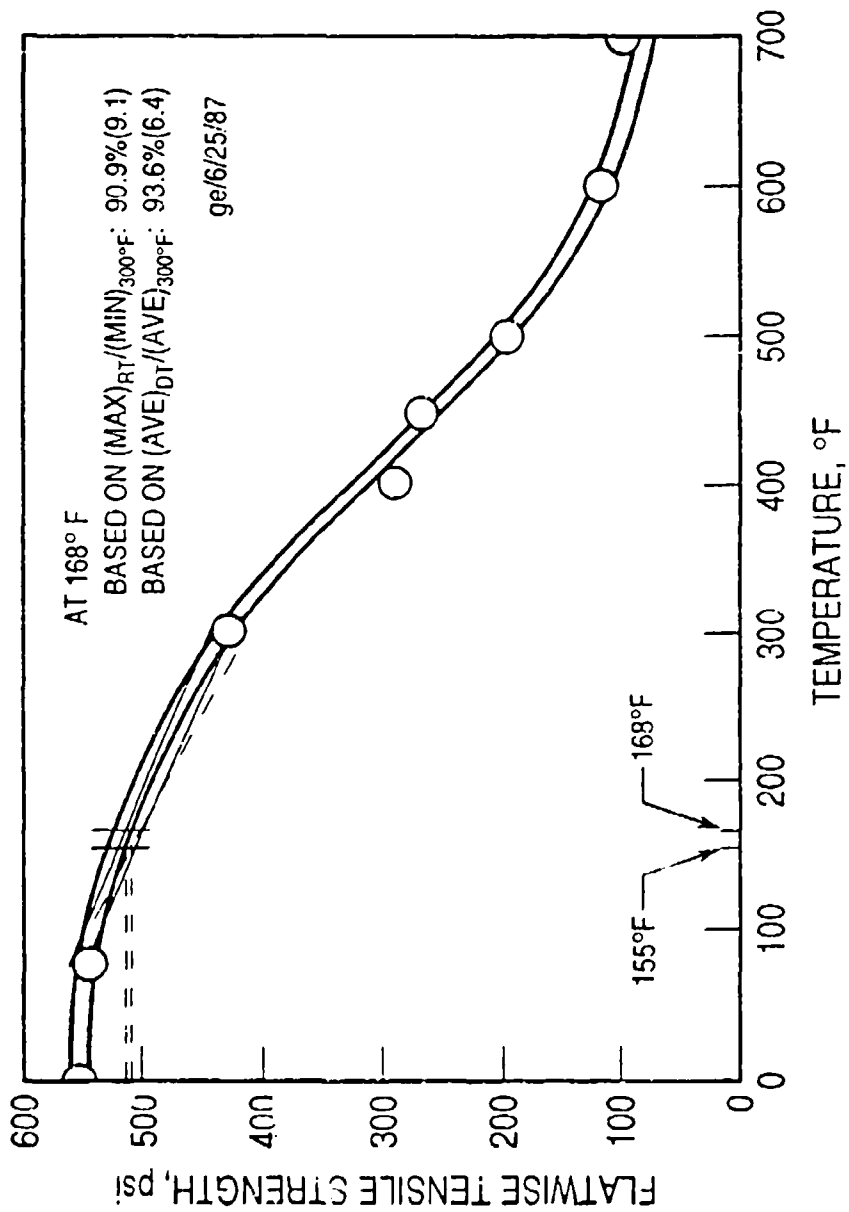
Figure 4. Typical Relationship Between Skin-to-Core Bond Strength and Test Temperatures

For applications which involve elevated-temperature exposure, the reduction in bond strength is an important factor to be considered. For example, see Figure 4 which was used in establishing the overpressure allowances for the AC-68 payload fairing. Inasmuch as the overpressure proof test was conducted at ambient room temperature, the internal pressure applied was increased by a finite amount to accommodate the reduction in bond strength that would be expected at the maximum temperature during ascent.
