ASC-TR-2010-5002

**THREATS TO AIRCRAFT STRUCTURAL SAFETY,
INCLUDING A COMPENDIUM OF SELECTED
STRUCTURAL ACCIDENTS / INCIDENTS**

**Engineering Directorate (ASC/EN)
Aeronautical Systems Center**

**MARCH 2010
Final Report**

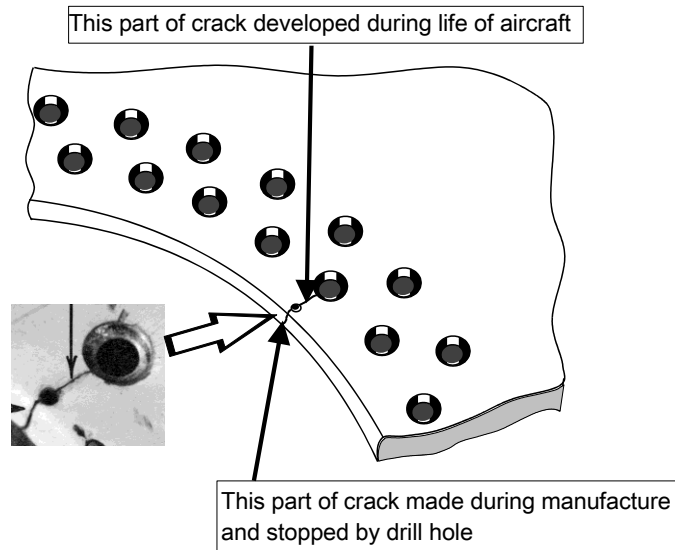
During the reconstruction of G-ALYP, a pre-existing manufacturing crack or tear was found at the edge of the ADF window cut-out (See Figure A4). This crack had been stop-drilled, which was the accepted repair practice at that time. Several other locations in this aircraft had similar kinds of manufactured cracks or tears that had also been stop-drilled in the factory [A4].

-VI-3. Crack and Drill Hole in Reinforcing Plate at Starboard Rear Corner of Front ADF Aerial Window Comet G-ALYP

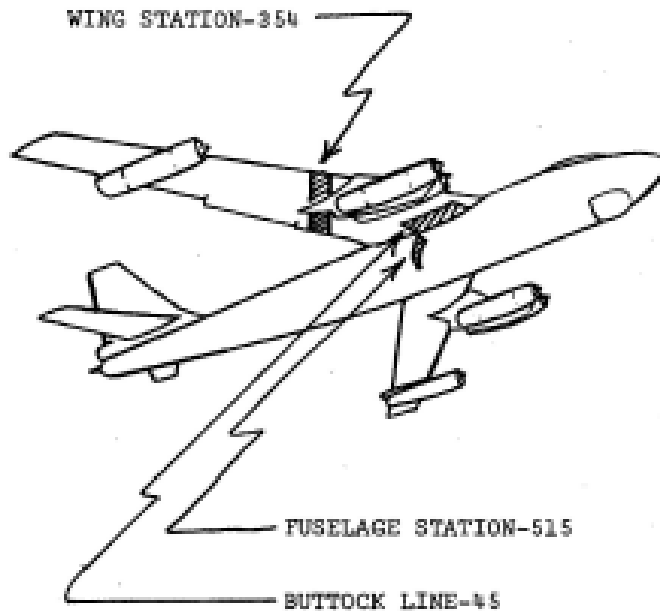
A structural crisis was reached within the USAF Strategic Air Command on 13 March 1958, when two aircraft broke up in midair in separate incidents. Near Homestead Air Force Base, Florida, a B-47B disintegrated at 15,000 feet, three minutes after takeoff. Its center wing section failed due to fatigue cracking at buttock line 45. The aircraft had a total of 2,077 hours at the time of the accident. See Figure A11 for the critical locations on the B-47.

Figure A11: Sketch Illustrating Critical Locations of the B-47 Aircraft

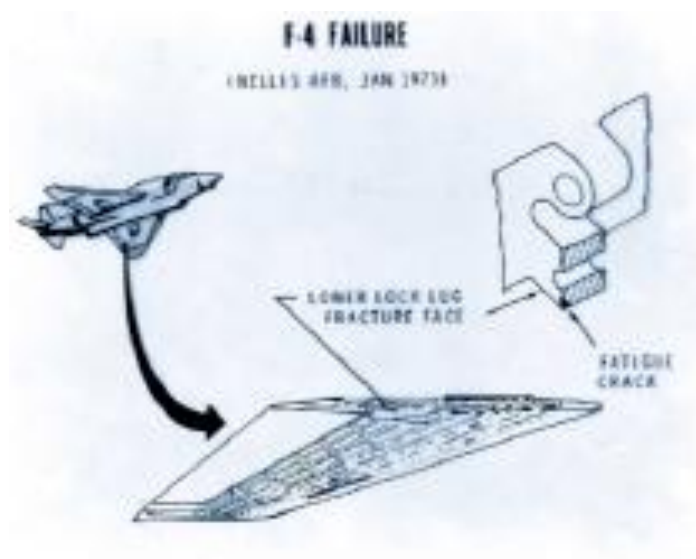
This failure is an example of multiple element damage (MED) overcoming the limited fail-safety associated with the wing fold lugs. The possible contribution of deficient manufacturing quality to this failure was never defined.

Figure A13: Sketch of F-4 Aircraft Illustrating Location of Failure

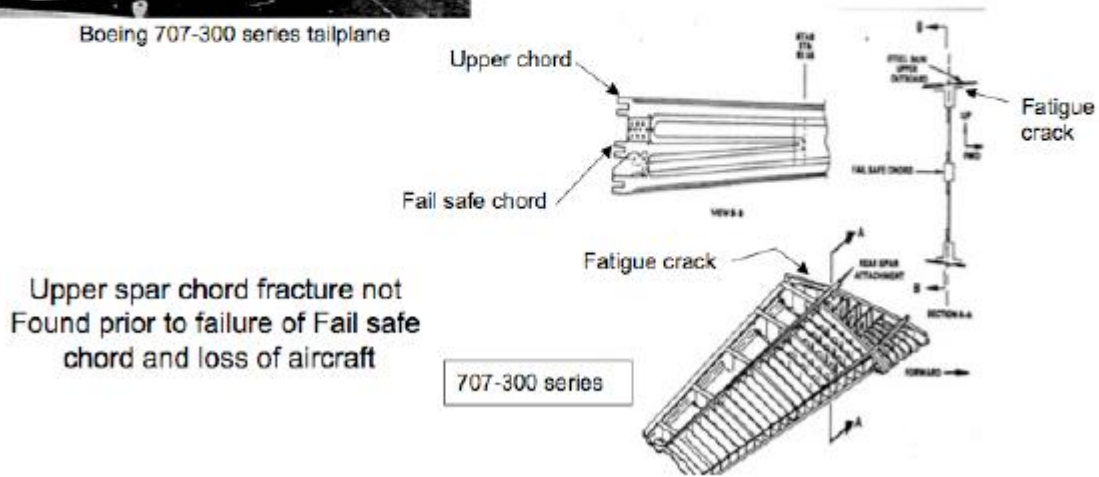
Dan Air
Lusaka, Zambia
May 14, 1977

Upper spar chord fracture not
Found prior to failure of Fail safe
chord and loss of aircraft

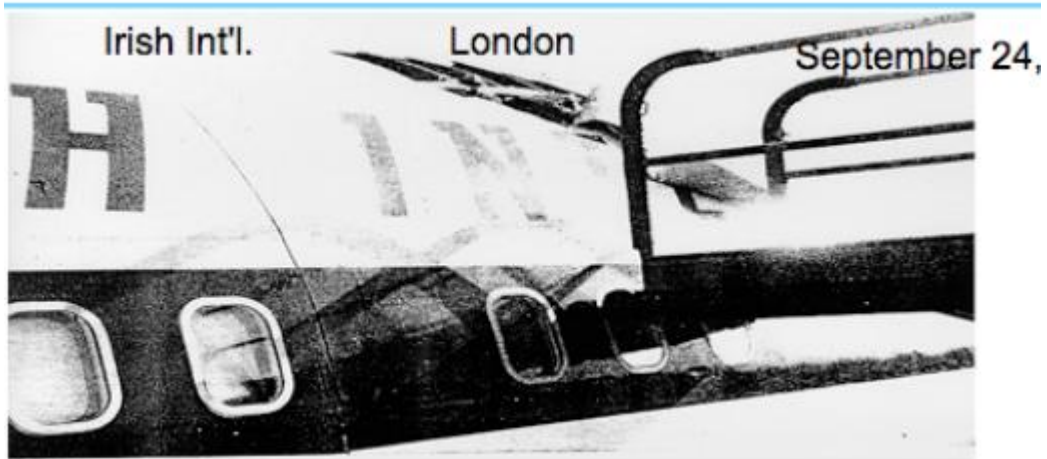
The location of the failure was in the main deck cargo door with frame failure and skin cracking along the upper hinge line. Note that the frame spacing in the cargo door is 10 inches rather than the normal 20 inch spacing throughout the rest of the fuselage. It is believed that the frame cracking occurred first followed by the skin cracking and the blowout. While the specific cause of the frame fatigue failures and skin cracking was not identified, it is expected that unanticipated high local frame stresses was the primary factor. It is not known whether or not there was any manufacturing or maintenance damage present. The main deck cargo door apparently was not included in the hydro fatigue test that was performed in the 1950s; thus, this critical area was not identified by the test. A photograph of the damage is shown in Figure A20.

Fatigue cracks
in these two frames

Blowout occurred following
failures of this frame

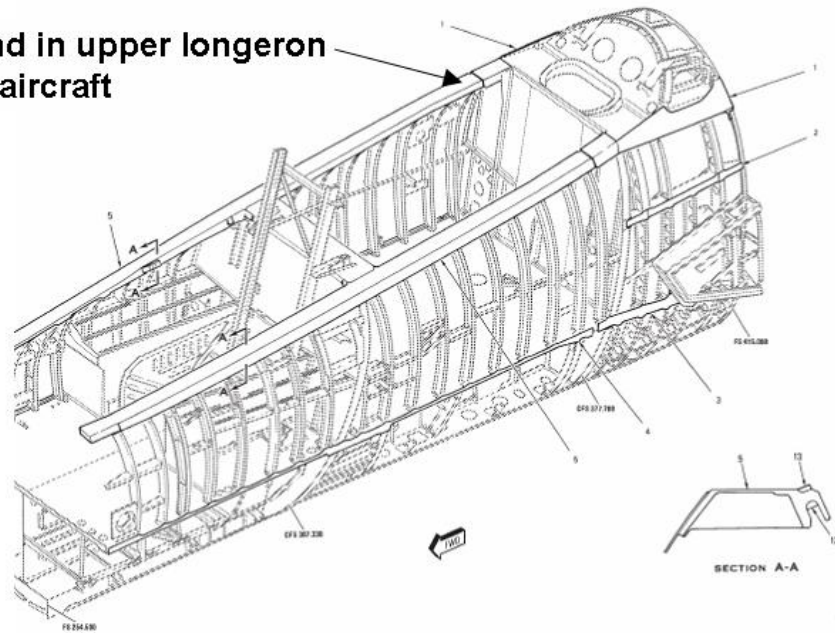
**Crack found in upper longeron
 of mishap aircraft**

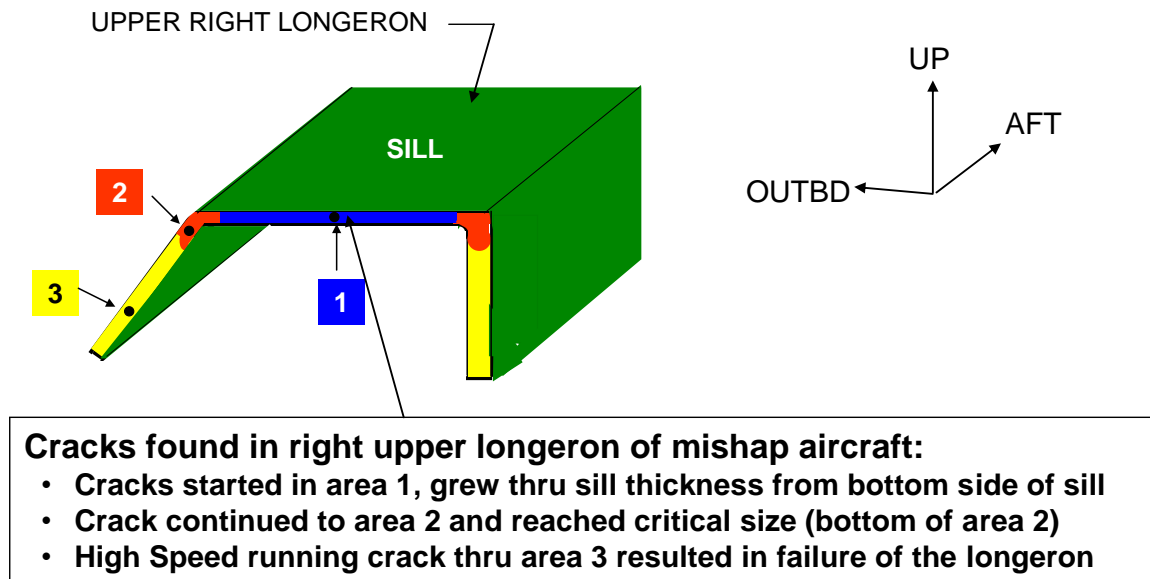
Based on the AIB report [A24], it appears that the fatigue cracking and failure are due to high stresses that were the result of poor workmanship and quality control (i.e., inadequate receiving inspection of fracture critical parts that were improperly manufactured and inspected by a subcontractor). This failure demonstrates the vulnerability of single load path (i.e., non fail-safe) structures to manufacturing discrepancies and emphasizes the importance of developing and enforcing rigid fracture control procedures (including factory inspections to ensure conformation to blueprint and in-service damage tolerance based inspections) on those parts where fail-safe designs are not practical.

Figure A24: Cracking Events Occurring in the F-15C Forward Fuselage Upper Longeron at FS377

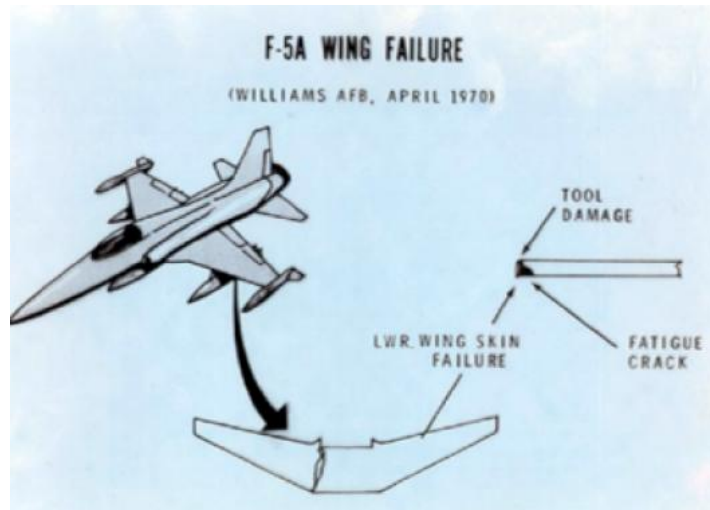
Figure B1 illustrates two T-38 aircraft; the T-38 aircraft is the two seat trainer version of Northrop's F-5 fighter. The sketch shown in Figure B2 depicts the failure of an F-5 at Williams AFB, which originated at a tool gouge in a radius of the single piece, 0.42-inch thick wing plank. The critical crack length of the fatigue crack was about 0.20-inches. A photo of the failure origin is shown in Figure B3. As a result of this failure a damage tolerance assessment was performed and damage tolerance inspection requirements established; however, these inspections were not completely successful in that additional catastrophic wing failures occurred at Randolph AFB and in PACAF in the mid 1970's. The final solution to this problem was a wing redesign to substantially reduce the stress levels, incorporate a tougher aluminum alloy and cold working of the fastener holes [B1, B2].

Figure B2: Identification of Tool Damage Location and Resulting Wing Separation Point

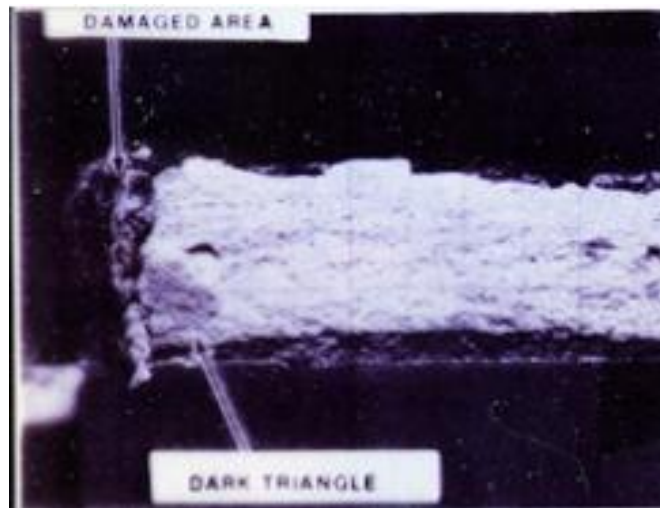
Figure B3: Tool Damage Led to Early Fatigue Cracking and Resulting Failure of the Monolithic Wing

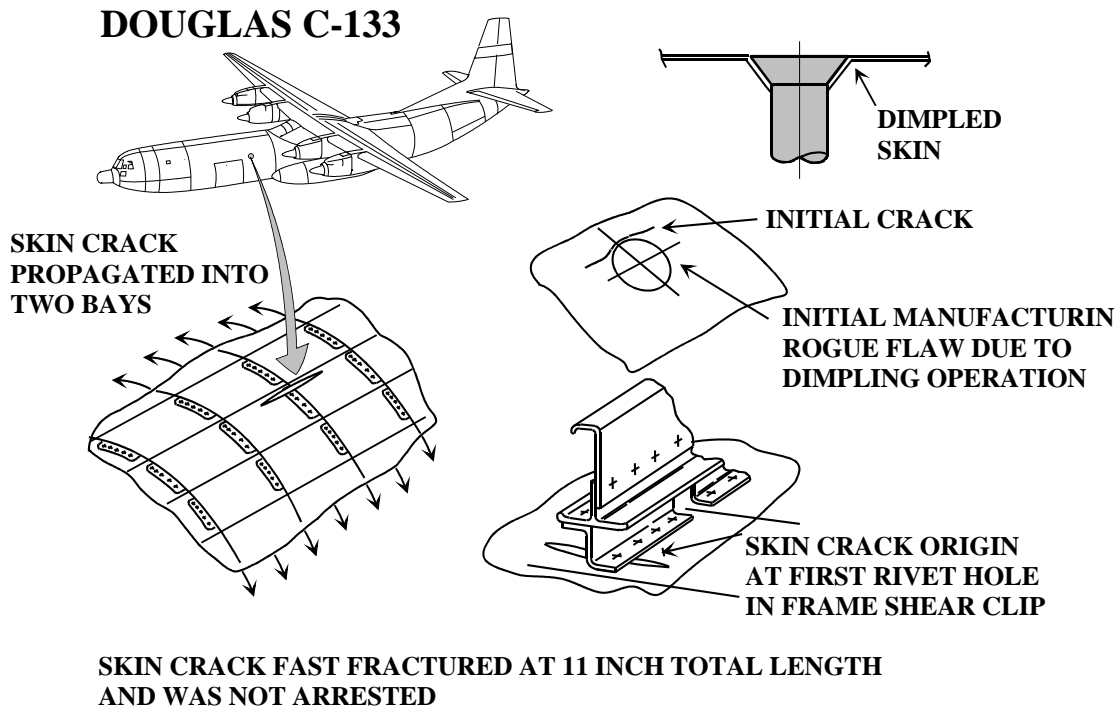
The fasteners were countersunk into dimpled skin. The crack that propagated to failure grew from a manufacturing flaw caused by the dimpling operation. A C-133 was successfully full-scale fatigue tested to 38,000 simulated flight hours. The high time airplane at the time of the accident had accumulated 16,000 flight hours. A Douglas Aircraft team designed a crack arresting system, so as to achieve fail-safety in the remaining C-133 fleet. A sketch of the initial manufacturing flaw and subsequent fatigue crack is shown in Figure B8.

Figure B8: Details of the Cracking that Led to Failure of C-133 Transport Aircraft

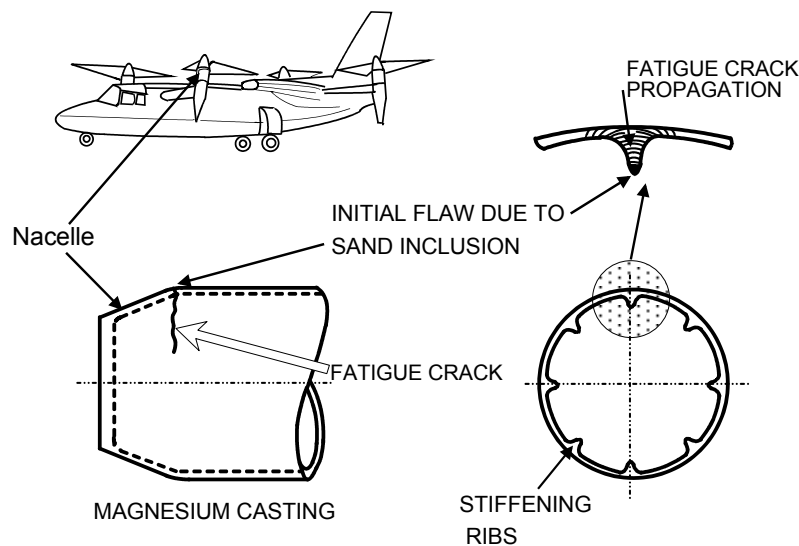
The Curtis Wright X-19 VTOL Experimental Aircraft, a tri-service research project, crashed during a flight test at the FAA Test Center in Atlantic City New Jersey in mid 1965. The aircraft crashed after a propeller nacelle magnesium casting failure. The cause of the crash was a manufacturing defect in the magnesium sand casting used in the propeller nacelle. This material flaw was a sand inclusion at the tip of one of the stiffening ribs in the most highly loaded location of the nacelle structure. Some of the details of this flaw are illustrated in Figure B10 [B5, B7].

Figure B10: Sketch of Flaw Details Associated with X-19 Aircraft Accident

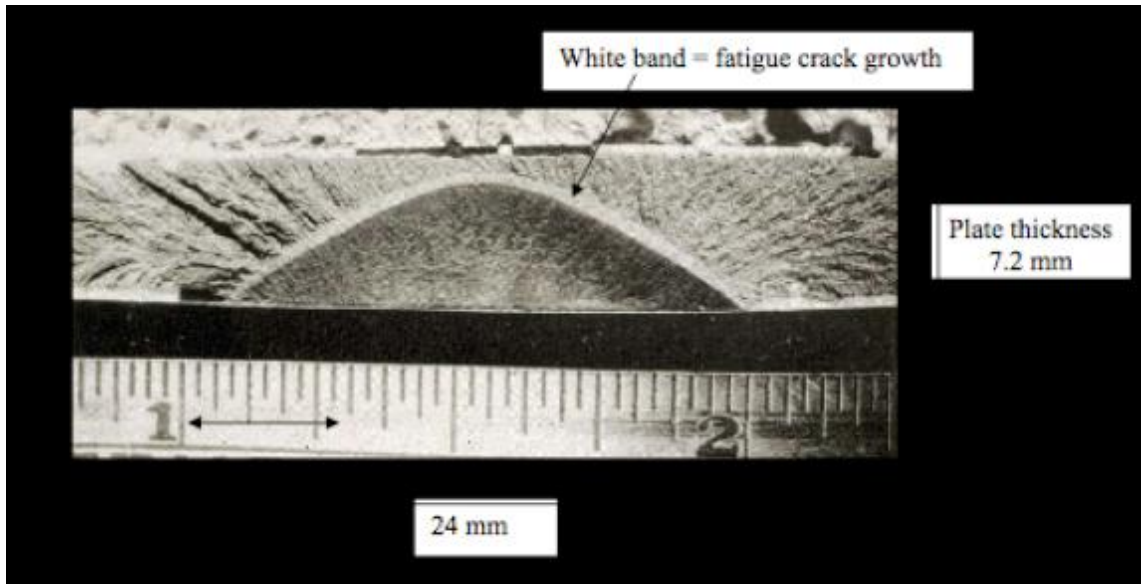
Figure B12: Photo Illustrating Forging Flaw and Subsequent Fatigue Crack that Caused the Failure of F-111 Aircraft after 105 Hours of Flight Time

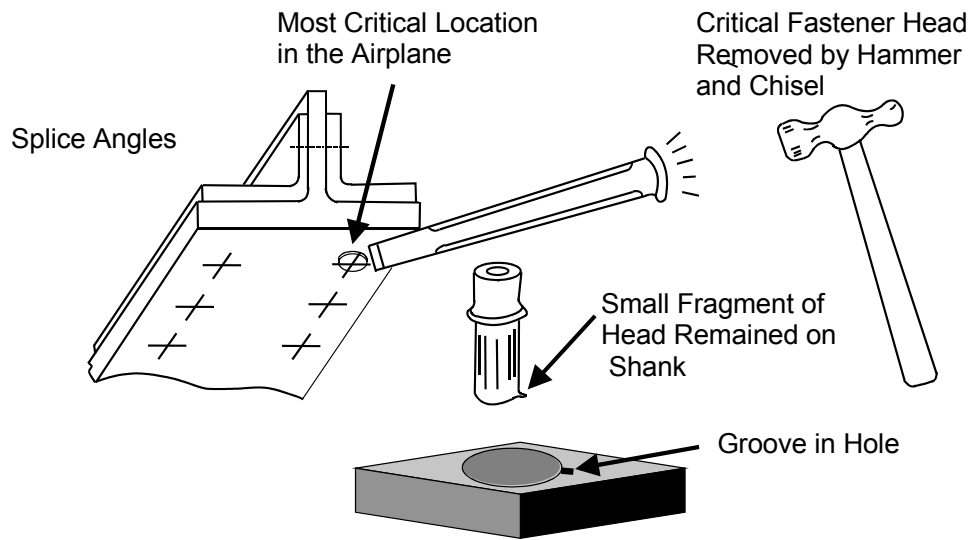
A Beech 99 commuter aircraft with a single spar wing was being maintained. During this maintenance a fastener was removed by knocking the head off with a hammer and chisel as illustrated in Figure C2. This action left a sharp fragment of the head on the shank of the fastener, which gouged the side of the fastener hole as the fastener was being driven out. The spar was re-assembled without removing the groove and the aircraft was returned to service. During a routine inspection, 2100 flight hours later in July 1990, a fatigue crack was found that had nucleated at the groove and propagated to the edge of the flange as shown in the photo in Figure C3. A limit load application would have failed the wing. The spar had a 10,000 hour fatigue life limit based on the most critical fastener hole in the spar cap. The gouge in the side of the hole is clearly a “*maintenance defect*”[C1].

Figure C2: Details of Maintenance Action that Led to Damage

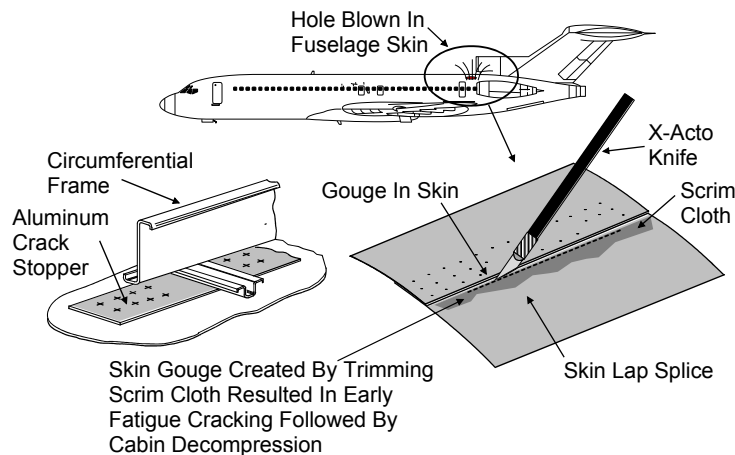
The second example concerns an Eastern Airlines 727 that suffered sudden cabin decompression caused by fatigue cracking induced by the X-Acto knife maintenance induced damage as shown in Figure C5. The rivets in the lap splice had been removed to clean out corrosion in the splice. Cold cure adhesive tape had been replaced and the excess tape trimmed off with an X-ACTO knife. The knife created a sharp gouge in the skin that became sites for the nucleation of fatigue cracks. Separate fatigue cracks linked together to form a long crack which eventually fast fractured and caused decompression. Fortunately, the fast fracture was successfully arrested by the aluminum crack stoppers located at the circumferential frames as shown in the sketch. The very large damage ‘crack arrest fail-safe’ capability designed into this fuselage saved this aircraft [C2, C3].

Figure C5: Maintenance Action that Led to Skin Failure by Fatigue

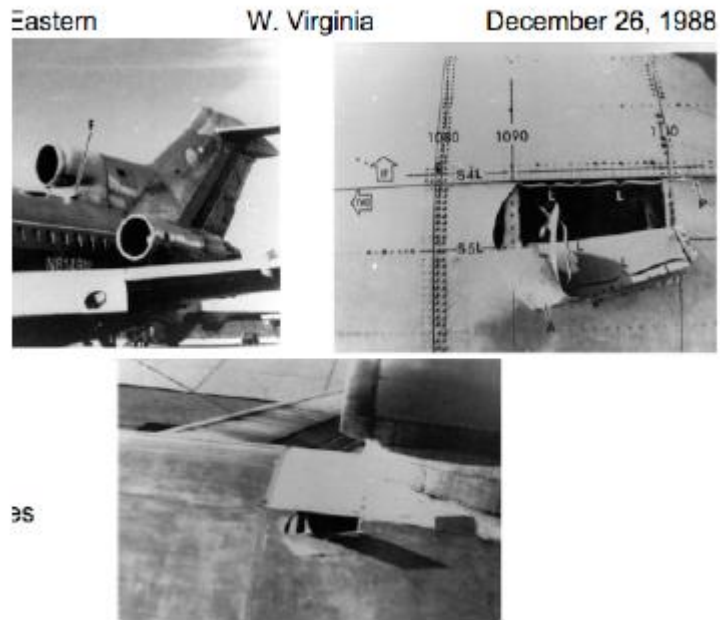
Figure C6: Photos Illustrating the Structural Damage Resulting from Fatigue Skin Failure

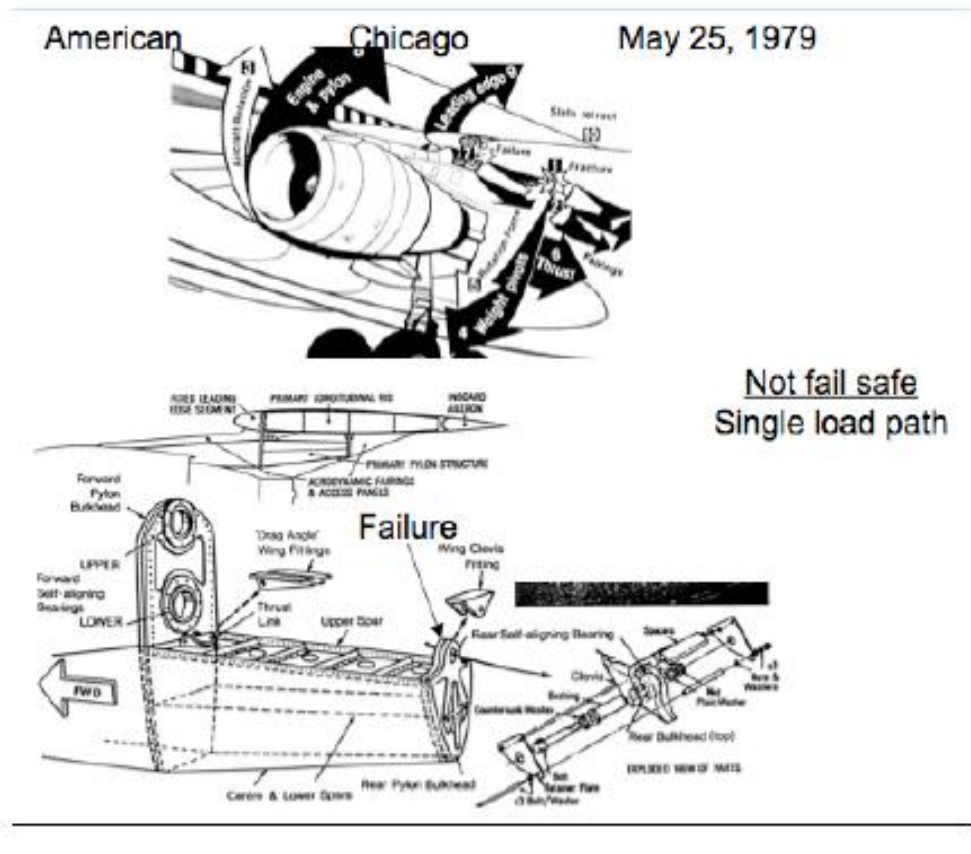
circumstances could result in very large impact loads at the rear bulkhead attachment point and inflict the type of damage observed. Inspection of other DC-10s where this expedited removal procedure was used revealed eight other aircraft with cracks ranging from 3 to 6-inches long. While the manufacturer, McDonnell-Douglas Aircraft, had designed the airplane including many areas of the pylons to be fail-safe, it was not fail-safe for this particular failure scenario. The rear bulkhead itself was split to achieve fail-safety, but the upper flange on the forward half of the bulkhead was a single load path, and when the upper flange failed, the loss of the pylon and engine ensued.

Figure C8: Diagrams Illustrating Nature and Result of the Maintenance Damage in the Cause of a DC-10 Pylon Failure

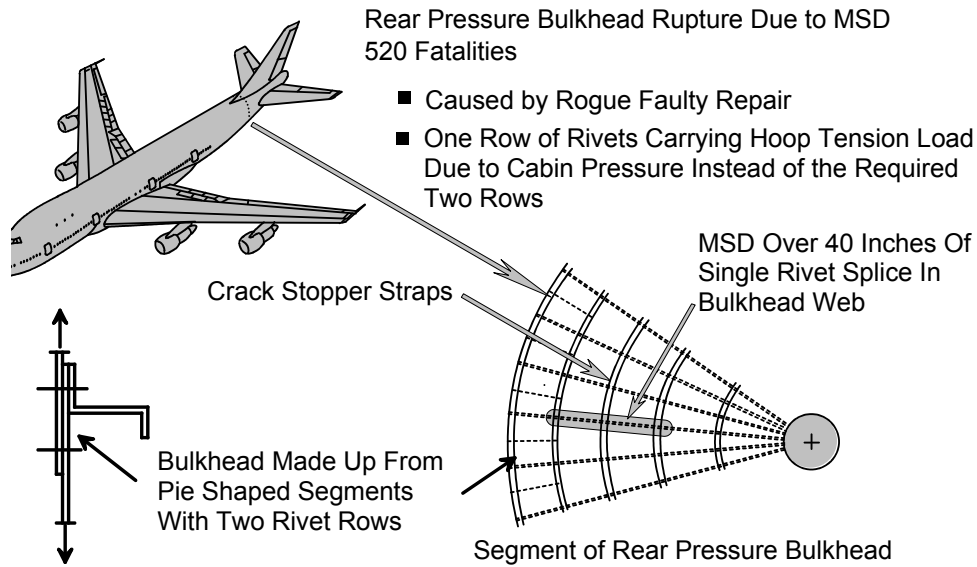
The rear pressure bulkhead of this aircraft had been damaged due to a tail strike in Osaka on June 16, 1978. At that time the aircraft had experienced 6516 pressurized flights. Boeing sent a maintenance team to Japan to conduct the repair. The domed bulkhead is made up of pie shaped pieces of 2024-T3 spliced together with two rows of rivets as shown in the sketch below. The lower half of the bulkhead was replaced due to damage. During the repair one row of the rivet holes had insufficient edge distance so a splice plate was installed over a 36-inch length of the bulkhead web as also shown in Figure C10 [C2, C7, C8].

Figure C10: Sketches of Location of Failure in 747SR Rear Pressure Bulkhead

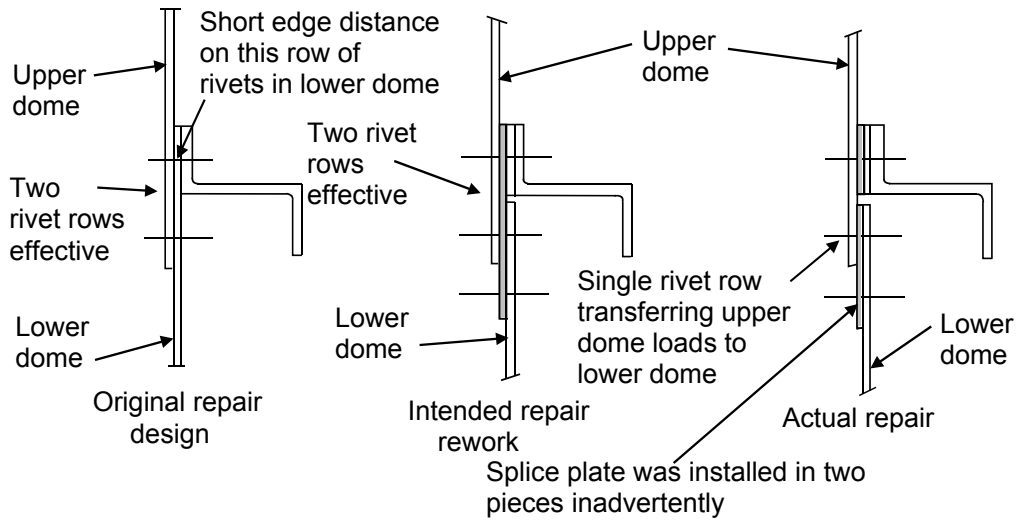
The splice plate was incorrectly installed in two pieces as shown in Figure C11 such that only one row of rivets was carrying load. Because of this overload, multi-site-damage initiated over a 40 inch length of the bulkhead web splice at the single row of rivets. The multi-site damage linked up into a critical crack, which did not arrest, because of the MSD, and caused the bulkhead to fail. Subsequent to this accident Boeing redesigned the bulkhead with heavier “super” tear straps.

Figure C11: Construction Details Associated with Initial and Repaired 747SR Rear Pressure Bulkhead

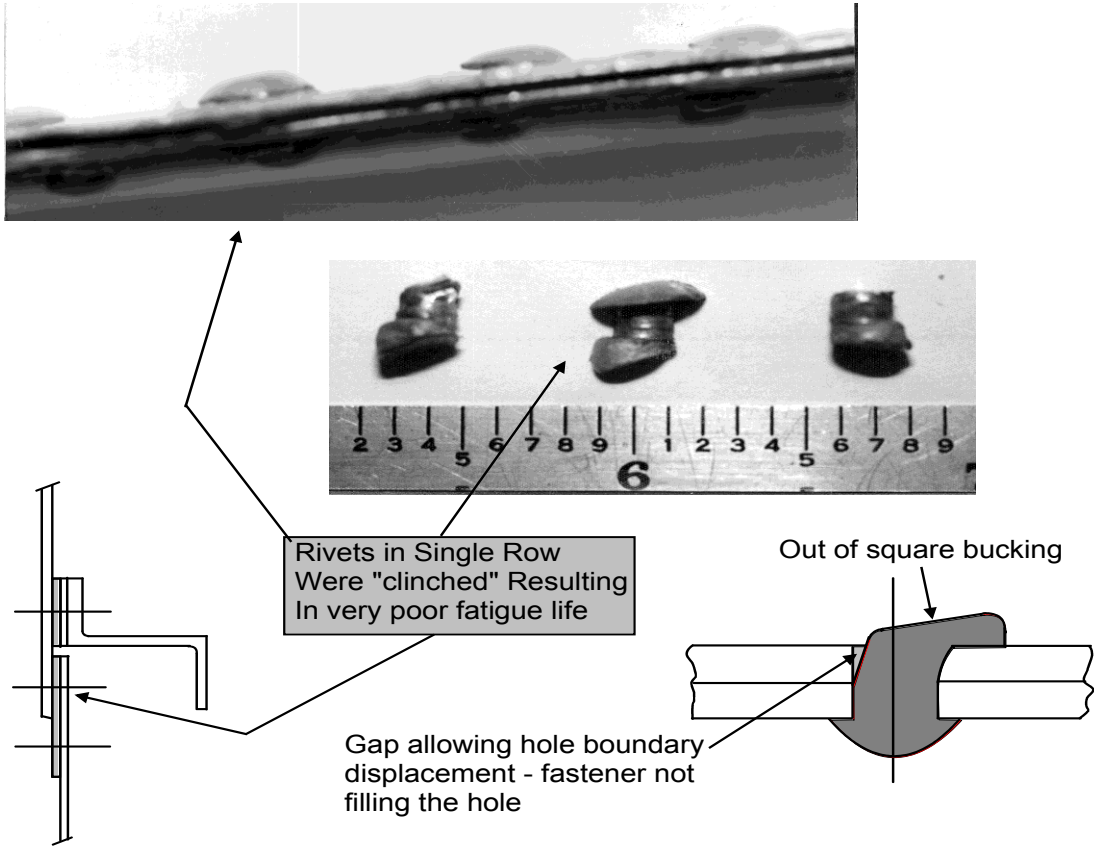
In addition to the manufacturing defect of the two-piece splice plate, the rivets in the single row were “clinched” as indicated in the photographs and sketches shown in Figure C12. Clinching is caused by misaligning the bucking bar to the rivet. Consequently the head is smeared to one side leaving a gap in the hole as shown in the figure. A clinched rivet does not properly fill the hole and will result in a much earlier crack initiation. Along with the high stresses caused by the single rivet row these repair defects contributed to the early development of the multi-site damage. In fact, it is quite possible that if these rivets had been properly bucked the airplane would have been retired before the accident took place.

Figure C12: Photos Illustrating Rivet Damage on 747SR Rear Pressure Bulkhead

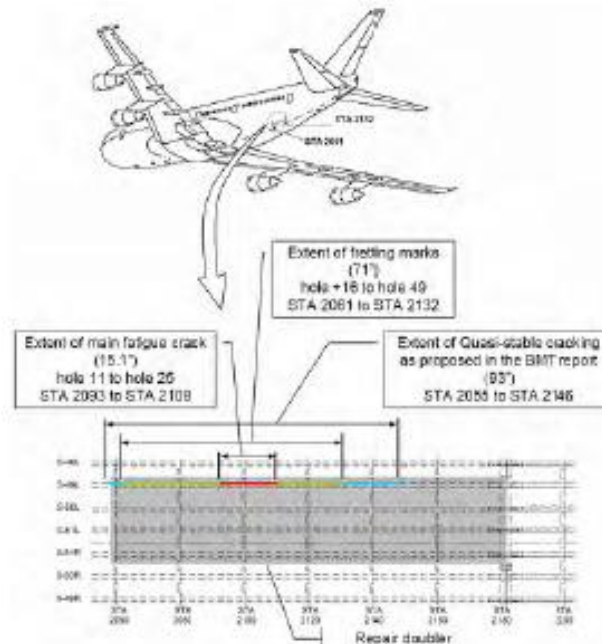
During the interim 22 years of service subsequent to the repair, fatigue cracks initiated at the root of this scratch at numerous sites, grew through the thickness and linked up forming a 15.1-inch long through the thickness crack centered at fuselage station 2100. Some multiple site cracking (MSD) was present both forward and aft of this crack which formed a total length of about 25.4 inches. It is evident from fretting marks and additional crack arrest and fatigue marks that the actual crack length that existed just prior to the final failure was very much longer. Based on the fretting evidence the Aviation Safety Council concluded that the crack length that existed at the time of the accident had to be at least 71-inches. Based on the indications of crack arrest followed by increments of fatigue striations, The Boeing Materials Technology organization (BMT) estimated the final crack length to be about 93-inches long. See Figure C14.

Figure C14: Crack Location under Edge of Repair Doubler [C9]

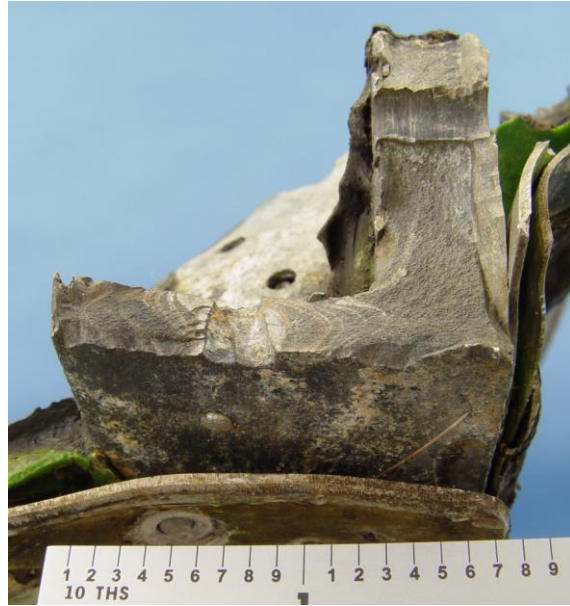
Figure C18: Photo of the Fracture Face of the Right Wing Rear Spar Cap [C13]

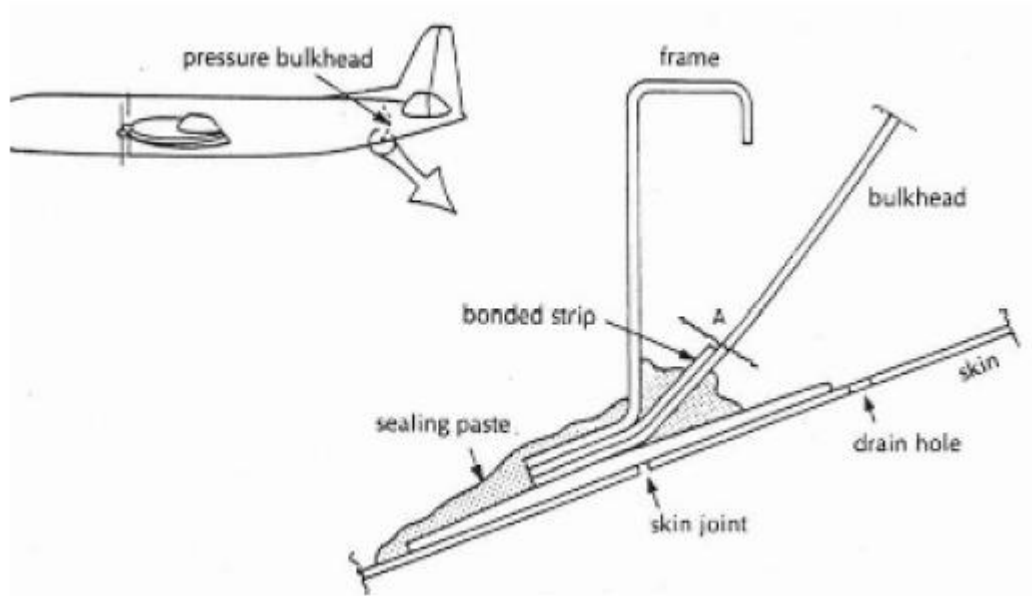
Figure D2: Sketch of Construction Details that Led to Corrosion and Subsequent Catastrophic Failure of the Vickers Vanguard 951 Aircraft

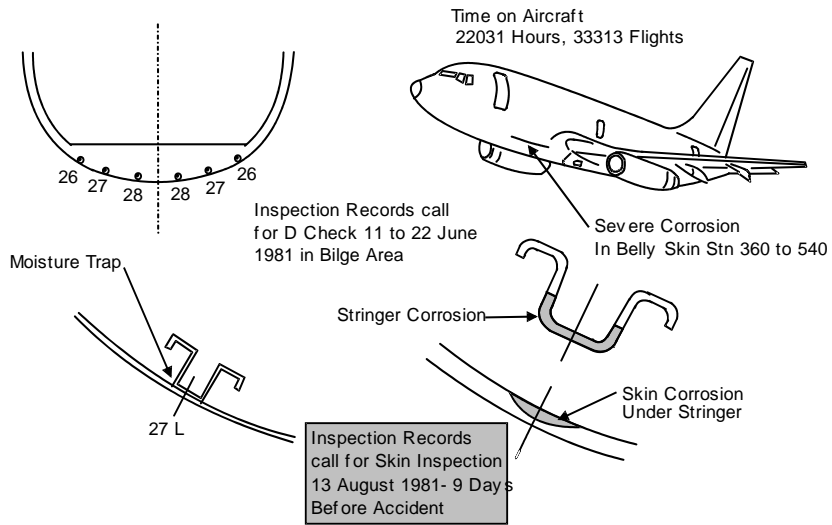
Figure D4: Sketches Illustrating the Locations and Causes of Corrosion on B737 Aircraft

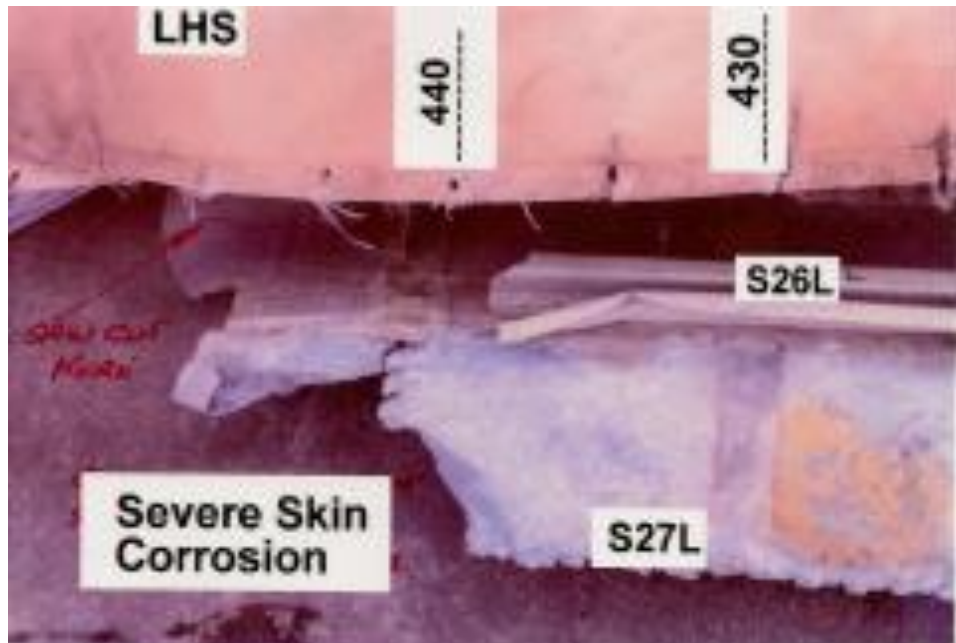
Two photographs of corrosion found in the lower lobe of this aircraft are shown in Figures D5 and D6.

Figure D5: Photo of Skin Corrosion in Lower Lobe of B737 Aircraft

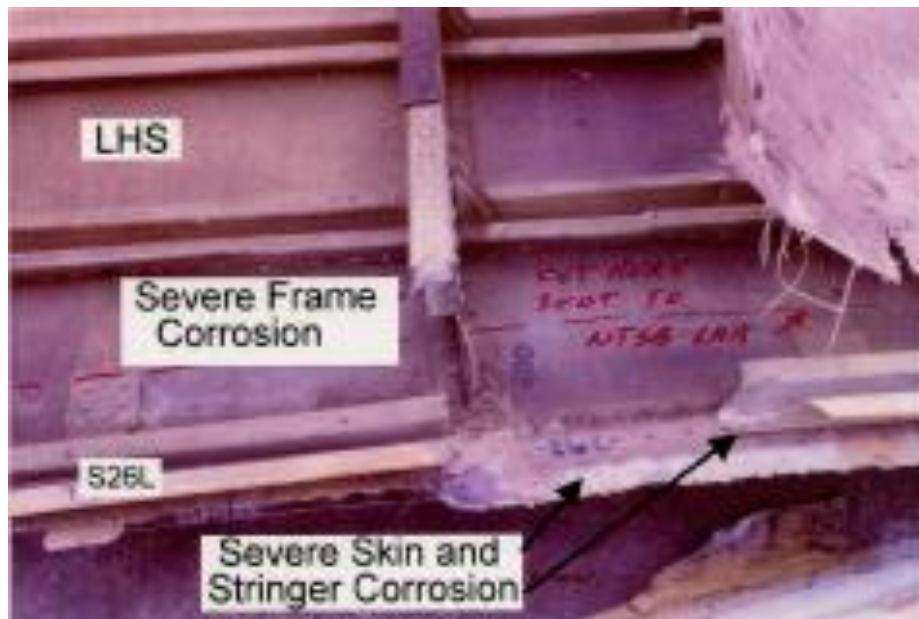
Figure D6: Photo Illustrating Loss of Frame and Stringer Due to Severe Corrosion

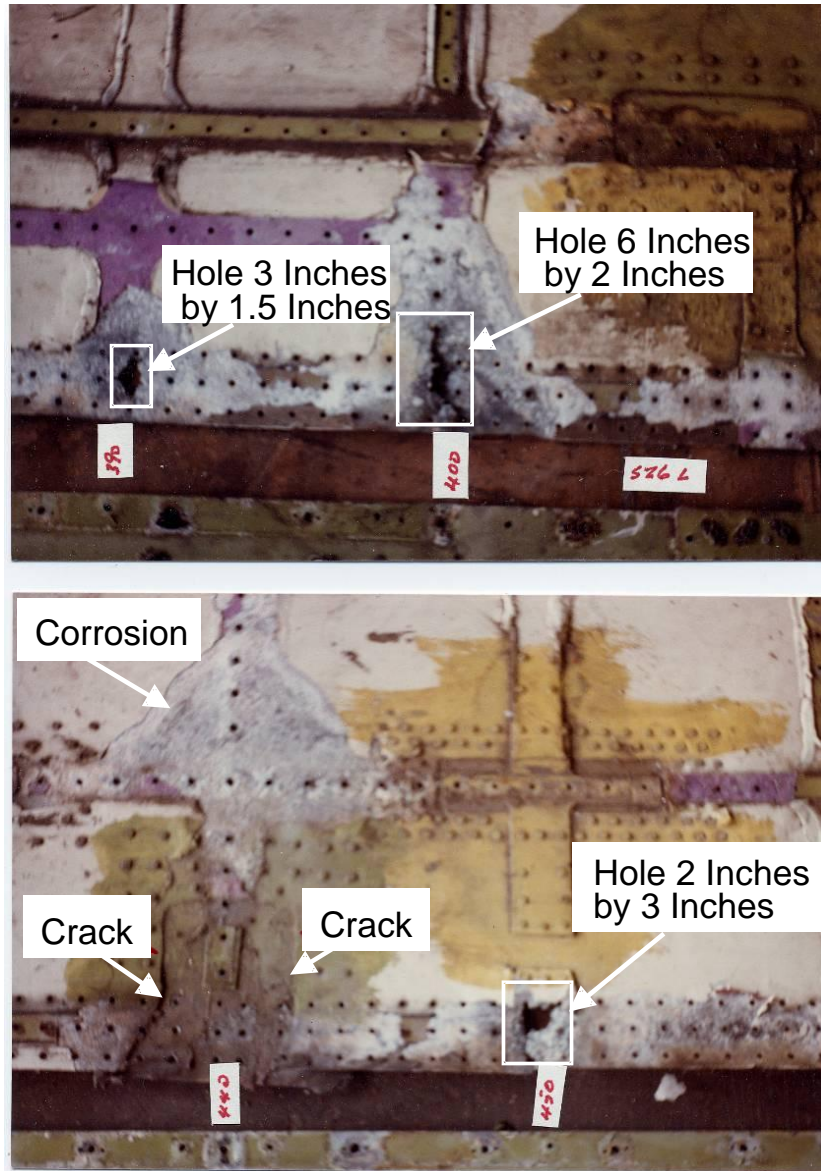
Figure D7: Photos Illustrating Severe Corrosion of FEAT B737 Aircraft

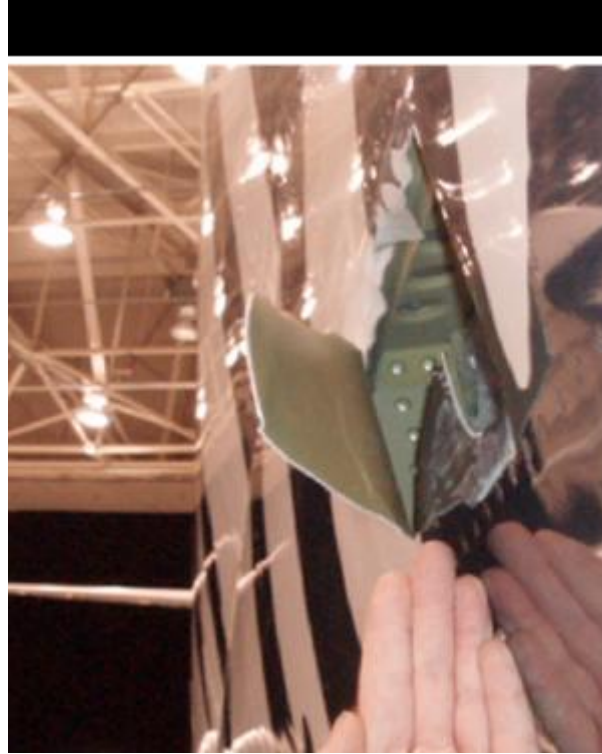
Figure E2: Photo of Skin Failure Following Ground Handling Damage

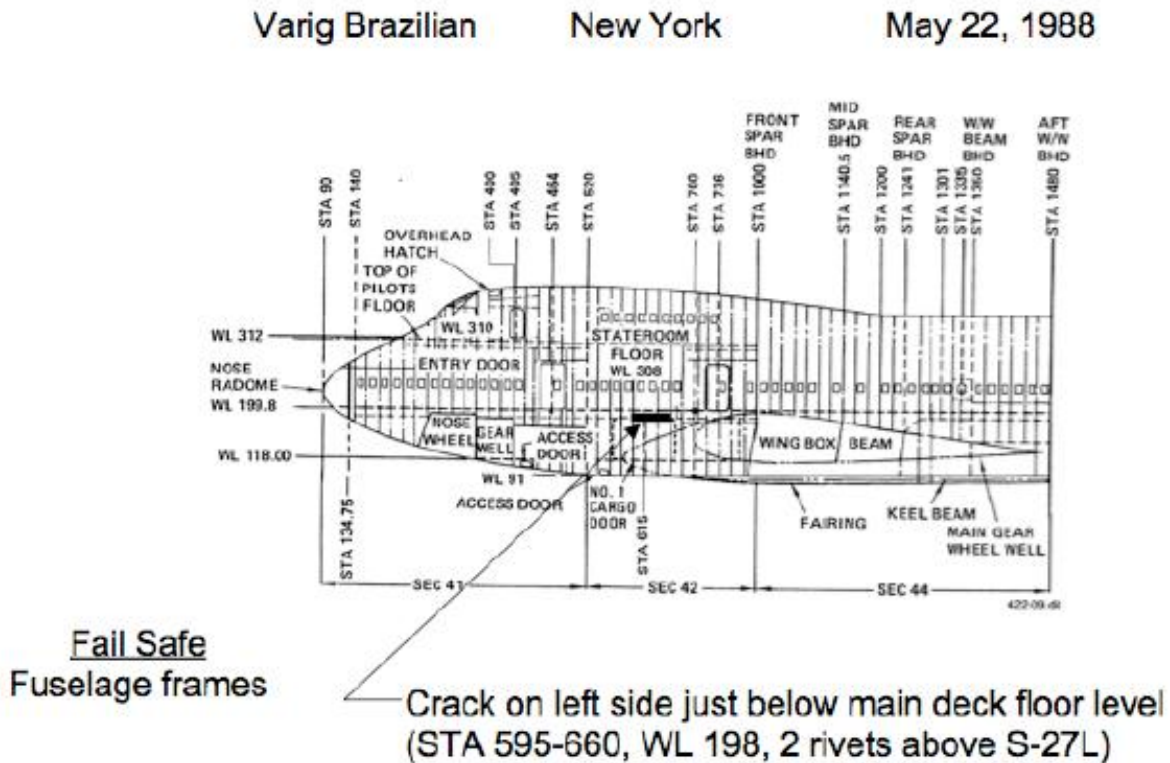
Figure E4: Sketch Illustrating Location of Handling Damage Induced Crack on the B`747 Aircraft

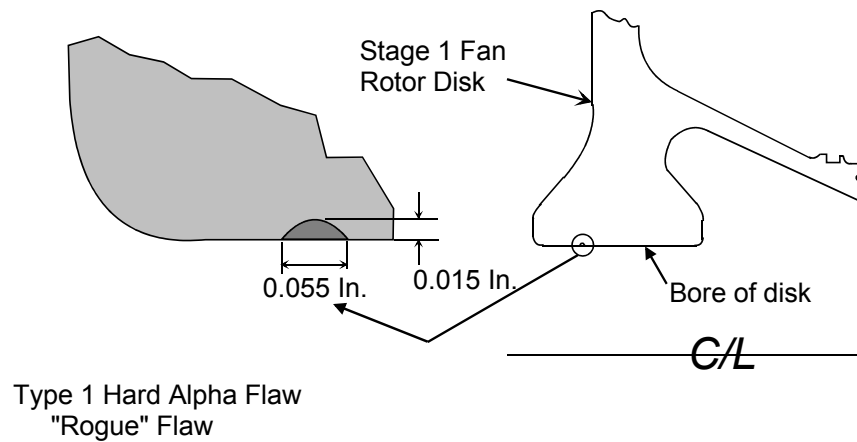
Sketch of Defect Size & Location

Figure F3: Sketch of General Electric Engine Defect Size and Location

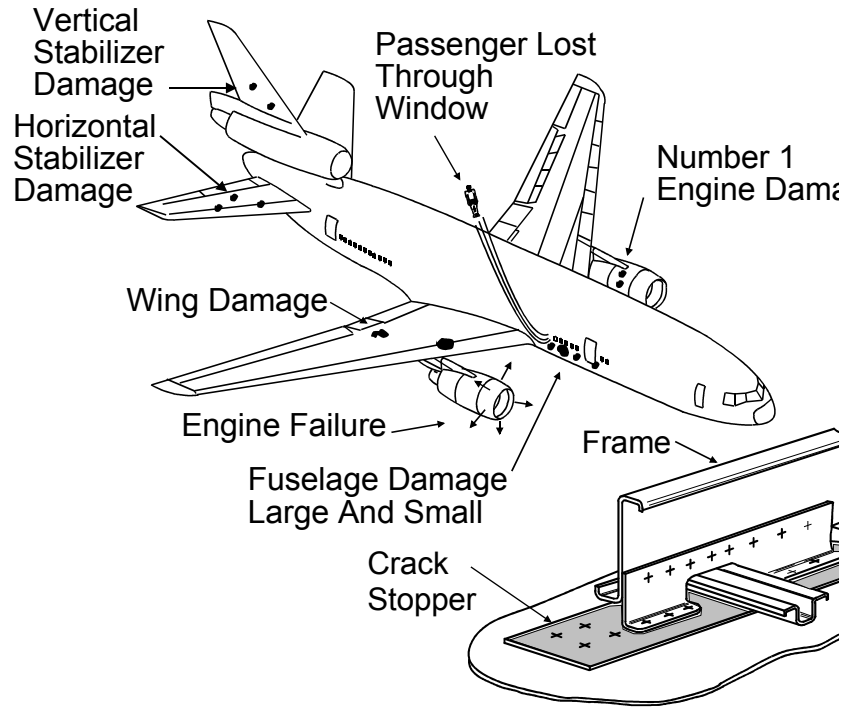
Figure F5: Sketch Illustrating Location of Fuselage Damage Due to an Uncontained Engine Failure and Construction Details

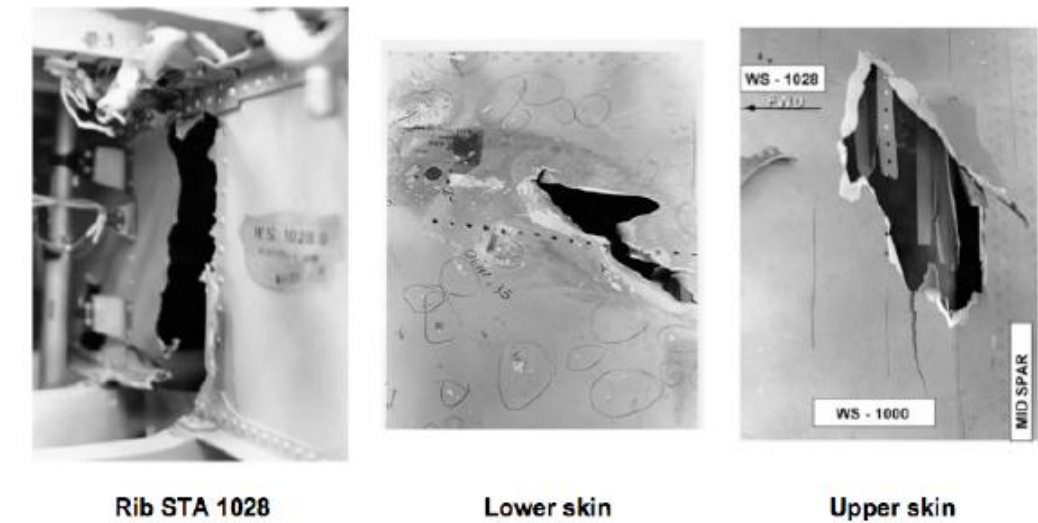
Figure F7: Photos of Wing Damage on the B747 Aircraft Caused By Engine Failure

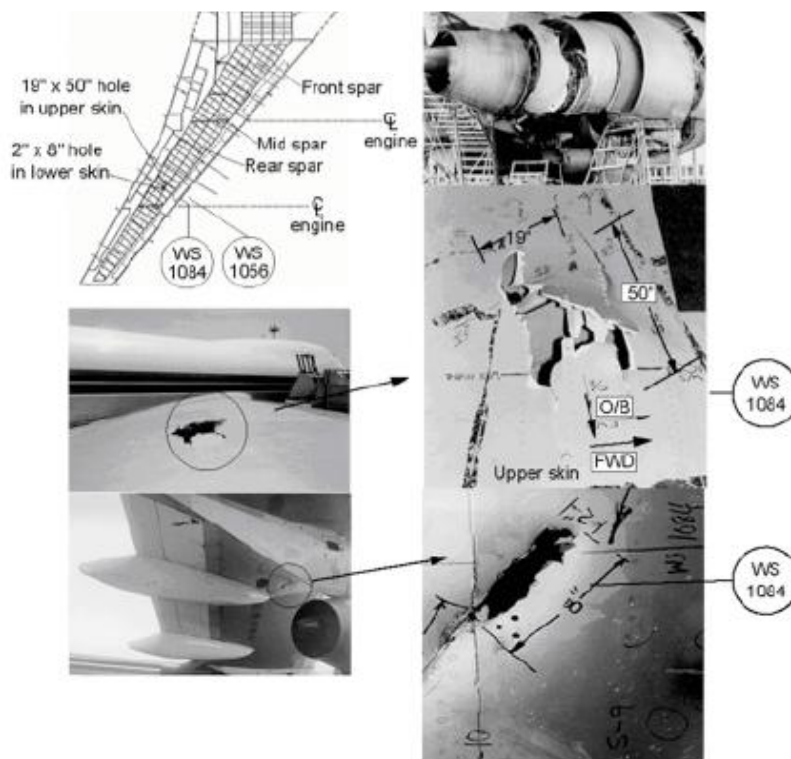
Figure F9: Photos of Wing Damage Caused by Engine Failure

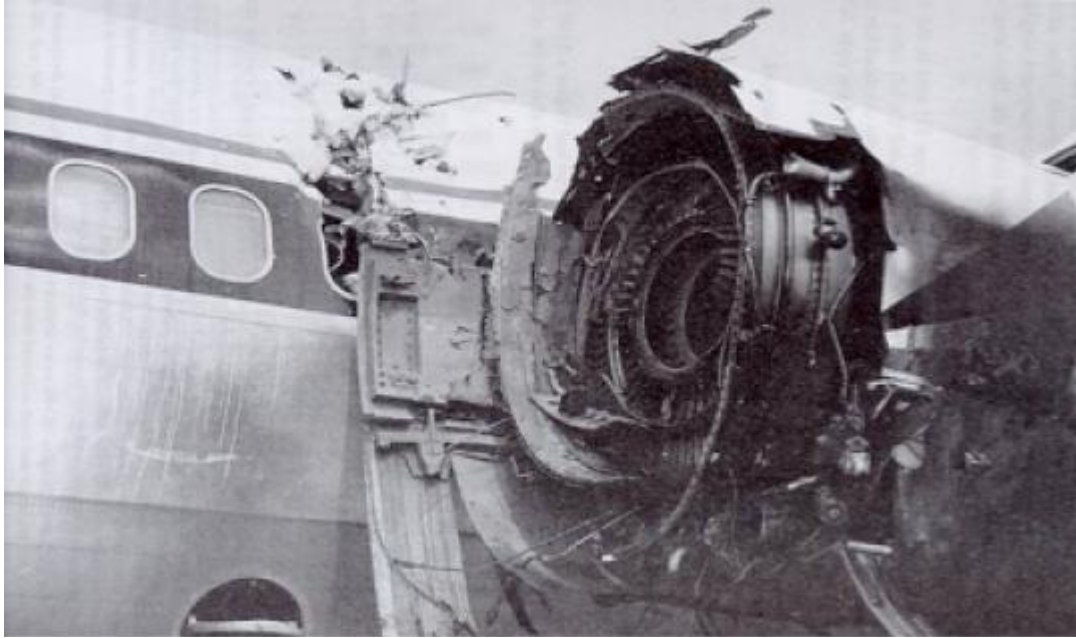
Figure F11. Photo of Engine and Fuselage Damage as a Result of Engine Failure

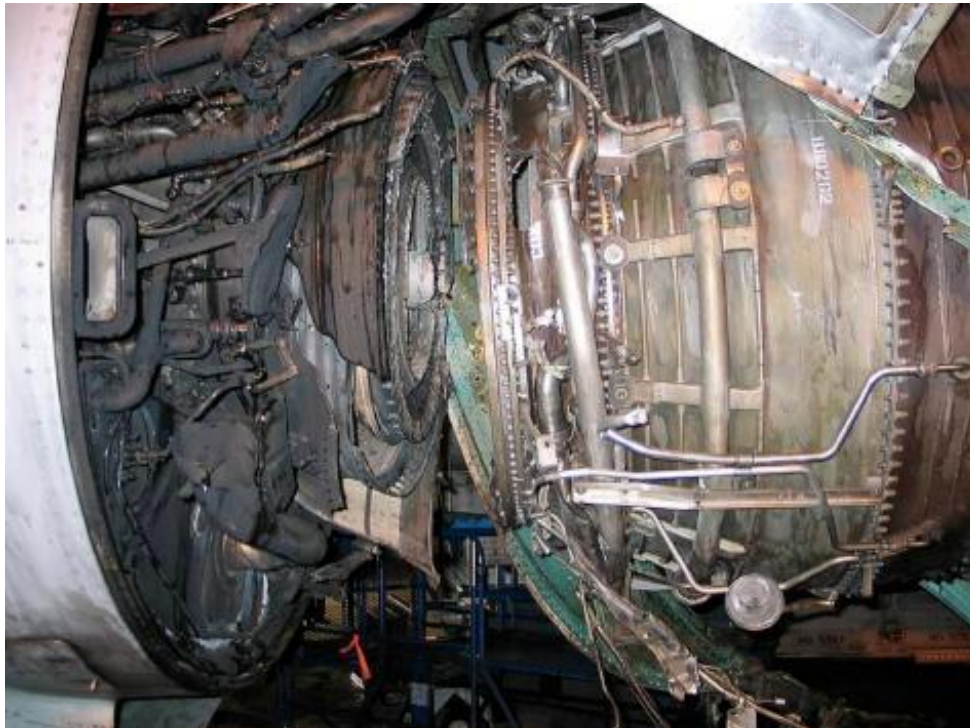
Figure F15: Photo of Damage Associated with Uncontained Rotor Failure in a GE CF6 Engine
