ASC-TR-2010-5002

**THREATS TO AIRCRAFT STRUCTURAL SAFETY,
INCLUDING A COMPENDIUM OF SELECTED
STRUCTURAL ACCIDENTS / INCIDENTS**

**Engineering Directorate (ASC/EN)
Aeronautical Systems Center**

**MARCH 2010
Final Report**

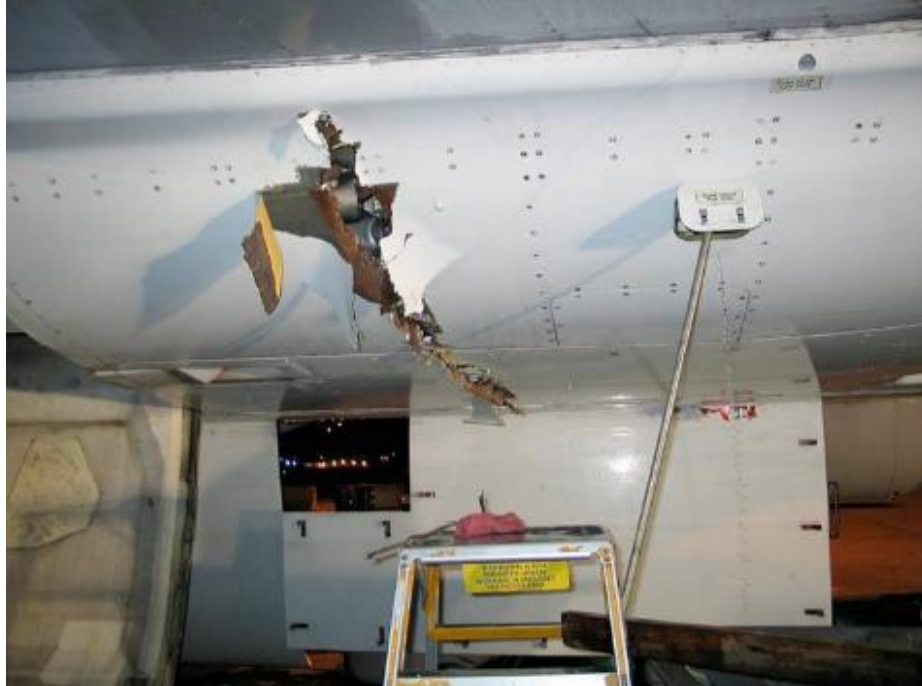
Figure F16: Photo of B747 Fuselage with Disk Penetration Damage Caused by Uncontained Rotor Failure

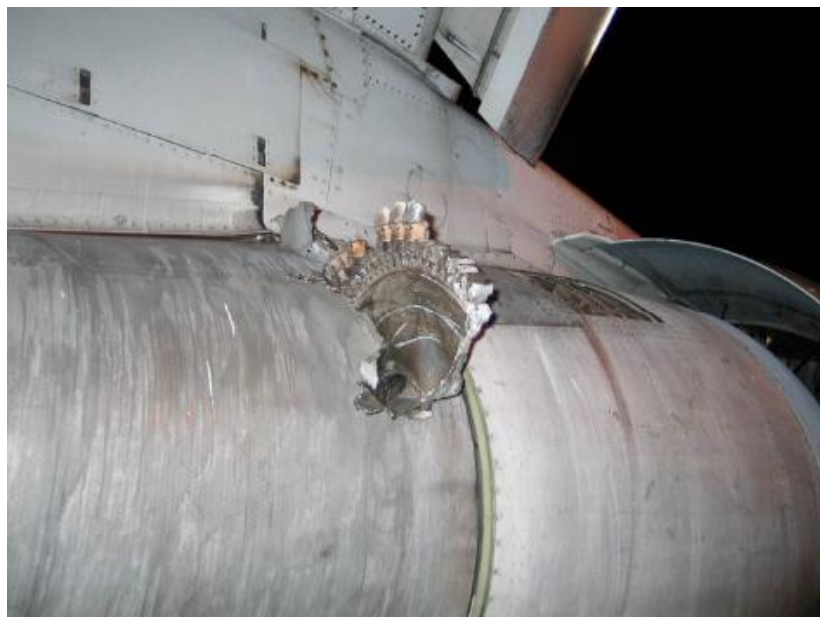
Figure F17: Photo of B747 with Disk Embedded in No. 2 Engine Resulting from Uncontained Rotor Failure in No. 1 Engine

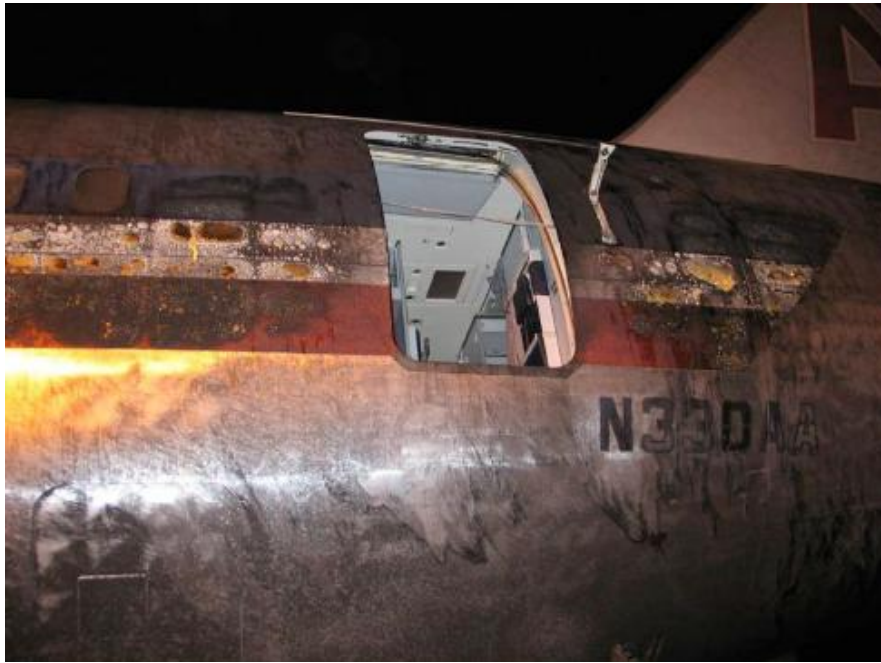
Figure F18: Photo of Engine Damage to the B747 Fuselage Resulting From Engine Failure

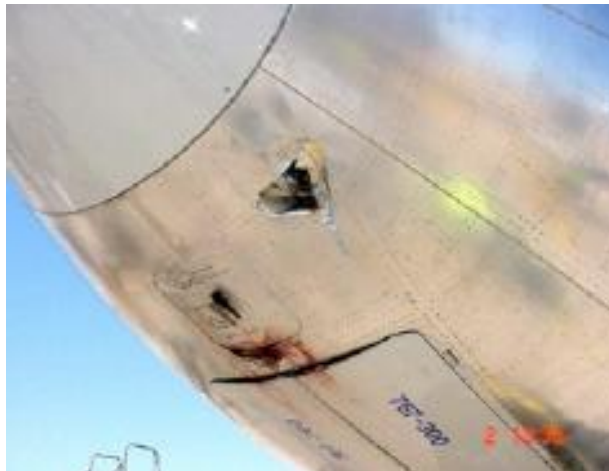
Figure G4: Photo of Bird Strike Damage to Underside of Fuselage of B767 Aircraft

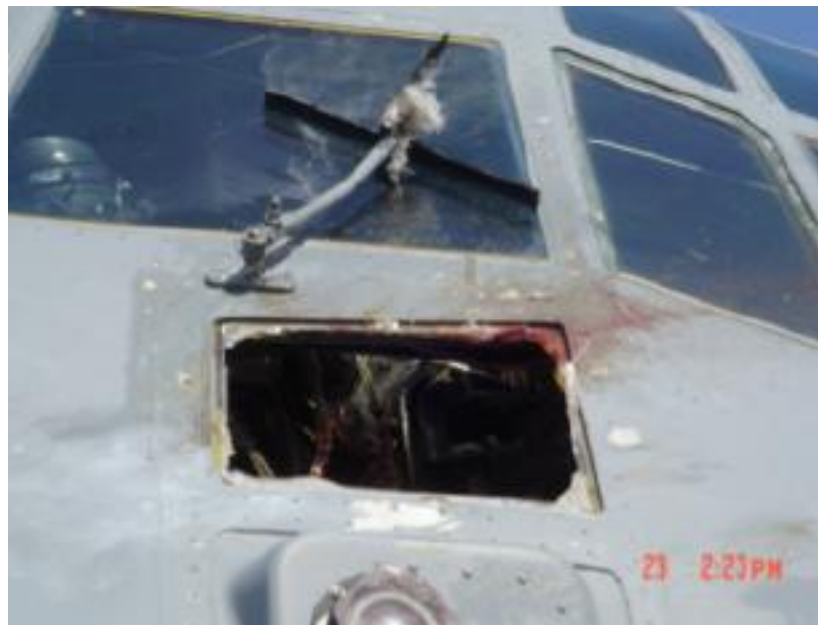
Figure G7.: Photo of Bird Strike Damage to Outside of the C-130 Aircraft

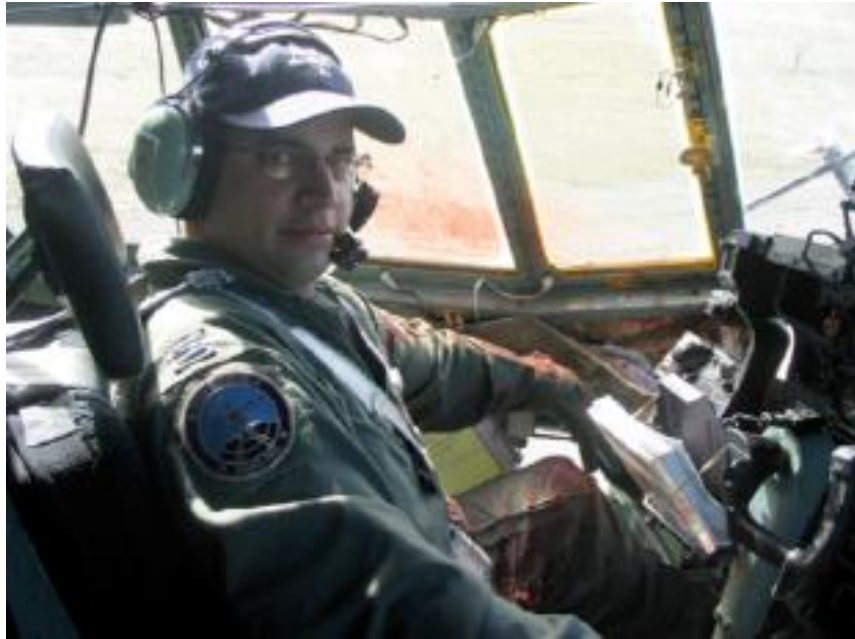
Figure G8: Photo of Bird Strike Damage to Front of C-130 Cockpit

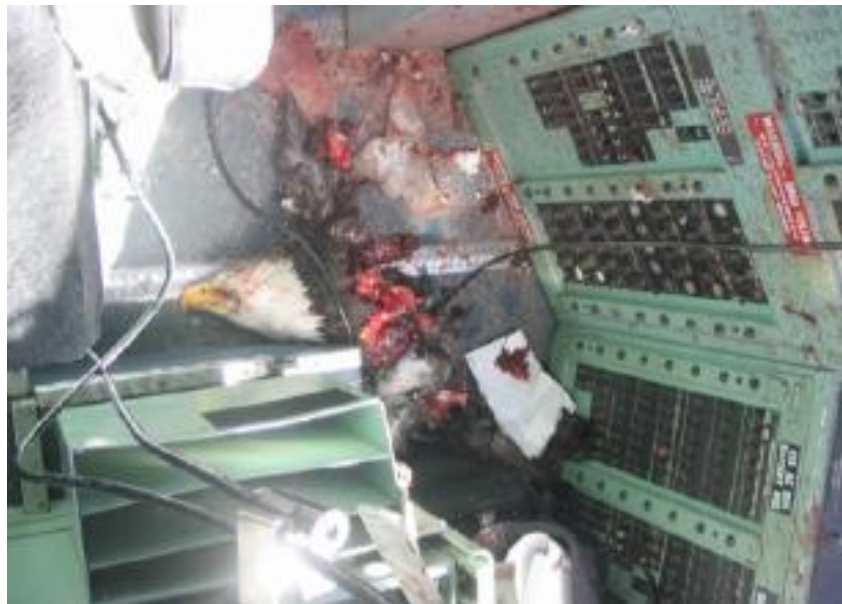
Figure G9: Photo of Bird Strike Damage to Interior of the C-130 Aircraft

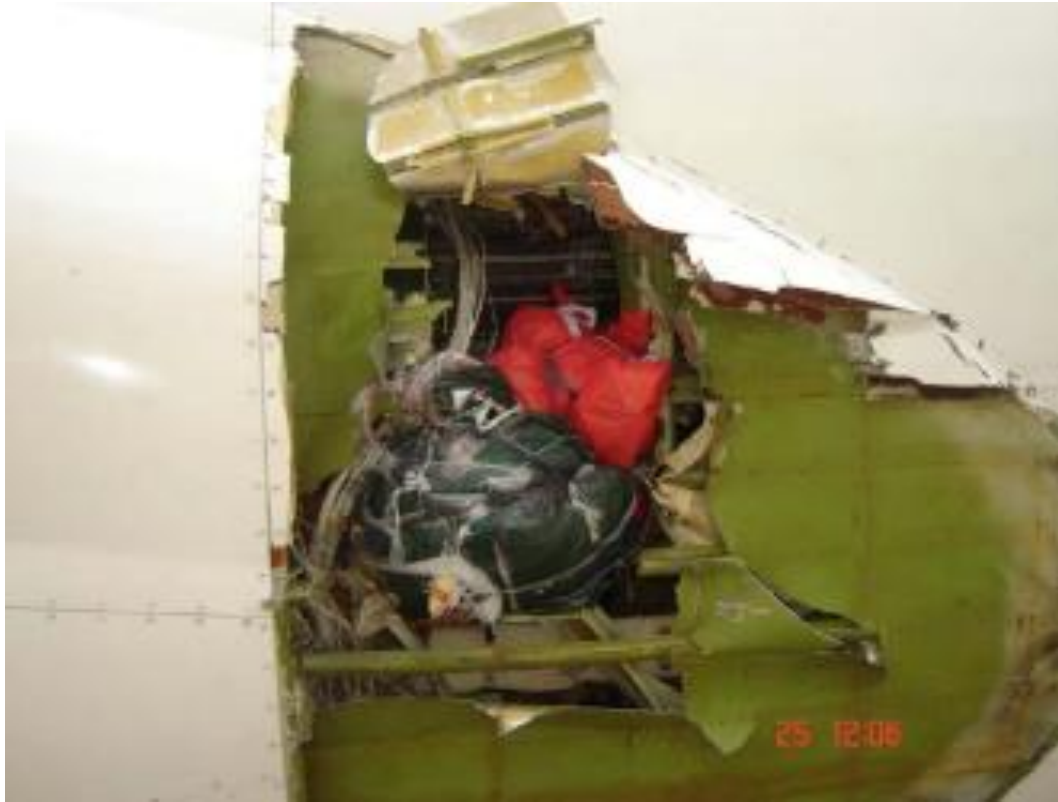
Figure I4: Alternate Close Up View of Boeing 747 Fuselage After On-Board Explosion Illustrating Loss of Structure

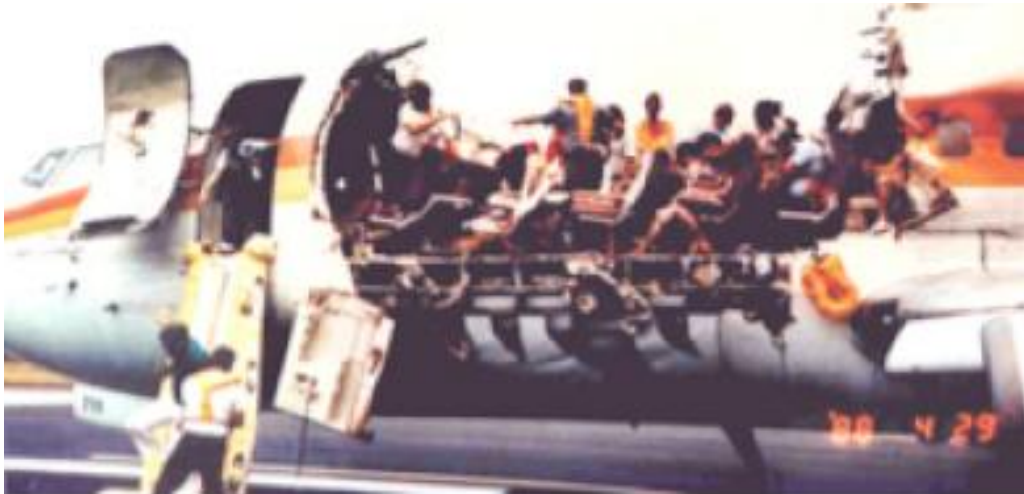
Figure J2. Photo Illustrating Extent of Aircraft Damage to Boeing 737 Aircraft Following Failure Due to Widespread Fatigue Damage

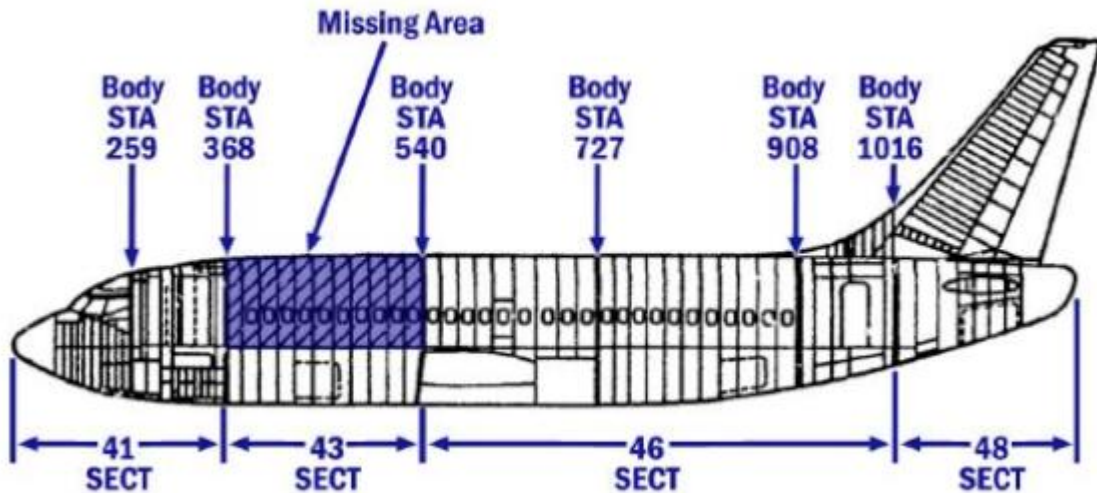
Figure J3: Sketch Illustrating Side View of Fuselage with Missing Area of Boeing 737 Aircraft

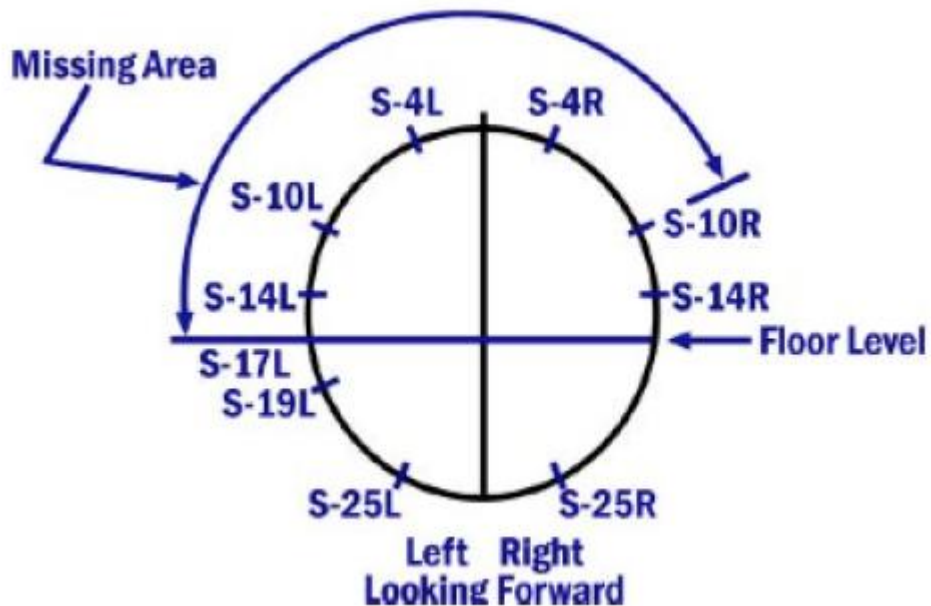
Figure J4: Sketch Illustrating the Fuselage Missing Area from a View Looking Forward

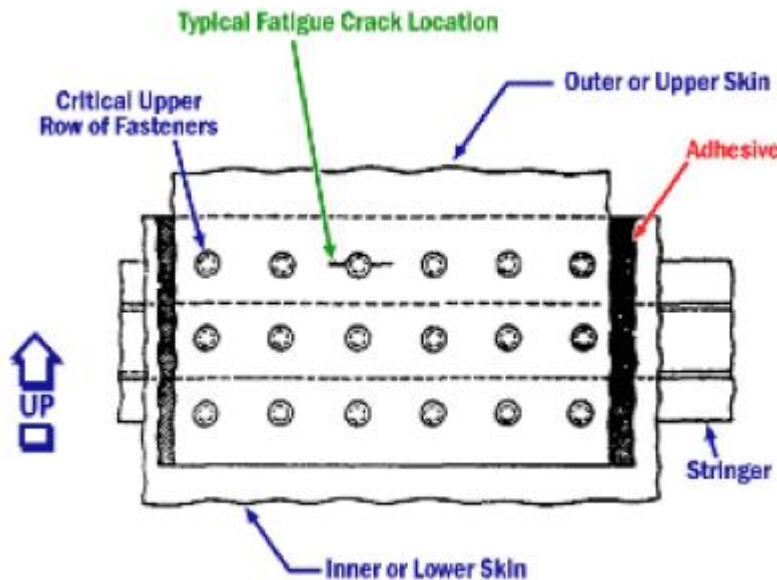
Figure J6: Sketch Illustrating the Location of Small Fatigue Cracks in the Skin

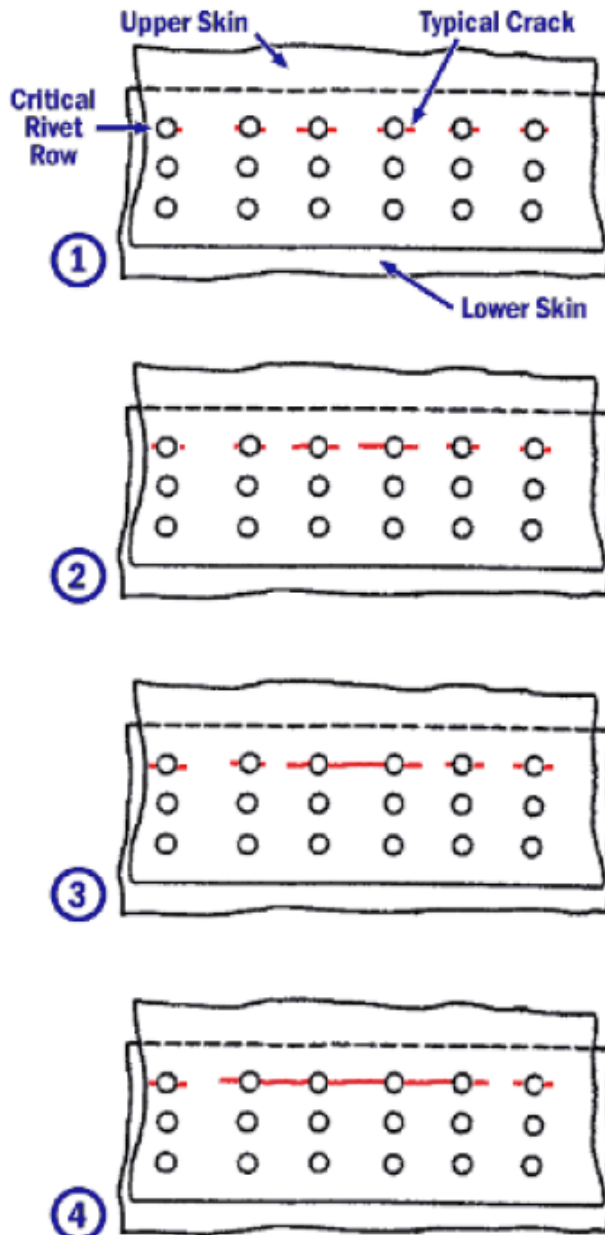
Figure J7: Sketches Illustrating the Development of Small Fatigue Cracks in the Skin

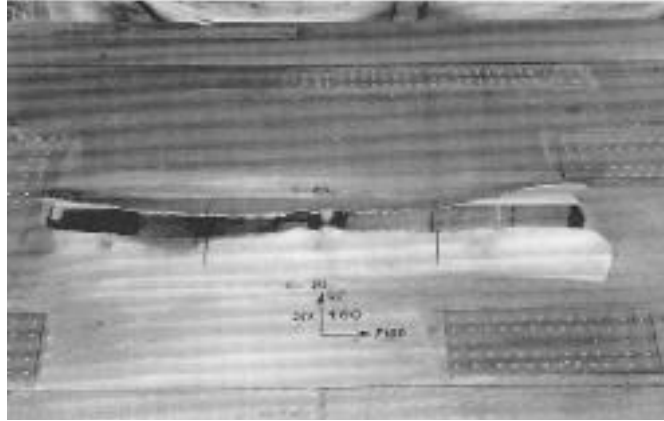
Figure K4: Arrested Two-Bay Crack with Fractured Frame in Boeing 737 Fuselage

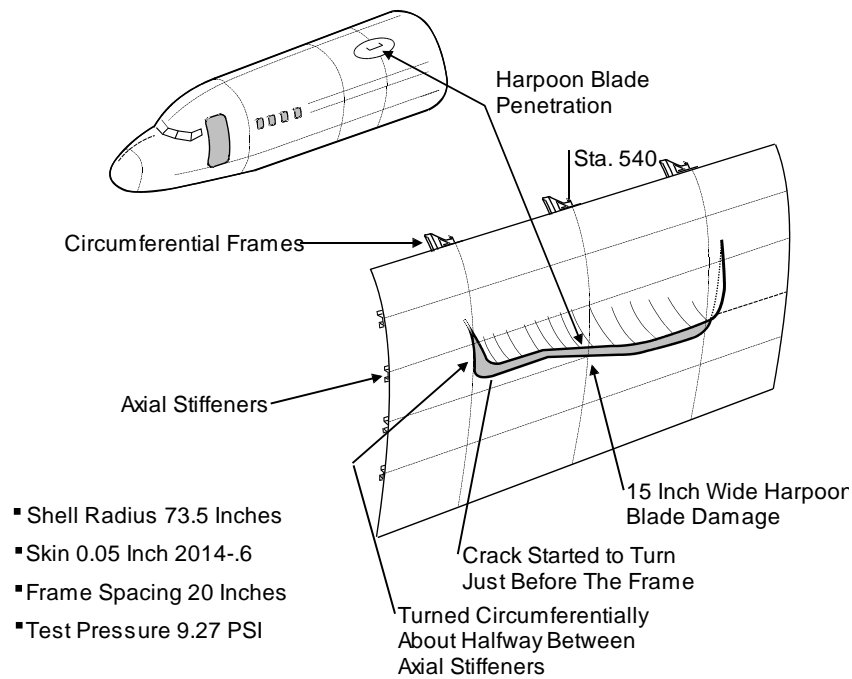
Figure K6: Details of DC-8 Arrested Fuselage Crack
