AFWAL-TR-80-2110

EVALUATION OF POWDER PROCESSED TURBINE ENGINE BALL BEARINGS

United Technologies Corporation
Pratt & Whitney Aircraft Group
Government Products Division
P.O. Box 2691
West Palm Beach, Florida 33402

June 1981

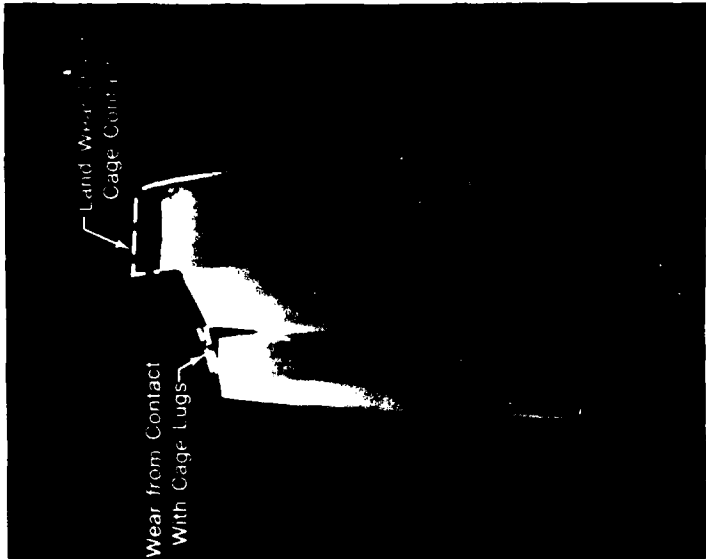
A visual examination was conducted with binocular assistance on the eight bearings run in the initial test. This revealed various degrees of wear on the inner ring lands and the mating cage bore surfaces. The inner ring land surfaces were worn uniformly in depth, axially, radially and circumferentially. One bearing with the greatest ring/cage clearance, see Figure 12, was measured and found to have the ring lands worn to a depth of approximately 0.070 inch. In addition, the inner race ball groove surface was worn due to contact with the cage ball-retention lugs. See Table 12 for a tabulated summary of post-test visual observations made on the test bearings.

The nature of the wear observed on the program bearings had the appearance of the abrasive type that can be generated by hard particles bridging any oil film between the OD land surface and the inner ring and the bore surface of the cage. This type of wear has been seen before on service engine bearings and in most instances has been attributed to dirt particles suspended in the oil. However, as described earlier, after a complete oil system cleanup and the successful running of P/M M-50 alloy bearings, a P/M CRB-7 alloy bearing that was run next still experienced the same type of distress as observed in the first test. It was then concluded that the problem was not due to dirt in the oil system from sources outside the test bearing itself.

Figure 12. Powder Metal Processed CRB-7 Alloy Bearing Wear. (Left) Pitting Shown on This Cage Bore Surface is The Worst Case, But Similar in Appearance to All Other CRB-7 Bearing Cages Tested. (Right) Inner Ring Wear Was Extensive, And This Was the Worst Case; 0.070 in. of Material Was Worn From The Land.

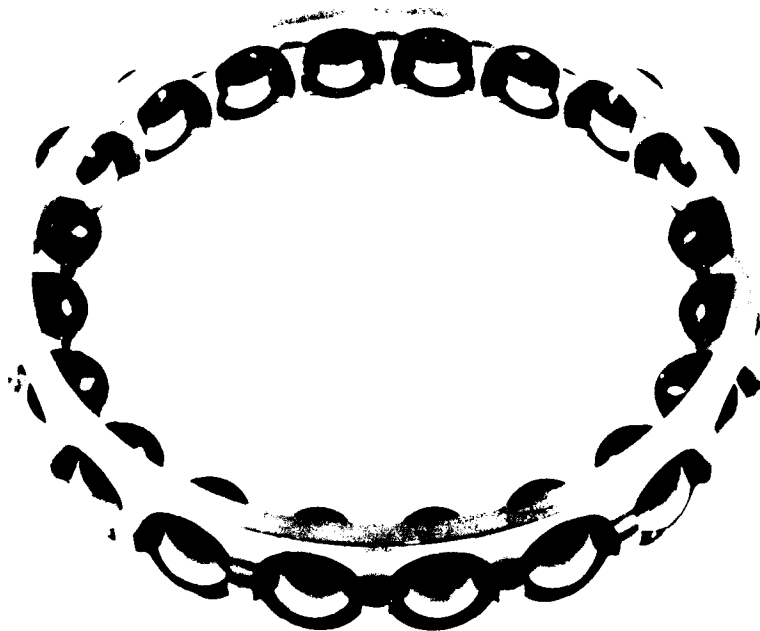
Figure 25. Replated Cage after 7 Test Hours.
No Evidence of Cage Distress by Contact With
Nickel Plated Inner Rings Was Observed.

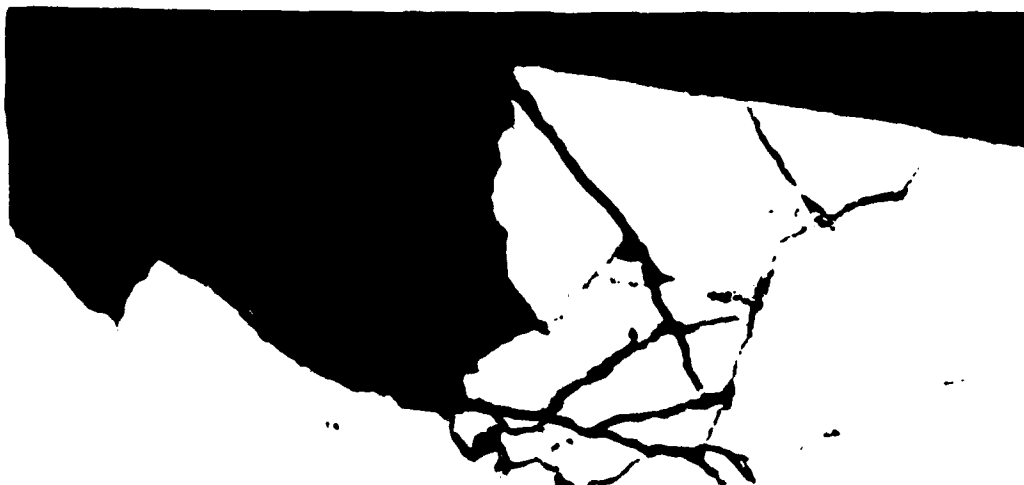
Figure 31. Photomicrograph of Ball Section Through Spall.
Numerous Transgranular Cracks Emanated From Apparent Spall Origin.
