AGARD REPORT 809

POD Assessment of NDI Procedures Using a Round Robin Test

This report was prepared at the request of the Structures and Materials Panel of AGARD

Published January 1995

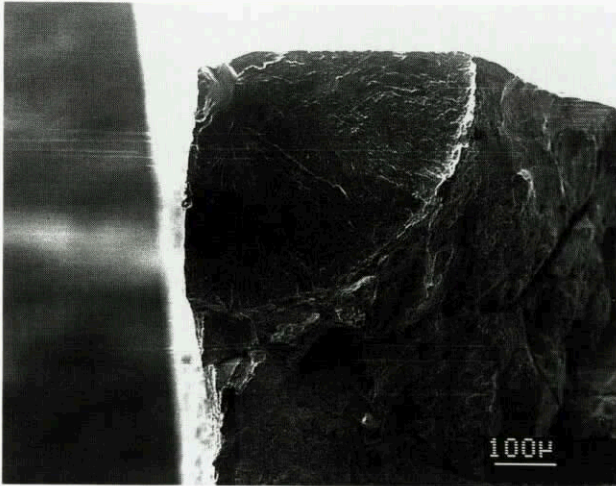
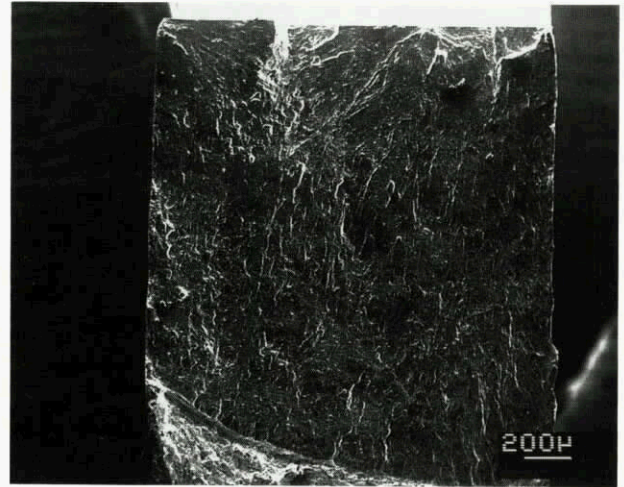
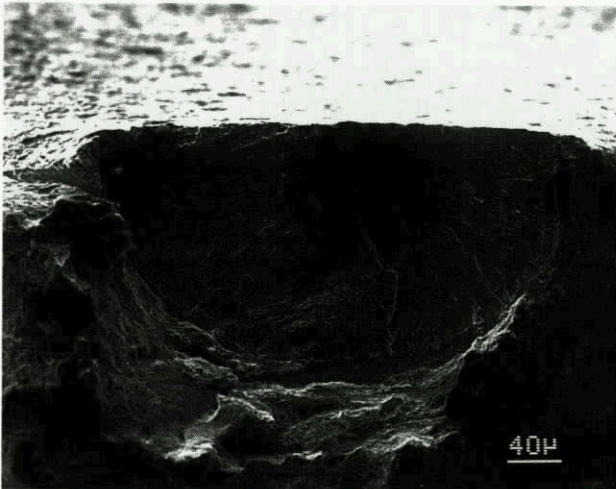
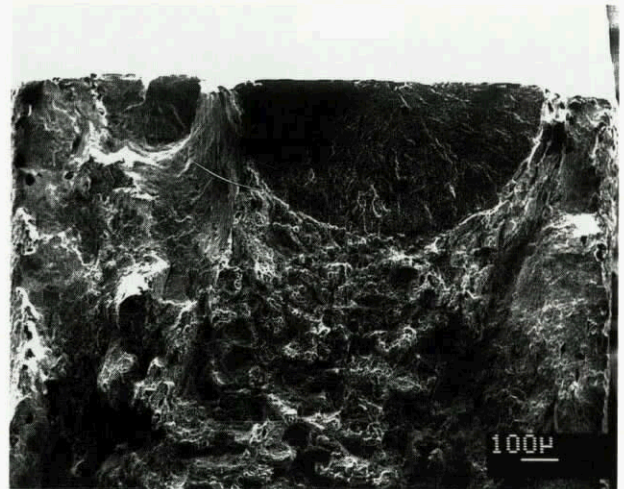
Figure 4. Examples of different crack types in the bolt holes

Destructive tests and examination of fracture surfaces indicated that most cracks initiated near the edges of the holes and formed corner cracks. Often, initiation occurred at the bore of the holes and grew radially inward towards the centre of the component. There were cracks which did not touch the top or bottom surfaces and these were termed middle cracks as well as cracks which touched both surfaces and were referred to as through cracks. Examples of different crack types are provided in Figures 4 and 5. Figure 6 provides the distribution of different crack types as a function of crack length indicating that the majority of cracks were small (less than 0.5 mm in length) corner cracks. Most holes had a single crack but multiple cracks, as many as seven, were also seen in many holes. Some cracks did not occur along the radii of the discs; many of these were initiated at what appeared to be voids or inclusions in the material and were often accompanied by larger cracks on the radii. Some totally internal cracks as well as outward propagating cracks were also seen.

The shape of cracks varied depending on their location; middle cracks were mostly semi-elliptical, corner cracks appeared as a quarter of an ellipse and through cracks were close to rectangular in shape. A combination of the above shapes was often seen in the case of multiple cracks. The crack size was measured in terms of total area of crack face and the maximum length. In cases where failure did not occur through a crack, the bore surface of the bolt hole was examined and if a crack was found, the crack length at the surface was measured.

a) A corner crack

b) A through crack

c) A middle crack

d) A multiple crack

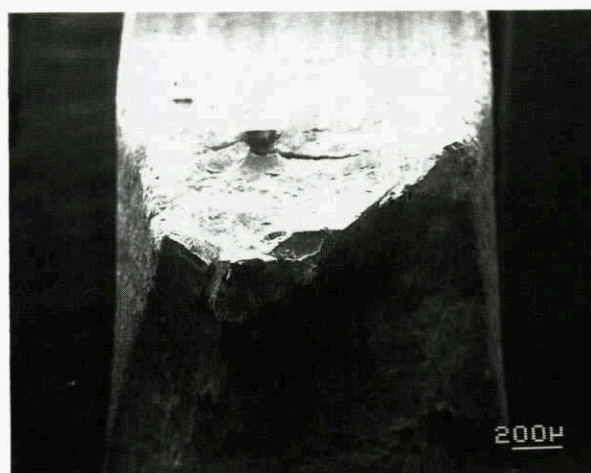
Figure 5. a) A small crack in the bolt hole bore

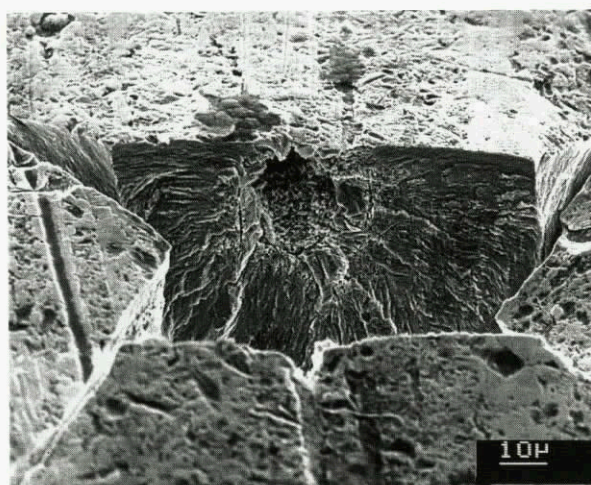
Figure 5. b) A crack initiating cavity

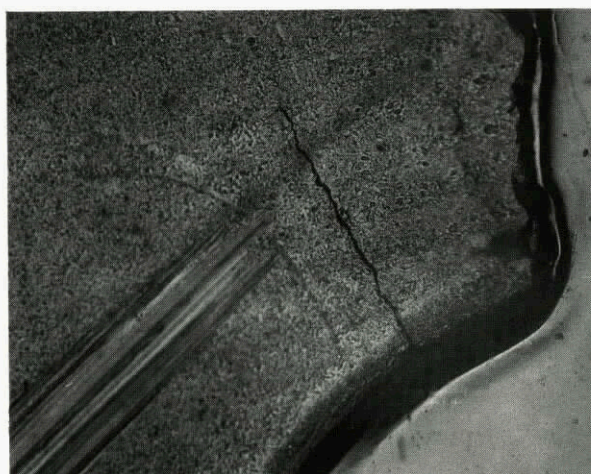
Figure 5. c) A cellulose-acetate replica of the disk surface, showing a crack

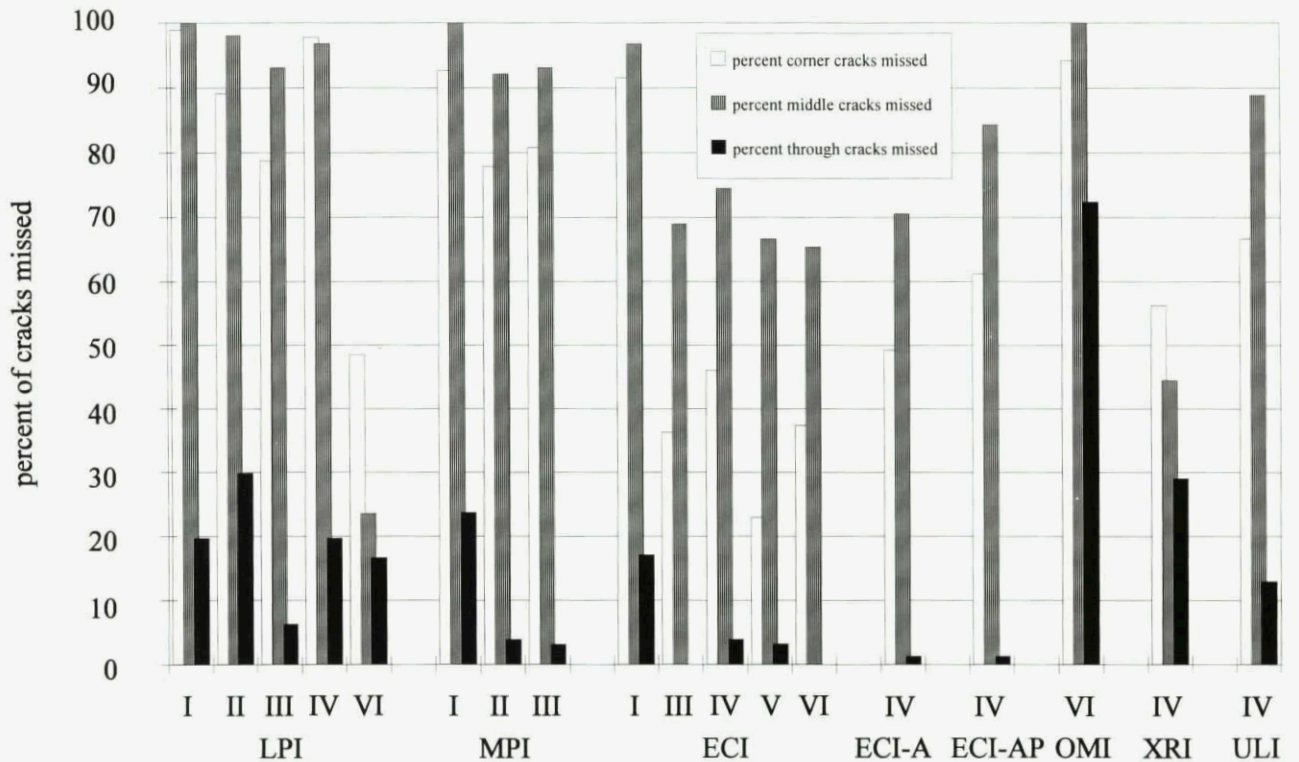
Figure 7 shows histograms of the percentages of cracks missed by each inspection procedure, organized by crack type. Through cracks were the easiest type to detect by all techniques, because they were generally larger and open to surfaces. However, only eddy current inspection was able to detect more than 90% of through cracks. Middle cracks were the hardest to detect for all methods, mainly because these cracks were mostly small and it was physically difficult to access or view the bore surface of the holes. There were a large number of small (<0.5 mm) corner cracks which were missed by all methods. In all cases, the eddy current inspections were the best performers.

Figure 7. Histograms of percentage of cracks missed for each crack type, by each inspection procedure
