AGATE Composite Airframe Impact Test Results

Marilyn Henderson
National Institute for Aviation Research
Wichita State University

Report Reference Number: AGATE-WP3.4-034026-088, Rev A
Work Package Title: WBS3.0 Integrated Design and Manufacturing
Date of General Release: March 1, 2002

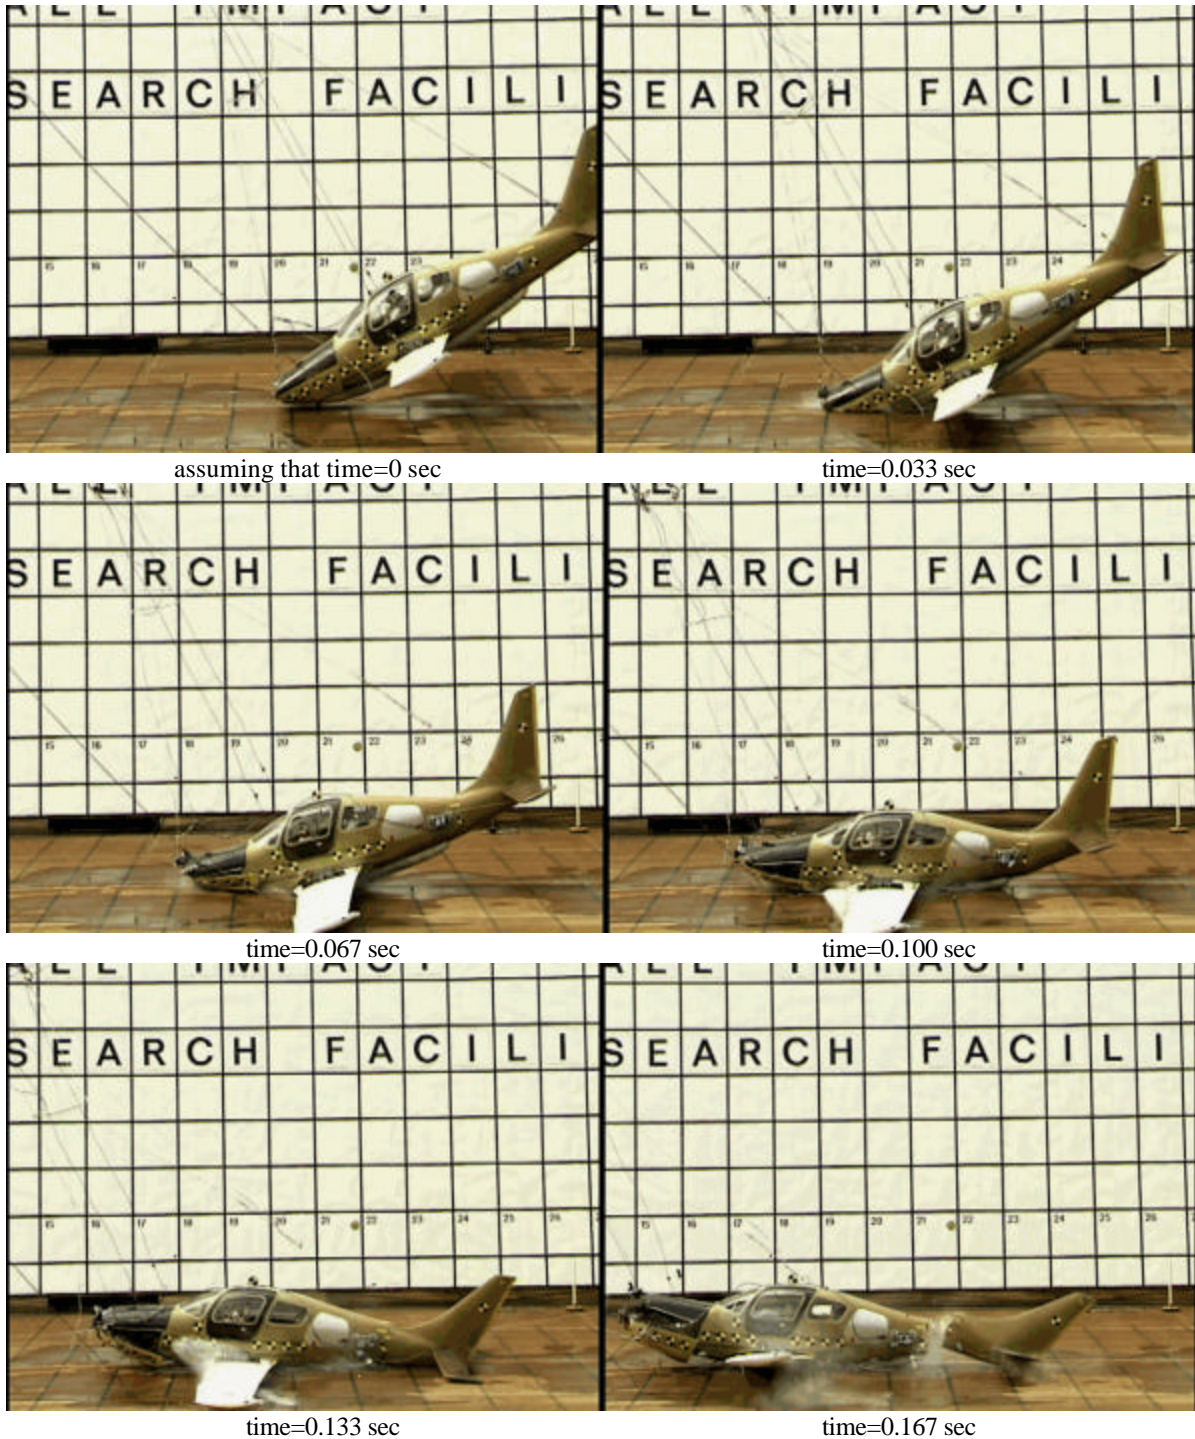
Fig. 29 – Photo Sequence from Drop Test Video (Closer View)

These images show that the engine mount failed and that the tail broke off the fuselage early in the event.

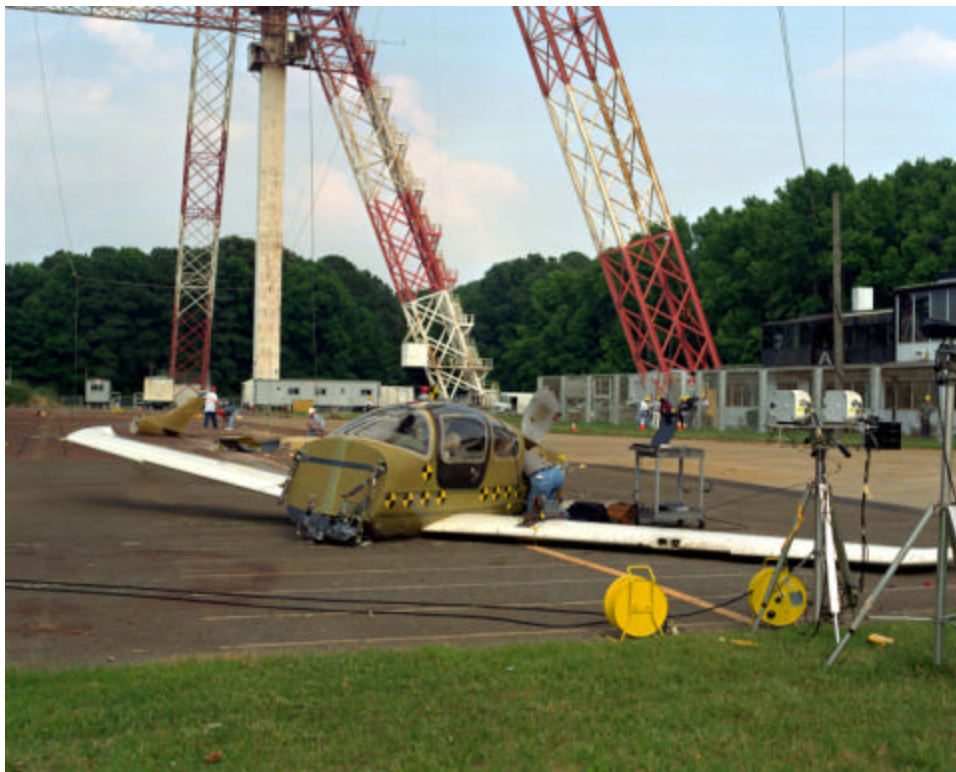
Fig. 36 – Photo – Fuselage (From Front)

The condition of the fuselage is documented in Figs. 36-39 from a number of different angles. It is noted that the cabin of the aircraft remained intact and did not suffer a great deal of damage above the cabin floor level. The most notable damage was a minor face sheet wrinkle under the windshield shown in Fig. 38. This is the only portion of the fuselage above the lower longeron that sustained any damage. The empennage is shown in Fig. 40. It separated from the fuselage at a fuselage station containing a number of discontinuities. The core thickness changes at this location. A shelf terminates and fuselage frame is located at this location. This fracture in no way posed any risk to the occupants. Furthermore, it no doubt occurred as a result of a bending moment that greatly exceeds the ultimate load associated with the production aircraft's flight and maneuver loads.

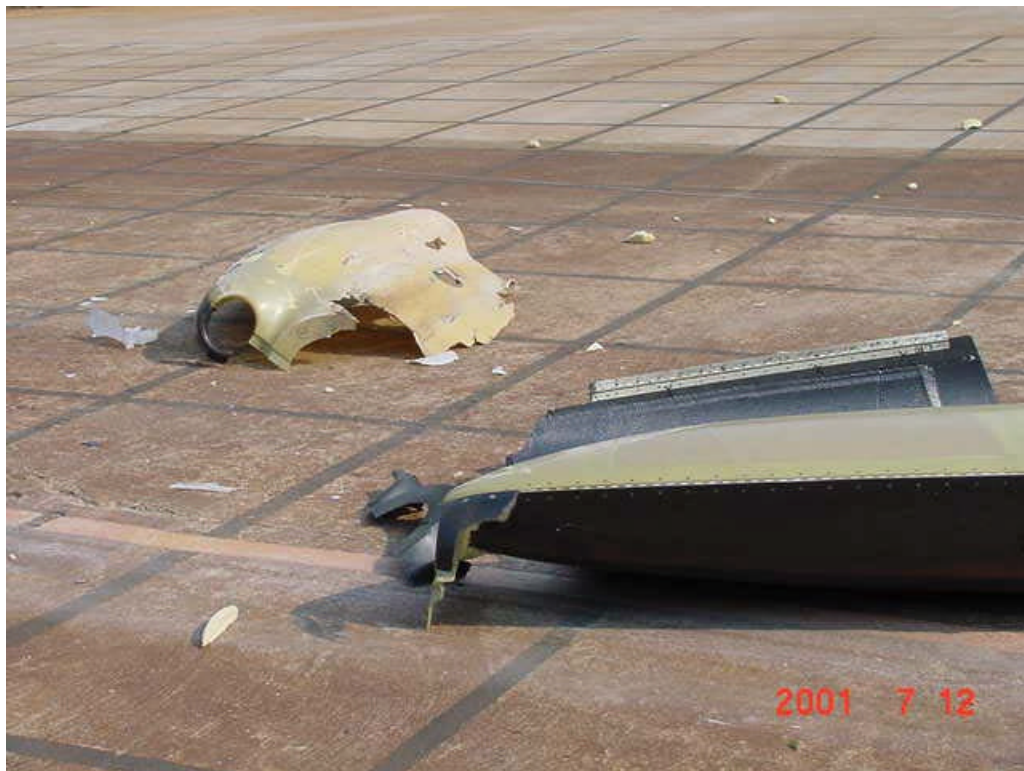
Fig. 41 – Photo - Cowl

The cowl is shown in Fig. 41. The cowl failed as a consequence of the engine impact following the failure of the engine mount. It ultimately ended up in two pieces that were shed during the slide out. The firewall is shown in Figs. 42 and 43. These figures document a portion of the engine mount failure. Fig. 42 shows the load-limiting devices, which didn't function as intended due to the structural failure of the joints of the load-limiting devices.

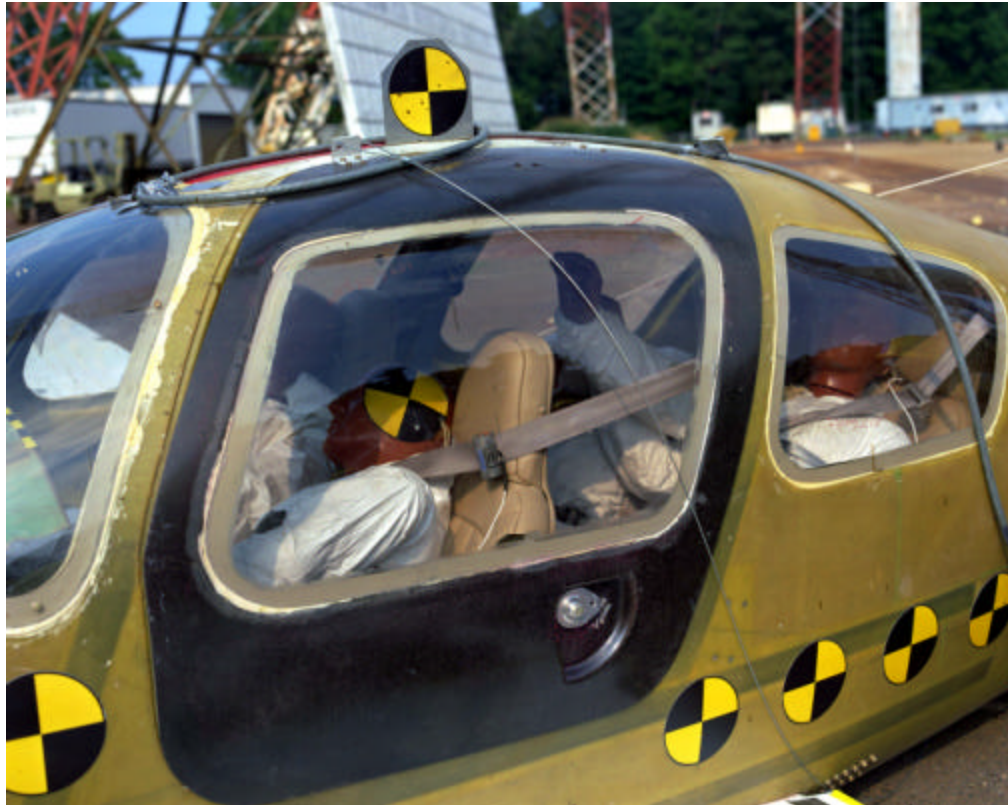
Fig. 44 – Photo – ATD's

The post-test condition of the interior is documented in Figs. 44-49. The final resting position of the ATD's is documented in Figs. 44 and 45; the post-test seat condition is documented in Figs. 46-49. The seat damage is particularly interesting in view of the favorable lumbar loads presented later in the report.
