R. & M. No. 3248

Behaviour of Skin Fatigue Cracks at the Corners of Windows in a *Comet* I Fuselage

By R. J. ATKINSON, W. J. WINKWORTH and G. M. NORRIS

June, 1960

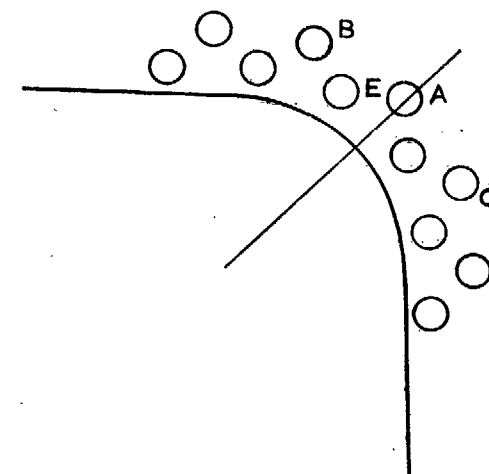
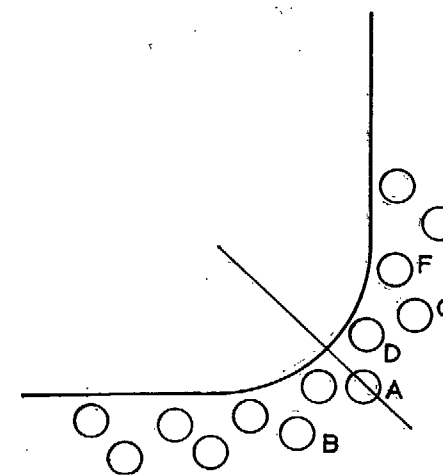
Rivet holes at which the cracks occurred.

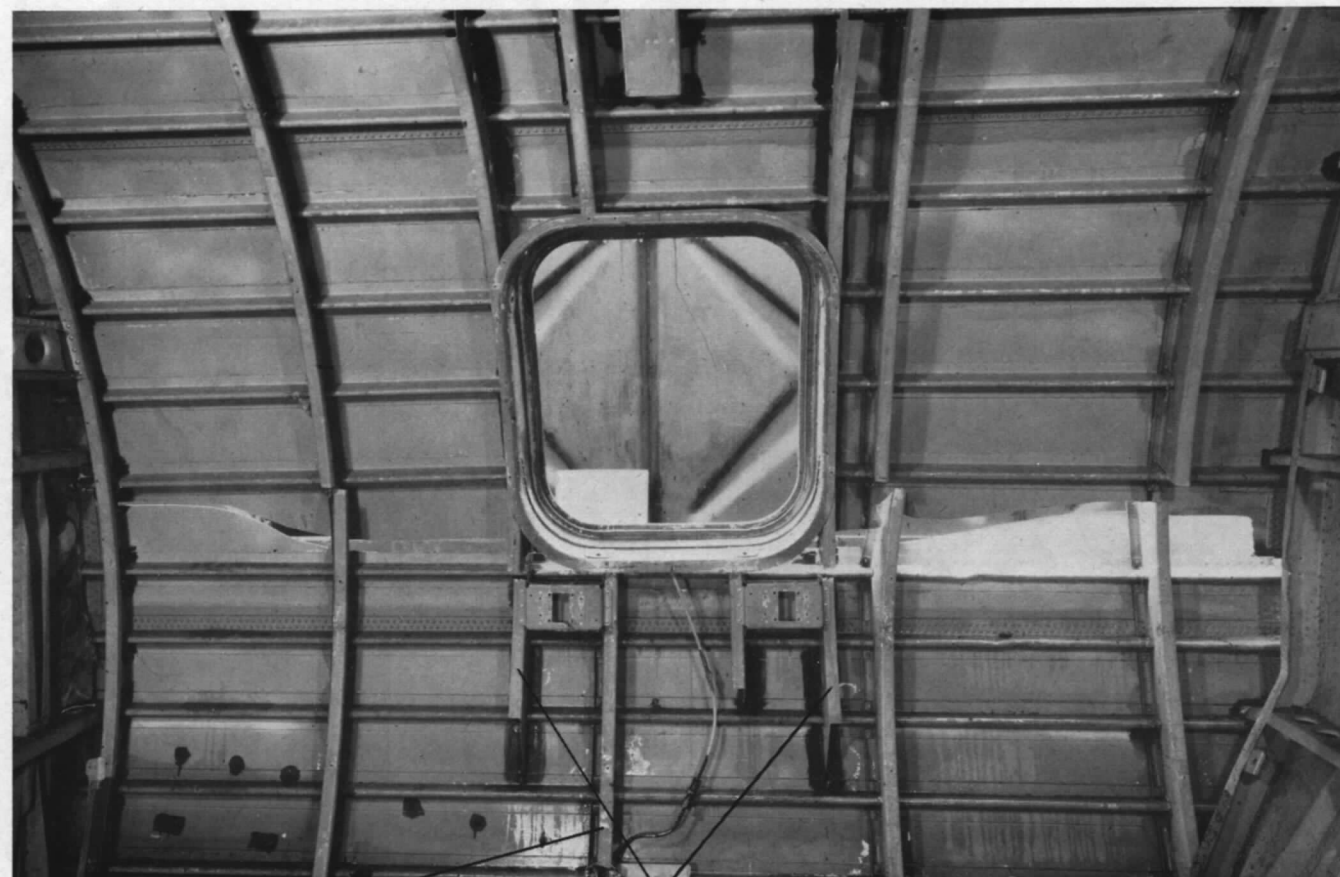
Differences of behaviour occurred during growth towards the frames and across the frames. During the first stage, several cracks became critical when about 3 in. long, *i.e.*, between the aperture and the frame. This condition was noted at most of the windows in the centre section where the skin was also riveted to the frames. The presence of this extra attachment appeared to have a strong influence in delaying crack growth across the frame, and was clearly demonstrated in the case where a crack extended a distance of 2 in. in one pressure cycle (Fig. 22). An exception however, occurred at the port forward escape hatch (where the riveted frame was a partial frame only—Fig. 6) when the crack at the bottom forward corner caused a catastrophic failure when 2.75 in. long (Fig. 6).

FIG. 6. Internal partial frames at forward escape hatches.
Failure at port forward escape hatch at 11,246 cycles.

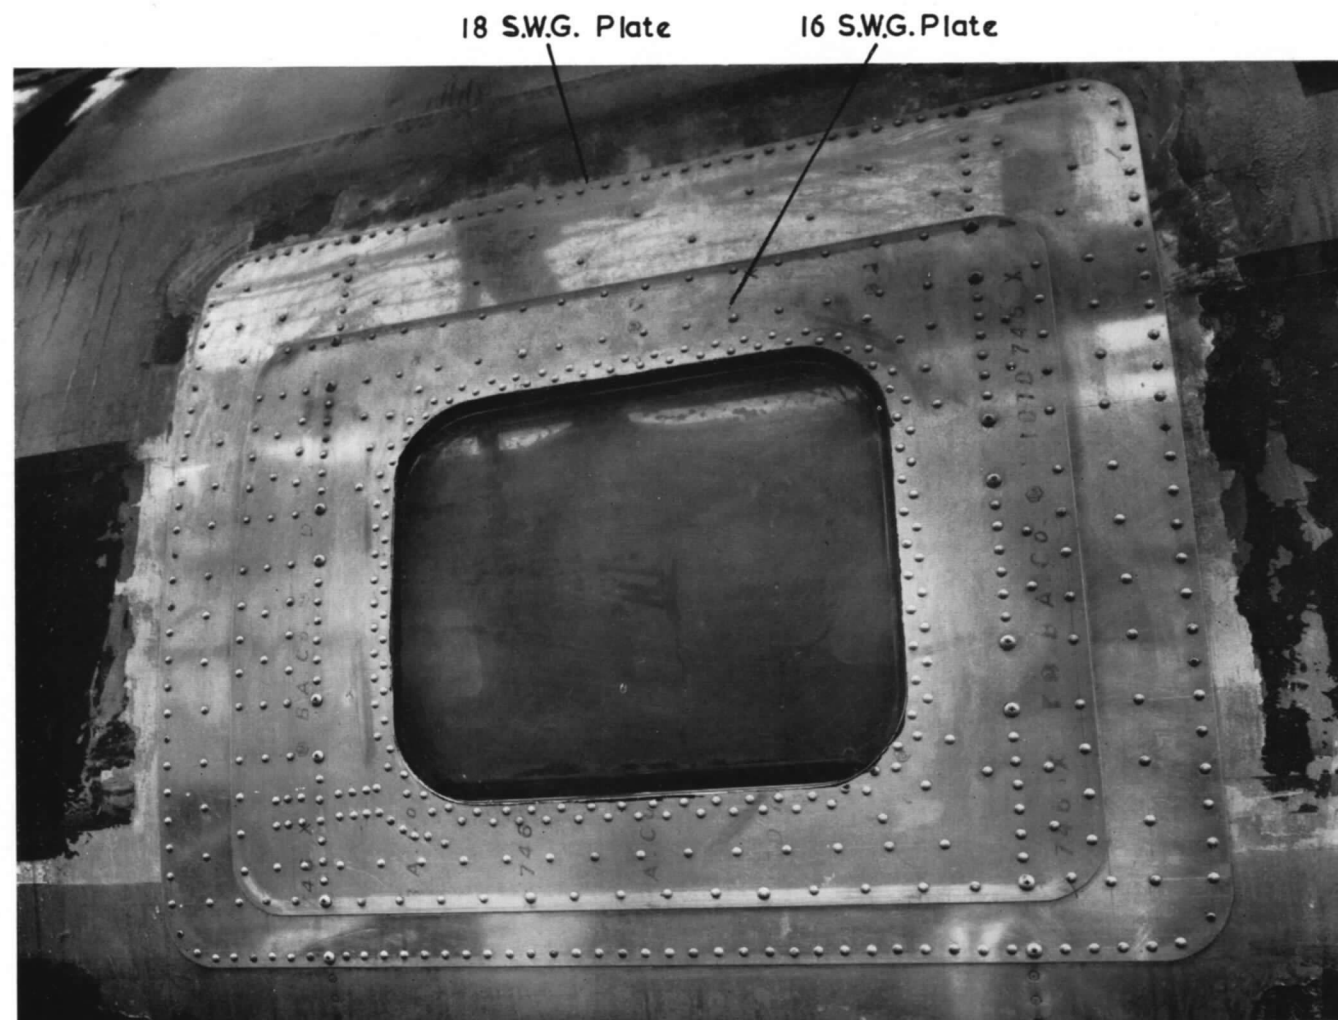
FIG. 13. Typical window repair.

Detailed visual inspections were made at frequent intervals. When a fatigue crack was found its subsequent development was observed continuously with an inverted periscope. When it was judged that a fatigue crack would soon develop catastrophically the affected aperture was repaired to prevent excessive damage to the specimen (Fig. 13).

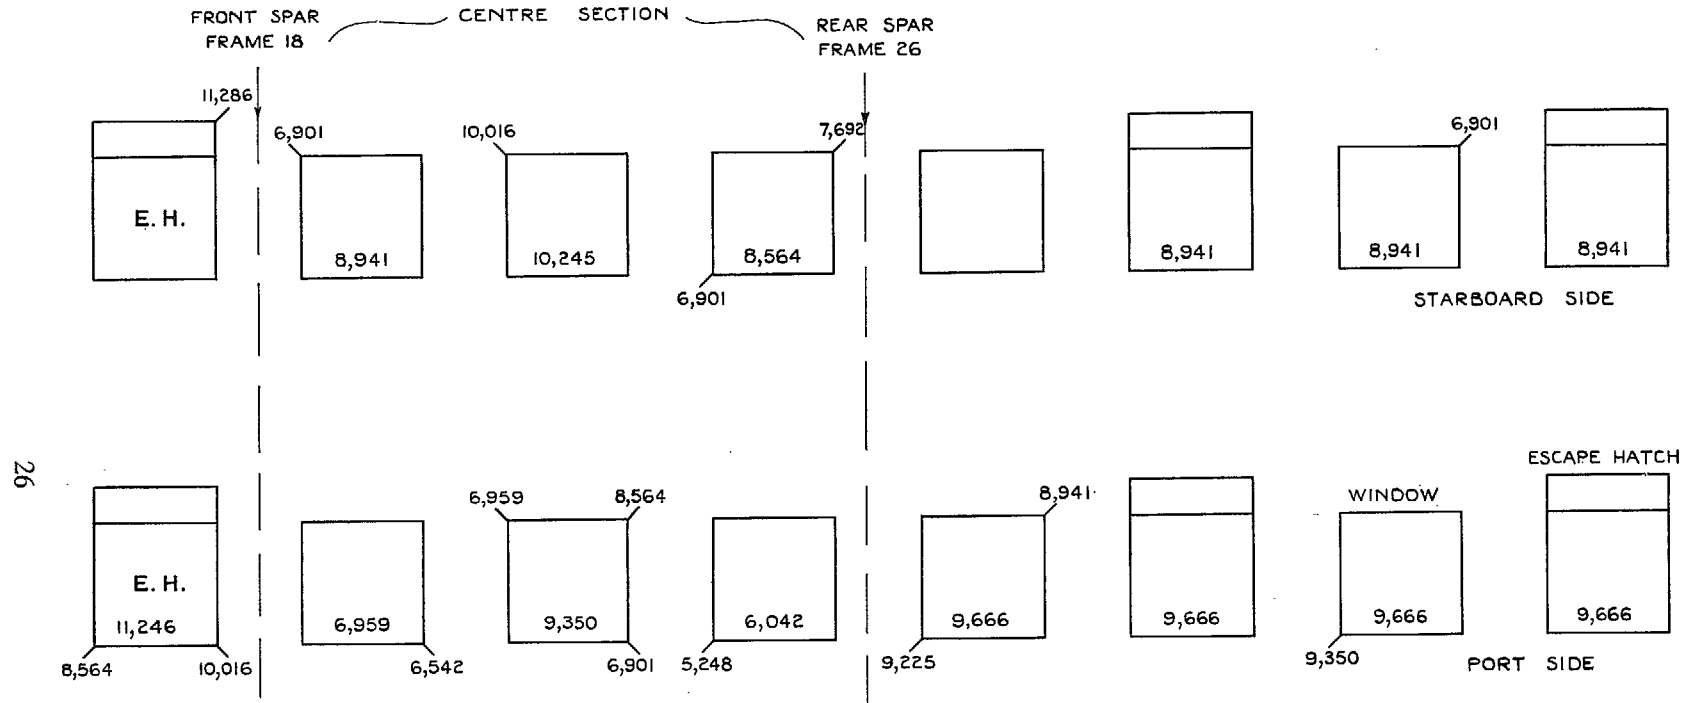
4.2. *Fatigue Test.* A total of 11,319 pressure cycles of 0 to 8.25 p.s.i. to 0 were applied to the fuselage. Fatigue cracks occurred in the skin at the corners of nine windows and two escape hatches, sixteen corners being affected (Table 2 and Fig. 20). No fatigue cracks occurred at the A.D.F. aerial hatches (at which the 22 s.w.g. reinforcing plates were subsequently removed for examination of the skin underneath), the crew and passenger doors, or at the freight hatches.

FIG. 20. Distribution of fatigue cracks at window and escape-hatch-aperture corners.

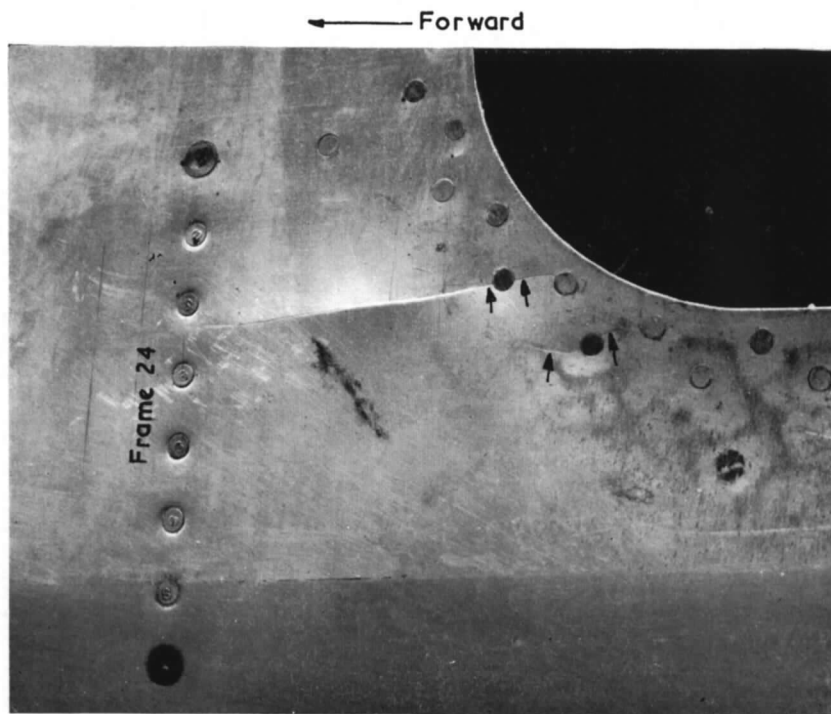
5. Discussion. 5.1. *Origins of the Fatigue Cracks.* All the fatigue cracks originated at the countersunk rivet holes in the skin at the window and escape hatch corners. Those cracks which eventually became catastrophic started at outer-row rivet holes. The few cracks that originated at holes in the inner row grew inwards to the edge of the aperture and did not become catastrophic. No cracks originated at the edges of the apertures.

FIG. 31. Third port window corner, 5,951 cycles.

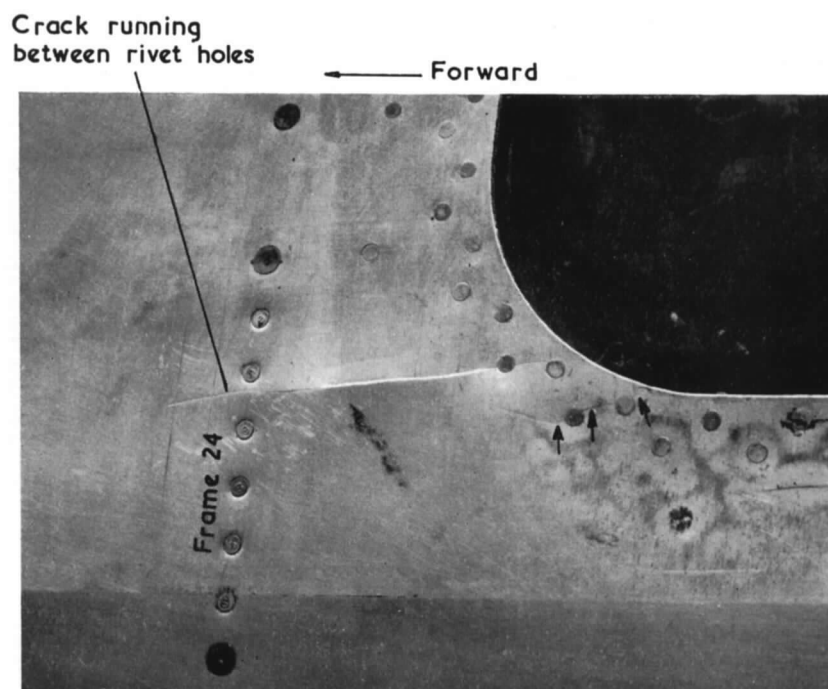
FIG. 32. Third port window corner, 6,042 cycles.

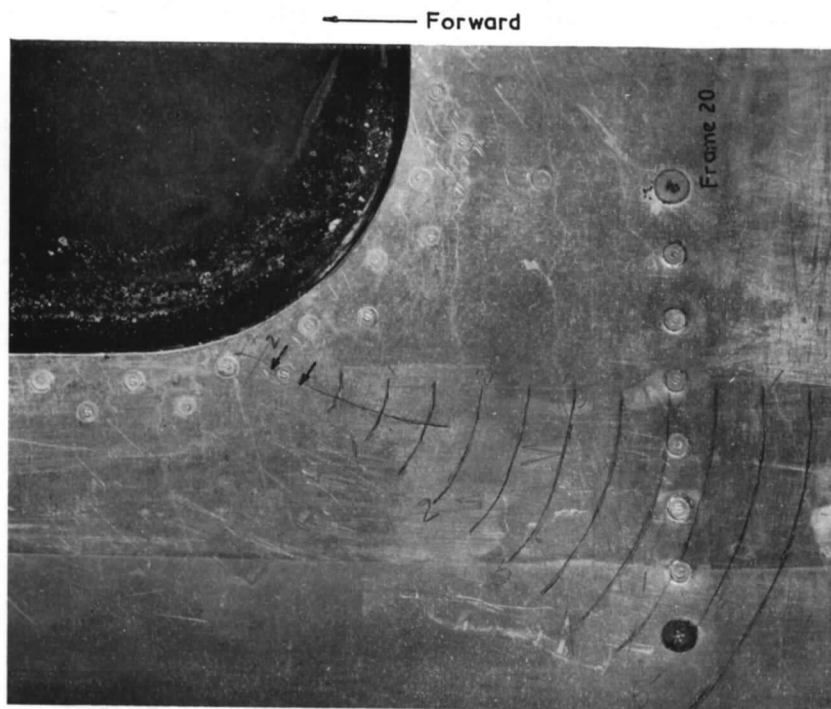
FIG. 33. First port window corner, 6,901 cycles.

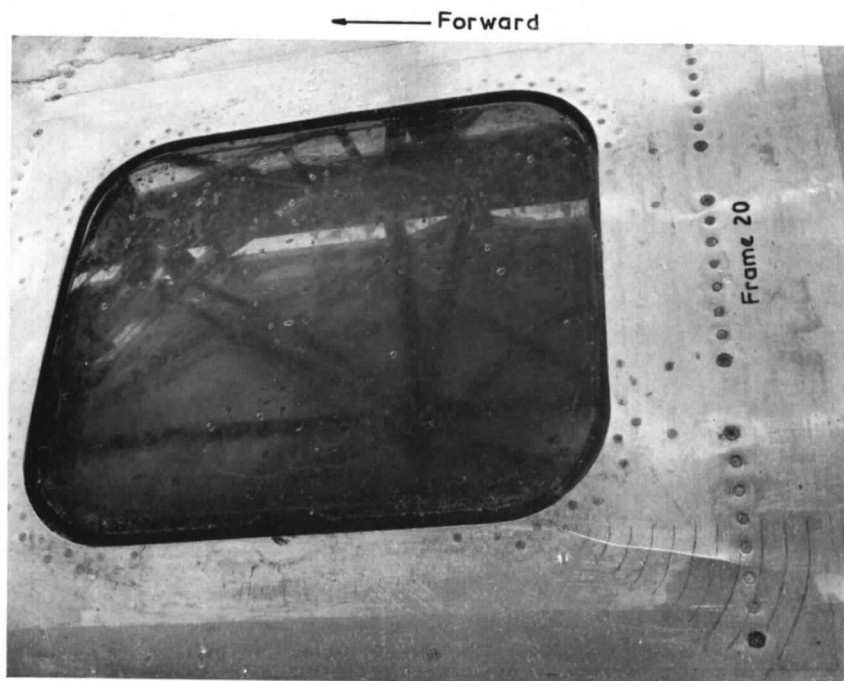
FIG. 34. First port window corner, 6,959 cycles.

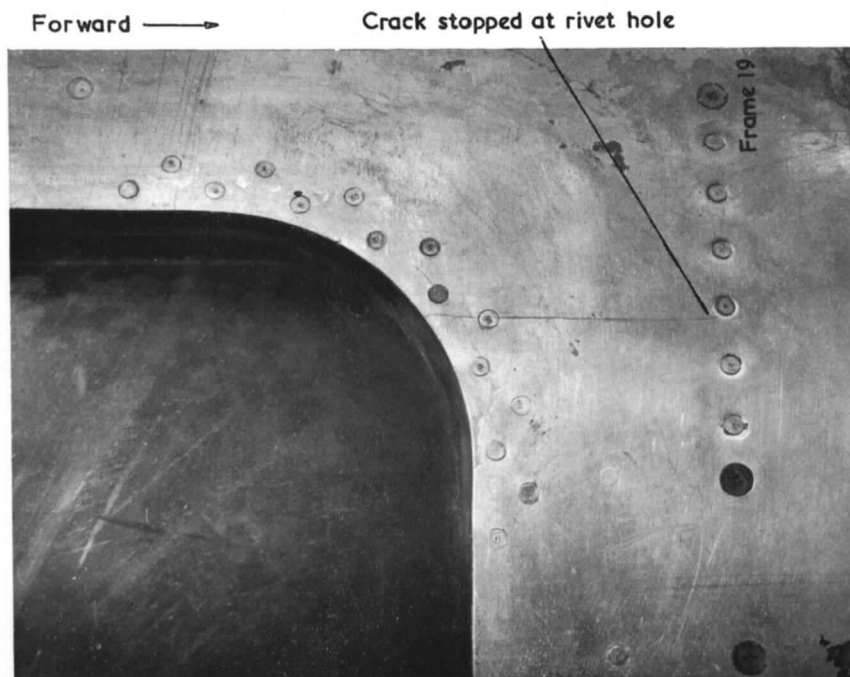
- (1) The frame with the normal bolted attachment appeared to have no influence whatever on crack growth.
- (2) Where the skin was riveted to the frames:
 - (a) Cracks passing between rivet holes were slowed down, but not stopped altogether.
 - (b) Cracks entering rivet holes were stopped temporarily; *e.g.*, one crack was contained for more than 1,800 cycles.

FIG. 35. Crack stopped at rivet hole in frame, 6,901 cycles.
First starboard window.

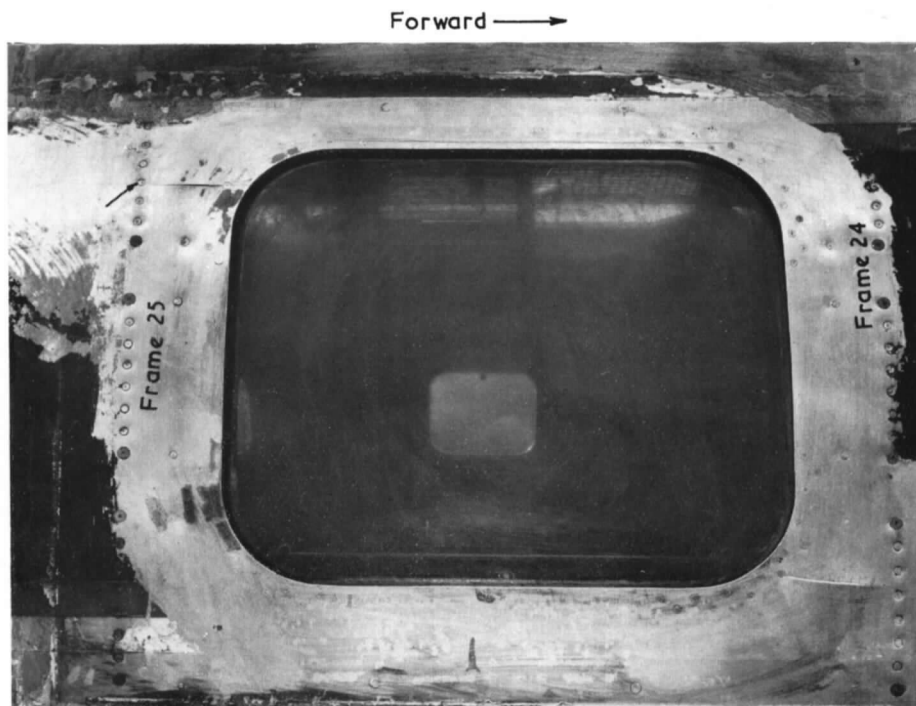
FIG. 36. Cracks stopped at riveted frames, 8,564 cycles.
Third starboard window.

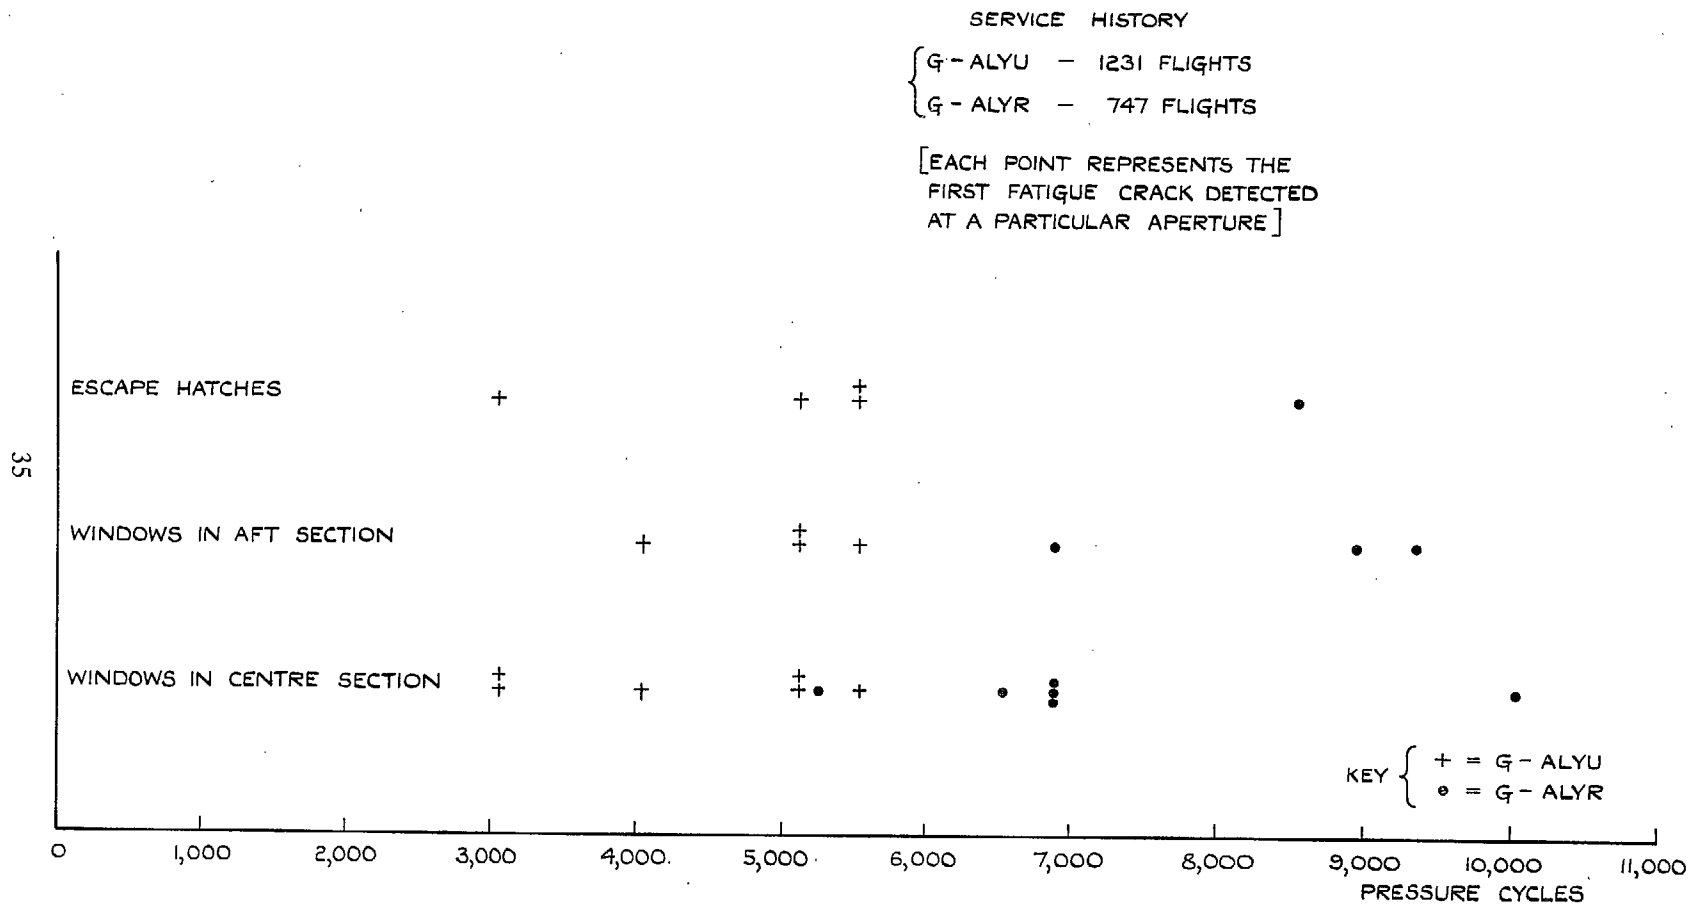
5.2. *Locations of the Fatigue Cracks.* The test on G-ALYR showed that fatigue cracks were initiated earliest and most numerous at the windows in the centre section, and though the first failure in G-ALYU was at a forward escape hatch⁴, fatigue cracks had also formed at several windows in the centre section by the time of this failure (Fig. 37).

FIG. 37. Distribution of fatigue cracks at apertures.
