**ATSB TRANSPORT SAFETY BULLETIN**  
Aviation Level 5 Investigations AB-2010-020  
Final

# **Level 5 Factual Investigations:**

## **1 December 2009 to 30 March 2010**

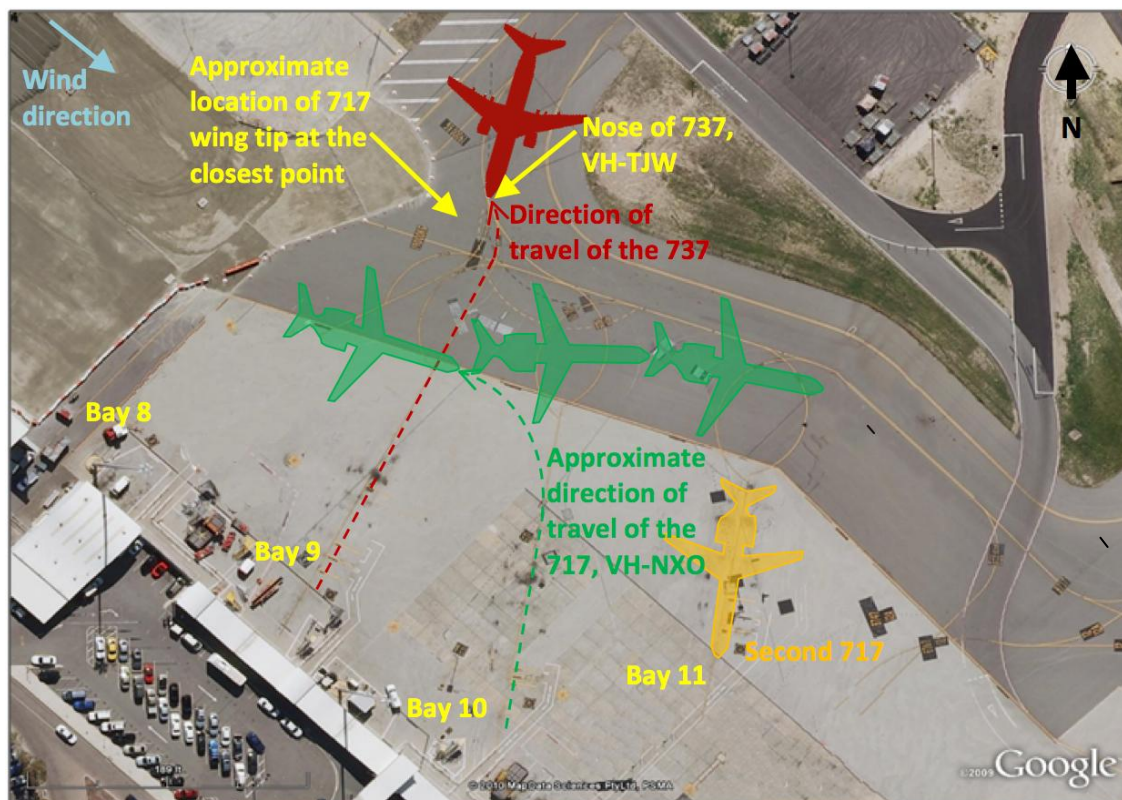
**Figure 1: Overview of parking bays and taxiway**

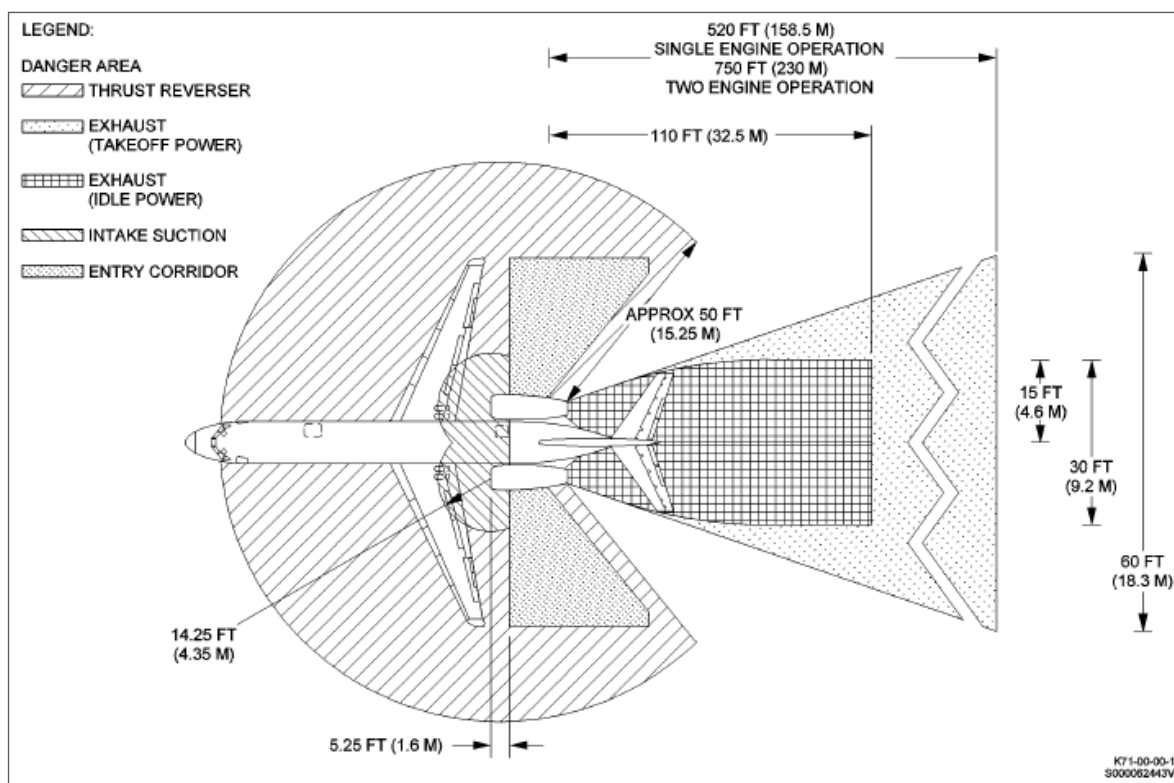
A turbine engine's inlet and exhaust areas provide a significant hazard to ground personnel. During operation, a turbine engine creates a low-pressure area around the inlet, which leads to large quantities of air surrounding the inlet being sucked into the engine. Therefore, it is necessary for ground personnel to remain a safe distance from the front of the engine. For the 717 this is a radius of 4.35 m from the centre of each engine, within the span of the wing (Figure 2).

Correspondingly, air exits the engine exhaust at a very high speed. For the 717 (two engine operations), air can be travelling at 240 km/h up to 16 m directly behind the engine when the engines are operating with ground idle thrust. The jet exhaust hazard area was localised to 9 m either side of the aircraft centreline.

**Figure 2: Boeing 717 engine hazard area and entry corridor, for normal and thrust reverser engine operation**

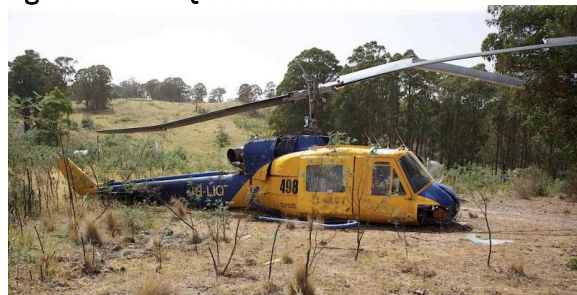
On 8 December 2009, at about 1645 Eastern Daylight-saving Time<sup>1</sup>, a Bell Helicopter Company TH-1F, registered VH-LIQ, was conducting aerial fire-fighting operations south-east of Tamworth, New South Wales (NSW). On approach to a water source, the pilot in command (PIC) noted a loss of engine power. The PIC reported that he lowered the collective<sup>2</sup> and rolled the throttle on; however, the engine continued to spool down. The PIC manoeuvred the helicopter to a cleared area and carried out an emergency landing. The helicopter landed heavily and sustained serious damage. The PIC sustained a fractured nose, while the other occupant (second pilot) was uninjured.

At the time of writing this report, the reason for the total power loss was unknown.

Figure 1: VH-LIQ at the accident site

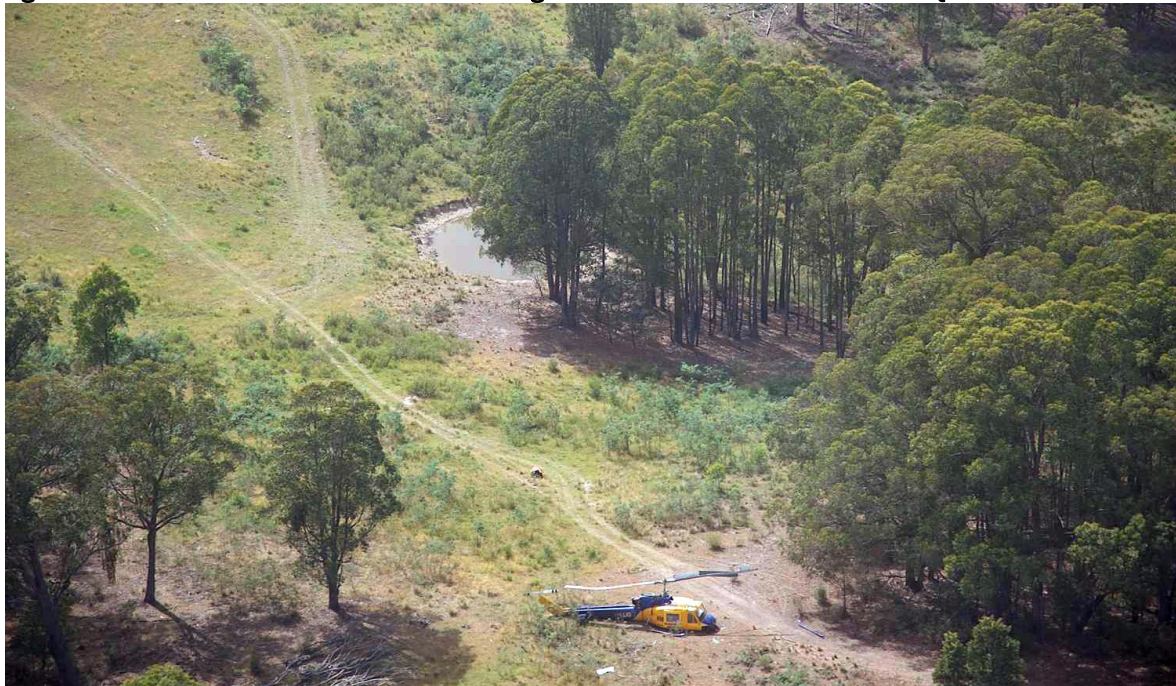
The PIC found a suitable clearing and conducted an emergency landing. He flared the aircraft and cushioned the impact using the collective. The helicopter landed heavily, reportedly yawing left and rolling slightly right. The helicopter sustained serious damage (Figure 2).

**Figure 2: Overview of the accident site showing the small dam south-east of VH-LIQ**

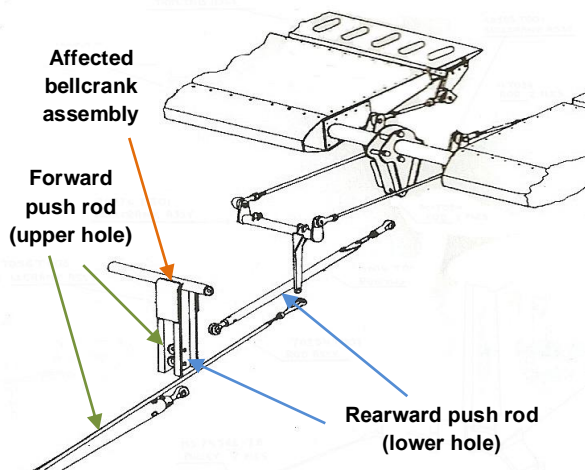
A subsequent engineering investigation by the aircraft's maintenance provider determined that the elevator push rods had been fitted in the reverse order during recent maintenance, thus

When the push rods were refitted into the bellcrank assembly, they were placed in reverse order; the forward push rod placed in the lower hole and the rearward push rod placed in the upper hole. While the elevator system still functioned correctly, the incorrect positioning of the push rods limited the nose down travel of the elevator. Ground simulations conducted by the maintenance organisation determined that the last 6° of elevator down was not available due to the incorrect fitment of the push rods.

**Figure 2: Elevator bellcrank assembly**

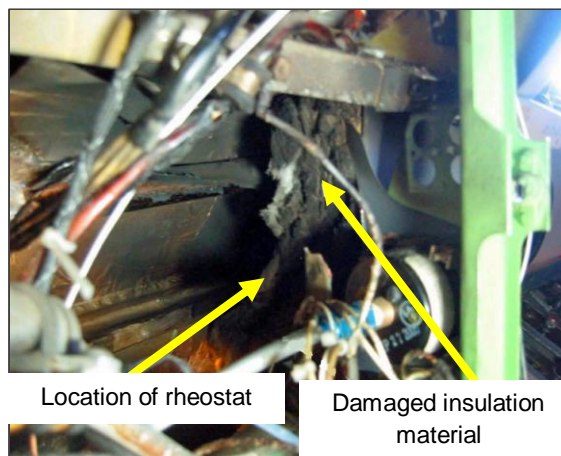
An engineering investigation conducted by the operator determined that the right red instrument panel light rheostat had developed a 'hot spot'. A small amount of insulation material located adjacent to, and above the rheostat had become detached and fallen onto the rheostat and wires within close proximity (Figure 2). The insulation material absorbed the heat from the 'hot spot' and transferred it to the wires, which produced smoke and flames.

Figure 2: Back of right instrument panel

Further examination identified that the rheostat had a broken moveable contact and a burnt contact surface; eight wires surrounding the rheostat were also damaged. The rheostat and affected wires were replaced.

- all of the operator's aircraft have been examined to ensure that there is sufficient clearance between the rheostats, insulation material, and surrounding wires. The operator will continue this examination as part of the aircraft's 375 hourly inspection.
- any insulation material located in close proximity to a rheostat has been removed.
- a search has been conducted to locate replacement rheostats that produce minimal heat. The operator is now in the process of selecting the most suitable rheostat and will seek the appropriate approval from the Civil Aviation Safety Authority for fitment.

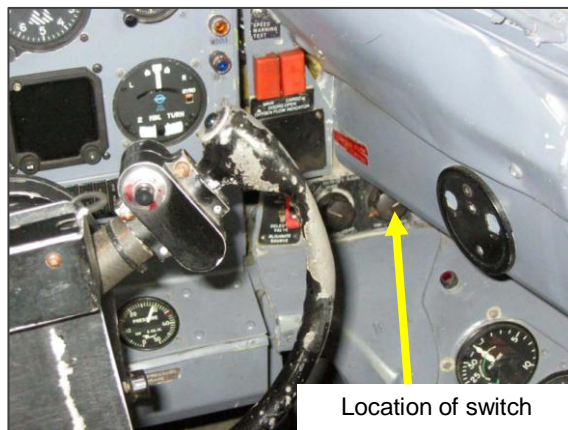
About 2 months prior to the incident, the aircraft was being operated on a night cargo flight. The pilot in command of this flight advised a Licensed Aircraft Maintenance Engineer (LAME) with aircraft electrical qualifications that the right red instrument panel light rheostat was not operating as expected. The defect was not recorded in the aircraft maintenance log.

**Figure 3: Location of right red instrument panel light switch**
