ATSB TRANSPORT SAFETY BULLETIN
Aviation Level 5 Investigations AB-2010-036
Final

Level 5 Factual Investigations: 1 April 2010 to 30 June 2010

Issue 2

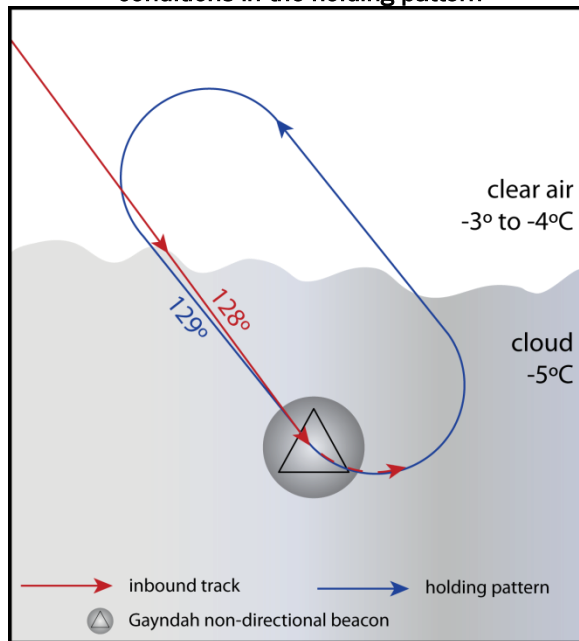
Figure 1: The inbound track and weather conditions in the holding pattern

The pilots reported that the air was clear at the northern end of the holding pattern and the air temperature was -3 to -4 degrees C. Icing conditions existed in the southern part of the pattern, which was in cloud with an air temperature of -5 degrees C.

The pilots noticed a build up of soft ice on the windscreen wipers and a dusting of ice on the leading edges of the wings. They discussed activating the de-ice boots, but decided not to. When they re-entered the clear air at the northern end of the holding pattern, they left the engine heat and propeller heat on.

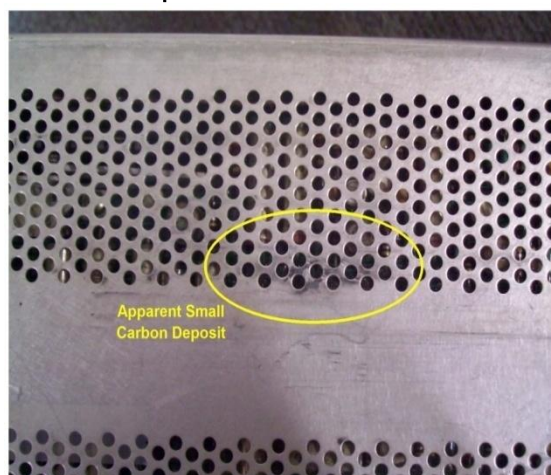
Figure 1: Indicator exterior casing small carbon deposit

The weather radar indicator was removed and a small carbon deposit was noticed on the exterior of the casing (Figure 1). The weather radar indicator was replaced in accordance with the aircraft maintenance manual and the aircraft was returned to service.

An inspection of the weather radar indicator confirmed that burning of a control circuit board had occurred, damaging the printed circuit board substrate. The damage was not the result of an aircraft system fault.

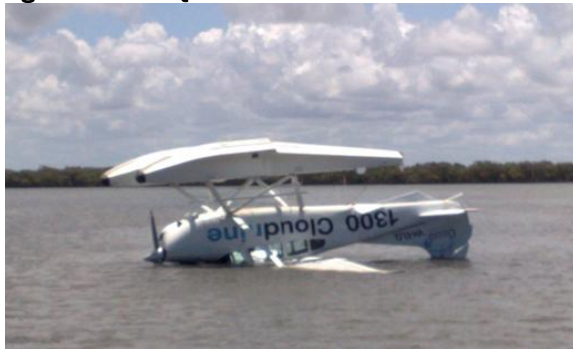
Figure 1: VH-ELQ

Shortly after, a crab pot was observed within the immediate vicinity of the aircraft. The pilot reported that it was likely that the crab pot became entangled around the aircraft's right water rudder during taxiing.

Shortly after, a crab pot was observed within close proximity to the aircraft. The pilot reported that it was probable that the crab pot had become entangled around the aircraft's right water rudder³,

An examination of the crab pot float and line by the Queensland Police Service determined that the float sustained damage consistent with the line being pulled with some force and subsequently, cutting into the foam structure. A grease-like substance and a number of indentations were also found on the float. These were compared with the surface of the aircraft's floats and found to be consistent. The Queensland Police investigation was, however, unable to determine where the contact was made, and for how long the crab pot was attached to the aircraft.
