Aviation Short Investigation Bulletin Fourth Quarter 2011

Issue 8

ATSB Transport Safety Report
Aviation Short Investigations
AB-2012-019
Final

AB-2012-019

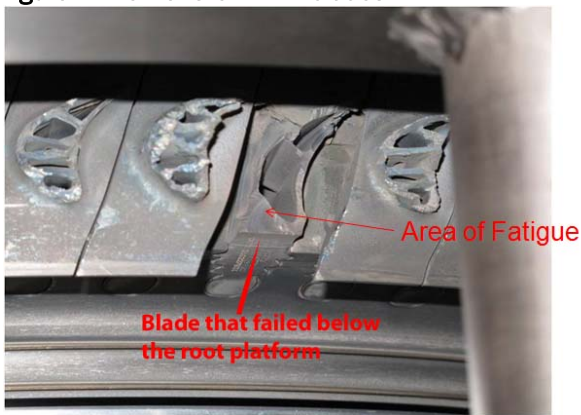
Figure 2: View of the HPT 1 blades

During the teardown examination, the LPT section proved difficult to remove due to case deformation. In the HPT module, four of the second stage blades had failed at $\frac{1}{3}$ or $\frac{1}{2}$ their height. All of that stage's blade shrouds were missing. Examination of the first stage of the HPT module found all of the blades had fractured. Further observation identified that only one HPT1 blade had fractured below its root platform (Figure 2). Microscopic examination revealed that blade's failure had initiated at the inner shank wall on the pressure side⁴.

The crack propagated via a fatigue mechanism through to the outer wall then spread laterally.

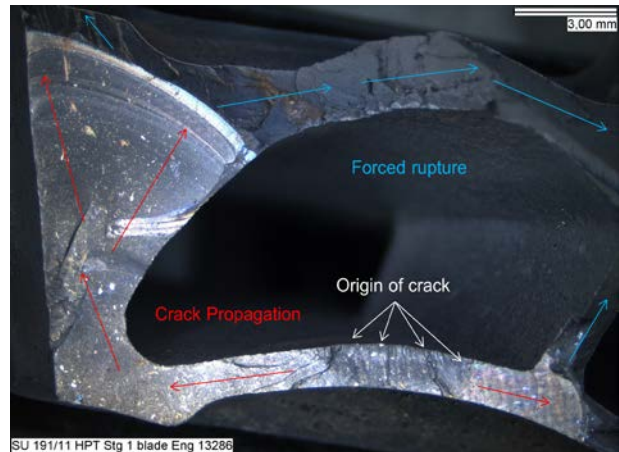
Figure 3: Micro-photo of crack surface

Final failure of the blade was through overload (Figure 3). The liberated blade created a domino effect on other blades and components, leading to an engine surge and damage extending into the engine compressor stages.

Failure initiation was considered to be driven by thermo-mechanical loads. The crack progressed due to a combination of these loads and the influence of corrosion/oxidation. The failure characteristics

were entirely consistent with those of previous HPT1 blades of this design standard.

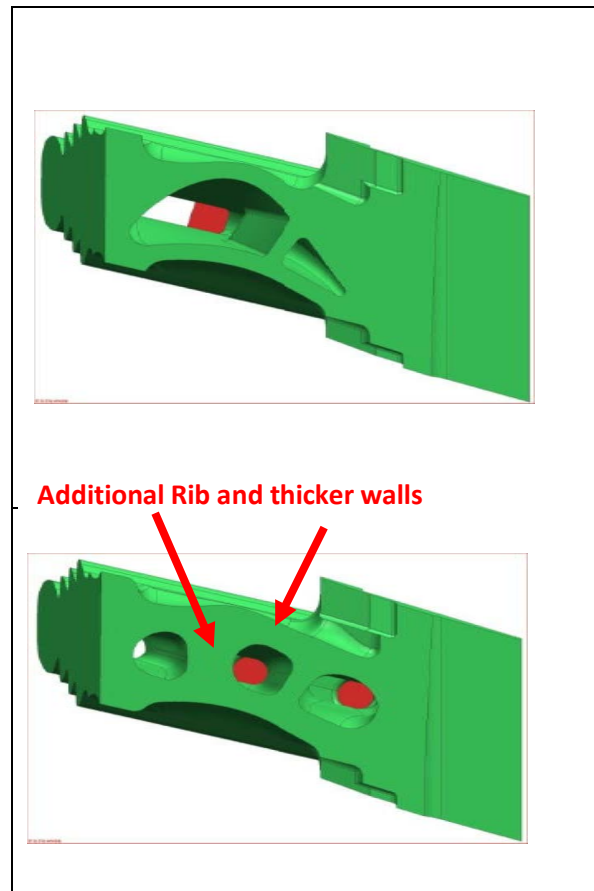
Figure 4: Cross-section of LIP standard (top) and Mk II standard (bottom) blades

A subsequent modification to the blades (designated 'Mk II') was introduced to lower the fatigue stresses within the blade, by adding a rib and increasing the shank wall thickness to further stiffen the cooling channel structure (Figure 4).

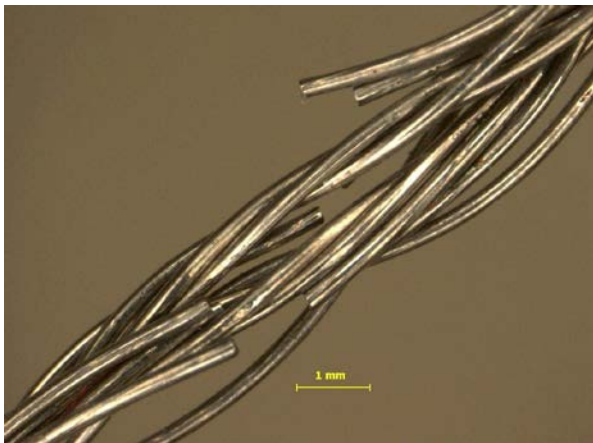
Figure 2: Overstress and fatigue fractures

A metallurgical examination of the cable conducted by the Australian Transport Safety Bureau (ATSB) revealed that the cable had failed through a combination of fatigue and overstress (Figure 2). While there was some evidence of pre-existing wear or fraying (Figure 3), this was considered normal.

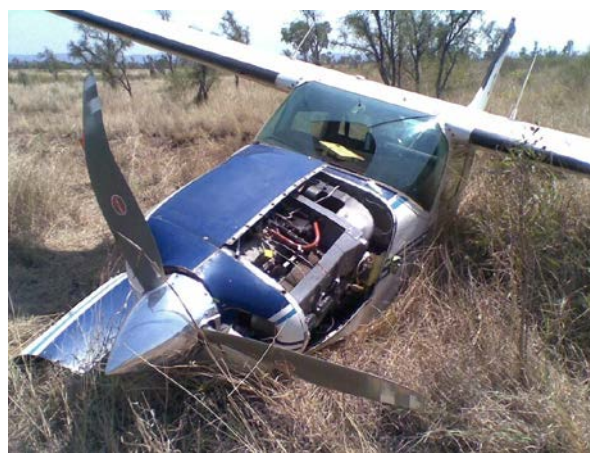
Figure 1: Accident site of VH-OCM

The operator examined the aircraft following the accident and found approximately 65 L of fuel in the right wing tank and 2 L in the left wing tank. No fuel was found in the fuel lines or in the fuel filter.

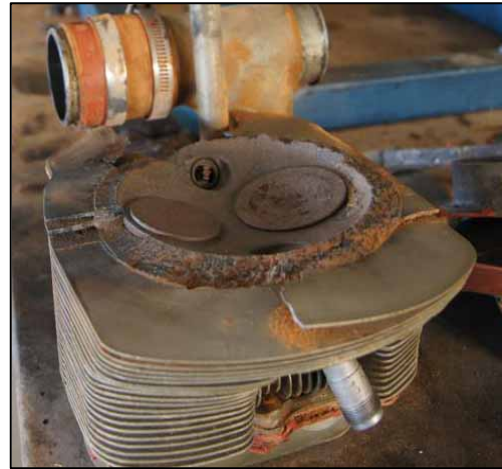
Figure 3: Failed number-4 cylinder

After all occupants had exited the aircraft, the pilot conducted a cursory examination of the engine and noted damage to the number-4 cylinder and its associated fuel injector.

The cylinder head and the fuel injector supply line had fractured and separated. The aircraft was eventually recovered and the engine removed for further examination.

circumference in the area of the cylinder head (Figure 3).

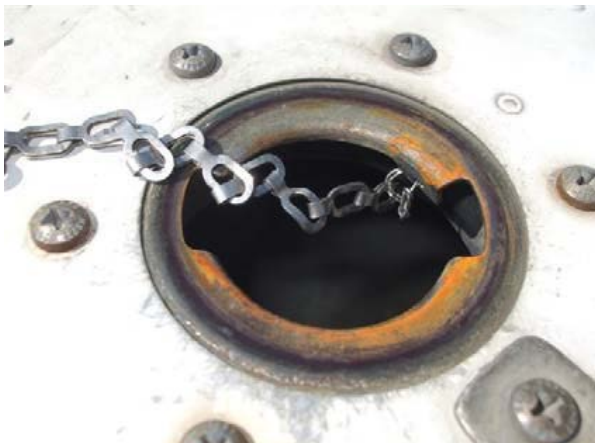
Figure 1: Right fuel cap receptacle

The right fuel tank receptacle lip showed signs of significant water contact in the form of surface rust (Figure 1). The receptacle was also found to be distorted, with the forward lip appearing to have been pushed down along its inner edge.

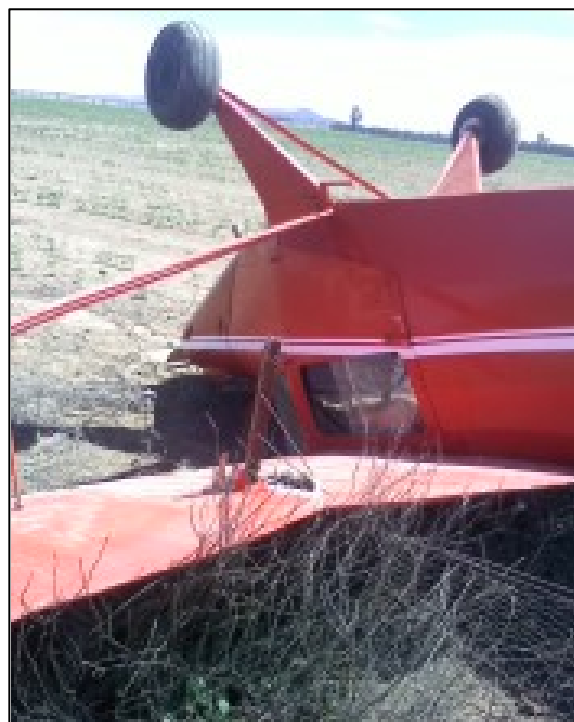
Figure 1: Wreckage close-up

The pilot was unable to regain control of the aircraft which subsequently struck a fence about 600 m down the runway on the left side of the runway and flipped over, coming to rest inverted. There were no injuries sustained, however, the aircraft incurred damage to the propeller, one wing strut and the wing surfaces (Figure 1).

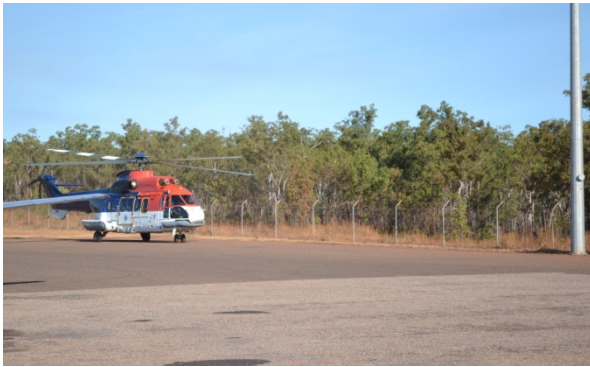
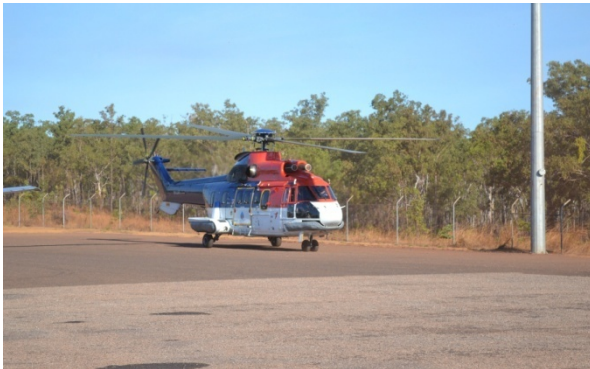
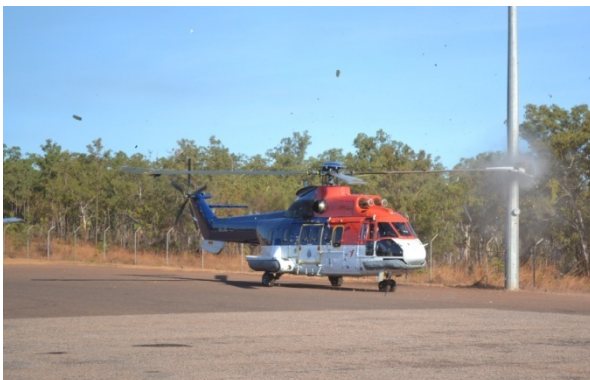
Figures 1, 2, 3: Accident sequence (Right wingtip of rear parked Metro appears in left of images)

Almost immediately there was a 'tick tick' sound then loud crunching sounds. The main rotor blades had struck the light pole (Figure 3) and started to break apart with debris flung about. The helicopter was rapidly propelled towards the light pole, toppling over onto its left side while vibrating vigorously and shedding blade debris in all directions.

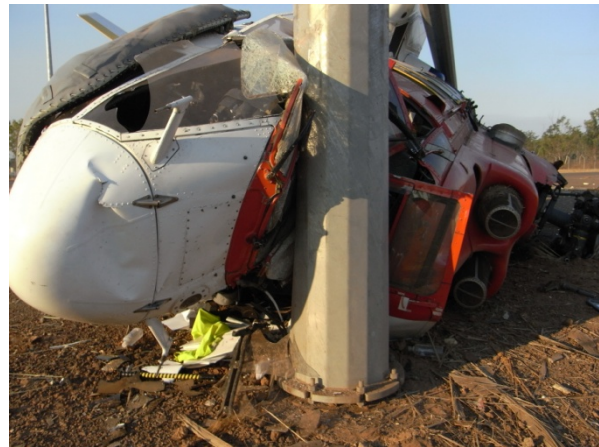
Figure 4: Helicopter wreckage

The priority for the PIC was to grab the overhead engine shutdown handles. But that was too difficult until the helicopter came to rest on its side (Figures 4 and 5). The PIC was then able to pull hard on the handle, successfully shutting down both engines.

The light pole bent where the main rotor blades had struck it. The upper section fell onto the helicopter with electrical wiring exposed, but unpowered. The left side of the cockpit was pushed inwards from contact with the light pole. The helicopter's tail section was also damaged.
