# Aviation Short Investigation Bulletin

Issue 9

AB-2012-044

**Publication date** 24 May 2012

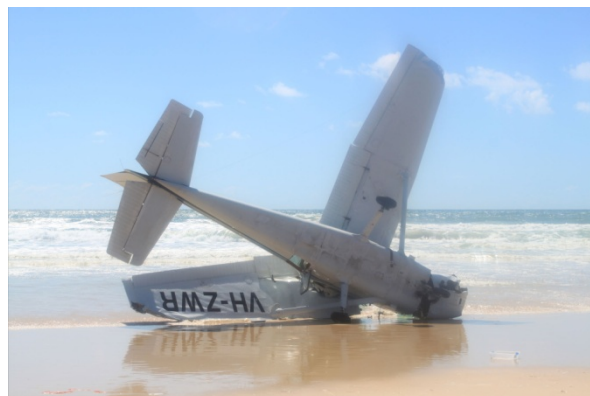
aircraft to a position above the high water mark, the aircraft was turned on its back by wave action.

**Figure 1: Aircraft shortly after the accident**
