Aviation Short Investigation Bulletin

Issue 17

AB-2013-050

Final – 23 April 2013

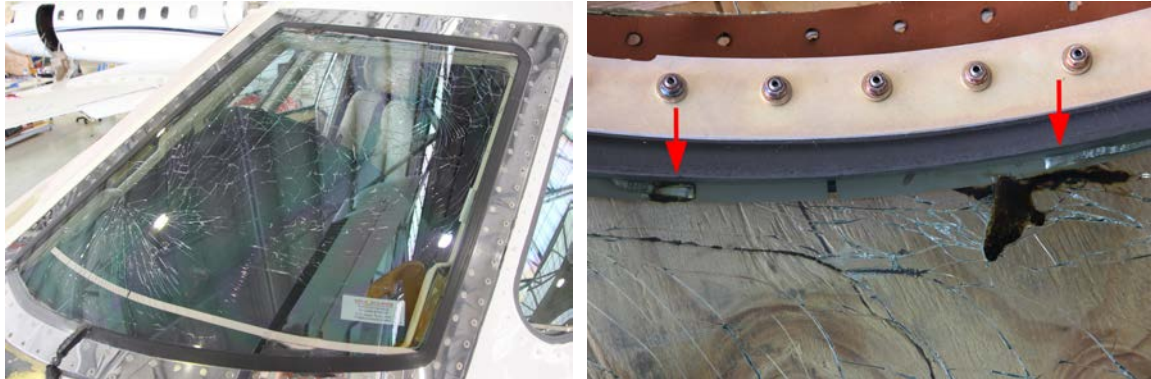
Figure 1: Shattered left windshield external (left) and internal (right)

The aircraft returned to Sydney on 26 January 2013 with no passengers on board. Subsequent examination of the left electrically heated glass windshield (part number 9914380-11) by the ATSB showed that the outer ply had shattered across the entire surface (Figure 1). A brown discolouration was observed towards the top right of the windshield (facing forward) along with staining around one of the soldered contacts (Figure 2). The damage was confined to the outer layer of the windshield.

A review of the aircraft maintenance documentation showed that the left windshield, serial number 05123H7884, had been installed on 5 July 2005 and had accumulated approximately 3,200 hours and 2,050 flight cycles since that time.

The windshield from VH-RCA had likely been affected by moisture ingress resulting in a degradation of the electrical connection between the bus bar and the heating film. The ATSB is satisfied that the issues leading to the non-structural failure of windshield part numbers 9914380-11/-12 have been addressed by the manufacturer.

The above changes were incorporated into part number 9914380-13/-14 which was released to service in early 2008. There have been no reported cases of either of these failure modes in the -13/-14 windshields.

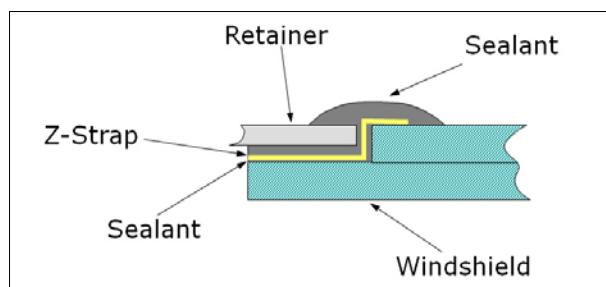
Figure 2: Schematic showing location of z-strap

The first issue was related to moisture ingress. Wear of the seal at the top of the windshield could allow moisture ingress to the bus bar and lead to degradation of the electrical connection between the bus bar and the heating film which could eventually begin to burn out. This could result in arcing that could eventually lead to failure of the outer non-structural face ply of glass. The manufacturer addressed the issue by adding a fiberglass z-strap along the boundary of the face ply to add an additional moisture protection layer and to also provide an indicator of seal wear.

The second issue was a breakdown of the bus bar at the bus bar solder joint as a result of differing thermal coefficients of expansion between the solder and bus bar material. Thinner bus bars (as a result of normal variation in production) were susceptible to progressively crack until the electrical circuit was opened and arcing began. The extreme heat and pressure build-up of locally vaporized interlayer material due to the arcing would then eventually lead to failure of the non-structural face ply. The issue was addressed by increasing the size and mass of the upper bus bar and moving it down sufficiently to allow for inspections if required.

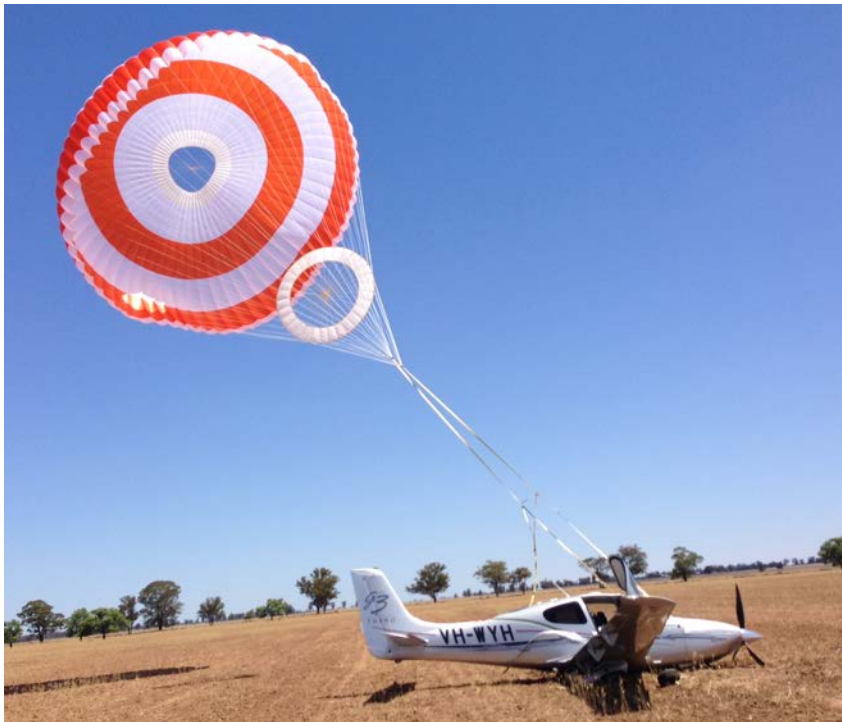
Figure 1: Parachute inflated at accident site

The pilot secured the cabin and about 16 seconds after the parachute deployed, the aircraft impacted the ground in a slight left wing low attitude (Figure 1). The pilot and passenger seat belt air bags deployed and the pilot and passenger exited through the passenger door. The pilot received minor injuries and the passenger was uninjured.

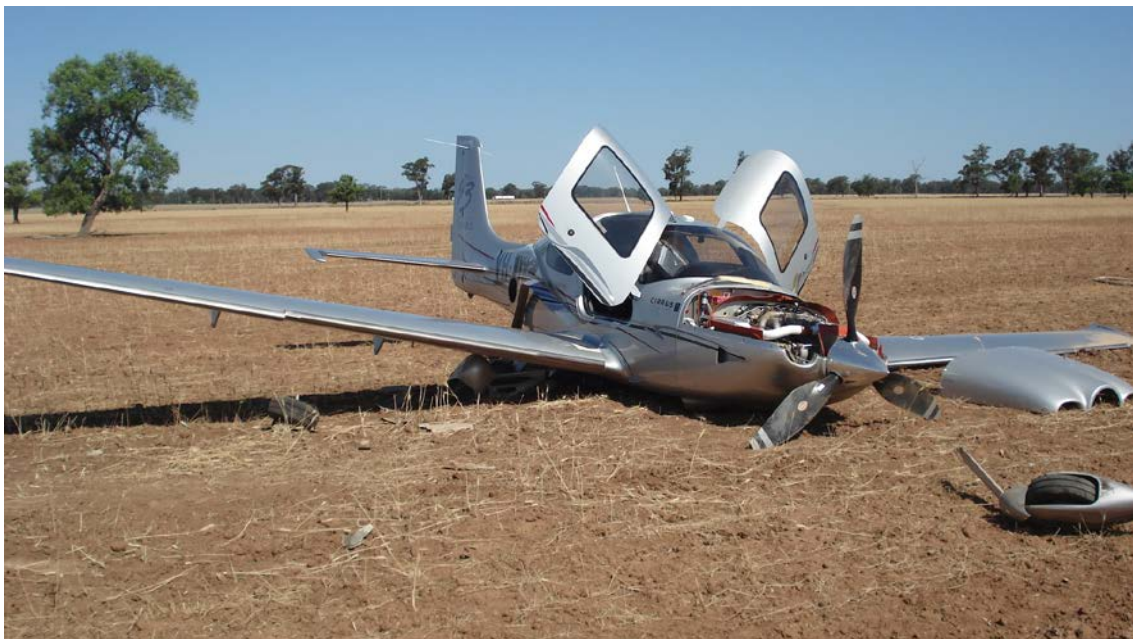
Figure 2: WYH at the accident site

The pilot inspected the paddock after the accident and found that it was very uneven with contour banks that were not visible from the air. The pilot believed that a safe landing on the landing gear would not have been possible.

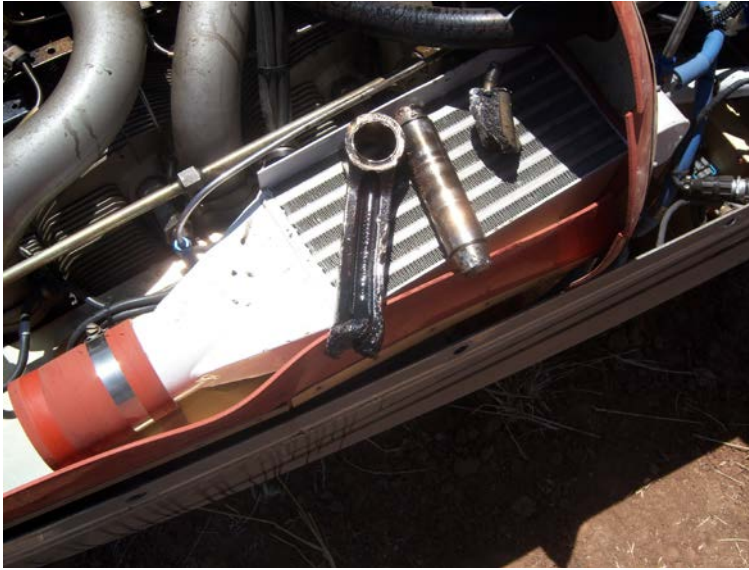
Figure 3: Engine number two cylinder failed parts

The engine was removed and examined at an engine overhaul facility. The inspection revealed that the number two cylinder connecting rod (Figure 3) had separated from the crankshaft due to extreme heat and ruptured the crankcase. A detailed examination did not identify any external oil leaks or internal defects that were not as a result of the lack of oil. 2.1 quarts of oil was drained from the engine sump.

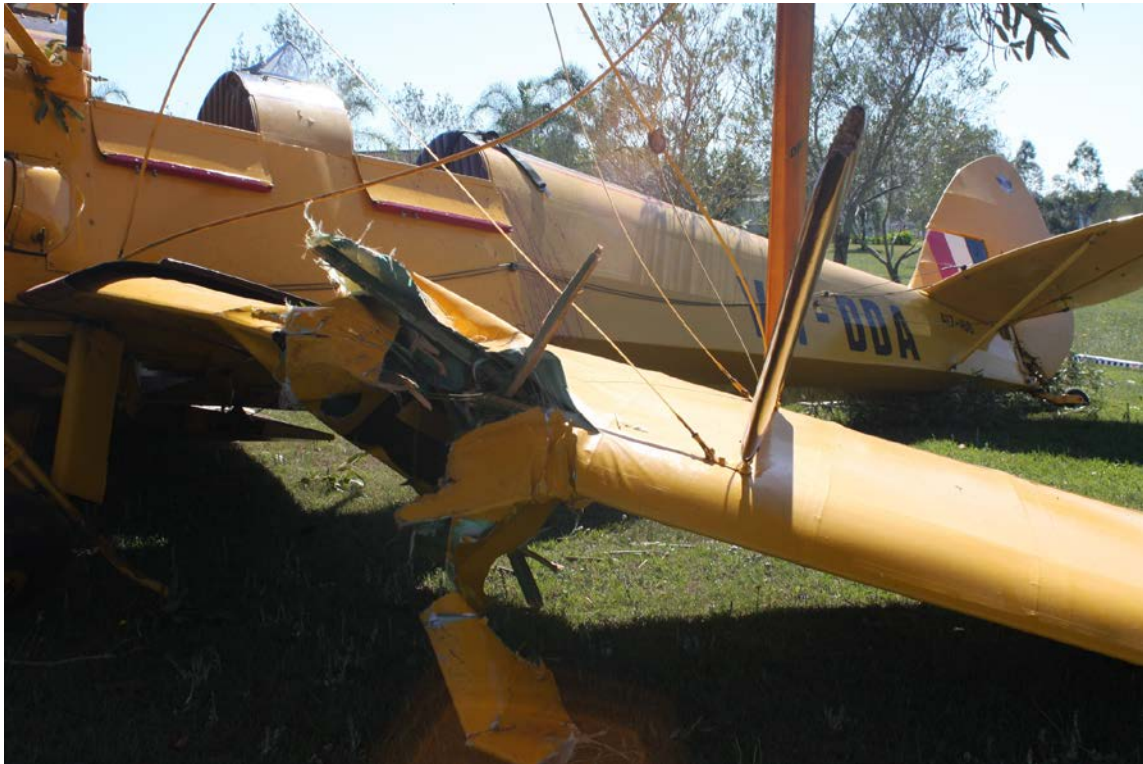
Figure 1: Damage to left wing following impact with a tree

A small fire caused by a fractured fuel line was quickly extinguished by ground crew and the aircraft sustained substantial damage.

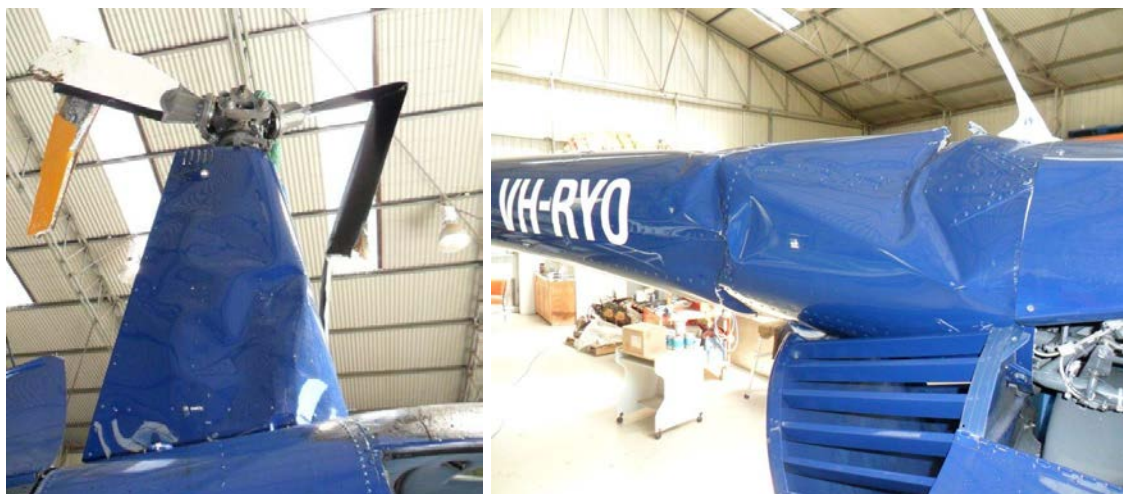
Figure 1: Helicopter damage

A witness reported hearing the rotor RPM behaving erratically and observing the helicopter pitching and rolling. The tail boom contacted the ground several times and the helicopter then rotated around the tail and came to rest on its right side.
