Separation issue involving a Cessna 208, VH-LNH, and a Cessna 207, VH-WOX

near Kununurra, Western Australia, 15 May 2015

ATSB Transport Safety Report
Aviation Occurrence Investigation
AO-2015-050
Final – 27 August 2015

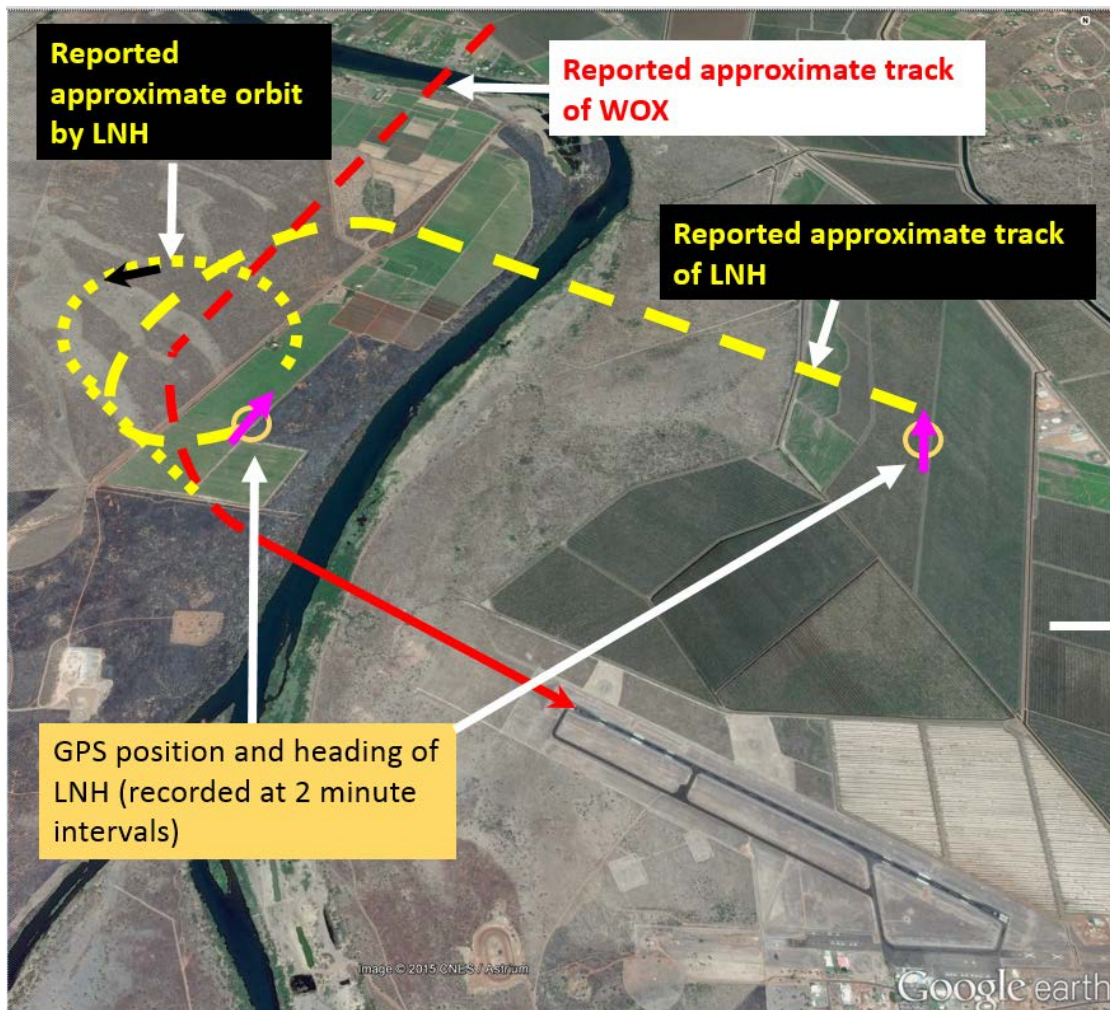
Figure 1: Kununurra aerodrome with the approximate aircraft tracks

At about 0812,¹ when about 5 NM from the airfield on an extended base leg, the pilot of WOX broadcast that they had completed airwork and were tracking to join on base for runway 12 (Figure 1). At the time, the first of the Caravans had landed and the pilot of the second Caravan, then ahead of WOX, had broadcast turning base. About 10 seconds later, LNH broadcast joining midfield crosswind. Eight seconds after the broadcast from LNH, the pilot of WOX reported being about 2 NM from the runway, on base leg. The pilot of WOX then broadcast that they had both the aircraft ahead on final approach, and LNH abeam WOX and turning downwind, in sight.

At about 0813, the pilot of WOX turned onto final for runway 12 and broadcast doing so. The Caravan ahead had landed and cleared the runway. LNH did not broadcast turning base and the pilot of WOX assumed that LNH was then still well behind WOX. When about three quarters of the way through the continuous left turn from downwind and approaching the final leg, the pilot of LNH configured the aircraft for landing and selected full flap. At that time, the pilot of LNH reported hearing WOX broadcast turning final. A few seconds later, the pilot of LNH sighted WOX ahead, to the right, slightly above, and in close proximity to LNH. The pilot of LNH then continued a steeper left turn to increase separation with WOX. As the aircraft turned to the north-east, the pilot of LNH sighted a company aircraft on downwind and at about 0815, broadcast conducting a left orbit. The pilot of LNH also asked the pilot of the following aircraft to conduct an orbit to increase separation between those two aircraft.
