Avoidable Accidents No. 6

# Experience won't always save you

Pilot experience is not always a protection  
against an accident

Research  
AR-2012-035

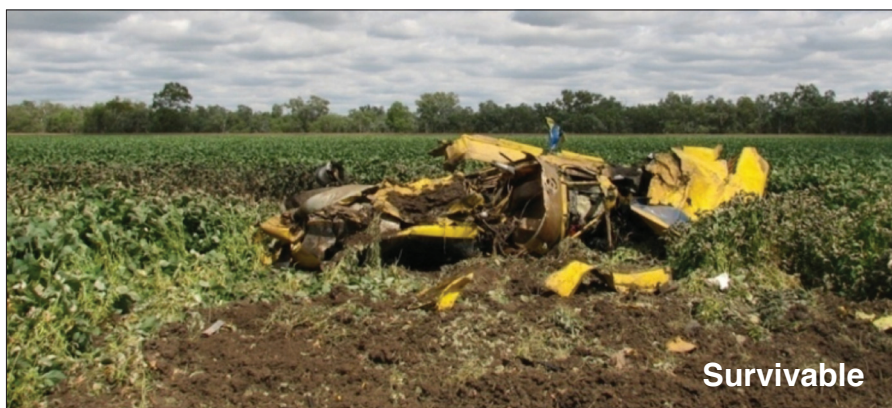
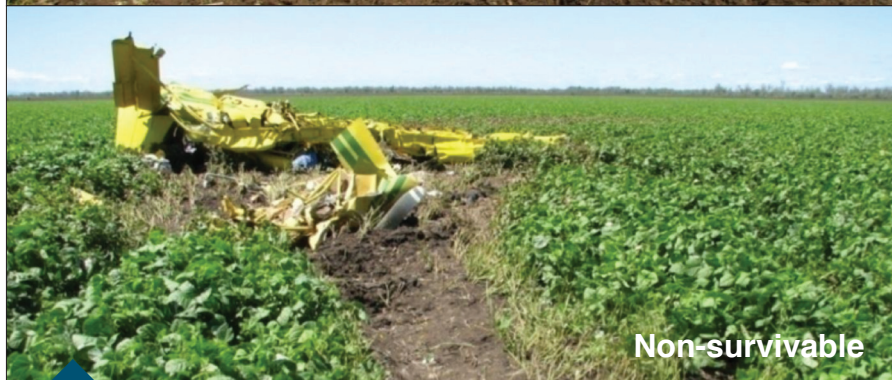
The two aircraft as they came to rest in adjoining fields

Although visibility at the time of the accident was reported as 'good', neither pilot had seen the other aircraft in sufficient time to avoid a collision. Agricultural pilots engaged in aerial application a few metres above the ground have no opportunity to visually scan for conflicting traffic. Even during procedure turns, where the aircraft is at 200 to 300 ft above ground level, pilots are concentrating on accurately aligning the aircraft for the next swath run and are not looking around for other aircraft. Basically, they rely on pilots of other aircraft to remain clear of their application area during aerial spraying operations.

The pilot of the departing aircraft did not know that the other pilot intended spraying operations near his airstrip that morning and unfortunately neither he, nor his loader, had seen or heard the aircraft operating nearby. He had kept his aircraft's engine running during the turnaround, while both he and his loader attended to refuelling and replenishing the aircraft. Consequently they did not see or hear the aircraft spraying nearby, in the direction of his intended flight path. The pilot may have thought that the possibility of a traffic conflict was unlikely because he was not operating near the end of the runway of the other operator's airstrip. Unfortunately experience does not compensate for a lack of situational awareness.

The midair collision rendered both aircraft completely uncontrollable and no amount of flying skill would have enabled either pilot to regain even some semblance of control in order to survive a ground impact. It was just by chance that one aircraft impacted the terrain in such a way that its structure afforded a survivable impact and the other aircraft did not. Although with any severe impact, the ability of a human body, even one fully restrained and protected, to withstand the deceleration forces depends on the health, fitness, strength and age of the person.

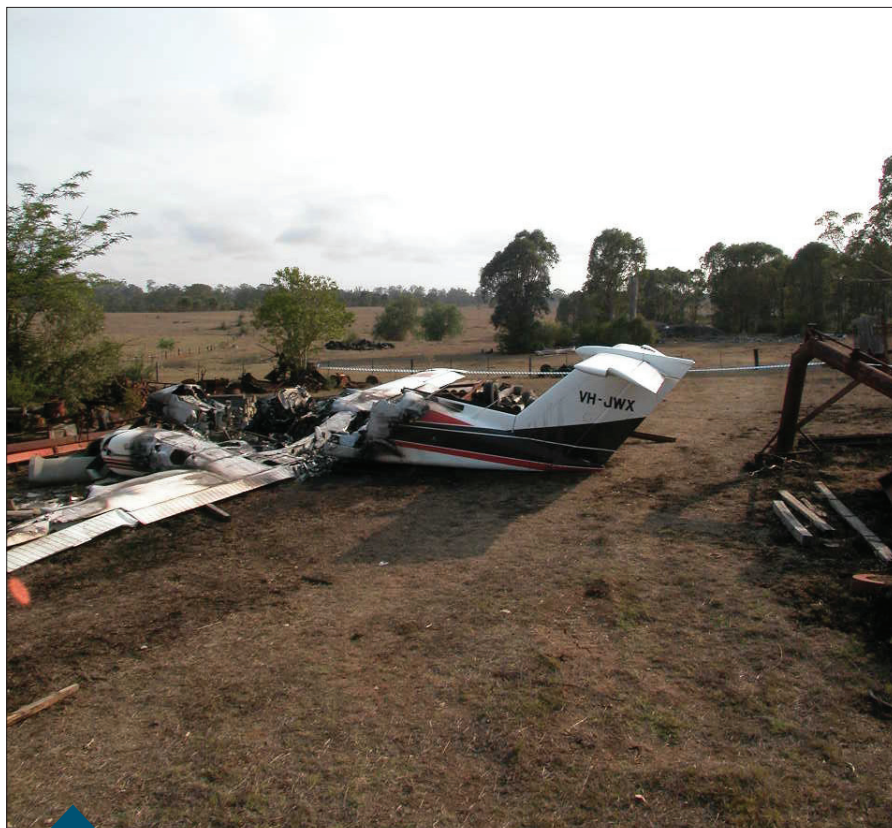
The burnt remains of the Duchess

The investigation determined that the simulated engine failure was conducted from a height where it was not possible to ensure a safe flight path, because visual reference with obstructions could not be achieved. In darkness there was insufficient illumination to see and avoid obstructions. By the time the ATO restored full power to the other engine, the aircraft had diverged from the runway centreline and it was too low to avoid a collision with a tree that was well outside the obstacle clearance surface for that runway.

The investigation found that simulated engine failure at night at low-level was contrary to the pre-flight briefing given by the ATO and was also contrary to the *Aeronautical Information Publication* that provided guidance recommending against low-level asymmetric operations at night. That safety advice resulted from a number of previous fatal accidents that occurred during low-level, asymmetric, night training.

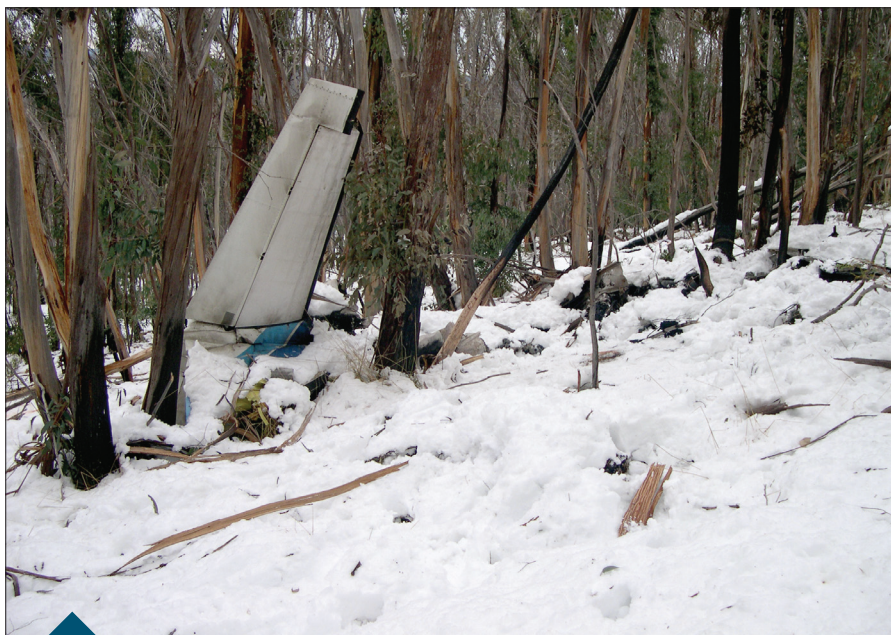
The snow-covered wreckage of the Piper Chieftain

Subsequent attempts to contact the pilot by radio were also unsuccessful and a search was commenced. Because of hazardous weather conditions over the following two days, the search for the aircraft was primarily conducted on foot and horseback. The aircraft was located on a tree covered ridge, partially covered by snow. It had flown into trees in a level attitude, slightly banked to the right. Initial impact with the ridge was at about 200 ft below the elevation of the Mount Hotham aerodrome.

The aircraft had broken into several large sections and an intense fire had consumed most of the cabin. The occupants had been fatally injured. The investigation determined that the aircraft systems had been operating normally. The aircraft was not equipped for flight in icing conditions, nor had the pilot flown in accordance with the instrument approach procedure.

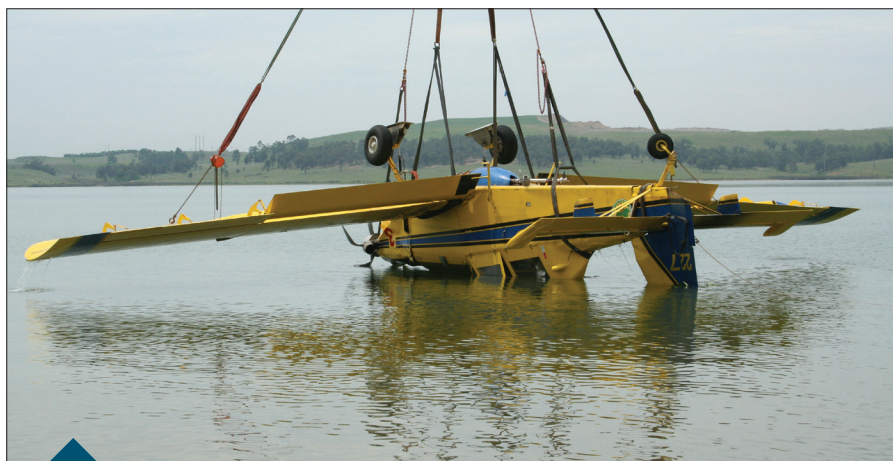
The investigation concluded that the right experimental ski breached the surface of the water which caused a substantial amount of drag to act on the right side of the aircraft, and as a consequence, it became uncontrollable.

The investigation also found that the process of the development and testing of the skis lacked appropriate consideration of risk and was a factor in the development of

The damaged aircraft during recovery from the lake

this accident. The project had been managed by the pilot, with minimal input from an aeronautical design engineer. As project manager, the pilot ignored several suggestions and warnings about the design and testing of the experimental water collection system made by his own staff, the design engineer and the Civil Aviation Safety Authority.

The lack of any risk assessment for the concept, design and testing of the water recovery system, despite the inherent risks involved, was a significant shortcoming in the process. That omission was directly attributed to the desire of the pilot to progress the development of the skis quickly, using mostly empirical methods. Furthermore, basic rescue equipment and trained water rescue personnel were not present for the water tests conducted on the lake.

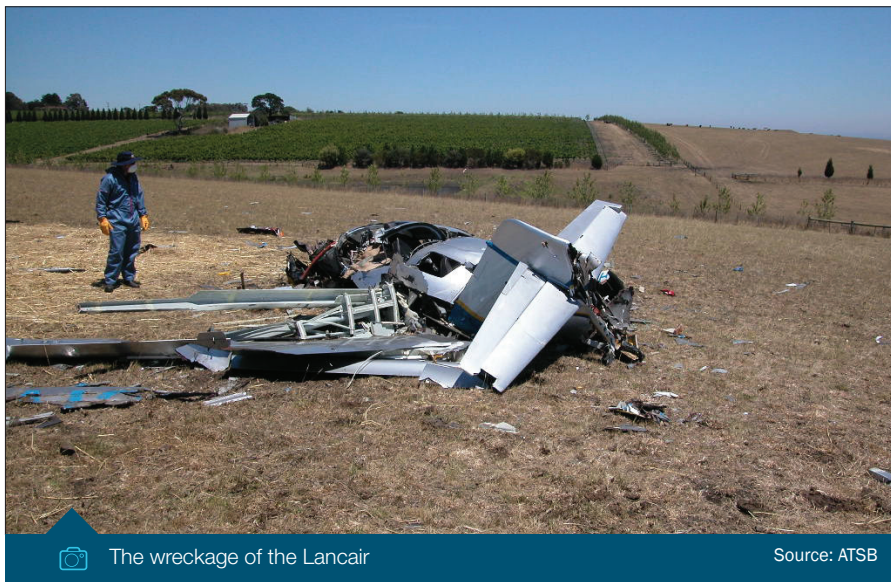
Recorded flight data from recording devices aboard the aircraft indicated that the aircraft had entered a stall at an altitude of 6,200 ft and rolled at the initiation of the stall. It continued to roll as it descended rapidly, accelerating to approximately 150 kts and descended at an angle of approximately 40 degrees from the horizontal, with low engine power that increased shortly before the aircraft impacted the ground.

The Lancair IV kit plane had been extensively modified from the original kit. The owner/builder replaced the high-performance piston engine with a turbo-propeller engine and had sought assistance from a number of people to redesign the aircraft to accommodate the new engine installation. During construction, the experimental designation concept was developed and the aircraft construction was subsequently changed and completed in accordance with the 'Experimental' designation that required less design justification for the changes. Those changes included a reduction in length to the three propeller blades and repositioning the wing further rearwards. Those design changes were likely to have changed the performance and handling characteristics of the aircraft, the cumulative effect of which would have been almost impossible to predict without the benefit of a skilled aeronautical engineering team.

The wreckage of the Lancair

Although a flight test schedule had been developed in accordance with the guidelines recommended in the test flight Advisory Circular produced by the Civil Aviation Safety Authority, there was no evidence that any significant re-evaluation of risk had been made during subsequent flight testing. Such a risk assessment process could have examined the results of test flights for hazards that became apparent from analysis of the observations and data from the previous flights.

The investigation found no evidence that any significant risk assessment was undertaken during construction of the aircraft and in the development of the test flight program.

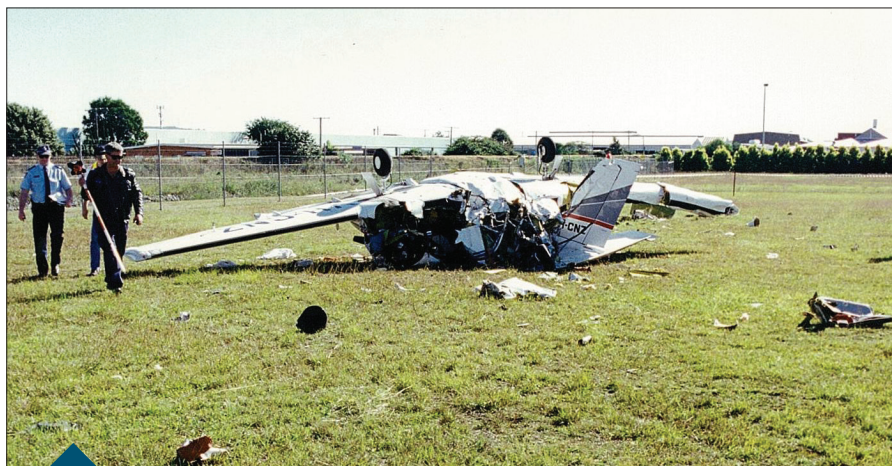
The two left fuel caps were later found along the runway and the investigation found that neither had been secured after the refuelling. The refueller reported that after filling the tanks he had placed the caps in the filler necks but not secured them and informed one of the pilots present that the caps were not secured.

The wreckage of the Piper Twin Comanche

The aircraft had impacted the ground inverted and rolling to the left. Ground contact marks and the condition of the propeller blades indicated that the right engine was developing significant power at impact while the left propeller was rotating at impact but that the engine was not developing power. The landing gear was locked in the extended position and the wing flaps were fully retracted - the takeoff configuration. There was no evidence of fire in the left engine.

While an unsecured fuel cap should have been detected and secured before flight, failure to do so should not have led to an accident with such tragic consequences. The investigation was unable to determine which pilot had been flying the aircraft but regardless of that fact, either pilot should have been able to handle the situation. The loss of fuel from an unsecured fuel cap did not represent an impending emergency, and required the pilot flying to either immediately reject the takeoff or continue the takeoff and climb to a safe height and speed. In any event, there was nearly 800 m of runway and overrun ahead on which to land before the aerodrome boundary.

Although the controller reported the problem to the pilots using the word 'smoke', the pilots should have been able to visually determine that the cause was not an engine fire, but fuel being siphoned from the open filler necks. Although it could not be determined if the mention of 'smoke' might have generated a conviction that the aircraft was on fire, the pilot's subsequent response was inappropriate. The left turn resulted in a turn away from the operating engine and with the aircraft not configured for optimum engine-out performance (the left propeller not feathered and the landing gear extended). Attempting to turn a multi-engine aircraft at a very low altitude and toward the inoperative engine is especially hazardous. The final flight path and impact attitude of the aircraft were consistent with what might be expected following loss of control when airspeed is allowed to decay below the minimum single engine control speed.
