TECHNICAL ANALYSIS REPORT

Report No. 20/02

Examination of a Failed Rolls-Royce RB211-524 Turbofan Engine

Boeing Commercial Aircraft Group, 747-436, G-BNLD

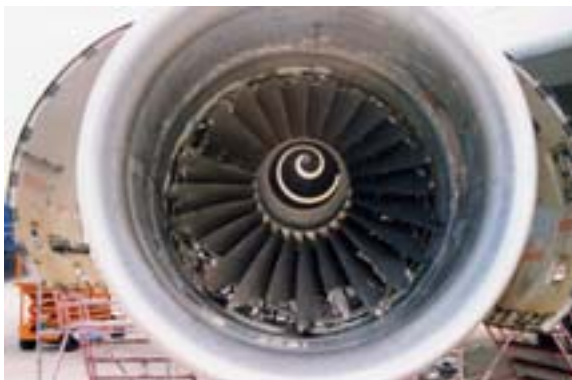
All low-pressure compressor (fan) blades showed severe mechanical damage and break-up of the tips and outer half of the blade lengths (figure 1). The leading edges sustained multiple chips and indentations consistent with debris impact (figure 2). A single fan blade (number 9) from the assembly of twenty-four had fractured from a position beneath the rotor annulus filler plates (figure 3), releasing the full aerofoil length from the rotor hub. Three other blades (numbers 13, 16 and 18) had lost substantial portions of their outer length, exposing the internal cavities and the honeycomb matrix filler (figure 4). The attrition liner normally present around the inside circumference of the fan shroud had completely worn away during the event, exposing the steel backing (figure 5). The primary impact point of the fractured blade was found at the one o'clock position (looking rearward) and presented as a large, linear indentation with an orientation matching the pitch angle of the blade tips (figure 6). The fan shroud had not sustained any punctures, damage or other evidence of a failure to contain the blade fragments.

Fig. 1. General view into the intake of the number-3 engine of G-BNLD after the blade failure.

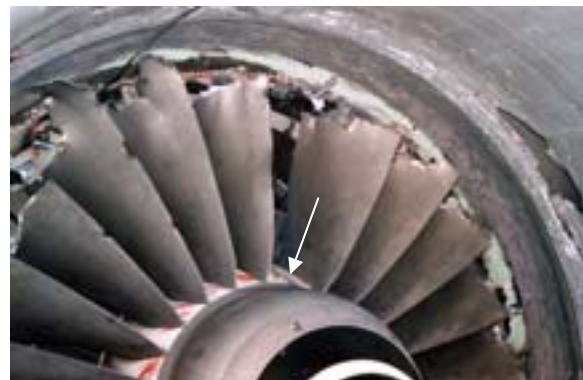
Fig. 2. Typical damage sustained by the engine fan (low-pressure compressor). Position of the failed blade is arrowed.

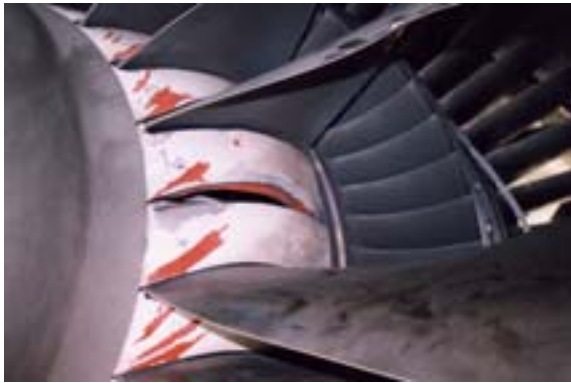
Fig. 3. View showing the fan rotor annulus filler plates around the failed blade position.

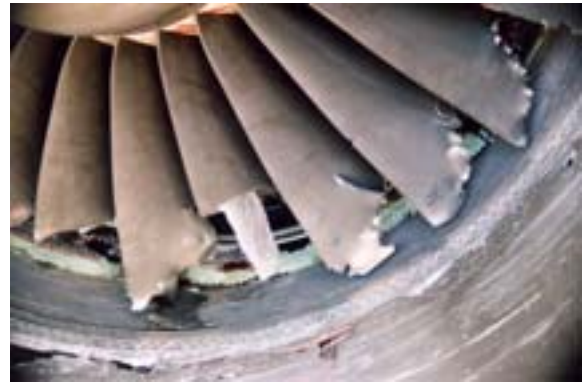
Fig. 4. Damage sustained by the fan blades – many had fractured through the internal cavity.

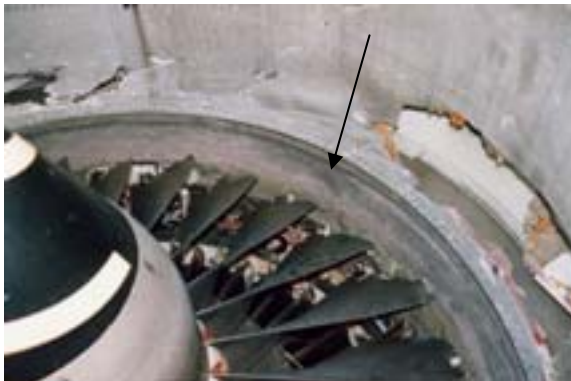
Fig. 5. View of the fan containment shroud showing the released blade impact point.

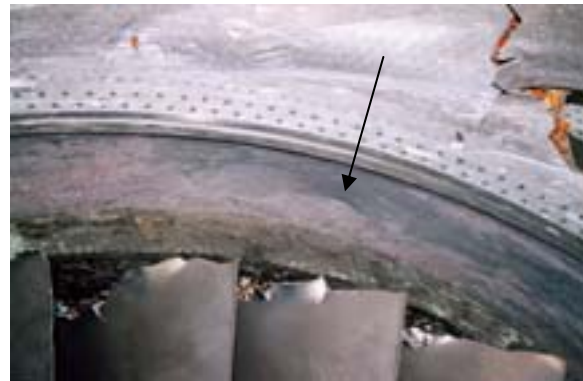
Fig. 6. Closer view of the blade primary impact point. Alignment with the blade pitch angle can be seen.

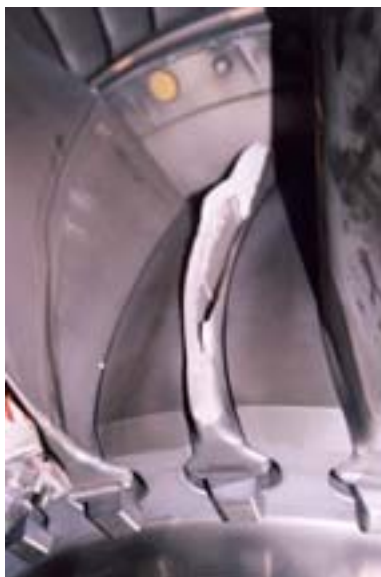
Disassembly of the fan centrebody assembly and removal of the annulus filler plates allowed the full width of the fractured number-9 blade to be examined. At the blade forward (leading) edge, the failure had occurred flush with the cylindrical surface of the rotor hub and tapered outward; ending approximately thirty millimetres above the hub at the rear (trailing) edge (figure 7). After removing the clamping ring, the blade stub and adjacent blades were easily removed from the rotor, with no significant seizure or lock-up noted (figure 8). The inside of the clamping ring showed evidence of impact against the forward end of the number-10 blade root block (figure 9); this blade being the trailing blade immediately behind the failed item.

Fig. 7 **Left** - Fractured blade stub after removal of the annulus filler plates.

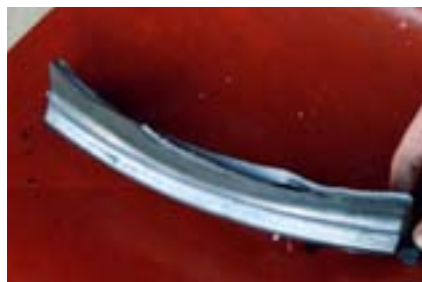
Fig. 8 **Top Right** – Blade stub after removal from the rotor disk.

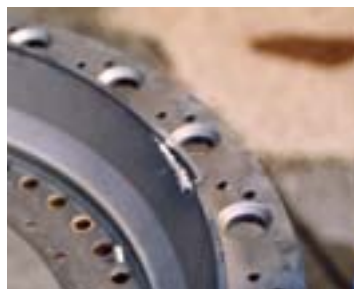
Fig. 9 **Bottom Right** – Blade retaining ring showing impact damage from the blade behind the failed item.

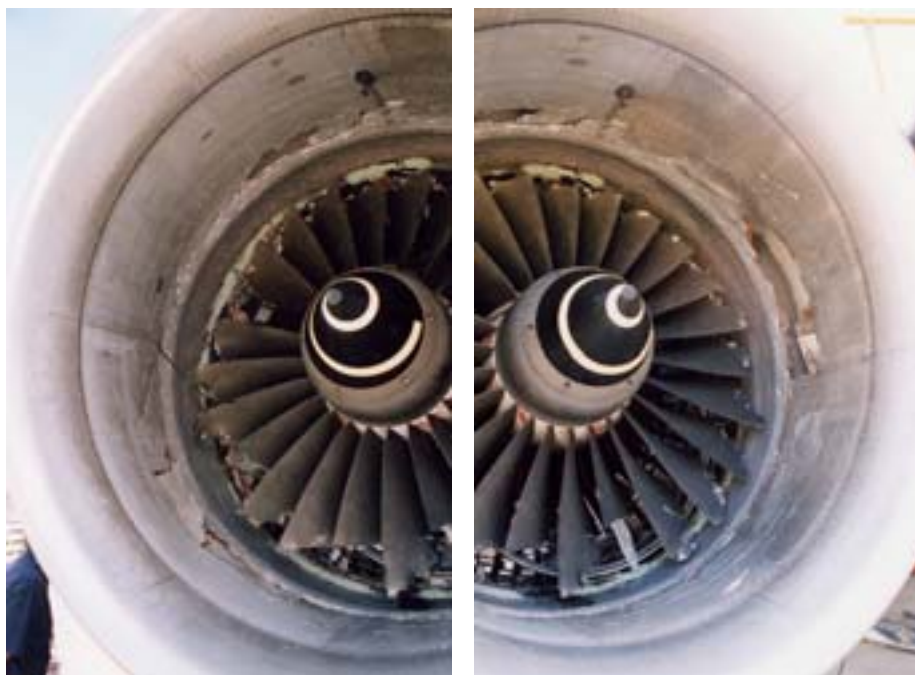
The intake (nose) cowl of the number-3 engine had been extensively damaged as a result of the engine failure. Internally, three dominant areas of major disruption and tearing of the acoustic lining were apparent, with each extending through to the external panels of the cowl. Figures 10 and 11 show the general level of damage sustained inside the engine intake. The three areas of major disruption were measured and characterised as follows. Figure 12 shows the locations as identified.

Figs. 10 & 11.
 General view of the intake cowl inner walls.

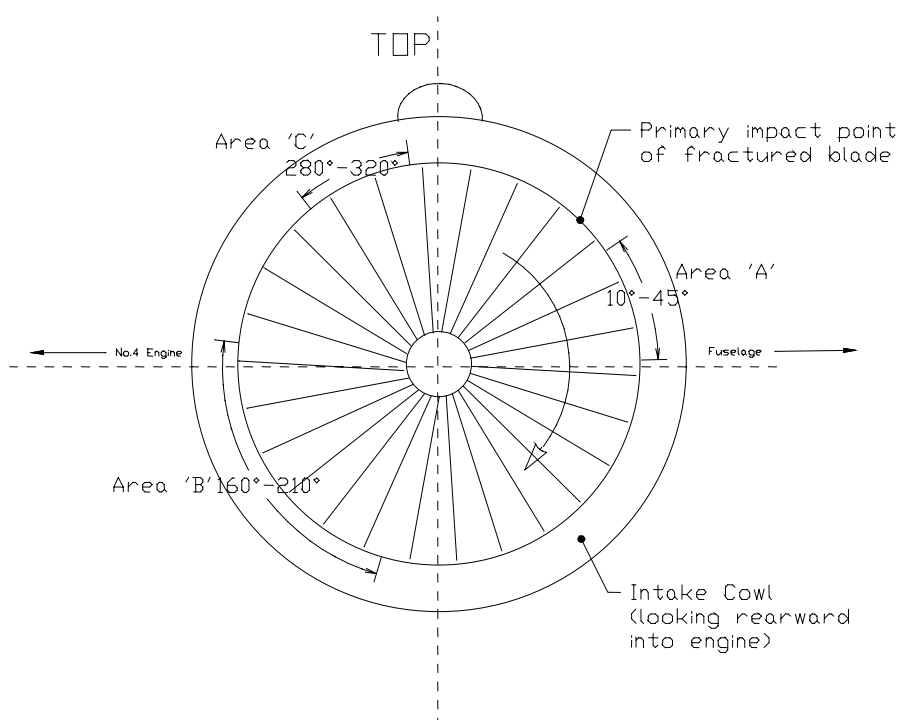
Fig 12 (Below)
 Illustration of the three principal areas of major perforation damage sustained by the intake cowl.

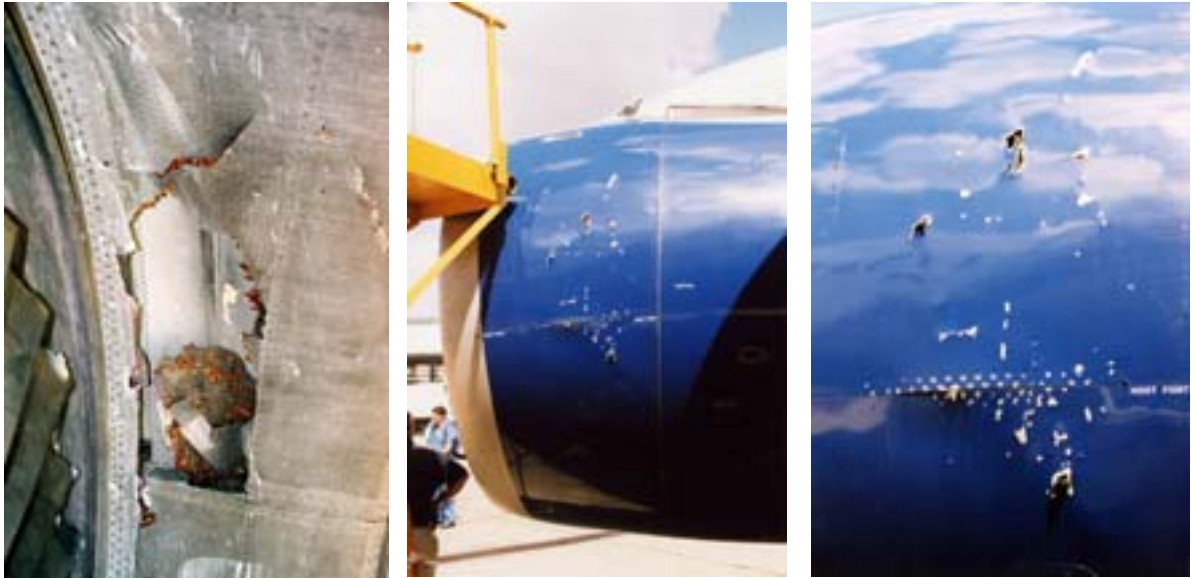
- Area ‘A’ 10° - 45° from primary impact point.

This damage presented as a punctured and impressed area of acoustic panelling measuring 88 x 35 centimetres, located between the fan case flange and the first circumferential intake cowl bulkhead (figure 13). The location of the damage corresponded with an area of multiple small punctures and indentations of the outer cowl skin on the left side of the engine (figures 14 & 15). An axial rivet line along an internal member had separated along a length of around 30 centimetres.

Figs. 13, 14 & 15. Damage sustained by left side of the intake cowl (Area A) – several minor punctures and the separation of the axial riveted seam.

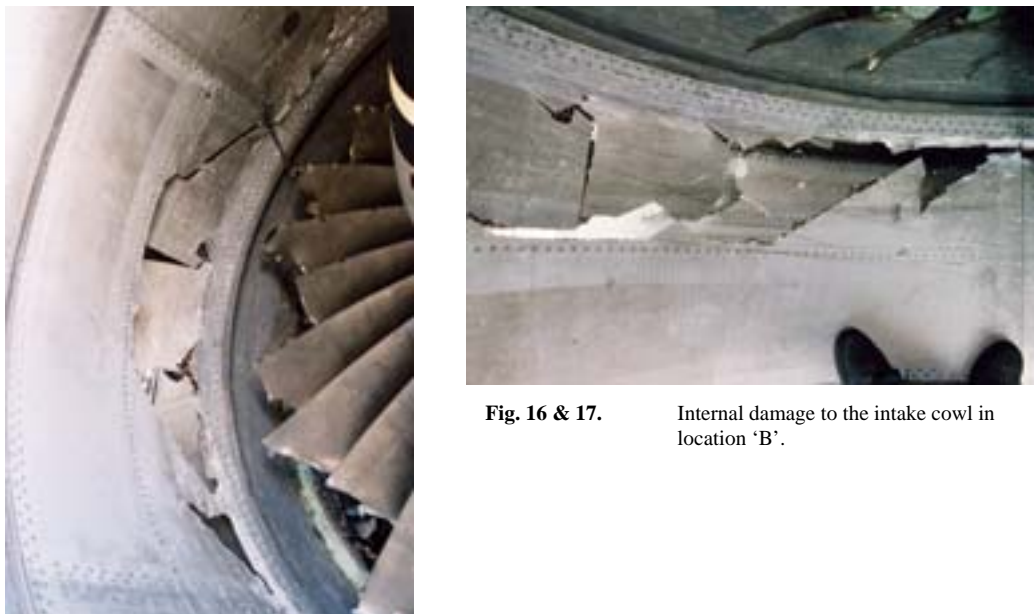
- Area ‘B’ 160° - 210° from primary impact point.

A larger area of damage similar to area ‘A’, measuring 130 x 26 centimetres and again located between the fan case flange and the first cowl bulkhead. Several large angular cuts in the internal acoustic lining characterised this area of damage (figures 16 & 17). Externally, the escaping fragment/s had torn away a large irregular area of cowl skin measuring 131 x 60 centimetres (figures 18 & 19), exposing the internal cowl void and the internal surfaces of the damage acoustic linings.

Fig. 16 & 17. Internal damage to the intake cowl in location ‘B’.

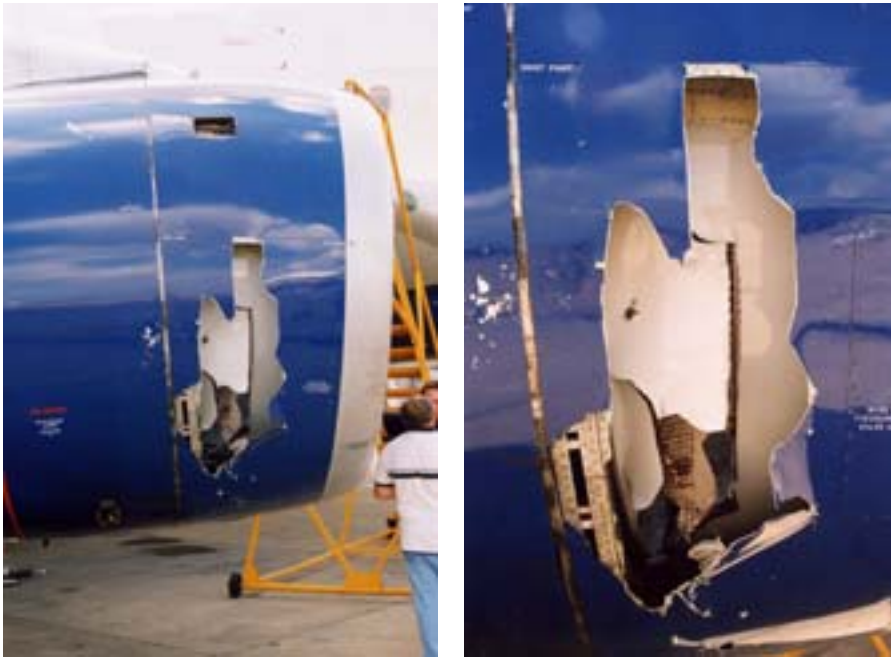
Figs. 18 & 19. External damage to the right side of the intake cowl.

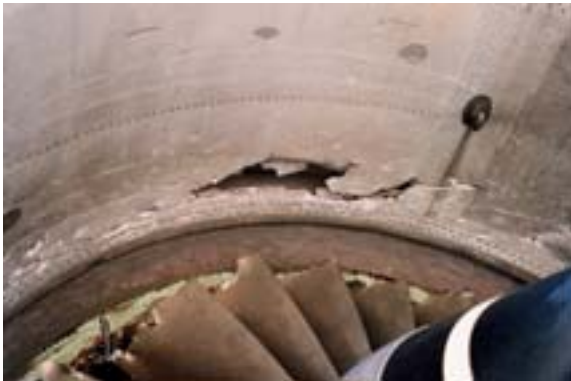
Fig. 20 (Top Left).

Damage to the upper internal surface of the intake cowl.

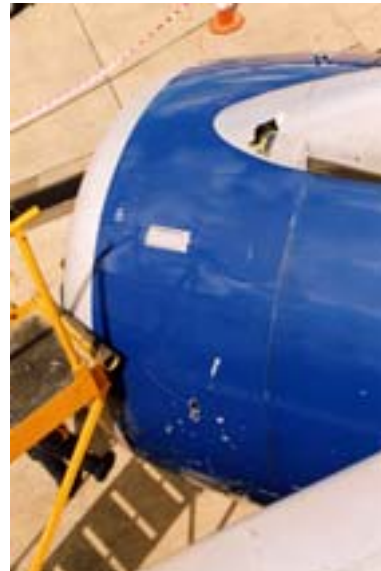
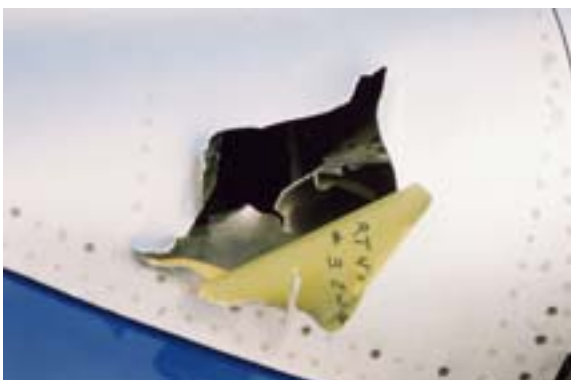
**Fig. 21 (Top Right)
Fig. 22 (Bottom Left)**

The smallest of the three major regions of damage, this area measured 75 x 15 centimetres and presented as a ragged tear within the acoustic liner adjacent to the inlet air probe body (figure 20). The passage of an energetic debris fragment through this area was evident from the ruptured engine strut forward fairing (figure 21) and the cowling skin beneath (figure 22). The debris damaged several wiring loom sections located within the fairing – those are detailed in section 1.6.

Perforation damage produced by debris travelling through the intake cowl and pylon forward fairing.

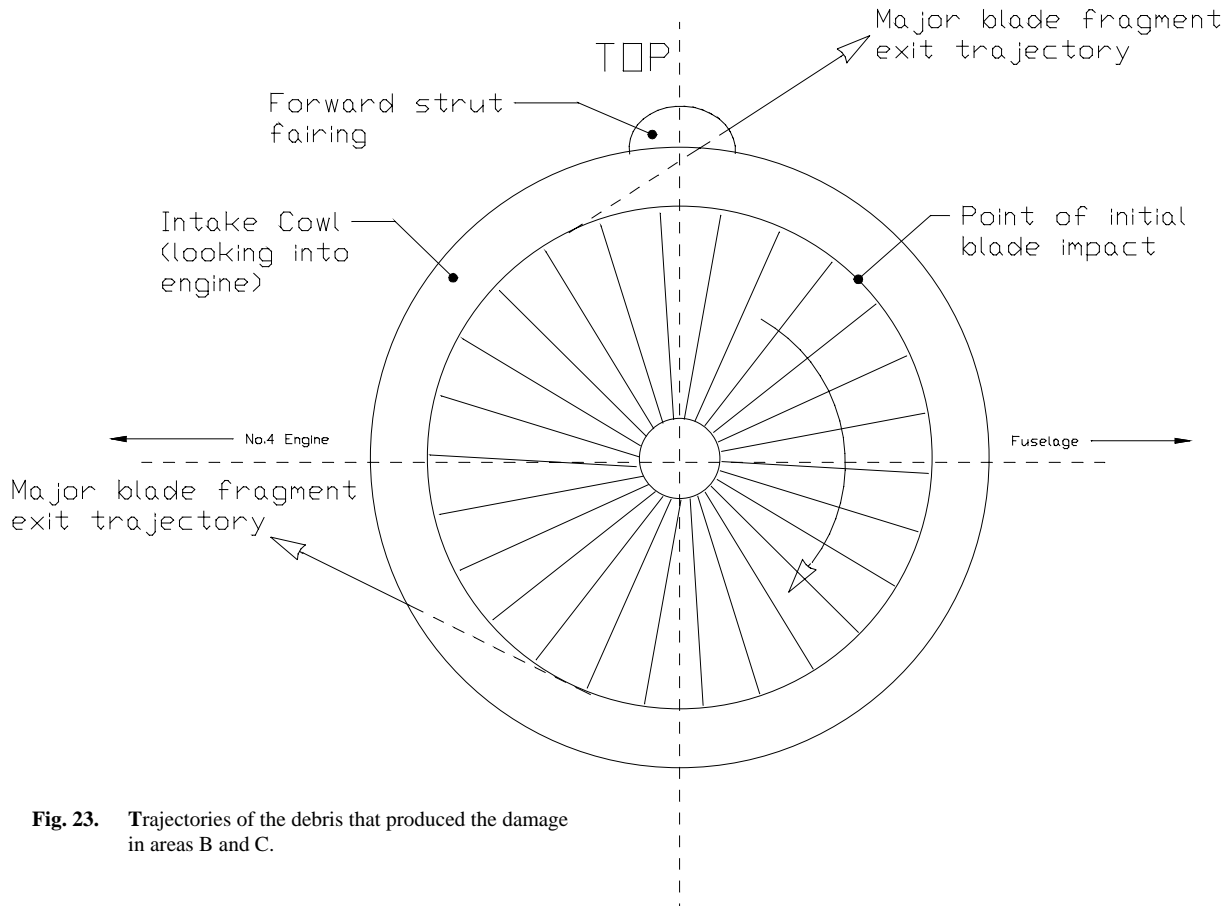
While the fan shroud showed no evidence of a failure to contain the initial blade impact, it was apparent from the intake cowl damage that two major sections of fan blade debris had punctured and escaped the intake cowl during the engine failure event. Figure 23 illustrates the approximate trajectories that these fragments followed. The liberated blade fragments both subsequently struck and damaged the aircraft structure (section 1.6).

Fig. 23. Trajectories of the debris that produced the damage in areas B and C.

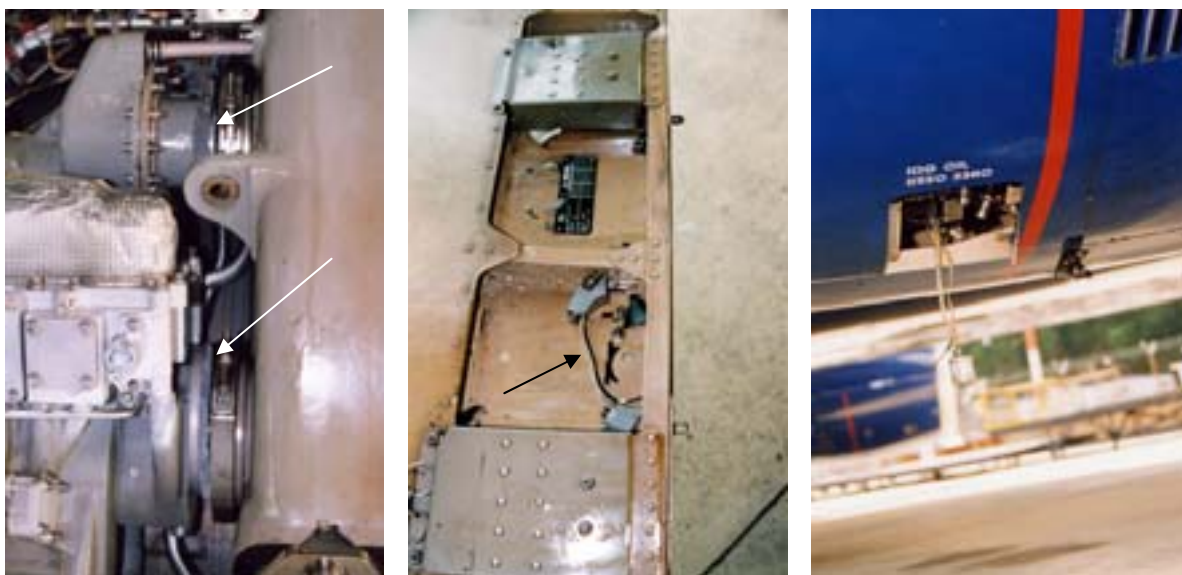
Fracture and separation of the fuel pump and generator drive housings from the accessory gearbox (arrowed).

Components and debris from the engine found within the base of the fan case cowls (arrowed).

Impact damage on the inside of the left fan case cowl.

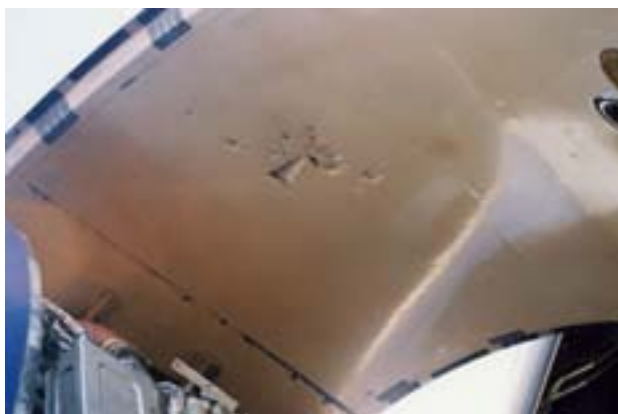
Fig. 27 (Top Right).

Loss of the IDG oil access door and one of the filler caps.

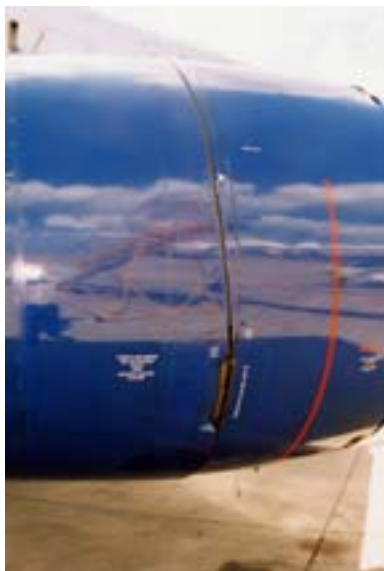
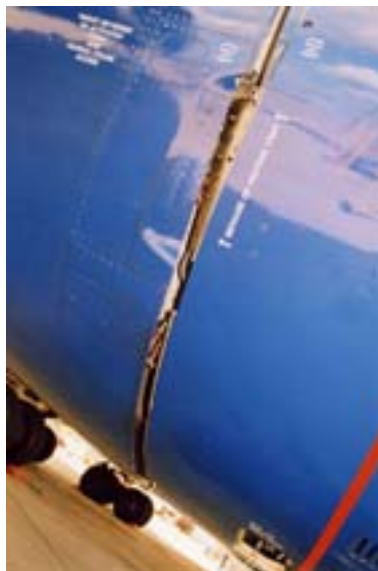
Fig. 28 (Left)
Fig. 29 (Right)

The number-3 engine thrust reverser assembly had moved axially during the failure event and was found approximately twenty-five millimetres rearward of the normal stowed position (figures 28 and 29). Through the opening thus created between the reverser sleeve and the fan case, it was evident that several rows of rivets between the thrust reverser assembly and the rear of the fan case had failed under shear loading. When compared dimensionally against the undamaged number-2 engine, the reverser assembly was found to be radially out of position and axially misaligned by up to fifteen millimetres. To check the integrity of the thrust reverser gearbox locks and the air-motor brake, a series of attempts was made at manually winding back the reverser sleeve with any two of the three devices unlocked (so as to test the remaining 'locked' unit). The result of these tests showed the assembly was actually jammed in the position found, with the manual drive unable to wind back the reverser sleeve, even with all three units unlocked.

Rearward movement and distortion of the thrust reverser doors.

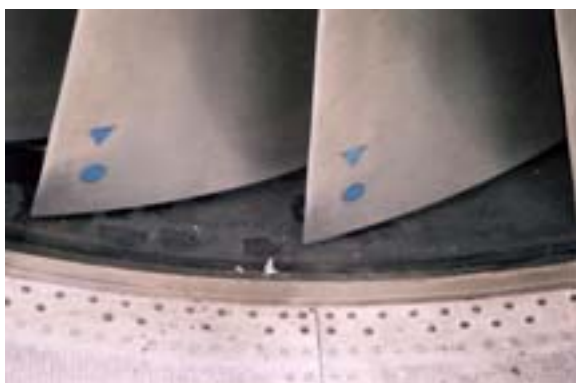
The number-4 engine (outboard of the failed engine) showed evidence of having ingested a small amount of liberated debris. Scratches and marks on the intake cowl lip and centrebody (spinner) were consistent with being produced by small fragments, such as that found embedded within the fan attrition lining at the 6 o'clock position (figure 30). A single fan blade also showed a small nick in the leading edge.

Fig. 30. Small fragment of blade debris found embedded within the fan attrition lining of the number-4 engine.

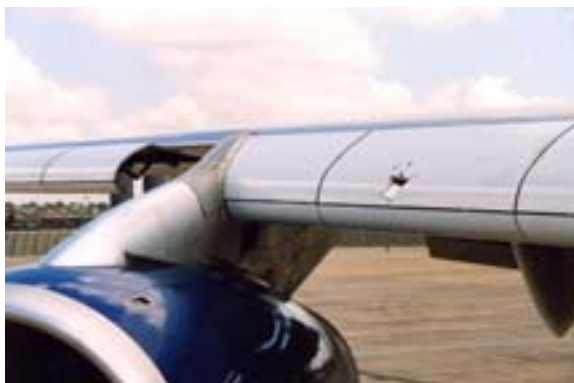
Fig. 31. Damage to the centre-section leading edge flap, right wing.

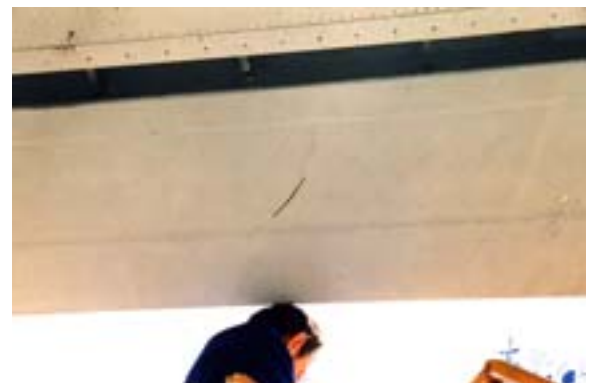
Fig. 32. Deep scoring to the undersurface of the aft trailing edge flap.

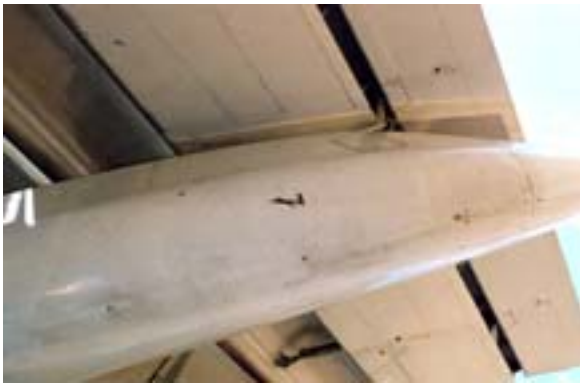
Fig. 33. Localised perforation and scoring of the number-five canoe fairing.

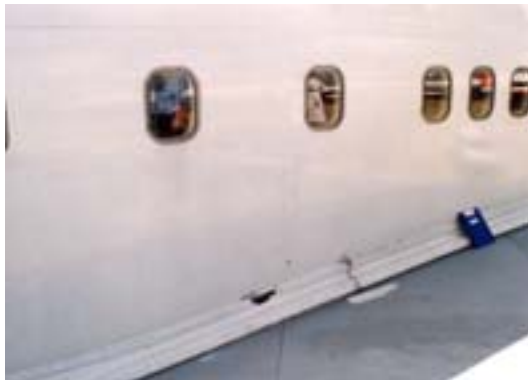
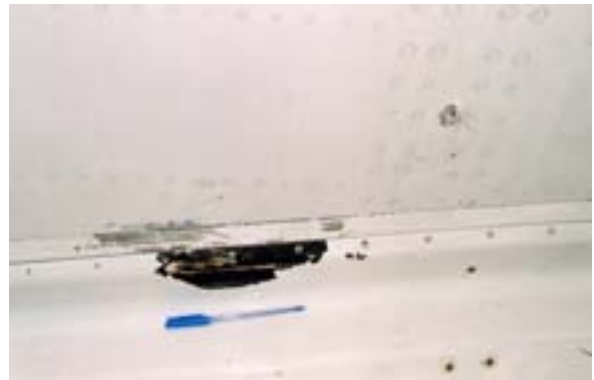
The right side of the fuselage sustained a single significant debris impact at the station 1140 bulkhead position, between stringers S26R and S27R (figure 34, approximately seventy-five millimetres below the cabin floor level and at the centre of the wing chord). Multiple gouges and scratches of the wing surface lead up to the impact point and the composite material strips at the wing – fuselage interface showed impact damage just aft of the fuselage impact (figure 35). Further scratches and scrape marks lead away from this area and over the trailing edge of the wing.

Figs. 34 (Left) & 35 (Right). Impact damage found on the fuselage and trim panels at station 1140, above the wing root.

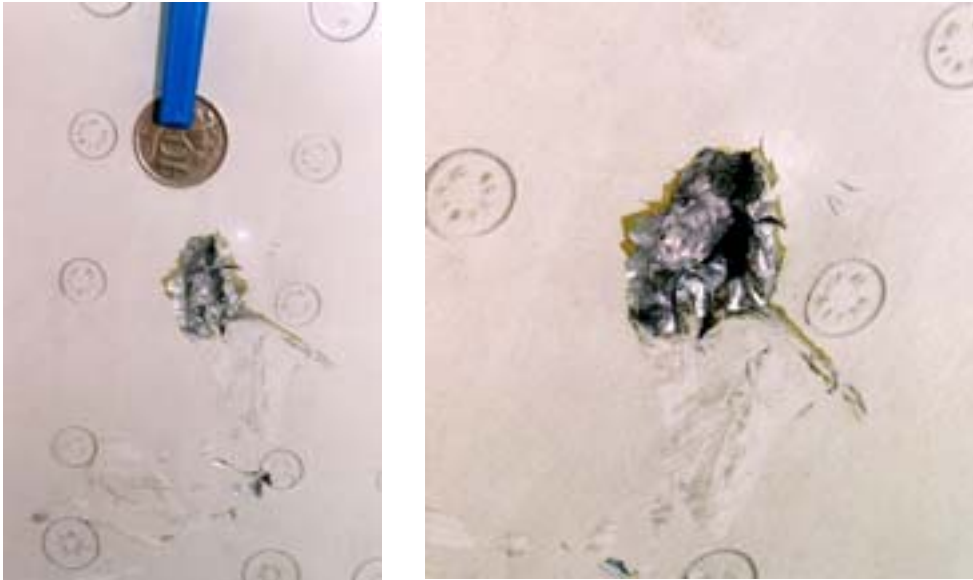
The principal fuselage impact damage presented as a ragged, circular gouge around twenty millimetres in diameter (figure 36). Perforation of the skin had occurred at the centre of the impact and the surface of the underlying station 1140 bulkhead could be seen through the hole (figure 37).

Figs. 36 (Left) and 37 (Right). View of the damaged fuselage area – perforation of the skin is evident at the centre of the damage.

To permit the return of the aircraft to the operator's maintenance facilities, temporary amelioration of the damage was effected by dressing and abrasive blending of the area to remove any roughness and reduce the stress-raising influence of the region. A sample of the skin material obtained during that process was examined using energy dispersive x-ray mapping techniques and confirmed the presence of traces of a titanium based alloy embedded into the aluminium skin material (figures 38-40). This confirmed that the damage was produced by impact with a titanium alloy component, most likely a fan blade fragment from the failed engine.

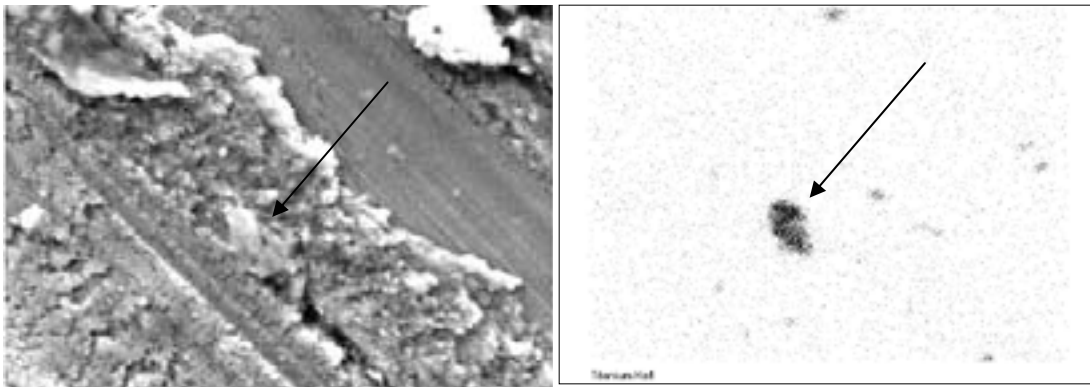
Scanning electron (left) and x-ray map (right) images of an area on the fuselage damage surface showing an embedded Titanium alloy (fan blade) fragment.

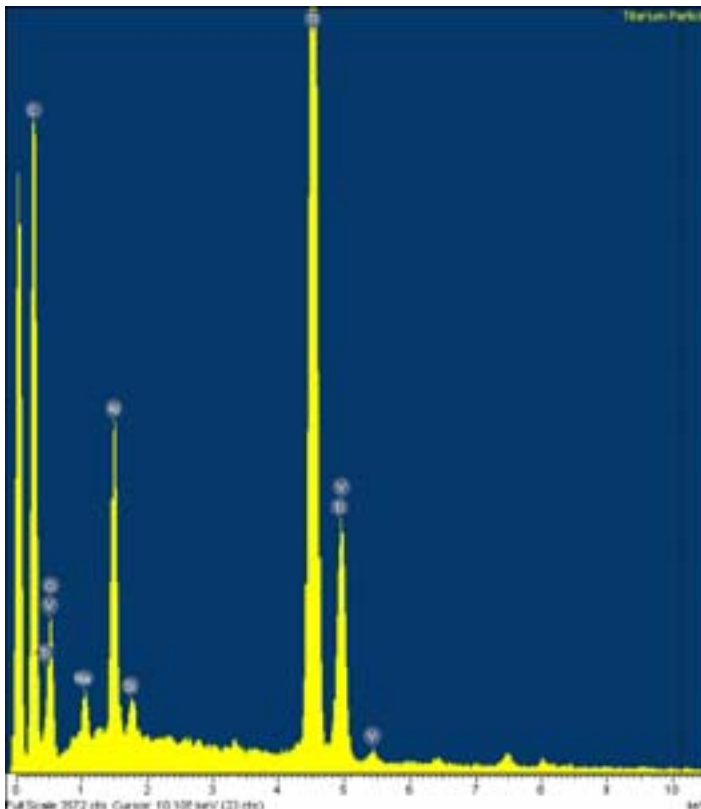
Fig. 40 (Left).

X-ray spectrum of the embedded particle, confirming it as a Titanium – Vanadium – Aluminium alloy.

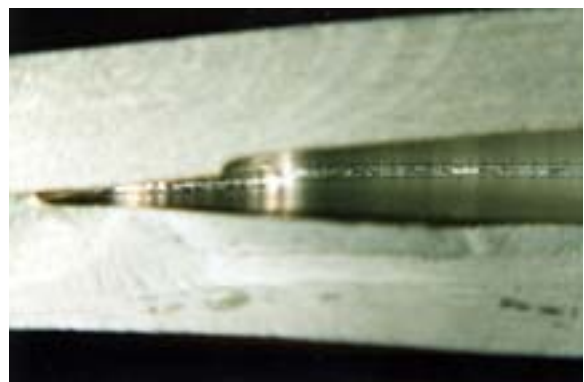
Fig. 44. Edges of the internal cavity, showing a continuous fillet of a metallic alloy.

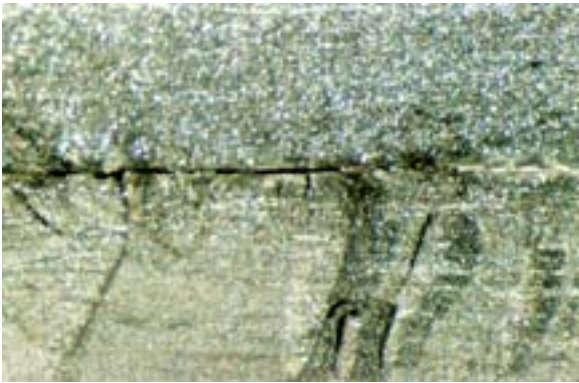
Fig. 46. Close view of blade centreline interface, showing an elongated void at the fracture initiation site.

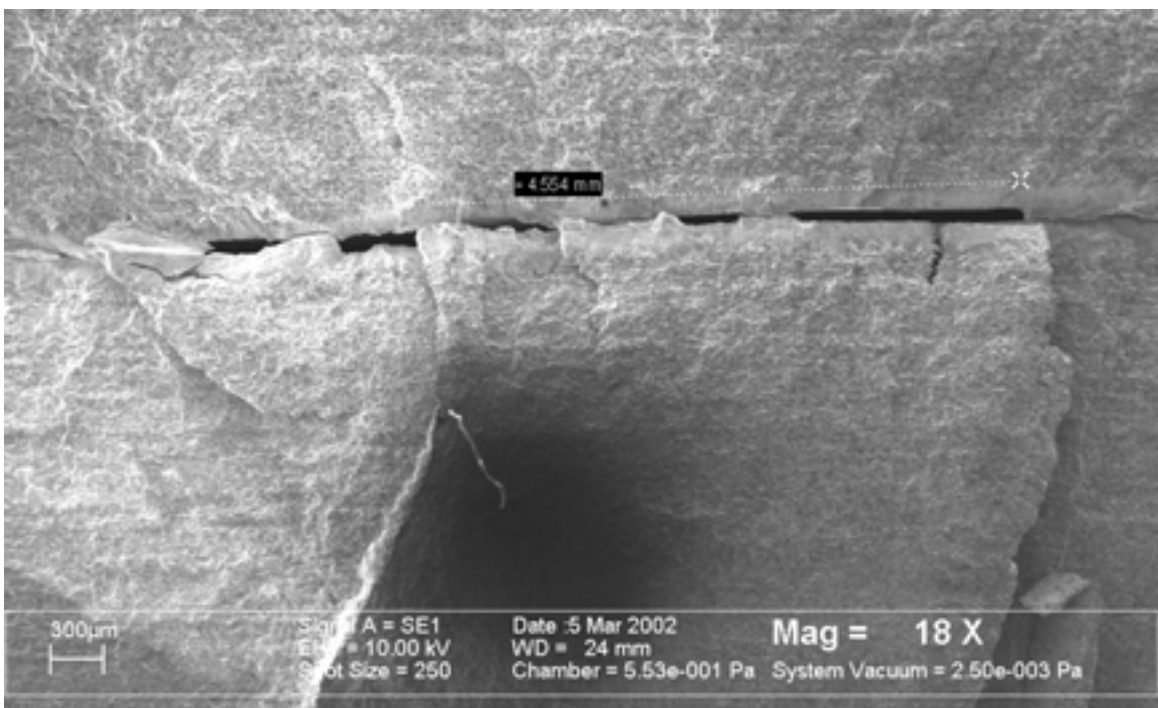
Scanning electron microscopy of the crack initiation region confirmed the presence of the void at the centreline interface and allowed accurate measurement of the exposed area (figure 48). Examination at higher magnifications revealed the void to have smooth internal surfaces and uniform, rounded edges - confirming it to be an area of incomplete fusion or lack-of-bond at the plate interface (figure 49). Along the interface to either side of the void was a half-millimetre wide band of material exhibiting fine, brittle fracture morphology (figure 50). Cracking was evident within this band adjacent to the edges of the void.

Fig. 48. Scanning electron image of the void at the blade panel interface. Total exposed length was approximately 4.5mm.

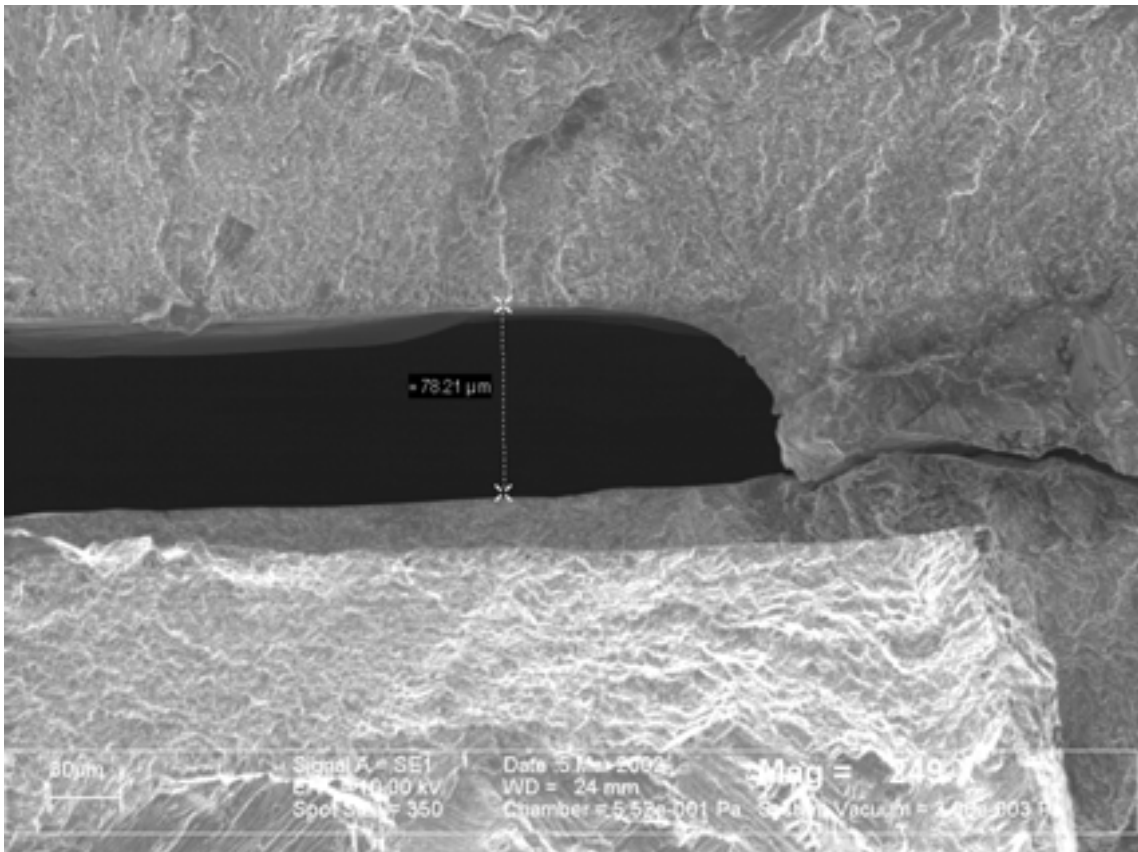
Fig. 49. Higher magnification electron image of the void inner edge. A clear, rounded end to the cavity suggested its formation during blade manufacture.

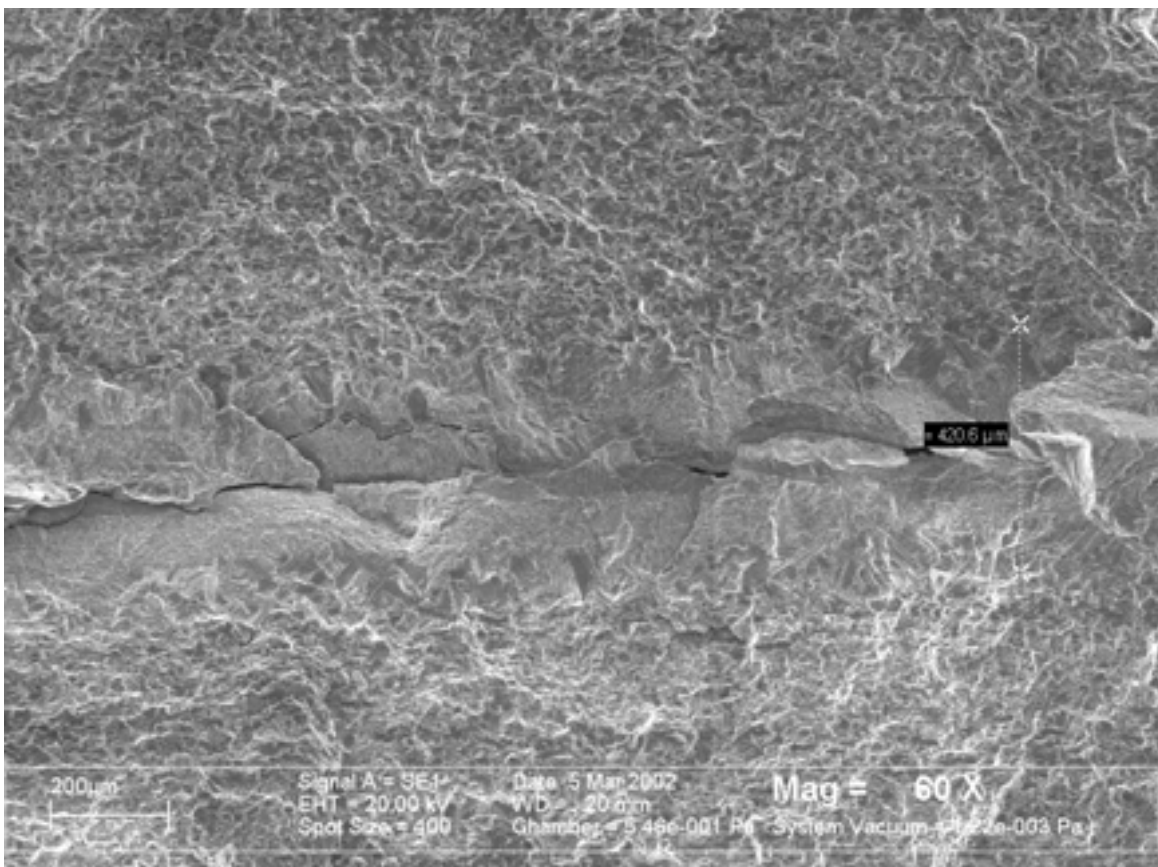
Fig. 50. Band of brittle fracture morphology extending along the blade panel interface. Note the cracking present within this region.

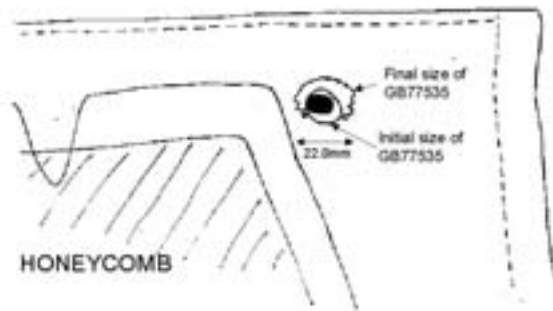
Following discovery of the lack-of-bond defect at the fracture initiation site, information was received from the engine manufacturer that confirmed the existence of a 14mm x 12mm incompletely bonded area on the original production radiograph taken during the blade manufacturing process (figure 51). After the failure, separation of the blade section along the interface showed that the original defect had grown to approximately 22mm x 16mm during service, as a result of debonding of the material surrounding the original flaw (figure 52).

Fig. 51. Tracing sketch of the original production radiographic image, showing the lack of bond defect and its subsequent growth.

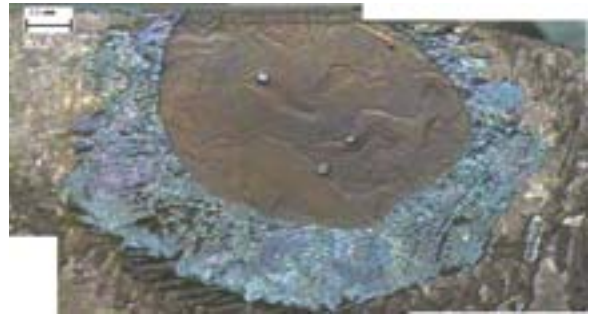
Fig. 52. The lack of bond defect after separation along the blade panel interface. The blue region shows the extent of further disbond that occurred after the blade was introduced into service.

Due to the nature of the diffusion bonding process used to fabricate the blades, a perfect, complete bonding across the complete blade root block was difficult to achieve. In order to assess the acceptability or otherwise of any defects that were present, procedures were developed by the manufacturer to detect, measure and assess bond-line flaws. The failed blade had been examined to these procedures and had been concessionally accepted for service.

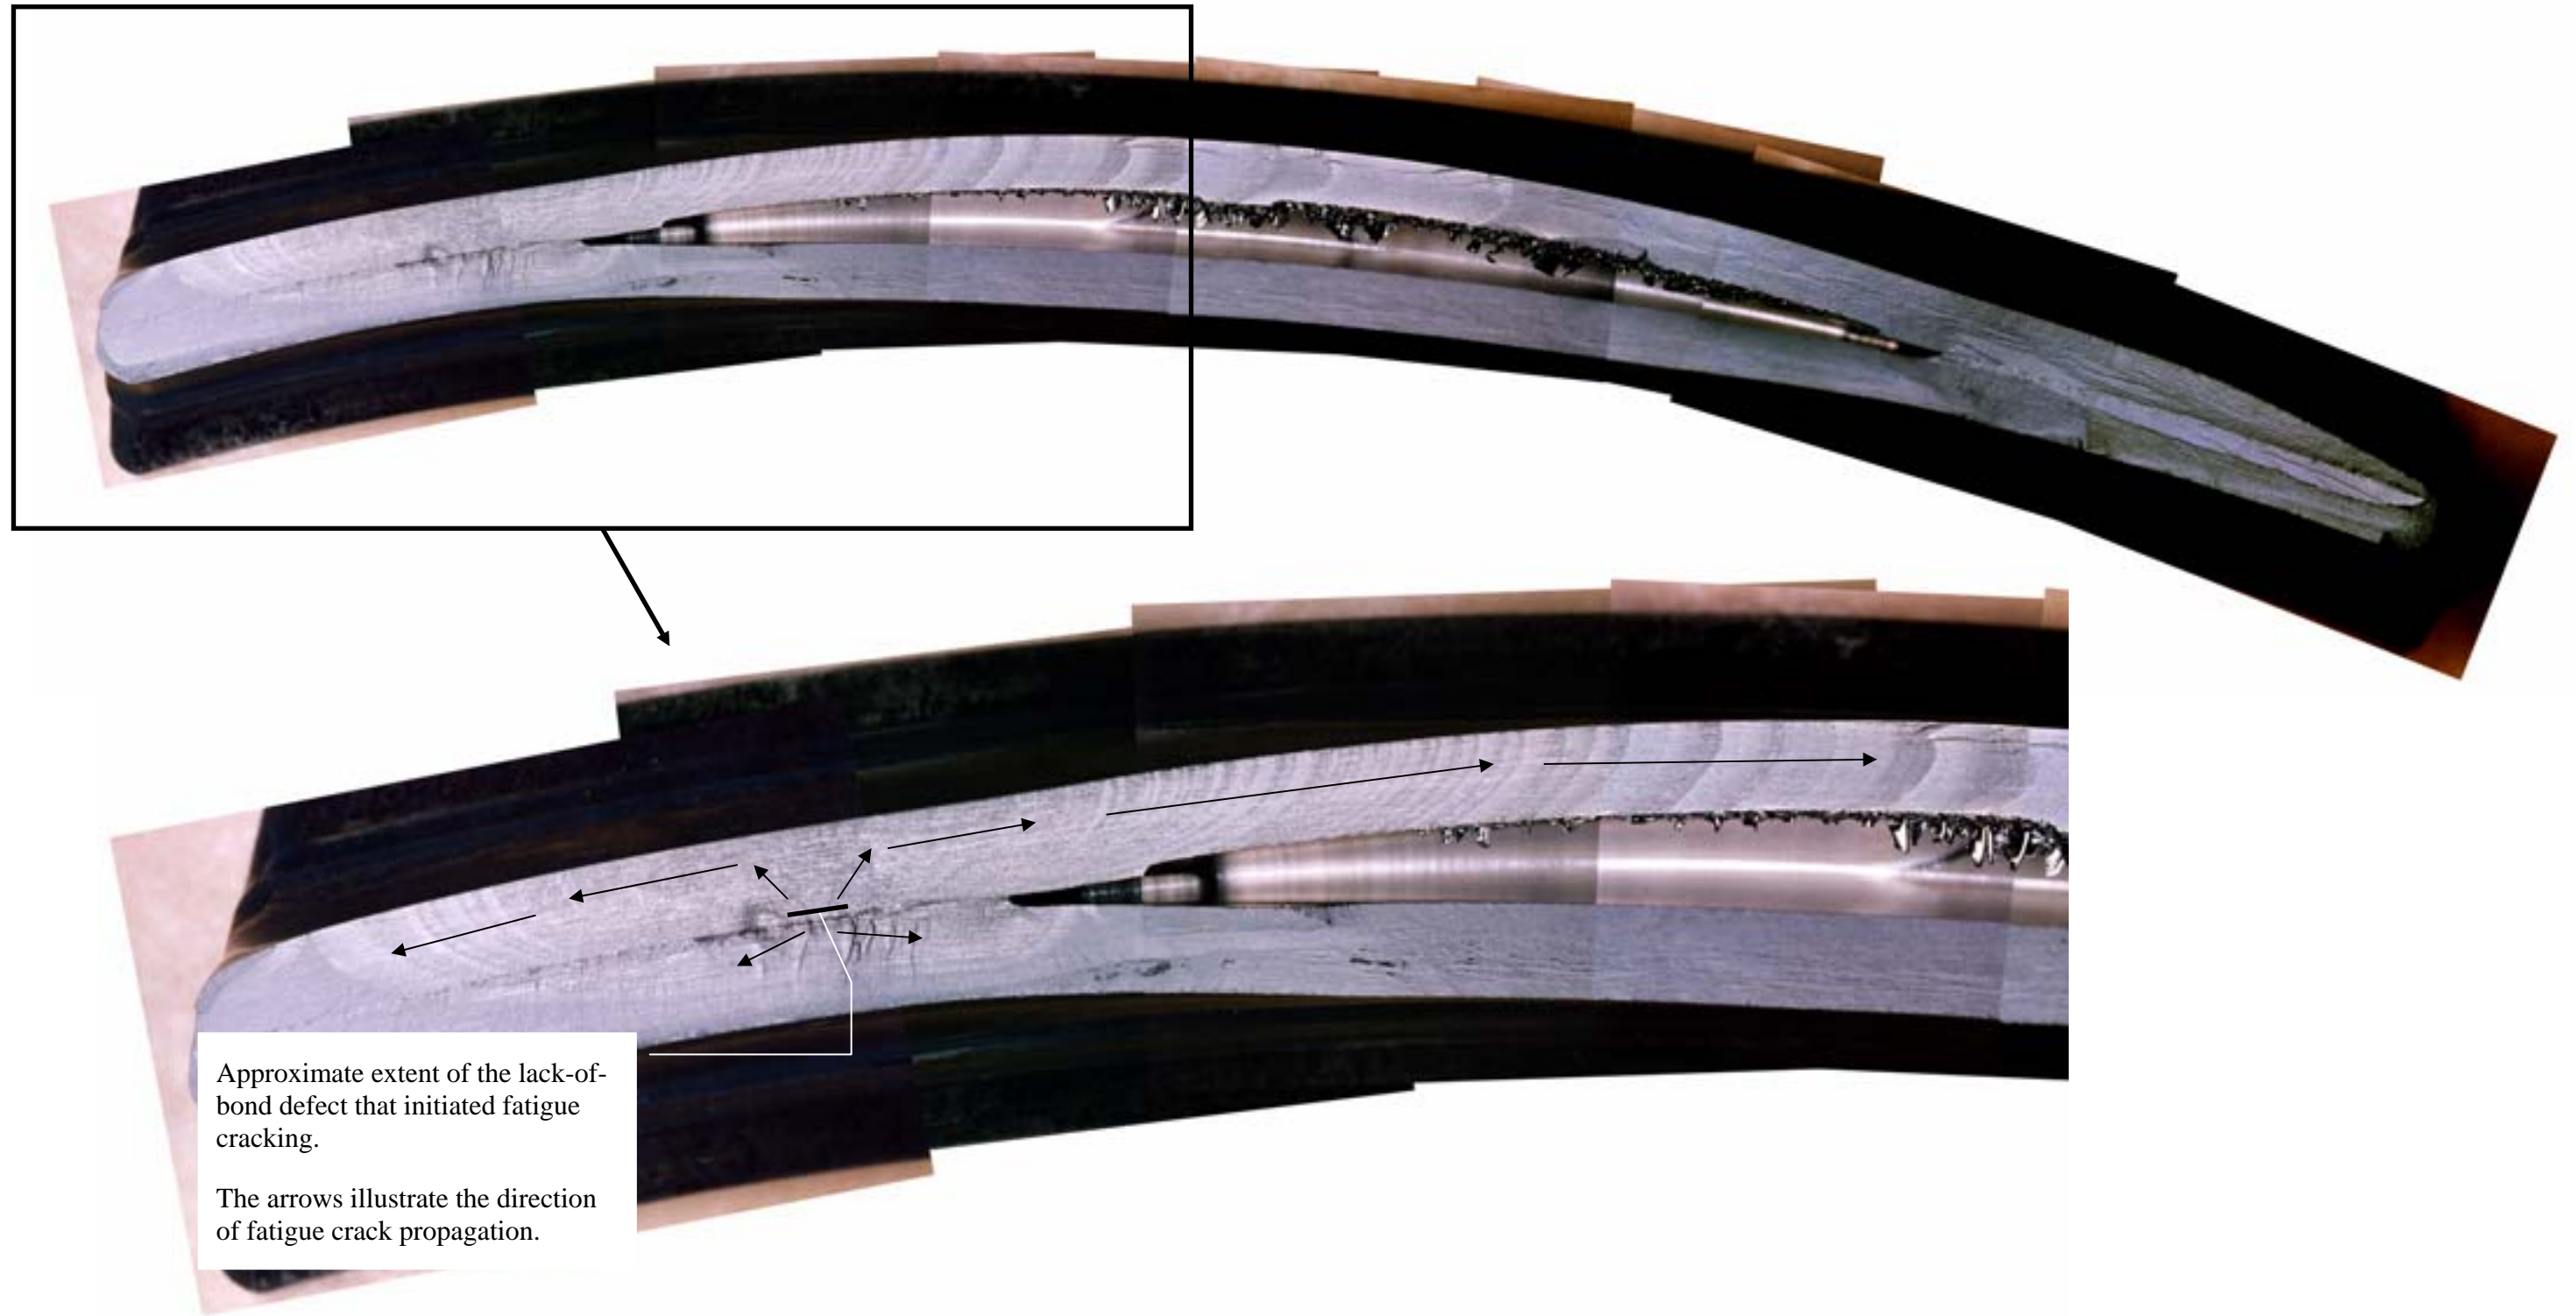
1.1. Attachment 1 – Fracture surface montage images.

Attachment A1 presents montage images of the blade fracture surfaces. Several characteristic features were evident on initial inspection and were subsequently the subject of closer visual and scanning electron microscopy.
