Report No. 8926-156

Corrosion Evaluation, Service Items

MODEL F-102

REPORT NO. MP-61-139

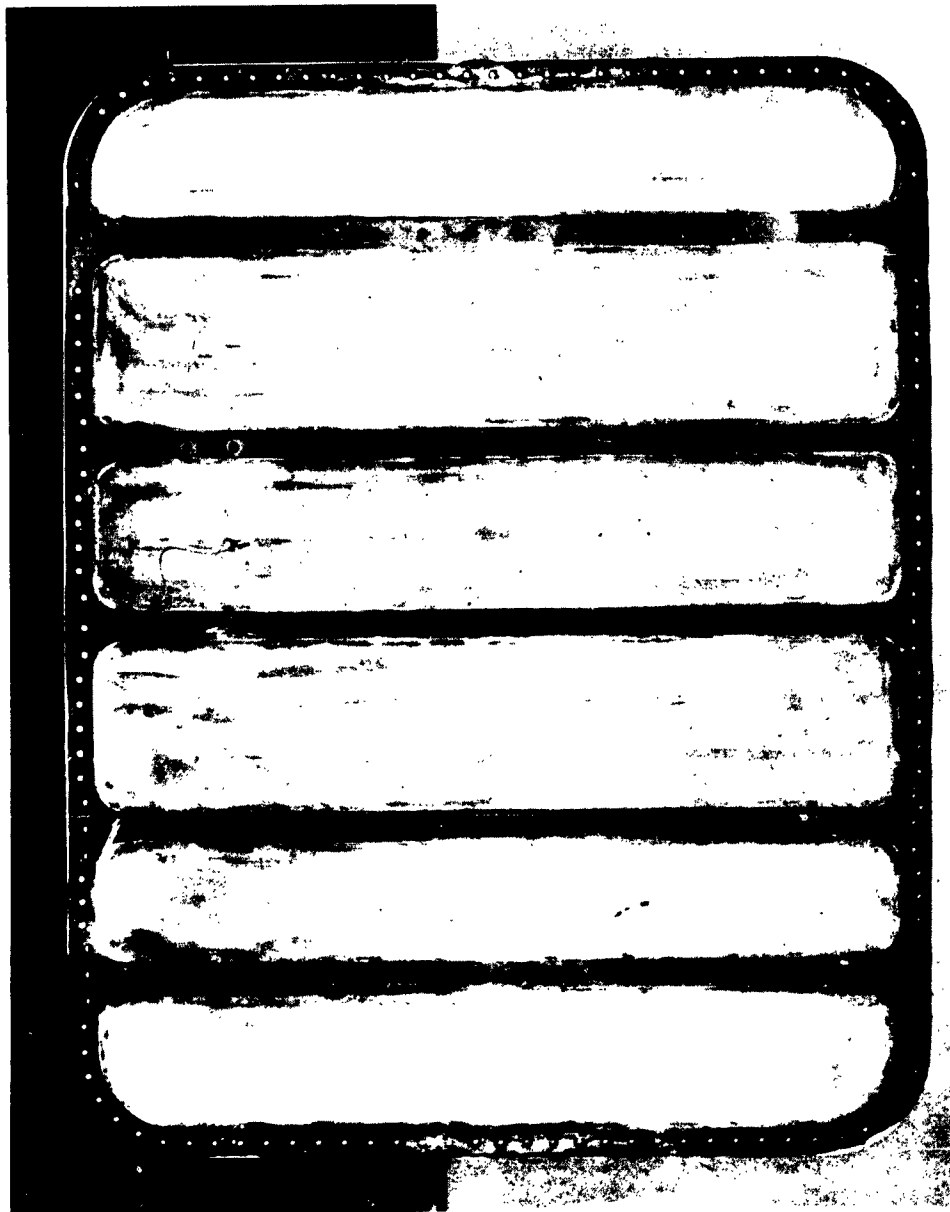
FIGURE 1. F-102 WING ACCESS DOOR DATE STAMPED JANUARY 19,1956.
