RESEARCH MEMORANDUM

PRELIMINARY RESULTS OF NATURAL ICING
OF AN AXIAL-FLOW TURBOJET ENGINE

By Loren W. Acker

NACA RM No. E8C18

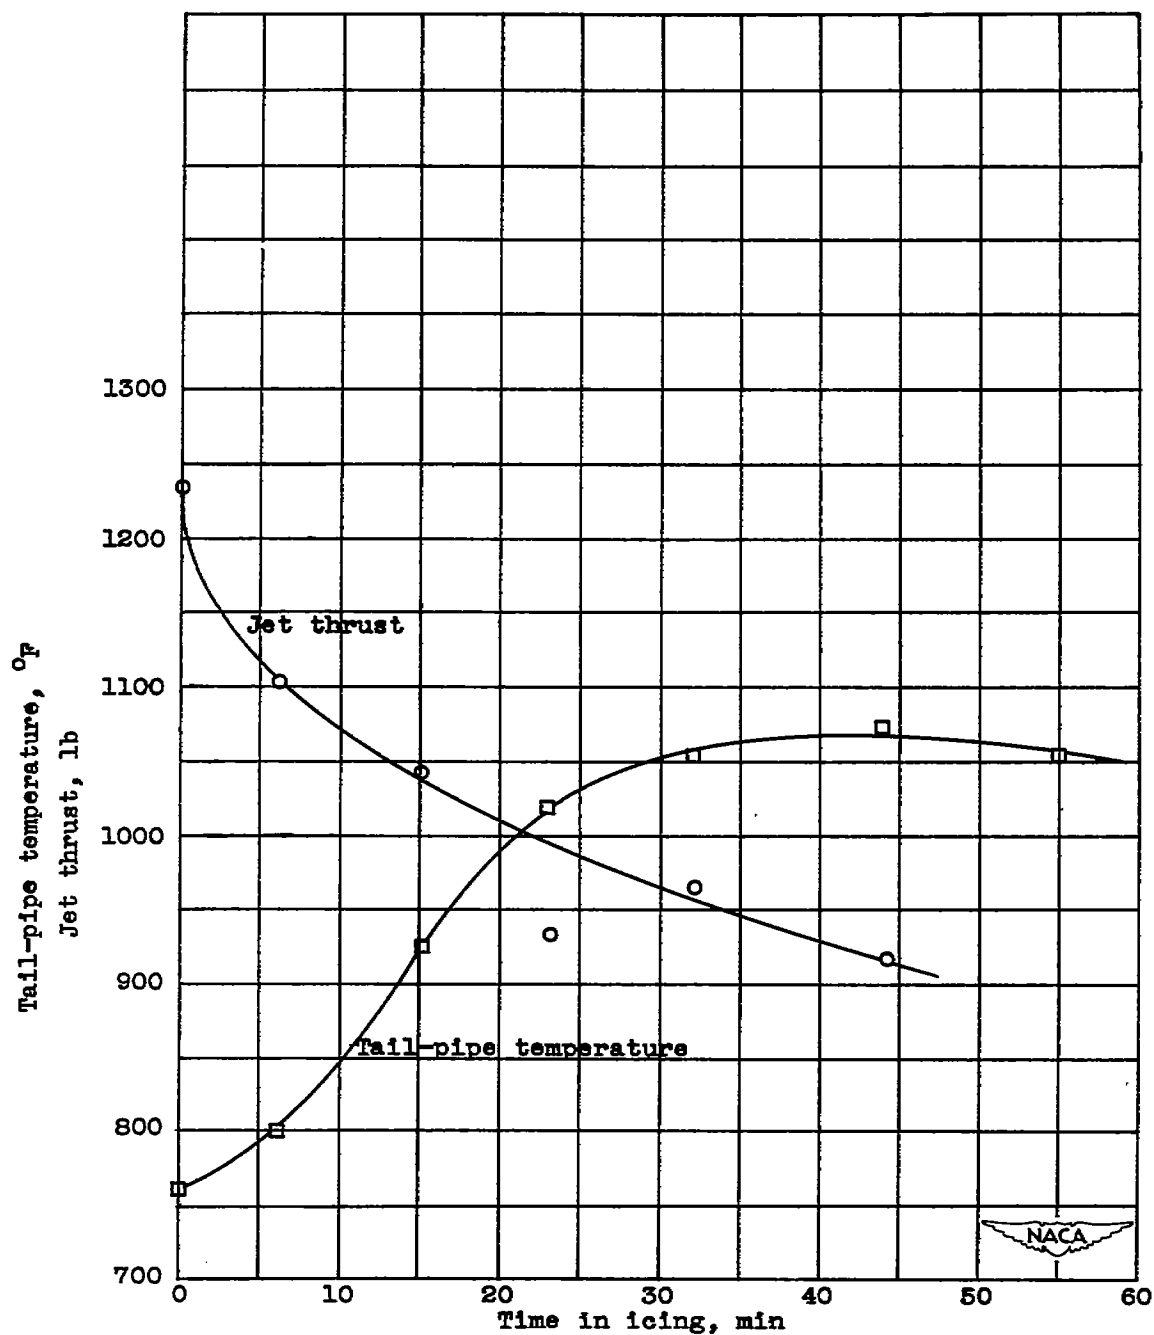
The effect of the ice formation on the engine thrust and tail-pipe temperature is shown in figure 4 as a function of time in the icing condition. The engine was operated at a speed of 9000 rpm in an icing condition for approximately 1 hour. Engine data were taken before the icing cloud was entered and periodically during the encounter with the icing condition. At the end of 45 minutes, the engine thrust had decreased from 1234 to 910 pounds, a reduction of approximately 26 percent. After 45 minutes, the tail-pipe temperature had reached its maximum rise from 761° to 1065° F. At this point during the encounter, the tail-pipe temperature appeared to stabilize. The greatest decrease in thrust and increase in tail-pipe temperature appeared to occur in the first 15 minutes of the encounter.

Figure 4. - Effect of time in icing condition on engine jet thrust and tail-pipe temperature at engine speed of 9000 rpm.

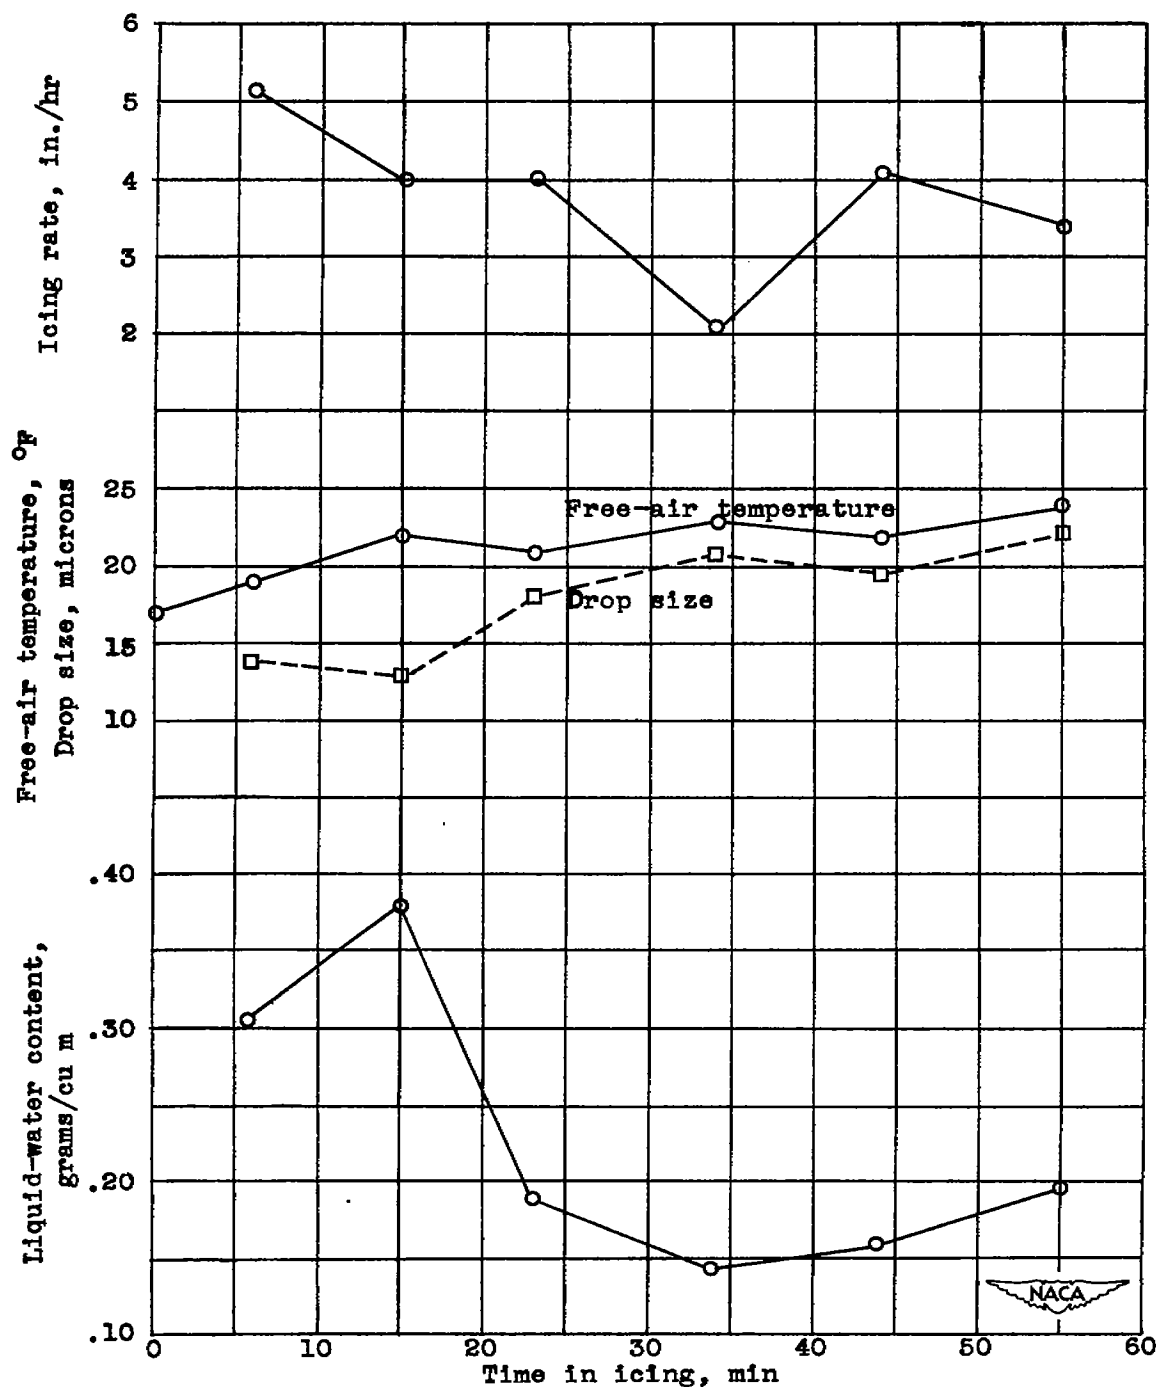
size, and liquid-water content. The icing rate varied from 5.1 to 2.1 inches per hour. The free-air temperature and the drop size showed a gradual increase during the encounter. The liquid-water content was highest during the first 15 minutes, reaching a peak value of 0.38 gram per cubic meter and decreasing to approximately 0.17 gram per cubic meter during the remaining 45 minutes.

Figure 5. - Time history of icing condition encountered.
