NASA  
DIRECTOR OF ENGINEERING DEVELOPMENT  
DIRECTOR, MECHANICAL ENGINEERING  
MATERIALS SCIENCE LABORATORY  
FAILURE ANALYSIS AND MATERIALS EVALUATION BRANCH  
MATERIALS SECTION  
DM-MSL-22, ROOM 2221, O&C BUILDING  
KENNEDY SPACE CENTER, FLORIDA 32899

NOVEMBER 23, 1992

92-2150

SUBJECT: SPRAYABLE SILICONE ABLATIVE COATING, GE PRODUCT CODE  
CPC-1050, POST LAUNCH EVALUATION ON LAUNCH COMPLEX  
40, CAPE CANAVERAL AIR FORCE STATION

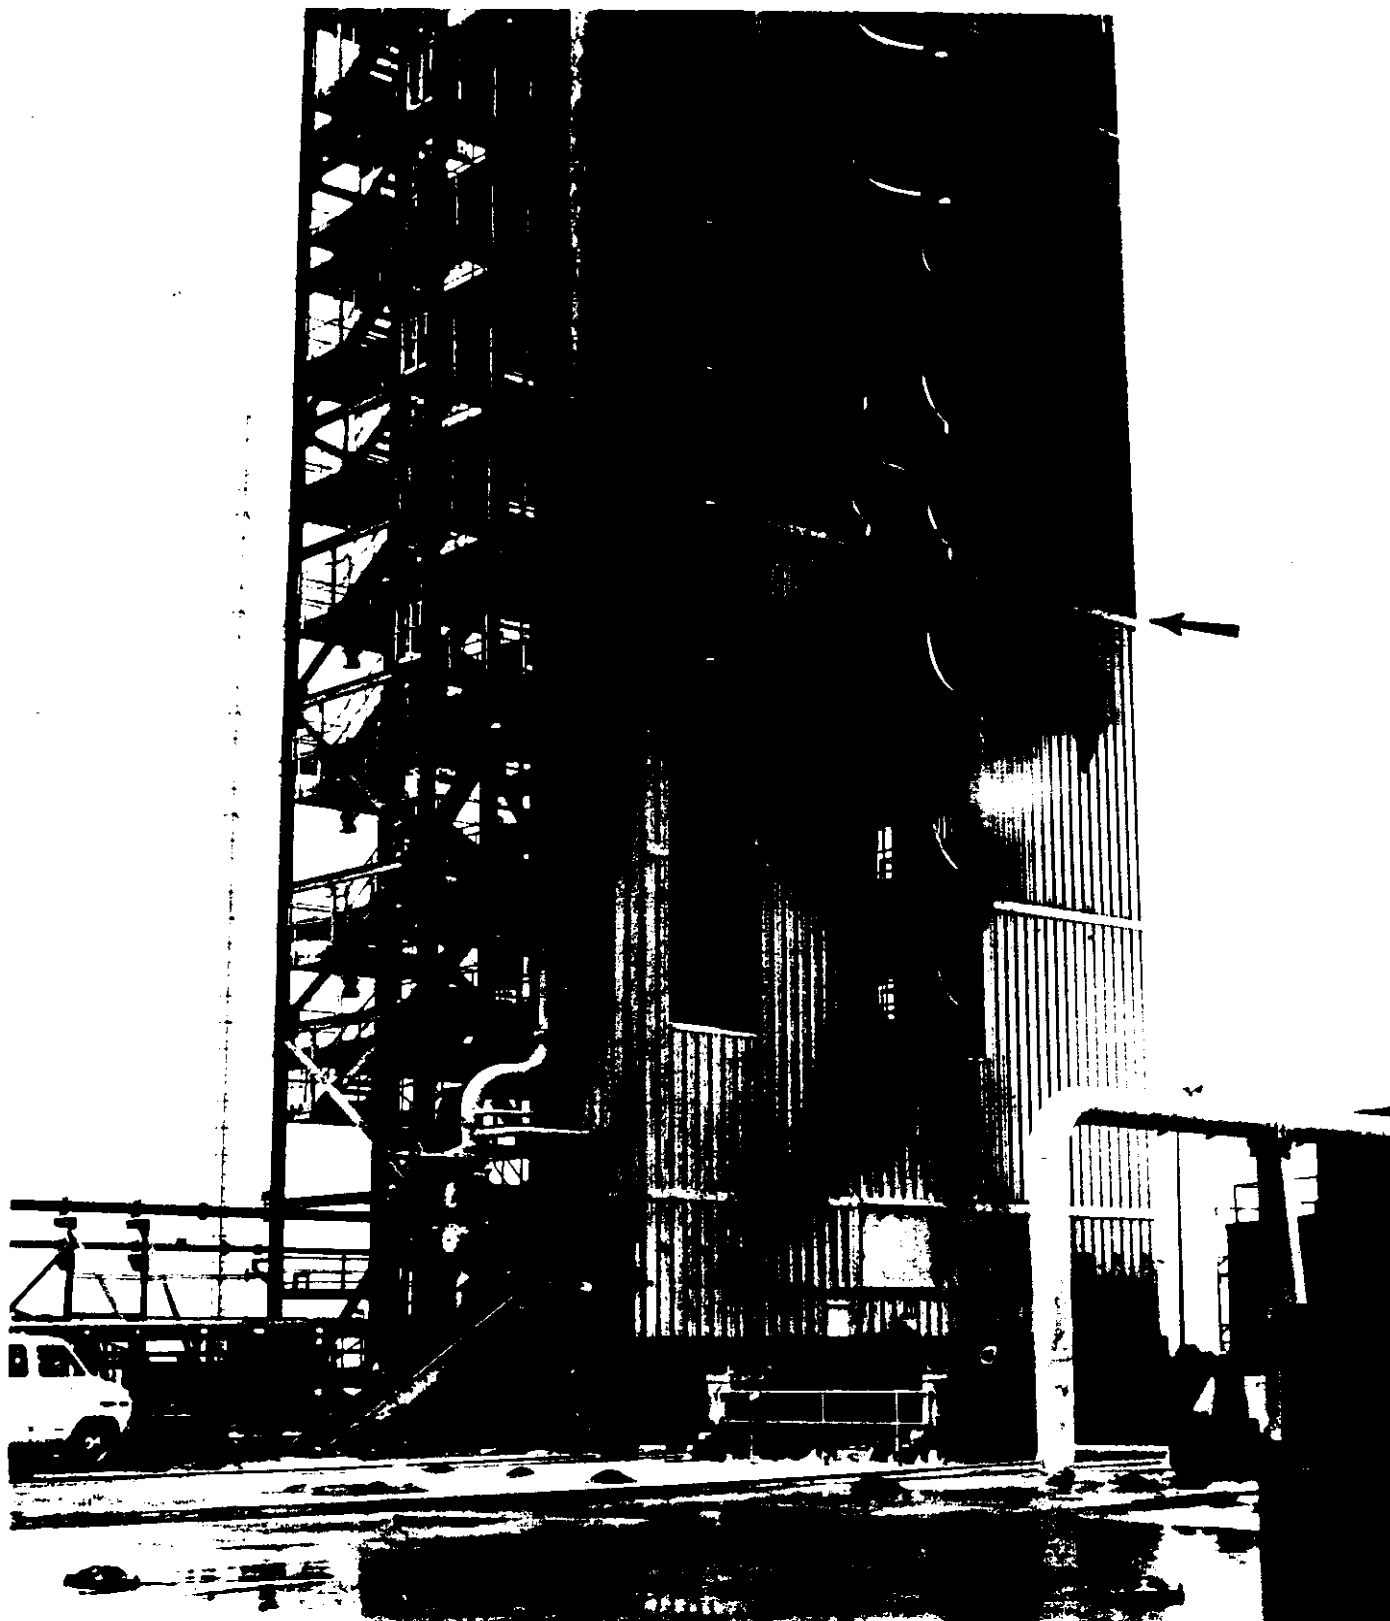
FIGURE 1

5.2 The ablative material applied to the structural steel on the CX-40 UT withstood the thermal and pressure shock loadings associated with the launch, exhibiting little or no loss of thickness due to ablation. Figure 1 shows an overall view of the UT. The arrow indicates the transition from the silicone ablative coating and the steel coated with 4-6 mils of inorganic zinc only. Approximately 30% of the surface of the silicone ablative on the east

face was covered with a black, sooty material easily removed with finger pressure. The sooty material is probably the combustion product from organic material used in the launch pad area. Low pressure water washing can be used to remove this material.

OVERALL VIEW OF LAUNCH COMPLEX 40 UMEILICAL TOWER. THE ARROW INDICATES THE TRANSITION FROM THE SILICONE ABLATIVE COATING (GRAY) TO INORGANIC ZINC PRIMER (GREENISH-GRAY).

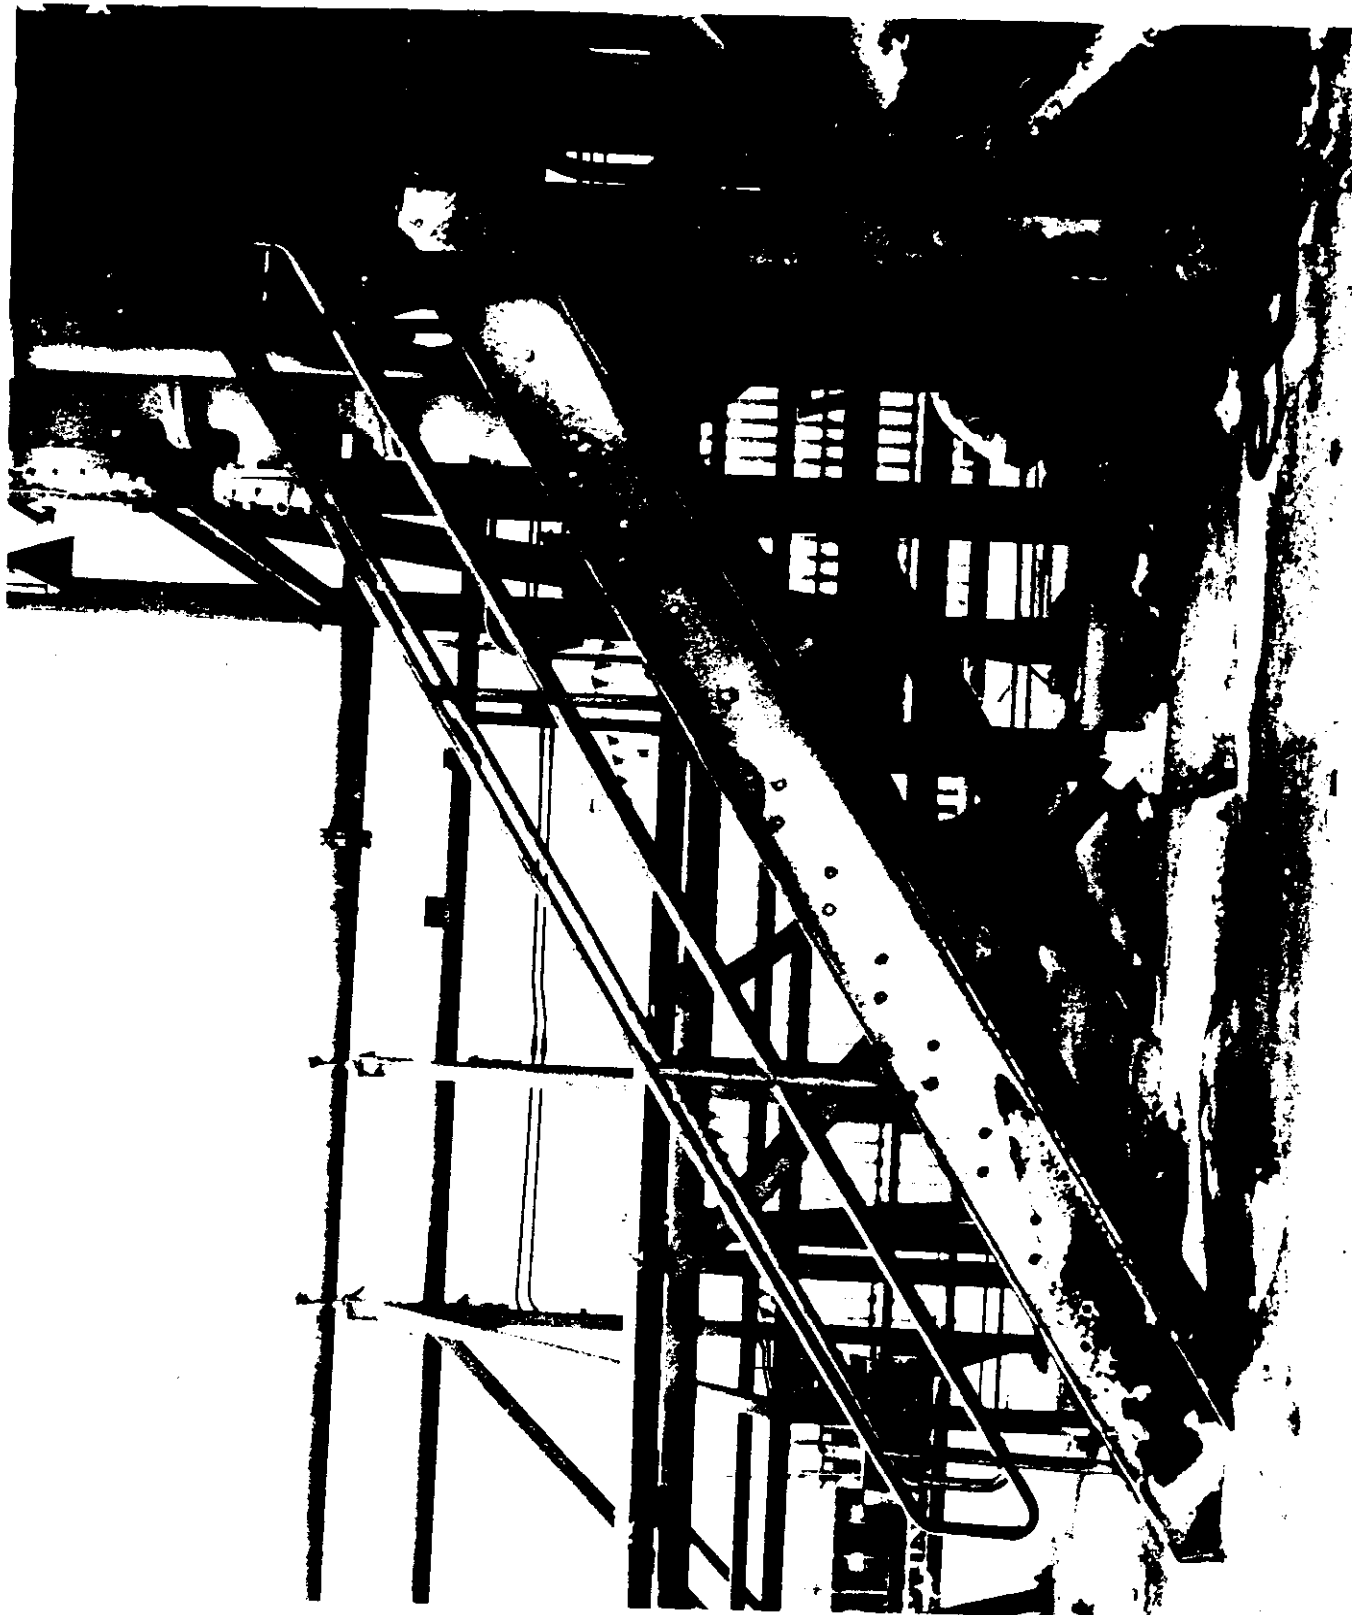
FIGURE 13

LAUNCH DAMAGE TO UNPROTECTED STAIRWAY ON SOUTHEAST CORNER OF UMBILICAL TOWER. THIS AREA SHOULD BE COATED WITH ABLATIVE.
