**NASA Technical Memorandum 110204**

**Structural Test Documentation and Results for  
the McDonnell Douglas All-Composite Wing  
Stub Box**

**Dawn C. Jegley and Harold G. Bush**  
*Langley Research Center, Hampton, Virginia*

**April 1997**

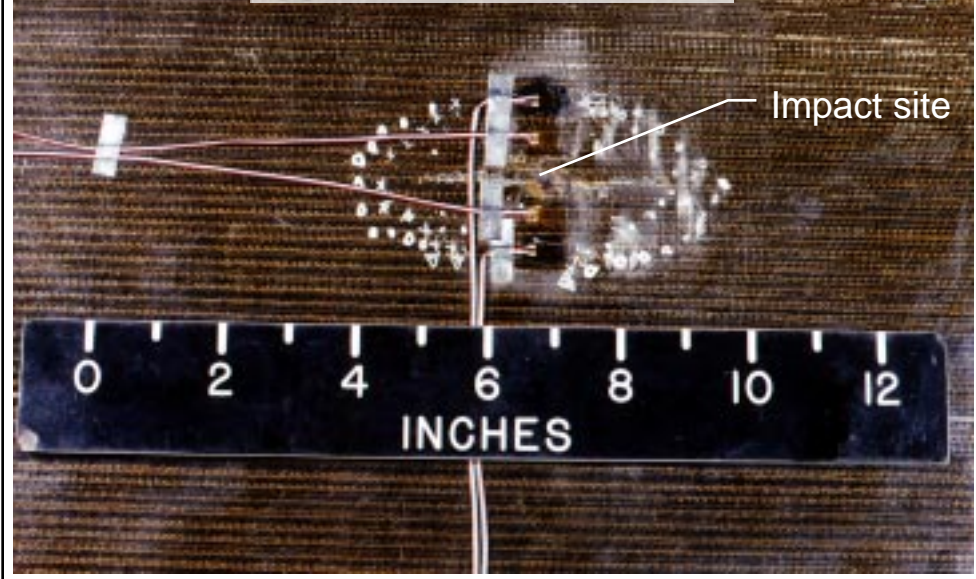
The purpose of the third test was to verify that the impact-damaged structure could support DLL without failing. A dropped-weight impactor was used to inflict visible damage to the upper cover panel midbay between two stringers aft of the access door. The impact site, marked DET1, is shown in figure 5. For purposes of this test, "visible damage" was defined as a 0.1-inch-deep dent in the surface.

In order to limit the dent depth to 0.1 inches, the damage was inflicted by a series of impacts at the same location. Four impacts were required to inflict the required dent depth. After each impact, the dent depth was measured and the region of skin around the impact site was nondestructively evaluated by ultrasonic scanning to determine the area of the structure which had been damaged. The impact energies of the four impacts and their effects are shown in table 1. After the fourth impact, the dent was 0.093 inches deep and the damage area was defined by an oval with an axial dimension of 5.75 inches and a width dimension of 2.75 inches. No further impacts were made since further growth in the size of the damage area was not desired. The stringer flanges and blades of the upper cover panel were not damaged in the impact process. A photograph of the damaged region, with the region of damage outlined by white marks, is shown in figure 20. Damage was easily visible by eye.

Figure 20. Visible impact damage region DET1.

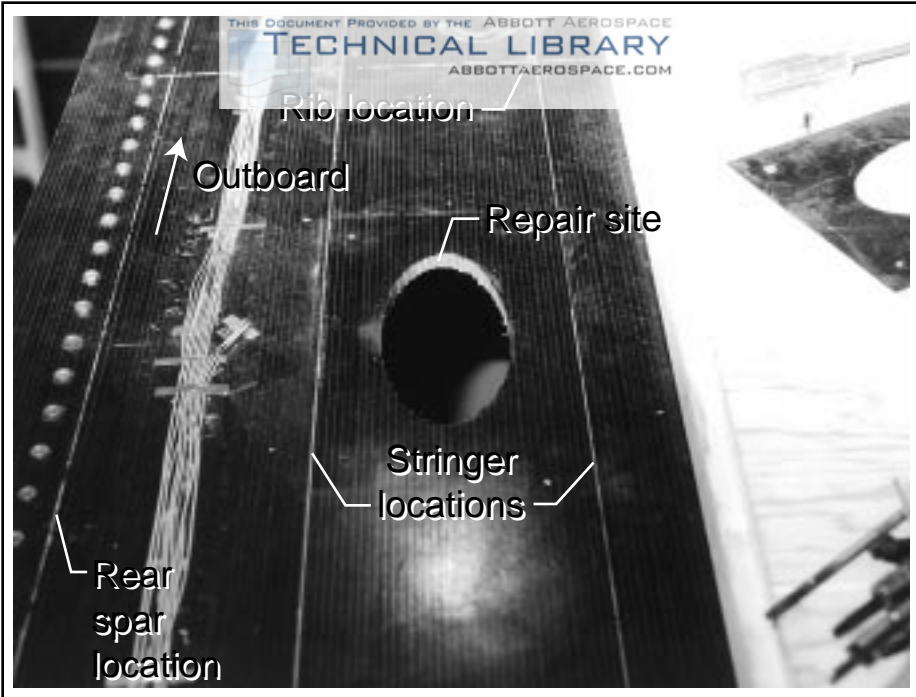
Figure 21. Upper cover panel prior to installation of repair.

A bolt-on metal patch was used to repair the upper cover panel. All materials for the patch were supplied by McDonnell Douglas Aerospace and personnel from American Airlines installed the patch. The structure was prepared for patch installation by cutting out the damaged section of skin, as shown in figure 21. The cutout was in the shape of an ellipse with dimensions 7.5 inches by 3.75 inches. The cutout was in the skin between stringers, as illustrated in figure 22. Bolt holes were drilled through the stringer flanges and skin. A 3/8-inch-thick aluminum plate was bolted to the external skin to cover the cutout. The plate dimensions were 11.7 inches by 7.28 inches. The completed repair is shown in figure 23.

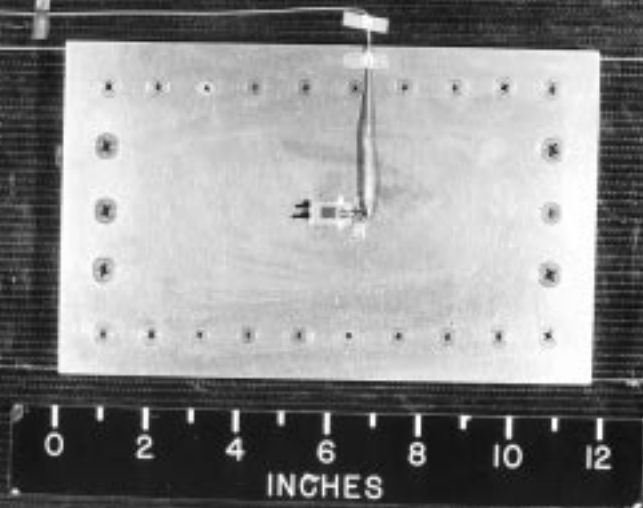
Figure 23. Completed repair.

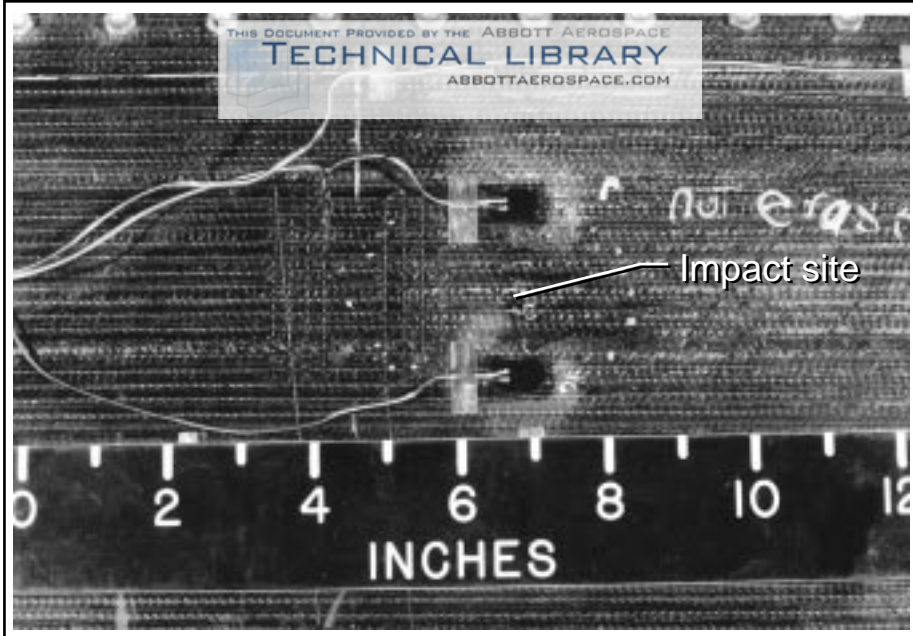
a) Impact region NDT1

A dropped-weight impactor was used to inflict nonvisible damage to the upper cover panel at two locations. An impact energy of 100 ft-lb was used to inflict the nonvisible damage. These impact sites are at a stiffener runout near the front spar and at the edge of a flange near the rear spar. The front and rear impact sites, labeled NDT1 and NDT2, respectively, are shown in figure 5. The damage area in the upper cover panel skin around each damage site was determined ultrasonically and that area was marked on the upper cover panel. Photographs of these damage regions prior to testing are shown in figure 24. The damage area at location NDT1 is an oval with dimensions of 4.0 inches by 3.0 inches. The damage area at location NDT2 is approximately "L" shaped with dimensions of 4.0 inches and 3.0 inches. The dent depth for the dent at location NDT1 is 0.014 inches. The dent depth at location NDT2 is 0.0134 inches.

No fiber breakage was visible on the outer surface of the structures and the dents were difficult to detect by eye. There was no way to gain access to the interior of the wing box at these locations to evaluate any possible damage to the interior structure, such as intercostals and stringers, prior to testing.

Figure 24. Nonvisible impact damage sites.

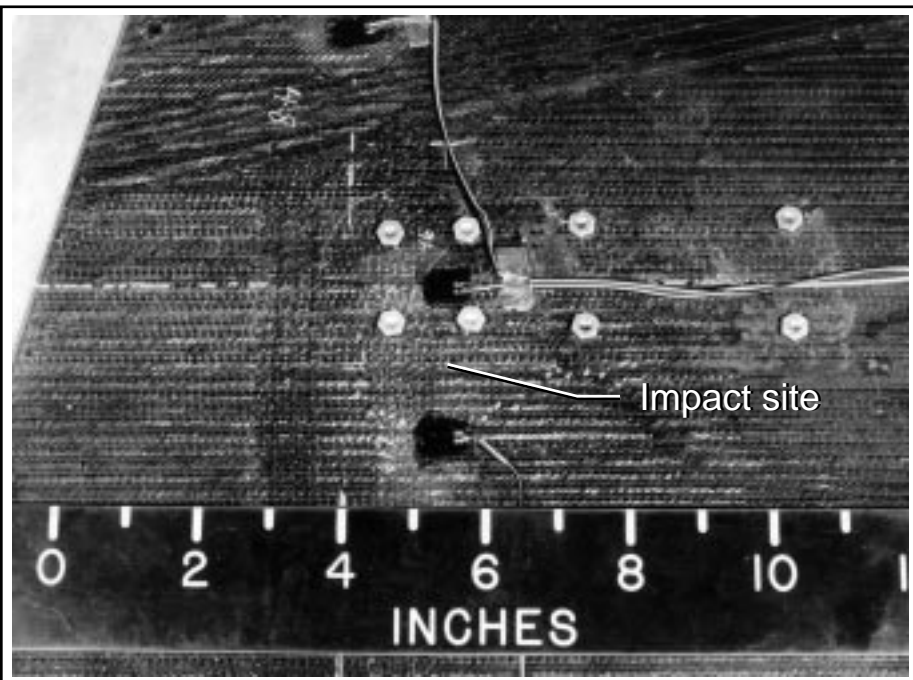
b) Impact region NDT2

Figure 24. Concluded.

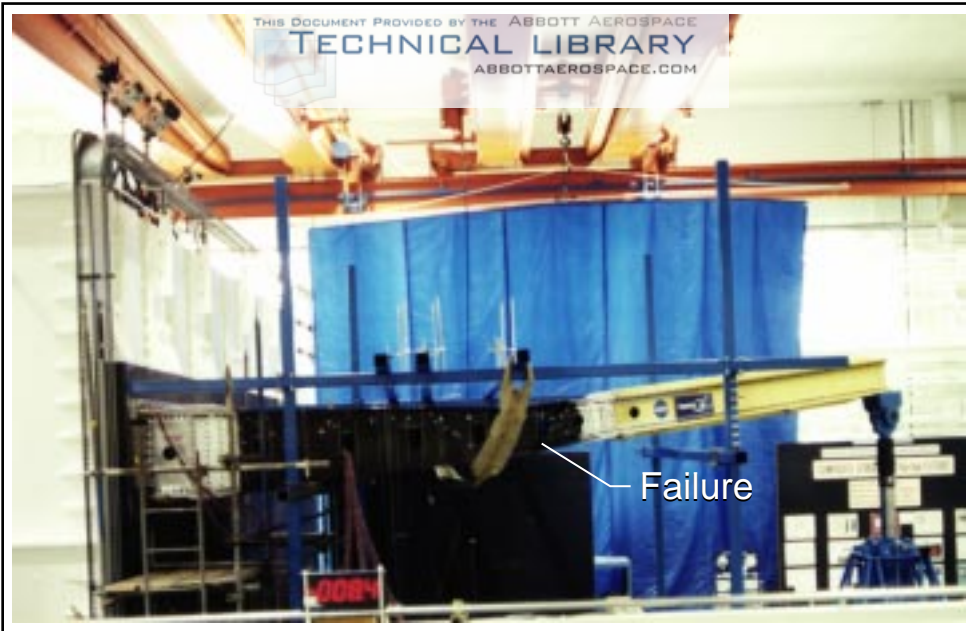
The maximum load supported by the structure at failure was 154 kips. A view of the entire structure after failure is shown in figure 63. Failure occurred across the entire width of the upper cover panel and into both spars. The lower cover panel skin remained intact. Photographs of the failures in the upper cover panel, and in the stringers between ribs 7 and 8 are shown in figures 64 and 65, respectively. Two independent failures occurred in the wing stub box. The first failure was in the unsupported region at the runout of stringer 6 where it terminates at rib 7 at a load of approximately 140 kips. During the test, the flanges and web of the stringer failed and the skin remained intact. This stringer has extensive damage in the form of delaminations between the skin and flange, broken stitches, bolts pulled through the flange, and cracking of the blade, as shown in figure 65b. The second failure was catastrophic and initiated at the nondetectable impact damage site at the runout of stringer 7. This failure began at a load of approximately 145 kips. This failure resulted in a crack that runs across the upper cover panel through impact damage site NDT2, as shown in figure 66, and across the upper cover panel into the spars. Failed stringers aft of the impact site are shown in figure 65a.

Figure 63. Side view of test specimen after failure.

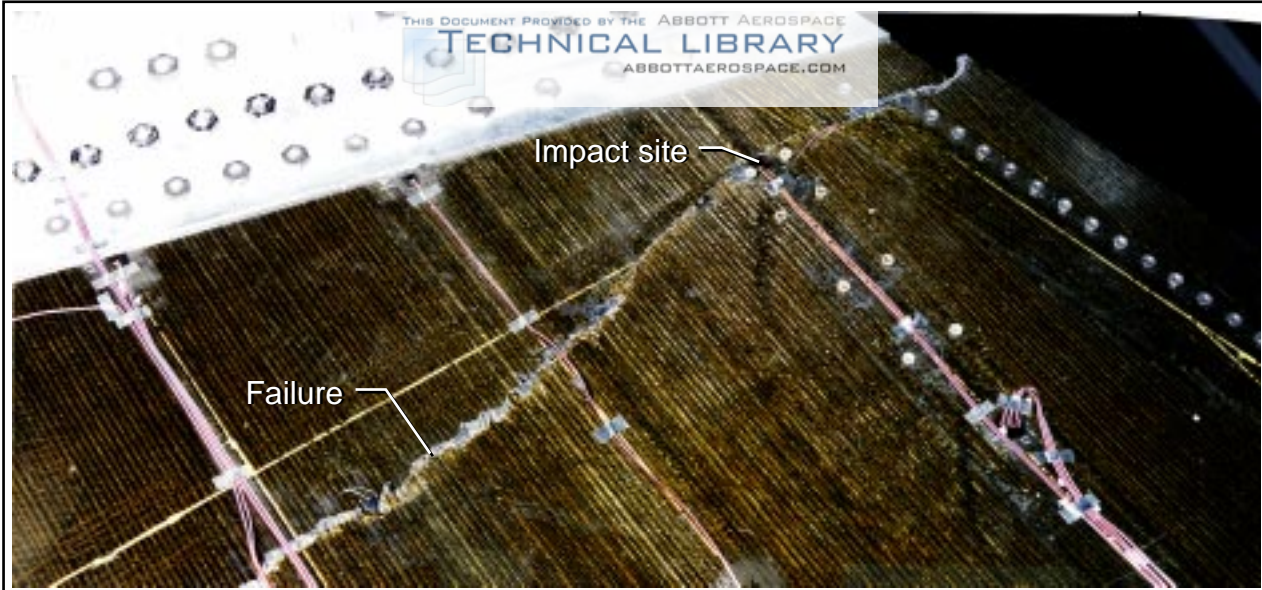
Results from strain gages closest to the impact damage site NDT2, (strain gages 43, 44, 45, 46 and 617), and back-to-back strain gages in the unsupported skin region, (strain gages 63 and 64), are shown in figure 62. C-scans of the damaged region made immediately after impact indicate the presence of damage at strain gages 44 and 45, so the structure may not perform as an undamaged structure at these locations. Nonlinear material behavior caused by the impact damage would explain the behavior of gage 45. Strain gages 43 and 46 at the impact damage site show linear behavior at higher loads than strain gages in the unsupported skin region which show linear behavior. The fact that the strain in the unsupported skin region becomes nonlinear before the strain at the impact damage site become nonlinear indicates that the behavior at the impact damage site was not influenced significantly by the buckling of the unsupported skin region.

Figure 66. Failure through impact damage site NDT2.
