NASA/TM-2013-217990
NESC-RP-10-00685

Composite Crew Module (CCM) Permeability Characterization

*Michael T. Kirsch/NESC
Langley Research Center, Hampton, Virginia*

May 2013

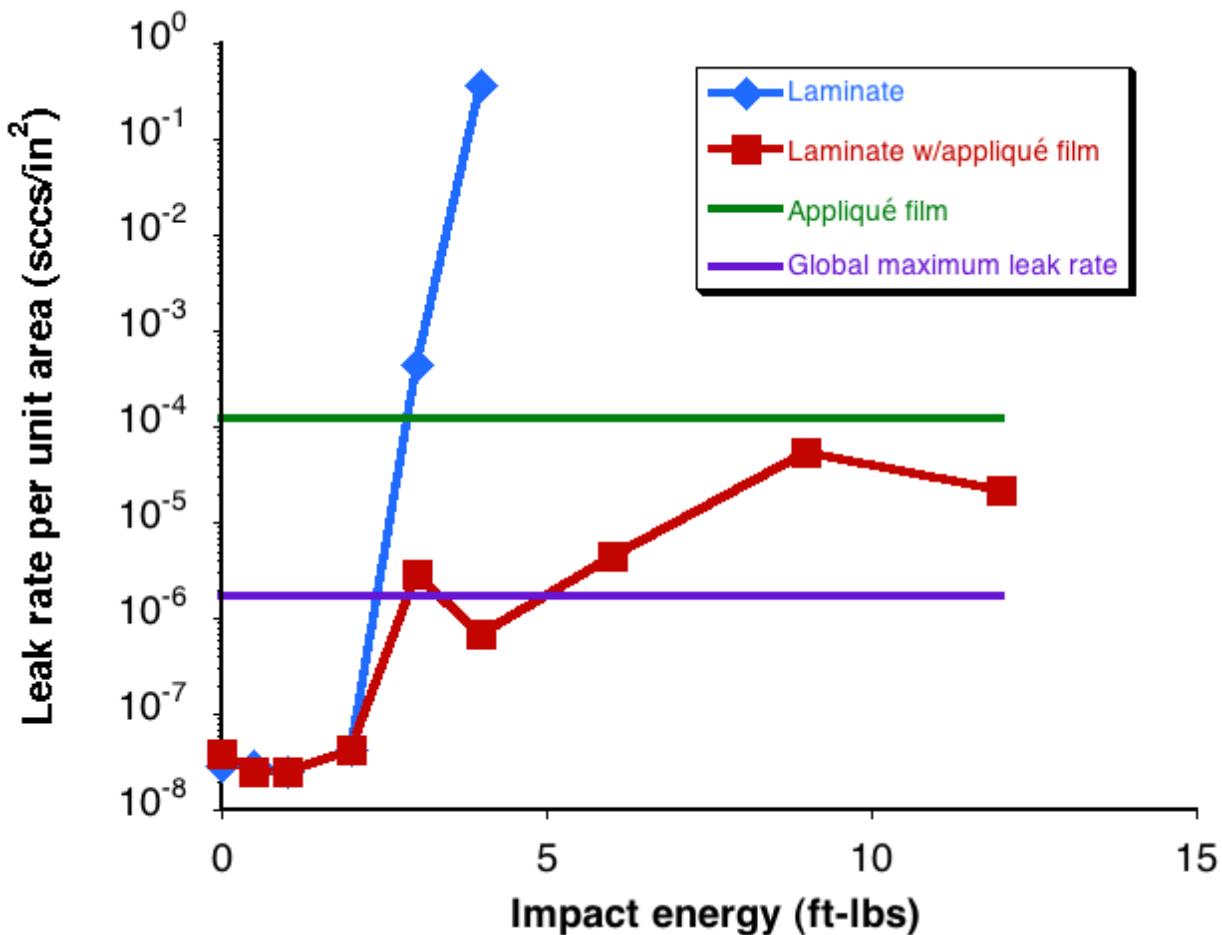
Figure 7.2-3. Effect of Appliqu^é Film and Impact Energy on the Leak Rate per Unit Area

Figure 7.2-3 contains two reference lines: a global maximum and appliqu^é film leak rates. The global leak rate is based on the CxP leak requirement ($1e-1$ sccs) divided by the CCM internal shell surface area ($400 \text{ ft}^2 = 57600 \text{ in}^2$). The figure shows the appliqu^é film is not sufficient to act as the sole permeability barrier on the entire 400 ft^2 . However, as discussed earlier, the permeability of the film to air may be significantly improved relative to the helium used in the leak measurement.

Figure 7.2-3 shows a permeability that is largely unaffected by impacts less than 2 ft-lb. This result is consistent with what was reported using the nitrogen flow technique [ref. 2] (i.e., there appears to be an impact threshold at ~ 2 ft-lb). However, this technique provides quantification below the impact threshold. The leakage rises rapidly with impact energy so that even one impact of the laminate at low energy (< 6 ft-lb) would produce a leak that is in excess of the global maximum leak rate. In contrast, the laminate with the appliqu^é film shows the same impact threshold, but rather than showing a continued rise versus impact energy, displays a

shallow rise and appears to approach an asymptote below the leakage rate of the pure appliqué film.

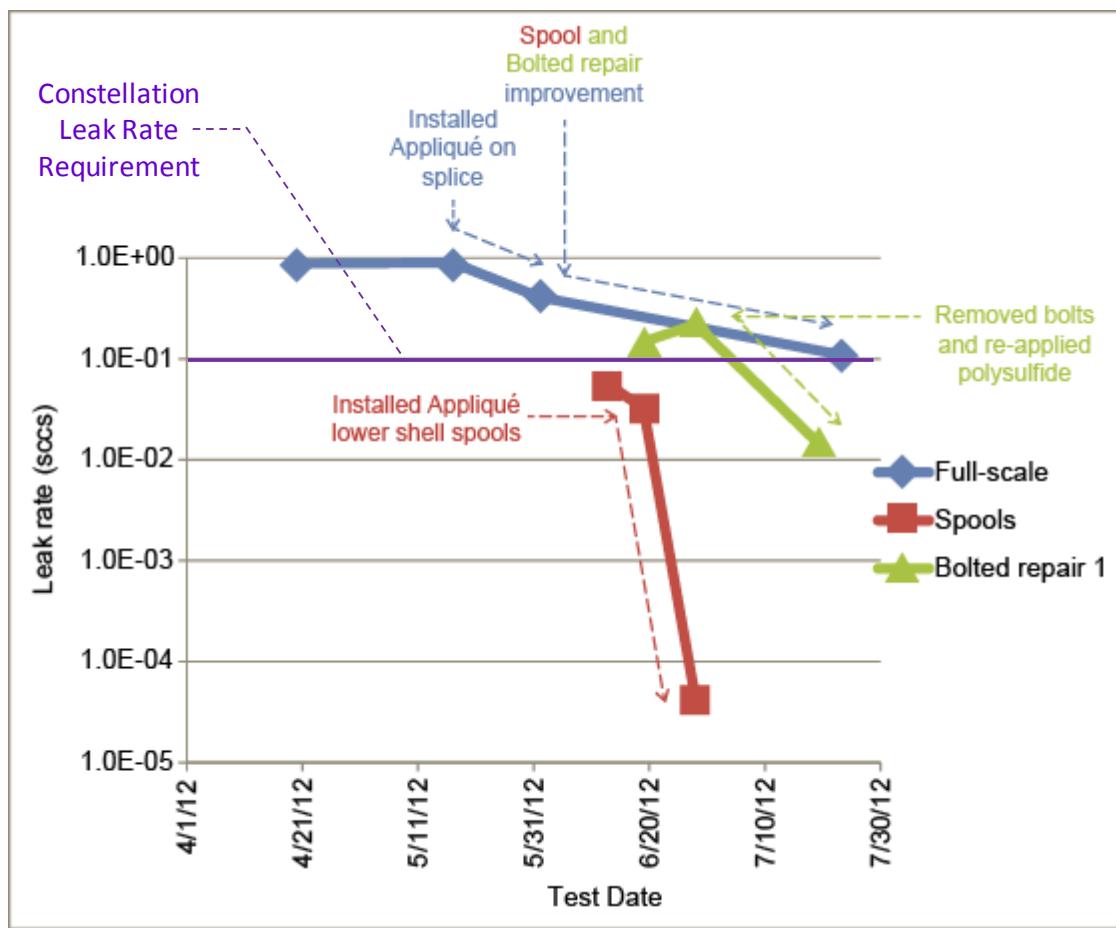
Figure 7.3-18. History of Leak Rate Measurements for Full-scale CCM and for Individual Features (modifications are identified)

1 (on lobed bottom) and the through-thickness inserts (spools) had leak rates that were of the same magnitude (i.e., 1e-1 sccs) as the overall vehicle requirement. Figure 7.3-18 shows the overall CCM leak rate, the insert leak rate, and the bolted repair leak rate on a time line as modifications were made to reduce the leak rates. Figure 7.3-18 also illustrates the effect of the improvements on the feature and the overall leak rate. Again, the leak rates from the feature tests were adjusted for the 2-atm pressure differential. After modification, these features had a leak rate that was lowered by at least a factor of 10. However, the rate for the bolted repair remained higher than the rates for the other bolted fittings, suggesting that this feature was not appropriately prepared for managing leakage. With the modifications, the overall leak rate was reduced to 1.1e-1 sccs, which is close to the maximum allowable leak rate of 1e-1 sccs.

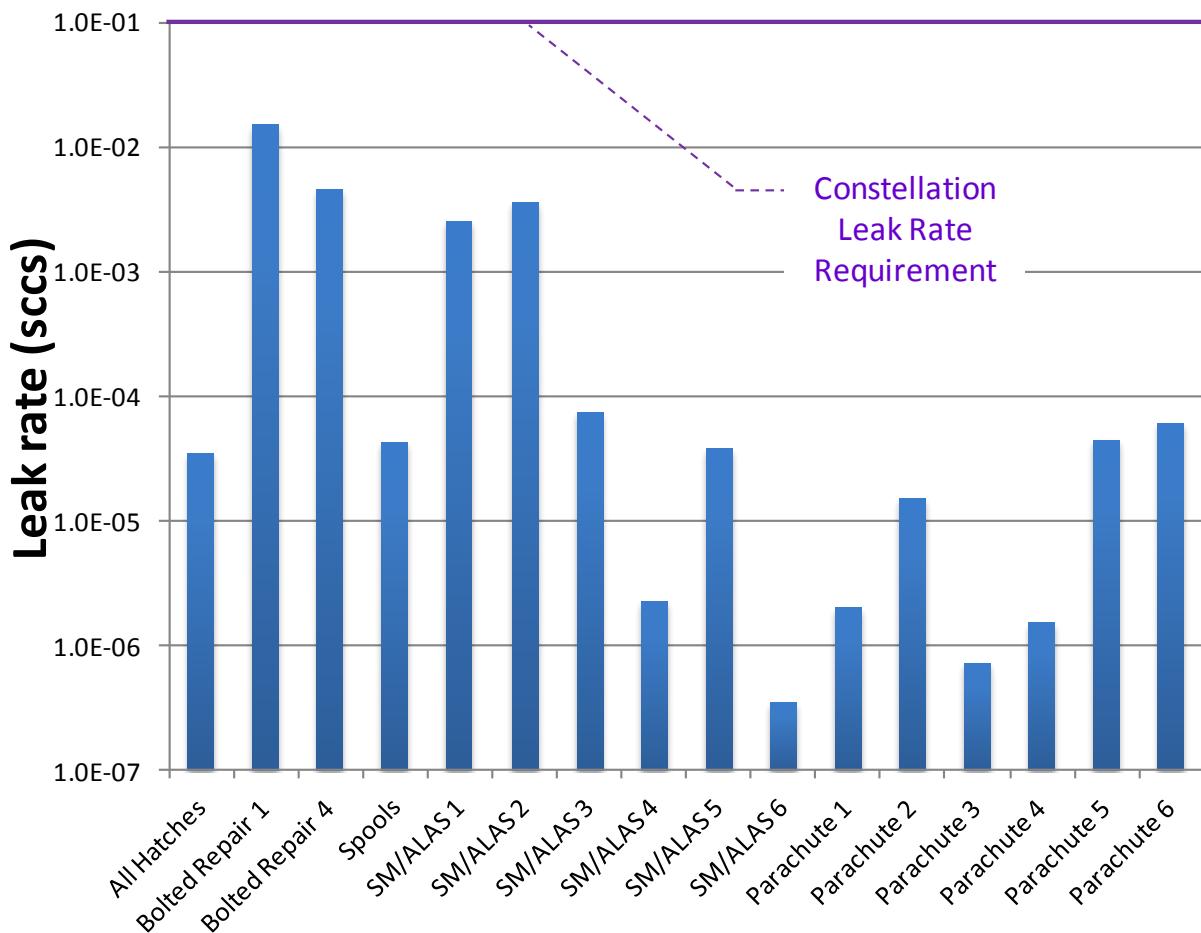
Figure 7.3-19. Local Leak Rate versus Feature

Figure 7.3-19 shows the leak rate for the local features studied with the results adjusted for a 2-atm pressure differential. Four features are noted as being significant contributors: the bolted repairs and SM/ALAS fittings #1 and #2. These features are out-of-family with the other bolted fittings and are significant contributors to the overall vehicle leak rate. It is clear from the remainder of the fittings that significant improvement in the leak rate of a bolted fitting is possible through the adoption of sealing method process improvements.

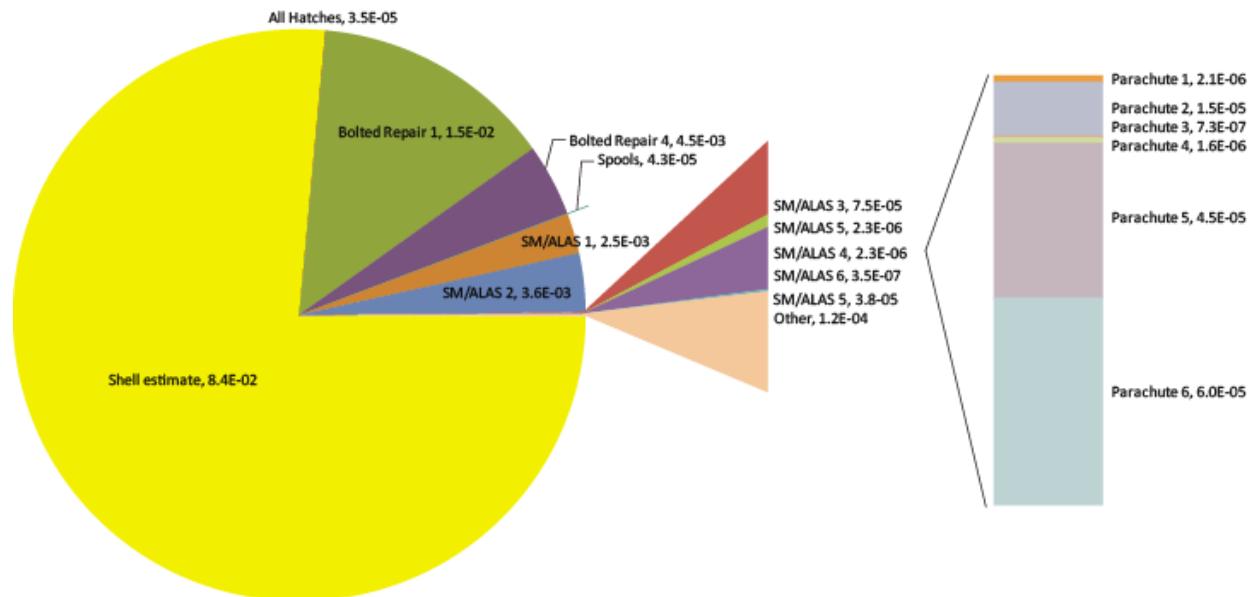
Figure 7.3-20. Global Leak Rate of 1.1e-1 sccs (separated by contribution)

The magnitude of the leakage from the composite shell was estimated by subtracting the local leak rates, summarized in Figure 7.3-19, from the final global leak rate of 1.1e-1 sccs. The shell leak rate is estimated at 8.4e-2 sccs. Figure 7.3-20 shows a pie chart where the global leak rate of 1.1e-1 sccs is divided into the contributing leak factors. While this figure shows that the shell

is the largest contributor to the overall leak rate, it suggests there may be a discrete leak source on the shell (i.e., the scaling of the coupon result suggests that this rate should be much lower). Possible sources for discrete leaks are the impact sites from the damage tolerance test investigation [ref. 3] that were not covered with appliqué film, the damage created by the test-to-failure, and other undetected regions of damage.
