NASA/TM-2013-217993

# Evaluation of Acoustic Emission SHM of PRSEUS Composite Pressure Cube Tests

*Michael R. Horne*  
*National Institute of Aerospace, Hampton, Virginia*

*Eric I. Madaras*  
*Langley Research Center, Hampton, Virginia*

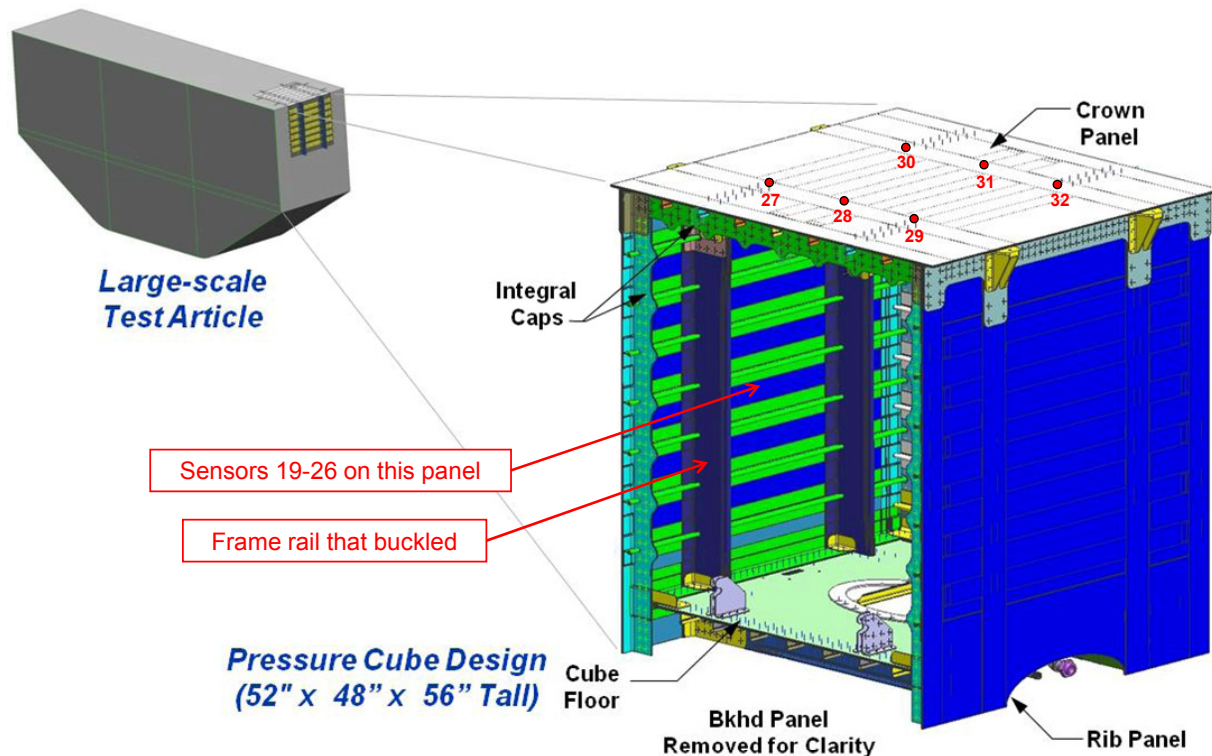
The AE sensors applied to the crown and one of the rib panels, as well as the section of the frame that buckled first during failure, are shown in figure 2. For purposes of illustration the bulkhead panel indicated as “blkhd panel removed for clarity” can be considered as the panel that blew out during failure, leaving the cube looking much as the figure illustrates, albeit, a little more ragged and fractured.

Figure 2. Schematic of Pressure cube with approximate locations of some of the AE sensors (red dots) mounted on the crown panel and other notations in red by the author. [4]

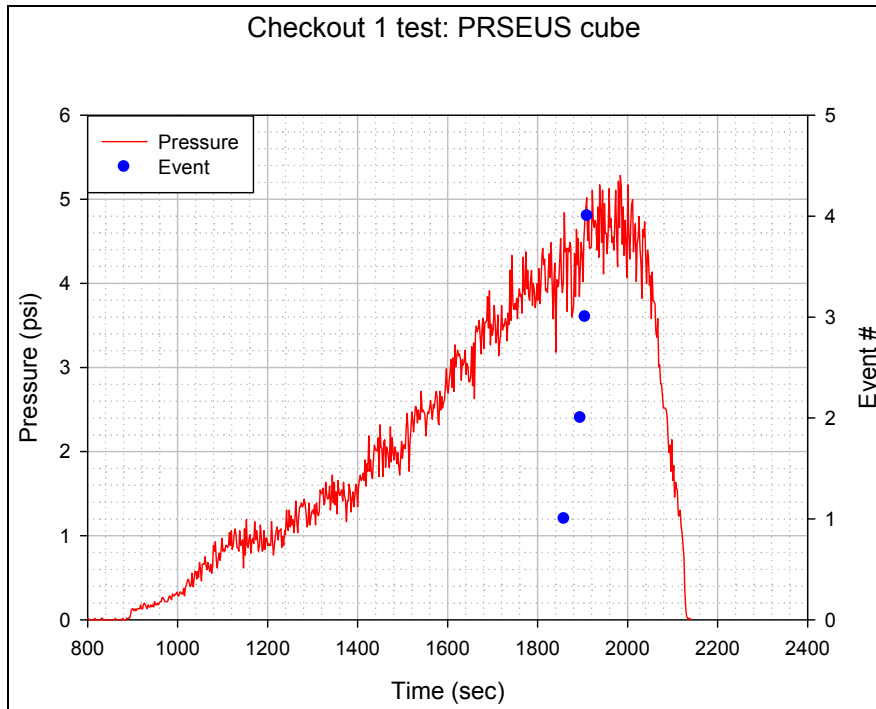
During checkout test 1, only four AE events occurred, near the peak pressure, as seen in the “Load profile and AE Events” plot in figure 6. The load profile (vs. time in test) is the red trace and AE events are indicated by the blue dots. Three events occurred at sensor 16 on the bulkhead panel that did not fail, and one at sensor 31 in the center of the crown panel, between the regions later discovered to have delaminated. Please note, as seen in figure 7 of the waveforms captured at all the sensors for event 1, there does not seem to be much signal on the sensors other than 16, indicating a source very local to that sensor. However, after filtering out frequency content below 50 kHz, neighboring sensors 11, 14, 17, 18 do indicate some wave content other than noise. None of these sensors are near the panel that eventually failed but these events are either much smaller than the ones from the second checkout test or, as in the case of the channel 16 signal, are not particularly similar to that of a damage induced AE signal. Sensor 20 is showing a type of continuous AE not seen on the other sensors, although its frequency content (50-75 kHz) is much lower than the 400 kHz seen at sensor 16 and neighbors.

Figure 6. Checkout test 1 (0.5P, P=9.2 psi) Load profile and AE events

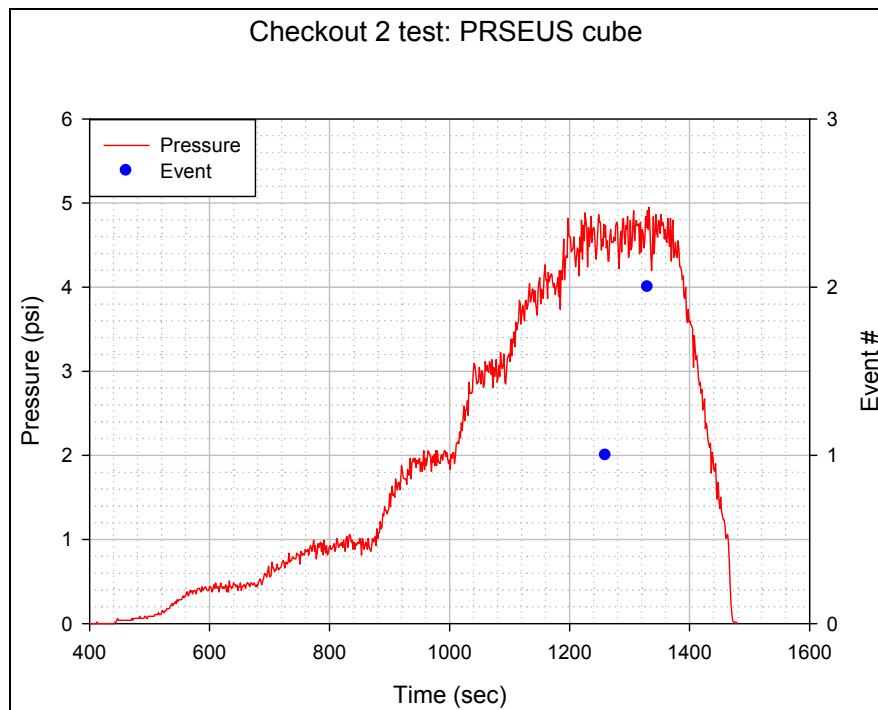
During checkout test 2, only two AE events occurred, near the peak pressure, as seen in the “Load profile and AE events” plot in figure 8. These events show less localized (geographically) and longer (in time) activity, indicated by the number of sensors with significant waveform, as illustrated in figure 9 of event 1. The event registered significantly on sensors 19 to 26, as indicated by the red arrowhead line. These signals look more like typical damage-induced AE signals. Also, these sensors are on the speckle-pattern rib panel which suffered a metal splice fracture and frame buckling during later tests. Compared to the signals from checkout test 1, these signals are more likely to be from a distributed structural “damage” source. The response of event 2 is similar and has indications on sensors 1-6, 8, and 10. Note that sensors 1-6 are on

the panel that eventually blew out entirely during the failure test. Sensors 8 and 10, albeit on another panel, are closest to the edge contiguous to the “failure” panel.

**Figure 8.** Checkout test 2 (0.5P) Load profile and AE events

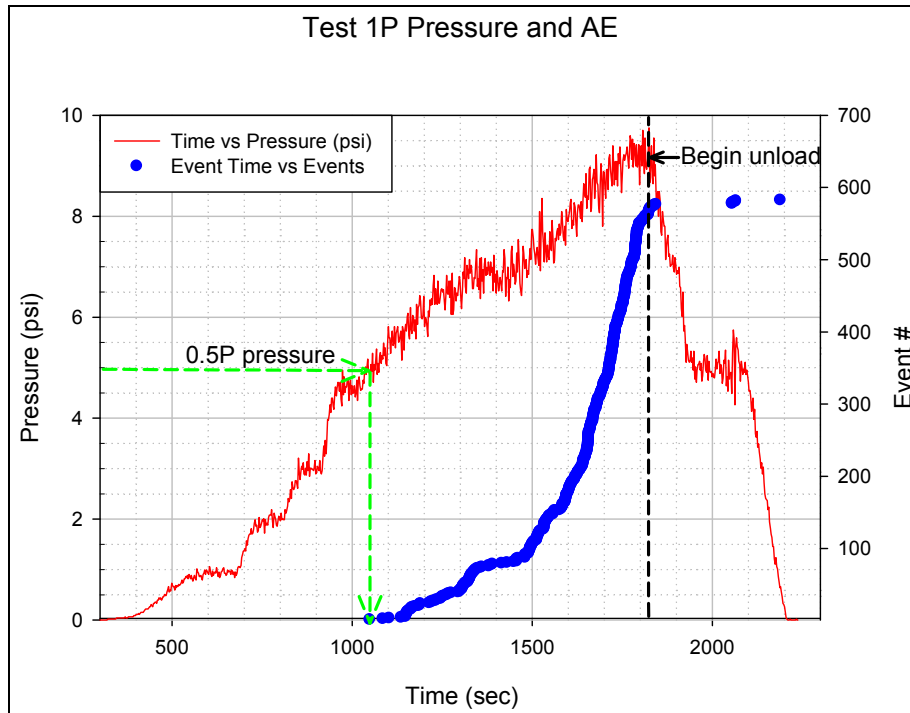
The load profile and AE event plot for the 1P test is shown in figure 10. The dotted green lines indicate the point in time where the pressure reaches the previous peak pressure achieved during the 0.5P tests. A Felicity Ratio of 1 indicates that no structurally destabilizing damage occurred during the 0.5 P tests. The black vertical line indicates the beginning of the unloading. Events after this point indicate that some damage, which created new surface, had occurred during this test. As the load reduces, the friction of these surfaces coming together creates acoustic emission as they interfere.

**Figure 10.** Pressure 1P Test Load profile and AE events

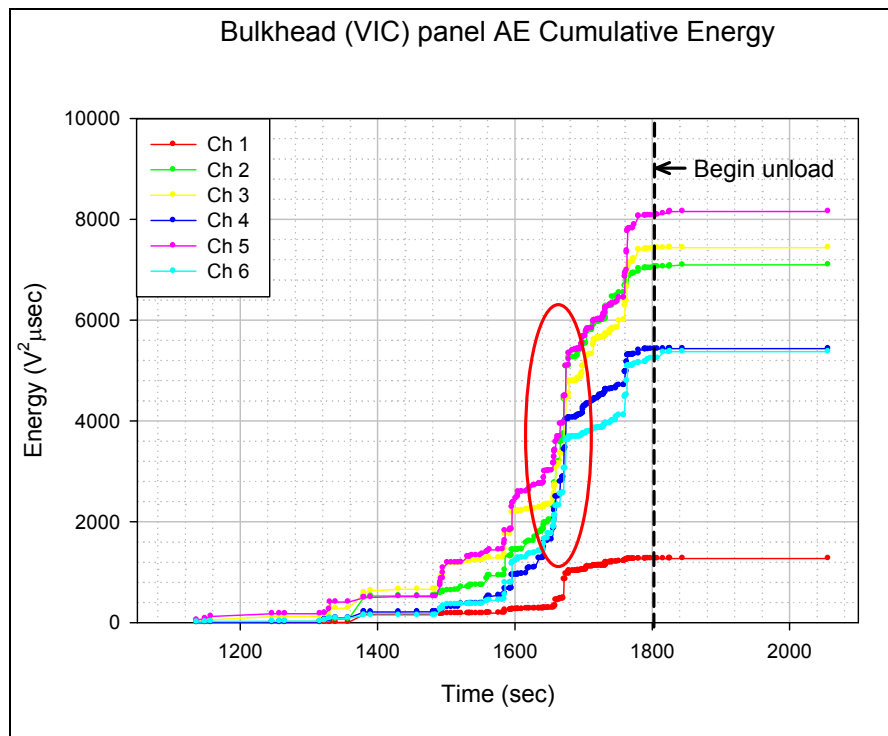
For this analysis, the cumulative energy of the events was calculated for each channel (sensor) and is plotted, versus time, for each panel as seen in figures 11-15. Red ovals indicate items of interest. In figure 11, the speckled bulkhead panel that blew-out during the failure test, has a significant rapid coordinated jump in energy occurring on all sensors around 1680 seconds (~ 8.6 psi). Sensor 1 with the lowest cumulative energy is bay-located. This bulkhead panel had the next-to-the-highest cumulative energies per sensor. Figure 12 shows the cumulative energy plot for the gray rib panel, which is opposite the failure initiating speckled rib panel. It has the lowest sensor energies of all the panels. Now, note that the cumulative energies of the gray bulkhead panel, as seen in figure 13, includes the highest energies, with the largest increases occurring at 1790 seconds right before unloading. This panel is farthest from the later failure locations, so hindsight allows us to suggest that these events were “structurally stabilizing” because their location is not involved in the final failure. However, they did occur on a bulkhead panel, suggesting that these types of panels may be more likely to fail and should be monitored more closely. Significant coordinated increases also occur on most sensors of that panel at 1610 seconds (~ 8.0 psi) and 1660 seconds (~ 8.5 psi), especially sensors closer to the floor (16, 17, and 18). The smallest increases occurred at sensor 13 (bay-located), and 15 (failed). Figure 14 shows a significant coordinated increase at 1720 seconds (~ 9.0 psi) of the cumulative energies of the speckled rib panel which later had initiated the final catastrophic failure. It also has the next lowest cumulative energies of the side panels. Comparable cumulative energies are noted for the crown panel as seen in figure 15. There is a coordinated increase around 1650 seconds (~ 8.4 psi) with sensor 27 having the greatest increase by 1700 seconds. Sensor 27 is closest to the metal splice failure on the affected frame. The greatest total cumulative energy occurs on sensor 31. After the 2P test, delaminations were discovered that run along the edges of the crown panel contiguous to the rib panels. Sensors 31 and 28 are closer to both of those edges than the other crown sensors. An explanation for the large total cumulative energy at 31 may be that the delamination damage (or delamination-initiating damage) was already occurring near both sensors 30 and 32. Although the energy at sensor 30 or 32 would be greatest from the damage nearest to each, the sum of the energy from both damage regions could be greater at the sensor in the middle, 31. This may also account for the higher total cumulative energy (vs. others on same

**Figure 11.** Pressure 1P Test: Speckled bulkhead panel AE energy

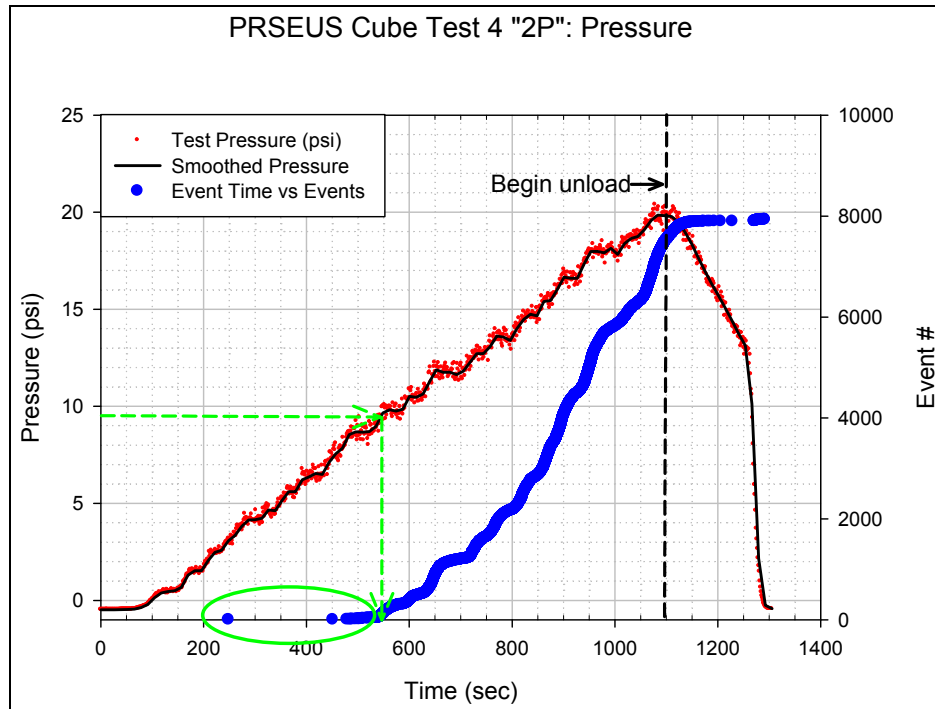
The load profile and AE event plot for the 2P test is shown in figure 16. Some randomness was seen in the test pressure values (red dots), so a smoothed version was calculated and is plotted as the black curve. The dotted green lines indicate the point in time where the pressure reaches the previous peak pressure achieved during the 1P tests. A Felicity Ratio of approximately 0.3 supports the conclusion that significant damage did occur during the 1P test. Since the trigger gain was reduced 3 dB from the 1P test to the 2P test, this FR is especially indicting because AE may have been sensed even earlier if the higher gain had been used. The overall larger number of events during 2P test compared to 1P test indicates more rapid damage progression. The larger number of events during unloading after 1100 seconds (~ 20 psi), than has occurred during previous unloadings, also indicates more significant damage had occurred during the 2P test than previously. Figure 17 is a closer view of the same data with a region of interest shaded in yellow between 16-18 psi (885-950 sec) indicated because of increasing strain gauge activity at that time.

**Figure 16.** Pressure 2P Test Load profile and AE events

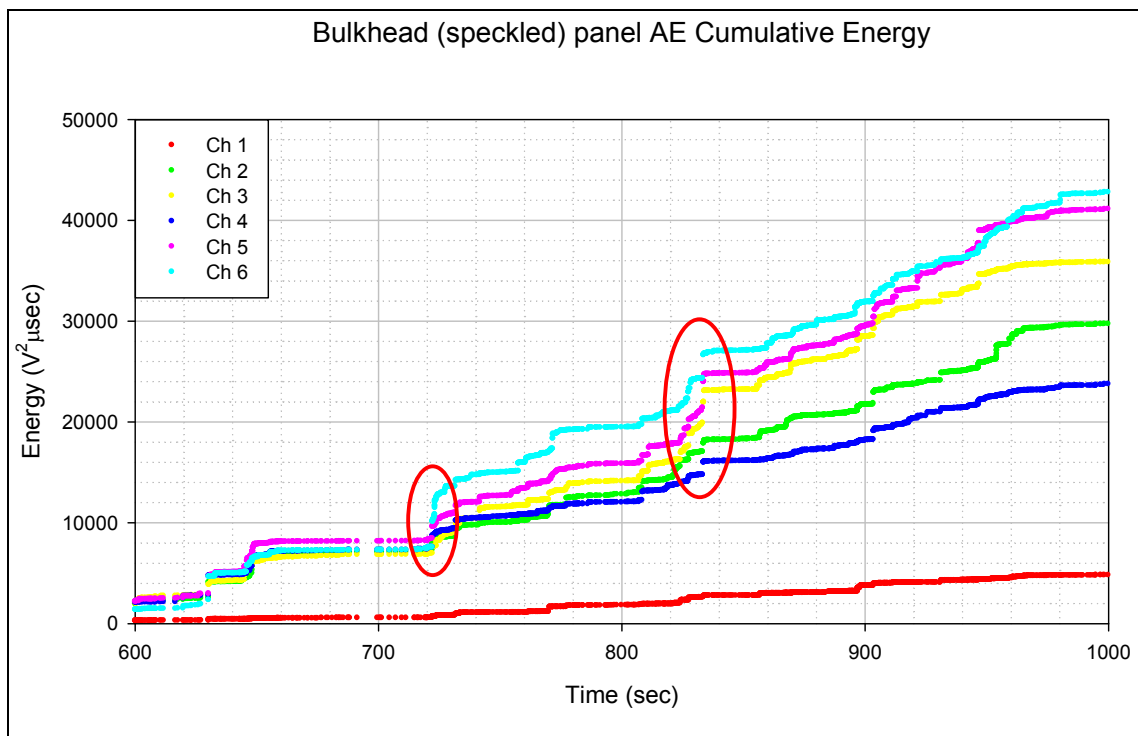
During the 16-18 psi window, higher rates of increase (excluding the noted jumps) in the cumulative energy, occurred on the speckled bulkhead panel (figure 23) and the speckled rib panel (figure 26). Also, on all the panels except the gray bulkhead panel, around 18 psi (950 seconds) at the end of the yellow shaded region, more rapid increases in cumulative energy occurred, especially on speckled rib and crown panels (noted for the delaminations that were discovered after this test). The largest cumulative energy at that point (around 1000 seconds, still approximately 18 psi) are on the speckled rib panel followed by the speckled bulkhead. Sensors 19 and 20 leading on the speckled rib panel may be due to delamination growth in the crown away from sensor 30 toward 27. On the crown, sensor 27 lead with highest cumulative energy for most of the test, followed by sensors 28 and 31. Sensor 27 is the closest crown sensor to the metal frame splice that had failed, suggesting damage development that lead to the splice failing. Both sensors 28 and 31 being high indicate that both delaminations in the crown were growing. As noted previously sensor 29 was weak during the entire series of tests.

**Figure 23.** Pressure 2P Test: Close-up of speckled bulkhead panel AE energy near window of strain gage activity

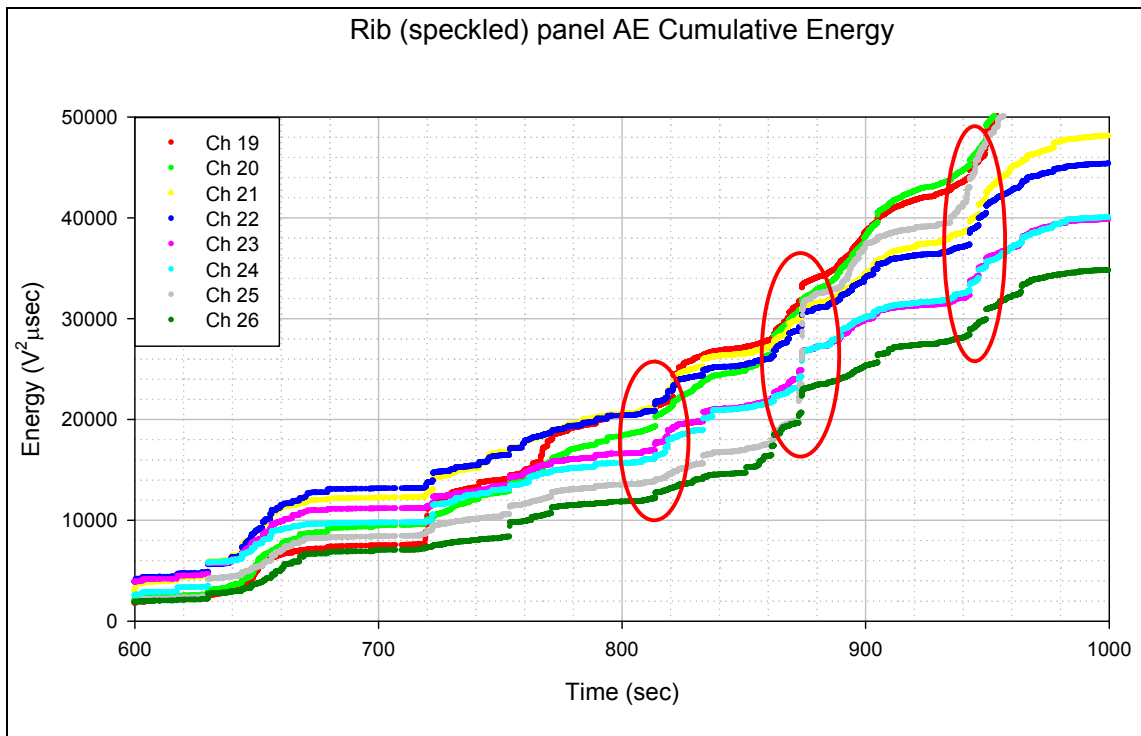
**Figure 26.** Pressure 2P Test: Close-up of speckled rib panel AE energy near window of strain gage activity

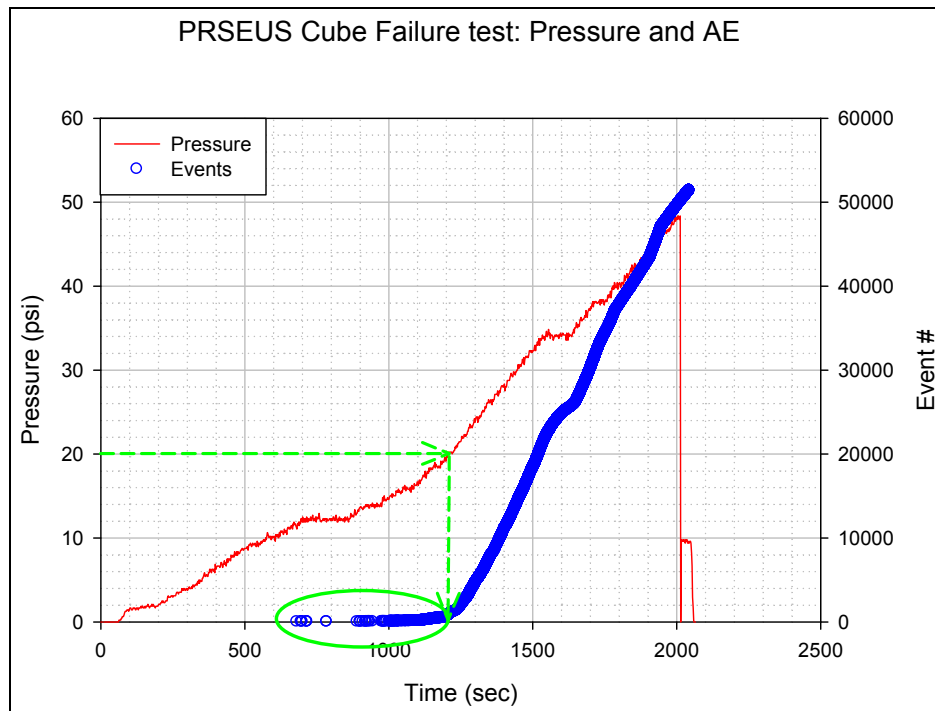
The load profile and AE event plot for the failure test is shown in figure 28. The dotted green lines indicate the points in time when AE starts and the time when the pressure reaches the previous peak pressure achieved during the 2P tests. A Felicity Ratio of approximately 0.6 indicates that more damage did occur during the previous 2P test Failure occurs a little after 2000 seconds at a pressure of approximately 48 psi (approximately 5 times the design pressure  $P=9.2$  psi). Figures 29-33 are the cumulative energy plots. All of the plots show a leveling off or reduction of AE rate around 1550-1600 seconds, which coincides with a pressure hold of approximately a minute. This illustrates the extent that AE event rate is affected by load rate.

**Figure 28.** Failure Pressure Test Load profile and AE events

Variations in load rate should be kept to a minimum during testing, especially when analyzing the AE for onset of different failure mechanisms. The overall behavior, more obvious in this test, but also occurring during previous tests, is that the sensors nearer the floor (especially 6, 12, 18) tend to lead in cumulative energy for each side panel. This could be due to the hatch or the different construction of the floor (relative to the other panels) either making more noise or increasing stresses at the edge of the other panels.

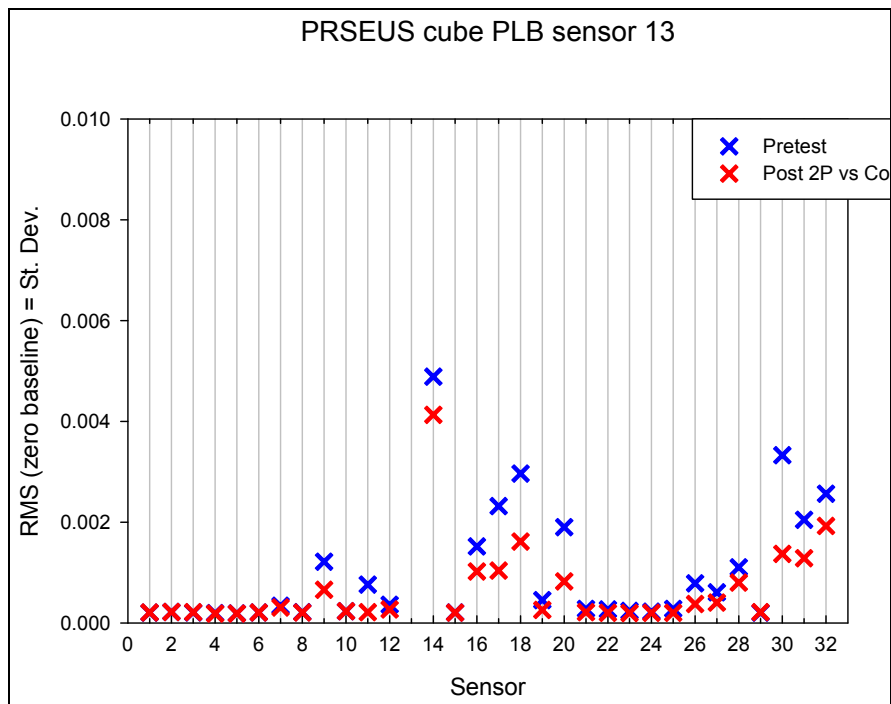
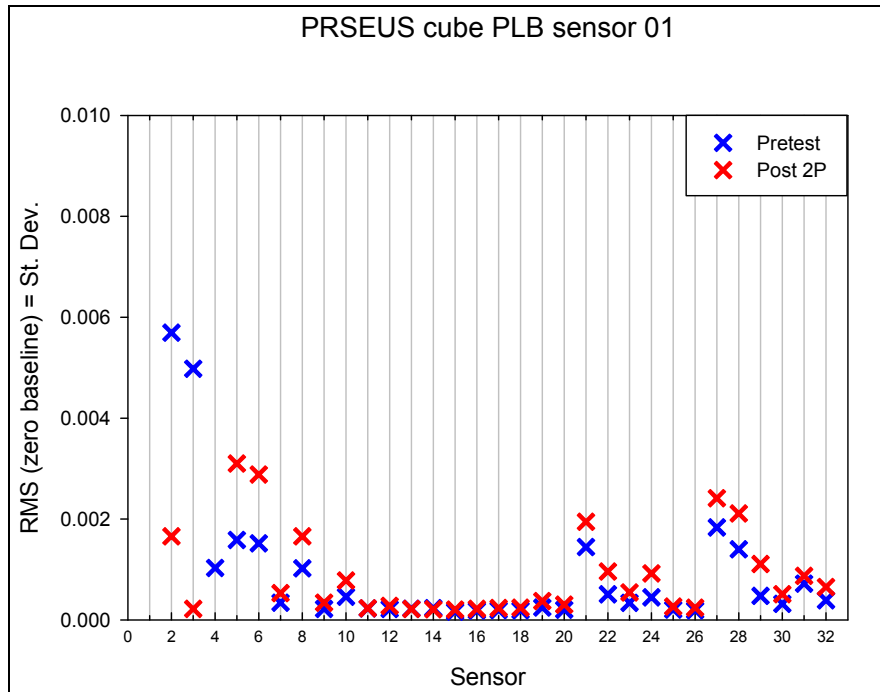
For these tests, an indication of the energies collected at all sensors due to one PLB is made by calculating the RMS (root-mean-square) value for each collected waveform. This is plotted in figures 36-37 with respect to each sensor. Figure 36, for a PLB at sensor 13, shows the expected behavior of attenuation from damage development because all the RMS values prior to testing (blue X) are higher than after the 2P test (red X). To accentuate the sometimes small differences in RMS value, the scale for RMS is such that the values collected at the PLB sensor are off the graph. Figure 37 illustrates the opposite behavior where the post test RMS values are larger than the pretest. Figures 38-41 are spectra of the waveforms collected at a PLB sensor and its nearest neighbors. The pre-test to post comparison of spectra of the “expected-behavior” responses, seen in figures 38 and 39, respectively, shows a decrease in energy post-2P across most all frequencies. Figures 40 and 41, illustrating the inverse behavior for the PLB at sensor 1, show the increase occurring predominantly in the frequencies below 150 kHz. Note that sensor 1 is on the panel that blew out during failure.

**Figure 36.** Change in response with damage accumulation of PLB at sensor 13

**Figure 37.** Change in response with damage accumulation of PLB at sensor 1
