NASA/TP—2001–211302

Polymer Matrix Composite Lines and Ducts

(National Research Announcement 8–21 Final Report)

Marshall Space Flight Center, Marshall Space Flight Center, Alabama

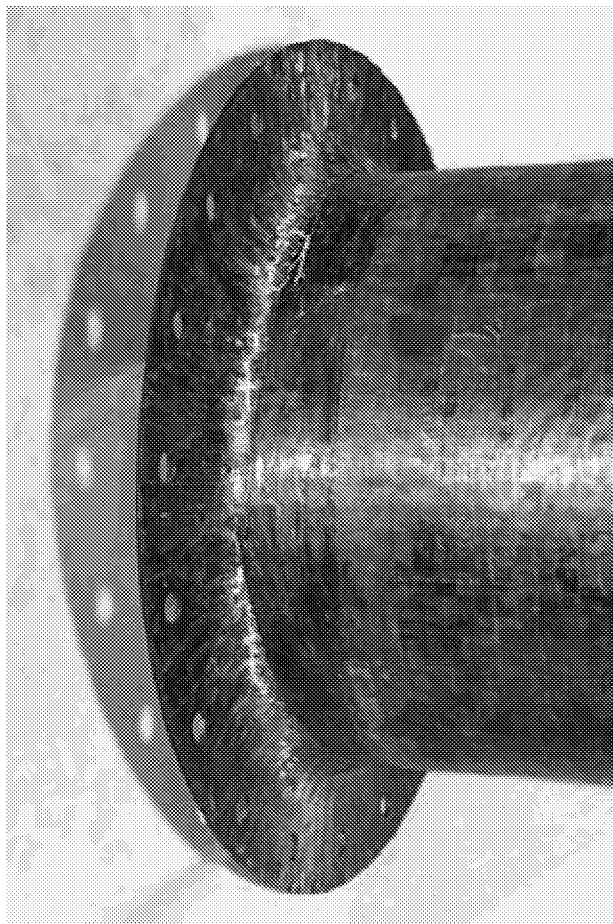
Figure 10 shows a completed feedline manufactured by TTL. A closer view of the flange area is given in figure 11. This area is particularly rough with obvious areas of nonconsolidation visible from the surface. This was of great concern since it could facilitate leaks and compromise the structural integrity of the feedline. A view of the microstructure in the acreage of the feedline is given in figure 12. Poor consolidation with large areas of delamination can be seen. The thermoplastic tape apparently was difficult to compact by the robotic head.

Figure 11. View of flange area of a feedline manufactured via TTL.

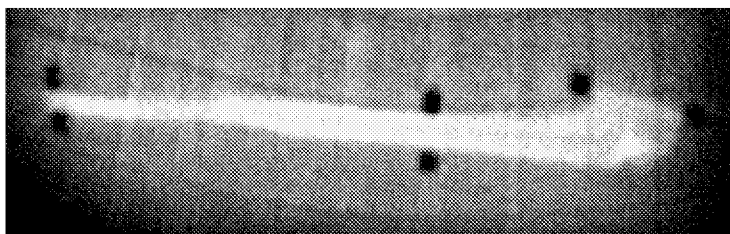
The feedlines were inspected using flash thermography, an NDE technique. Flash thermography consists of hitting the test article with a pulse of heat and then monitoring the release of the heat with an infrared camera. Areas that have anomalies will give off heat at a different rate than the rest of the tube, thus identifying the location and general shape of possible defects. A sample picture of a thermography image is shown in figure 13. In this figure, it can be seen that an anomaly appears (which turned out to be plastic tape).

Figure 13. Flash thermography image showing foreign object (plastic tape) inclusion.

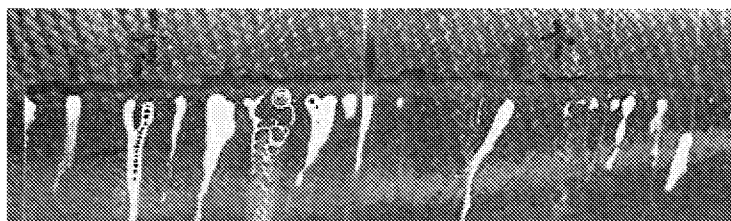
Once proof testing was completed, the next series of tests performed were leak checks at 50 psi using gaseous helium (GHe). The test article was enclosed in a bag (excluding the flange bolts and seal joint) to capture any GHe leaking through the parent material. A probe connected to a helium (He) mass spectrometer was inserted into the bag to sense for any He leakage. The test article sat for 10 min before a leakage reading was recorded. If leaks were found, the test article was set aside and not used for cryogenic testing. The tubes with leaks were taken to the damage tolerance facility in MSFC's PEC and examined further to determine the possible cause of the leaks. Figure 16 shows a bubble-leak detect solution being applied to one of the test articles manufactured by HLU. In this particular feedline, a line of small leaks was apparent.

Figure 16. Leak as detected by bubble-type solution in a test article.

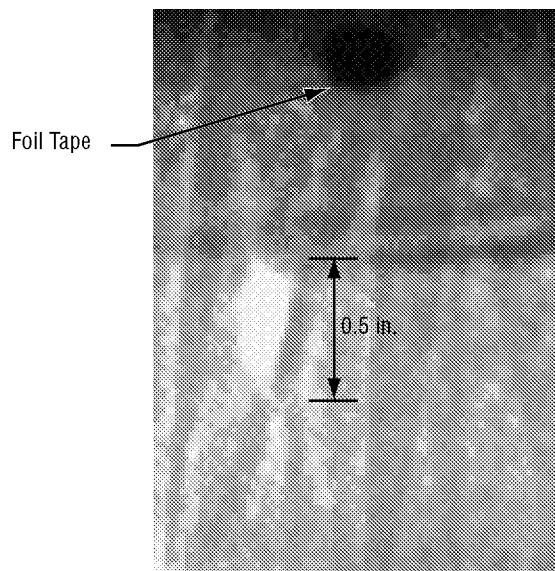
Eight HLU feedlines that were autoclave cured were inspected using flash thermography. Feedline HLU-1 showed no anomalies. For feedline HLU-2, only one major indication was found. The abnormality appears hot (white) which would indicate a void or inclusion of some material that blocks the flow of heat into the tube. The thermogram for this anomaly is given in figure 18.

Figure 18. Anomaly noted on thermograph of feedline HLU-2.

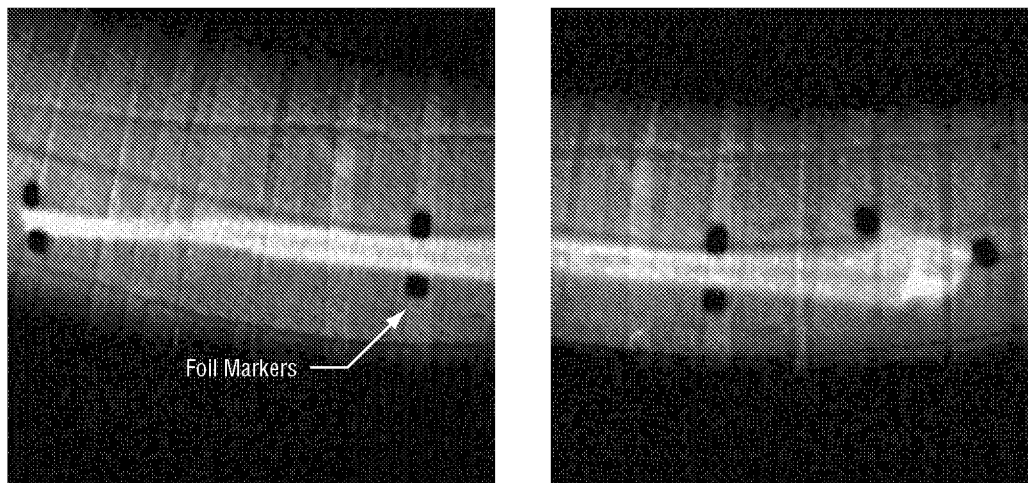
A large inclusion was found on the inner radius of feedline HLU-3. The thermographs are shown in figure 19. Since this anomaly was so large, the feedline was scrapped for subsequent testing. This provided an opportunity to dissect the feedline to determine the cause of the anomaly. Upon sectioning, it was found that the anomaly was a piece of plastic tape under the innermost ply of prepreg. This can be clearly seen in figure 20.

Figure 19. Large inclusion found on feedline HLU-3.

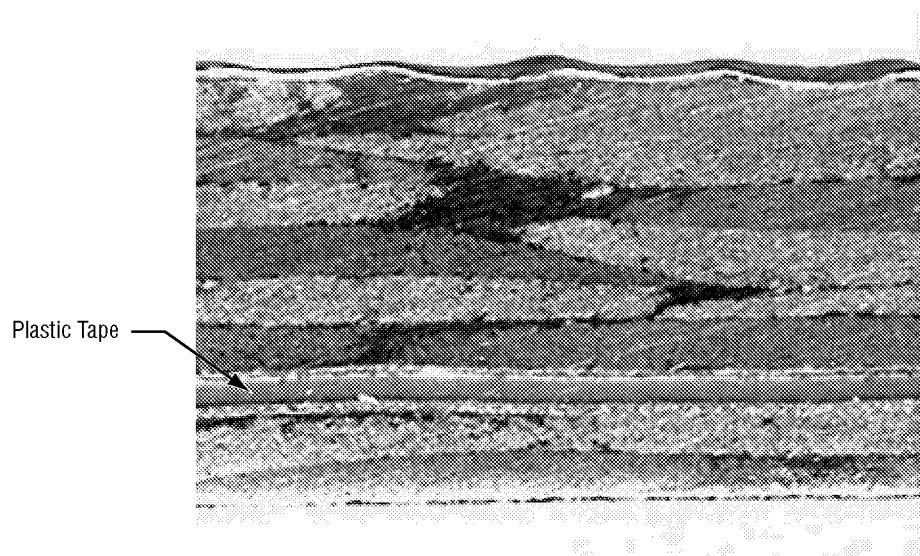
Figure 20. Cross section of plastic tape causing anomaly in figure 13.

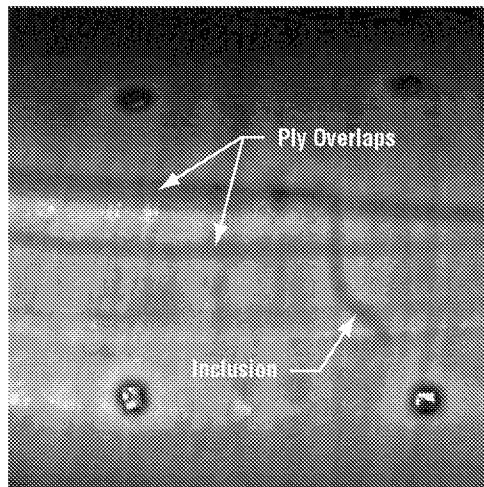
In feedline HLU-4, dark bands found throughout the acreage of the tube (both circumferential and axial), most likely indicate ply overlaps and resin pockets. In figure 21, these dark bands are illustrated along with an inclusion. A delamination was found below a ply splice in the tube acreage. Visual inspection of the region found a surface crack along the upper edge of the indication at the ply splice.

Figure 21. Dark regions and anomaly found in tube HLU-4.

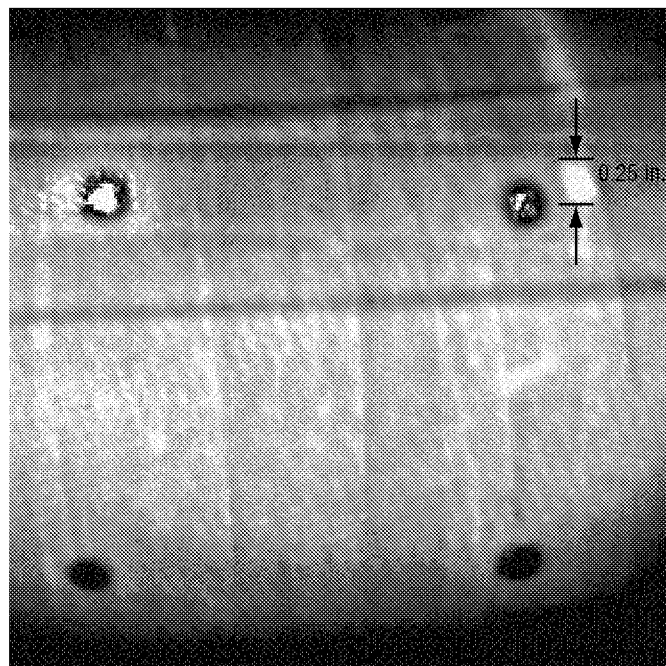
Figure 22a. No surface features, but strong thermal indication.
Possible "thin film" inclusion.

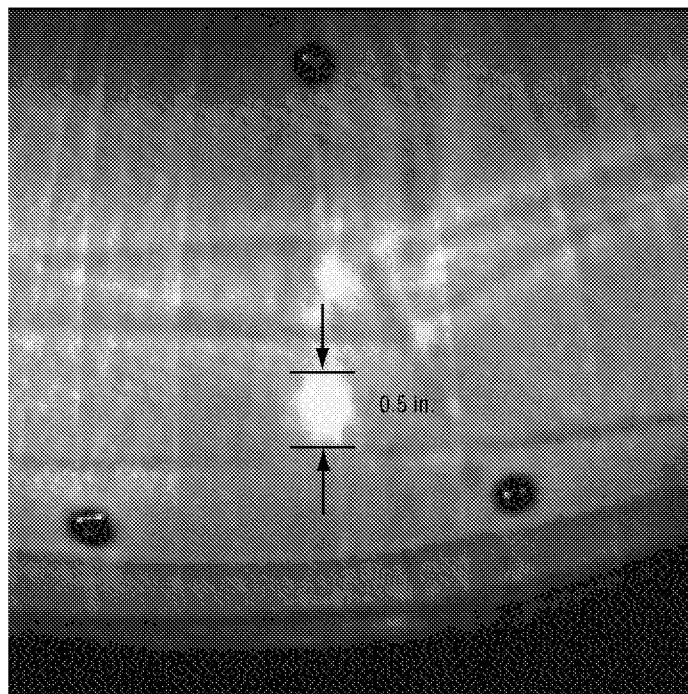
Figure 22d. A bump is visible on the surface indicating an inclusion with possible internal void.

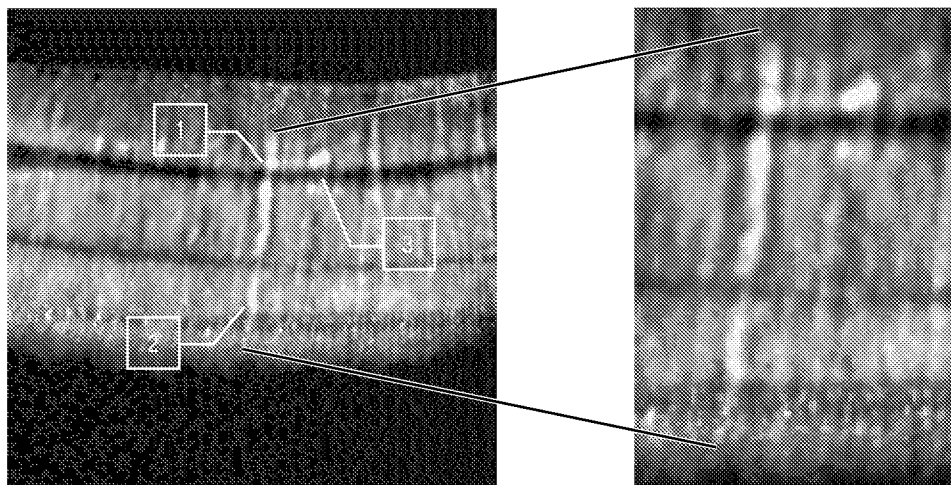
For feedline HLU-6, indications 1, 2, and 3 in figure 23 appear on the surface as small bumps and may be inclusions or ply wrinkles with embedded voids.

Figure 23. Anomalies on feedline HLU-6.

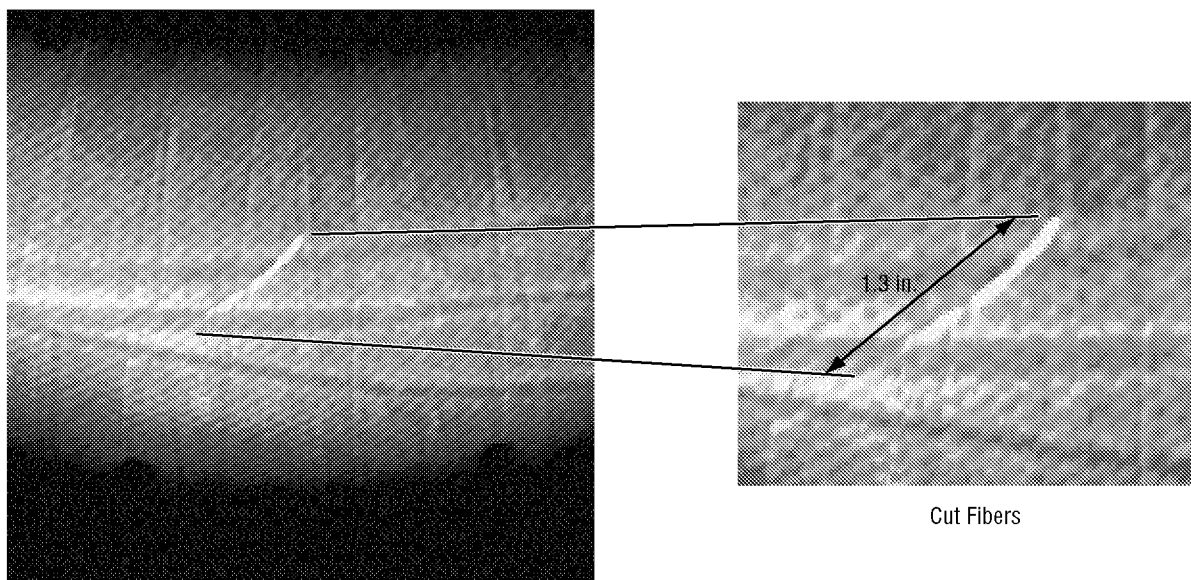
Feedline HLU-7 appears to have been scuffed and the indication shown in figure 24 is visible as a scratch with exposed fibers. In addition, on feedline HLU-7, a faint surface ripple is visible, indicating a deeply embedded inclusion. The thermograph is shown in figure 25.

Figure 24. Thermography image of scuff on feedline HLU-7.

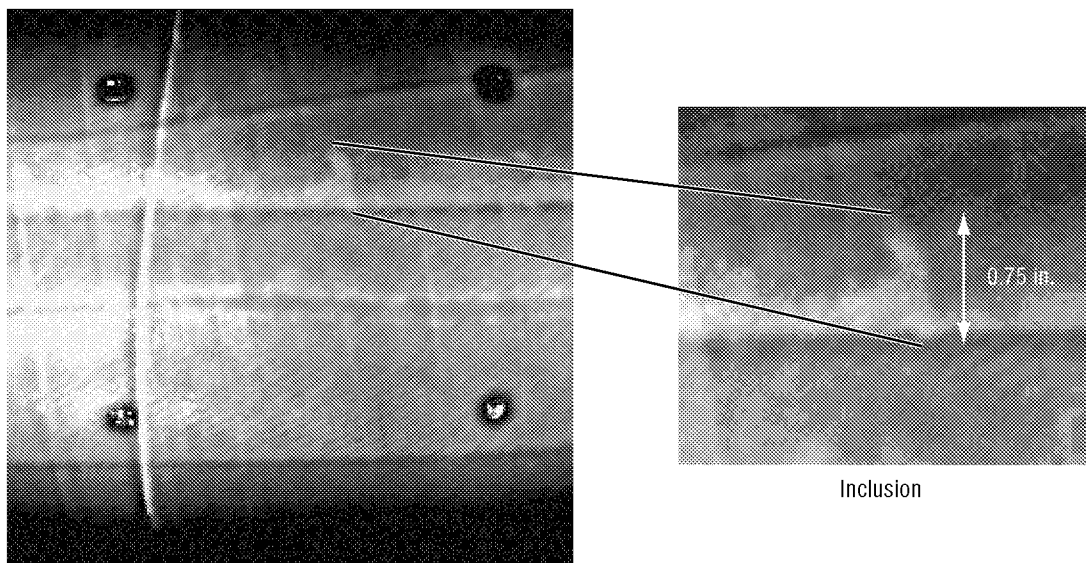
Figure 25. Thermograph of possible deep inclusion on feedline HLU-7.

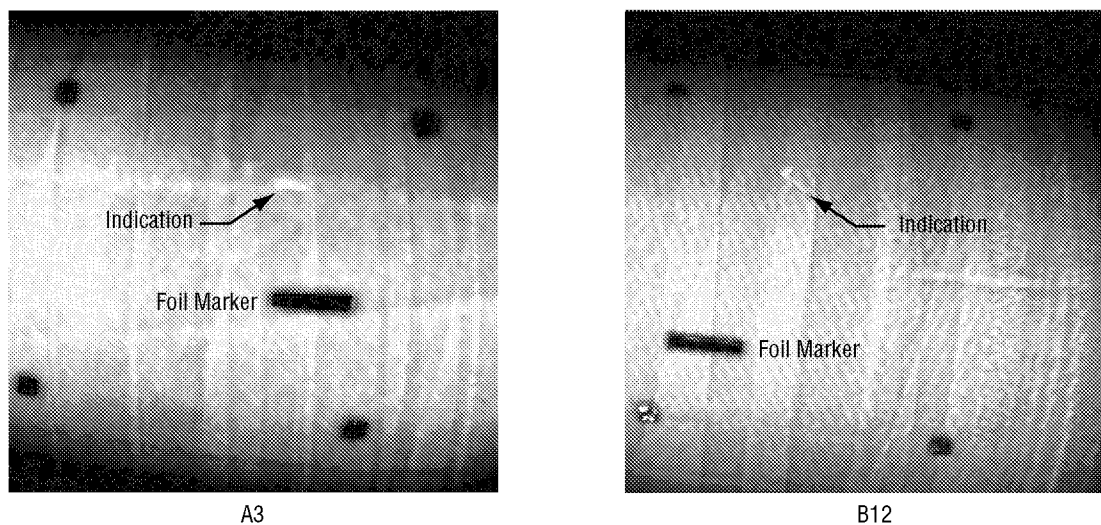
On feedline HLU-8, three small thermal abnormalities were detected as shown in figure 26. The size of each indication was <0.25 by 0.5 in. At region A3, the indication correlates with a surface crack. At position F3, the indication appears to be within the laminate. At position B12, the indication is visible on the surface as a scratch.

Figure 26. Anomalies in feedline HLU-8.

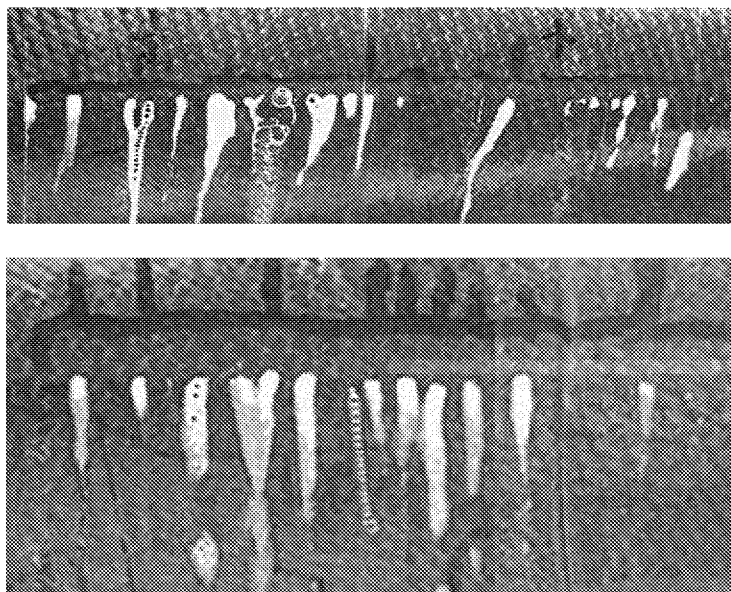
Of the eight test articles manufactured by HLU, two leaked prior to cryogenic testing. Feedline HLU-5 had two areas of linear pinhole leaks and feedline HLU-6 leaked at several sites. Figure 30 shows the two areas of linear pinhole leaks in feedline HLU-5. The tube was pressurized with 20 psi of GHe and a leak detect solution was squirted on the outside. The resulting trail of very small bubbles indicates very small leaks.

Figure 30. Two areas of pinhole leaks on feedline HLU-5.

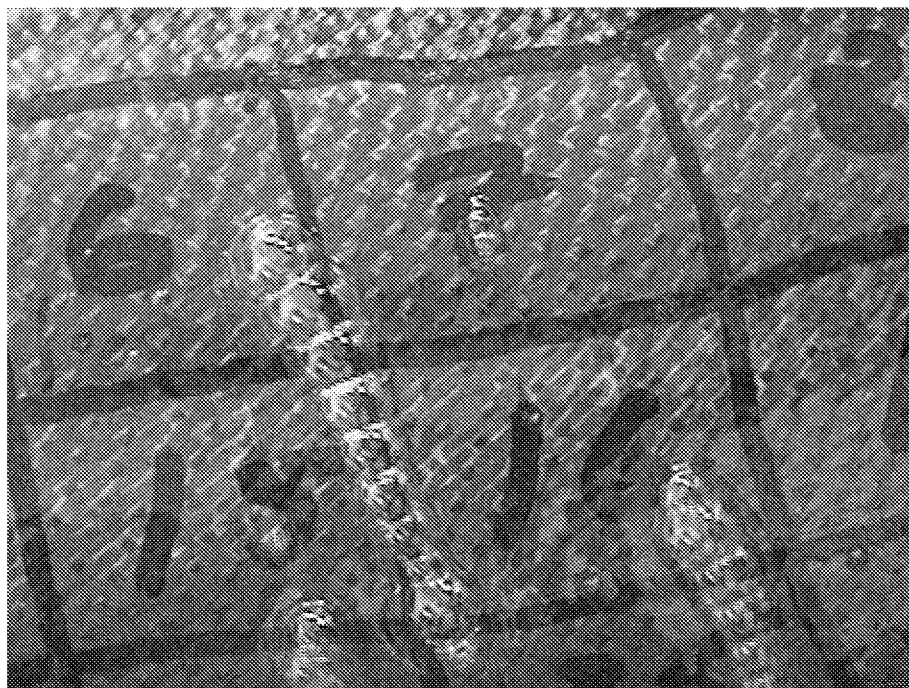
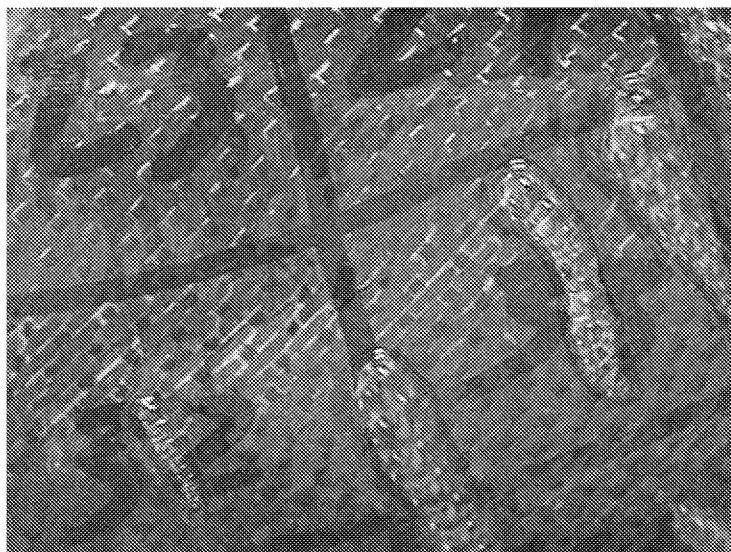
Figure 31 shows some of the leaks on feedline HLU-6. Note that these leaks form larger bubbles than those on feedline HLU-5 (as shown in fig. 30). This indicates larger “holes,” as does the fact that the pictures in figure 31 were taken with the tube at only 3.5 psi. The area of leaks on feedline HLU-6 was marked off into a grid pattern with each grid numbered so the leaks could be better identified.

Figure 31. Samples of leak areas on feedline HLU-6.

Figure 31. Samples of leak areas on feedline HLU-6 (continued).

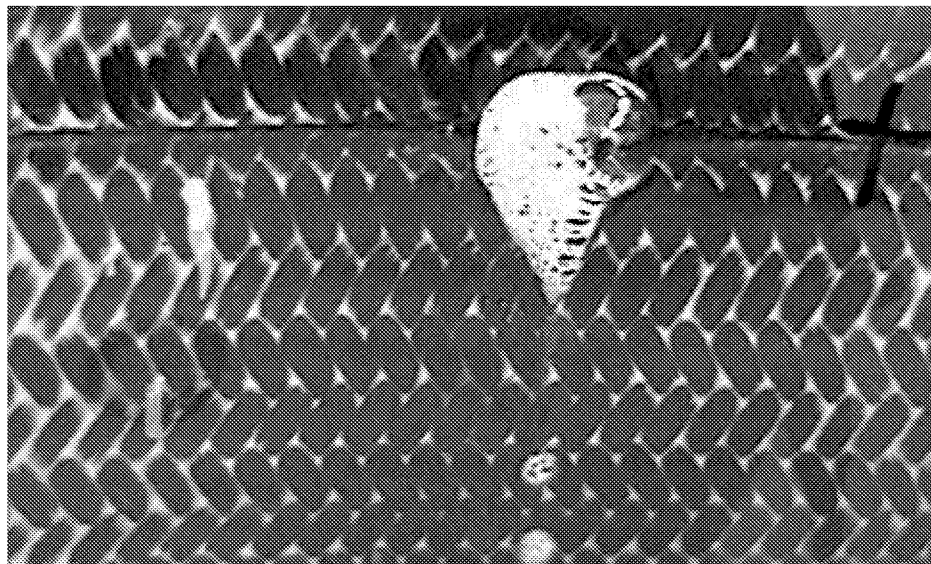
Of the four feedlines manufactured by SARTM, two leaked prior to cryogenic testing. Feedline SARTM-1 demonstrated three areas of leakage and feedline SARTM-3 showed one area of leakage. Figure 32 shows the three leaks in feedline SARTM-1. One of the leaks is large compared to the other two. The feedline was pressurized at 5 psi when the photograph was taken.

Figure 32. Feedline SARTM-1 showing three leak paths.

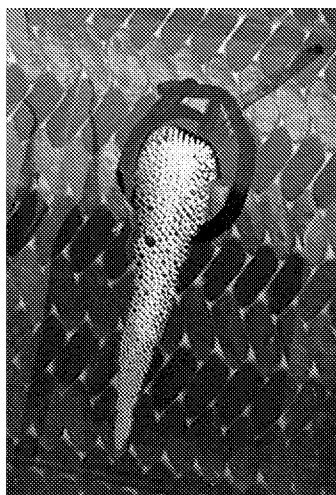
Figure 33 shows the one leak found in feedline SARTM-3. Due to the large size of the bubbles, the leak is significant. The feedline was pressurized at 2.5 psi when this photograph was taken.

Figure 33. Feedline SARTM-3 showing one large leak path.

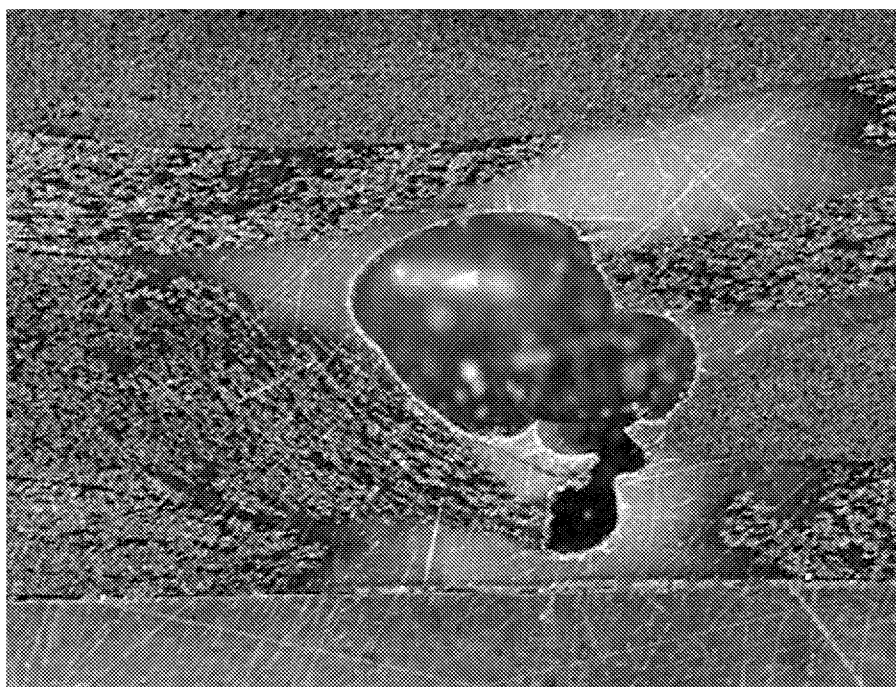
Since these feedlines would not undergo any further testing, they were sectioned at the areas of leakage and photomicrographs taken. Figure 34 shows the cross section of feedline SARTM-1 in which an air bubble appears to be responsible for the leakage seen. Figure 35 shows the cross section of feedline SARTM-3. A small region of the preform is resin starved and provided the large leak path seen.

Figure 34. Cross section of leak area on feedline SARTM-1.

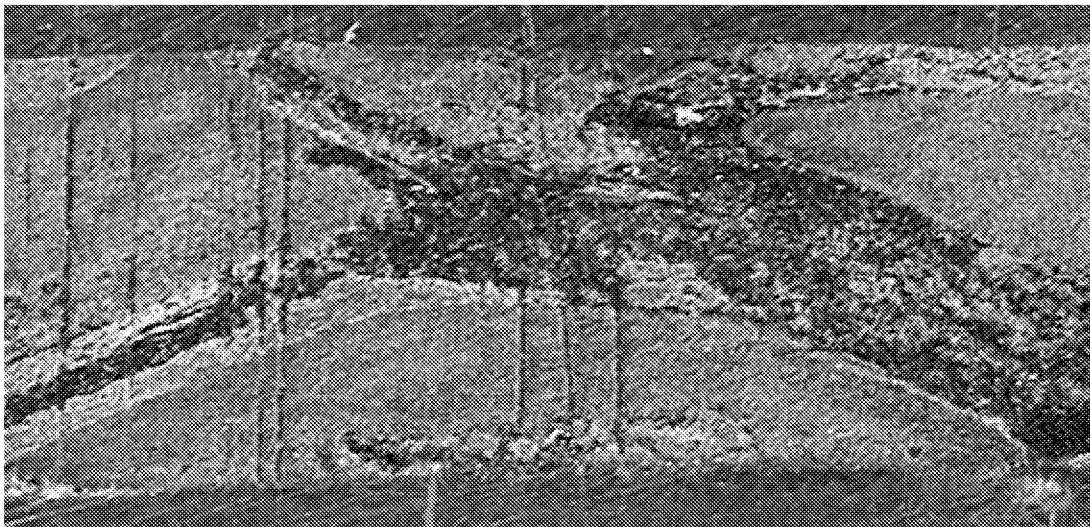
Figure 35. Cross section of leak area on feedline SARTM-3.

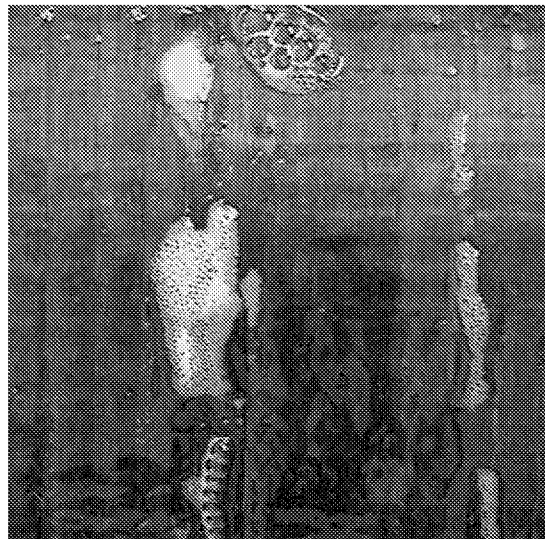
Four feedlines manufactured via TTL were leak tested. All four feedlines showed leakage around the flange buildup area. Figure 36 shows the leakage on feedline TTL-2. The feedline was pressurized at 5 psi for these leak tests. Some of the leaks are very small while others are larger as evidenced by the larger bubbles forming.

Figure 36. Feedline TTL-2 showing ring of leakage around flange buildup area.

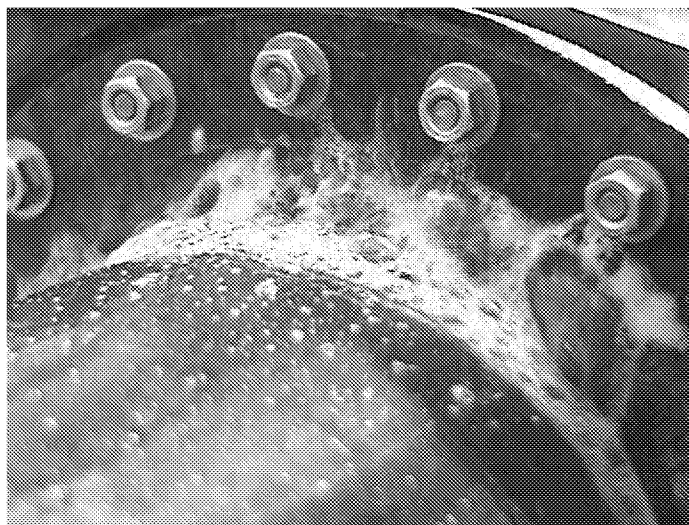
These feedlines also showed leakage at the flange transition areas. Some of these leaks were so exceptionally large that maintaining pressure in the feedline was difficult. Figure 37 shows the flange on feedline TTL-3. The tube was only at 2 psi and it can be seen that the leak detect solution is being splattered into the air since the leak is of such a gross nature.

Figure 37. Flange area of feedline TTL-3 showing gross leakage.

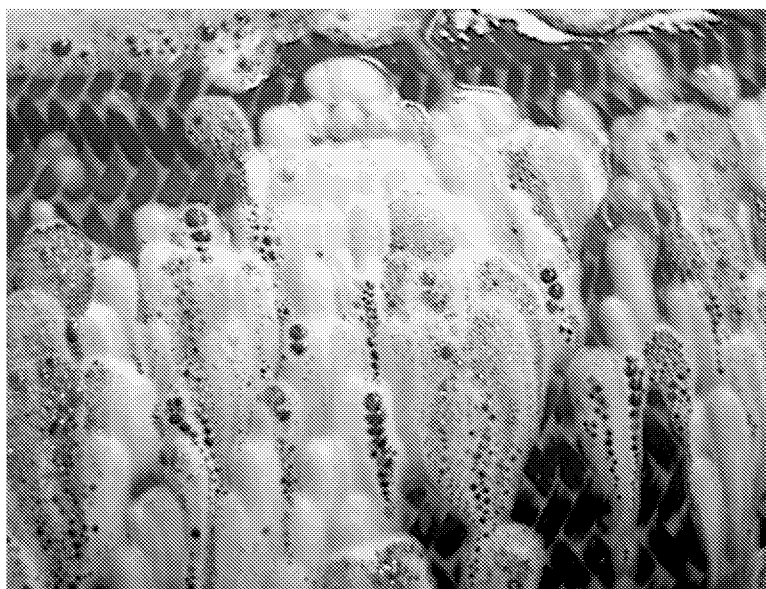
SARTM-2 was the first feedline of this type to be tested. During the first cryogenic cool-down cycle with LN_2 , strain gauge readings were being lost. Upon closer inspection, it was noted that LN_2 was pouring out from the insulation around the feedline. The insulation was removed and it appeared that the LN_2 was seeping out of the tube across its entire acreage. The cryogenic testing was stopped and a GHe leak check was performed. The feedline was filled with 10 psi of GHe and a leak detect solution was sprayed over the feedline. Leakage was observed over the entire area of the feedline. Figure 39 shows the extent of the leakage on this tube. Feedline SARTM-4 was then filled with LN_2 and yielded the same results as feedline SARTM-2. Cryogenic testing on these feedlines was terminated at this point.

Figure 39. Leakage across feedline SARTM-2 after first introduction of LN_2 into the feedline.

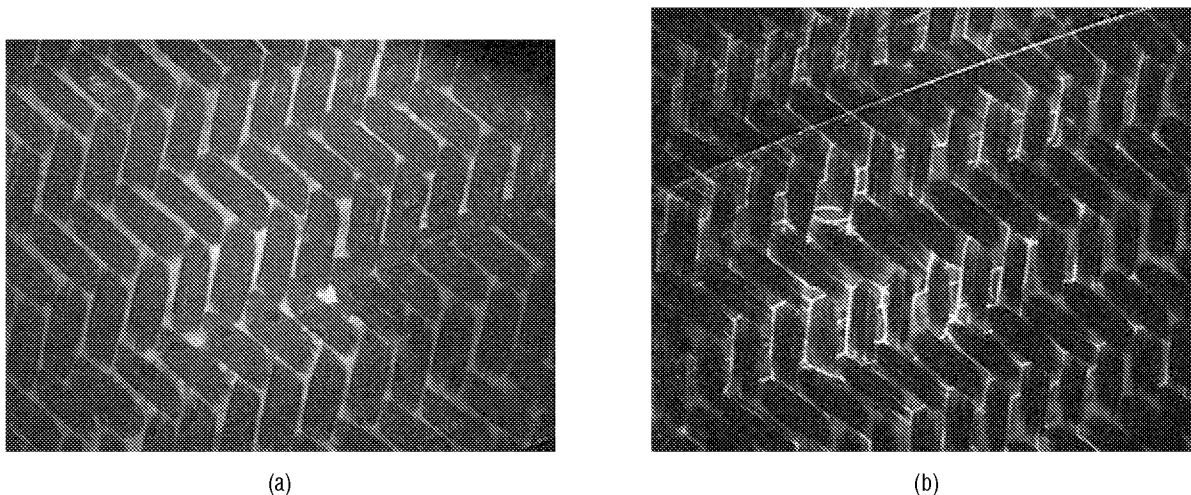
Feedline SARTM-2 was then dissected for inspection as to the mechanisms behind this gross leakage. Figure 40 shows a view of the inside surface of the tube after a UV dye was placed on the surface. For comparison, a SARTM tube that did not undergo cryogenic testing is also shown. Many matrix cracks can be seen on the specimen that saw one temperature drop to LN_2 temperature.

Figure 40. Inside surface of SARTM feedlines: (a) No cryogenic temperature and (b) LN₂ temperature excursion.

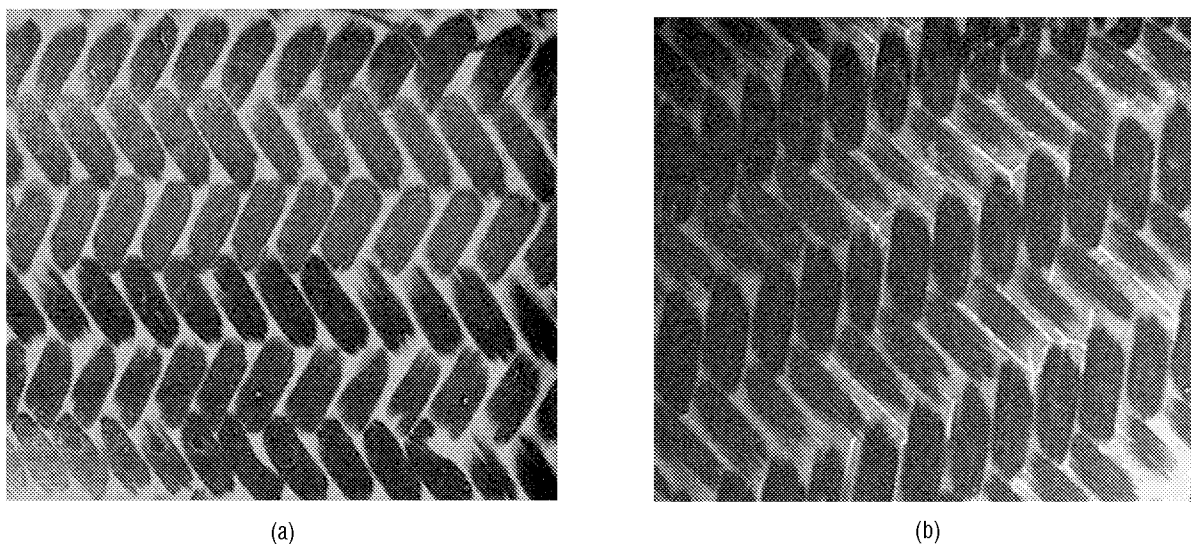
Figure 41 is a view of the outside of a SARTM feedline that saw a temperature drop to LN₂. A section of a SARTM feedline that did not experience cryogenic temperatures is also shown for comparison.

Figure 41. Outside surface of SARTM feedlines: (a) No cryogenic temperature and (b) LN₂ temperature excursion.

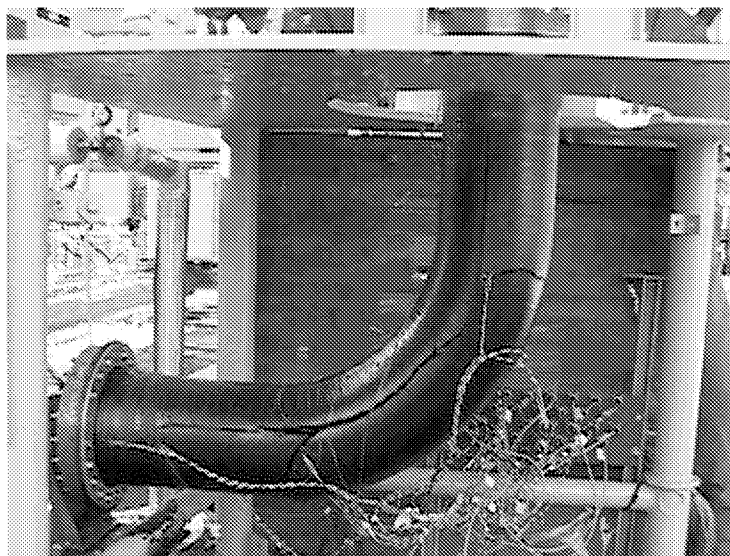
Feedline HLU-2 was hydrostatically tested for burst strength. The feedline was installed such that both flanged ends were rigidly fixed to prevent any movement. A maximum pressure of 545 psi was reached and then the feedline catastrophically failed. A photograph of the failed feedline is shown in figure 42. A longitudinal split is seen on most of the feedline with a radial split occurring about three quarters of the way up the tube.

Figure 42. Feedline HLU-2 after failing at 545-psi internal pressure.

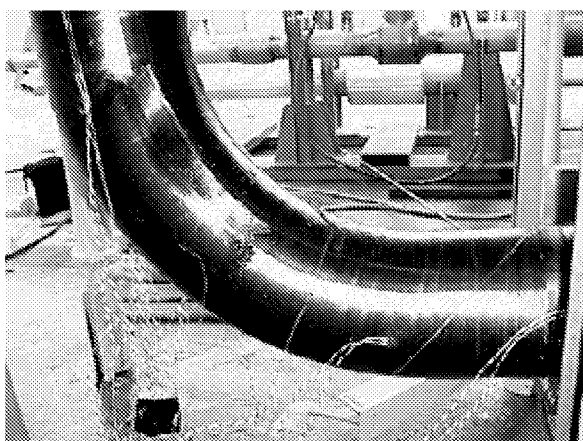
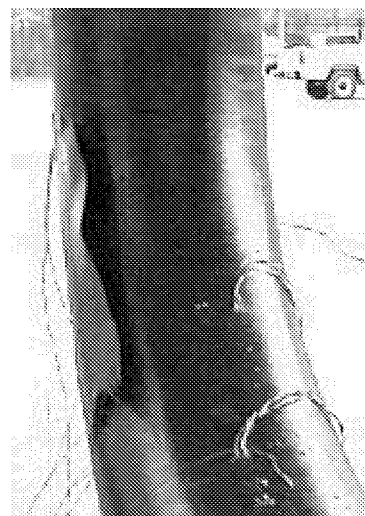
Feedline HLU-7 was then hydrostatically tested for burst strength. It was also installed such that both flanged ends were rigidly fixed to prevent any movement. A maximum pressure of 364 psi was reached and then the feedline catastrophically failed. Photographs of the failed feedline are shown in figure 43. A large split about one fourth of the tube length is seen along one side.

Figure 43. Feedline HLU-7 after failing at 364-psi internal pressure.

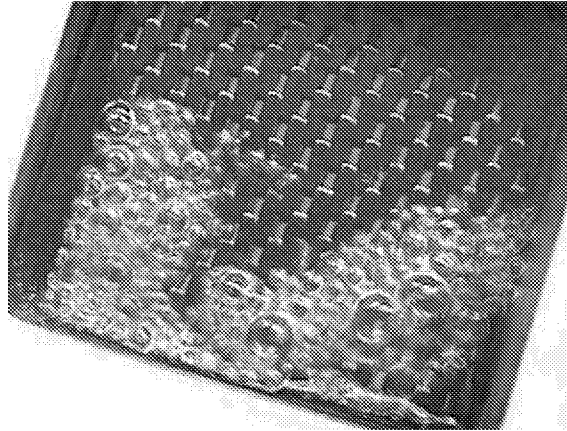
Specimen 1 showing gross leakage on one side of the specimen.

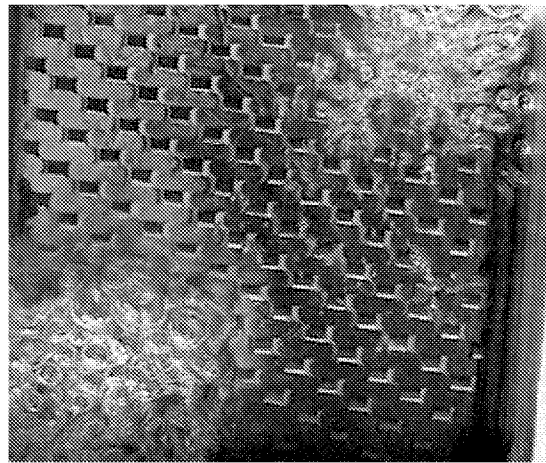
Specimen 6 showing leakage across certain areas of the laminate.

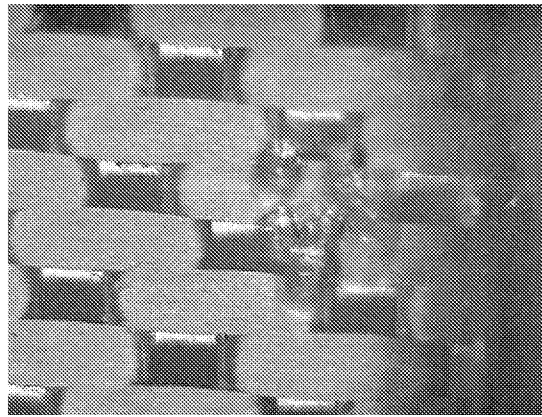
Close-up view of above specimen showing leakage at stitch.
