**U.S. ARMY**  
**H-25 HELICOPTER DROP TEST**  
**22 October 1960**

James W. Turnbow, Ph.D.

Technical Report 60-76

SUBJECT: U. S. Army H-25 Helicopter Drop Test Report

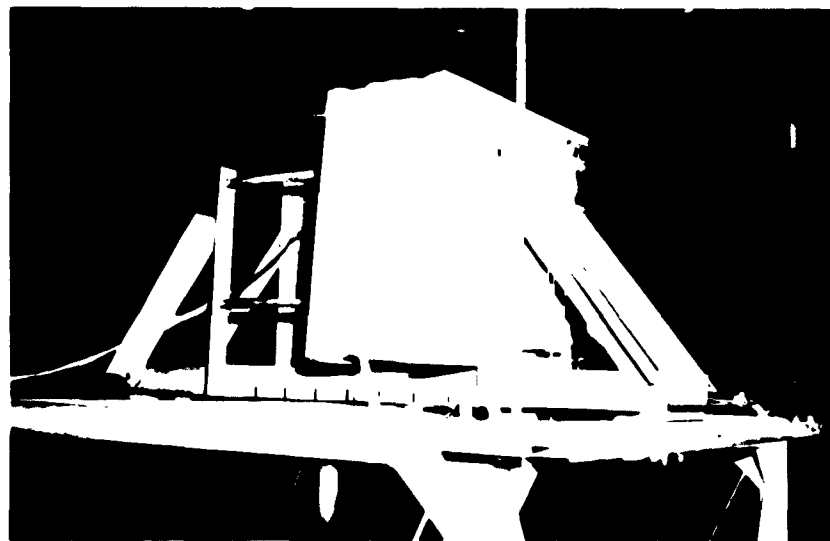
Figure 18. FSF Oscillograph Shock-Mount  
Showing Energy Absorption Device  
After Test Drop

Two separate energy absorption devices were installed in the helicopter for the crash tests. The vertical shock device limiting the maximum loading to the electronic package to 12.0 G's was mounted externally on top of the helicopter. The longitudinal shock device limiting the maximum loading to the electronic package to 8.0 G was mounted in the helicopter on the shelf above the main fuel cell. The resultant design loading on the electronic package from the simultaneous loading of the two devices was 14.5 G.

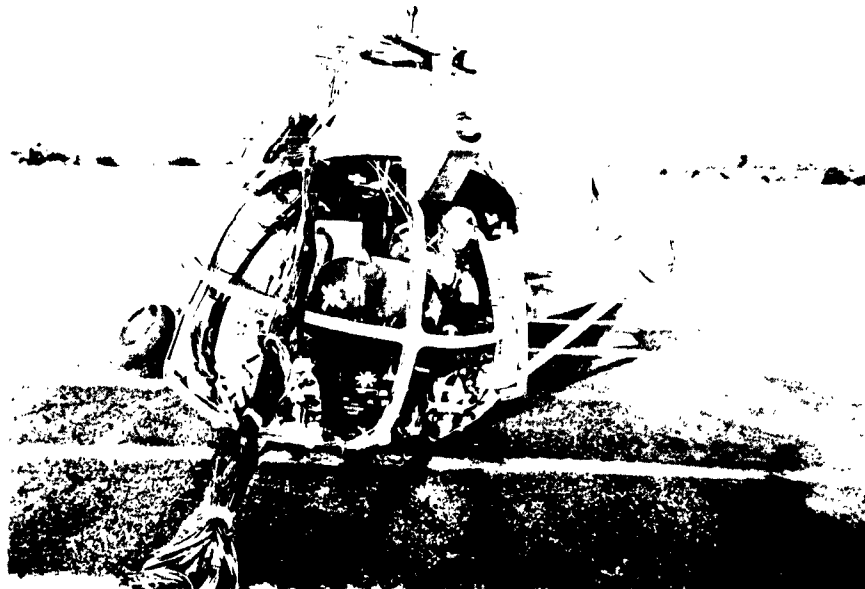
Figure 20. Post-Crash Front View

A post-crash examination was made to determine the extent of damage to the vehicle and injury to its occupants. The following observations were made:

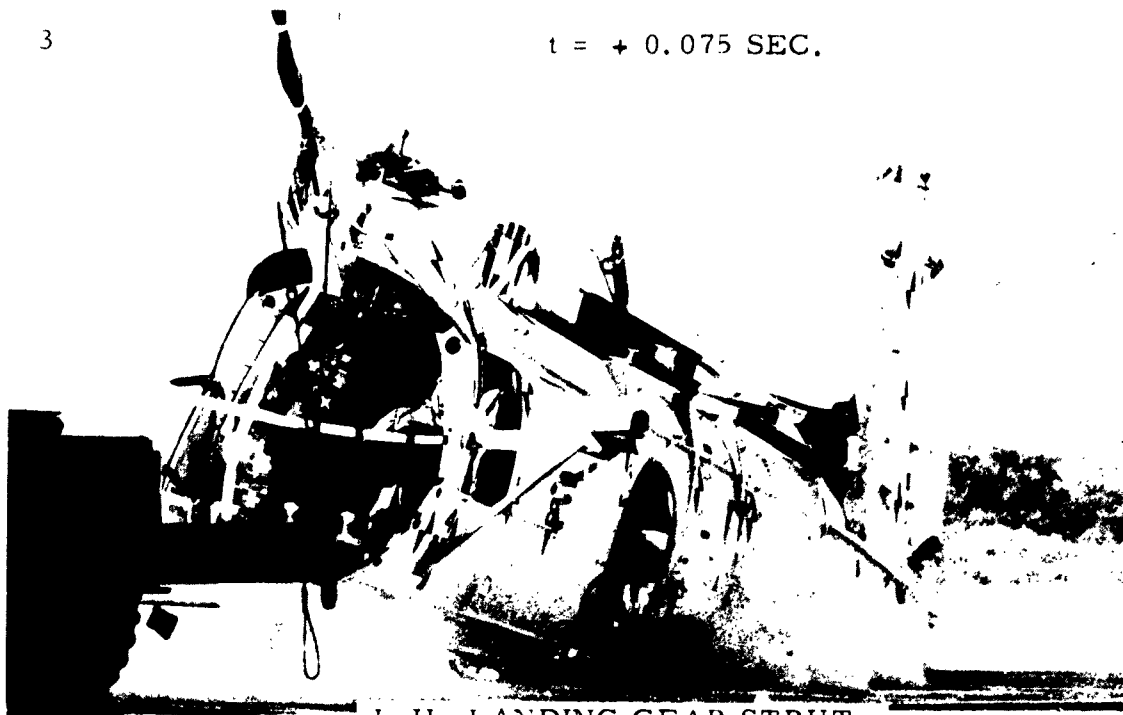
Figure 40-3. Sequence Photograph, H-25 Drop Test

L. H. LANDING GEAR STRUT  
PUSHES THROUGH FUSELAGE

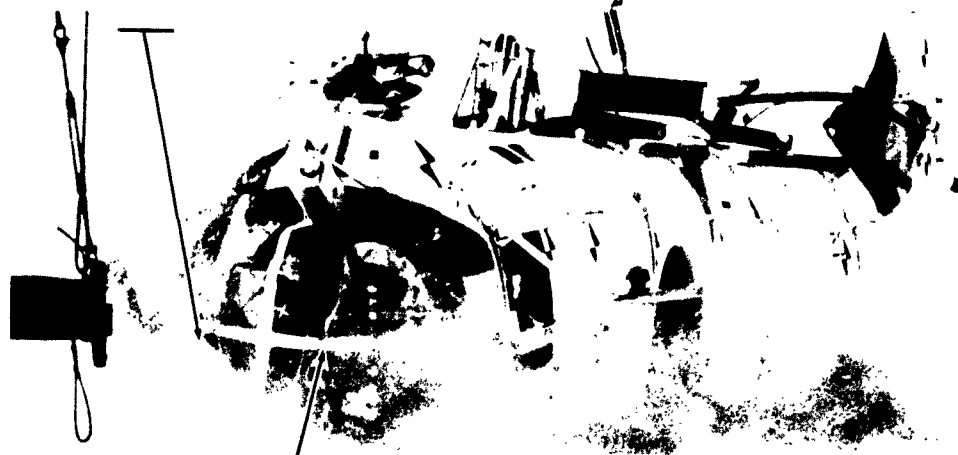
Figure 40-7. Sequence Photograph, H-25 Drop Test

TRANSMISSION LIFTING  
TO NEAR NORMAL POSITION

RANGE EXTENDER TANK  
MOVES INTO CONTROL PEDALS

PILOT'S HAND MOVING FORWARD  
INTO INSTRUMENT COLUMN

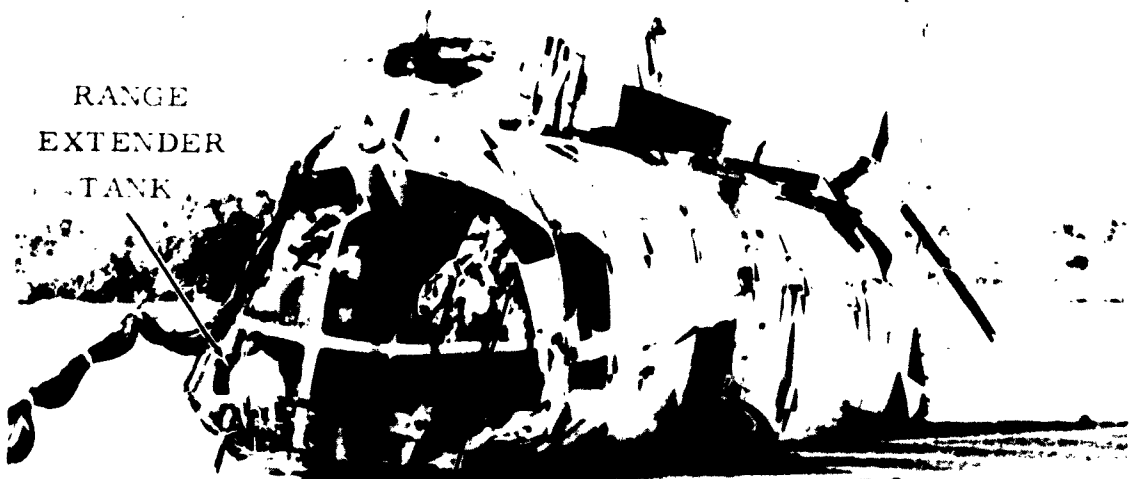
Figure 40-8. Sequence Photograph, H-25 Drop Test

RANGE  
EXTENDER  
TANK

PILOT'S HEAD AGAINST STRUCTURE
