AGARD Corrosion Handbook Volume-1 Aircraft Corrosion: Causes and Case Histories

AGARDograph No.278

## AIRCRAFT CORROSION: CAUSES AND CASE HISTORIES

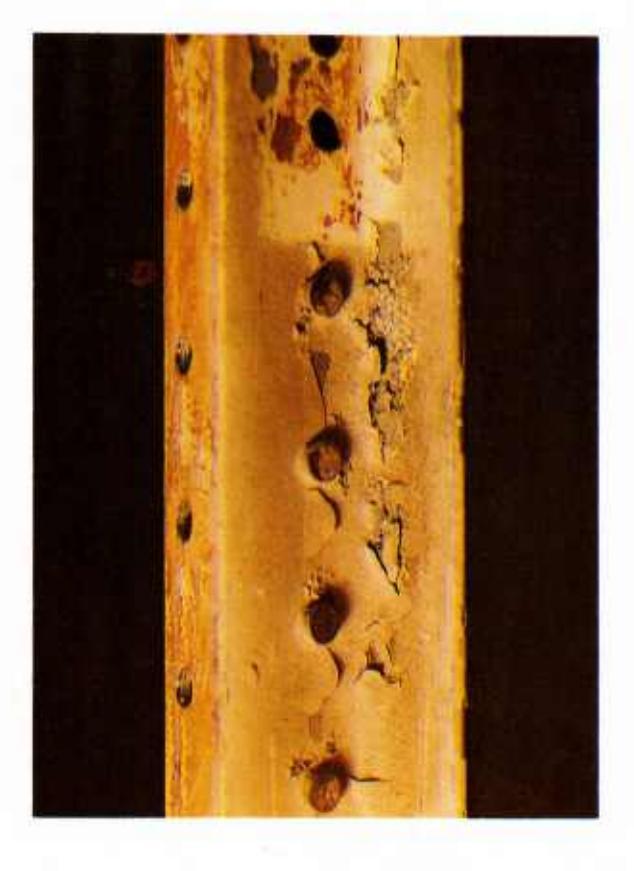
Fig. 7-3 Flaking of the chromate pre-treatment and primer on an aluminium alloy stringer and corrosion of the exposed metal

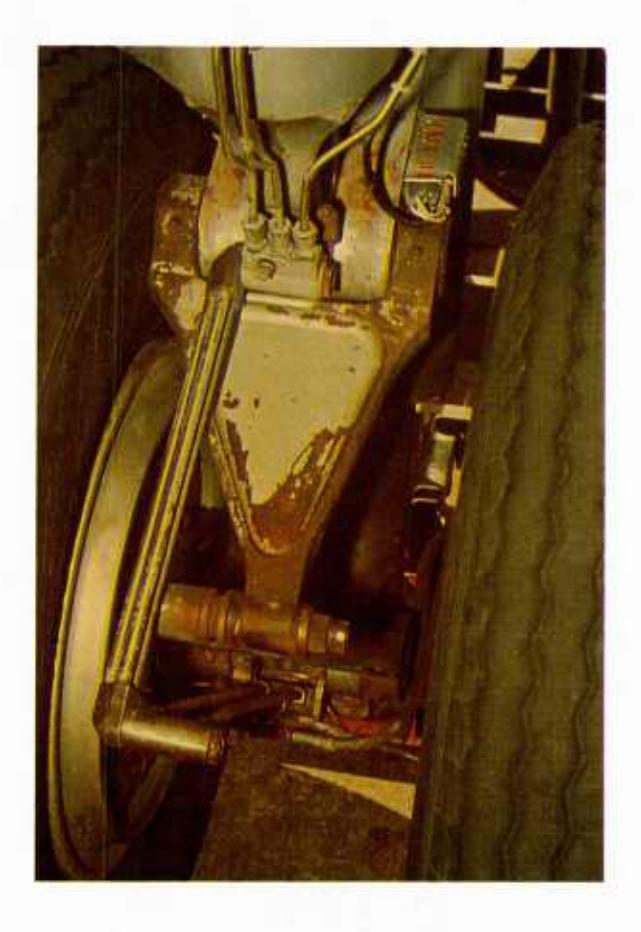
Fig. 7-7 Erosion-corrosion damage on the undercarriage of a transport aircraft

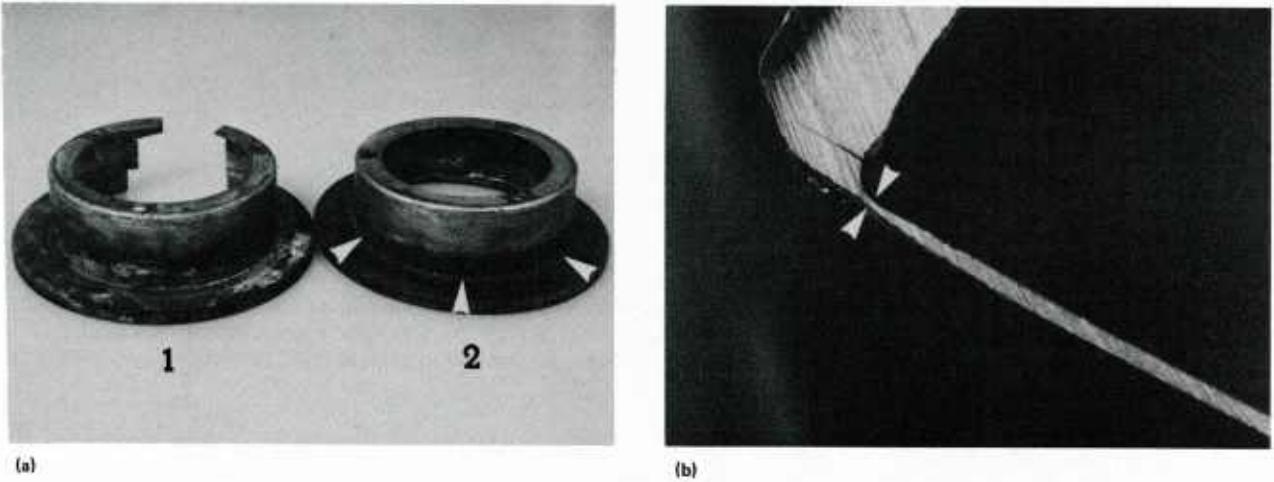
The brake disc assemblies were removed from both main wheels of a light single engine aircraft (Fig. 7-9(a)). Both brake disc assemblies were severely corroded in the fillet radius area between the disc and the sidewall, and there was a 12-15 mm band of corrosion around the outside surface of the wall as shown in Figure 7-9(a).

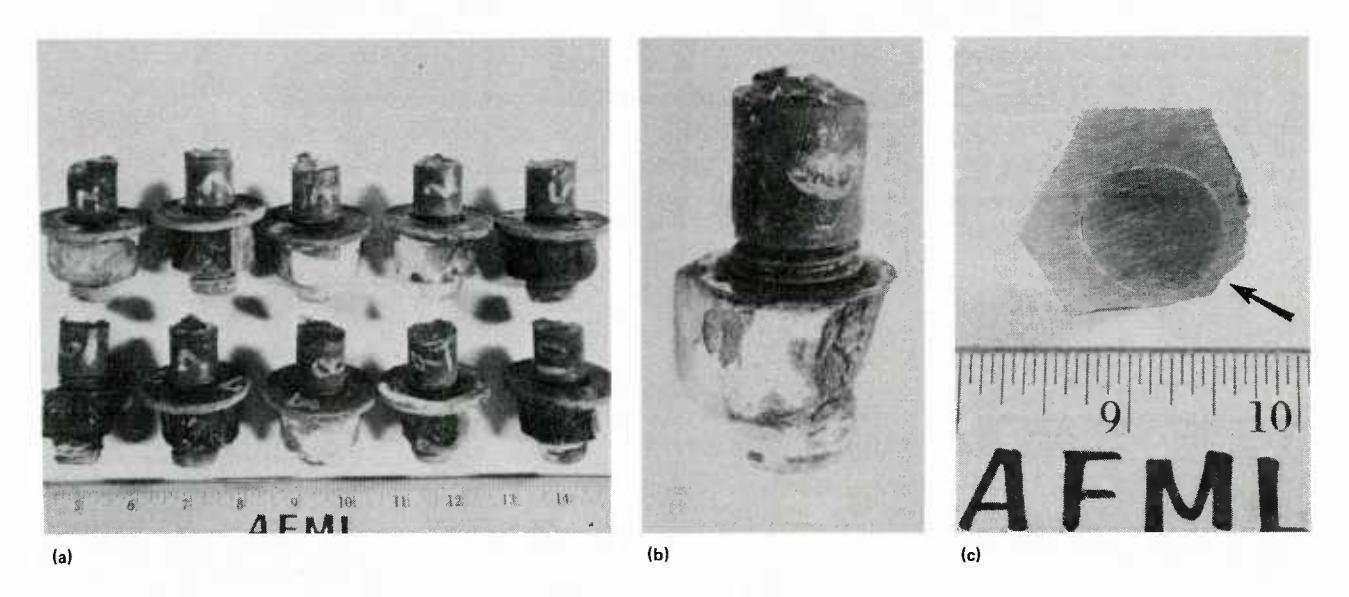
Visual and optical examination verified that considerable corrosion existed on all part surfaces. However, the most severely affected areas were found to be on the surfaces of the nuts, as shown in Figure 7-10(b). Cross-sections through the nuts and bolts revealed the severity of corrosion, and showed that nearly one-third of the cross-sectional area on all ten nuts had been lost to corrosion. The depth of corrosion, in some areas, extended almost to the bolt surface, as shown in Figure 7-10(c).

Fig. 7-10 Corrosion of structural steel fasteners

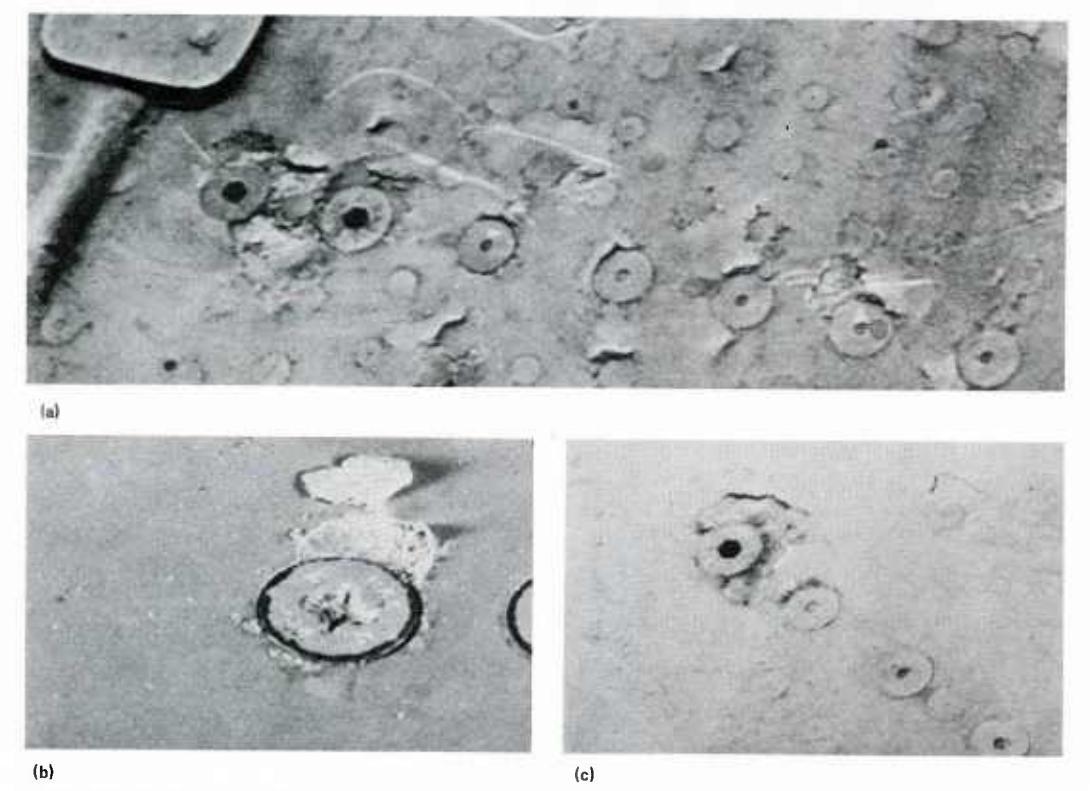
Fig. 8-1 Galvanic corrosion occurring around cadmium plated steel fasteners in a 7075-T6 aluminium skin

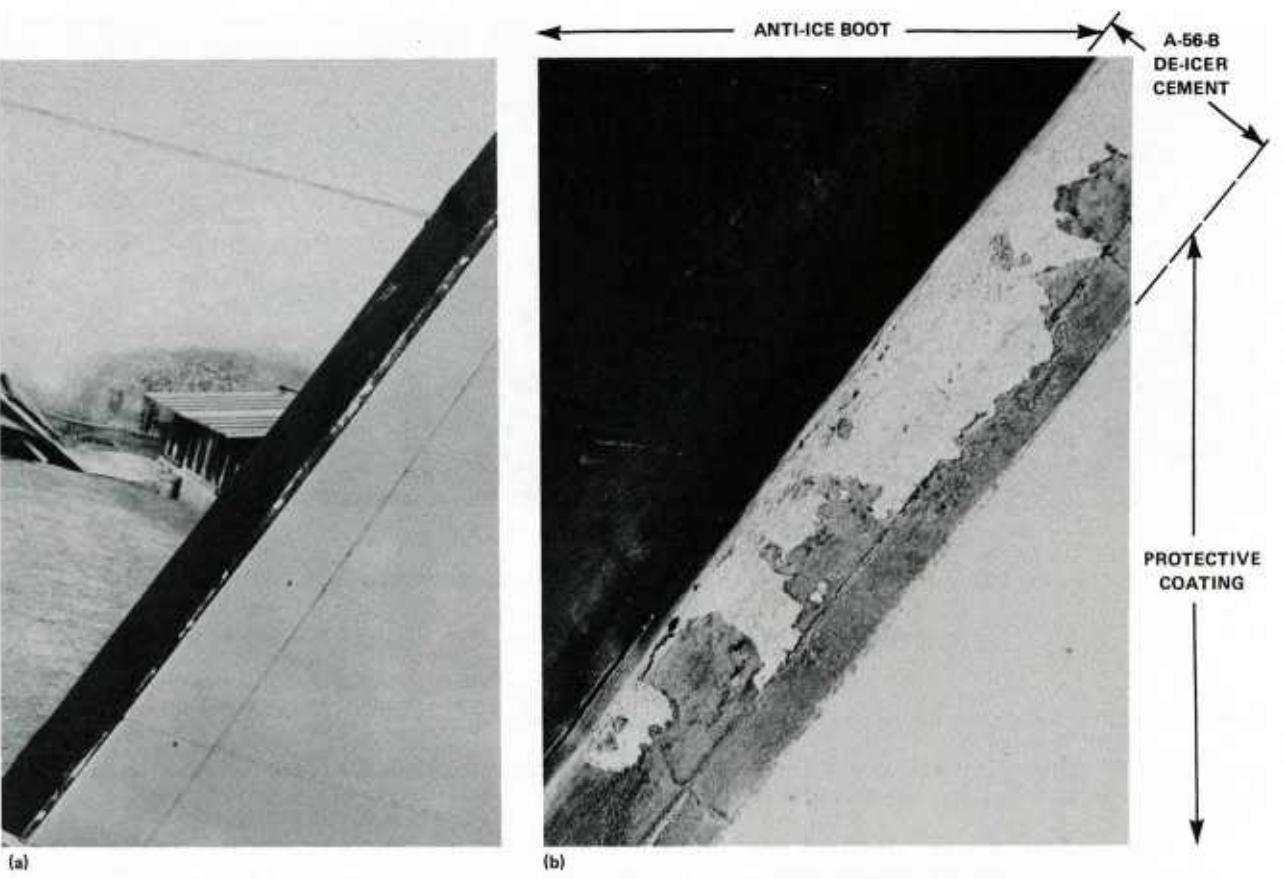
Fig. 8-4 Galvanic corrosion in an aluminium alloy skin due to contact with a conductive cement
(a) General view of a tail section leading edge showing de-icing boot and aluminium panels.
(b) Close up showing the exposed cement between the de-icing boot and aluminium skin.

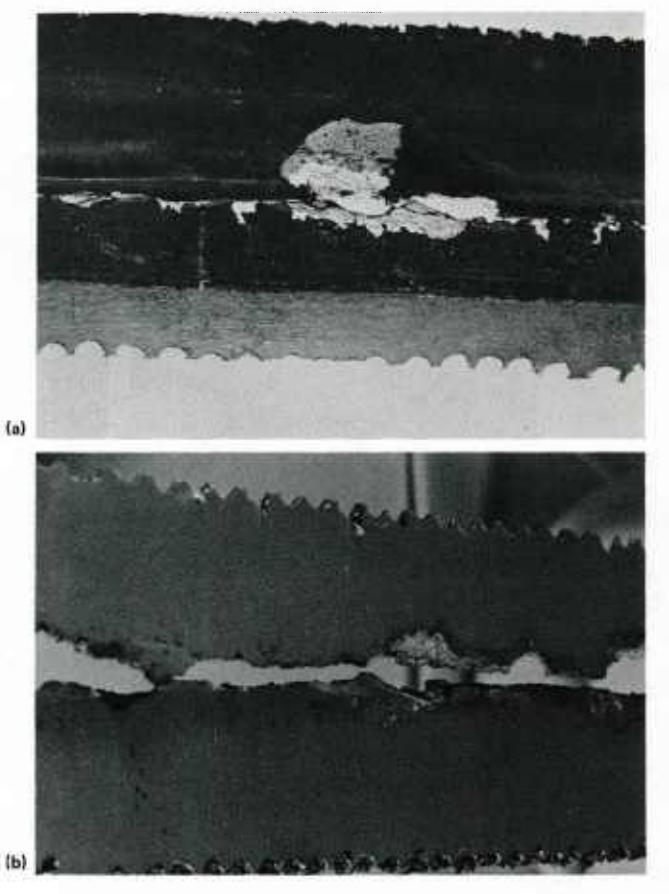
- Fig. 8-5 Selected areas of corrosion from Figure 8-4
- (a) Penetration of the aluminium skin viewed from the out-
- side.(b) Corrosion and penetration of the aluminium skin viewed from the inside.

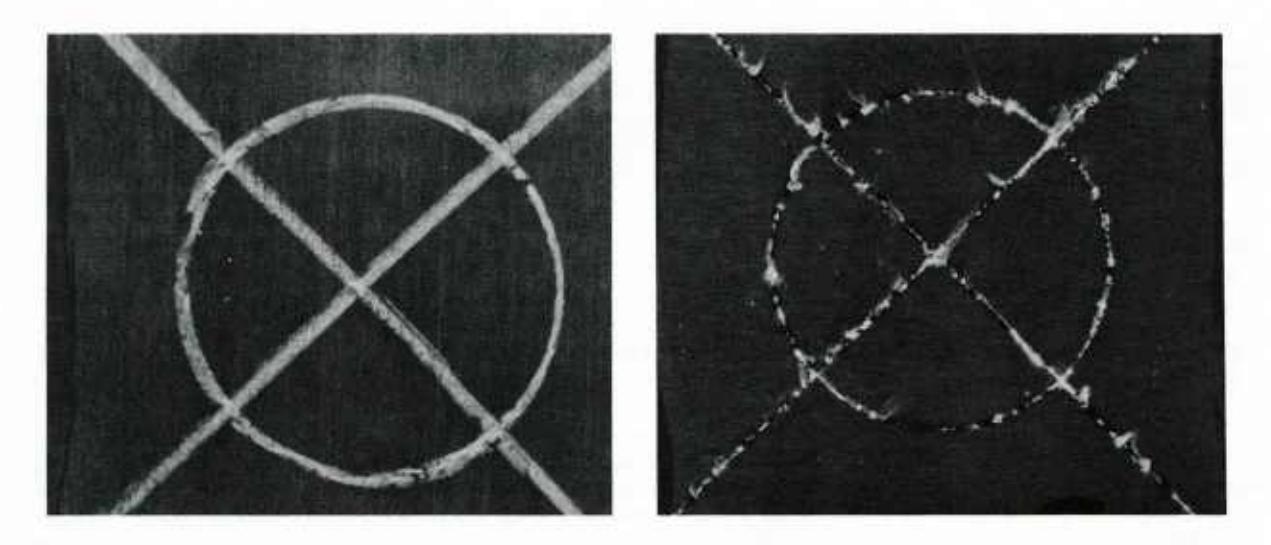
Whether the reported "lost disc" actually fell out of the wing cannot be ascertained, but nevertheless the laboratory trials demonstrate unequivocally that severe galvanic corrosion can occur, even when a thin film of graphite comes in contact with a high strength aluminium alloy. Table 3-2 shows that graphite (carbon) is one of the most noble materials, and will give rise to a strong electrochemical potential when coupled with aluminium alloys. Marking of any aerospace hardware should only be performed with safety-checked markers, such as grease pencils.

Fig. 8-9 Galvanic corrosion in aluminium alloy wing skin due to conductive markers

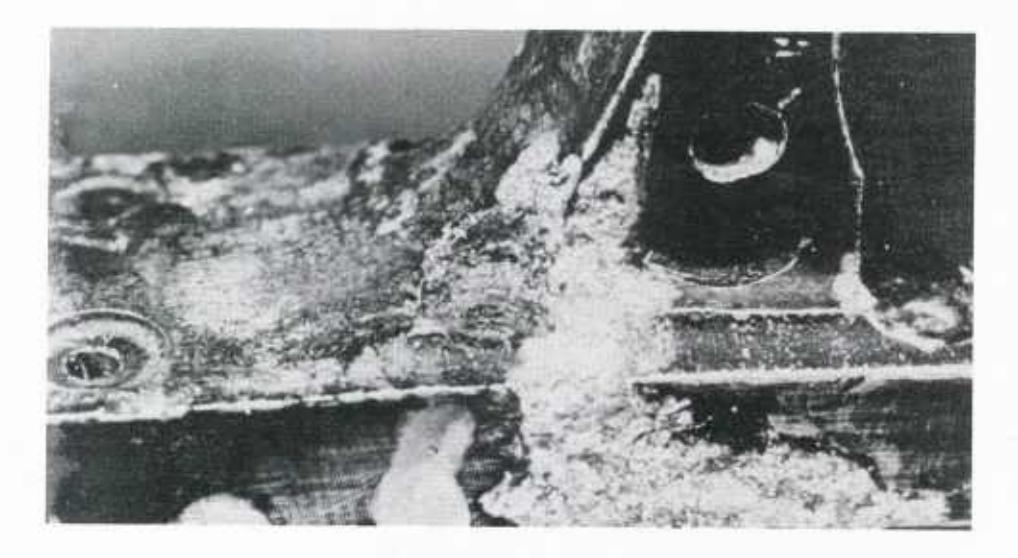
Fig. 9-1(a) Severe pitting in a magnesium alloy casting

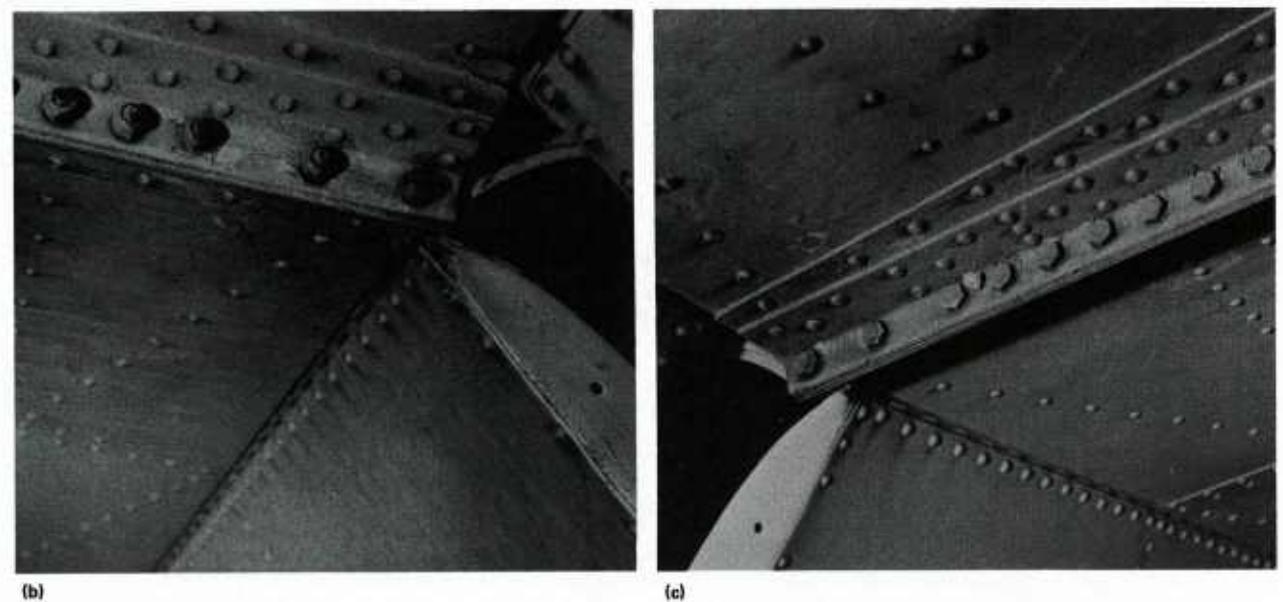
Fig. 9-3 Crevice corrosion in the outer wing coupling flange of a transport aircraft (a) Crevice corrosion in aluminium lap joint. (b) and (c) Corrosion around bolts and under nuts in the under wing structure.

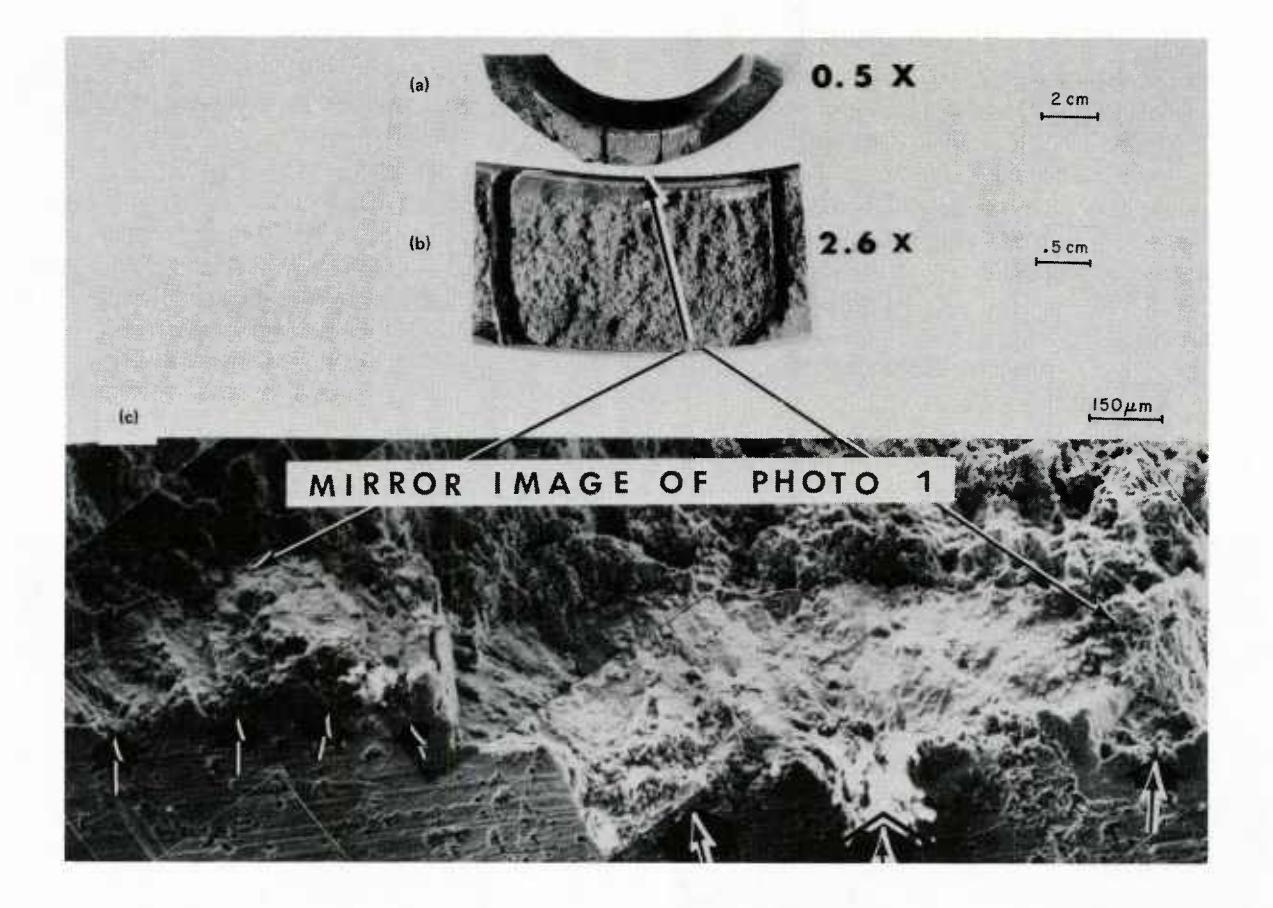
Fig. 9-6 Pitting corrosion and fatigue of a 2014 aluminium alloy main landing gear strut

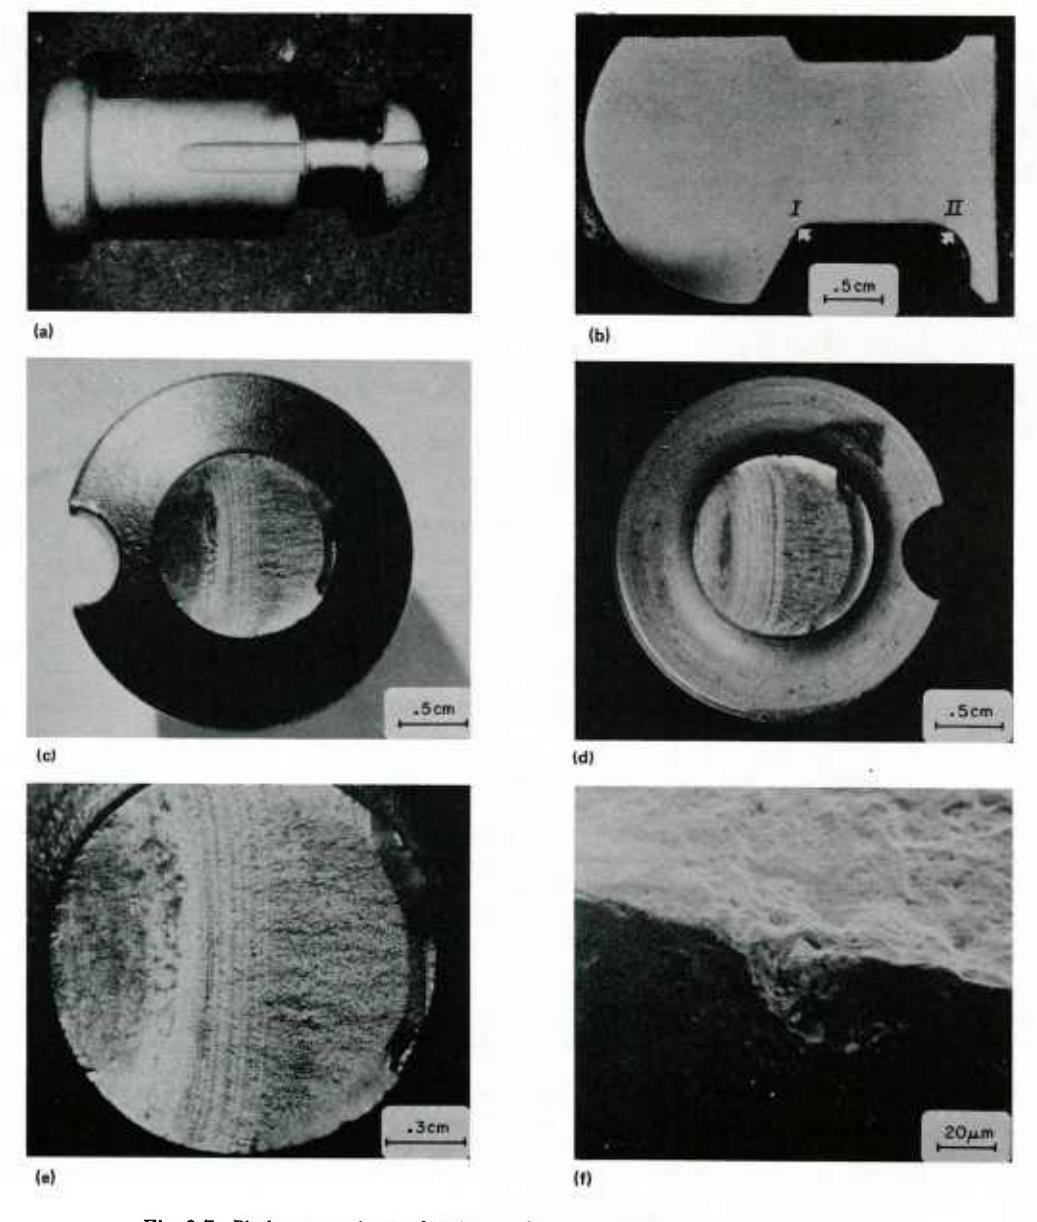
All of the failures initiated at the side of the latch knobs facing towards the wing lower side, and in every failure almost half the cross-section showed a fatigue fracture surface. An investigation with the scanning electron microscope revealed that the failures were initiated by corrosion pits. This is illustrated in Figure 9-7(f), showing a corrosion pit at the origin of one of the fatigue fractures.

Fig. 9-7 Pitting corrosion and fatigue failure of a 4340 steel tip tank latch knob

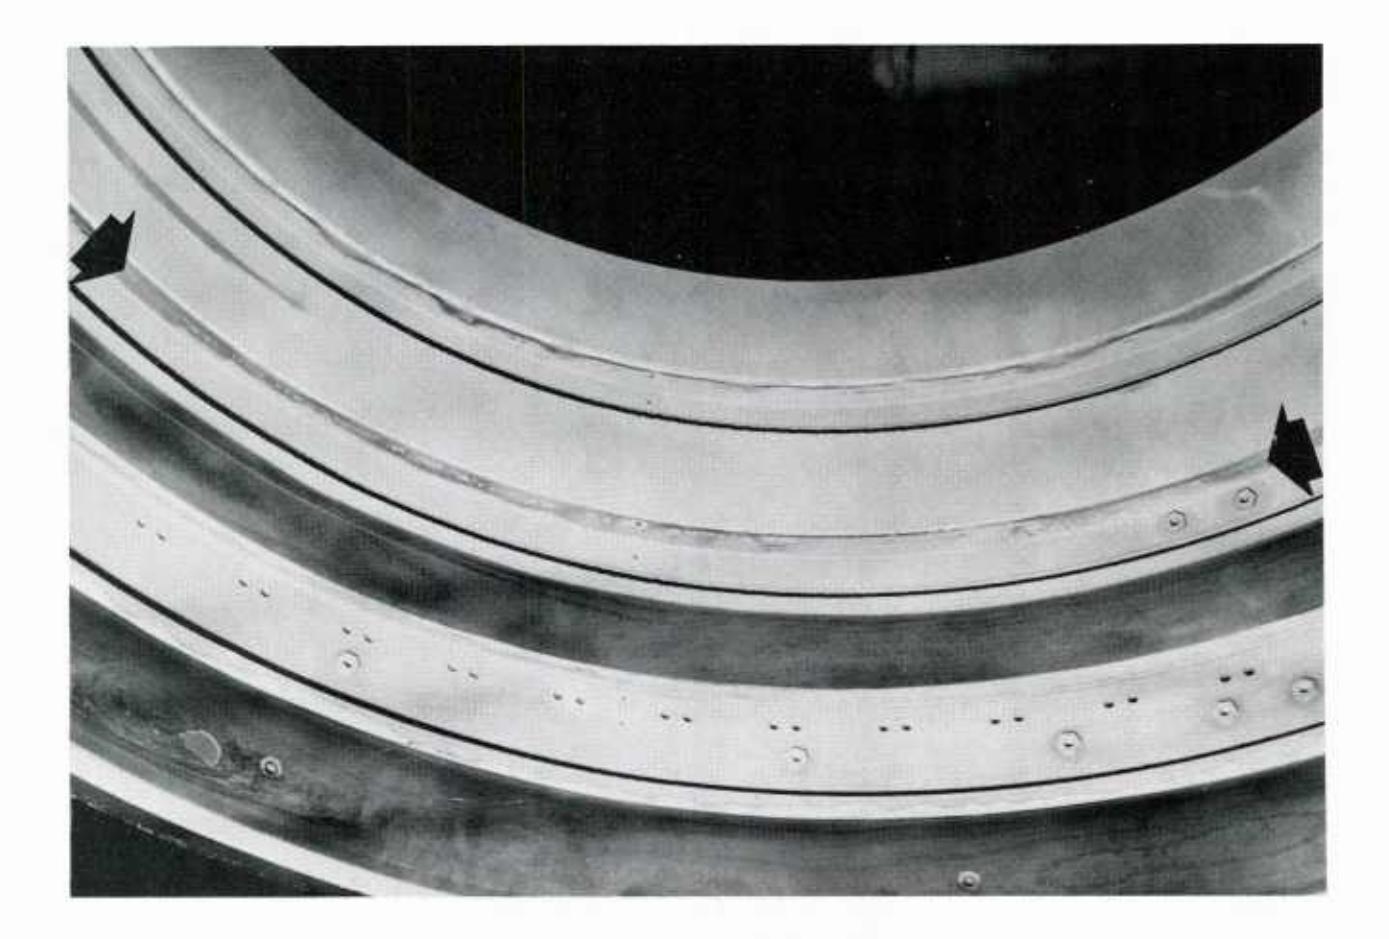
Fig. 11-2 Fretting corrosion in a magnesium alloy (EZ-33) compressor casing, indicated by arrows

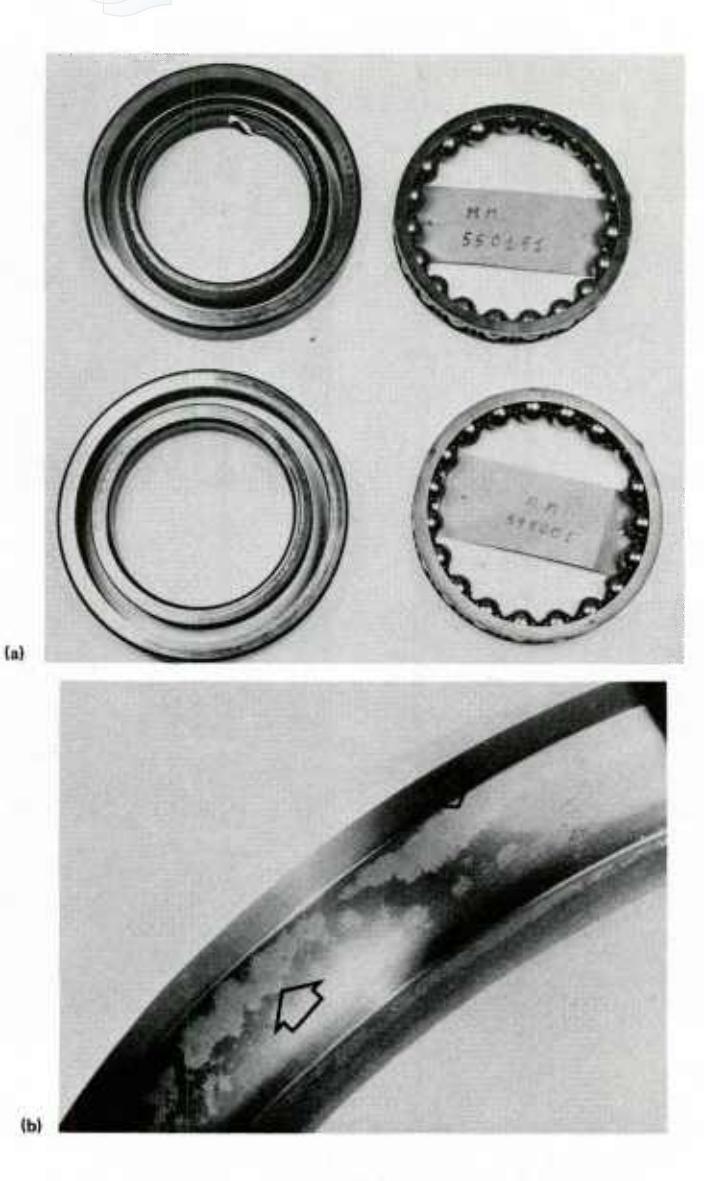
According to Reference 11-1, oscillatory motion may occasionally lead to the appearance of a series of elliptical-shaped blemishes that develop centrally located cavities as the fretting progresses. Some indications of this exist in Figure 11-4(b). Strictly static loads applied perpendicular to the bearing surface should not cause wear; however in conjunction with a minute oscillating motion they are conducive to fretting corrosion. The vibratory stresses associated with the propellers appear to have been sufficient in this case to cause the fretting action. The problem of abrasion is one which may affect either non-lubricated bearings where contacting surfaces have equal hardness and are therefore mutually abraded, or in bearings where lubrication fails. The extent of abrasion in the bearings of Figure 11-4 is not known.

Fig. 11.4 Fretting corrosion in propeller shaft ball bearings

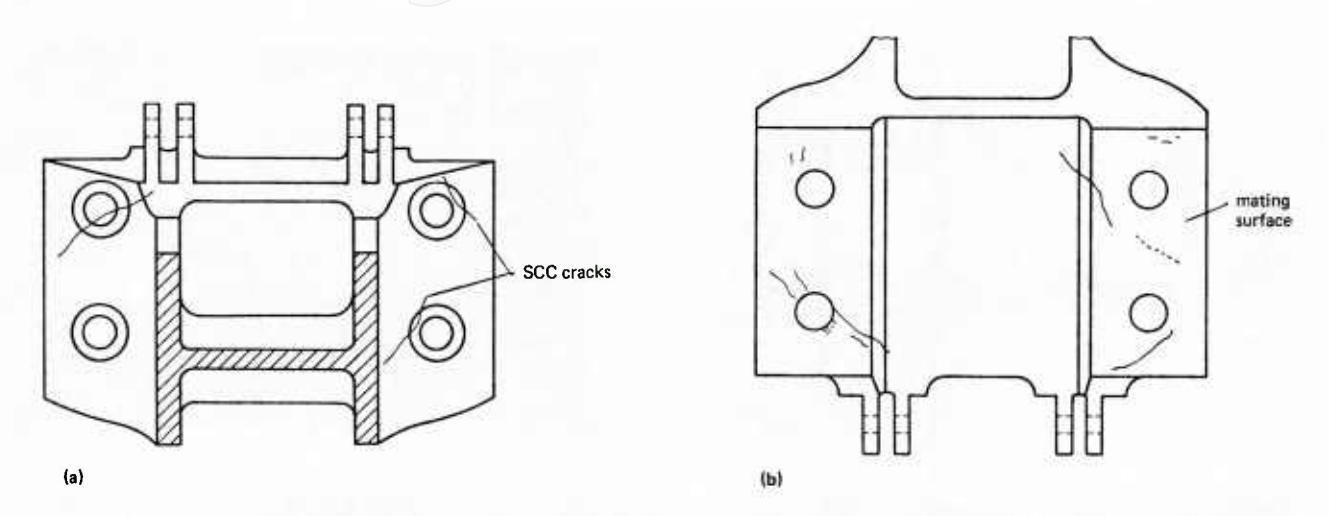
Fig. 13-27 Stress corrosion cracking in the 7079-T6 spars of a vertical fin, case history 13-2. (a) Sketch of the front spar showing the location of the cracks. (b) Sketch of the rear spar showing the location of the cracks.

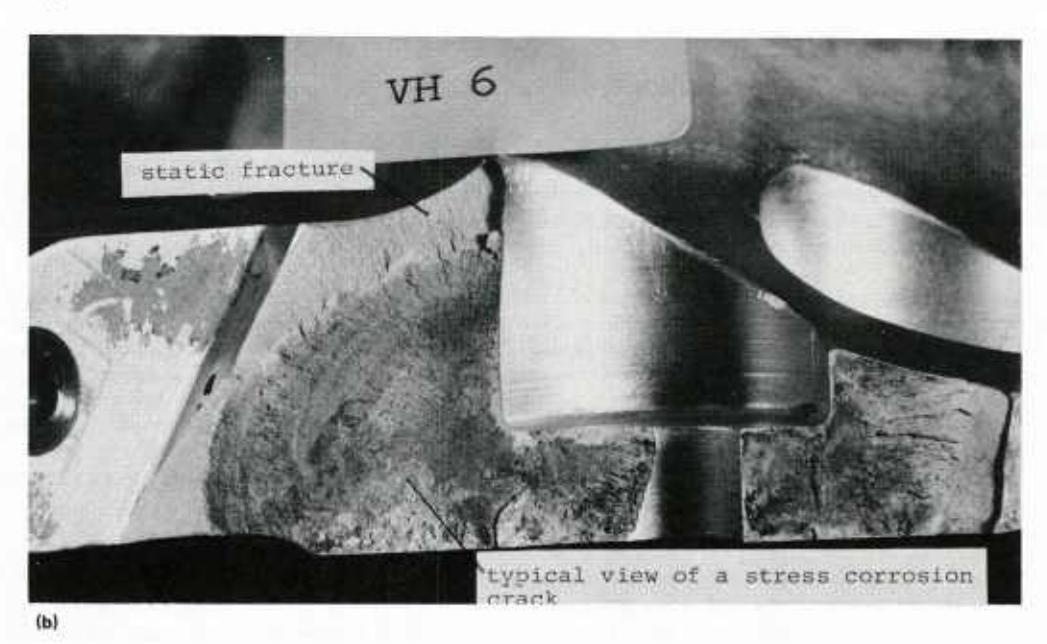
Fig. 13-28 Stress corrosion cracking in the 7079-T6 spars of a vertical fin, case history 13-2.

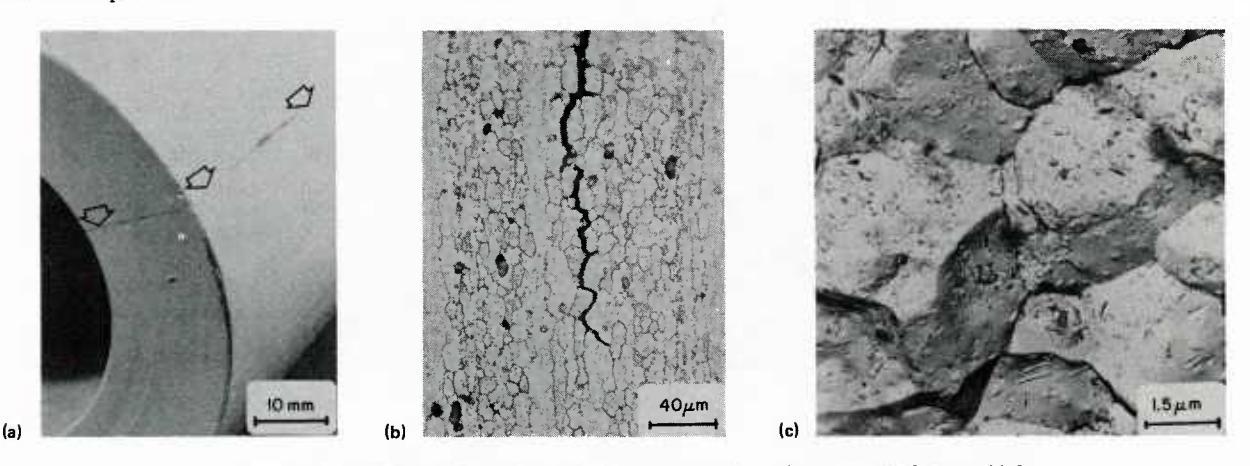
Fig. 13-29 Stress corrosion cracking in a 7079-T6 bearing housing, case history 13-3.

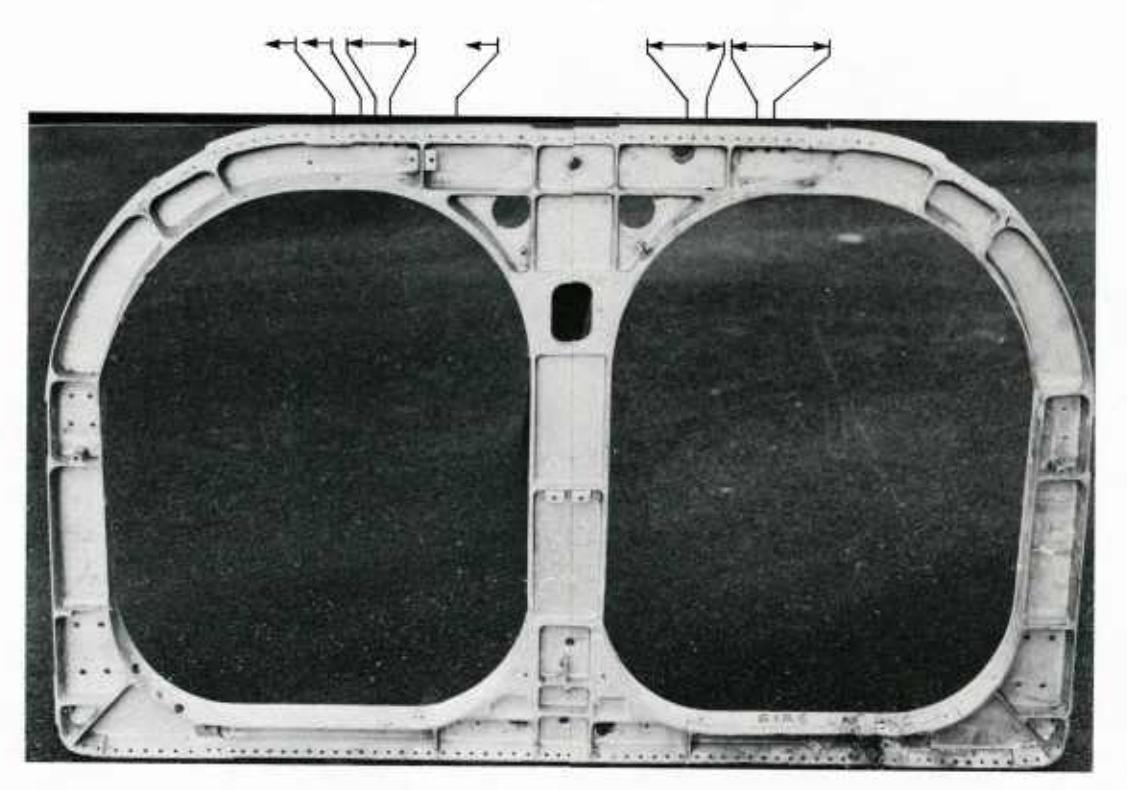
Fig. 13-39 Stress corrosion cracking in a 7075-T6 fuselage frame, case history 13-8. Arrows indicate the directions of cracking away from fastener holes.

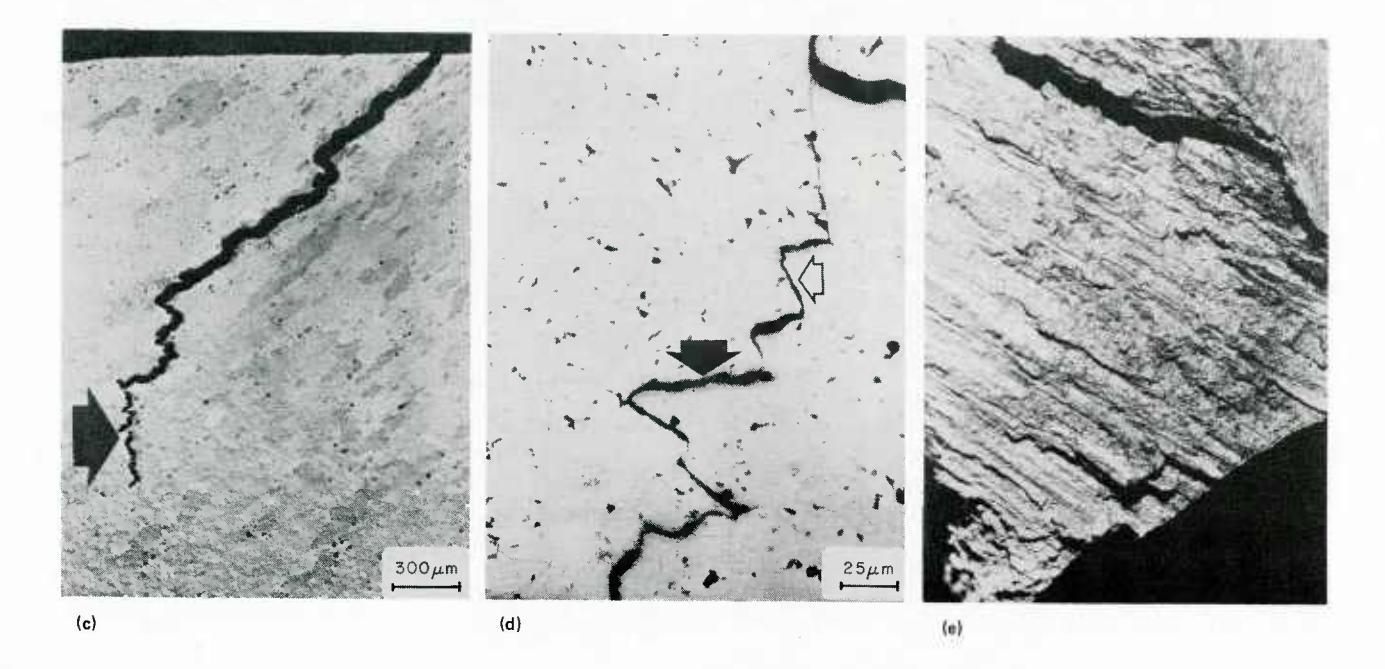
Fig. 13-44 Cracking in a 2014 aluminium nose wheel steering damper, case history 13-9.

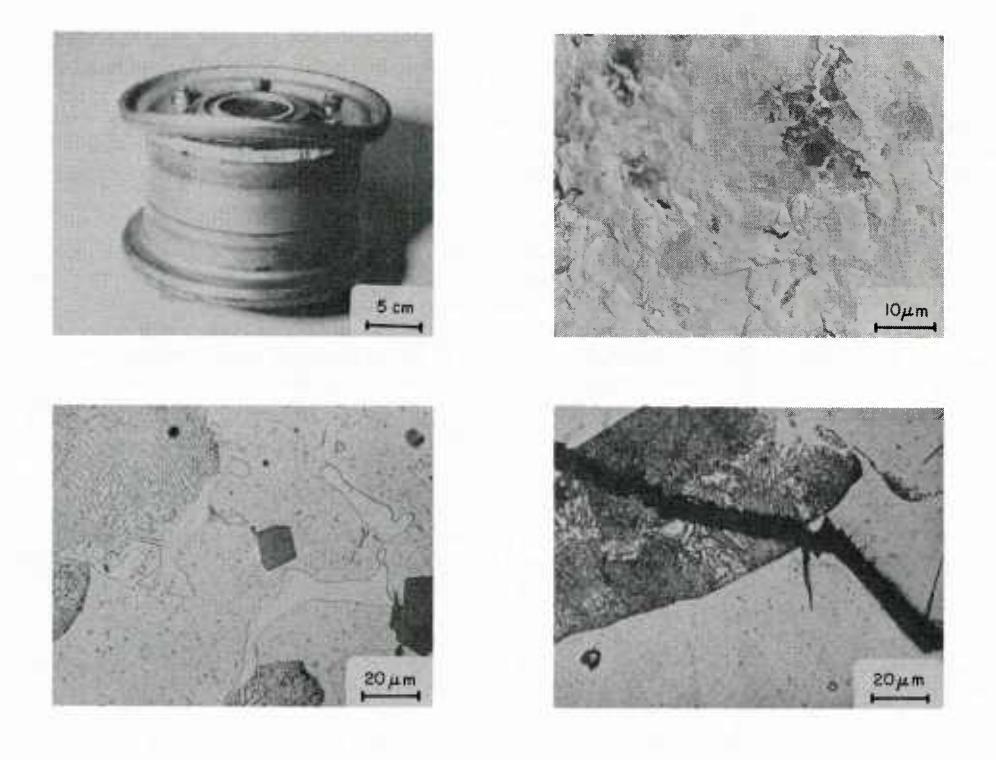
Fig. 13-47 Stress corrosion cracking of a magnesium alloy nose wheel, case history 13-12.

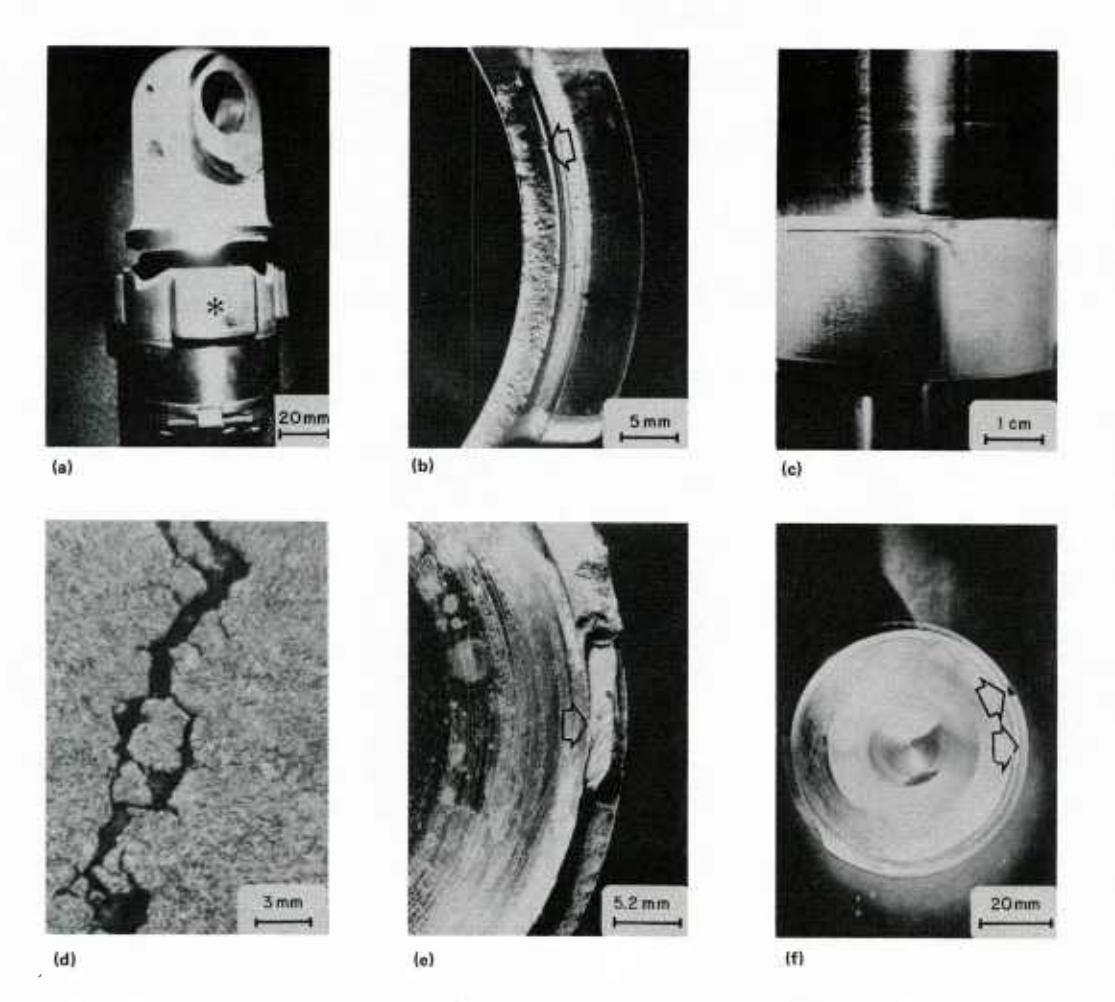
Fig. 13-51 Corrosion induced failure of four 4340 landing gear retraction cylinders, case history 13-16.

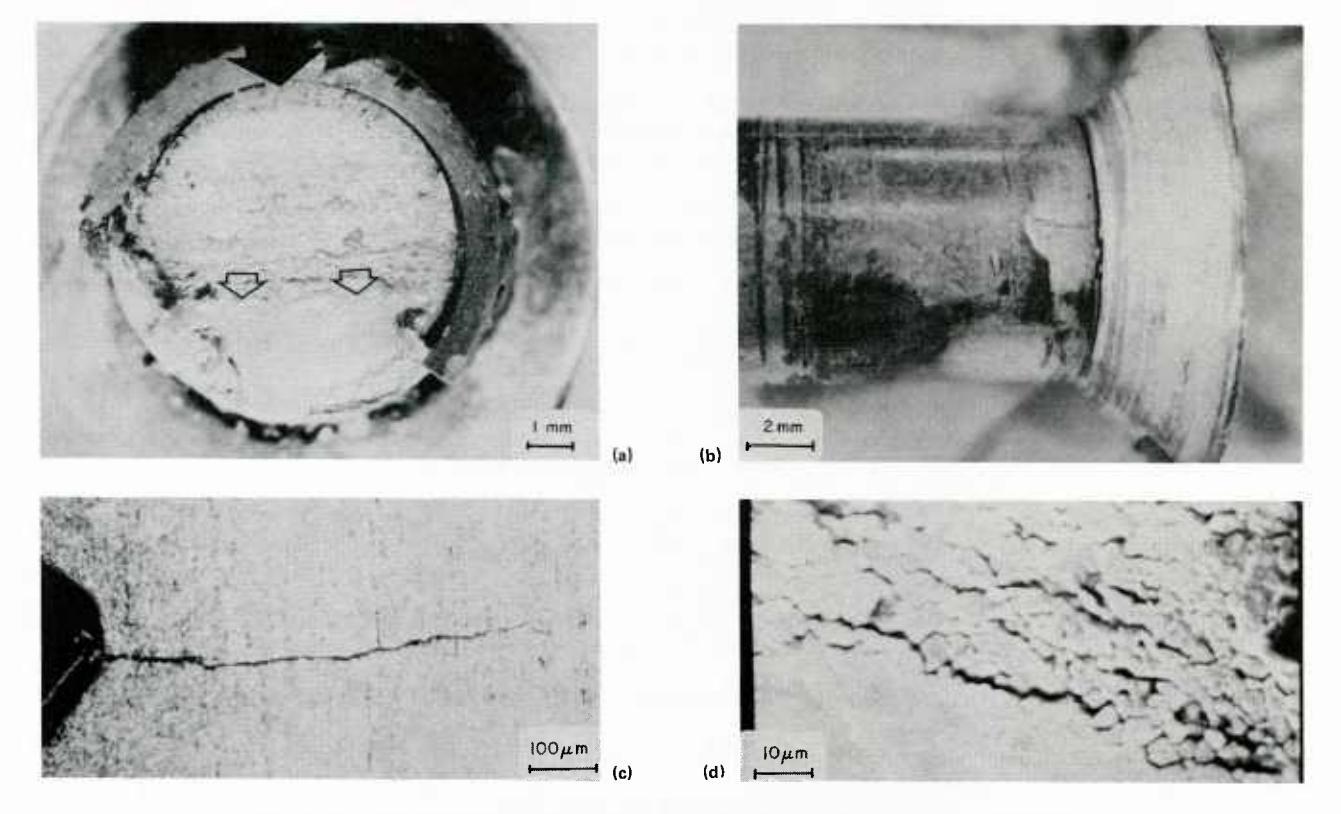
Fig. 13-52 Corrosion induced failure of a 1040 plain carbon steel bolt, case history 13-17.

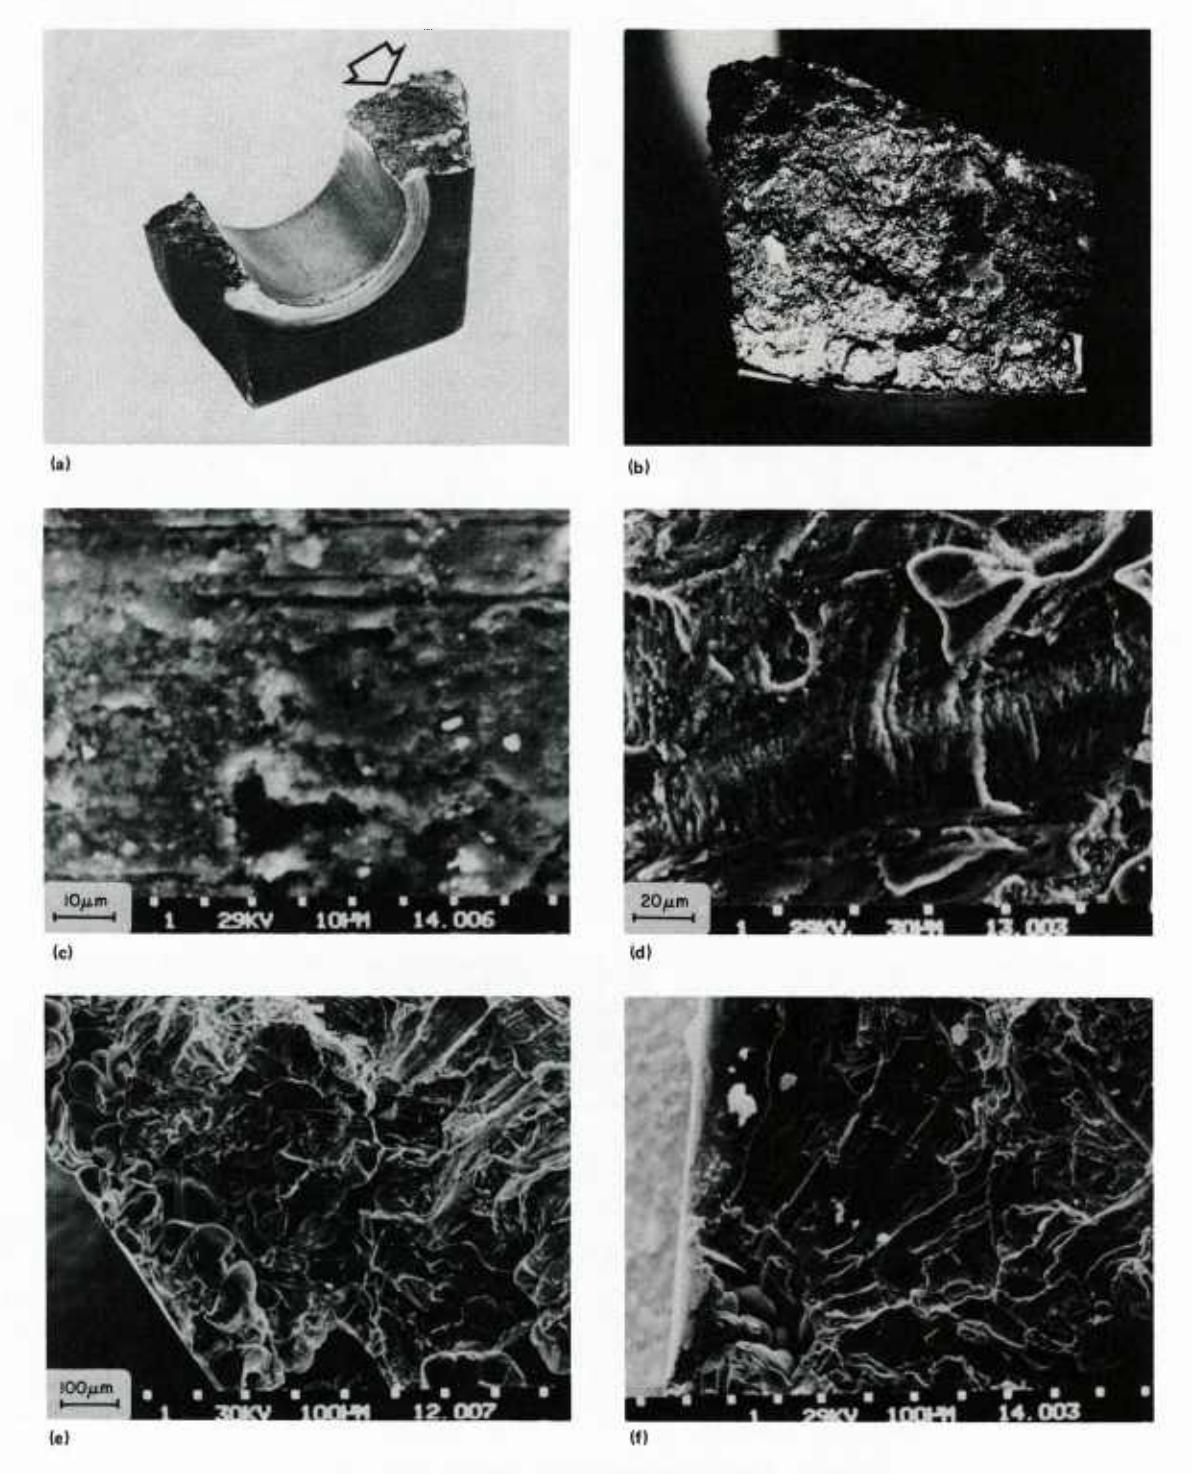
Fig. 14-11 Corrosion fatigue of a cast aluminium rocker arm journal bearing

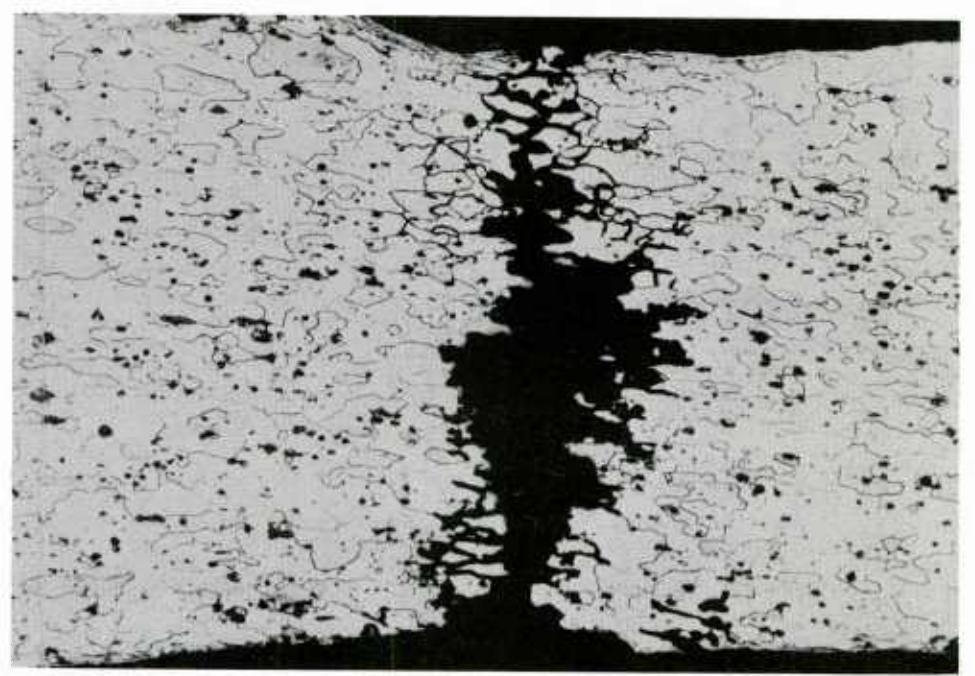
Fig. 15-6 Typical perforation corrosion caused by micro-organisms. Alloy: 2024 (Al-Cu-Mg)

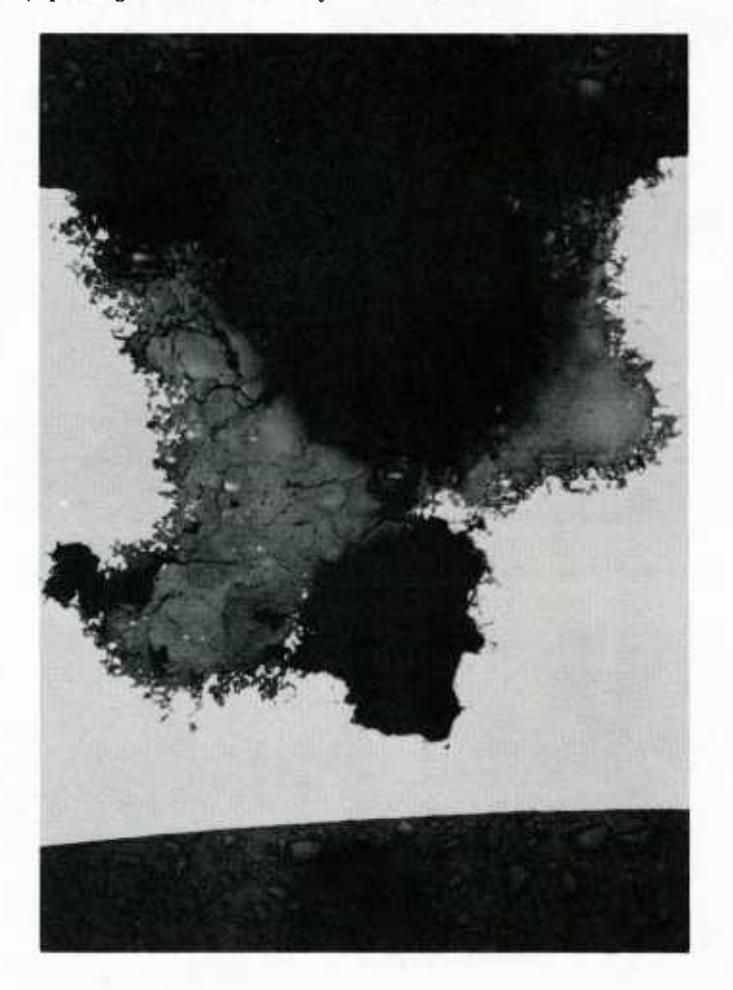
Fig. 15-7 Typical microbiological corrosion. Alloy 5052 (Al-Mg)
