AGARD Corrosion Handbook Volume-1 Aircraft Corrosion: Causes and Case Histories

AGARDograph No.278

## AIRCRAFT CORROSION: CAUSES AND CASE HISTORIES

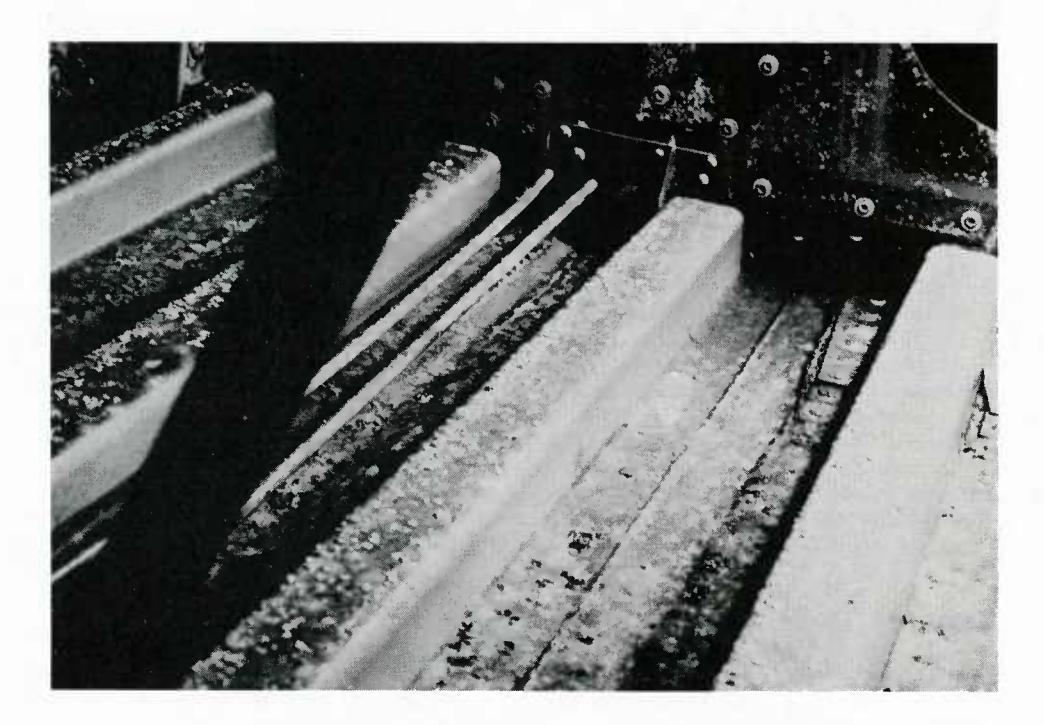
Fig. 15-8(a) Typical view of integral fuel tanks with microbiological corrosion

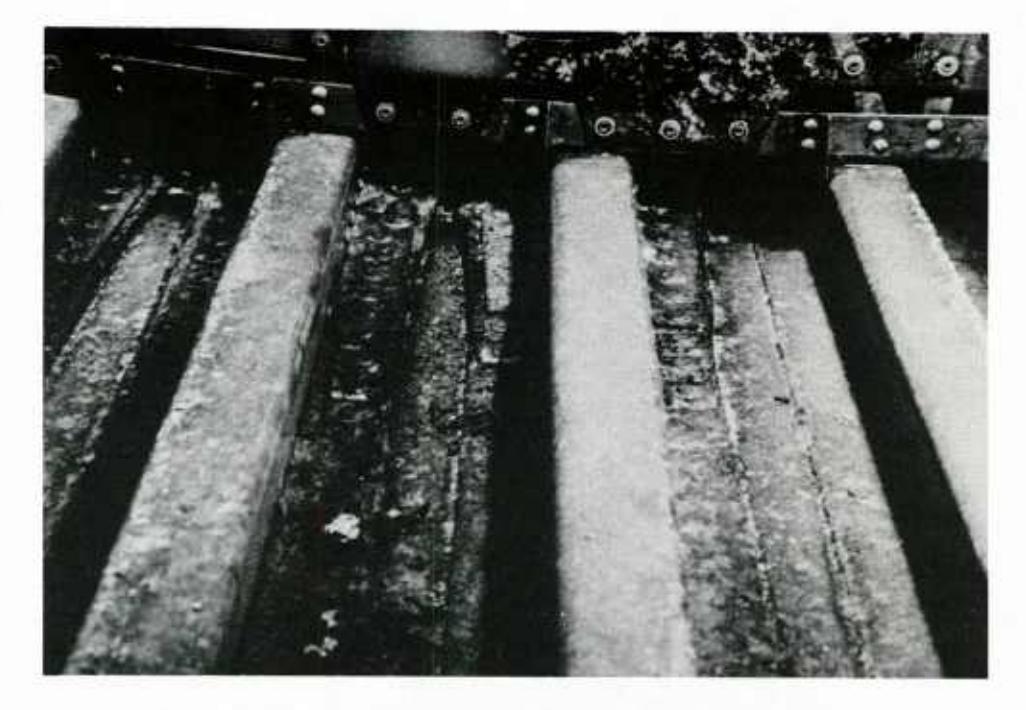
Fig. 15-8(b) Typical view of integral fuel tanks with microbiological corrosion

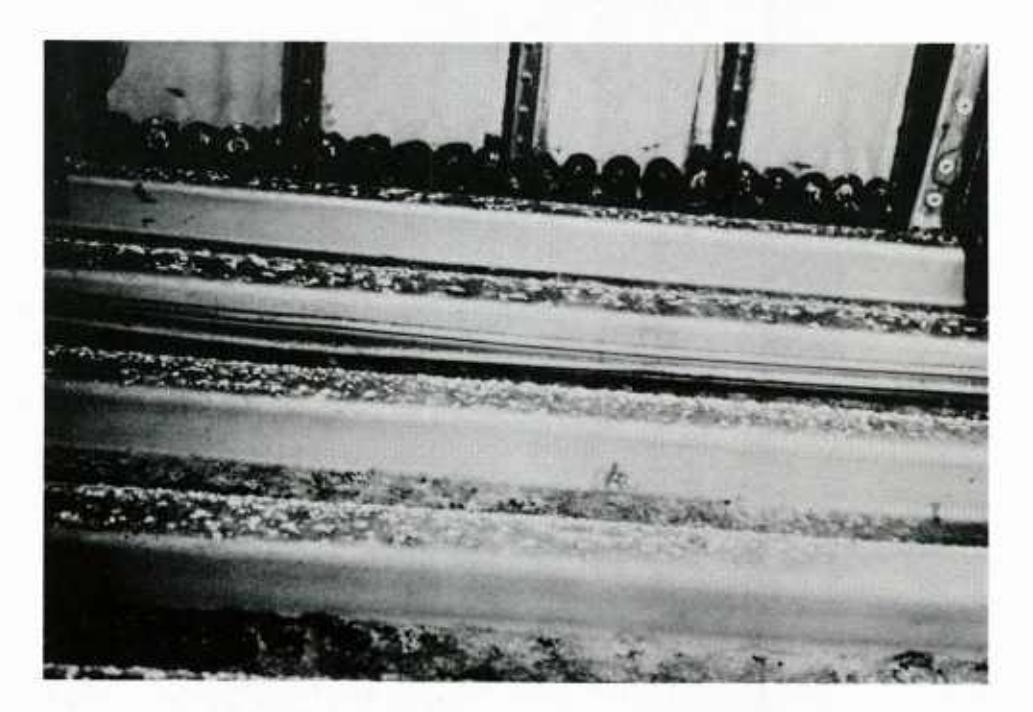
Fig. 15-9 Typical view of integral fuel tanks with microbiological corrosion
