The Response of Aircraft Oxygen Generators Exposed to Elevated Temperatures

April 2003

DOT/FAA/AR-TN03/35

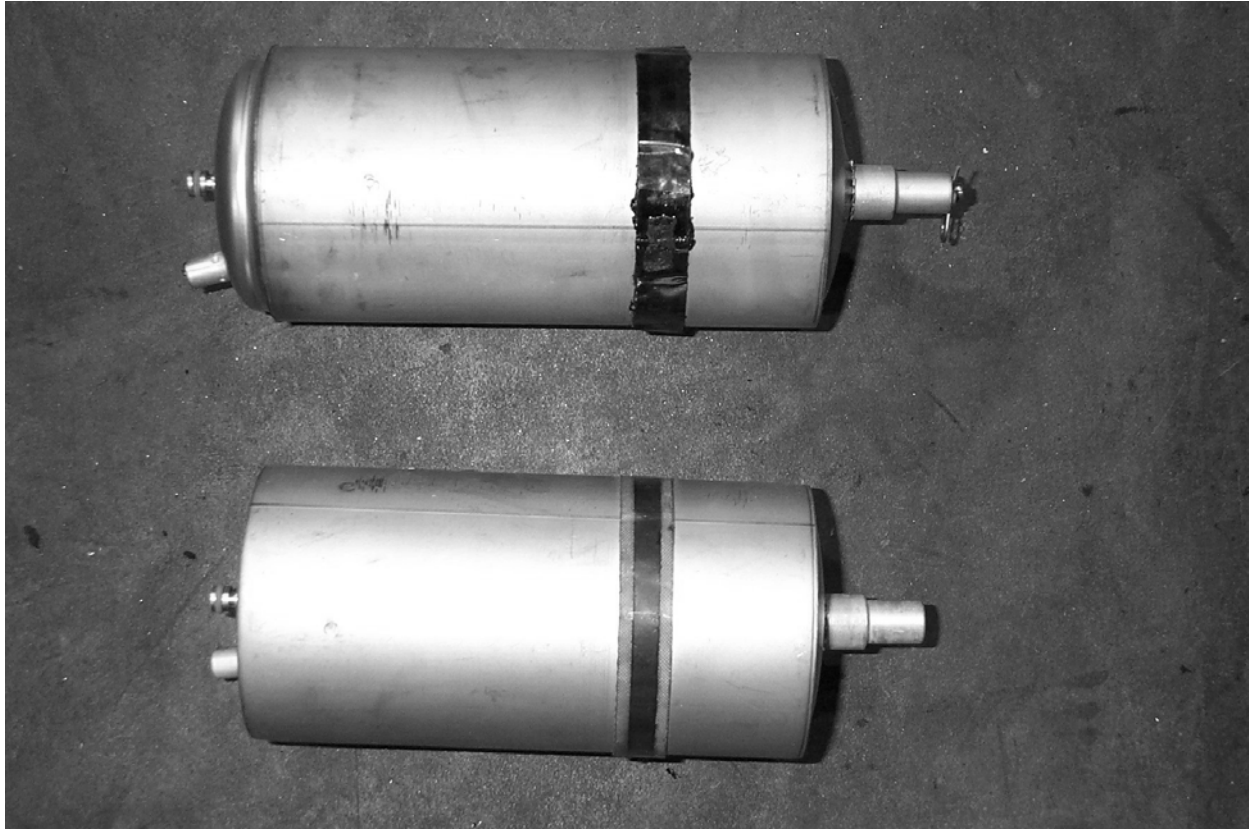
than could be discharged from the generator, and the outer case was significantly bulged outward due to internal pressure. Figure 2 shows the outwardly bulged generator from test 18 next to a normal generator. All of the generators that activated in the furnace were disassembled and the primer caps were examined. In all cases, the primer caps had activated. Table 1 summarizes the results of the testing.

FIGURE 2. OUTWARDLY BULGED GENERATOR (TOP) AND NORMAL GENERATOR (BOTTOM)

1. Activated after 5 minutes but flow rate was much lower than normal.
2. Flow rate through normal outlet was much lower than normal. Oxygen also leaked out of primer cap end and generator body bulged outward due to internal pressure.

1. Exposure to furnace temperatures at or above 600°F was necessary to cause the self-activation of sodium chlorate oxygen generators.
2. Exposure to a furnace temperature of 500°F for 3 hours did not cause activation of the particular generator designs used in this test project.
3. Due to the uncertainty of the self-activation temperature of primer caps or electrically activated ignition squibs in other generator designs not tested in this project and the literature data stating that decomposition could occur as low as 482°F, it is recommended that generators not be exposed to ambient temperatures above 400°F.
