Development of a Cavitation Erosion Resistant Advanced Material System

Project Report for the Modular Advanced Composite Hull form (MACH) Technology Project

November 2005

Report No. UM-MACH-RPT-01-05

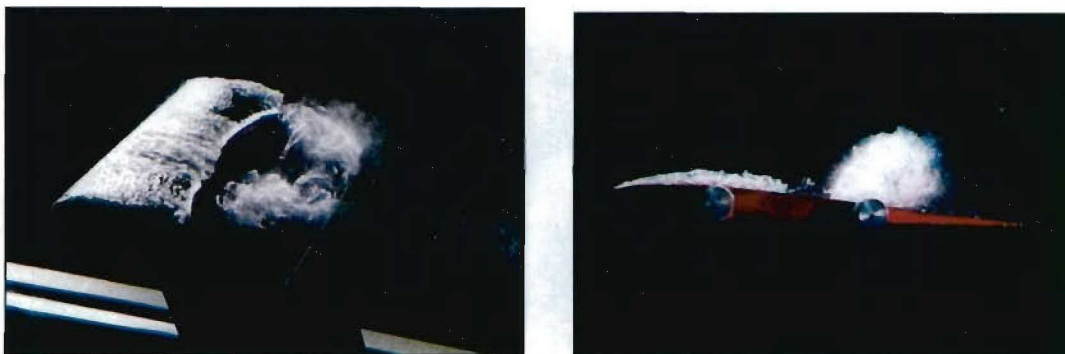
**Figure 1.1 - Photographs of cavitation generated by high speed lifting body shapes.
[University of Tokyo]**

There is a current need to evaluate the cavitation erosion resistance of materials and protective systems for advanced ship hull sections. Examples of the cavitation generated by moving bodies due to geometric shape changes are illustrated in Figure 1.1. The damage and material loss caused by cavitation erosion of naval surface vessels has traditionally only been seen in the areas of the propeller and rudder components. These components are typically constructed from relatively cavitation resistant materials such as stainless steel or NiAl (Nickel Aluminum) bronze. Both of these materials have a long history of being used in cavitating environments and are repairable when damage does occur. The downfall of these materials however is their excessive weight when evaluating these materials for the construction of a complete high-speed hull form. Most

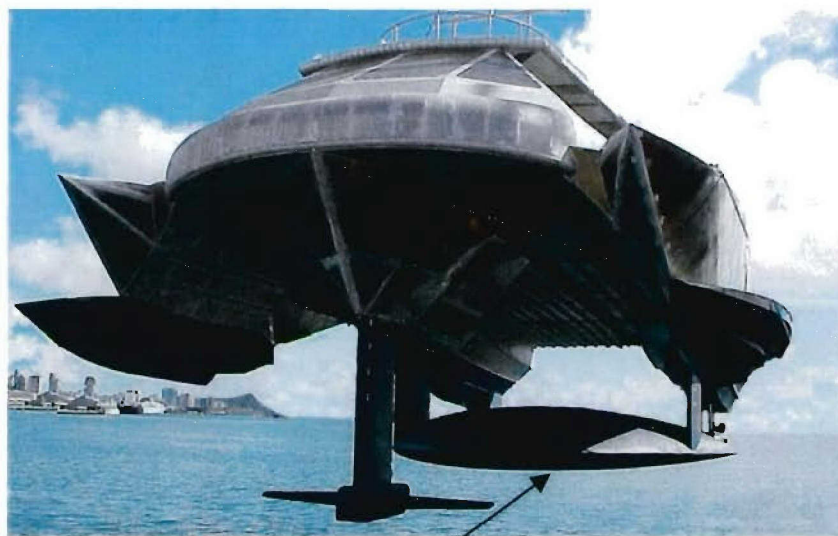
Parabolic underwater lifting body

Figure 1.2 - Midfoil Craft with Underwater Lifting Body

Figure 1.2 shows one example vessel called the MIDFOIL developed by Navatek where a hydrofoil and a parabolic lifting body shape are combined with a catamaran hull to achieve additional buoyancy and dynamic lift which greatly improves the performance and sea-keeping of the vessel. Relatively inexpensive pilot tests on the MIDFOIL and similar vessels have shown that this method has great advantage for fast military support craft and commercial vessels such as ferries. Recent studies have shown that the addition of underwater bodies can dramatically improve speed, reduce fuel consumption and increase payload. These efforts have also demonstrated that composite material construction can bring about increased structural efficiency.

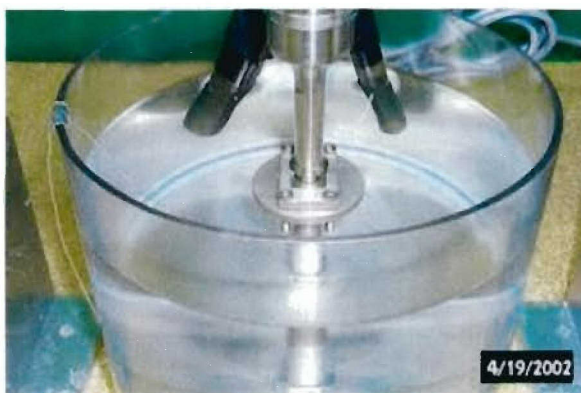
Figure 4.2 – Close-up photograph of the specimen holder

horn oscillates above the test sample at a precisely controlled distance and produces cavitation bubbles that impinge on the surface. The peak-to-peak tip displacement is OEM calibrated and adjustable on the amplifier. It is set to 0.050 mm for these tests. The test sample is mounted 0.50 mm away from the oscillating tip. Bulk fluid temperature in the container is maintained at 23-27° C by the use of a cooled water recirculation system. The temperature is monitored by a thermocouple in the tank. The erosion rate of the material is determined by periodically stopping the test and drying and weighing the sample. Weight was taken using an Ohaus Adventurer scale that has a 65g capacity and a precision of 0.0001g. The testing method is calibrated periodically using standard 6061-T6 Aluminum or Ni 200 as a reference material.

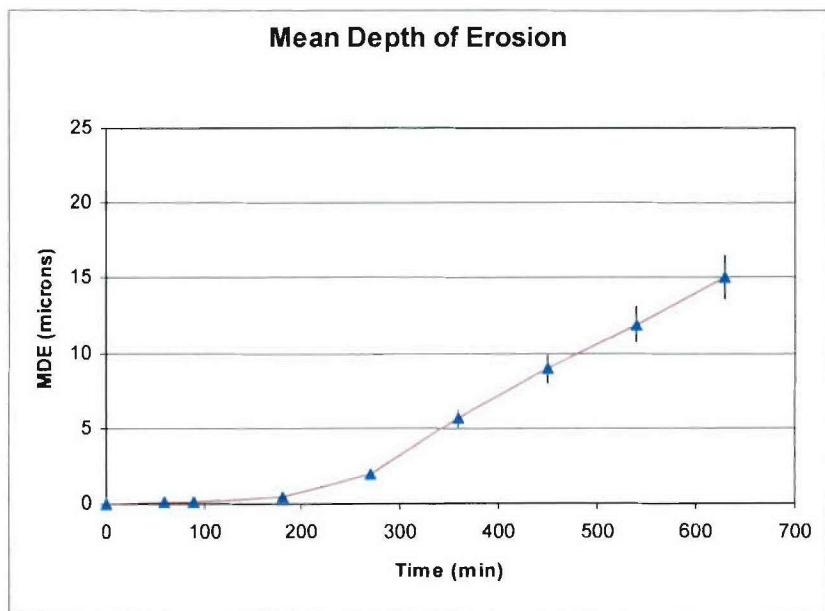
Figure 4.3 - Example Cumulative Erosion-Time Curve

A typical MDE curve from a metallic sample is shown in Figure 4.3. Given the shape of the cumulative erosion-time curve, it is not meaningful to compare the absolute MDE for different materials after the same exposure time. The reason is that a selected time may still be within the incubation or acceleration stage for a very resistant material, whereas for a weak material the same time may be within the maximum rate or deceleration stage. The most common single-number for comparison of different materials is the maximum rate of erosion. This can be defined as the slope of the straight line that best approximates the linear, (or nearly linear) steepest portion of the MDE curve and is expressed in micrometers per hour.

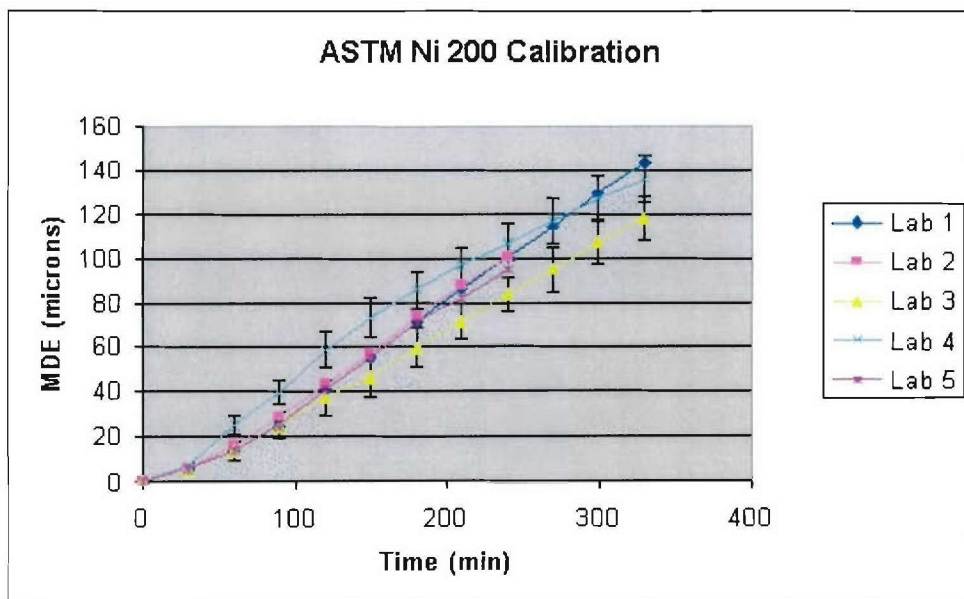
Figure 4.4 - MDE for Ni 200 from independent lab tests using ASTM procedures

The ASTM G32 standard recommends calibrating the test apparatus and procedures using a Nickel 200 material and comparing the results with those provided in the standard. The standard lists results from five independent labs and these are shown in Figure 4.4. The error bars on the curves represent a single standard deviation.

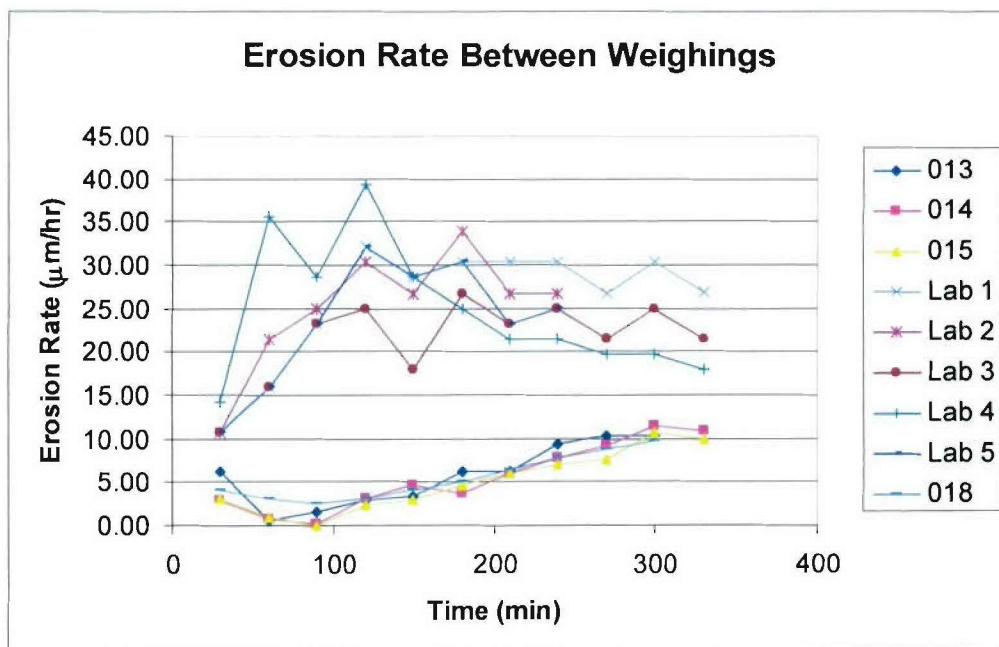
Figure 4.5 – Erosion rate of Ni 200 samples Using Modified Procedures

The results of testing Nickel 200 with the modified procedures are presented in Figure 4.5. Also plotted are the erosion rate results from the calibration lab data. This plot highlights a discrepancy in the data between the two methods. Although the data from the modified test method appears to be repeatable between tests, the erosion rates calculated are much lower than those provided by the ASTM standard data. Several reasons for these discrepancies have been identified. The area of the cavitating horn tip in the standard is larger by a factor of 2.3 than that used in the modified test. The tip area will affect the overall mass loss area and thus the reported quantity of MDE. In an effort to account for this difference, the results for the calibration tests have been normalized with respect to tip area and are compared in Table 4.1. The results show that the

normalization process provided starting values of MDE that are comparable; however, the results from intermediate times vary significantly. Part of this trend can be attributed to the drop in erosion rate of our test samples shown in Figure 4.5. The difference in horn tip area could also cause a difference in cavitation intensity under the horn. As outlined in the theory section, the force imparted on a substrate by a cloud of bubbles is much greater than the force from a single bubble. Given this behavior, it does not seem unreasonable that the cavitation cloud under a larger horn tip may be more intense and result in more damage to the material. It is also possible that an unidentified material discrepancy exists in the tested nickel samples. In any case, further efforts to correlate data between the modified testing method and that of the standard method were not pursued. The following section will discuss the repeatability testing that was done on the modified testing method. Given the fact that this effort seeks to rank each material's relative erosion rate, it was determined that repeatability of the method was the most important aspect of the test method.

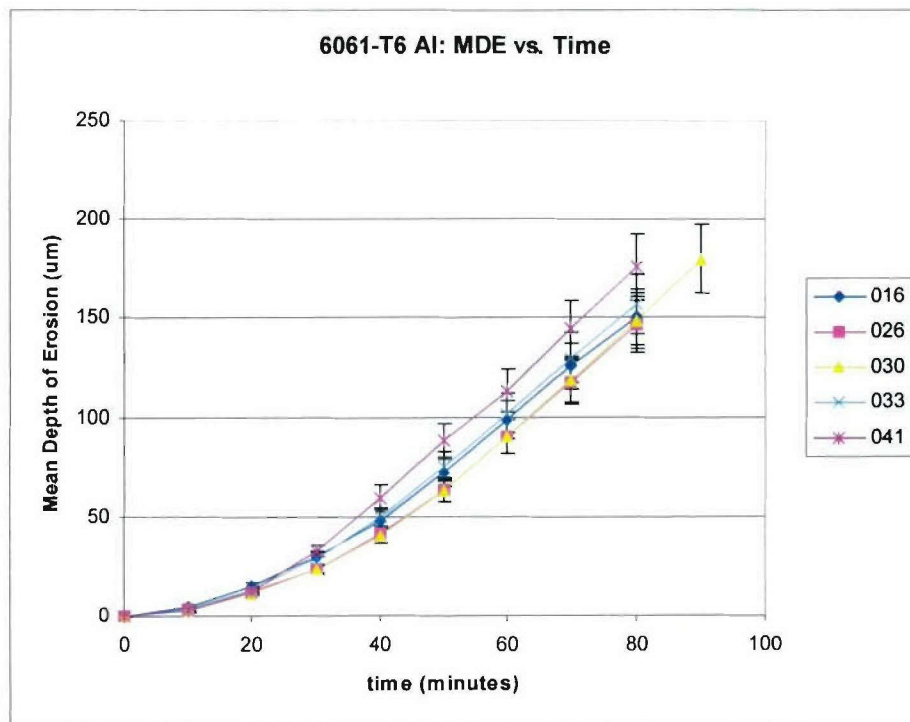
Figure 4.6 – Repeatability of 6061-T6 Aluminum Samples

Since current testing focuses on obtaining relative rankings of cavitation resistance, repeatability was determined to be more critical than the ability to correlate test data with data found in published sources. 6061-T6 aluminum was chosen as the standard for checking the consistency and repeatability of the test method because of its higher availability and shorter test times than Nickel 200. Figure 4.6 shows the cumulative mean depth of erosion (MDE) curves for multiple aluminum samples. As can be seen from the plot, all test data points are within one standard deviation of each other as shown by the error bars. By periodically running one of these samples throughout the testing, it is ensured that the test apparatus and test method remain reliable and provide consistent relative data for the erosion rate of different materials systems.

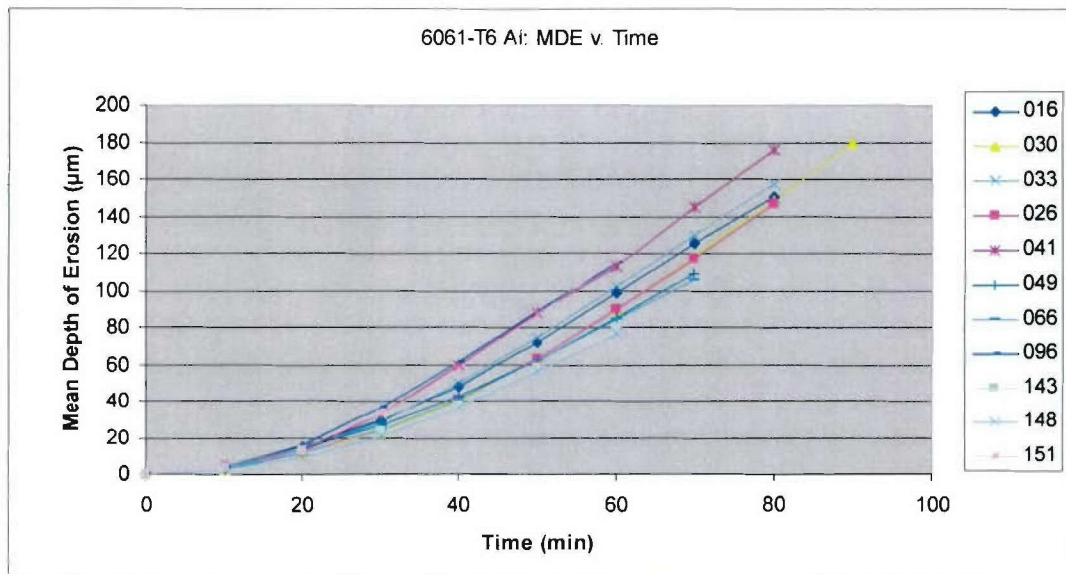
Figure 5.1 – Plot of MDE versus time for all Aluminum 6061-T6 samples

Figure 5.1 shows a plot of all the aluminum samples tested. Eliminating the highest and lowest values from tests #109 and #147 respectively, the average erosion rate is 152 $\mu\text{m/hr}$. It should be noted that test #041 and test #151 used opposing sides of the same sample. Very good agreement is shown in the erosion results between these tests. Figure 5.2 is a typical example of the excessive damage of aluminum samples. Given its low damage tolerance, this material would not be a good choice in a cavitating environment.

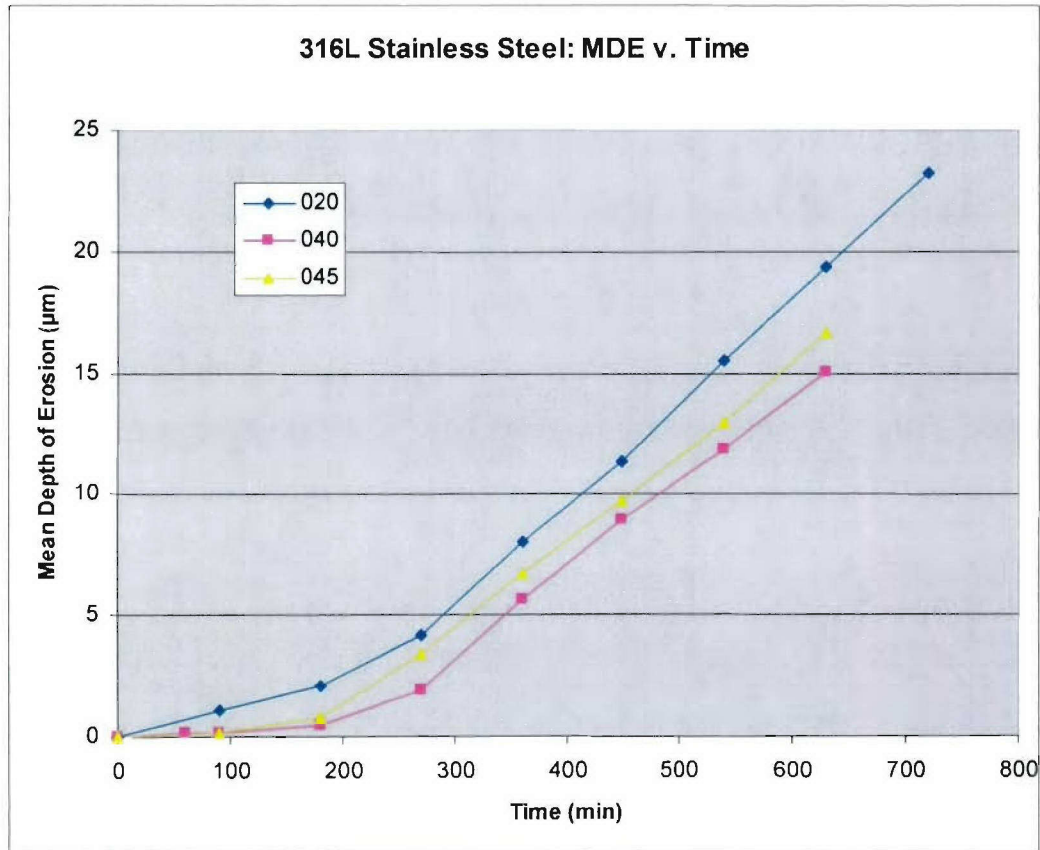
Figure 5.3 – Plot of MDE versus time for 316L stainless steel samples

Figure 5.3 shows a plot of the three 316L stainless steel samples tested. Figure 5.4 shows the damage to sample #040 which is typical for these materials. When compared with the aluminum, the stainless samples exhibit much less pitting and less overall mass loss. The remaining structural materials, NiAl bronze, ferralium, Zeron 100, AL6XN and titanium all fall within $0.65 \mu\text{m/hr}$ of each other as depicted in Figure 5.5. Each of these materials shows similar damage patterns to that of 316L stainless steel. Based on this data, it appears that any of the stainless steels tested would provide a good cavitation erosion resistant material. If weight is a primary concern, then titanium may be a good choice.

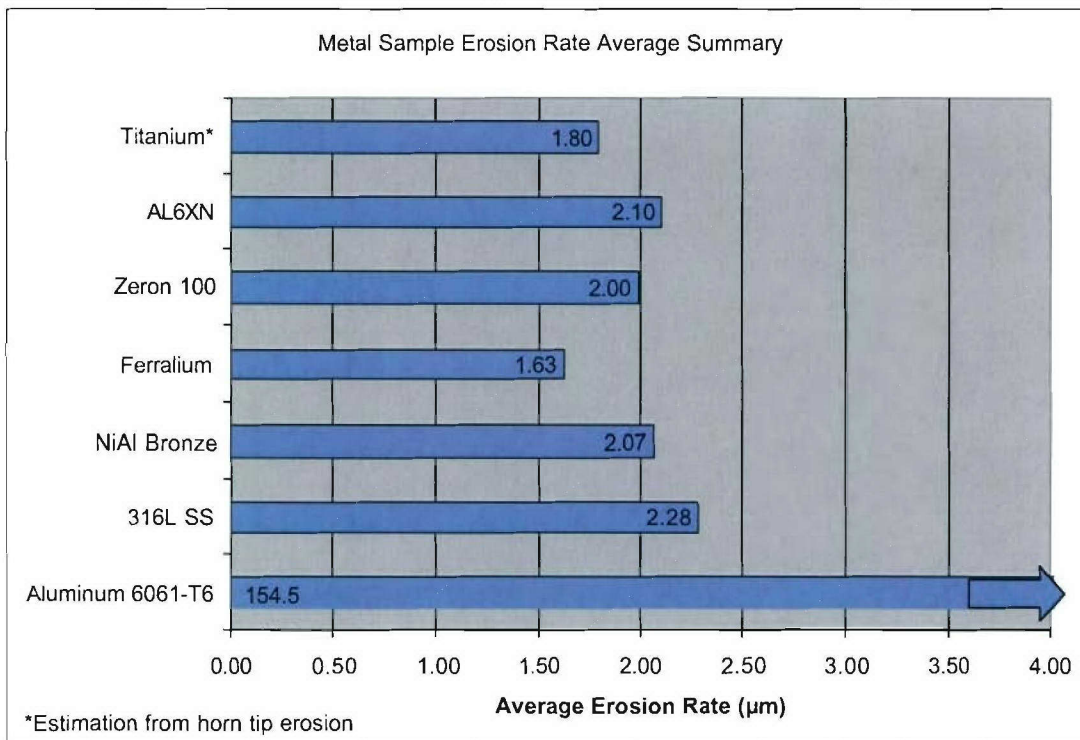
Figure 5.5 – Summary results of cavitation resistance of candidate metal samples

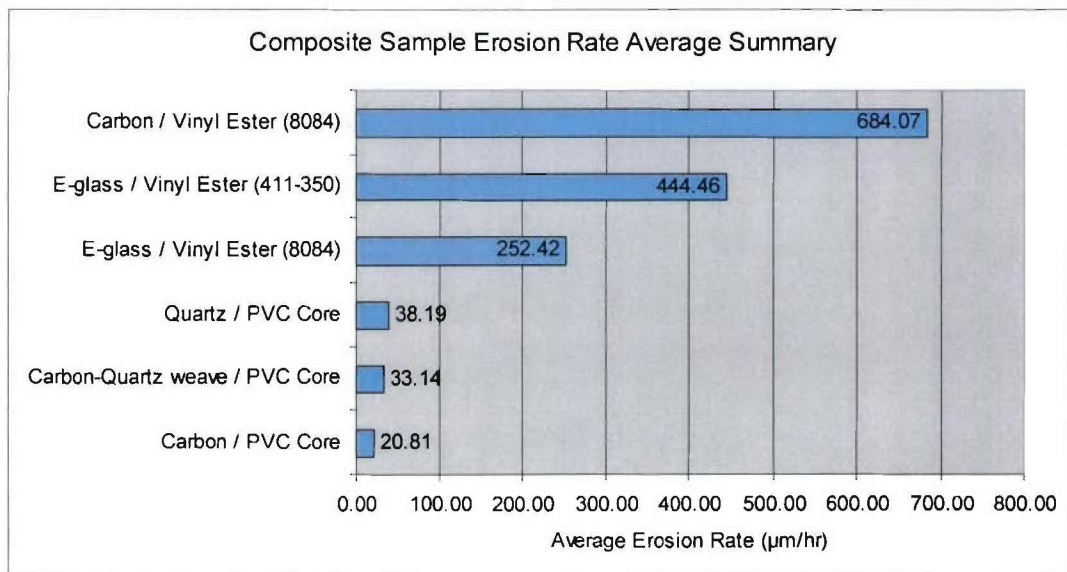
Figure 5.7 – Summary results of cavitation resistance of composite samples

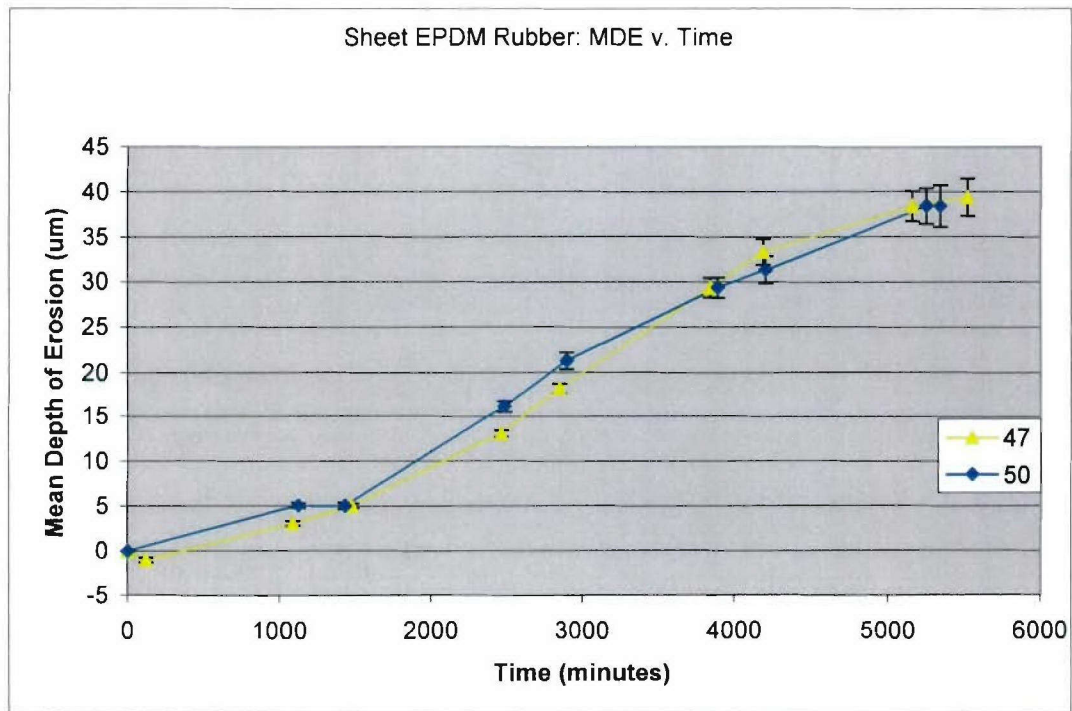
Figure 5.10 – Sheet EPDM results

for samples #047 and #050 are shown in Figure 5.10. The peak erosion rate for these samples did not occur until more than 1500 minutes (25+ hrs) of testing had occurred. Even though the results from the sheet EPDM rubber appear to be good, the manufacturing concerns of bonding a complex geometry with a continuous sheet material prompted an investigation into a paintable or spray on formulation. There exist a number of liquid EPDM rubber variants that are applied with brushes or rollers and only require a room temperature cure. The sample chosen for testing was Liquid Rubber™ from Pro Guard Coatings. Pro Guard Coatings supplies the roofing and other industries with easy to apply rubber formulations. The test samples from both sheet and liquid EPDM rubber are pictured in Figure 5.11. It should be noted that the pictures show damage after only 122 minutes for the liquid EPDM. A total of 5 liquid EPDM samples were tested and only sample #080 provided a reliable erosion rate of (80 $\mu\text{m/hr}$). The other four samples experienced premature delamination or severe pitting damage and loss of material. Discussions with Hal Gouldner [Gouldner, 2002] of Pro Guard Coatings indicated that previous in-house testing of their liquid EPDM formulations also produced poor results. The reason that he gave related to the molecular and surface bond strengths being inadequate. The difference between their product and sheet EPDM is the amount of cross-linking present due to the curing process. The Liquid Rubber™ EPDM is a non vulcanized cure at room temperature. Vulcanization is a chemical process by which the monomer base chains of the material are cross-linked. It is often done at elevated temperatures and in the presence of other chemicals that provide the chemical cross-link between monomer chains [Bhowmick et al., 2001]. Sulfur is the most common cross-link

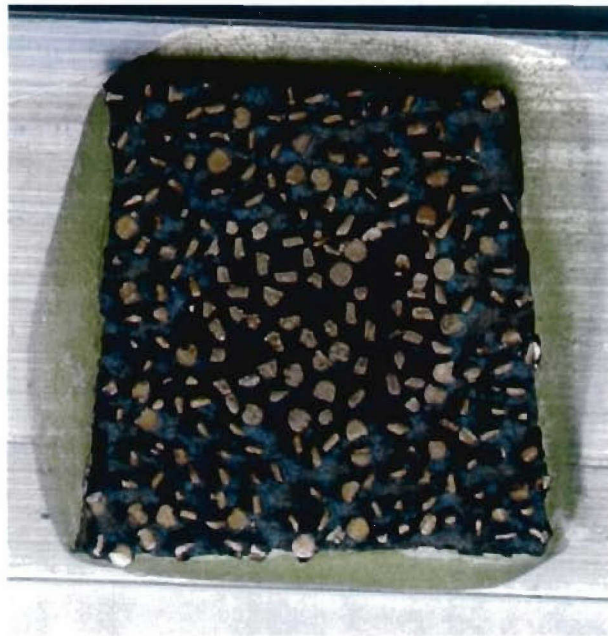
Figure 5.16 – Cuproprene sample showing damage to embedded copper-nickel granules

Cuproprene is manufactured by Dunlaw Engineering Limited and consists of a monolayer of cupro-nickel granules embedded and chemically bonded in a polychloroprene rubber sheet. The material is used primarily on submerged and splash zone structures for its anti-fouling capabilities. The material is available in sheet form and was bonded to an aluminum substrate using a two-part epoxy. The single sample erosion rate of $9.5 \mu\text{m/hr}$ represents mass loss in the cupro-nickel granules as shown in Figure 5.16. The rubber sheet showed little sign of cavitation damage.
