TRW-27590-6001-RU-00

6
IMPROVED JET TAB THRUST VECTOR CONTROL FOR THE BGM-34C BOOSTER.

9
FINAL REPORT, May 75 - Jun 77,

TRW SYSTEMS GROUP ✓
ONE SPACE PARK
REDONDO BEACH, CALIFORNIA 90278

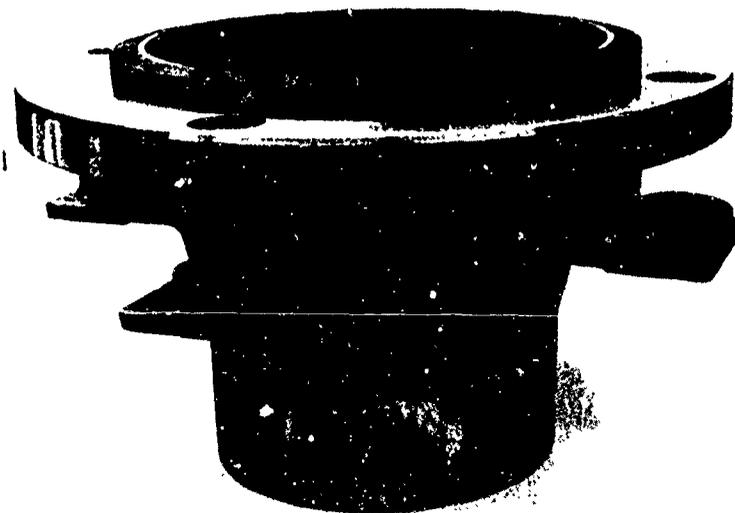
Figure 4-3. Nozzle Assembly

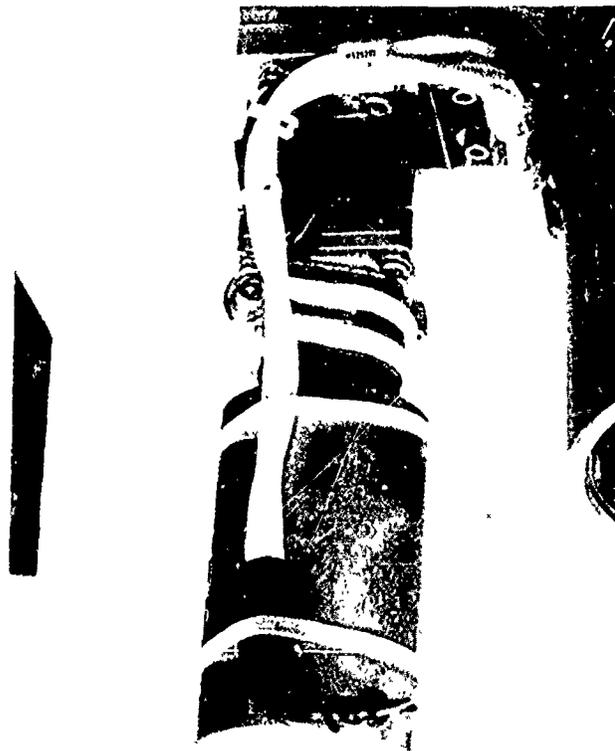
Figure 4-8. Actuator Installation

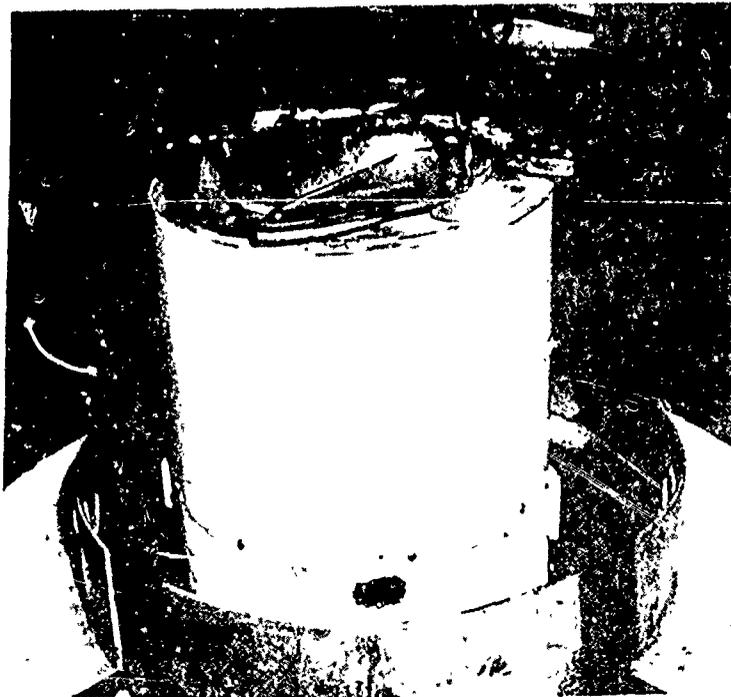
The reduction in the jet tab TVC size allowed the use of a simple fiberglass cylinder, the same outer diameter as the solid rocket motor, to meet the design criteria. Mandrel lay-up molding of the fiberglass part resulted in a much lower cost than the complex sheet metal structure. The shroud shown in Figure 4-10 was used during three PFRT test firings with no problems. The shroud, which connects to the rocket motor skirt, has an elastomer insert which fits to the nozzle housing outer diameter. Provisions are made for feed through of the electrical control cable which connects to the RPV.

Figure 4-10. Protective Shroud

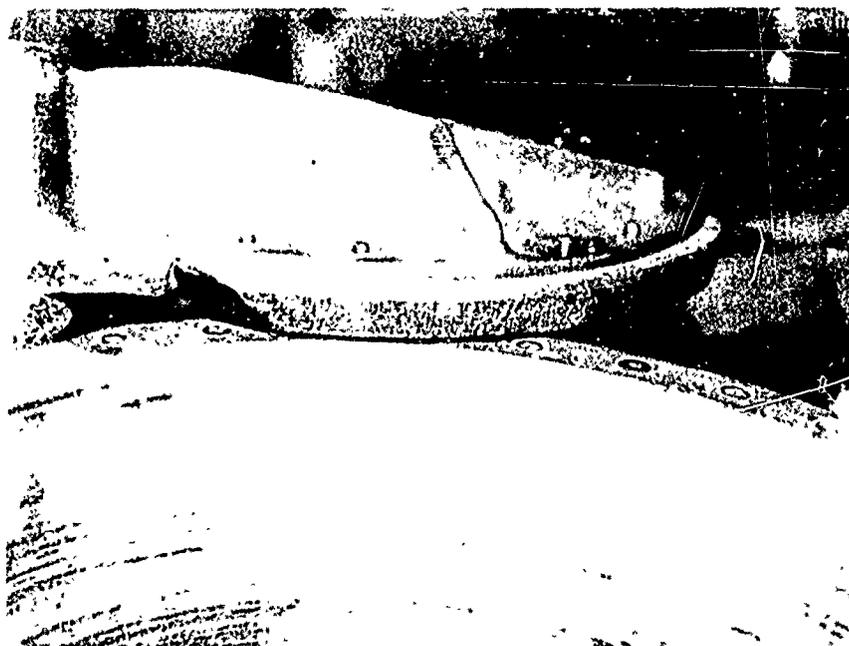
Figure 5-2. Ablative Scraper Ring Segment

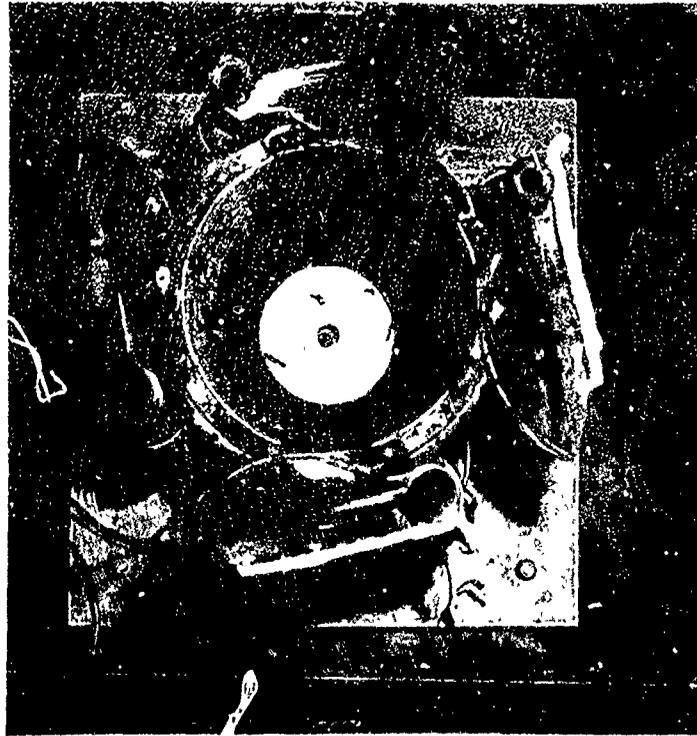
The performance of the molybdenum scraper ring was excellent with no noticeable erosion occurring. The carbon phenolic exit ring installed in one quadrant exhibited very little material loss. In fact, post test char swell between the exit ring and the carbon phenolic tab face reduced the gap to nearly zero.

Figure 5-7. PI-2 Post Test

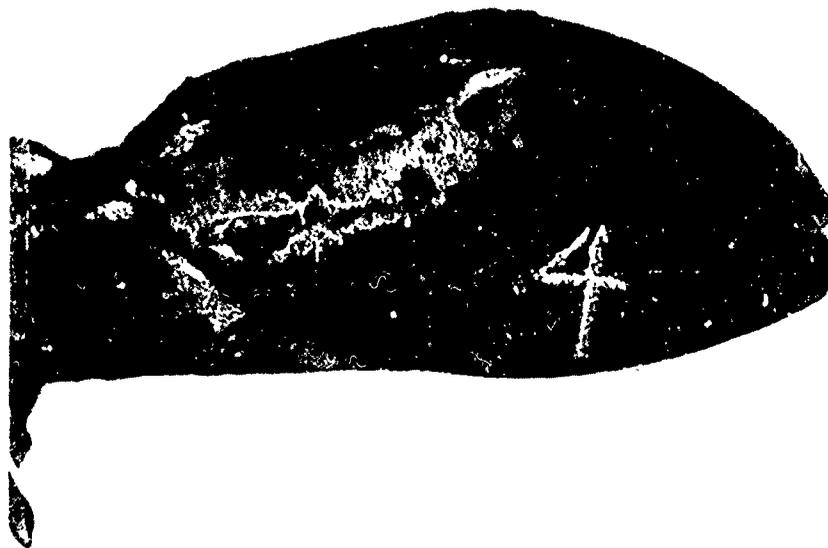
PI-2 subjected the tab system to a more extensive duration to determine the capability of meeting the longer duration firings during PFRT. As indicated in Figure 5-6, the duty cycle used during test firing PI-2 provided 2.2 seconds of insertion time on the carbon phenolic tab and on two of the three molybdenum tabs, and 2.6 seconds on the third molybdenum tab. With the exception of the carbon phenolic tab, the post test condition of the unit as shown in Figure 5-7 was excellent. The maximum amount of erosion experienced on the three refractory tabs was nearly identical and amounted to .10 inch. However, material erosion occurred over a larger area on the .25 inch thick tab than was experienced with the two .375 inch thick parts. Erosion of the carbon phenolic tab face was severe over the entire exposed area (Figure 5-8).

Figure 5-8. Carbon Phenolic Tab Facing-Post Test

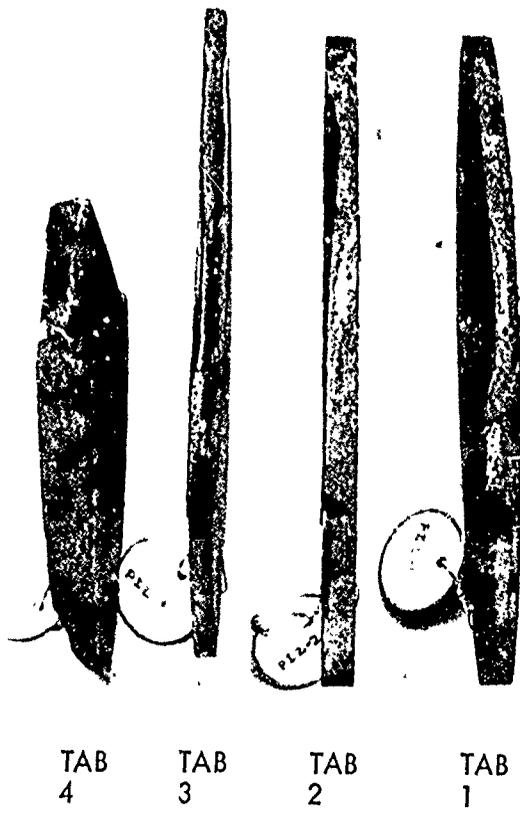
Figure 5-12. Tab Facing Erosion Test PI-2

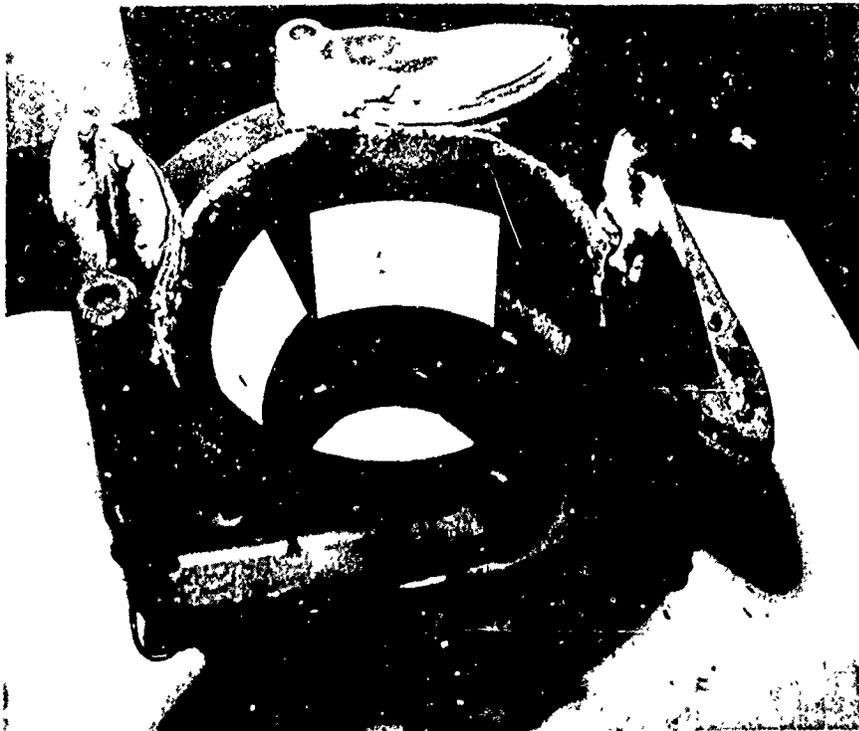
The post test condition of the hardware on both test units was very satisfactory. Test unit PFRT-02 is shown in Figure 5-19. Erosion of the phenolic liners for both the silica phenolic and pitch carbon fabric phenolic materials was considered acceptable. In general, erosion of the liner immediately under the tab was equivalent in both materials and as can be seen in Figure 5-20, occurred back to the screws retaining the liner to the housing. Erosion of the molybdenum tab facings was well within acceptable limits. Total exposure time for each tab was in excess of three seconds during motor burn time with up to one additional second of exposure during tail off. The .25 inch thick molybdenum showed only minimal material loss (Figure 5-21), while the .375 inch material had a local material loss of nearly half the thickness (Figure 5-22). While

Figure 5-19. PFRT-02 Test Unit Post Test

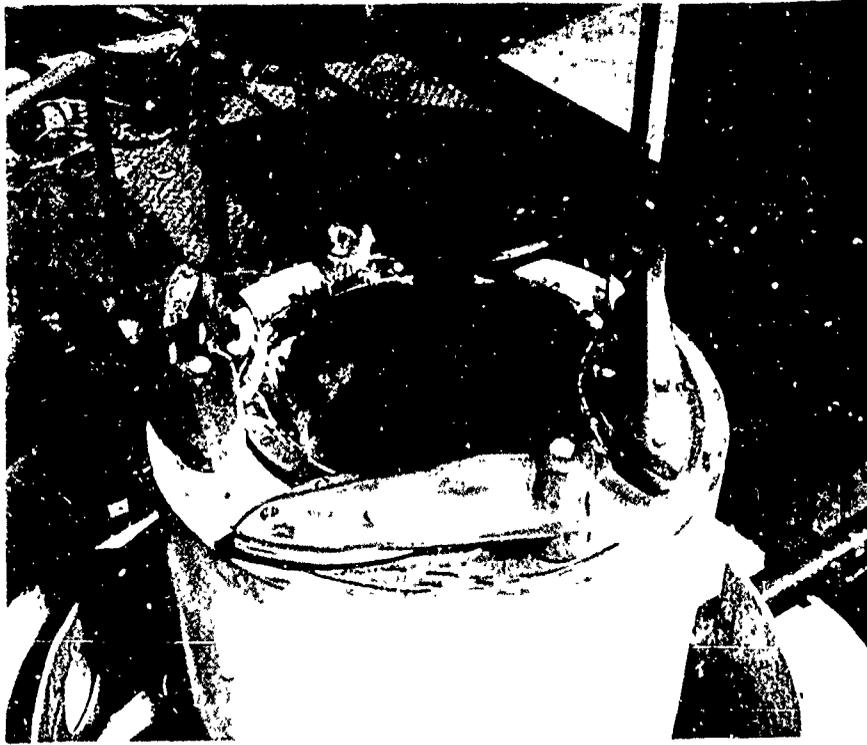
Figure 5-30. Test Unit PFRT-04 Post Test
