Andover C. Mk. 1  
Airfield Criteria Trials

CP No. 1220\*  
December, 1968

J. Howell,  
Engineering Division,  
A and A.E.E., Boscombe Down

SUMMARY

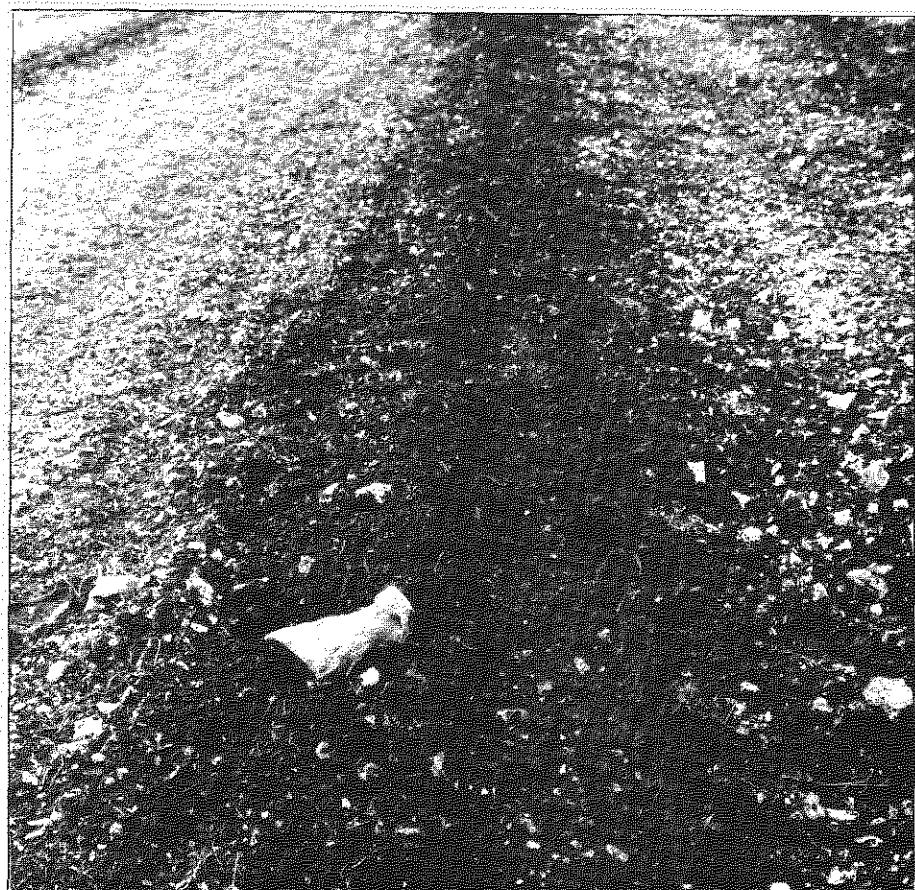
FIG. 9. PLOUGHED LANDING STRIP AT A. & A.E.E.  
GENERAL SIZE OF FLINTS COMPARED WITH WHEEL TRACK.

As described in para.3.3.3 the soil of the test strip contained a high proportion of flints of various sizes and this gave rise to a problem in relation to tyre, propeller and airframe damage. It was considered at one time that the tests might have to be abandoned, but by a process of stone-picking to remove the larger obstacles and frequent harrowing and ploughing to provide a fresh soil layer,

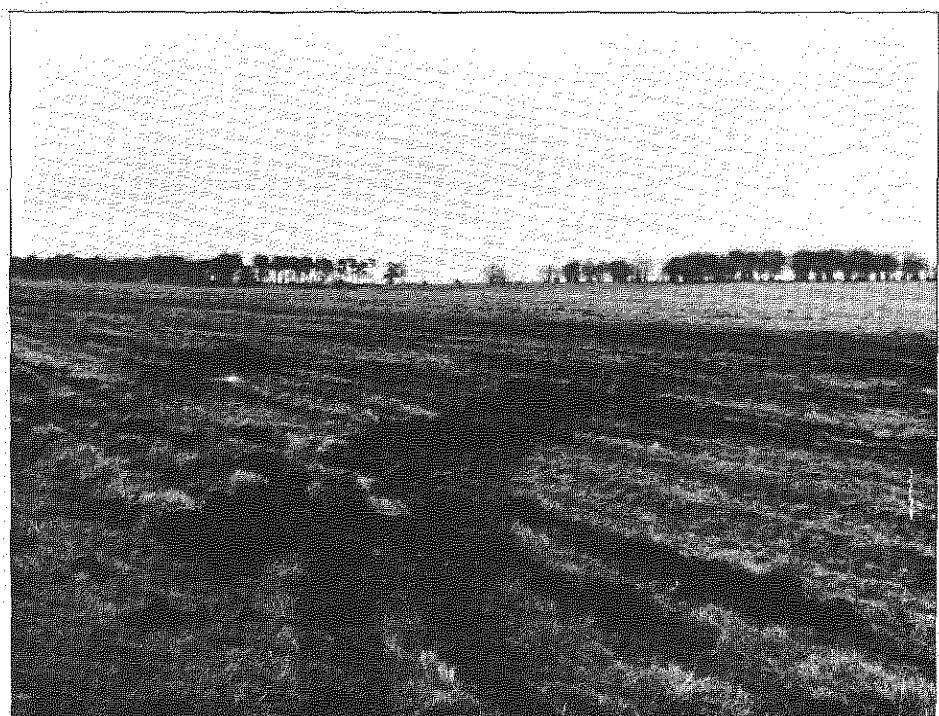
FIG. 15. UPAVON GALLOPS. TEXTURE OF WET, FIBROUS SOIL AREAS.

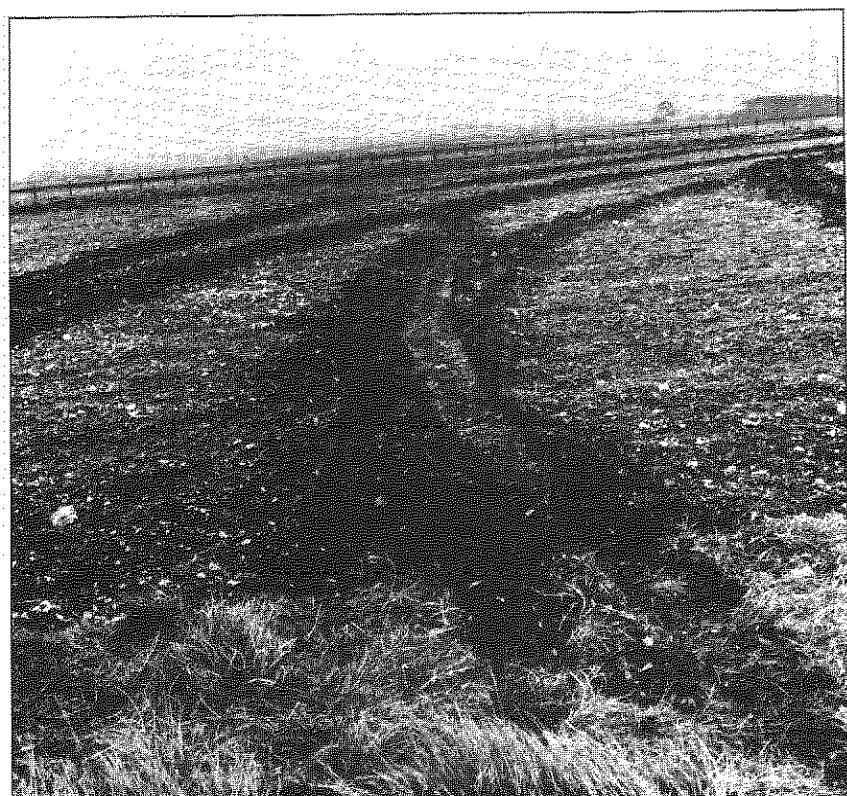
FIG. 29. A. & A.E.E. SOFT EARTH STRIP. RUTTING IN TURNING AREA. 2 INCH WET SOIL ON FROZEN SUBGRADE.

When the soil surface was soft to 3 in. the general order of rutting was 1-2 in. for the nose-wheel and  $\frac{3}{4}$ -1 in. for the mainwheels, there being some filling of the ruts by loose soil behind the wheels. The soil tended to form 1-2 in. banks at either side of the wheel ruts (Fig.28). Where the aircraft was stationary the local ruts were of the order of 5 in. and 3 in. for the nose and mainwheels respectively. In the later stages of the tests, when the soft layer was increased to a nominal 6 in., heavy braking resulted in severe rutting, necessitating some digging to free the mainwheels in order to avoid the use of extreme power to move the aircraft. This might have resulted in the scouring of the propellers and undersurfaces by debris. The ruts caused were of the order of 1 ft. with soil banked to 3 in. at the sides of the ruts.

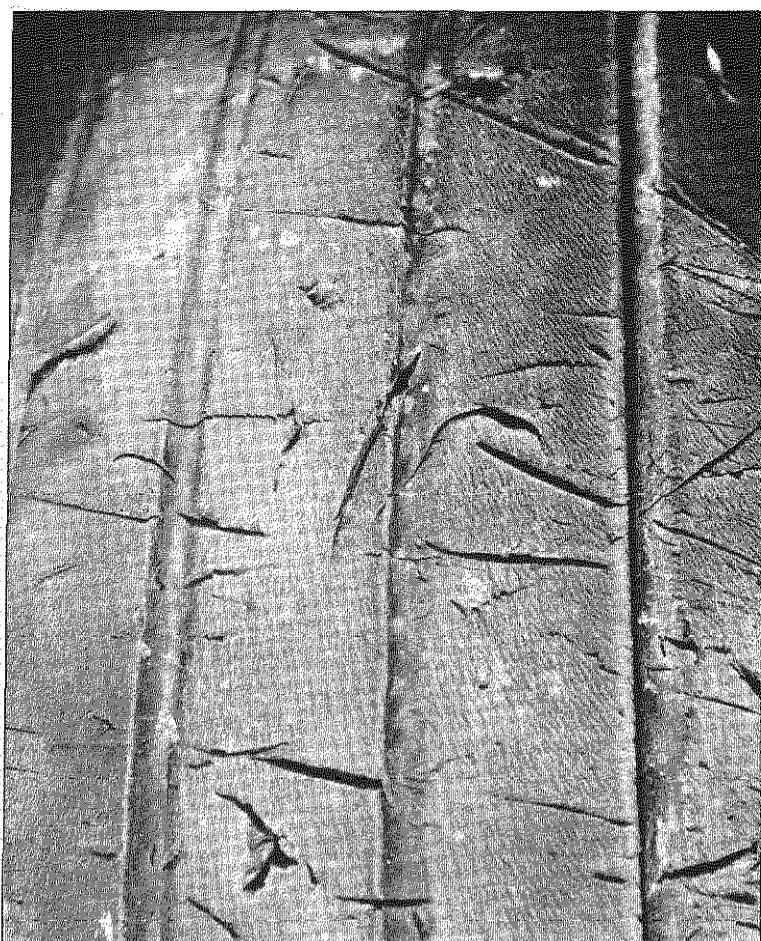
FIG. 30. TYPICAL TYRE DAMAGE FROM SHARP STONES  
IN A. & A.E.E. SOFT EARTH STRIP.

In the event, 10 nose wheel and 12 main wheel tyres were changed during a total of 60 movements (1 movement = 1 take-off and landing or 2 taxi runs). One series of tests was conducted when the strip had started to thaw following a period of severe frost. In this condition the upper 2 in. of the surface consisted of waterlogged soil resting on, and quite distinctly separate from, a hard frozen sub-grade (Fig.29). The purpose of the test was primarily to investigate ground handling in such conditions but a secondary effect was that the sharp stones embedded in the frozen sub-grade caused the most severe tyre damage experienced in the whole of this phase of the trial. One nose-wheel tyre was punctured such that it deflated slowly, the other was partially severed by a large radial cut, deflating instantly, and all the mainwheel tyres were cut to an extent necessitating replacement, in two normal speed taxi runs (See Figs.16 and 30).
