**DOT/FAA/AR-01/27**

# **Engine Debris Fuselage Penetration Testing, Phase I**

August 2001

Final Report

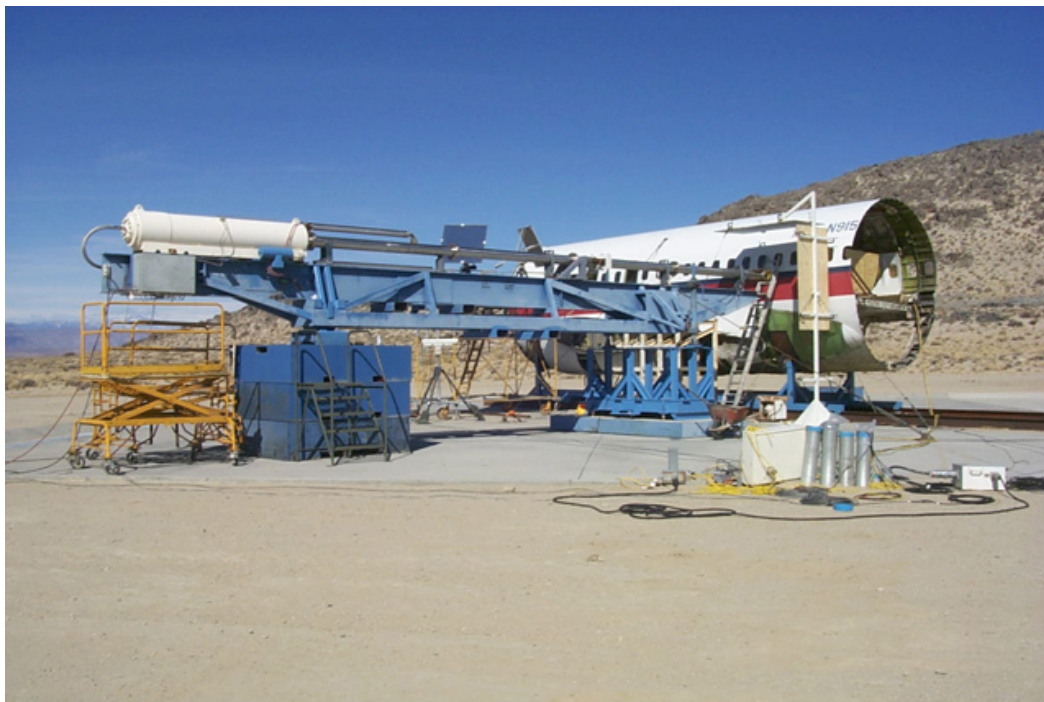
The test setup is shown in figure 5. The fuselage could be rolled  $\pm 30$  degrees and translated along a track to line up the different target areas. The gun had a limited elevation control and was typically close to horizontal and aligned with the upper radius of the fuselage section. Table 1 displays the fragment launch orientations and the shotline obliquities for each of the test shots. The fragment pitch angle was limited by the diameter of the gun and the sabot design. It was determined that with initial pitch angles of  $15^\circ$  the polystyrene foam in the sabot would fail randomly and result in spectacular fragment and sabot stopper plate impacts. For this reason most of the shots were at a reliable 0 degrees pitch.

FIGURE 5. TEST SETUP SHOWING GAS GUN AND FUSELAGE

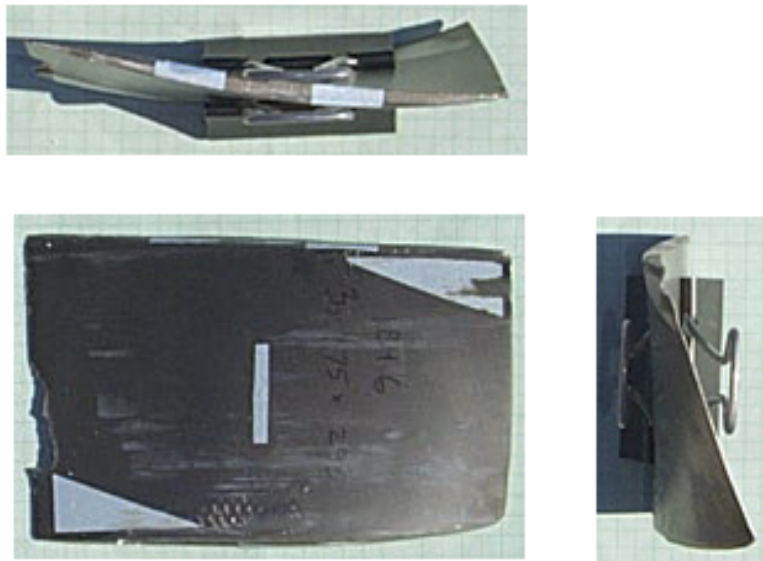
Figures 6 and 7 show examples of the fan blade fragments used in these tests. They were cut from a used fan blade. The reflective tape was used to enhance the blade visibility in the high-speed film. Typically, after a test a blade was reusable. The corners would get chipped away but the fragments seldom broke up. The large blades were 7 to 9 in. long and about 3 by 0.25 inch thick. The medium size blades were about half the length of the large ones. SRI International shot some 25-gram 1.3 by 1.0 by 0.25 inch projectiles.

FIGURE 6. LARGE BLADE FRAGMENT USED IN SHOT 26B

FIGURE 7. MEDIUM BLADE FRAGMENT USED IN SHOT 41

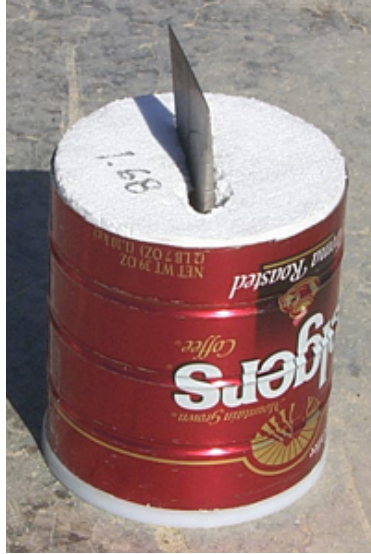
An example of the sabots can be seen in figure 8. A coffee can, Teflon, and Styrofoam to build the sabots were used. The Teflon was used as a backing plate to prevent the gas blast from destroying the foam. The coffee can had to be made slightly smaller in diameter to fit the gun, but worked wonderfully. The previous tests' sabot designs were very heavy and outweighed the projectile by many times. Stopping those sabots at the energies of this test was going to be expensive. Three sabot stopper plates of 3 in. Society of Automotive Engineers (SAE) 4140 steel were broken during the pretest experiments.

FIGURE 8. FINAL SABOT DESIGN WITH LOADED FRAGMENT

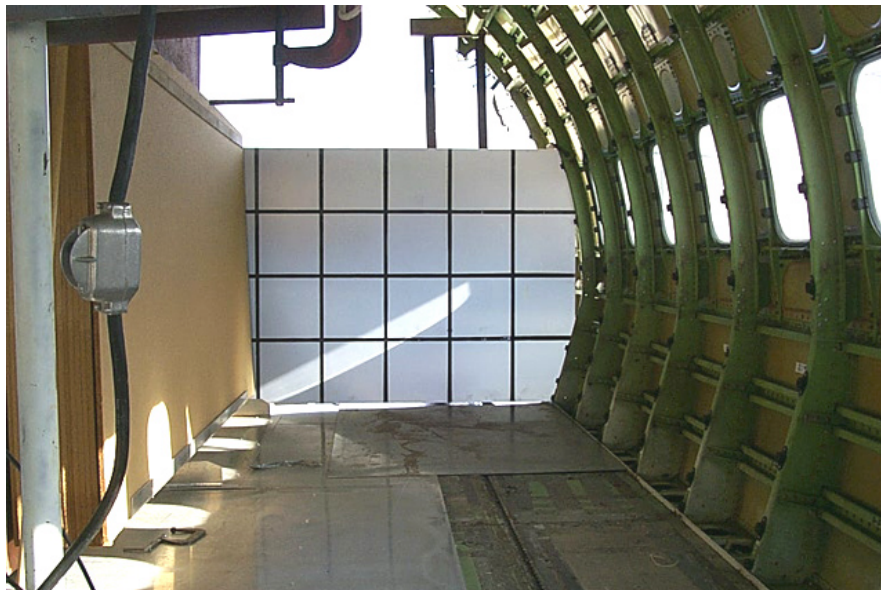
The interior, as shown in figure 9, displays the backboard and particleboard projectile catcher. The interior wall panels, trim, overhead stowage, and insulation were removed. Two, 2000 Watt cinema lights were used to illuminate the scene.

FIGURE 9. INTERIOR SETUP OF AIRCRAFT FUSELAGE

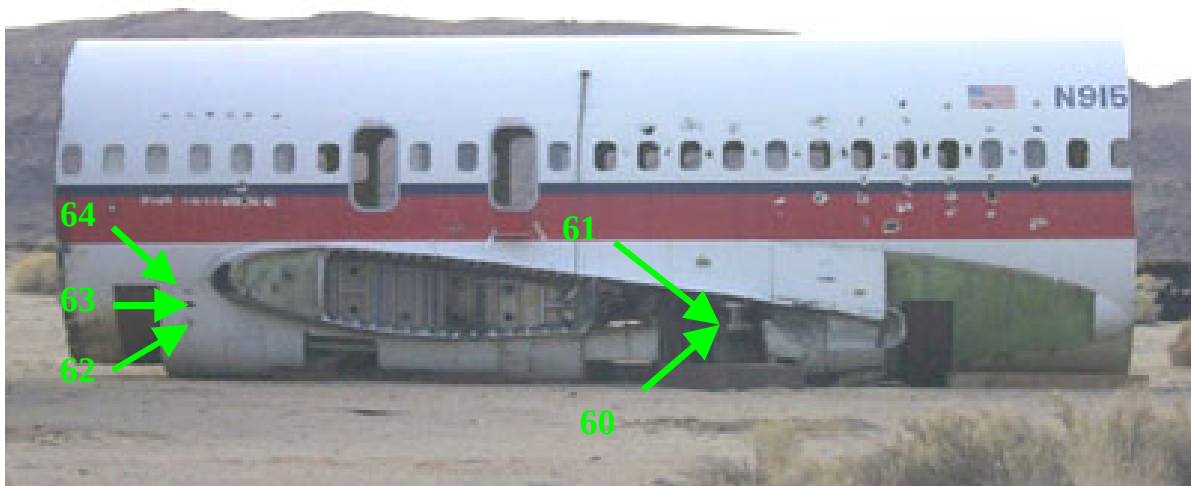
A map of the shot locations for the cabin area test is shown in figure 10. Each shot number and it's location on the fuselage are shown in the figure. The windows are numbered from aft forward. The complex structure shots, test 60-64 are shown in figure 11.

FIGURE 10. AIRCRAFT FUSELAGE SHOT MAP, INTERIOR VIEW

FIGURE 11. AIRCRAFT FUSELAGE TESTS 60-64 LOCATIONS

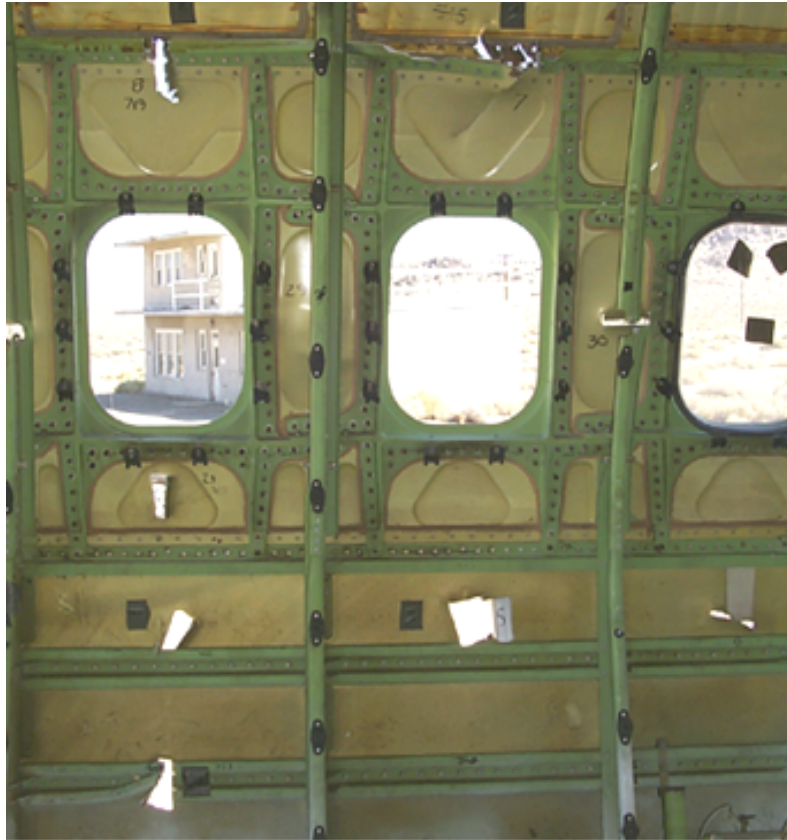
Figures 23 and 24 show typical posttest impact areas from the inside and outside.

FIGURE 23. EXAMPLE EXTERIOR DAMAGE AREAS

FIGURE 24. EXAMPLE INTERIOR DAMAGE AREAS
