**DOT/FAA/AR-02/80**

# **Impact Damage Characterization and Damage Tolerance of Composite Sandwich Airframe Structures – Phase II**

October 2002

Final Report

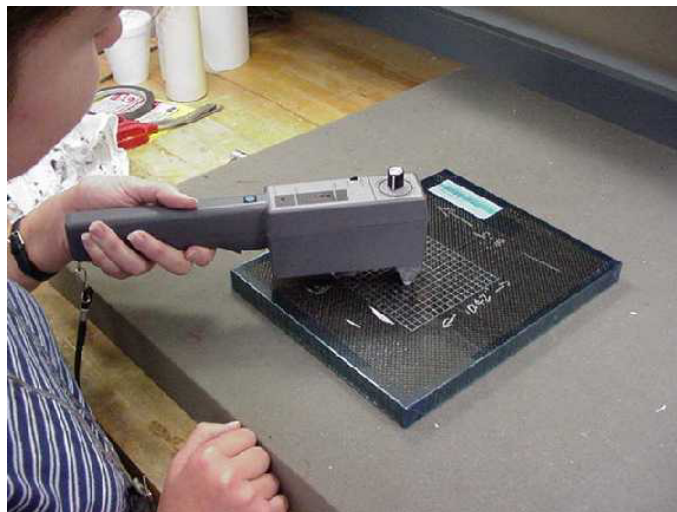
FIGURE 5. MITSUI WOODPECKER AUTOMATED TAP TESTER

In mechanical tap testing, the impact (tap) force is measured using an accelerometer that is mounted behind the impactor. The magnitude of the force and impact duration will depend on the constitutive properties of the sandwich components, impact energy, and impactor properties. The duration of impact (period) has been reported to be rather insensitive to the magnitude of the peak impact force for sandwich panels [5], which ensures repeatability. However, the impact duration will be significantly altered when the local stiffness of the sandwich structure is reduced due to the presence of damage. This change in impact duration is used to identify damage in sandwich structures. In the present investigation, the Mitsui Woodpecker Automated Tap Tester [6] (shown in figure 5) was used to identify the impact damage in sandwich panels.

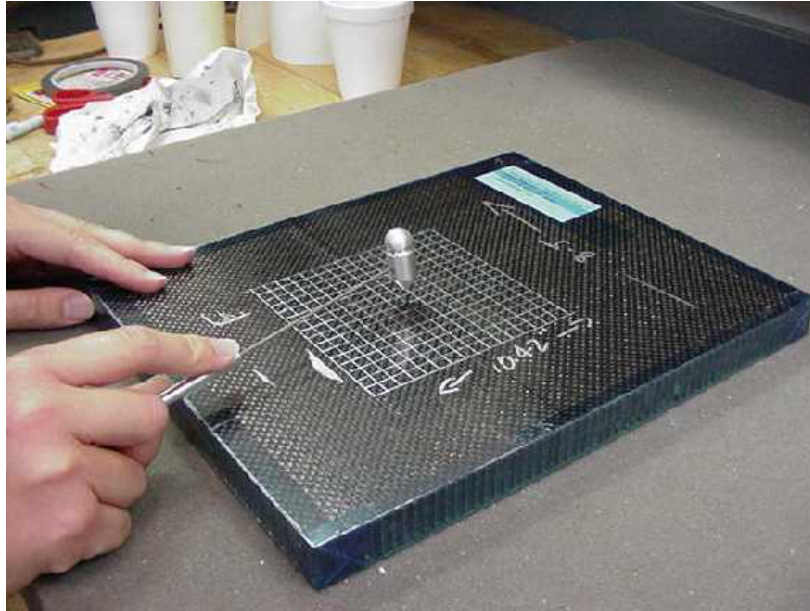
FIGURE 6. MANUAL IMPACT HAMMER (AIRBUS DESIGN)

In acoustical tap testing, the characteristic resonant sound emanating from the tap test is analyzed by the human ear. The audible resonant sound will depend on the sandwich local impedance and tap mass and hammer characteristics. The damaged region is characterized by a dull (dead) sound, which can be attributed to the decreased participation of the higher frequency modes. The manual tap test hammer (Airbus design) used in this investigation is shown in figure 6.

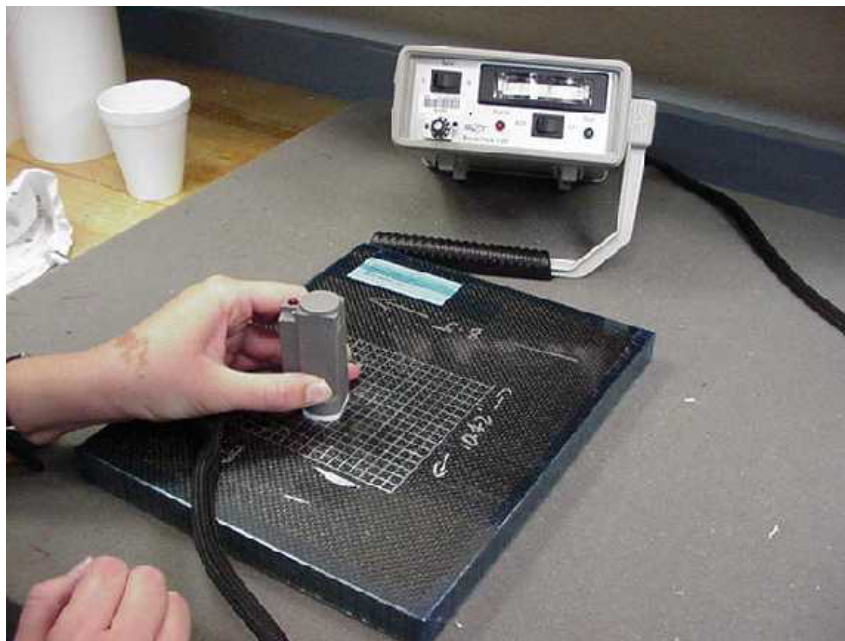
FIGURE 7. V-95 BOND TESTER USED FOR MECHANICAL IMPEDANCE ANALYSIS

In the MIA method [7], the stiffness of the structure in contact with a probe tip is measured. The mechanical impedance (stiffness) of the structure is a function of the constitutive properties of the sandwich components. The MIA method has been frequently used for identifying flaws in adhesive bonds. The presence of facesheet or core damage will reduce the mechanical impedance of the sandwich structure, and can result in a phase or amplitude change to the displayed signal, depending on the frequency of the probe. The probe consists of two piezoelectric crystals with the driver positioned behind the receiver within the same holder. The driver converts electrical energy into sonic vibrations and the receiver, in direct contact with the test surface, converts the modified vibrations into electrical signals for processing by the instrument. The V-95 Low-frequency bond tester used in the present study is illustrated in figure 7.
