DOT/FAA/AR-96/110

Evaluation of Lightweight Material Concepts for Aircraft Turbine Engine Rotor Failure Protection

July 1997

Final Report

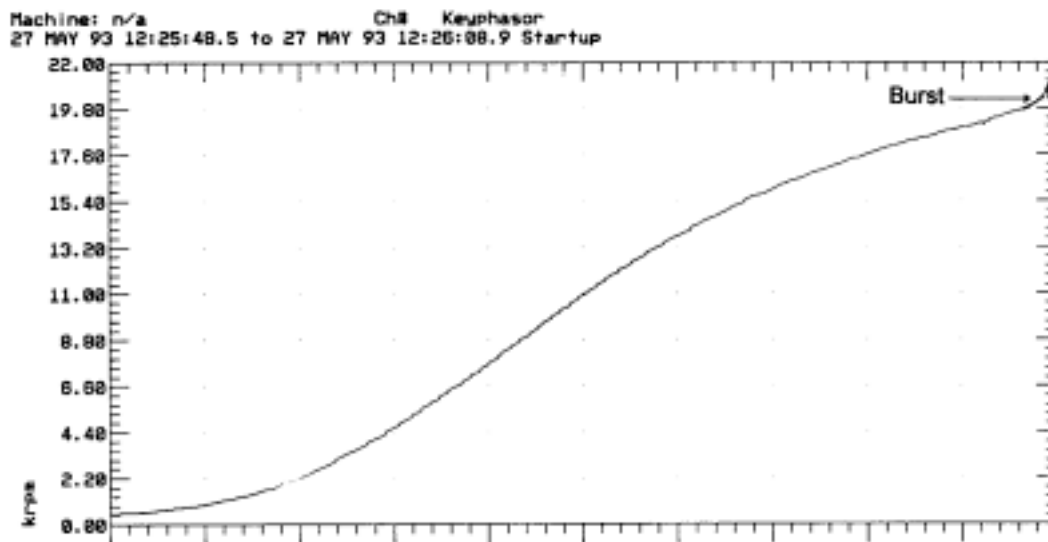
FIGURE 5. TYPICAL PLOT OF THE CONTAINMENT RING BURST TEST

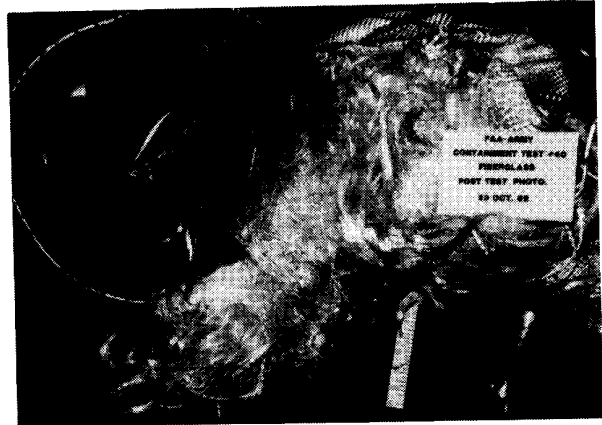
FIGURE 14. POSTTEST PICTURES OF RINGS 31, 35, 36, AND 37

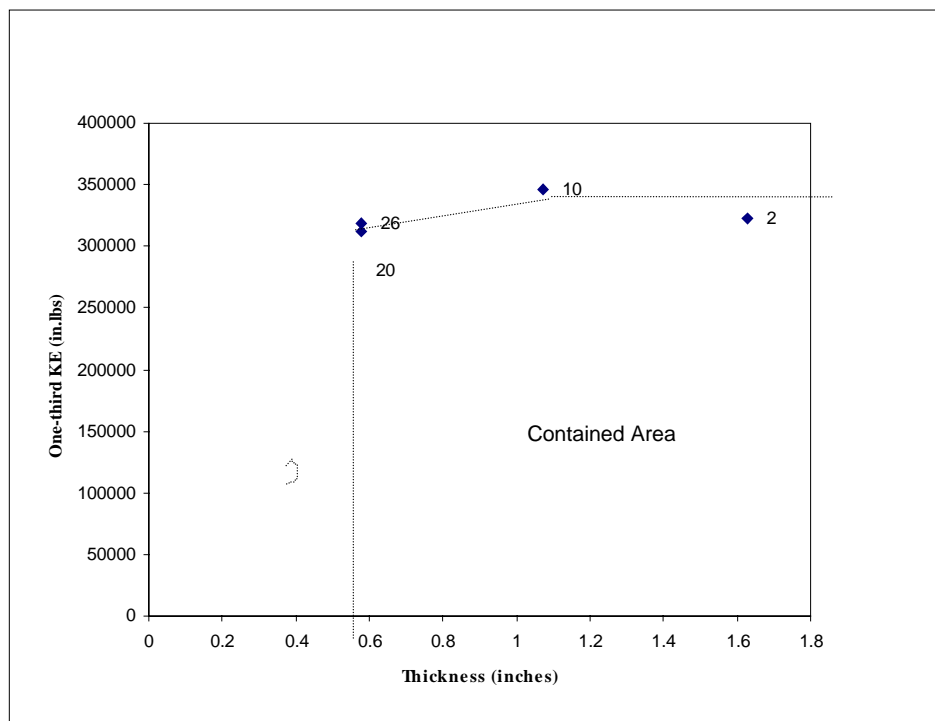
FIGURE 19. GROUP 2—FIBERGLASS-PHENOLIC

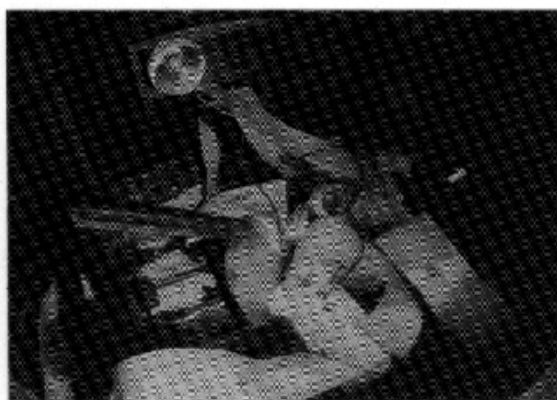
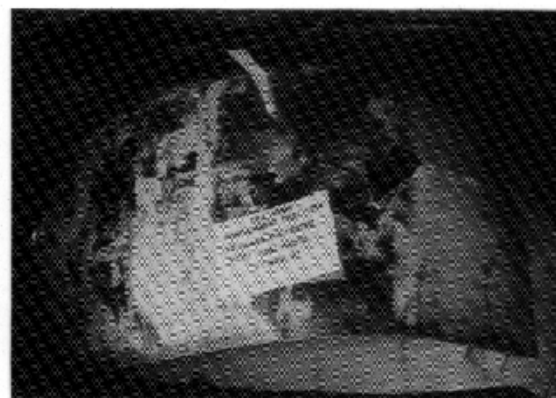
FIGURE 23. FAILURE EVENT AND POSTTEST PICTURES OF RING 28

Group 3, fiberglass impregnated with polyester resin, had five systems (rings 3, 9, 17, 24, and 28). Rings 3, 9, 17, and 24 contained all fragments. No significant damage on the outer most layers of these rings was recorded. Normalized weight and thickness of ring 3 were 47.52 lbs and 1.65 inches, ring 9 were 36.50 lbs and 1.18 inches, ring 17 were 22.00 lbs and 0.71 inch, and ring 24 were 20.86 lbs and 0.69 inch respectively. KE_w and KE_t of ring 3 were 21 kips/lb and 619 kips/in, ring 9 were 26 kips/lb and 820 kips/in, ring 17 were 49 kips/lb and 1,527 kips/in, and ring 24 were 47 kips/lb and 1,429 kips/in respectively. System 24 represented the threshold configuration. System 17, however, provided higher energy absorbed per unit weight, and it was selected for ranking. One disc fragment penetrated ring 28 and escaped. Figure 20 shows the posttest pictures of rings 3, 9, and 17. Figures 21 and 22 show the failure event of ring 3, 9, 17, and 24. Figure 23 shows the failure event and posttest pictures of ring 28. Figure 24 shows the contained area of group 3. The residual energy of the fragment leaving ring 28 at the speed of 317 inches per second or 18 miles per hour was approximately 467 in-lbs.

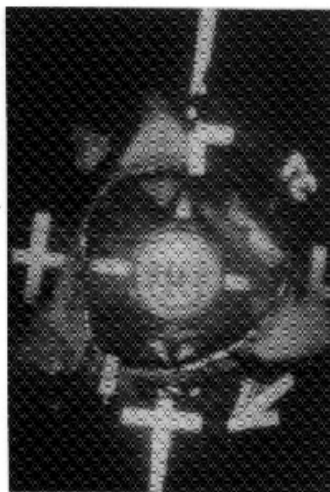
FIGURE 29. FAILURE EVENT OF RING 32

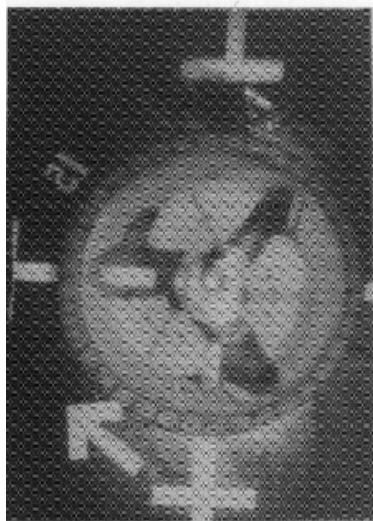
FIGURE 44. FAILURE EVENT OF RING 15
