Burning Behavior Within a Seat Armrest Cavity

September 2002

DOT/FAA/AR-TN02/105

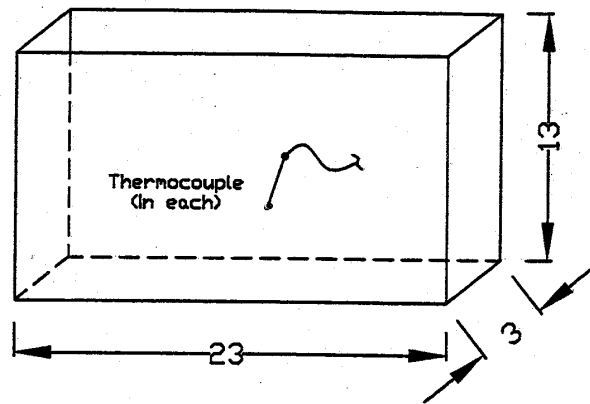
FIGURE 1. OPEN BOX

Test no. 1 used the box without the lid in place (figure 1). The fuel load was one-half sheet of newspaper to create a worst-case scenario. The starting temperature was 70°F, and the maximum temperature reached 265°F as the newspaper burned. Practically all of the newspaper was consumed in the open cavity.

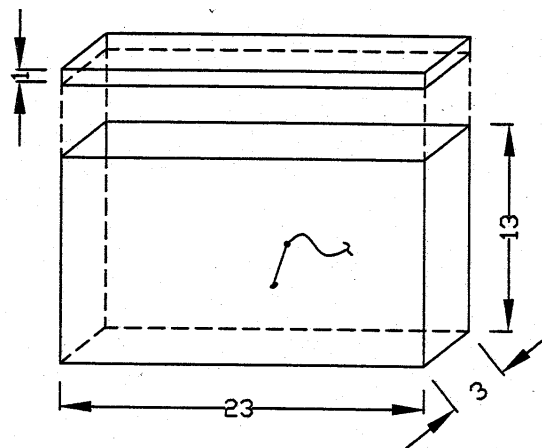
FIGURE 2. BOX WITH LID

Test No. 2: The same scenario as test no. 1 was employed with a lid placed on the box immediately after ignition (figure 2). The starting temperature was 69°F. At 31 seconds, the maximum temperature was 296°F and the fire self-extinguished with only partial burning of the paper. The quantity of paper consumed was significantly less than in test no. 1, likely due to oxygen starvation.

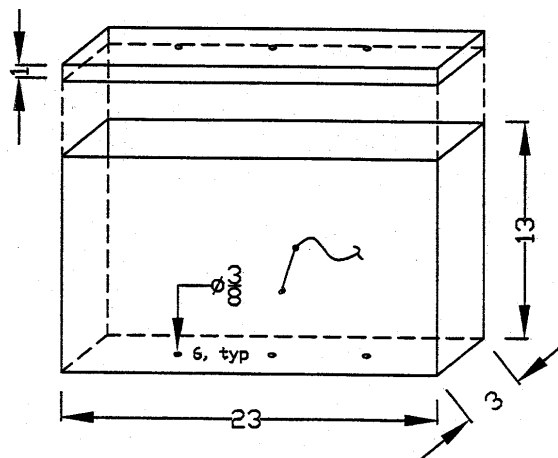
FIGURE 3. BOX WITH LID, HOLES IN BOTH

Test No. 3: The same fire load was used as in test nos. 1 and 2. The box had three 3/8" holes in the lid and three 3/8" holes in the base of the box. This would simulate air leakage into the armrest compartment. The starting temperature was 70°F, and at 13 seconds, the maximum temperature was 276°F. The lid was removed at 1 minute 22 seconds. There was no flaming present. The temperature decreased to 97°F and a considerable amount of unburned paper was still in place.

Test No. 4: The same fire load and the same box with holes in the top and bottom were used as in test 3. The start temperature was 82°F, reaching 390°F at 15 seconds and 254°F at 30 seconds. The lid was removed at 30 seconds, much earlier than in test no. 3 to observe the conditions inside the cavity. A flame-up occurred, indicating oxygen replenishment, and the lid was placed back on the box, extinguishing the fire.

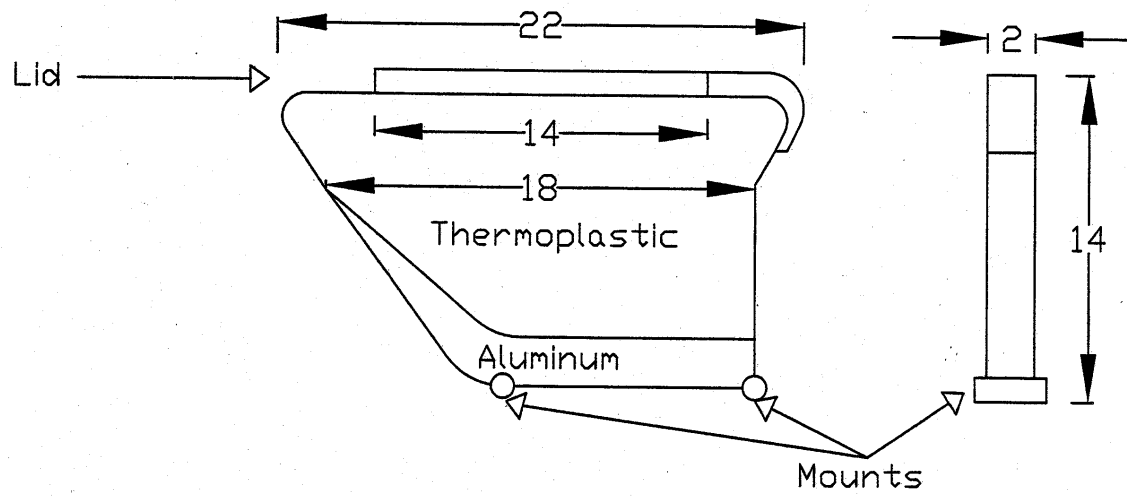
FIGURE 4. TYPICAL ARMREST

ARMREST FROM TRANSPORT AIRPLANE DIRECTORATE (figure 4). Test nos. 9 through 12 were completed using an armrest supplied by the Transport Airplane Directorate with a fabric bag in the bottom of the cavity. The armrest had three 3/8-inch-diameter holes in the inner thermoplastic siding. The inner side had additional exposure which was covered by a fire-resistant cloth bag inside the armrest cavity.

The armrest provided by the Transport Airplane Directorate had a cloth bag in the bottom of the cavity. The bag was fire resistant and sustained virtually no burn damage during the four tests.
