Improvements to Filter Debris Analysis in Aviation Propulsion Systems

DSTO-TR-2773

The accurate analysis of metallic wear debris is fundamental to determining the health of aviation propulsion oil-wetted systems. The oil filter is an excellent source of wear debris, however methods for removing and assessing the debris have traditionally involved tedious visual examination of the filter pleats and manual counting of particles. This report describes two enhanced methods for extracting and assessing filter debris: the first method uses a manual extraction and capture process; the second method uses a commercially available instrument for automatic extraction and quantification.

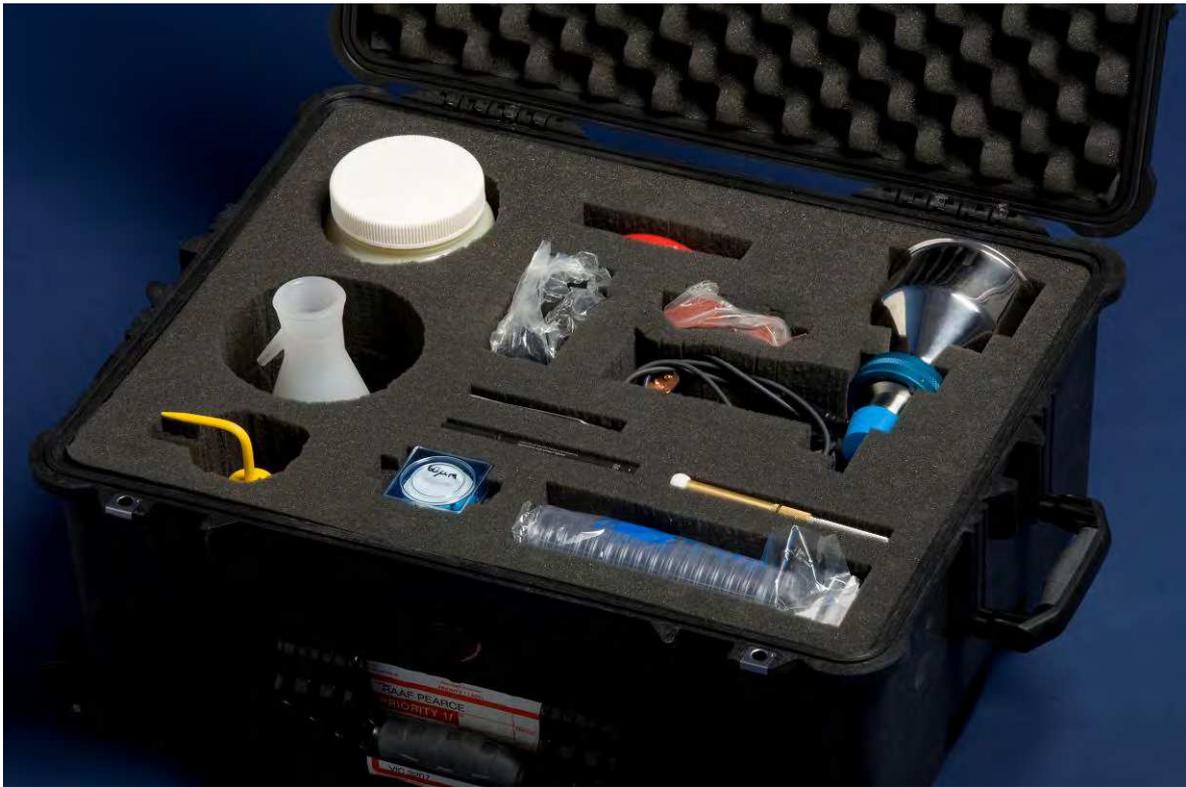
Figure 1: Filter Debris Extraction Kit

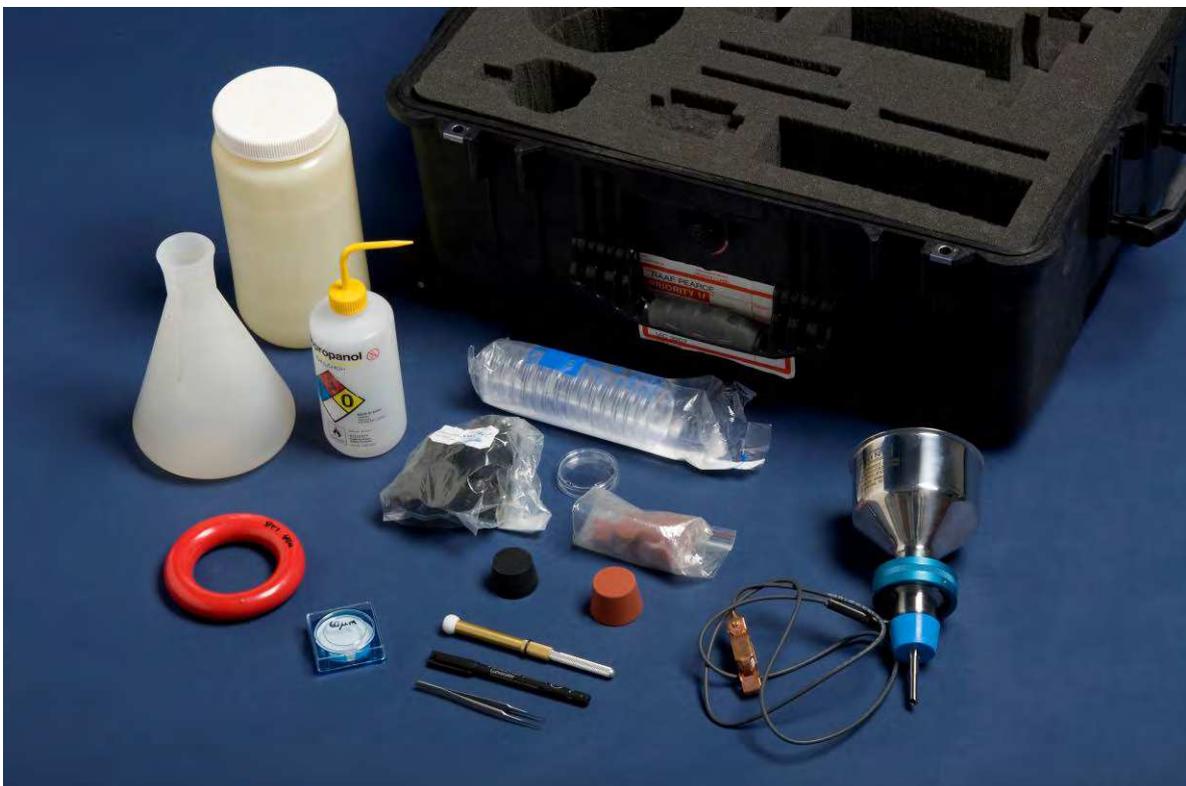
Figure 2: Contents of Filter Debris Extraction Kit

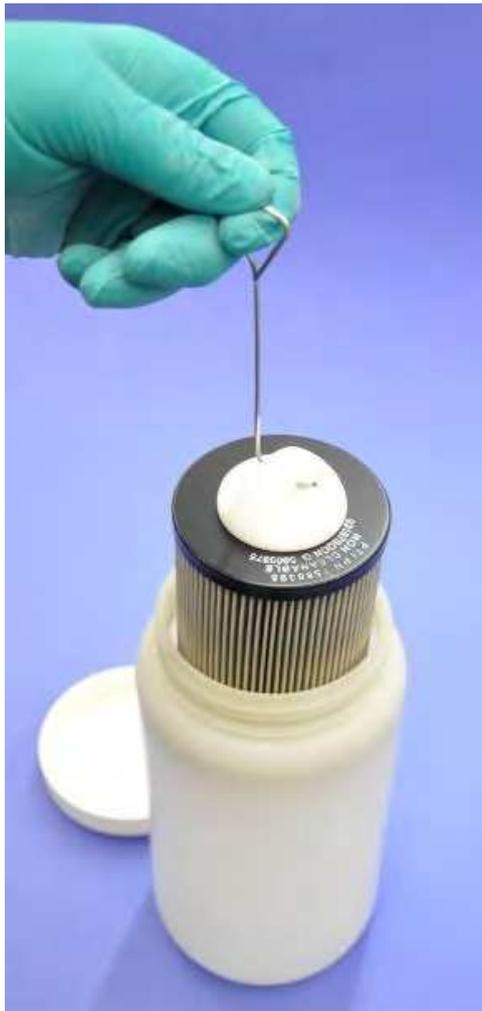
Figure 5: Plugged filter element being lowered into the cylindrical extraction container.

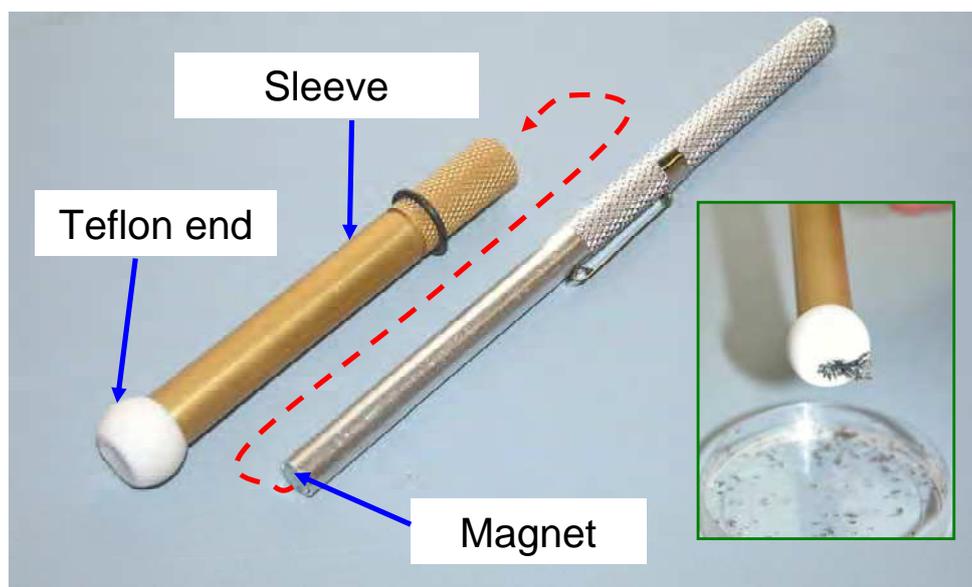
Figure 6: Ferromagnetic debris extraction tool

assembled tool is then held approximately 5 to 10 mm above the filter patch to capture the ferromagnetic debris. Once the ferromagnetic debris has been captured it can be transferred to a separate receptacle for analysis by removing the magnetic probe.

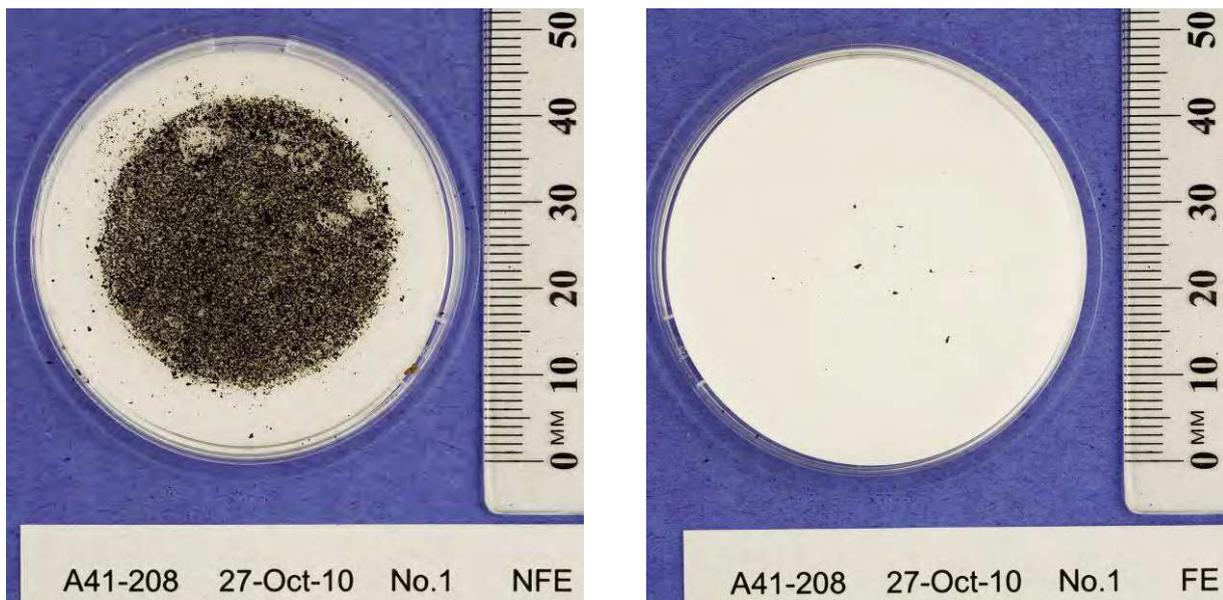
Figure 7: Example of bulk filter debris patch (left) and extracted ferrous debris patch (right)

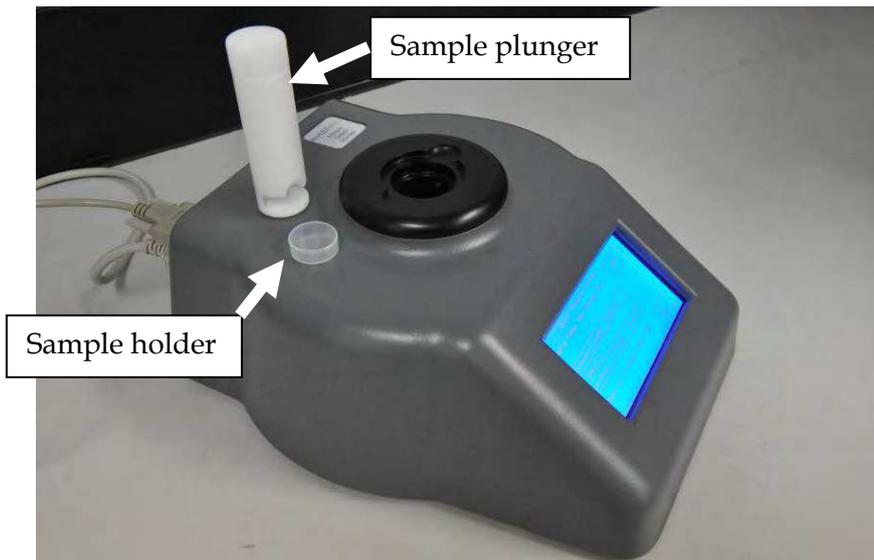
Figure 8: ANALEXfdMplus instrument used to quantify the ferromagnetic debris extracted from the trial filter patches

In order to quantify the ferromagnetic debris an ANALEXfdMplus ferrous debris monitor (manufactured by Kittiwake) was used (Figure 8). This device provides a single numerical value that is proportional to the disturbed magnetic field caused by the bulk debris sample. This technique is quick and convenient to do, however it does not provide any indication about particle size or morphology. This instrument was selected as it represents one of the few modern commercially available ferromagnetic debris quantifying instruments. The application of this instrument was purely to demonstrate what could be done regarding in-field quantification and does not represent an endorsement of this particular product.

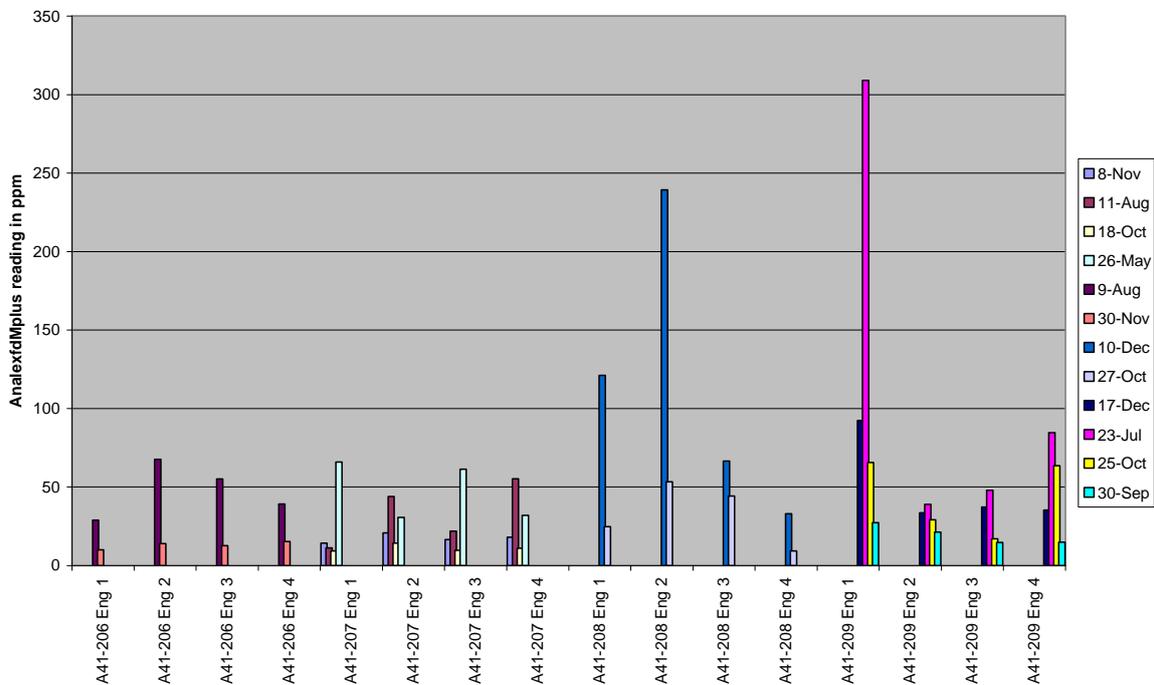
Figure 9: Summary of ferromagnetic debris from all filters analysed during the trial

The ferromagnetic debris that had been extracted from the original filter patch was collected using the ferromagnetic debris extraction tool and placed in a standard 4 mL sample holder used with this instrument. This sample holder was then placed in the sample plunger and then inserted into the instrument to obtain a reading. A minimum of three tests were conducted on each sample and Figure 9 shows the averaged results.

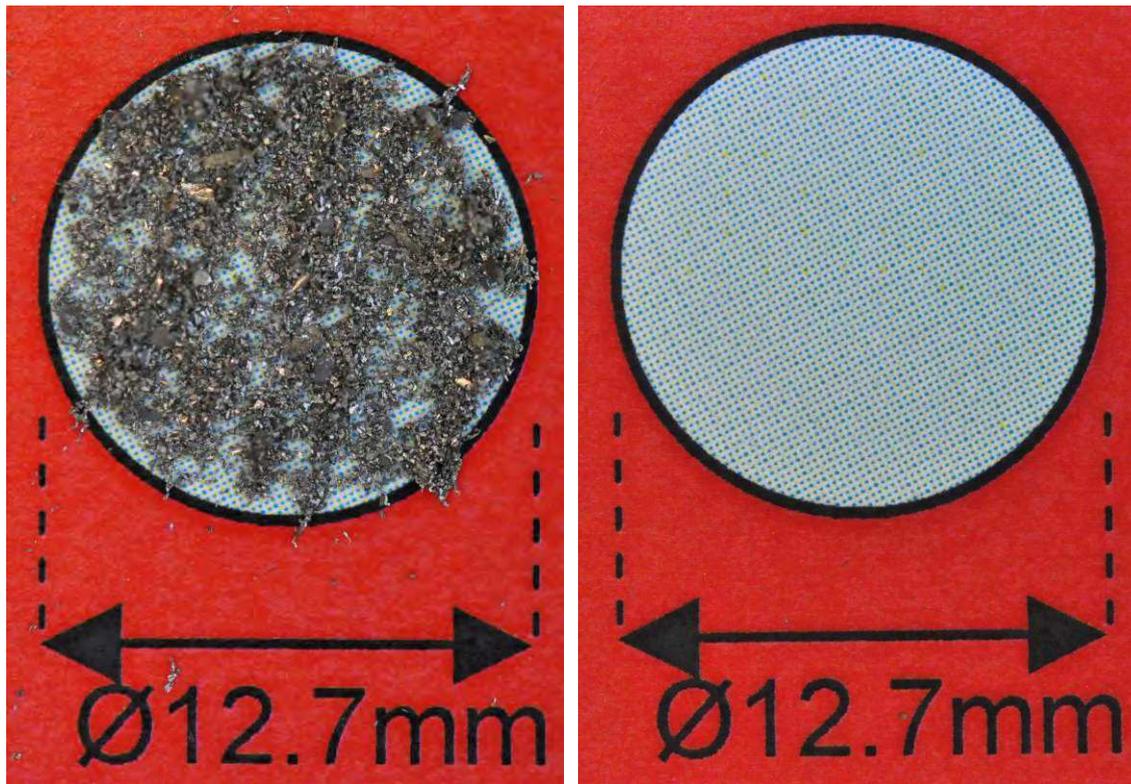
Figure 10: Ferromagnetic debris consistent with F117 limit (left) and template used to determine quantity of debris (right)

1. A quantity of AISI 52100 ferromagnetic debris covering a circular area of diameter 12.7 mm (0.5 inch). This is the stated limit for filter debris in the F117 wear debris guidance [9]. Filters typically capture a far higher total number of particles than chip detectors due to the capture efficiency associated with chip detectors (i.e. the placement and strength of the chip detector will determine this efficiency).

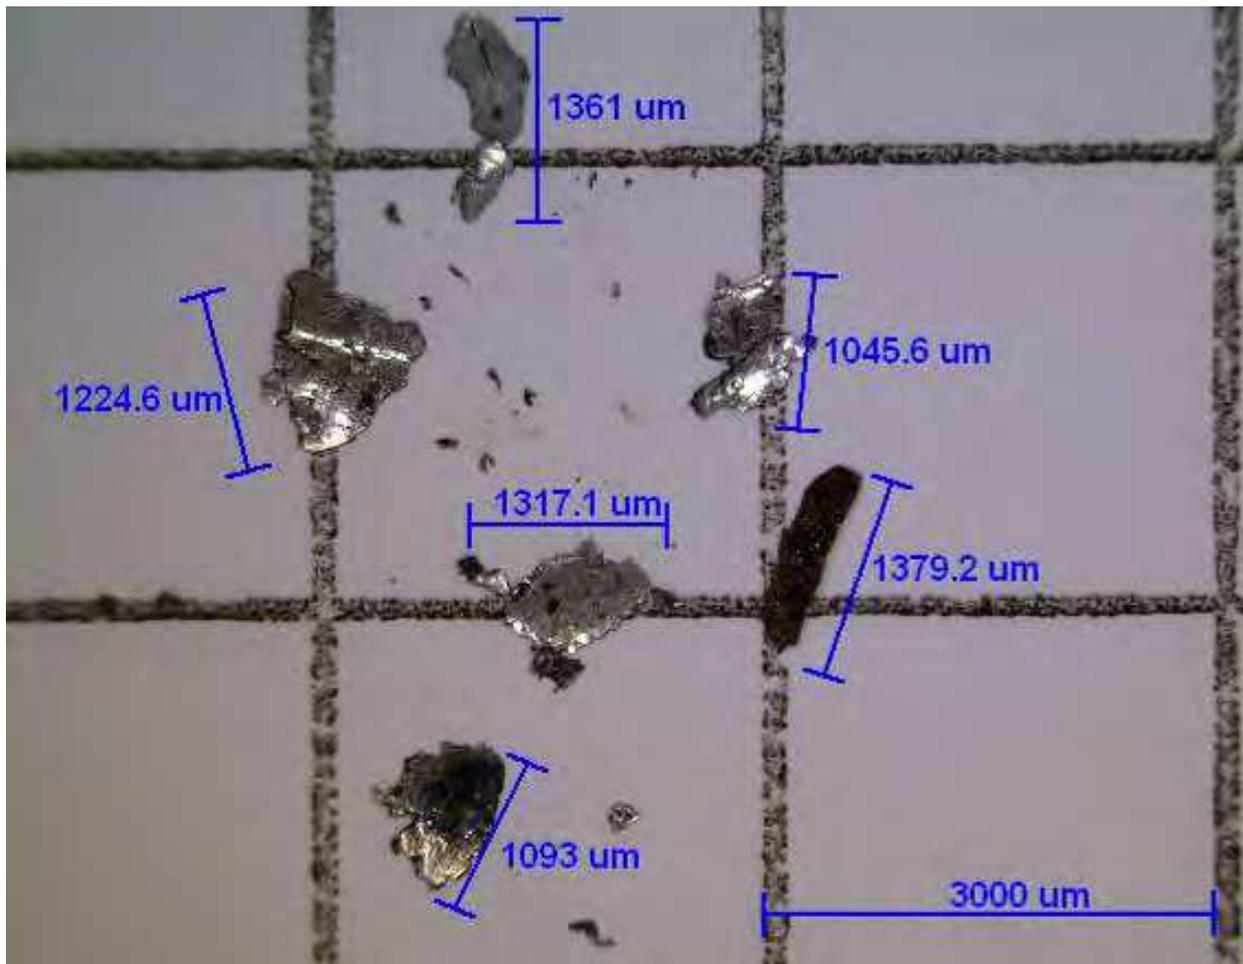
Figure 11: The AISI 52100 bearing steel rolling contact fatigue spalls generated in the DSTO dedicated bearing failure rig used to simulate Condition C debris

2. A sample consisting of 6 small flakes of AISI 52100 bearing material (Figure 11) that was generated by DSTO in a dedicated bearing failure rig. The flakes represent typical rolling contact fatigue wear debris. The quantity is consistent with Condition D stated in the F117 magnetic chip detector wear debris guidance [9, 10].

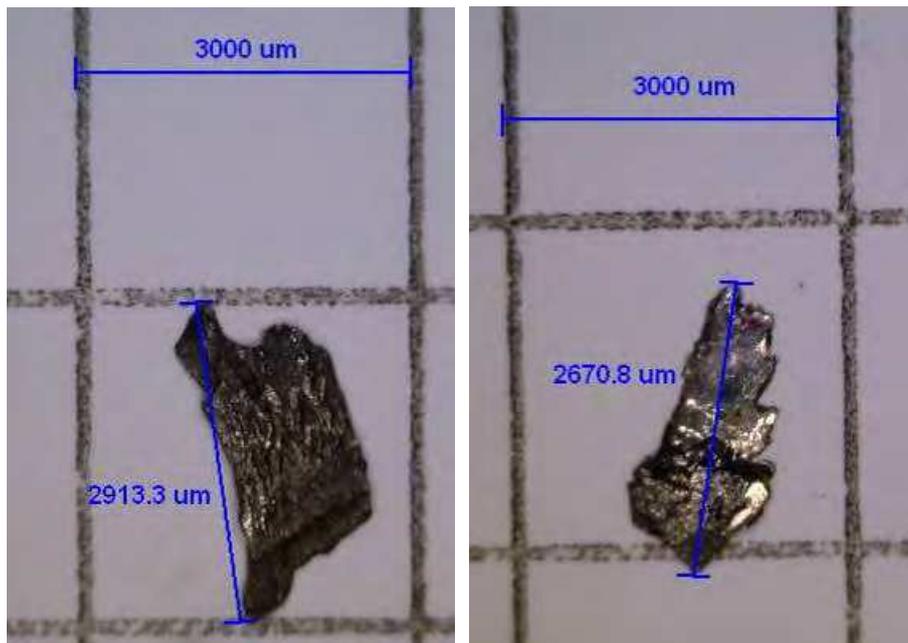
Figure 12: The two large rolling contact fatigue spalls captured from a helicopter gearbox incipient failure and used to simulate the large rolling contact fatigue chips condition for the F117-PW-100

3. A sample consisting of two large spalls of AISI M50 bearing steel (Figure 12) that was captured from a helicopter gearbox incipient failure. These particles are considered to be consistent with the 'chips' classification described in the assessment guidance. They are the type of debris that would be expected to be generated in the latter stages of rolling contact fatigue of rolling element bearings.

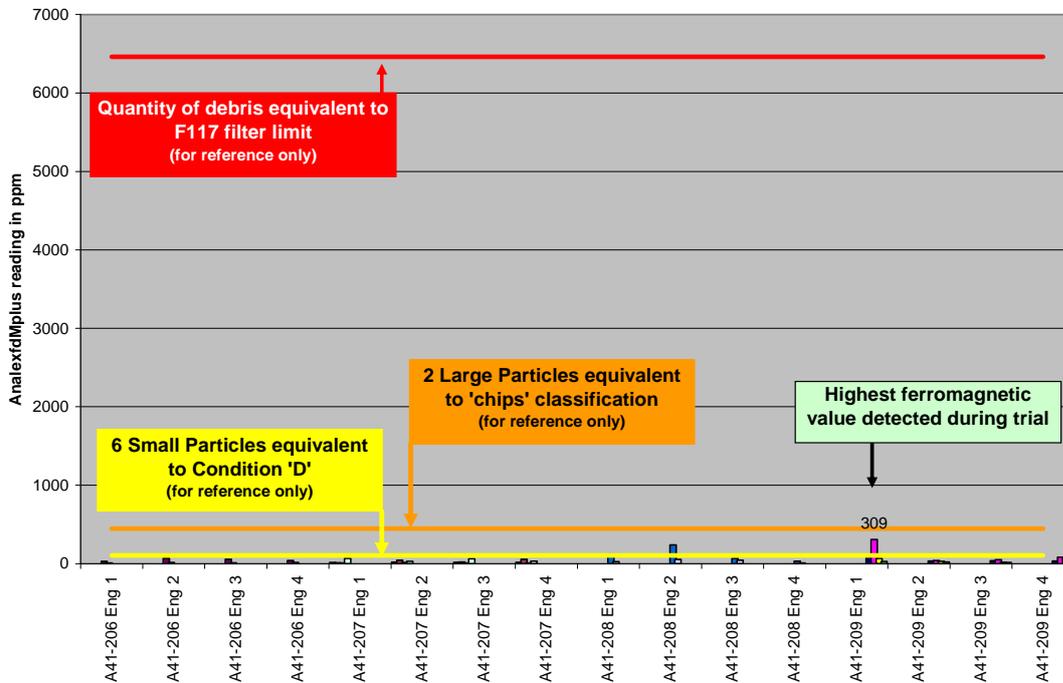
Figure 13: Ferromagnetic debris data with the three additional tests overlaid. The uppermost horizontal bar represents the approximate ferromagnetic debris limit for F117 filter elements

The results of these additional tests are plotted together with the trial results in Figure 13 and demonstrate how little ferromagnetic debris was generated during the trial.

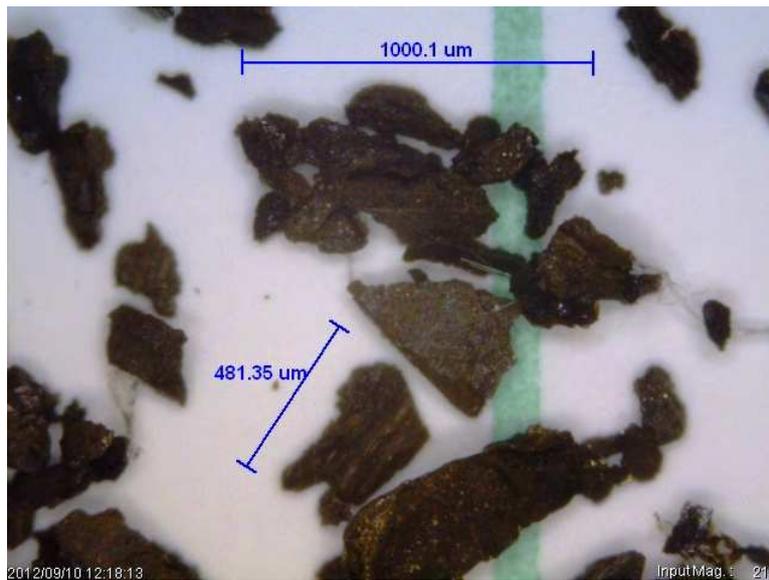
Figure 14: Optical image of the agglomerate particles. The fine ferromagnetic particles are just visible in most particles

The vast majority of debris exhibiting ferromagnetic behaviour was found to be agglomerations consisting of normal carbon-based oil degradation product infused with small (i.e. < 10 microns) ferromagnetic particles consistent with normal engine oil system by-products. The small quantity of ferromagnetic debris provided the magnetic characteristic of the bulk particle. The bulk agglomerate particles were in the 200 to 1000 micron range as shown in Figures 14 and 15. Figure 16 shows a Scanning Electron Microscope (SEM) image of an agglomerate particle showing the bright ferromagnetic debris diffused through the bulk particle. Figure 17 shows the EDS spectrum of one of the metallic particles within the agglomerate particle.

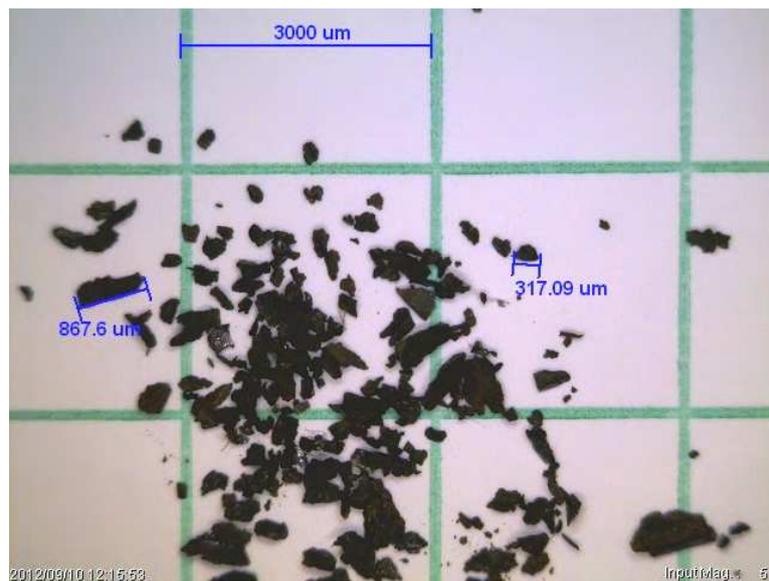
Figure 15: Typical view of the agglomerate material found in all filter patches

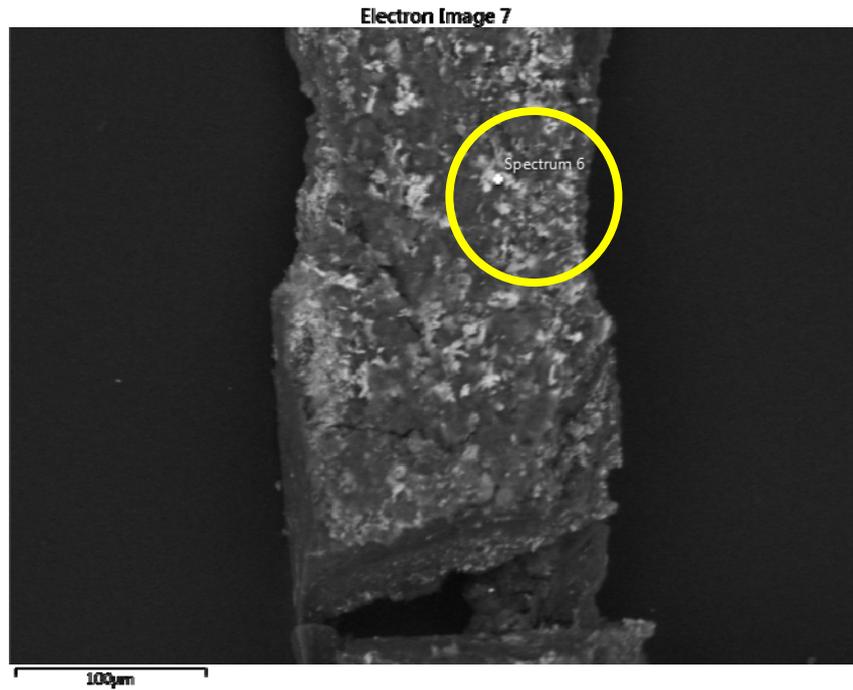
Figure 16: SEM image of an agglomerate particle showing the small ferromagnetic material as bright spots interspersed throughout the bulk particle. Yellow circle indicate the location that the EDS (Figure 16) was taken.

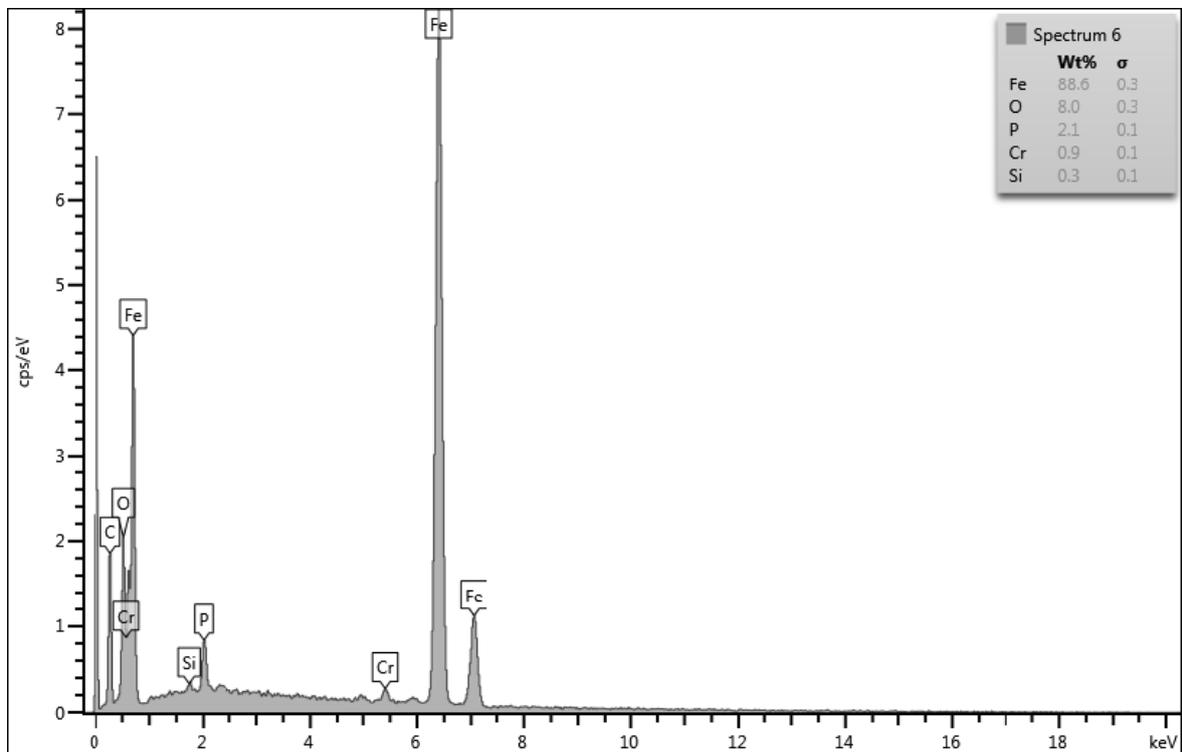
Figure 17: SEM EDS spectrum of the bright spot indicated in Figure 16

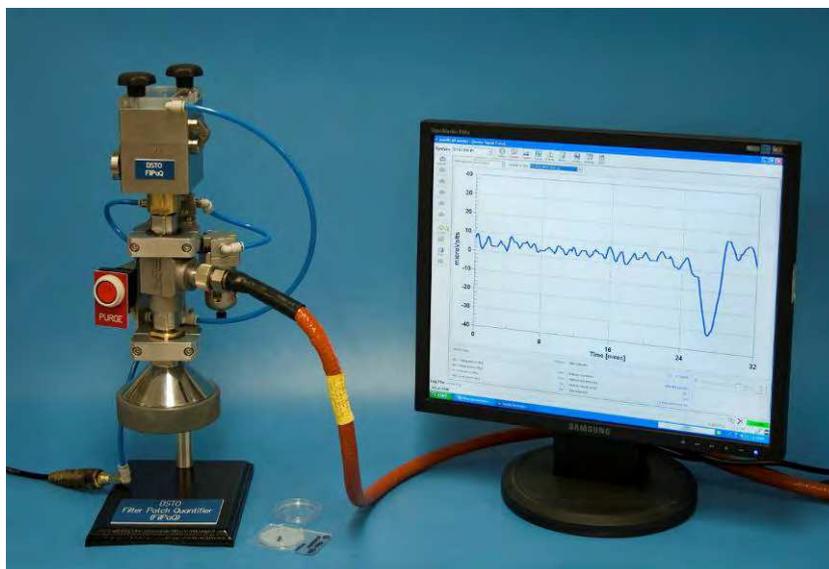
Figure 18: DSTO-designed device for quantifying metallic debris captured on a filter patches

3. DSTO prototype instrument: this instrument was developed to alleviate the tedious manual counting of debris captured on filter patches. The instrument is currently developed to approximately Technology Readiness Level (TRL) 5 and would require commercial assistance to be fielded in the ADF. This instrument is a combination of a commercial inductive sensor and DSTO-designed hardware. The instrument produces a detailed count of metallic debris size and count for particles in the 100-1000 micron range and is shown in Figure 18.

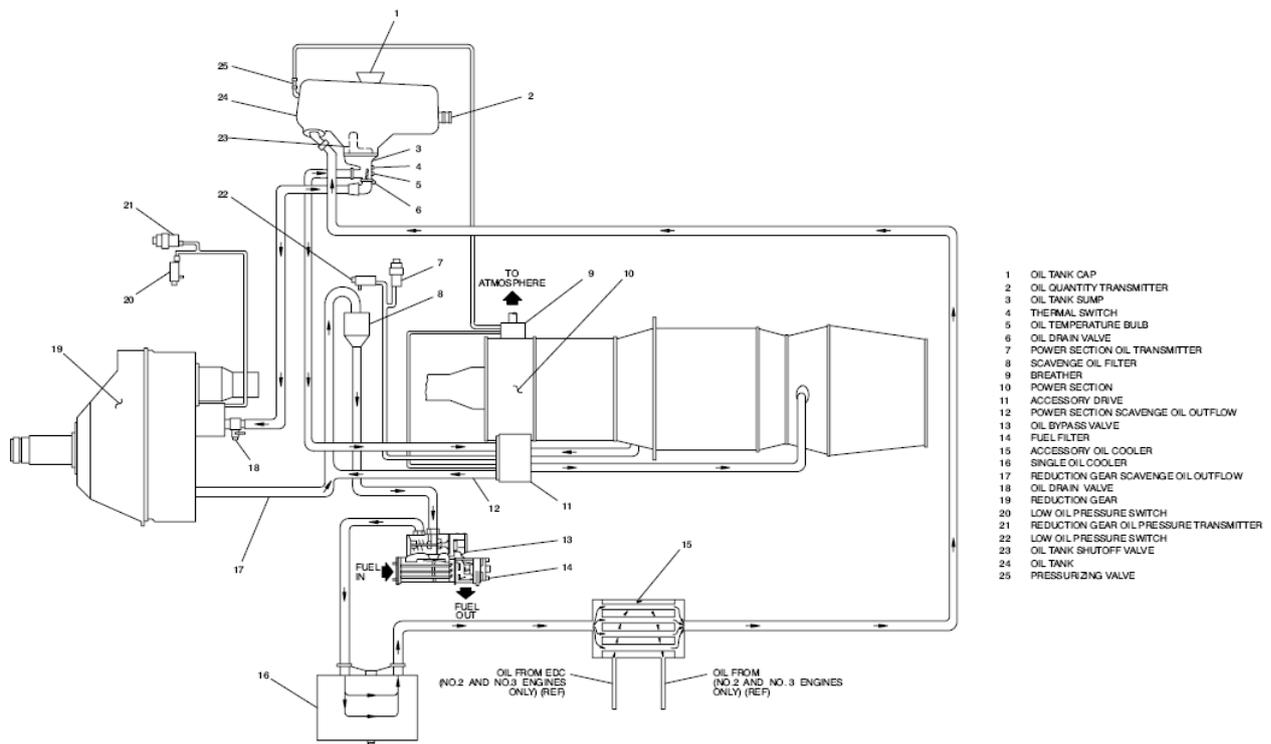
Figure 19: T56-A-14 Oil System Schematic

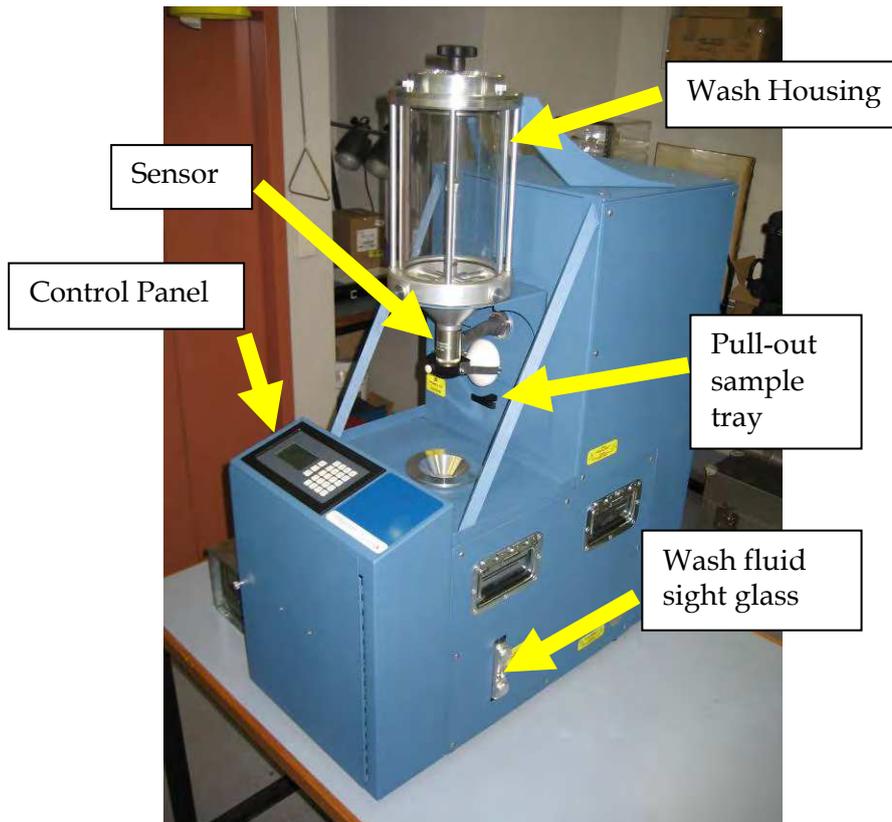
Figure 20: FC290 instrument undergoing assessment by DSTO

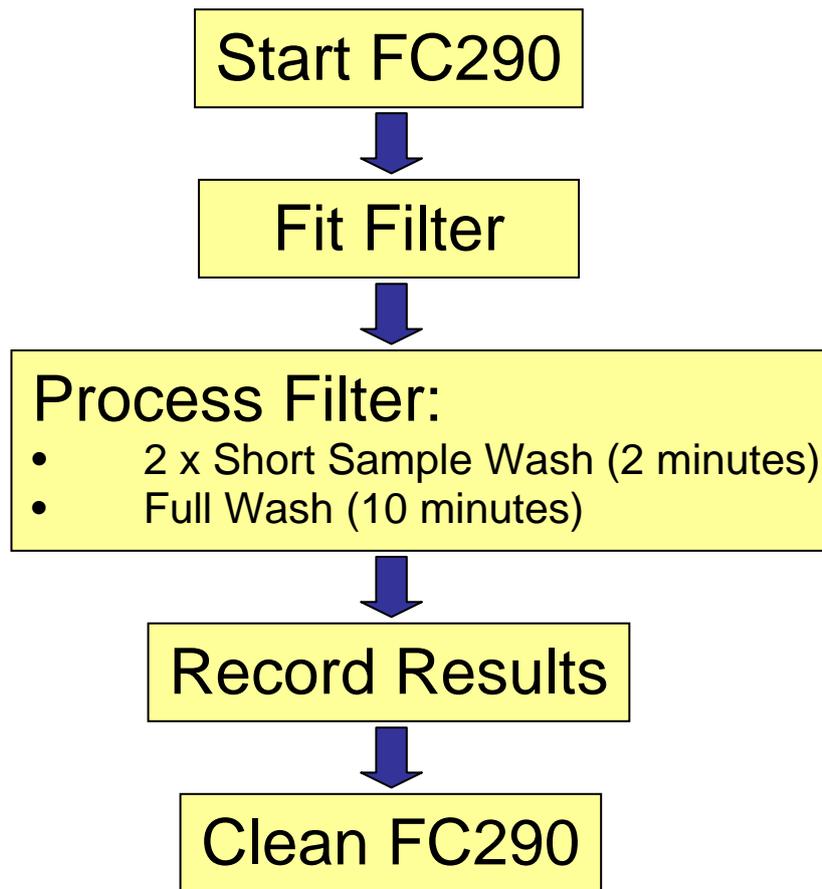
Figure 22: Overview of complete filter debris extraction cycle used by RAAF

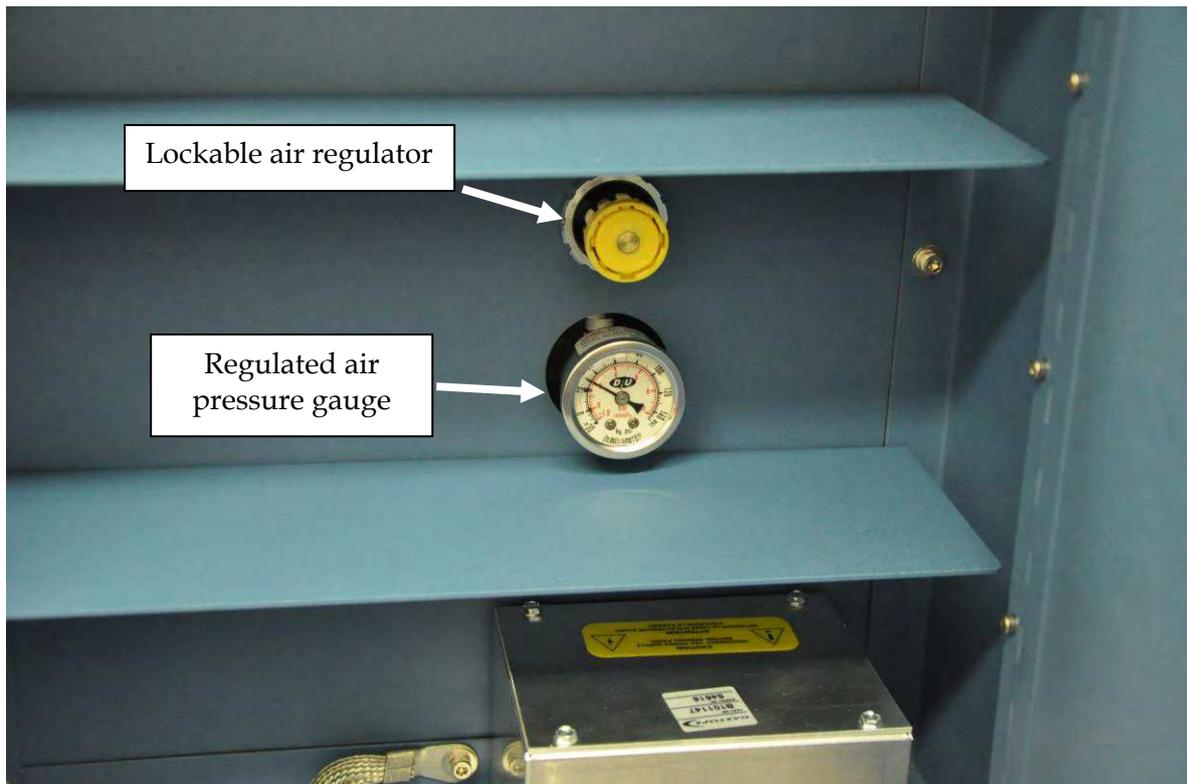
Figure 23: Compressed air regulator and gauge located in front compartment of FC290

The regulated compressed air pressure and the data bin sizes are the two primary settings for this instrument. The compressed air pressure influences how well the debris is extracted from the filter. The pressure was determined by initially setting the pressure at 30 psi (210 kPa) and then increasing the pressure until pulsed fluid was observed to flow from the uppermost part of the filter. This indicated that full extraction was occurring. The compressed air regulator located in the front compartment of the instrument (Figure 23) must be set at 40 psi (280 kPa) to ensure full extraction.

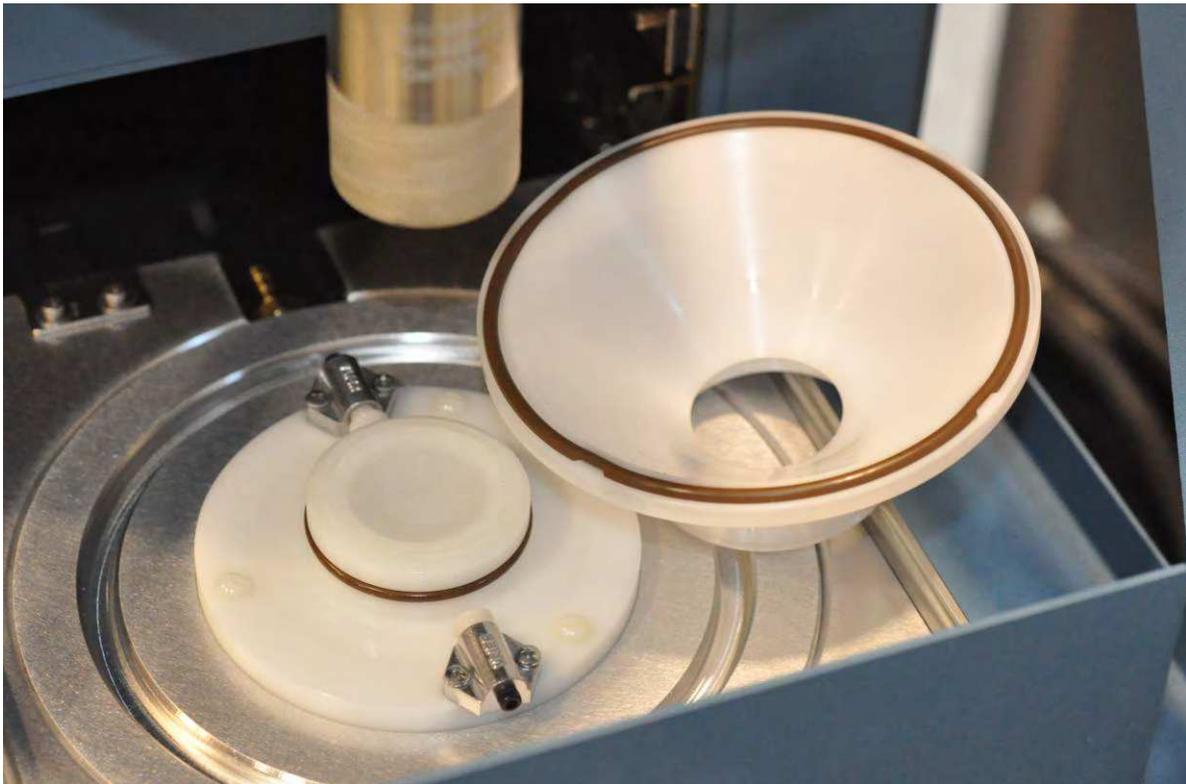
Figure 24: Sample filter patch holder as delivered.

press fit over the base and this was assessed to be insufficiently robust for the expected RAAF usage. Additionally, the filter patch support gauze was considered to be too light-weight for repeated usage. DSTO incorporated a stainless steel filter patch holder manufactured by Millipore that uses a simple cam-lock method of attaching the funnel to the base. This provides a better mechanism for securing the filter patch that is both easier to use and more robust. It is important to note that the use of stainless steel prevents the FC290 models currently owned by ALSPO being upgraded to include the XRF capability, however this upgrade is not anticipated and DSTO recommends the use of external XRF units should that be desired in the future.

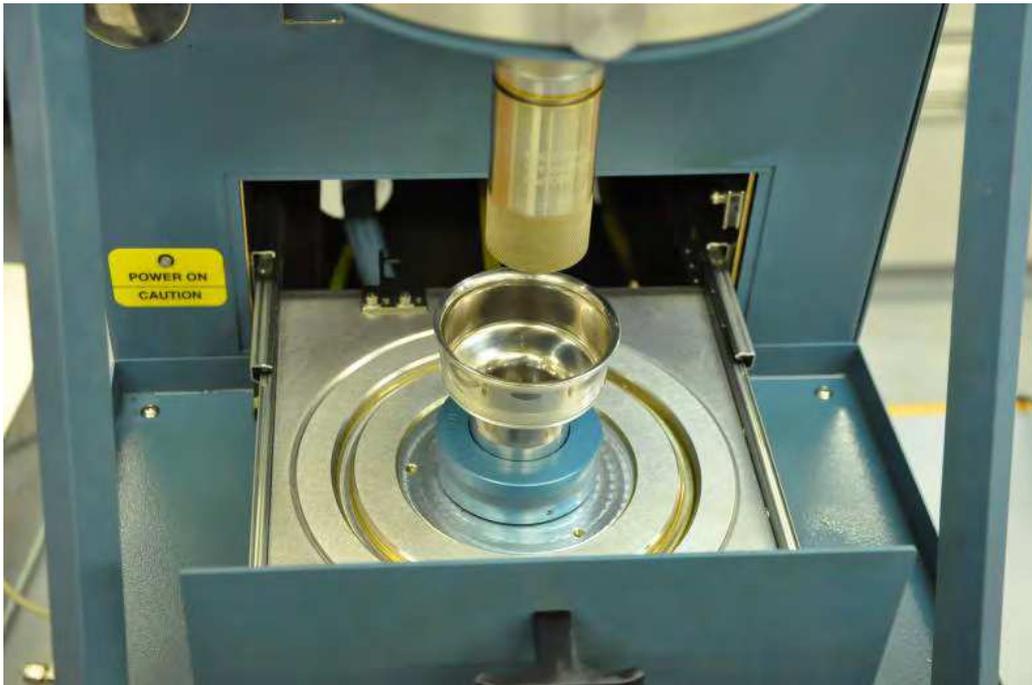
Figure 25: Stainless steel funnel and filter patch holder

Two sizes of funnel were available from Millipore and initially the small version (shown in Figure 25) was trialled. Whilst this size was found to be suitable, the fluid would tend to accumulate in the funnel and in some instances come close to spilling over. The larger size Millipore funnel would not fit under the inductive sensor, therefore approximately 25 mm was removed from the upper portion of the funnel rim.

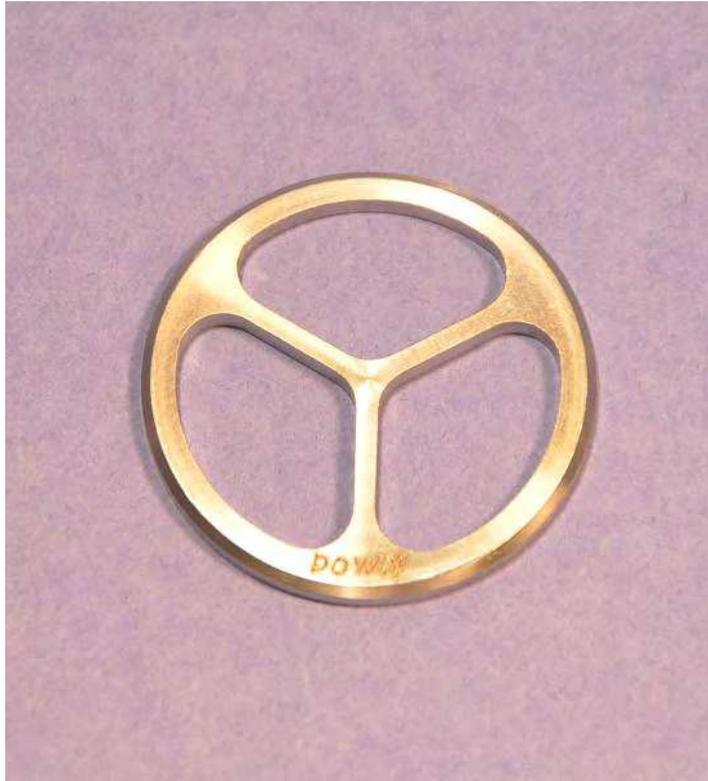
Figure 26: Stainless steel replacement filter patch support

A thin gauze disc is supplied with the FC290 in order to support the filter patch during the sample phase. This item was also assessed as being sufficiently robust to meet the RAAF expected usage and a replacement was made from stainless steel (Figure 26). The cam-locking mechanism of the Millipore funnel enables the nylon filter patch to be locked in place around the periphery of the filter patch. This also allows the supporting ring to be a simple design that minimises resistance to flow of the slurry. The support ring has the word "DOWN" engraved on one side to ensure it is inserted with the bevelled edge facing down and hence allows it and the filter patch to be locked in securely. Appendix F contains details of the support ring.

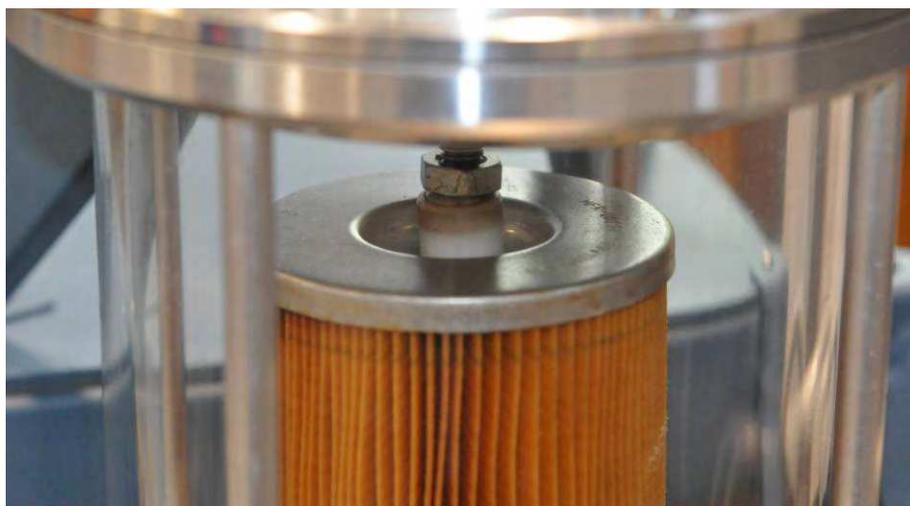
Figure 28: Top of T56 ESF in the FC290 showing the Wash Housing plunger bearing directly onto the solid top of the filter element.

Adapters are required to secure the filter element to the wash housing connection (see Figure 21). Most modern filter elements have an open clean oil exit port at the top and bottom; these type of filters require an upper and lower adapter to ensure the slurry does not re-enter the filter element and result in particles not being detected. The top adapter is completely solid and the lower adapter has an opening to allow it to fit onto the Wash Housing hub and allow the wash fluid and compressed air to enter the bore of the filter element. The T56 external scavenge filter is different to most conventional filter elements in that the bore of the element is only open at one end. This means that the upper adapter is not required for the T56 ESF and the wash housing lid simply bears down on the solid end of the filter element (see Figure 28).

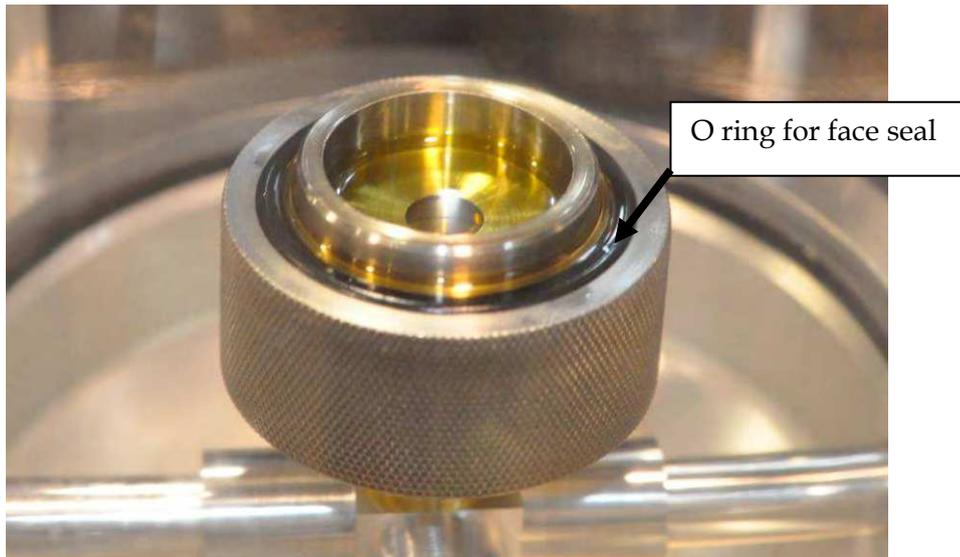
Figure 29: Bottom adapter for the T56 ESF showing o ring for sealing on filter element face.

Due to the design of the T56 ESF, the lower adapter required an O-ring to provide a seal on the lower face of the filter element. Figure 29 shows the adapter and O-ring seal with filter removed for clarity. Figure 30 shows the T56 ESF clean oil opening and face that seals against the O-ring. Adapters were also produced for the AE2100 External Scavenge Filter. The drawings for these adapters appear in Appendix G.

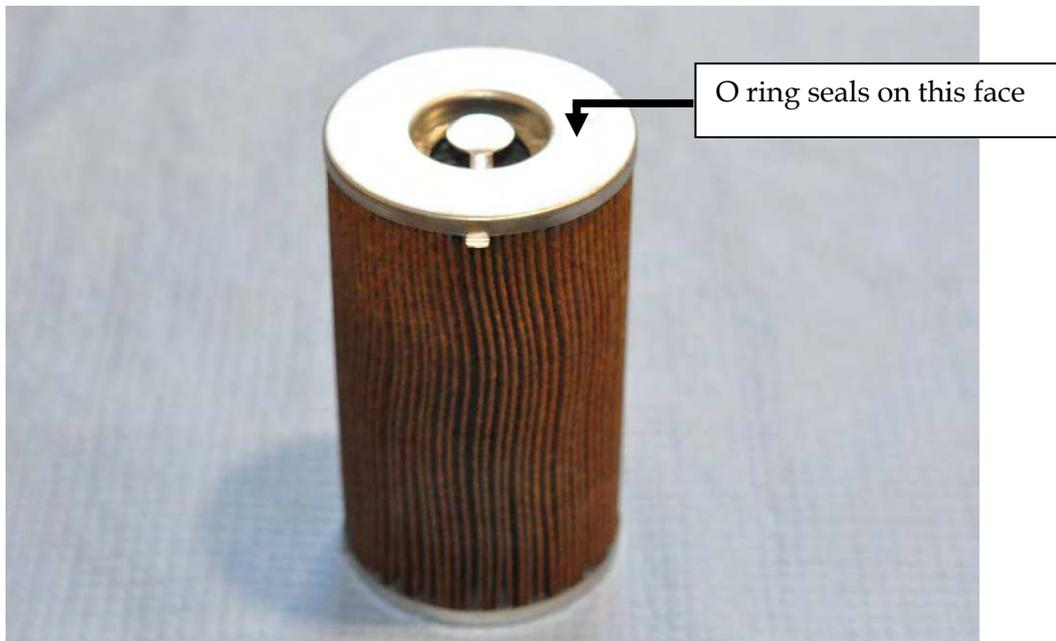
Figure 30: T56 ESF showing clean oil exit port and face that seals on the o ring.

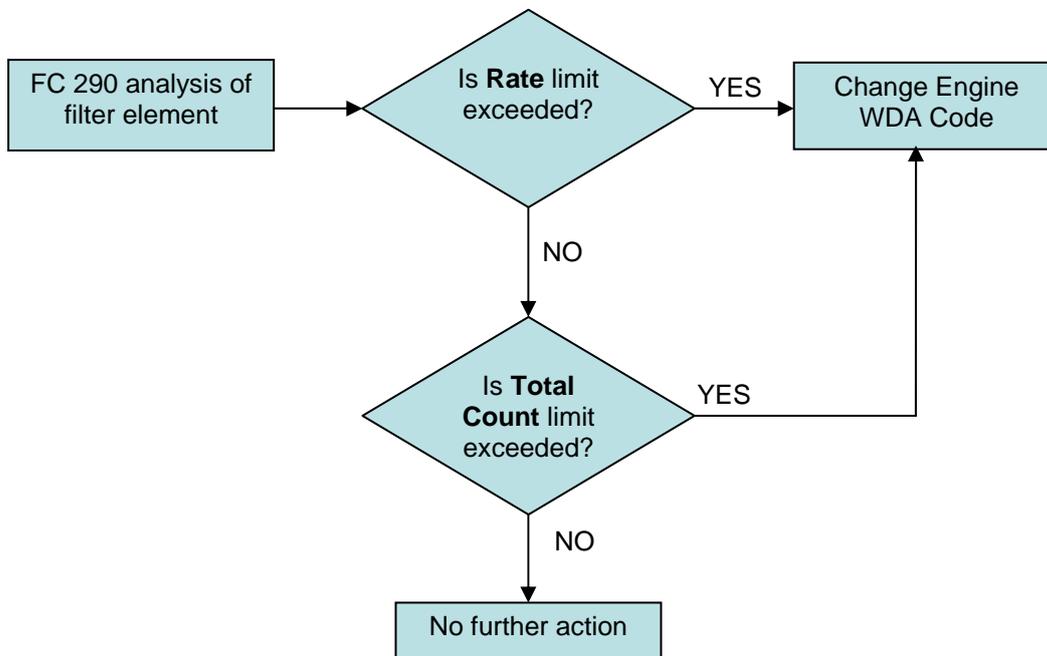
Figure 31: Proposed FC 290 Limit Logic

Traditionally only a count rate limit has been applied to the ESF, however DSTO experience with this sensor indicates that the total Fe count is also a robust way of confirming an incipient failure and augments the Count Rate limit. Therefore in addition to the Count Rate limit (in Fe counts/hour) a Total Counts limit (in Fe Counts) has also been proposed. If either limit is exceeded, then the subject engine Wear Debris Alert Code would change (as per current practice). The associated logic is shown in Figure 31. The procedures and actions defined in the current wear debris program [13, 14] are unaffected by these new limits. The proposed FC 290 limits are intended to replace the extant wear debris rate limits for the External Scavenge Filter (both engine variants) [13, 14].
