Improvements to Filter Debris Analysis in Aviation Propulsion Systems

DSTO-TR-2773

The accurate analysis of metallic wear debris is fundamental to determining the health of aviation propulsion oil-wetted systems. The oil filter is an excellent source of wear debris, however methods for removing and assessing the debris have traditionally involved tedious visual examination of the filter pleats and manual counting of particles. This report describes two enhanced methods for extracting and assessing filter debris: the first method uses a manual extraction and capture process; the second method uses a commercially available instrument for automatic extraction and quantification.

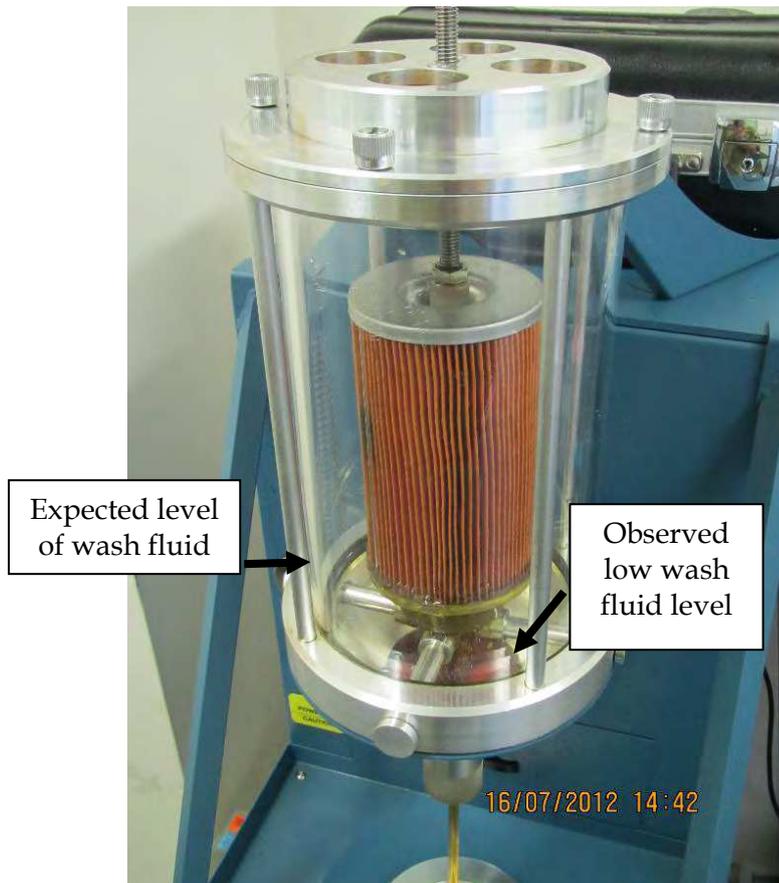
Figure 32: FC290 in operation showing abnormally low fluid level during Wash Cycle. Expected level also indicated.

During the trial of the FC290 crazing of the wash housing was identified by operators along with an abnormally low level of wash fluid in the wash housing during the processing of filters (Figure 32). A further symptom was the pooling of wash fluid on top of the mist filter which is fitted to the wash housing lid assembly (Figure 33). After initial troubleshooting by the operators and discussions with the OEM, it was determined that the mist filter had become blocked and subsequently caused an artificially high pressure in the wash housing; this had also caused the low wash fluid level. The blocking of the mist filter with wash fluid was not categorically determined, however it was likely to have been caused by the regulated air pressure which had initially been set at 60 psi (420 kPa). The regulated air pressure was subsequently reviewed and was lowered to 40 psi (280 kPa) following testing by RAAF operators. Initially crazing observed on the wash housing wall (Figure 34) was thought to be related, however further advice from the OEM suggested it was benign wear and tear. The mist filters will be replaced on condition (based on observed pooling of fluid on the mist filter) to avoid further issues.

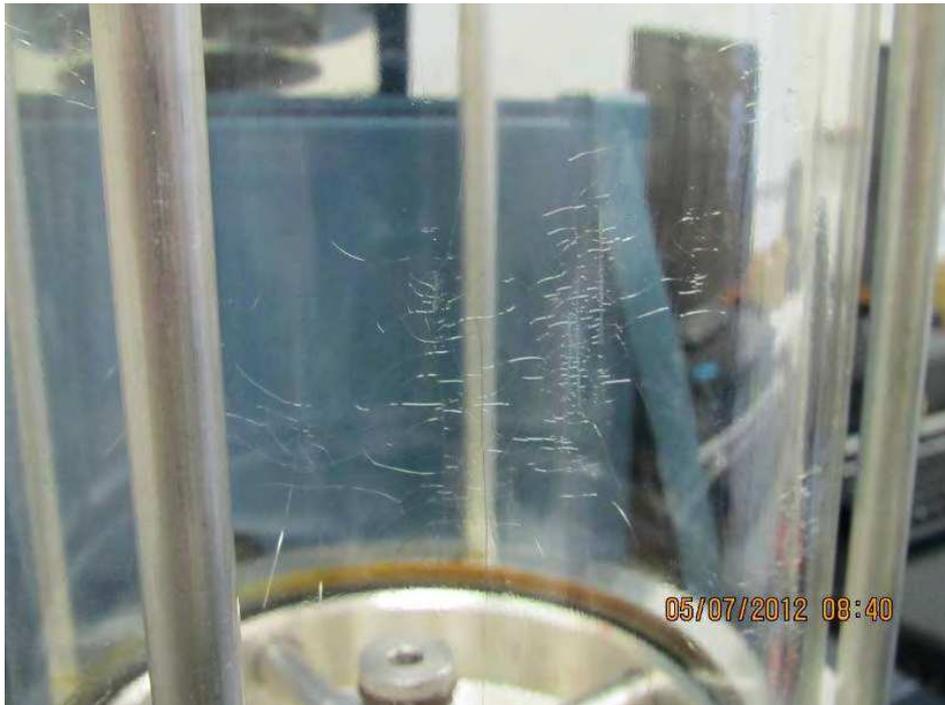
Figure 34: Wash Housing showing crazing

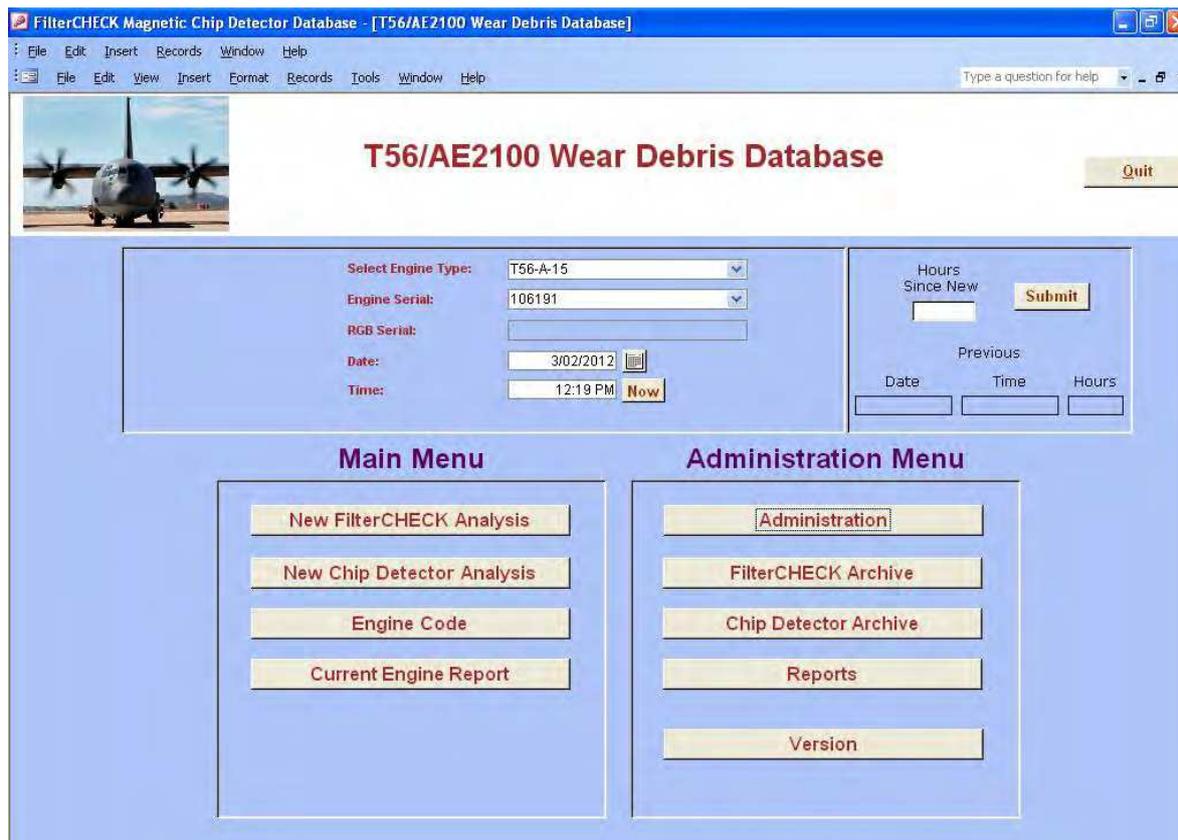
Figure 35: Main Introductory Screen of Wear Debris database

A dedicated database was developed to enable all wear debris analysis (i.e. filter and magnetic chip detector data) to be housed in the one location and allow automatic downloading from the instrument. The database followed a logical work flow for input of data from magnetic chip detectors and FC290 results. Figure 35 shows the main introductory screen for the database. The database was created to run with Microsoft Access 2003 and was developed to a point where it operated on a stand alone computer.

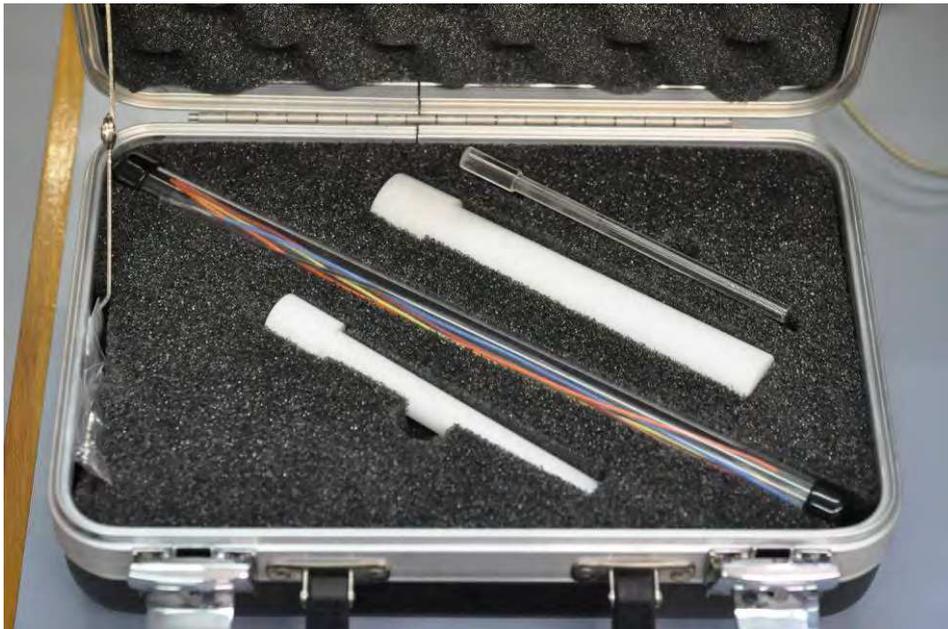
Figure 36: MetalSCAN Performance Test Kit

The FC290 manual does not specify any routine calibration of the FC290 [15] and this was specifically confirmed with the OEM. However, DSTO recommend that the performance of the FC290 sensor be routinely checked to ensure accurate operation. This can be easily achieved in-situ using the MetalSCAN Performance Test kit (Figure 36) that has been provided by DSTO with both RAAF FC290 instruments. MetalSCAN is the name of the sensor used in the FC 290. The test kit contains five colour-coded test straws each containing a spherical particle of known size and composition (Table 11, Figure 37). Each straw is passed through the sensor (Figure 38) to confirm that the sensor identifies the particle and that the particle is recorded in the appropriate size bin. The straw must be inserted and retrieved from the lower sensor port due to lack of access to the upper port; this means that for every insertion two particles should register (one for the upward pass and one for the retrieval pass). The sensor is sensitive to the velocity of the particle and several attempts are usually required to ascertain a suitable straw velocity. As the size bins are not specifically used in the RAAF T56 application, the particle detection (i.e. count) is all that is required. If the instrument fails the in-situ performance check then the OEM must be notified for corrective action (note that there is currently no agent for this equipment in Australia). Appendix L contains a pro-forma developed to aid the performance check process.

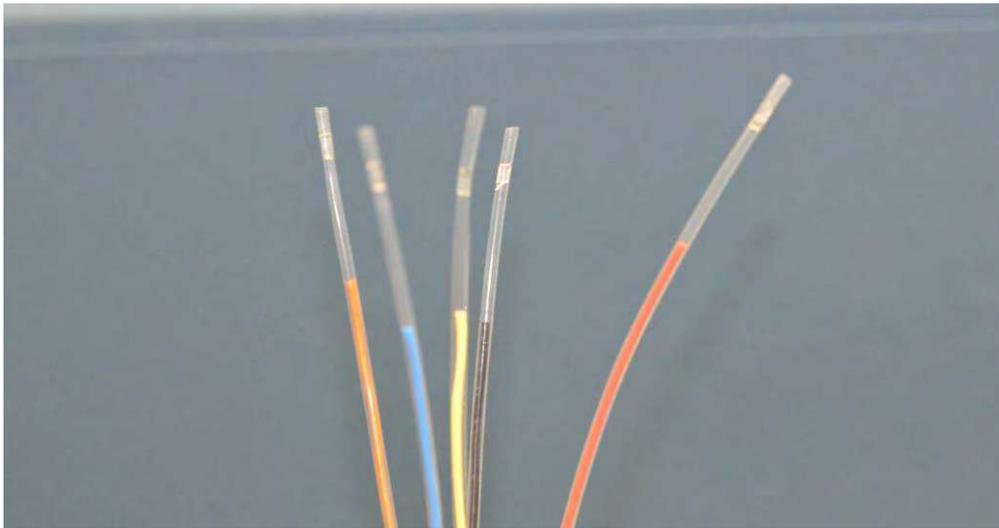
Figure 37: Test straws showing embedded particles of known size

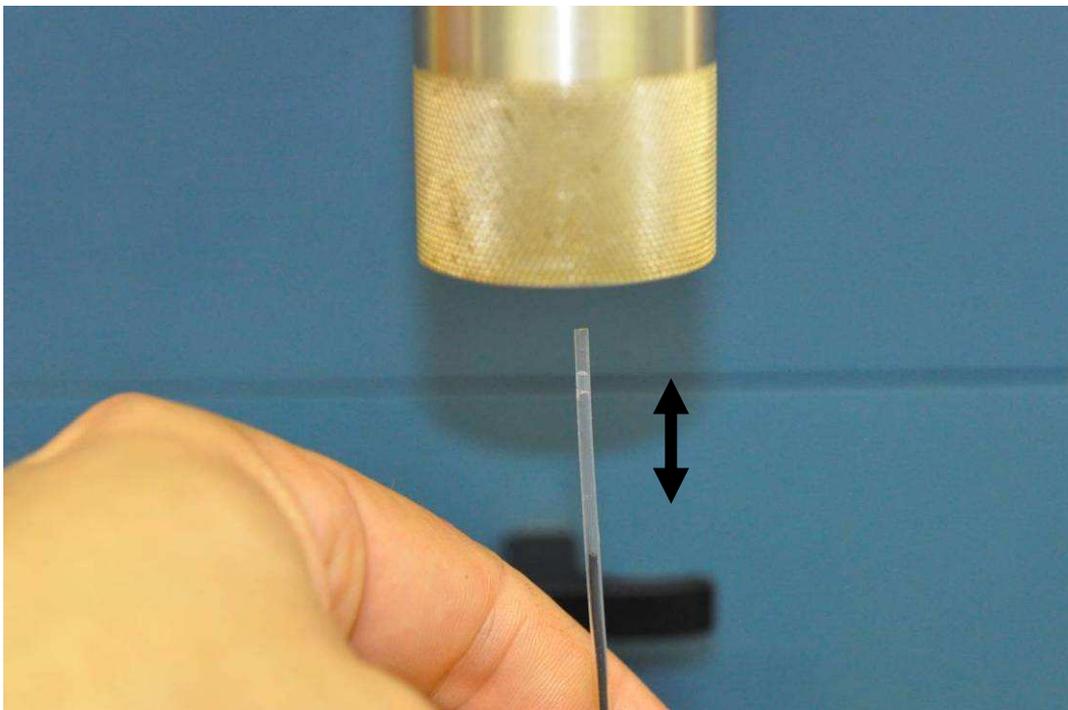
Figure 38: Inserting test straw into FC290 sensor
