# RESEARCH MEMORANDUM

BUFFETING OF EXTERNAL FUEL TANKS AT HIGH SPEEDS

ON A GRUMMAN F7F-3 AIRPLANE

By Howard L. Turner

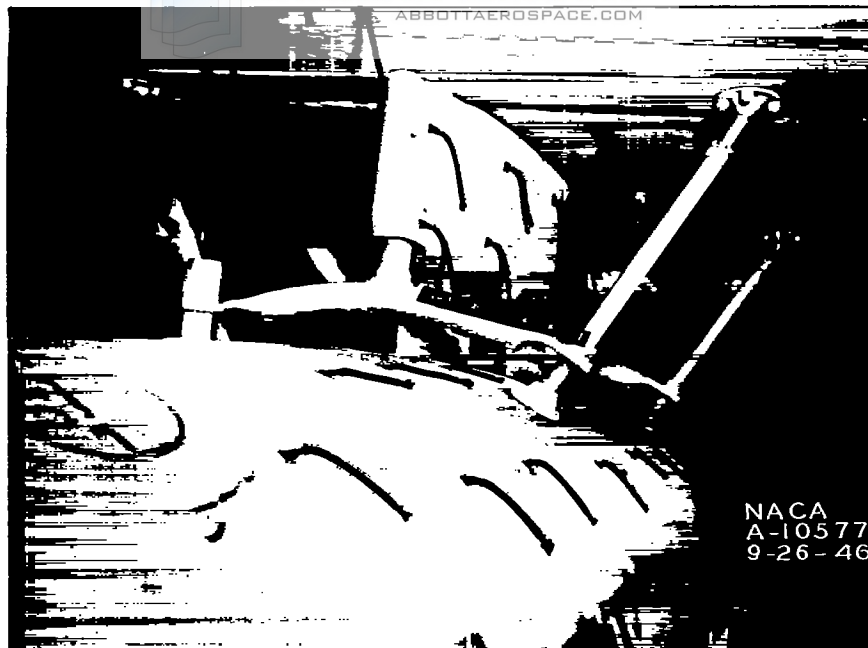
Figure 5.- Wing position, sway brace,  
configuration 3.

Note: Pylon access hole, shown open in figure 4 was closed during flight tests.
3. Service-type sway brace - modified (fig. 5)
  - (a) Round service-type sway braces with rubber on the bottom of the sway brace pads
  - (b) Round auxiliary sway braces
  - (c) Adjustment screws and auxiliary braces torqued to exert a force of 9000 pounds per sway brace on tank

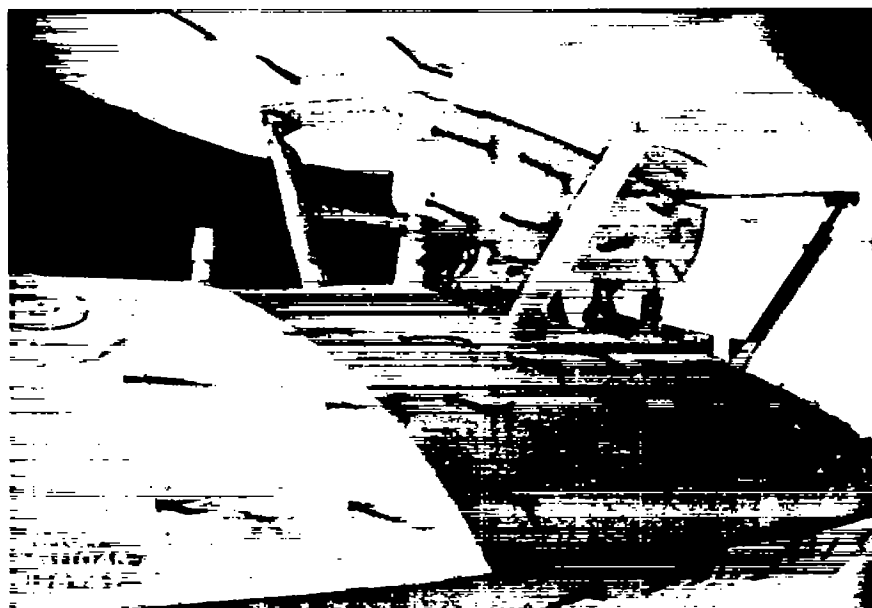
(a)  $M \approx 0.246$

(b)  $M \approx 0.640$

Figure 8.- Tuft study of auxiliary fuel tank in flight at various Mach numbers, wing position, Grumman F7F-3 airplane.

Tuft studies.-- Tuft studies were used to determine the flow around the tanks in the wing and fuselage positions. Figure 8 shows two enlargements from 35-millimeter photographs of the tuft action around the tank and pylon fairings of the wing tank position, sway brace configuration 1. Figure 8(a) indicates the tuft action at low speed ( $M=0.246$ ). Figure 8(b) indicates tuft action at a Mach number of approximately 0.64 during severe buffeting conditions.
