VIBRATION OF TURBINE BLADES IN A
TURBOJET ENGINE DURING OPERATION

By W. C. Morgan, R. H. Kemp
and S. S. Manson

April 22, 1948

NACA RM No. E7L18

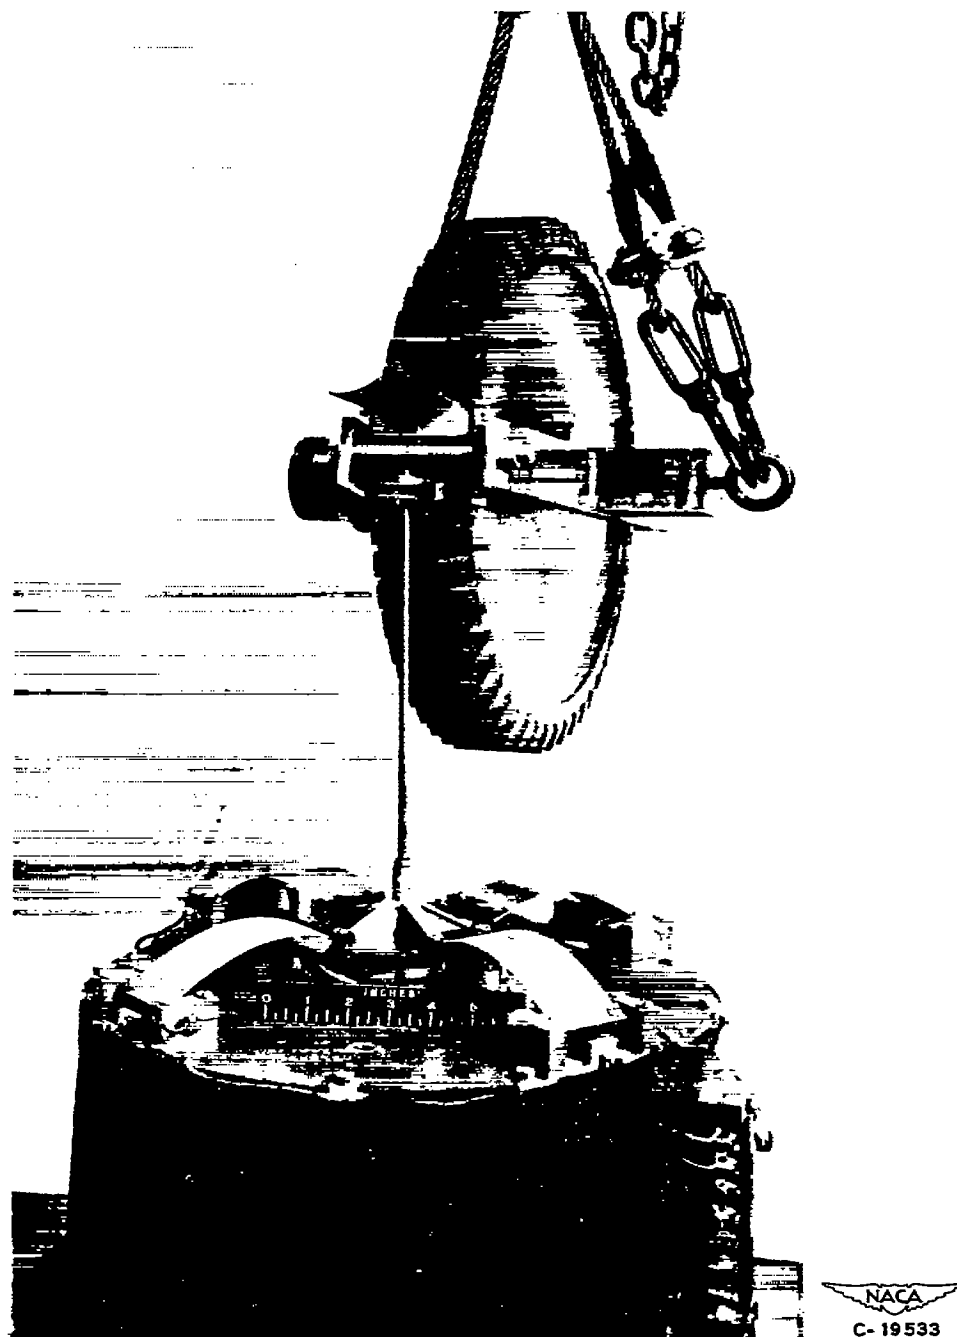
Figure 1. - Excitation equipment used in determination of nodes in turbine blade during various natural vibration modes.

Modes of vibration. - The nodal patterns in the various natural modes of vibration were determined by preliminary bench tests on a blade similar to those used in the dynamic investigations. In producing these patterns, the blade was inserted in a turbine disk with a tight fit in order to approximate the rigidity in a completely bladed wheel; vibration was excited by a speaker-type unit of variable frequency. In order to avoid mechanical damping or restraint of the blade, the excitation force was transmitted through a steel rod attached to a stub blade adjacent to the test blade in

the turbine disk. The turbine disk was suspended in a sling above the exciter (fig. 1).

The excitation frequency was varied until resonance was observed by means of a crystal pickup. Location of the nodes was accomplished by moving the needle point of the pickup device along the lines of a grid drawn on the concave face of the blade until an oscilloscope signal indicated a minimum amplitude. Location of a sufficient number of such points was recorded to establish the location of the nodes for each of the resonant frequencies.

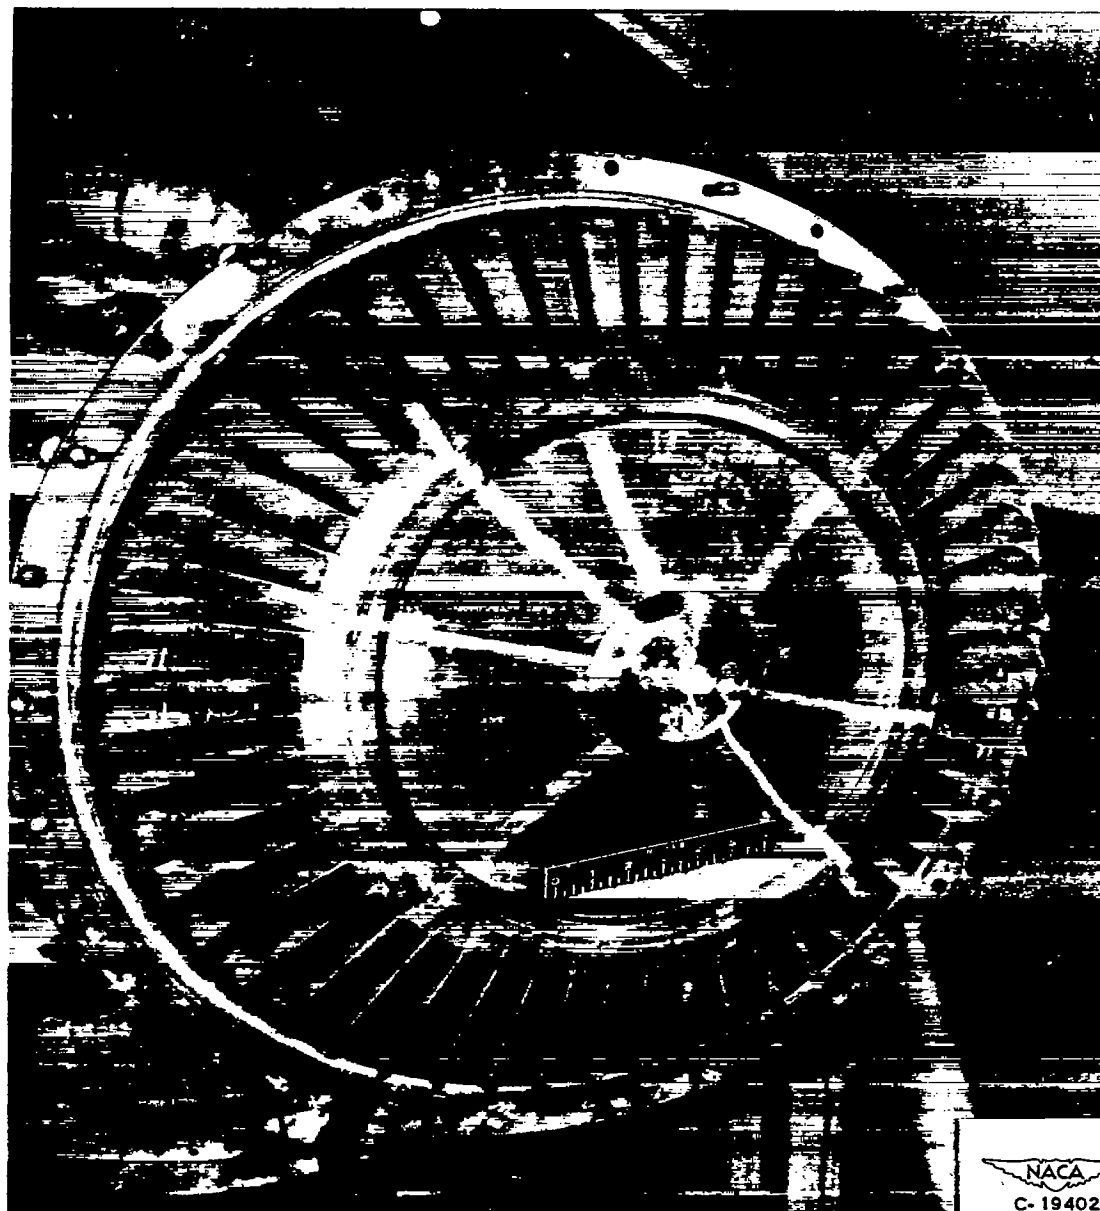
Figure 2. - Installation of high-temperature strain gages on turbine blades showing location of blades and lead wires.

The instrumented blades were inserted in the turbine wheel, the lead wires cemented to the rear face of the turbine rotor, and the lead-wire cement baked by radiation from infrared lamps. The lead wires were connected to a circular terminal block at the center of the turbine wheel (fig. 2).

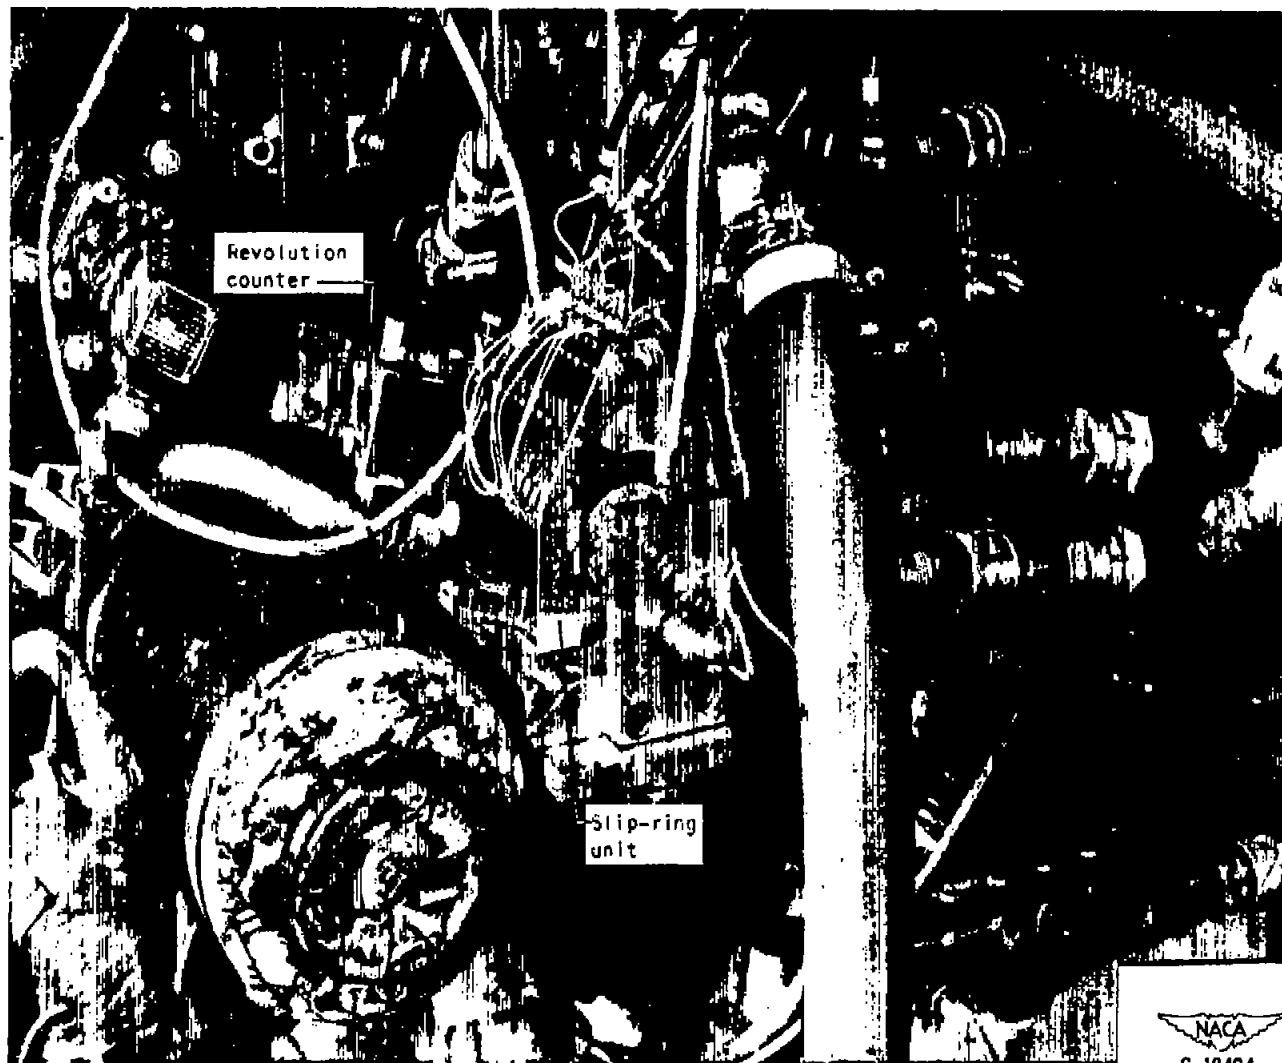
NACA
C-19404
8-20-47

Figure 3. - Slip-ring unit for transmittal of turbine-blade strain-gage signal to stationary instrumentation.

Several components of the engine were modified in order to provide passage of the lead wires from the strain gages to the slip rings necessary for transmittal of strain-gage signals to stationary observation and recording instrumentation. The principal modifications consisted of axial passages bored through the turbine wheel, the compressor, and the shafts connecting these components. A hollow auxiliary shaft, connected to the compressor, extended through the accessory housing on the forward end of the turbojet engine to provide a connection to the slip-ring unit on the accessory housing (fig. 3). A magnetic revolution counter, which

also appears in figure 3, was used in order to provide a more accurate determination of turbine speed than could be obtained with the standard turbojet tachometer.

The slip-ring unit was of the cylindrical type with all rings of the same diameter. The strain-gage signals were transmitted through brushes mounted at an angle to the radii in the plane of each slip ring. The slip rings were monel metal and the brushes were silver graphite.

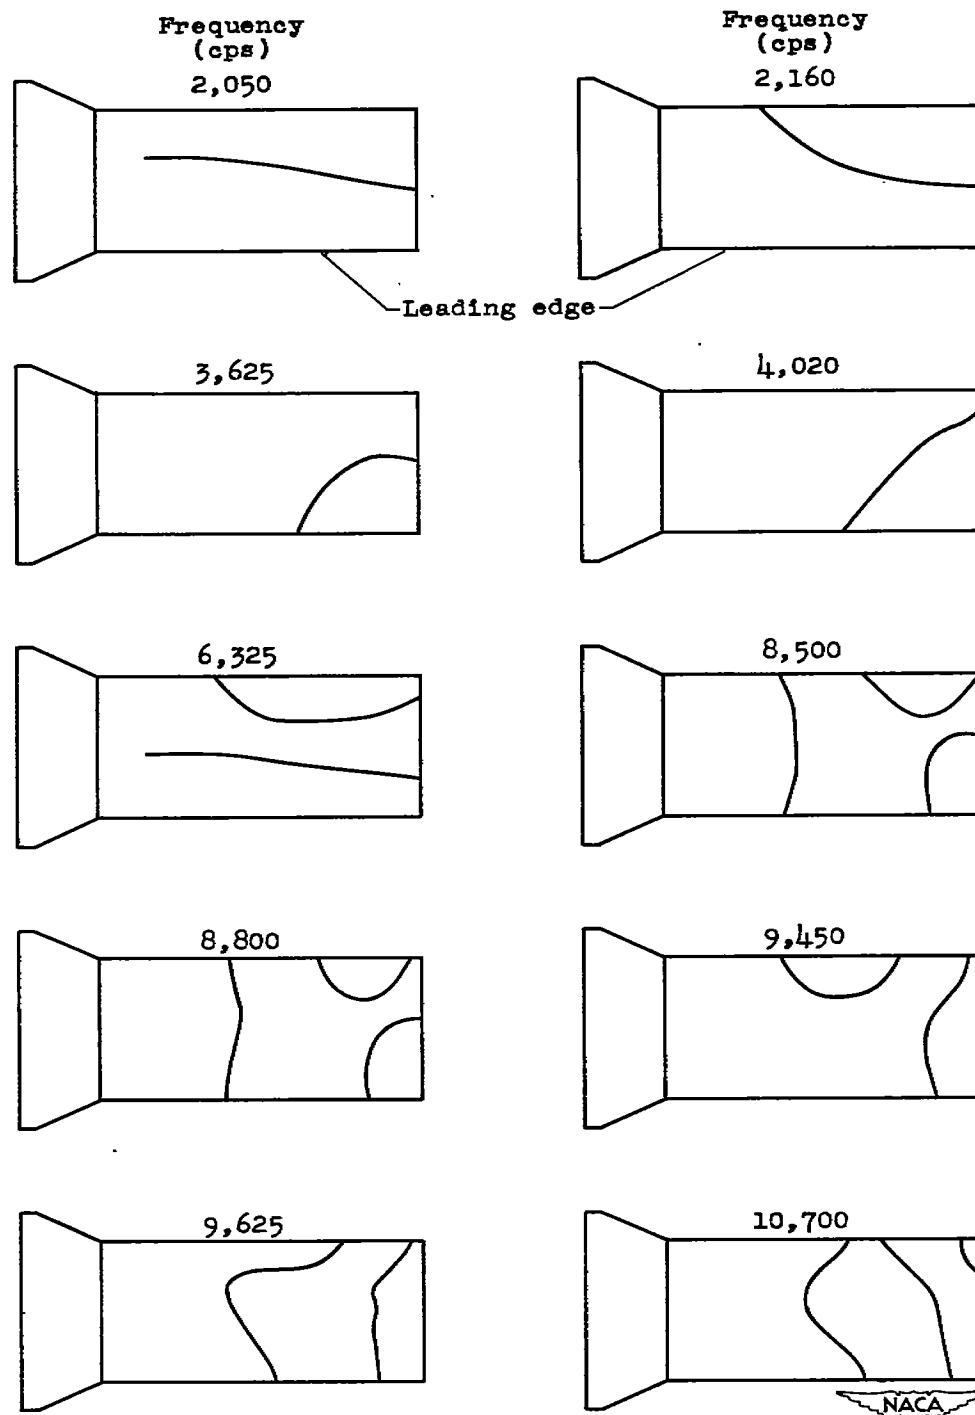
Figure 4. - Nodal patterns of 10 vibration modes determined.
Fundamental frequency, 1270 cycles per second.

Nodal patterns were obtained on a blade of the same type as those instrumented with strain gages to determine the approximate frequencies of resonant vibration of the blades. The nodal patterns of 10 vibration modes that were excited by means of the

speaker-type exciter are shown in figure 4. The fundamental bending mode, not shown in the figure, occurred at a frequency of 1270 cycles per second. A point of interest was the similarity of the nodal pattern at 8500 cycles per second to that at 8800 cycles per second, a similarity apparently caused by the simultaneous occurrence of two modes mechanically coupled. Although similarity often exists among vibration nodal patterns at very high frequencies, the node patterns at 9450, 9625, and 10,700 cycles per second are dissimilar.

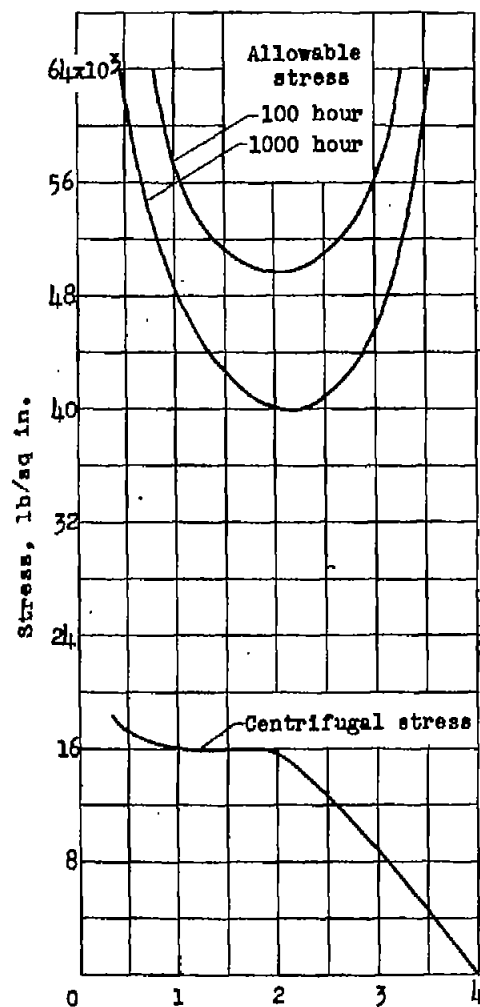
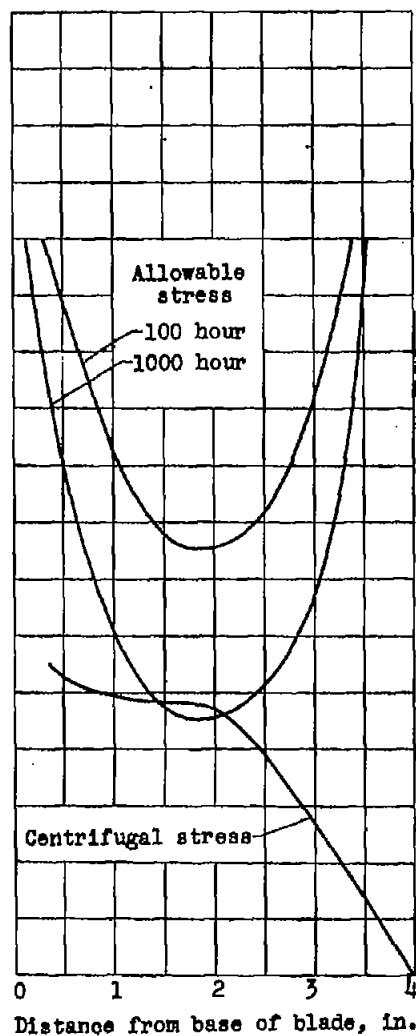
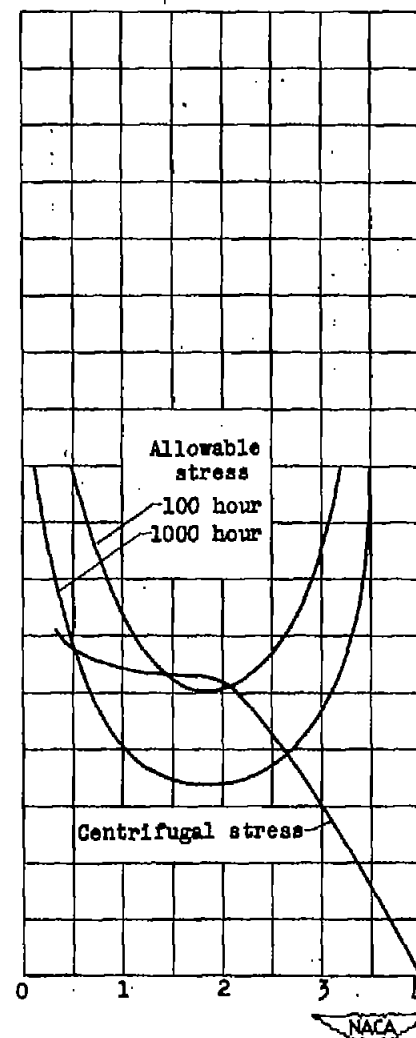
(a) Turbine speed, 10,000 rpm.

(b) Turbine speed, 11,000 rpm.

(c) Turbine speed, 11,500 rpm.

Figure 5. - Comparison between calculated centrifugal stress and allowable stress as computed from stress-rupture data for turbine blade at several turbine speeds.

The centrifugal stresses in the blade at different speeds of operation were first computed in order to assist in the interpretation of the significance of the vibratory stresses. The results are shown in figure 5. The centrifugal stresses at various locations along the length of the blade are shown for turbine speeds of 10,000, 11,000, and 11,500 rpm. Bending stresses due to gas loading are not included in these calculations because the stress values are to be used only qualitatively. Also plotted in this figure are the allowable stress values at each location along the blade, based upon the temperature distribution in the blade (reference 2) and the stress-rupture values for Vitallium at each temperature for durations of 100 and 1000 hours. For speeds below 11,000 rpm, a margin of safety exists between the operating centrifugal stress and the stress-rupture values. At or above 11,000 rpm, little margin of safety exists at any location in the blade and even small vibratory stresses may be sufficient to precipitate fatigue failure.

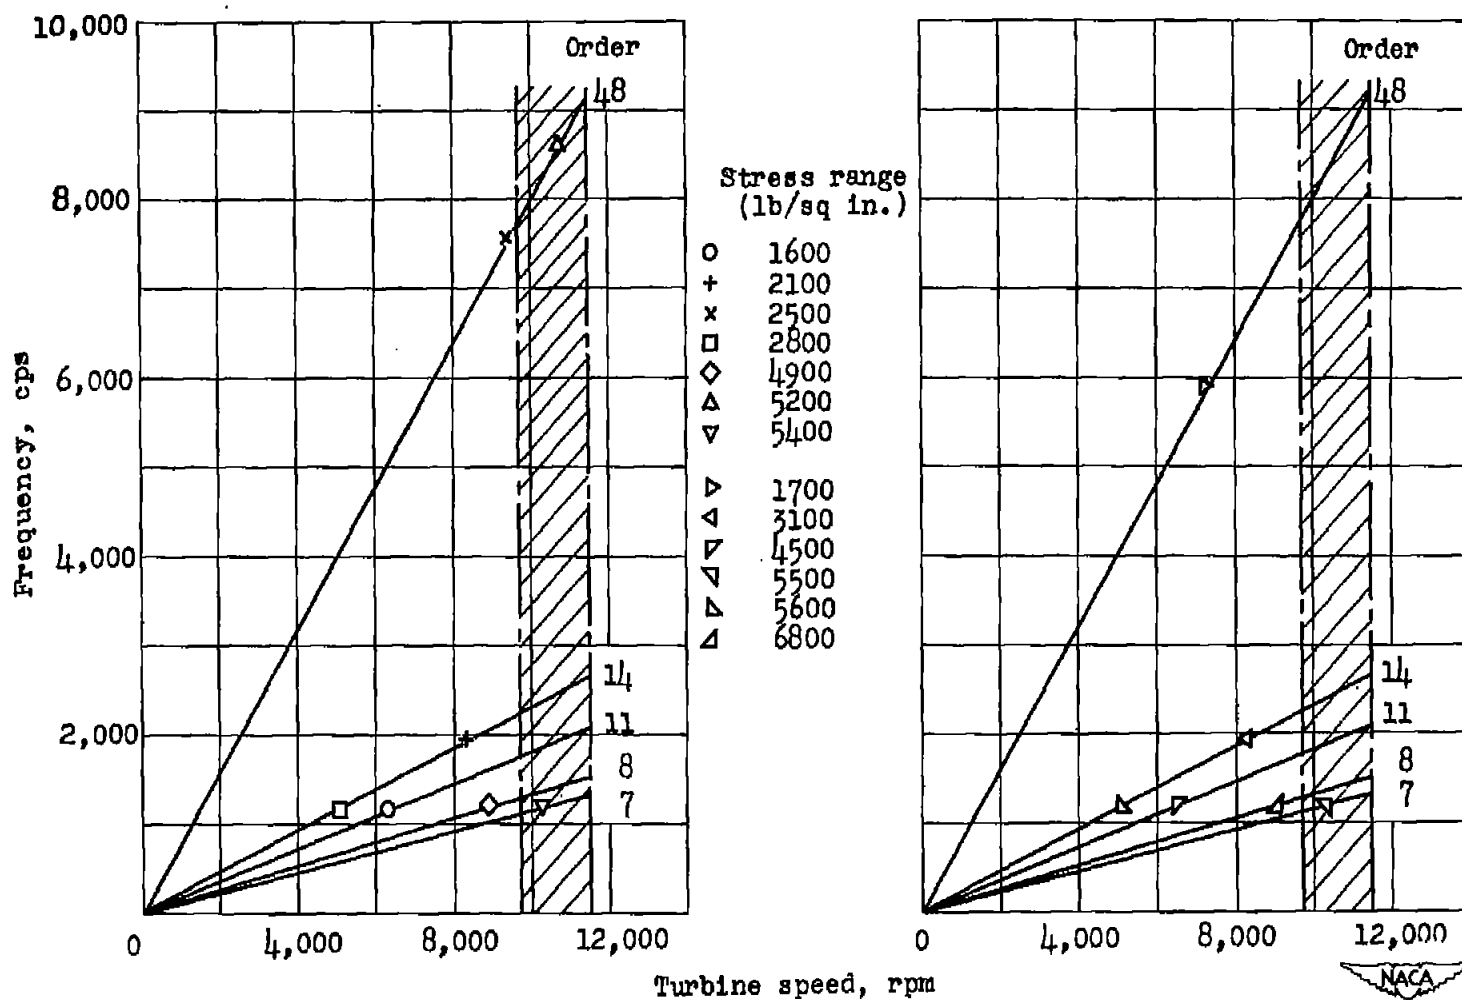
(a) Blade A.

(b) Blade B.

Figure 6. - Resonance spectrums showing occurrence of vibration. Shaded area indicates cruising range.

An analysis of the vibration data obtained on two of the blades is shown in figure 6. These blades were standard turbine blades mounted diametrically opposite. Each of the data points represents an engine speed at which vibration was observed and the frequency of the blade vibration. Also shown are a series of solid lines labeled order. Each of these lines represents the locus of points at which the frequency in cycles per second is a definite multiple of the frequency of turbine rotation in revolutions per minute. Such lines therefore define, at any engine speed, the frequency of any exciting force that occurs at a definite multiple of engine speed. For example, because there are 14 combustion chambers in this engine, an excitation due to the velocity profile of these combustion chambers would occur 14 times for every engine revolution. The frequency of combustion-chamber excitation at any

engine speed is therefore represented by the line for fourteenth order. A correlation between the observed points of blade vibration and the lines of multiple order is useful in ascertaining the sources of vibration excitation.

In addition to those points of sustained vibration shown in figure 6, several transient vibrations in the first bending mode at 1200 cycles per second were recorded near full-speed operation of the engine. These vibrations were recorded on the oscillograph film but were not visually identified on the oscilloscope screen. The duration of any of these vibrations was short, approximately $1/50$ second; the cause of the vibrations was not ascertained. These vibrations could not be neglected, however, because of their occurrence at the speeds producing the greatest severity of temperature and centrifugal-stress conditions. Another point of interest not demonstrated in figure 6 was the absence of significant vibrations during a run in which the engine was accelerated from 4000 to 11,500 rpm within a period of 15 seconds while the oscillograph was continuously operated. Apparently sufficient damping existed to prevent the building up of vibration during rapid acceleration.

Inspection of figure 6 shows that the important orders of excitation are 7, 8, 11, 14, and 48. Excitations of the forty-eighth order are to be ascribed to the 48 nozzle blades in the turbine. In blade A, this source of excitation produced a stress range of 5200 pounds per square inch at a speed in the cruising range of the engine, where the temperatures are high and the margin of safety is low. The frequency of this vibration was 8600 cycles per second. Blade B was also excited by the forty-eighth order but at a different frequency, probably because of differences in the blade mounting. This vibration at a frequency of 5900 cycles per second did not occur within the cruising range.

The fourteenth-order excitation can be attributed to the 14 combustion chambers in the engine. This source produced first torsional vibrations at a frequency of 2000 cycles per second with a stress range of 2100 pounds per square inch in blade A and a stress range of 3100 pounds per square inch in blade B. Because the engine speed at which these vibrations occurred was below the cruising range of the engine, sustained vibrations due to this source are not likely and, moreover, they occur when the temperatures and the centrifugal stresses are relatively low so that greater vibrational stress is tolerable. The combustion chambers also produced fundamental bending vibrations at a frequency of 1170 cycles per second in both blades at a speed of approximately 5000 rpm but these vibrations are probably not of great importance because of the low speeds at which they occurred.

Vibrations due to eighth-order excitations may be of importance. Although these vibrations in the fundamental bending mode at 1200 cycles per second occur at a speed below the cruising range, their relative amplitude is high. In blade B, the highest vibratory stress range observed of 6800 pounds per square inch was excited by an eighth-order effect.

The seventh-order excitations, which are important, produced vibrations in the fundamental bending mode at a frequency of 1200 cycles per second. The stress range for both blades produced by this excitation was relatively high (about 5500 lb/sq in.) and occurred at a speed of about 10,300 rpm, which is within the cruising range of the engine and is accompanied by high blade temperatures and centrifugal stresses. Several possibilities exist as the source of this order of excitation. One of the more probable causes may be that inequalities of mass flow from the various combustion chambers produce numerous harmonics of engine speed and the lowest order that can excite blade vibrations at any speed within the operating range of the turbine is the seventh. Another possibility is that the response of the blade to excitation is nonlinear and would therefore tend to introduce a one-half-order excitation of the combustion chambers (reference 4).
