TECHNICAL NOTE 3269

ADDITIONAL STATIC AND FATIGUE TESTS OF HIGH-STRENGTH
ALUMINUM-ALLOY BOLTED JOINTS

By E. C. Hartmann, Marshall Holt, and I. D. Eaton

Aluminum Company of America

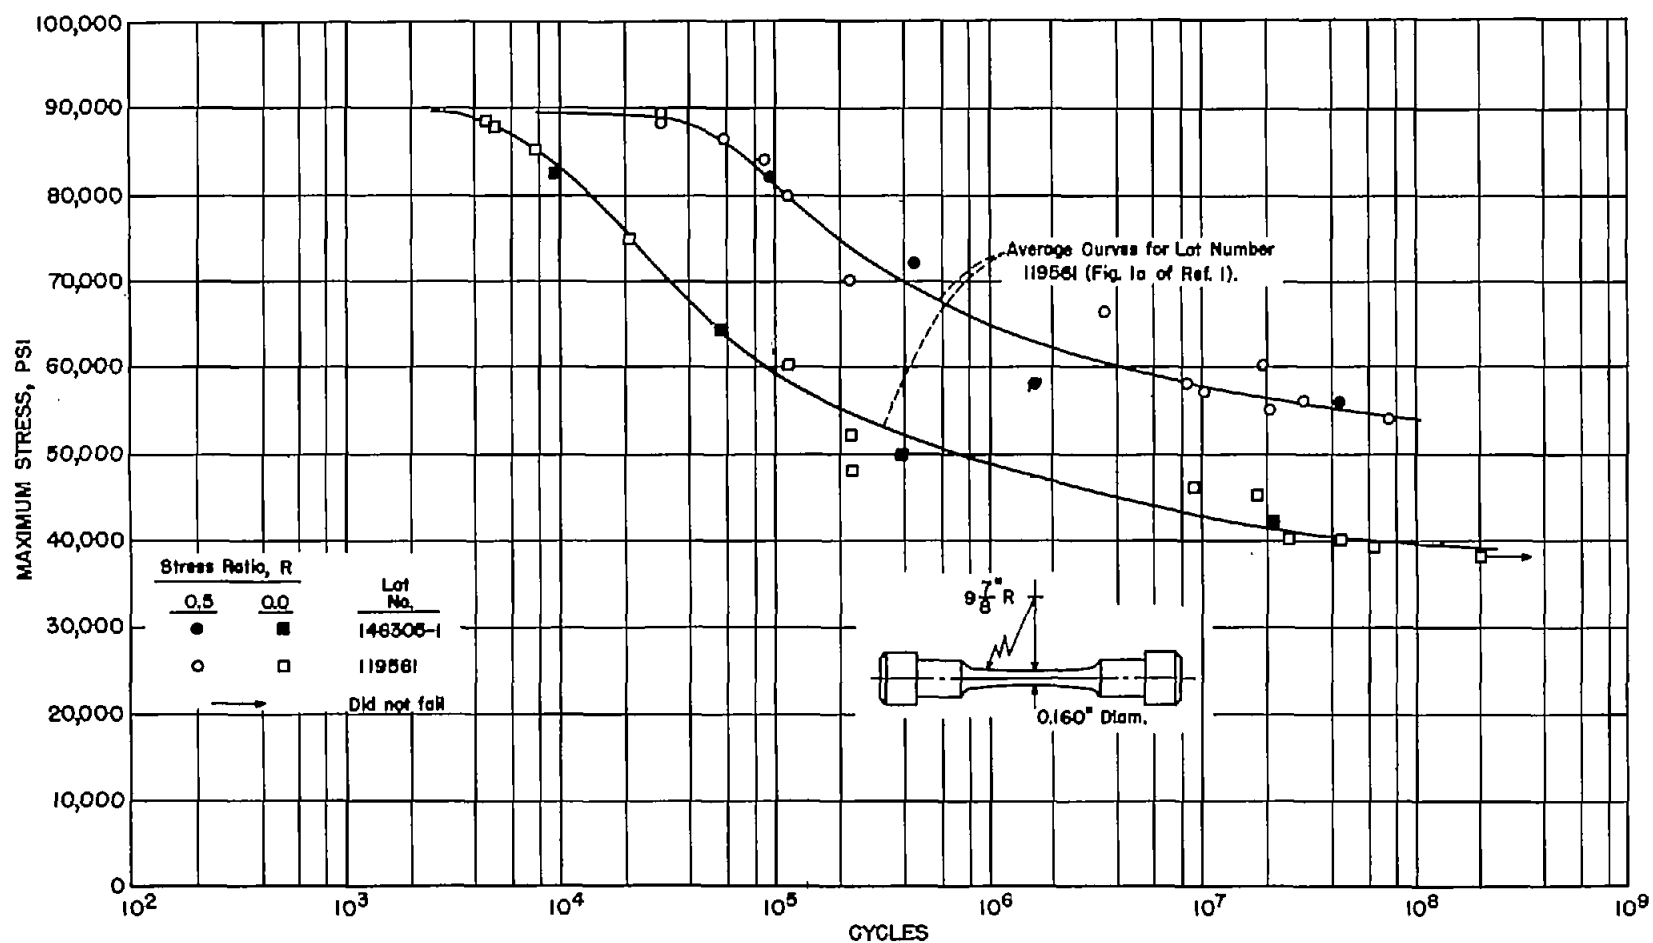
Figure 1.- Direct tension-compression fatigue data for 75S-T6 extruded bar
 (1 1/4 by 4 inches).

Direct-stress fatigue tests were made on polished round specimens as described in reference 1 to determine the degree of agreement of basic fatigue strengths for the old and new lots of 75S-T6 and 24S-T4 aluminum alloys. The fatigue test results for the two lots of each alloy are plotted in figures 1 and 2 where it is seen that the direct-stress fatigue strengths for the two lots of 75S-T6 compare very well and that the fatigue strengths of the new lot of 24S-T4 are slightly higher than the results obtained on the original lot, but such small differences are not considered significant in light of the data in reference 3.

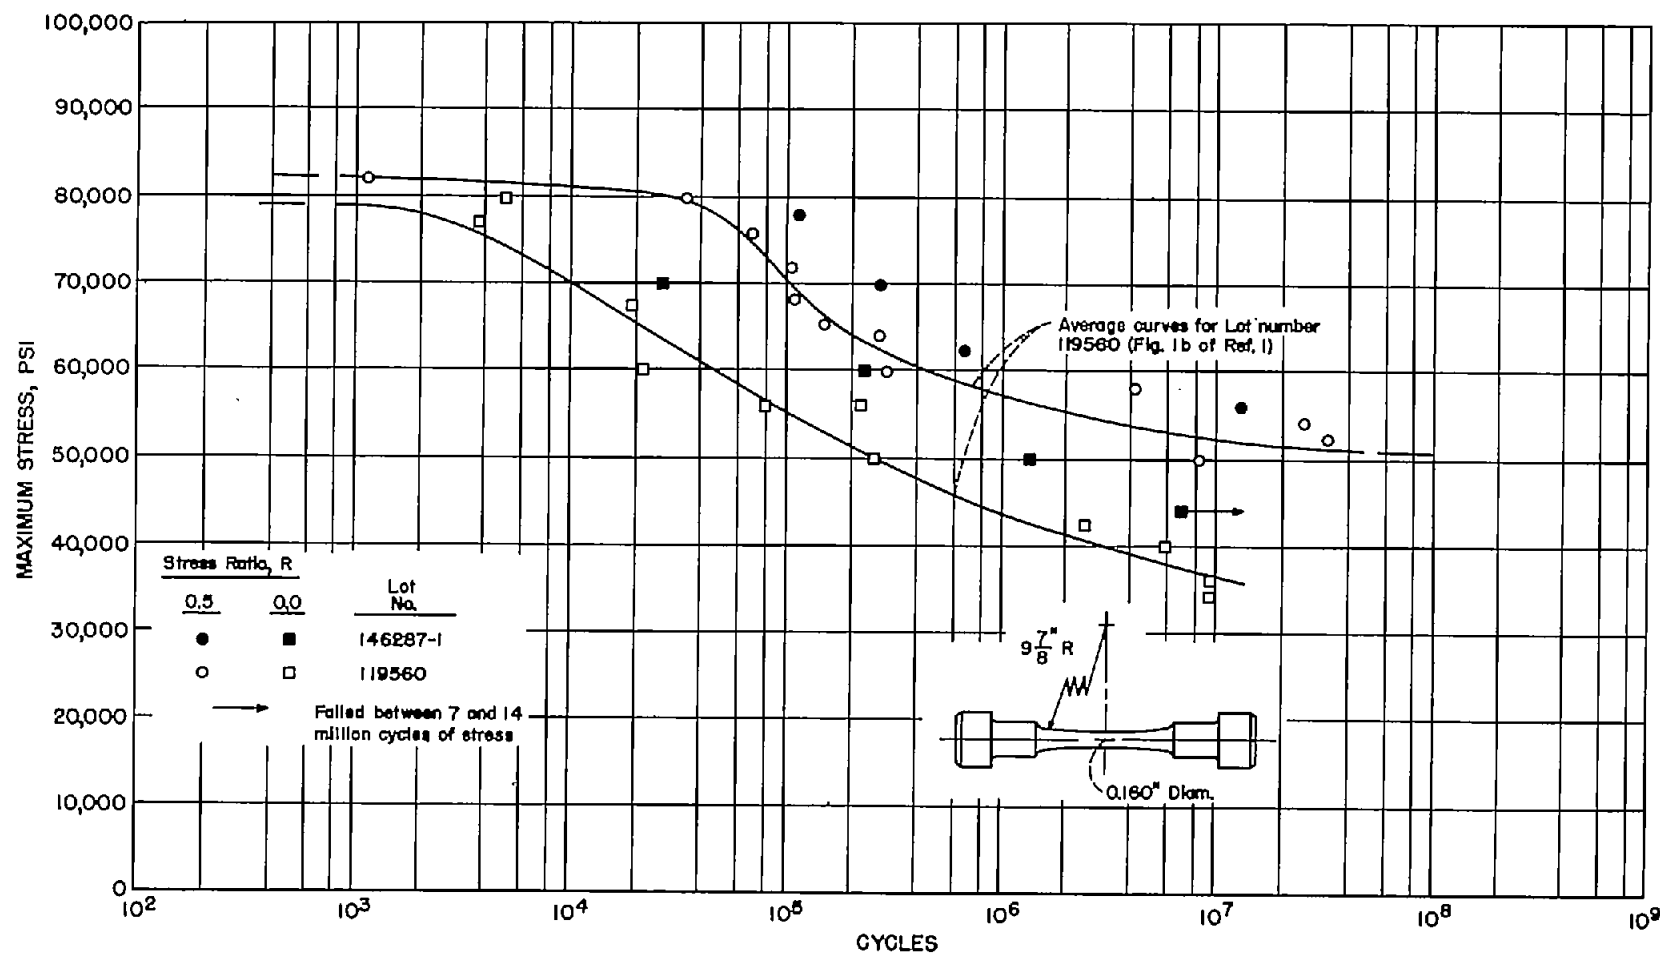
Figure 2.- Direct tension-compression fatigue data for 248-T4 extruded bar ($\frac{1}{4}$ by 4 inches).

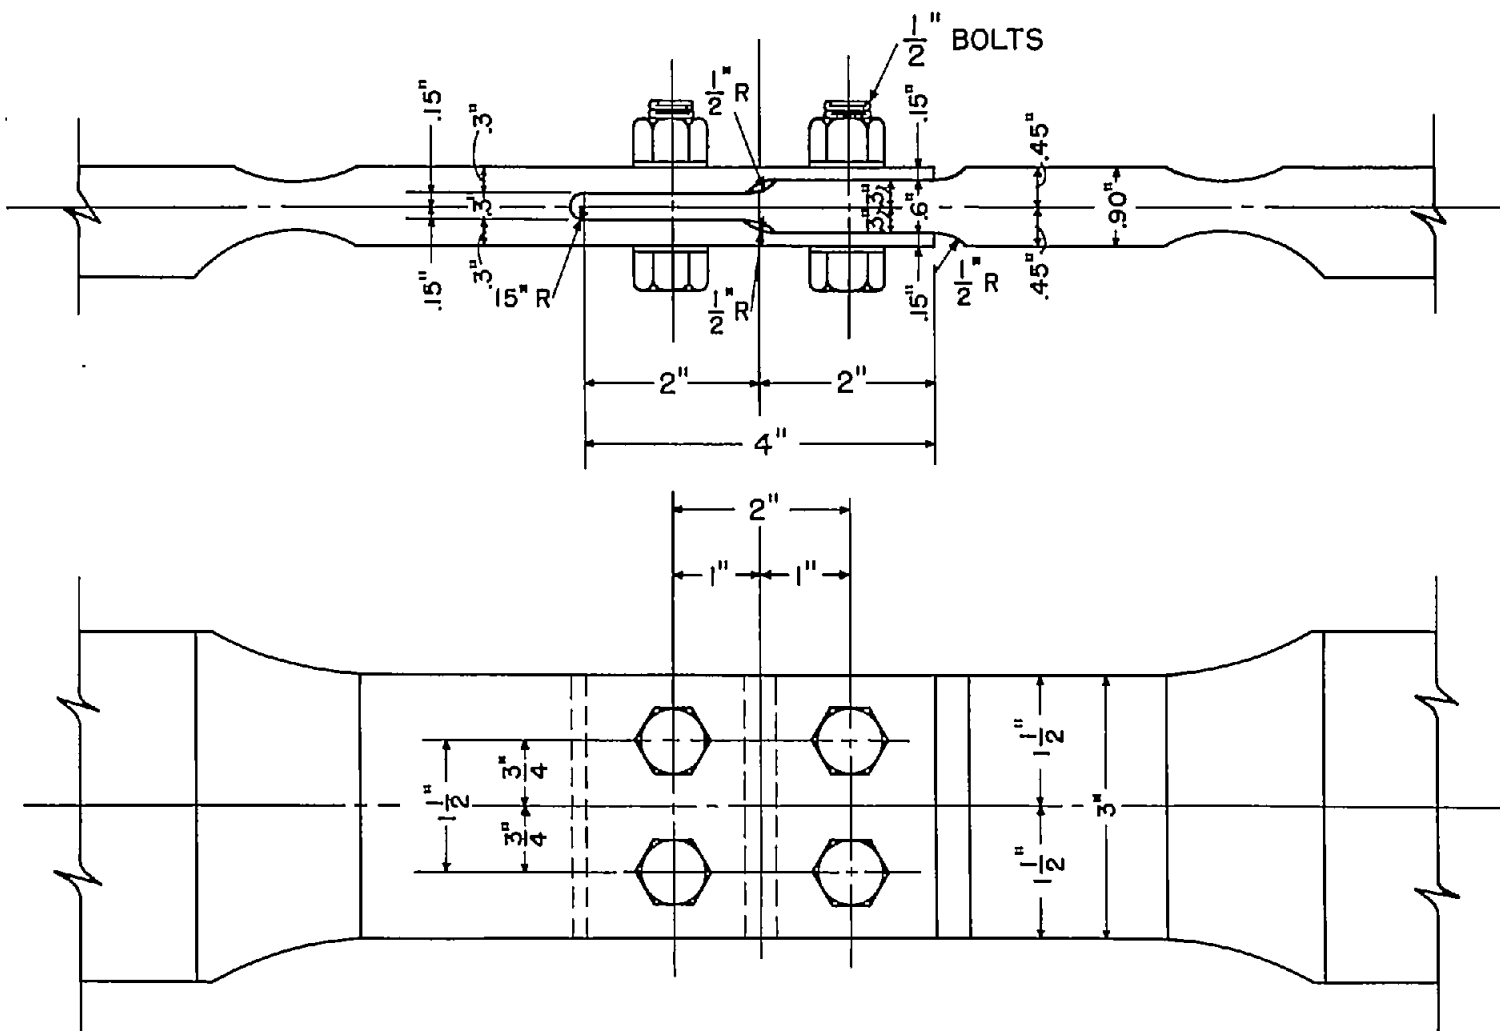
Figure 3.- Stepped double-shear joint specimen.

The stepped double-shear joint, the new joint type used in this investigation, is shown in figure 3. It can be seen that the net-section area is 1.2 square inches at the first row of bolt holes and 0.6 square inch at the second row of bolt holes. The bolt holes were reamed to 0.0010 to 0.0020 inch under the measured bolt diameter.

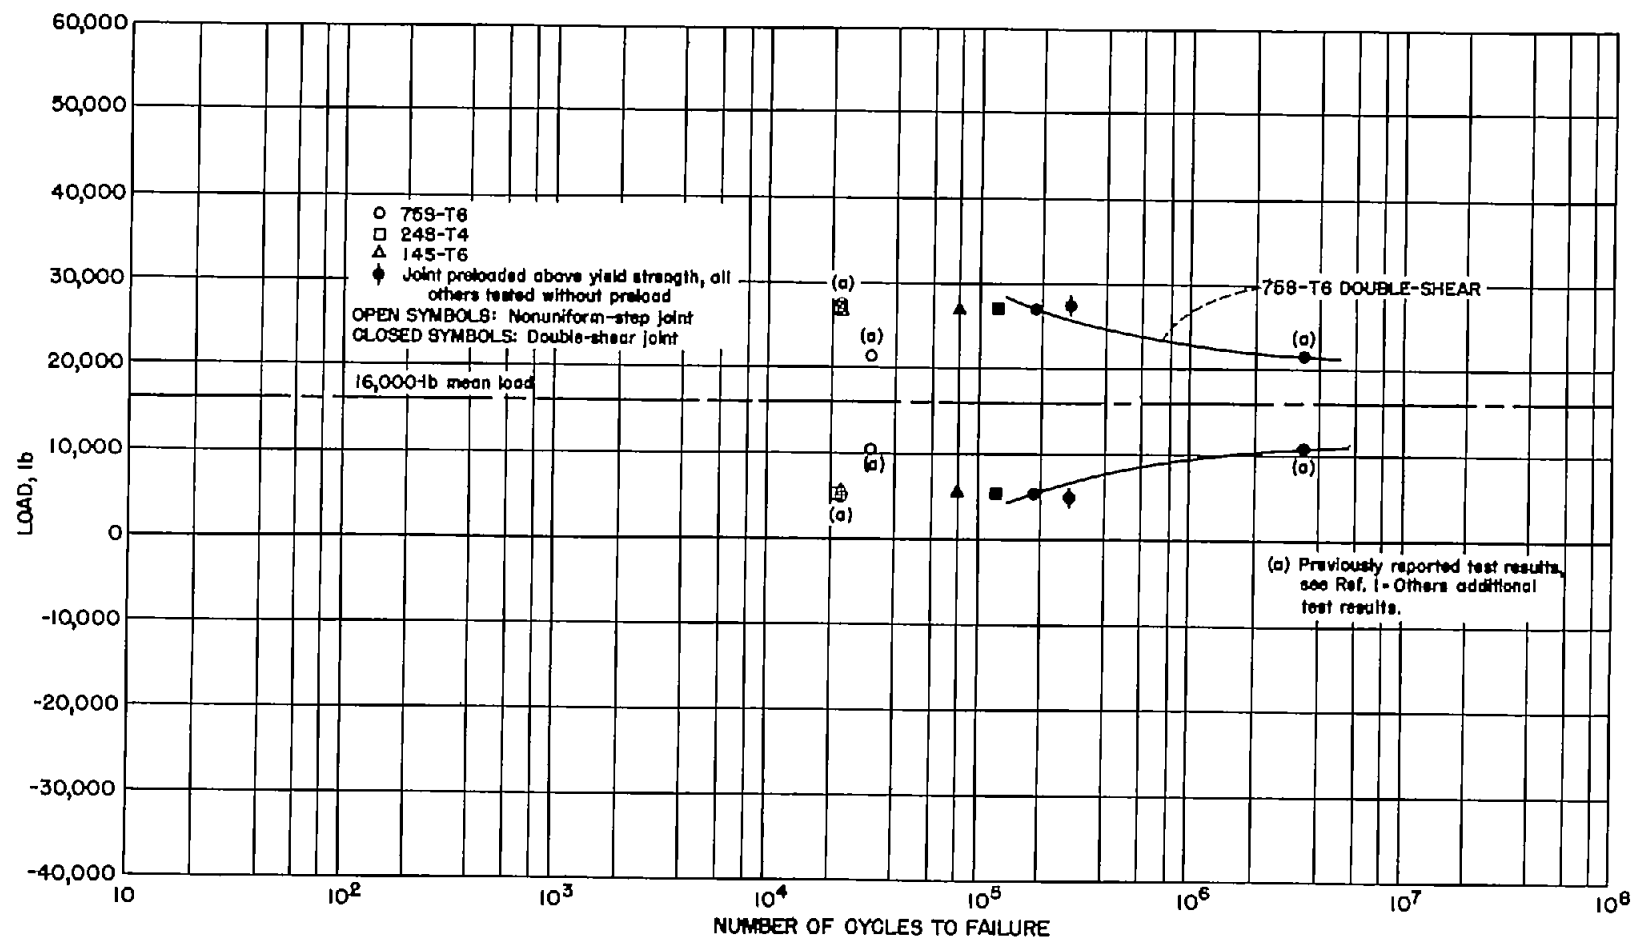
Figure 8.- Direct-stress fatigue curves for double-shear and nonuniform-step joints of 75S-T6, 24S-T4, and 14S-T6 aluminum alloys. Mean load, 16,000 pounds.

Direct-stress fatigue test results for the double-shear and nonuniform-step joints of the three aluminum alloys under consideration are plotted in figure 8 and are included in the summary of table V. For the conditions of 16,000-pound mean load $\pm 10,670$ pounds, it can be seen that there is no significant difference in the fatigue lives of the nonuniform-step joint in any of the three alloys studied. At a load of 16,000 pounds $\pm 10,670$ pounds, the fatigue life of the 75S-T6 double-shear joint exceeds the fatigue lives of the 24S-T4 and 14S-T6 double-shear joints by ratios of 1.5:1 and 2.3:1, respectively.

The direct-stress fatigue test results for the plain-scarf and double-shear aluminum-alloy joints, which had been preloaded with a static load, have been plotted in figures 8 and 11 and are included in the summary in table VI. It can be seen that the ratio of the fatigue life of the plain-scarf joint with preload to that of plain-scarf joint without preload is 5.9:1. The preloaded plain-scarf joint failed through the first row of bolt holes similar to the failure of the plain-scarf joint without preload shown in figure 15(b) (joint 2) of reference 1. The like ratio for the double-shear joints was found to be 1.4:1. As shown in figure 15, the preloaded double-shear joint failed in one of

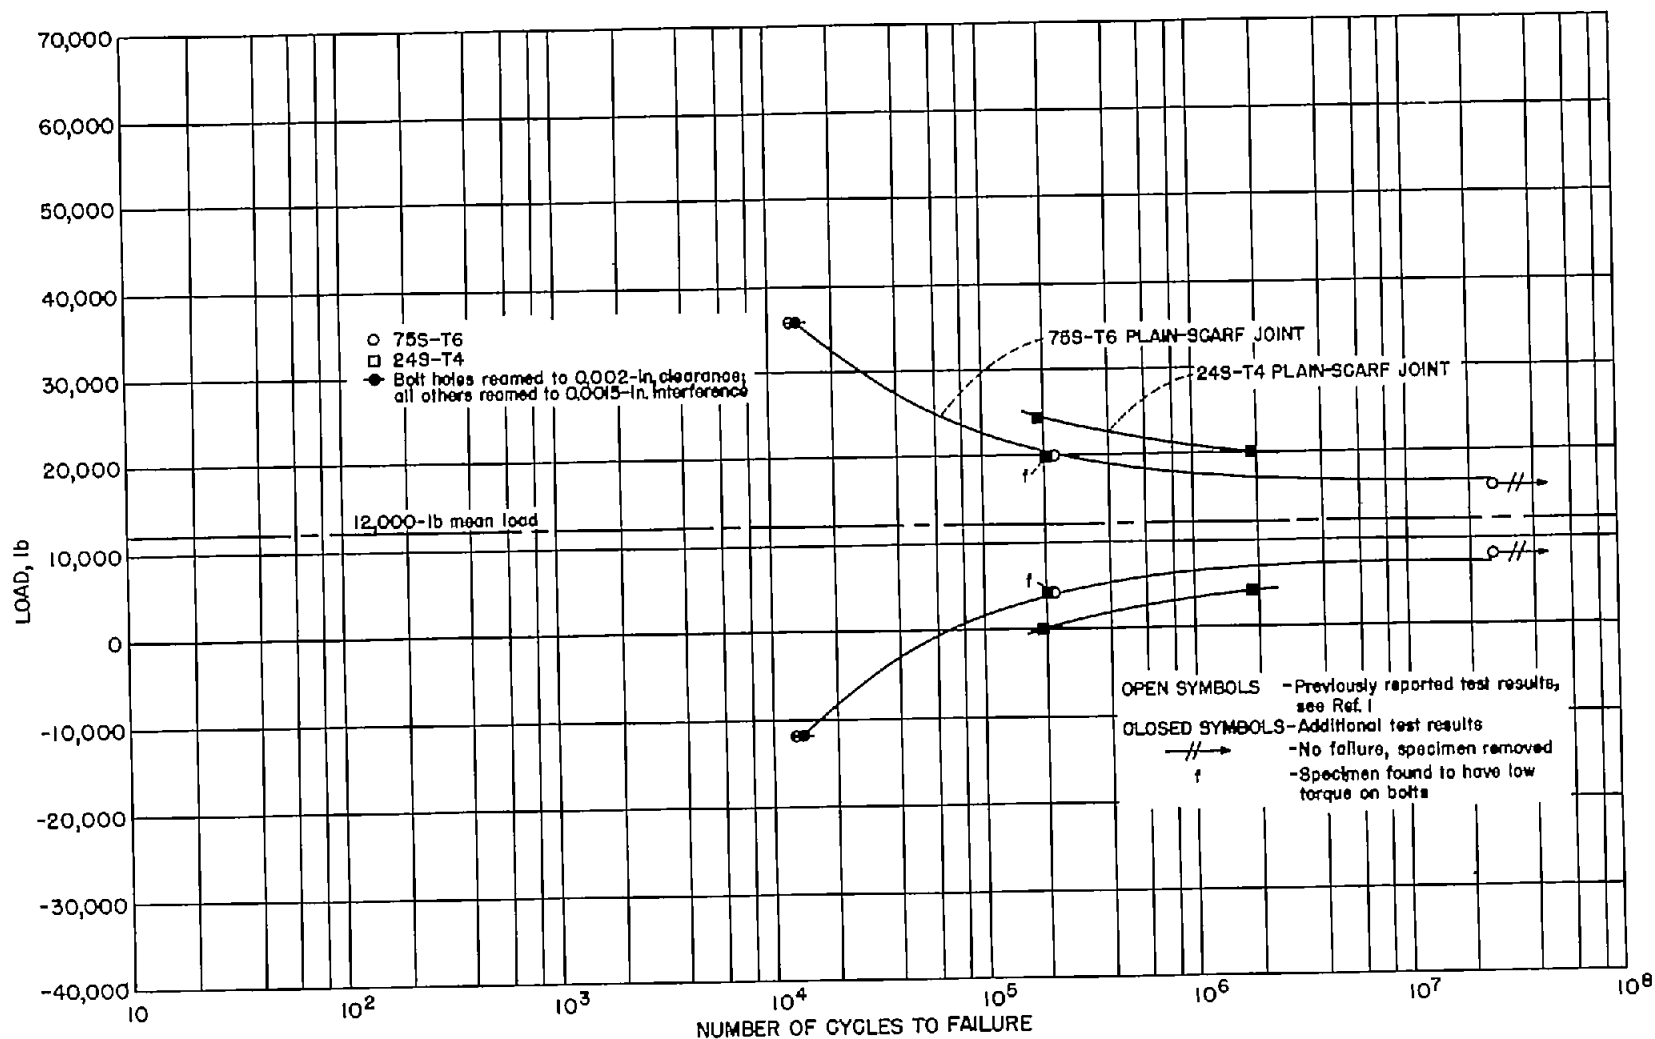
Figure 9.- Direct-stress fatigue curves for plain-scarf joints of 75S-T6 and 24S-T4 aluminum alloy. Mean load, 12,000 pounds.

The summary of results of direct-stress fatigue tests for the plain-scarf joints of 75S-T6, 24S-T4, and 14S-T6 at a mean load of 16,000 pounds and various variable loads, given in table X of reference 1, is extended in table V and figure 9 to include similar comparisons of 75S-T6 and 24S-T4 plain-scarf joints tested with a 12,000-pound mean load and various variable loads. It can be seen that the 24S-T4 plain-scarf joint gives consistently greater fatigue life than the 75S-T6 joint with the ratios of fatigue lives ranging from 1.4:1 to 18.5:1 for the mean loads and stress ratios used in these tests. For like stress ratios the fatigue-life ratios are larger in favor of 24S-T4 at the 12,000-pound mean load than at the 16,000-pound mean load.

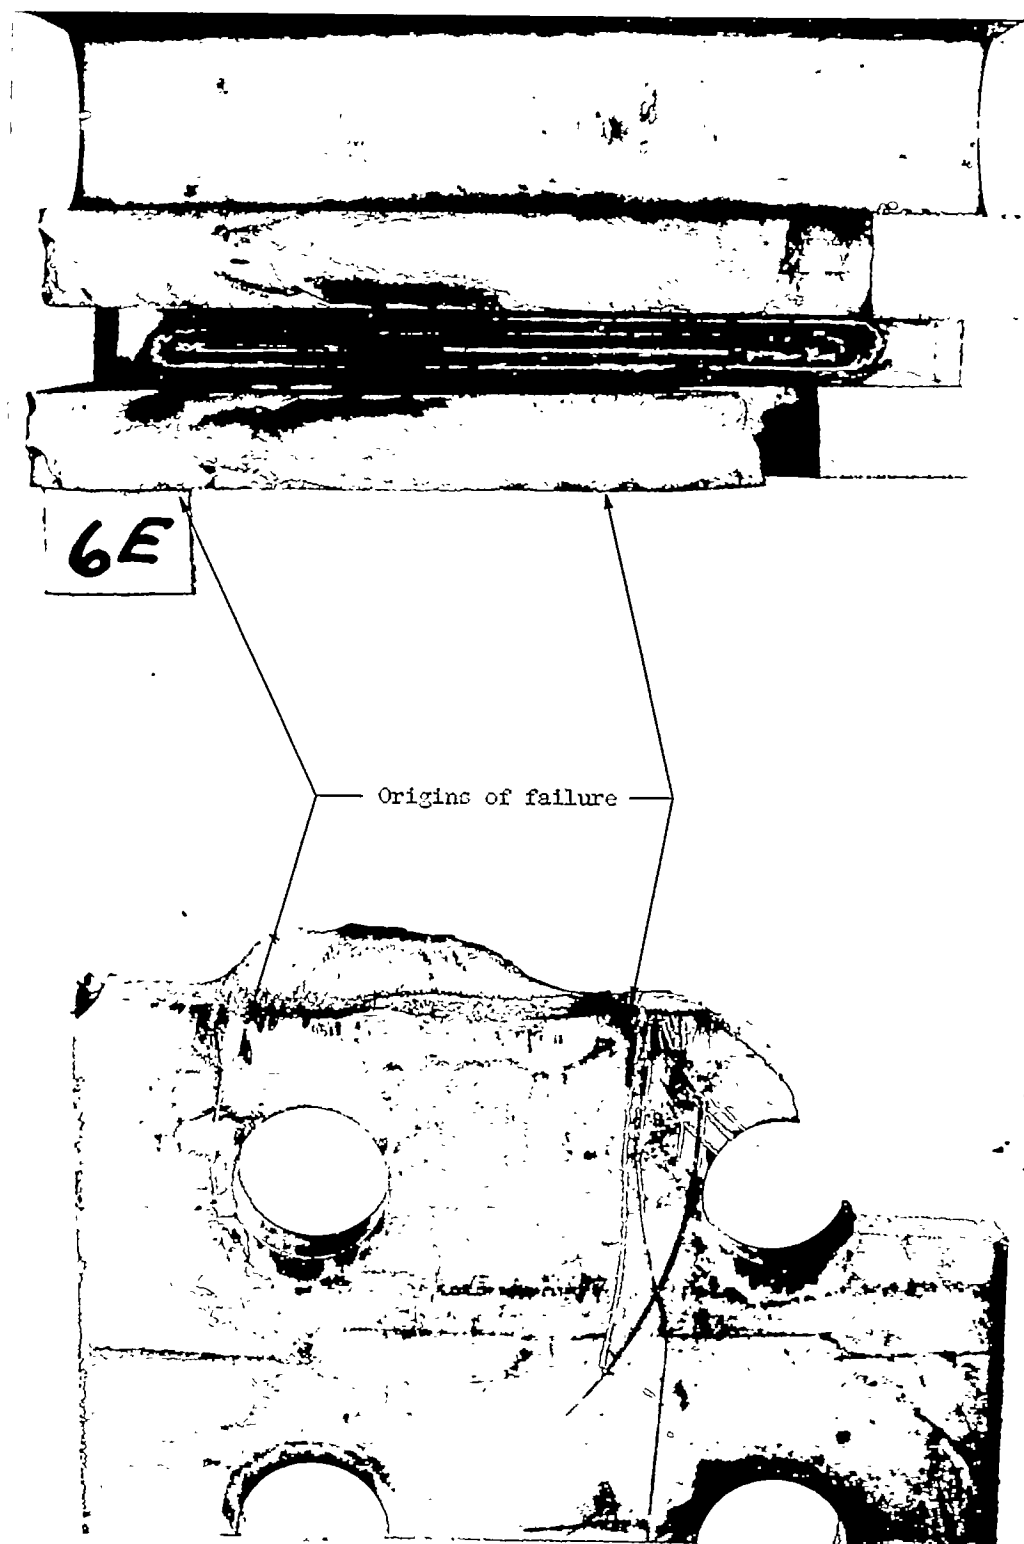
Figure 16.- Failure of double-shear joint which had been loaded to high static loading previous to fatigue test. L-83696

the outside members in a pattern quite unlike that of the corresponding joint without preload shown in figure 15(b) (joint 9B) of reference 1. Figure 16 shows the fractured surface of the preloaded specimen. Metallographic examination indicated that the fracture originated in a fretted area on the faying surface. No sign of additional fractures was evident in the tongue of this specimen. Unless the galling caused some reduction in life of this specimen, it would appear that the location of the critical section in the double-shear joint was changed by the preload imposed with little gain in fatigue life of the joint. It has been said that preloading to 67 percent of ultimate strength increases the fatigue life from two to tenfold. The result of the test on the preloaded plain-scarf joint is in agreement with such a statement. The National Bureau of Standards has reported results of fatigue tests on sheet with static preload (ref. 4) which show beneficial as well as detrimental effects of preloading on fatigue life. It would appear from the two tests made on bolted joints that preloading may or may not have significant beneficial effects on the fatigue life of a joint.

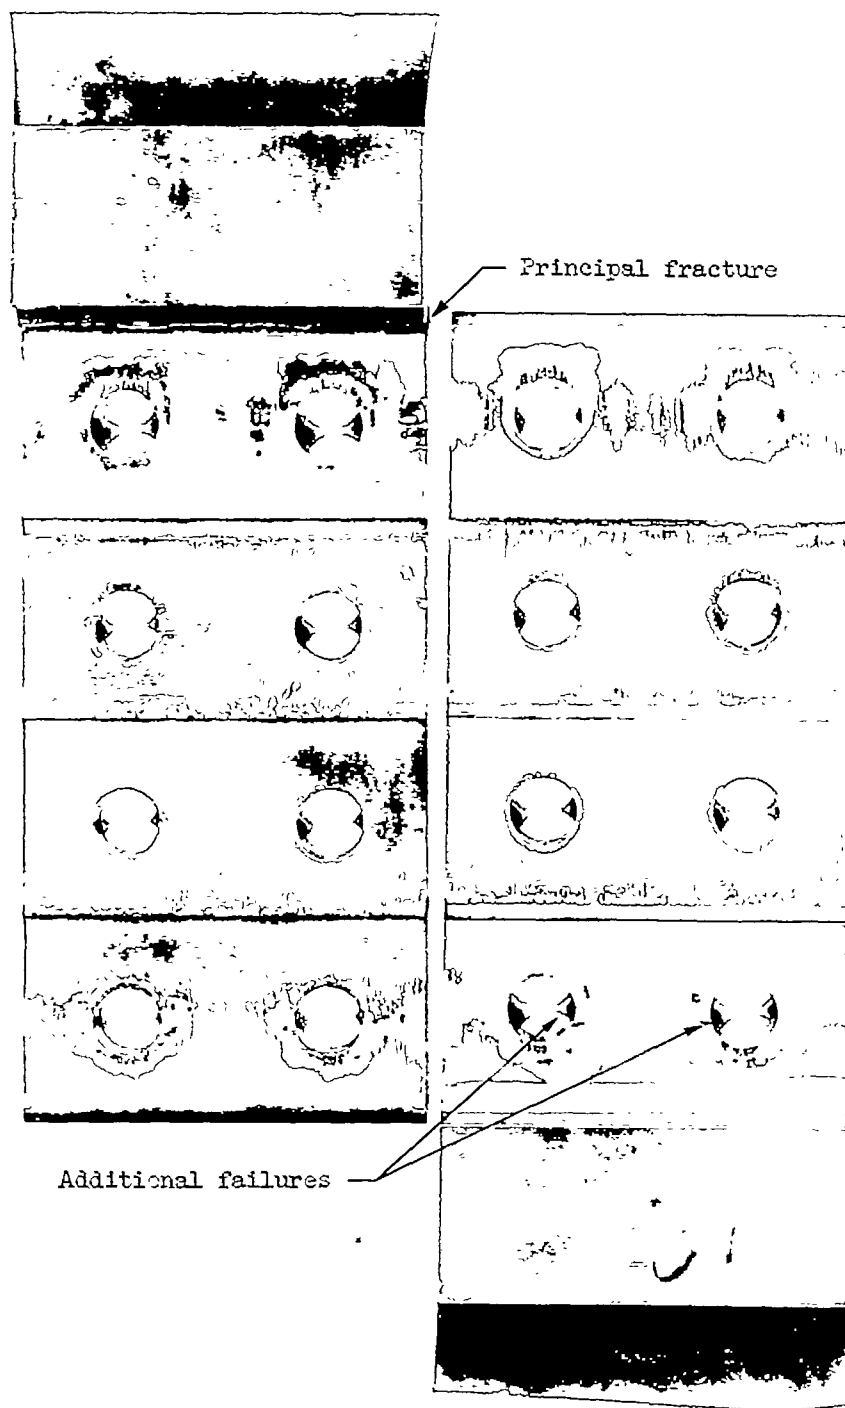
Figure 17.- Failures in 24S-T4 nonuniform-step joint. L-83697

When the bolts were removed individually from the reassembled joints, it was found exceedingly difficult to obtain evidence of the existence of some of the cracks by means of the penetrant inspection methods used. In the case of the smallest crack no evidence of its existence was found. Further, no indication was obtained of the existence of the crack, about 0.009 inch long, shown in figures 17 and 18 when the methods were used with this joint in the disassembled condition.

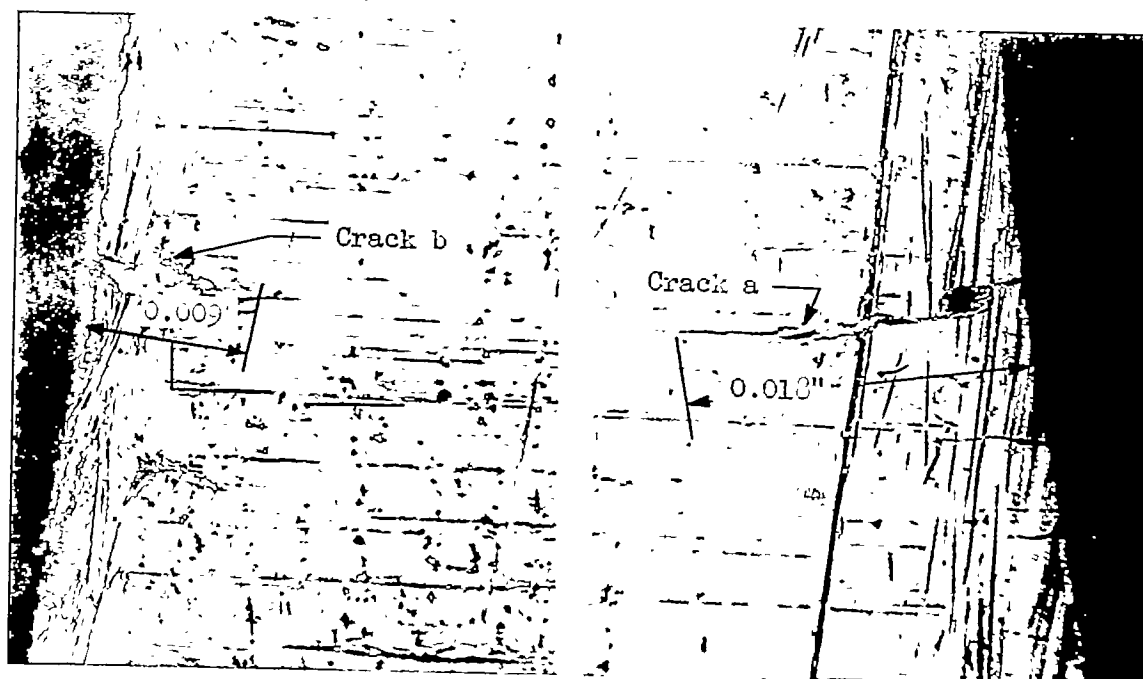
Figure 18.- Enlargements of additional failures in 24S-T4 nonuniform-step joint. (For locations, see fig. 17.) Two photographs at top are of Faxfilm replicas.

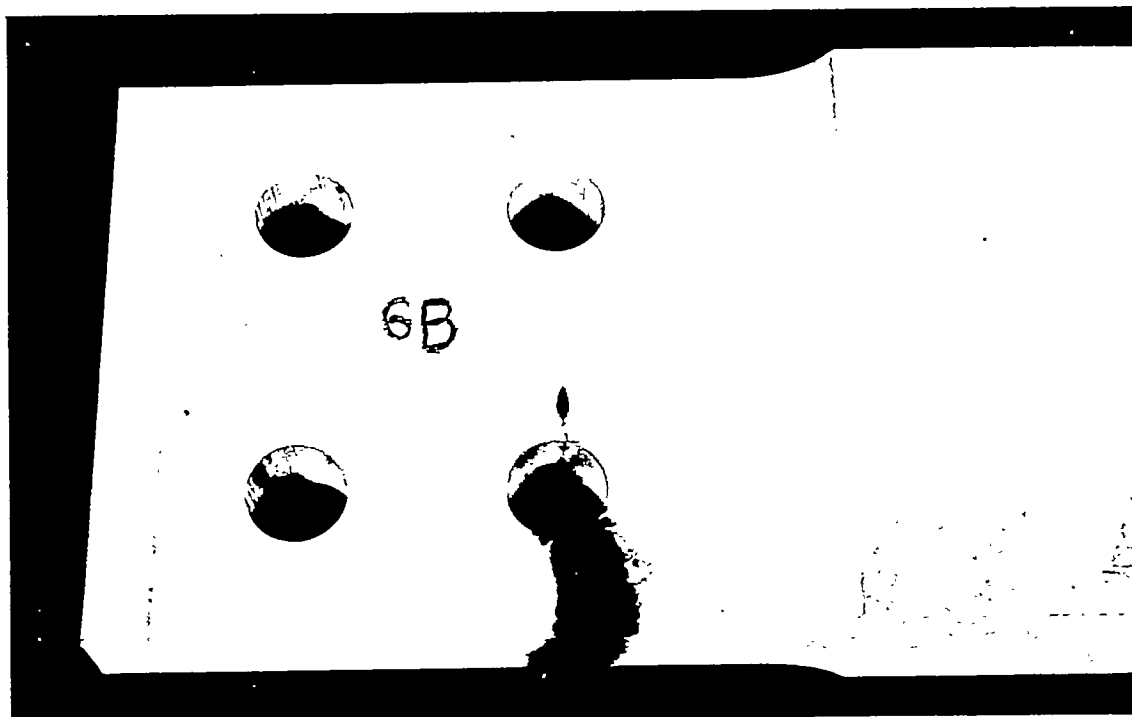
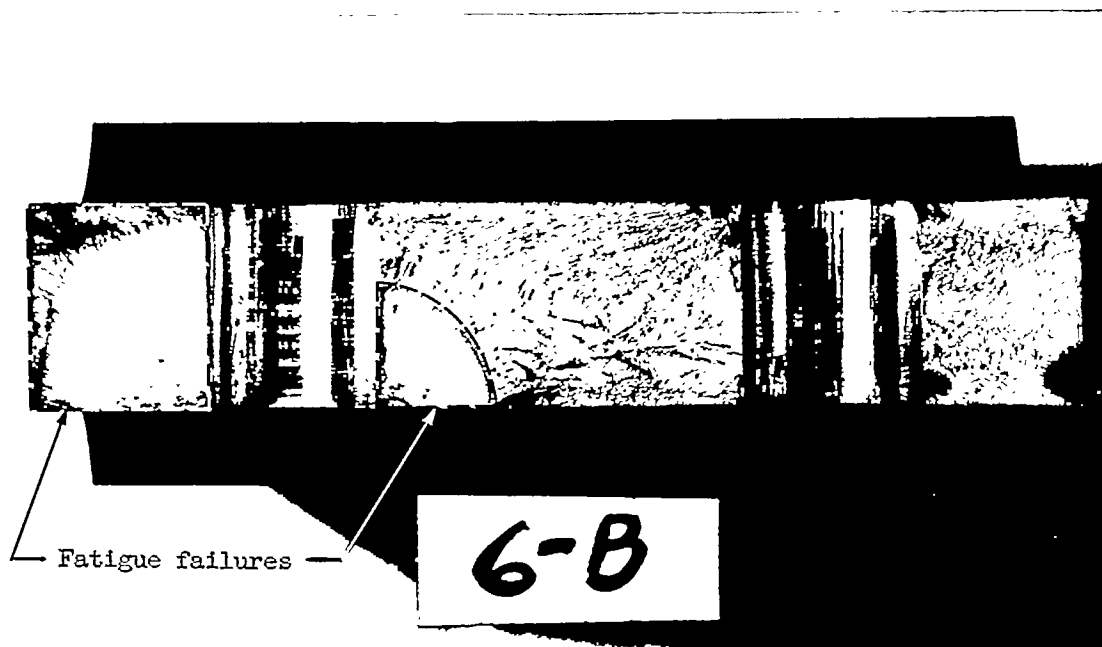
Figure 19.- Failures in 75S-T6 double-shear joint.

The static loads required to fail the 75S-T6 and 24S-T4 double-shear joints after the fatigue cracks shown in figures 19 and 20 had been developed are given in table VII. Included in the table are comparisons with the expected load based on the net area obtained by correcting for the cracks and the load-carrying capacity of a similar joint not having previous cyclic-stress history. Outlined on the fractured surfaces in figures 19 and 20 are the areas involved in reducing the net area for estimating the effective load-carrying section of the specimens. It can be seen that one section of the 75S-T6 joint between the bolt hole and the outside edge was completely fractured by the fatigue loading whereas the 24S-T4 joint did not completely fracture in this area. Before subjecting the 24S-T4 joint to the static loading, however, a saw cut was made into the bolt hole from the outside edge in order to produce more nearly identical conditions in the two specimens. The location of the cut is shown in figure 20. Thus for purposes of the comparison this section of the joint has been considered as though it had been completely fractured in fatigue. Further, the additional failure in the centrally located portion of the joint adjacent to the bolt hole in the 75S-T6 joint caused a substantially larger reduction in the section than was the case in the 24S-T4 joint. Thus the cracked 75S-T6 joint would be expected to be subjected to a larger eccentricity of loading than the cracked 24S-T4 joint.

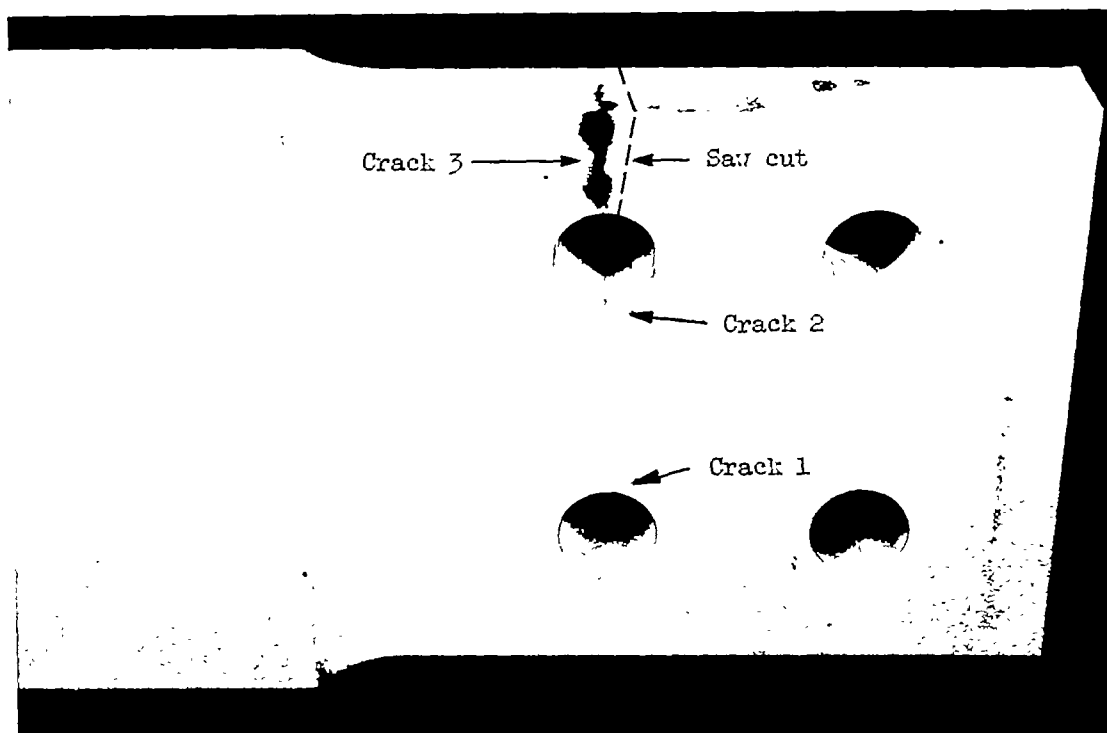
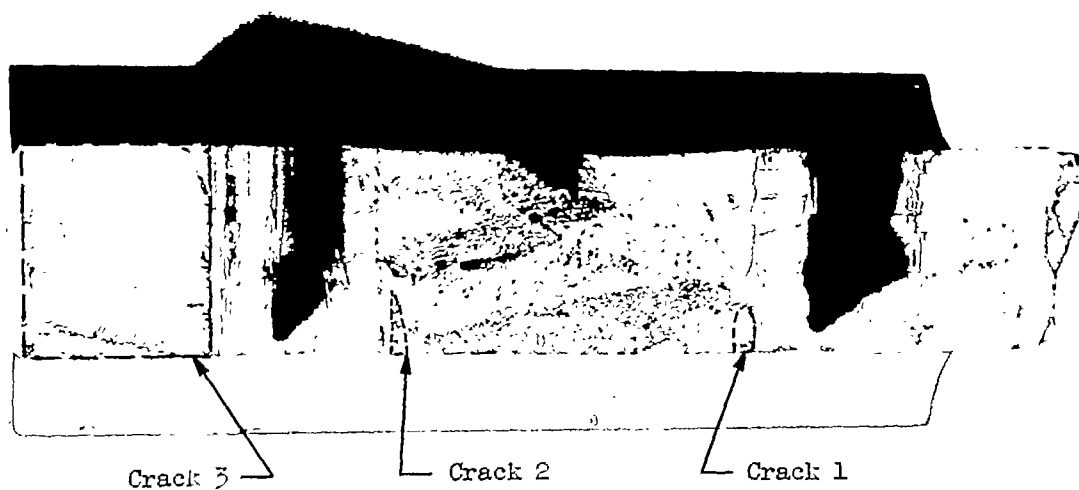
Figure 20.- Failures in 24S-T4 double-shear joint. Specimen 6D. (For enlargement of small cracks see fig. 21.)

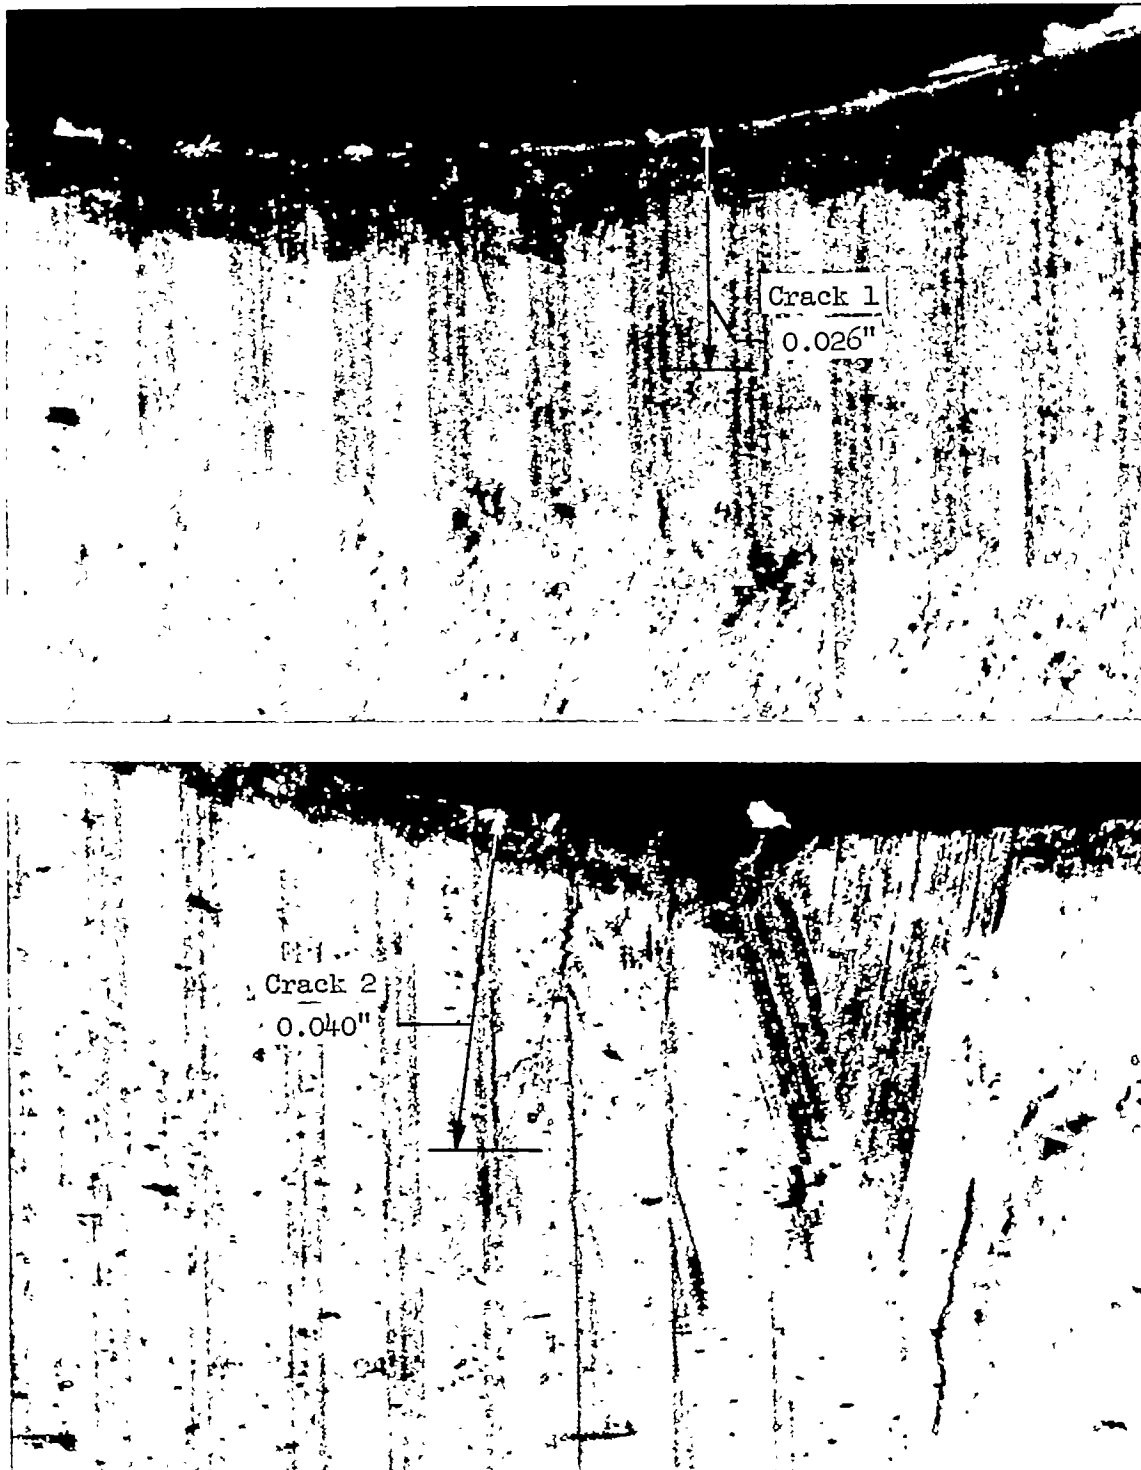
Figure 21.- Enlargement of failures in double-shear joint. 50X. (For location see fig. 20.)
