November 1944 as  
Advance Confidential Report E4K02

EXPERIMENTAL STUDY OF THE COATING FOUND ON SCUFFED CAST-IRON  
PISTON RINGS DURING OPERATION IN NITRIDED-STEEL CYLINDERS

By J. Howard Kittel and Walter A. Vierthaler

Aircraft Engine Research Laboratory  
Cleveland, Ohio

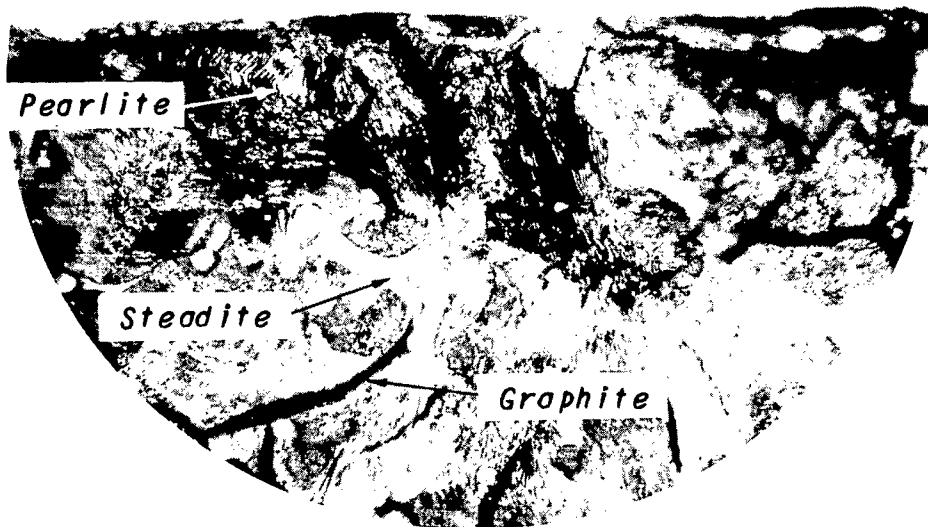
Fig. 1

*Figure 1. - Transverse section of the running face of a new cast-iron piston ring. Etched in nital. X1500.*

A photomicrograph of a transverse section of a new cast-iron piston ring is presented, for convenience of reference, in figure 1. The structure consists of a number of constituents randomly distributed over the cross section. The cross section shows the presence of graphite, pearlite, and steadite.

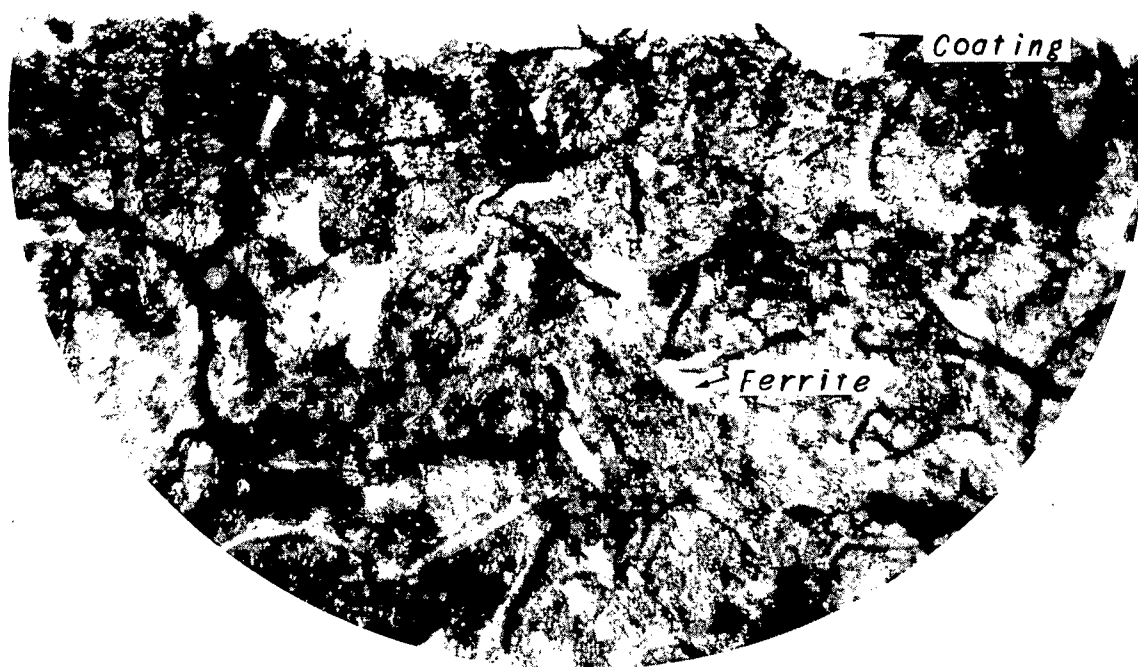
Fig. 3

*Figure 3. - Transverse section through scuffed portion of the running face of a cast-iron piston ring showing coating material after test. Etched in nital. X1500.*

The coating present on scuffed cast-iron rings was not seen anywhere on the surface except at the scuffed regions. The entire scuffed area did not, however, show the presence of the coating, possible because of the extreme thinness of the layer at some points. The scuffed portion of the face of a cast-iron piston ring is ridged, as is shown in figure 2. Photomicrographs of high magnification, such as the one shown in figure 3, indicate that the coating, as a rule, tended to fill hollows in the surface profile of the basis metal.

Because the boundary between the coating and the basis metal in many places is not clearly definable, and because the basis structure appears to protrude into the coating material itself, it seems probable that the coating originates from the piston-ring constituents rather than from the cylinder barrel.

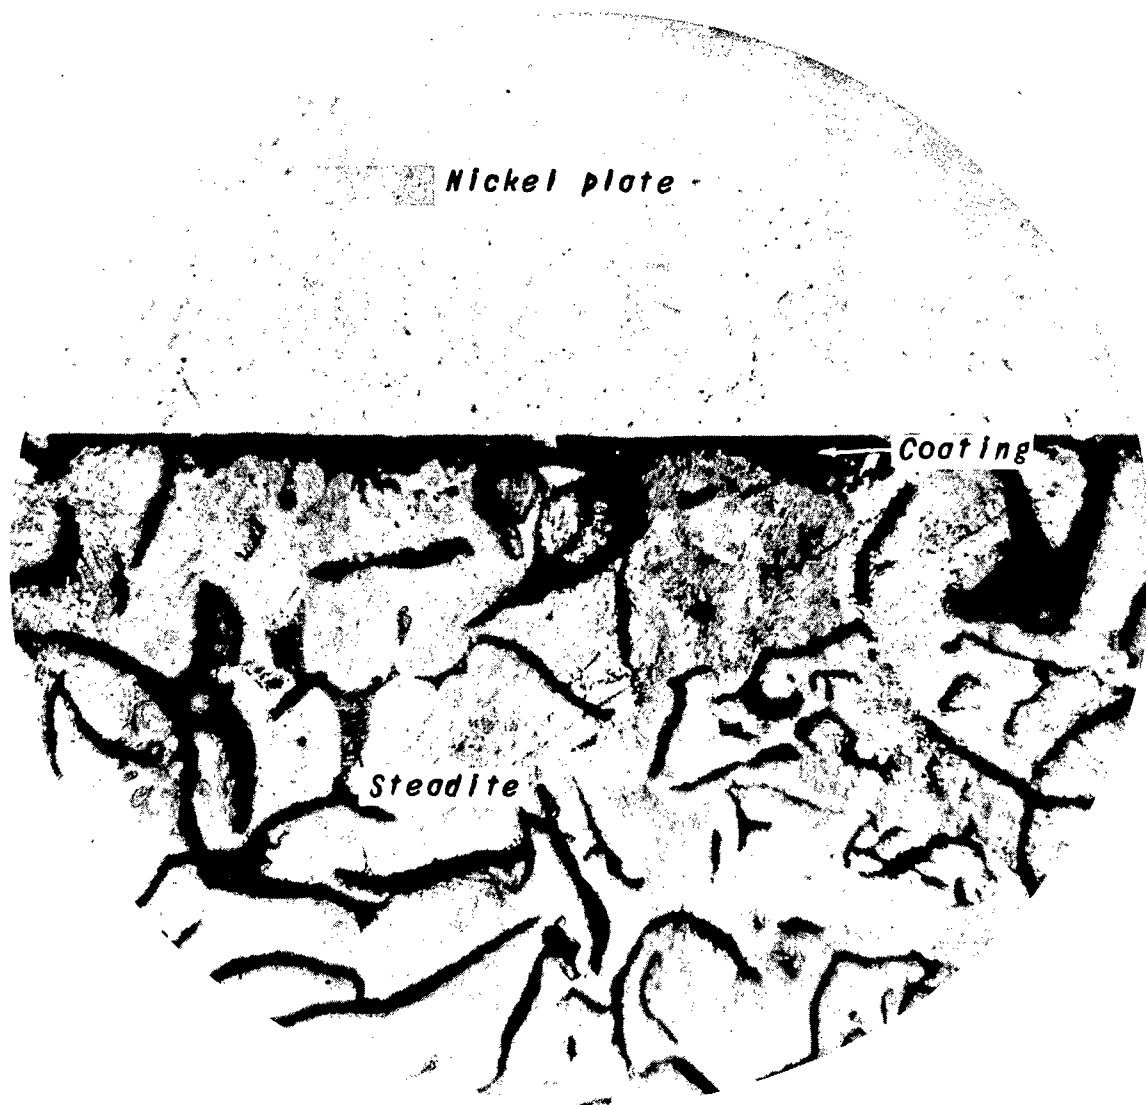
Fig. 4

*Figure 4. - Transverse section through scuffed portion of the running face of a cast-iron piston ring showing coating material after test. Same area as figure 3. Etched in hot concentrated potassium hydroxide. X1500.*

Figure 4 is a photomicrograph of the same area as shown in figure 3 but the etching reagent employed in this case was potassium hydroxide, which chiefly attacked the coating material and the steadite. The uppermost surface of the coating, despite its appearance in figure 2, was fairly smooth. The surface finish of the

scuffed areas ranged from 20 to 30 microinches, rms as compared with a surface finish of from 6 to 10 microinches, rms on a normally operated unscuffed ring. The maximum thickness of coating observed to date in transverse sections is about 0.0001 inch.

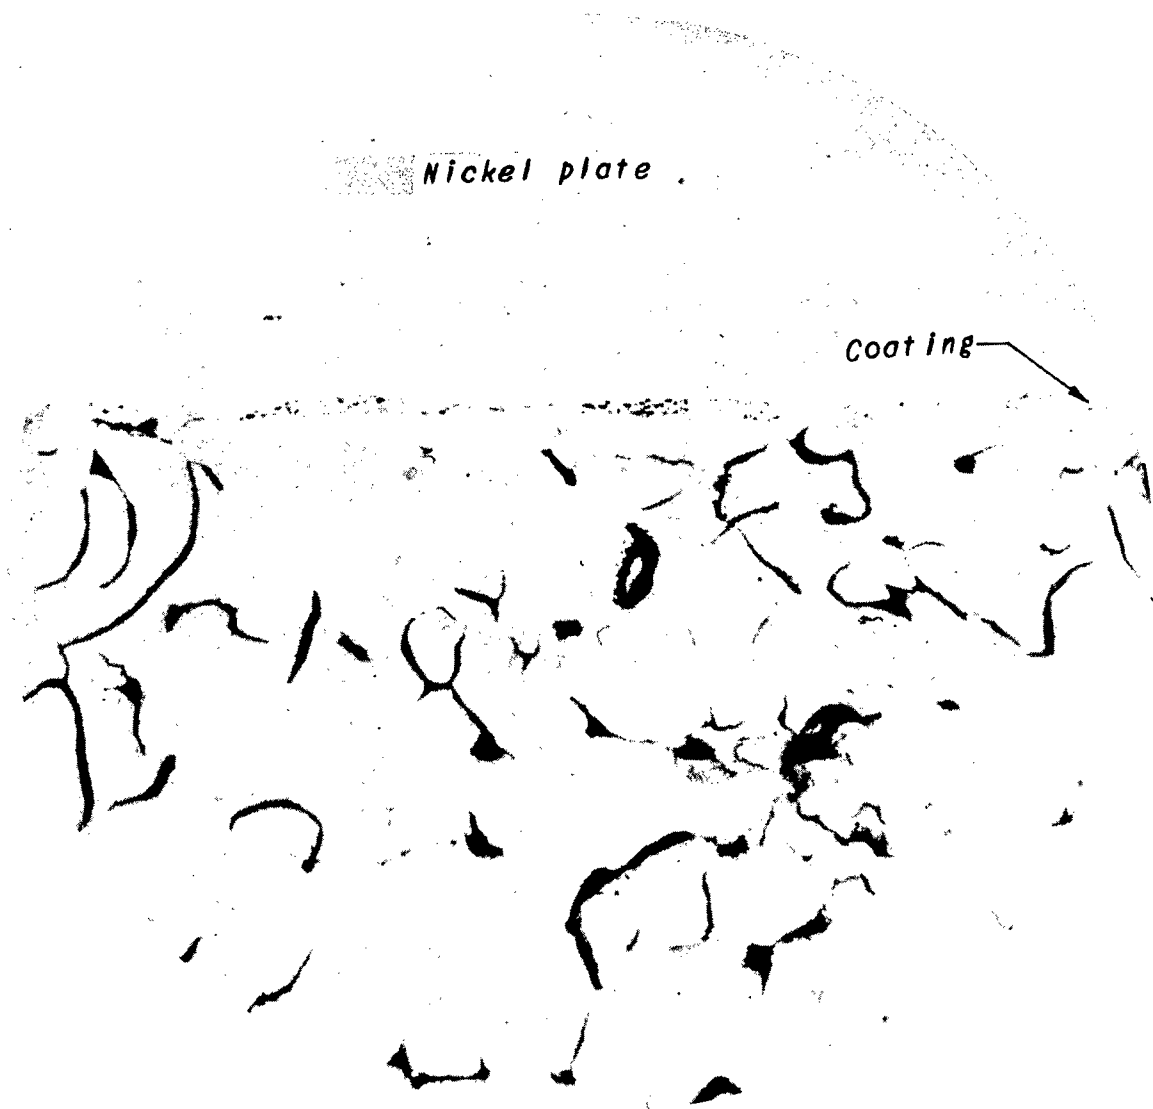
Fig. 5

Figure 5. - Transverse section through scuffed portion of the running face of a cast-iron piston ring showing coating after test. Small particles of graphite or voids are visible in the coating material. Unetched. X1500.

The coating material appears to have been formed in part from steadite that had been exposed at the surface and had flowed over the running face. The coating material and steadite exhibit about the same response to metallographic etching reagents. It is entirely possible, however, that metallurgical and chemical differences exist between the coating material and steadite as usually encountered in the ring. Although the microstructure typical of the steadite can be seen below the surface, the coating material itself and the steadite for some small distance below the surface do not manifest an optically resolvable structure. Voids or inclusions of graphite may be seen embedded at random in the coating. (See fig. 5.) The taper section shown in figure 6 indicates that the coating is far from uniformly distributed over the ring face.

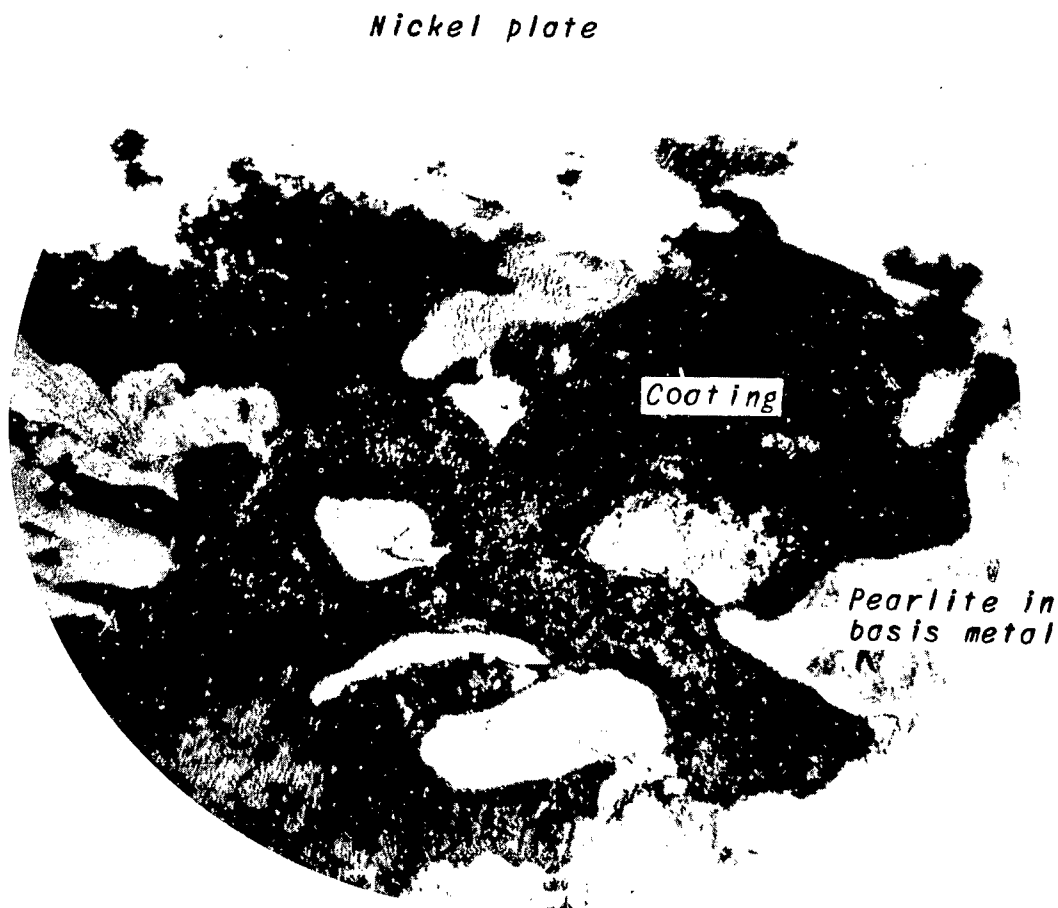
*Figure 6. - Taper section through scuffed portion of the running face of a cast-iron piston ring showing coating material after test. Etched in hot concentrated potassium hydroxide; oblique illumination; effective vertical magnification, X37,500; horizontal magnification, X1500.*

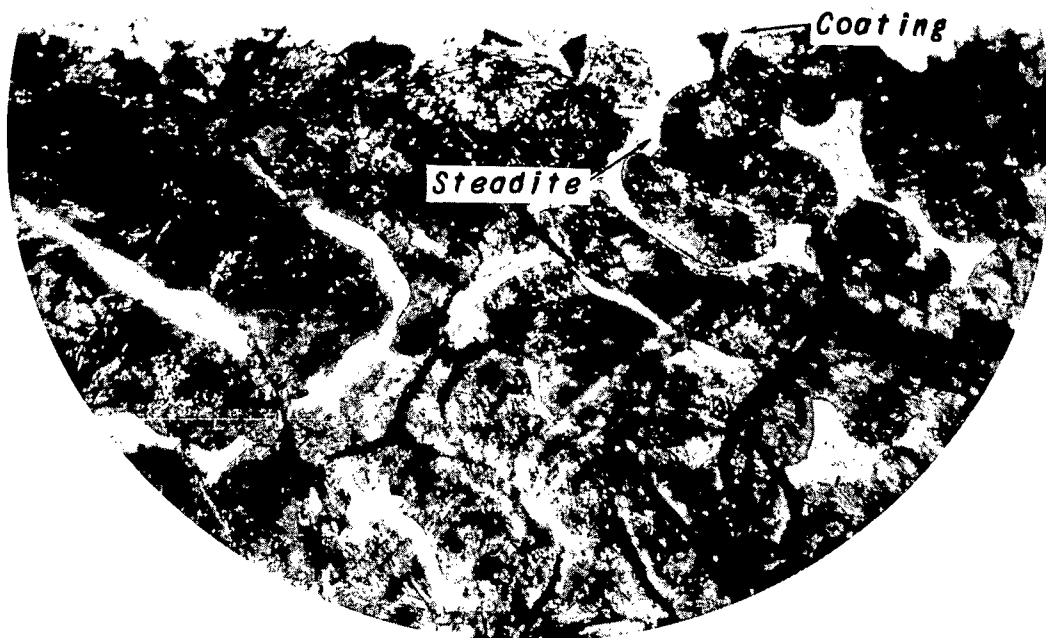
*Figure 7. - Transverse section through scuffed portion of the running face of a cast-iron piston ring showing coating material after test. Etched in nital. X1500.*

The thin coatings observed on portions of scuffed cast-iron piston rings were not easily attacked by dilute nitric acid but were visible attacked by hot concentrated potassium hydroxide. Steadite showed approximately the same chemical behavior. A transverse section of a coated cast-iron piston ring etched with nital (fig. 7) shows steadite apparently merging into the coating. Figure 8 shows the same area as figure 7, but in this case the section has been etched with hot concentrated potassium hydroxide. The apparent merging of the steadite into the coating is shown here even more clearly; it appears possible, therefore, that steadite is associated with the formation of the coating on scuffed cast iron.

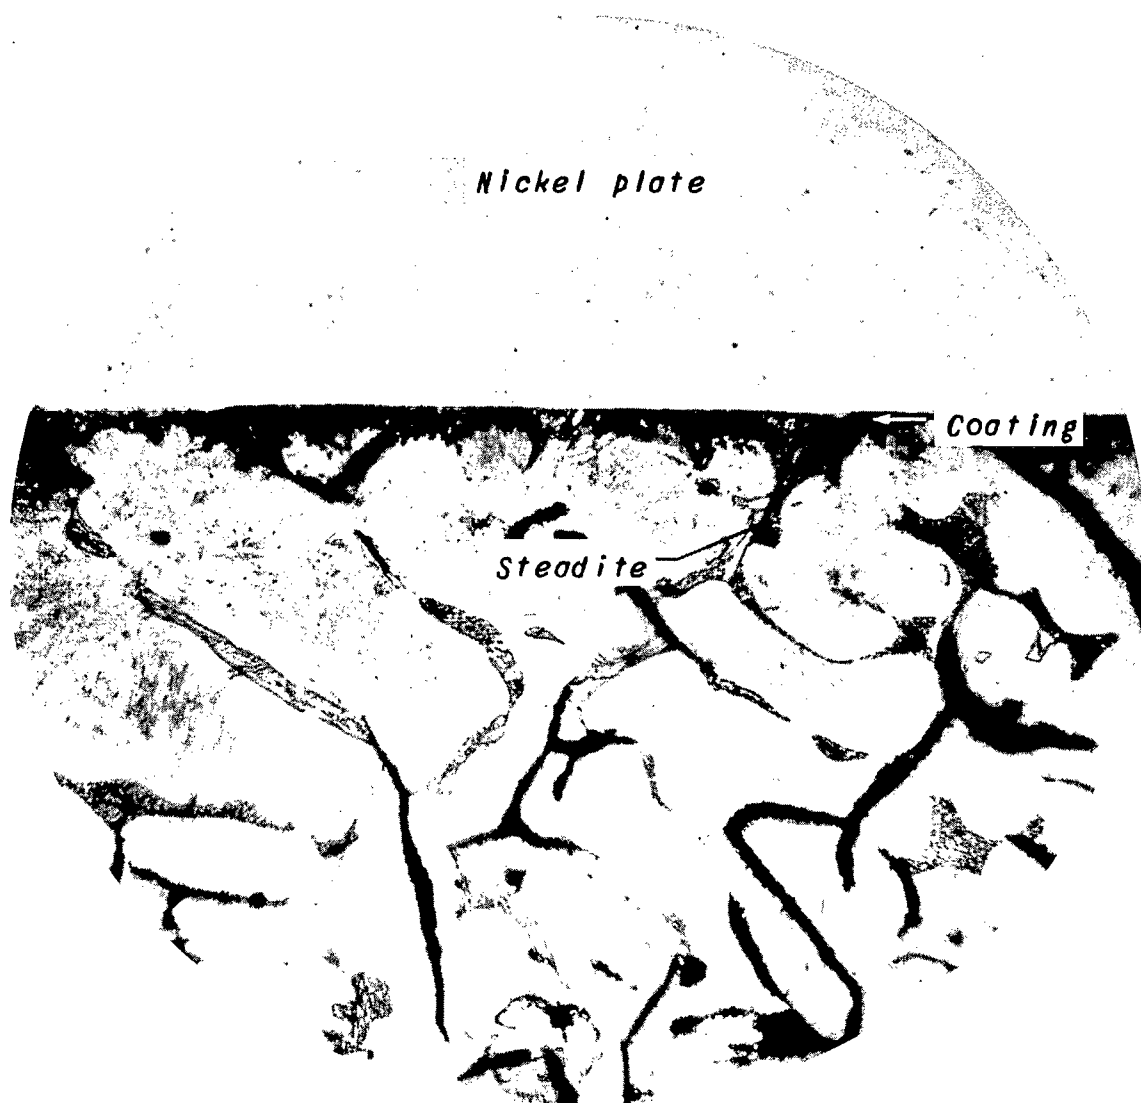
Fig. 8

Figure 8. - Transverse section through scuffed portion of a cast-iron piston ring showing coating material after test. Same area as figure 7. Etched in hot concentrated potassium hydroxide. X1500.

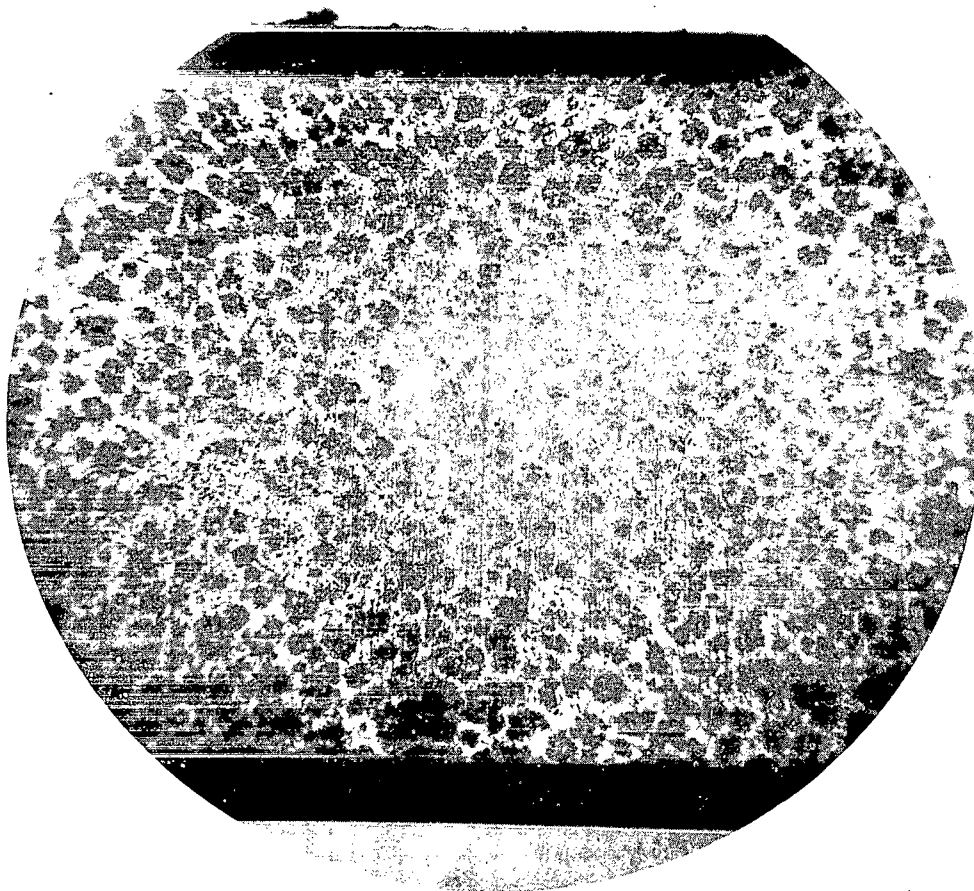
Fig. 10

*Figure 10. - Running face of a normally operated, unscuffed cast-iron piston ring. The light reflective areas are steadite. Etched with Stead's reagent. X35.*

Figure 9 presents a plan view of a new cast-iron ring face that has been etched with Stead's reagent. On the basis of results obtained from the use of Stead's reagent, it appears that a large part of the face area is composed of steadite (which is the reflective or light portion of the surface). It seems likely then, that the machining of the piston ring may cause some steadite to flow over the surface. Figure 10 shows a piston ring that has been run but has not scuffed. There is more steadite in evidence on this ring than on the new ring in figure 9. The scuffed section of ring shown in figure 11 shows more steadite than either figures 9 or 10. This evidence, also, indicates that the coating is at least partly steadite.
