NASA Contractor Report 3762

Lightning Protection Guidelines and Test Data for Adhesively Bonded Aircraft Structures

J. E. Pryzby and J. A. Plumer
Lightning Technologies, Inc.
Pittsfield, Massachusetts

Prepared for
Langley Research Center
under Contract NAS1-15884

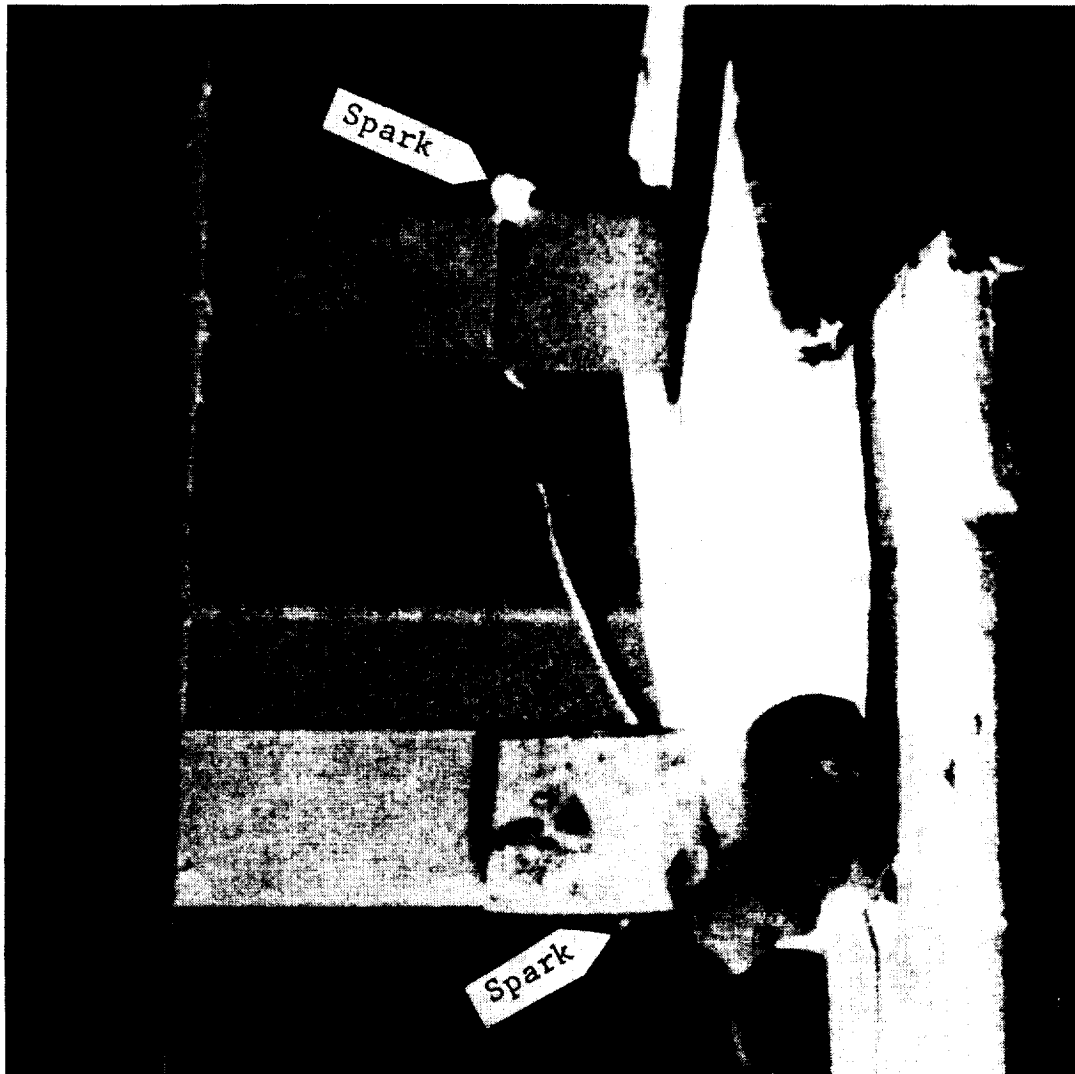
Figure 2.10 - Typical Test of Riveted Aluminum Lap Joint Specimen. Spark at 20 kA occurs at corner of bond. Reverse side of specimen is visible in mirror.

The specimens were bonded with nonconductive sealants, so that all current would be forced (initially, at least) to flow through the rivet. At moderate current levels all current is conducted through the rivet and no sparking is visible. At higher currents, of 5-10 kA per rivet, the voltage rise through the rivet path is sufficient to establish other paths, which result in visible sparks. A typical test is shown on Figure 2.10.

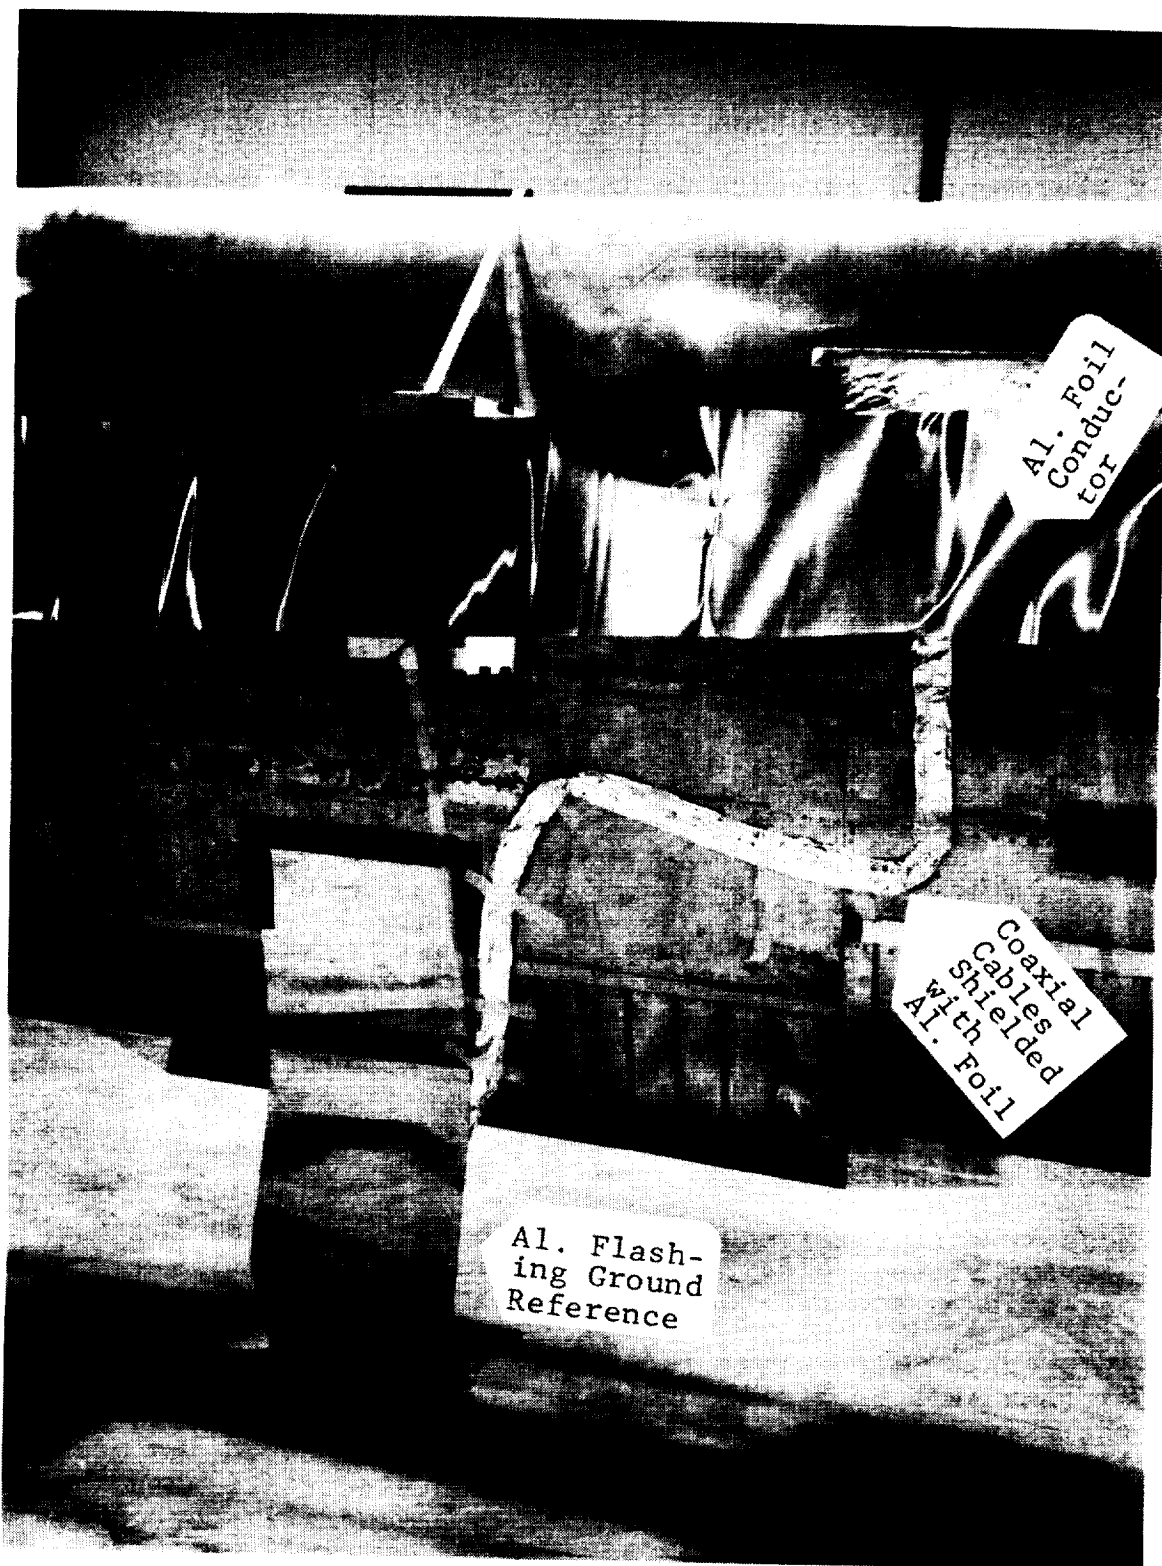
Figure 3.6 - Lab Setup for Measurement of Bond Line Voltages
on Bonded Aluminum Wing.

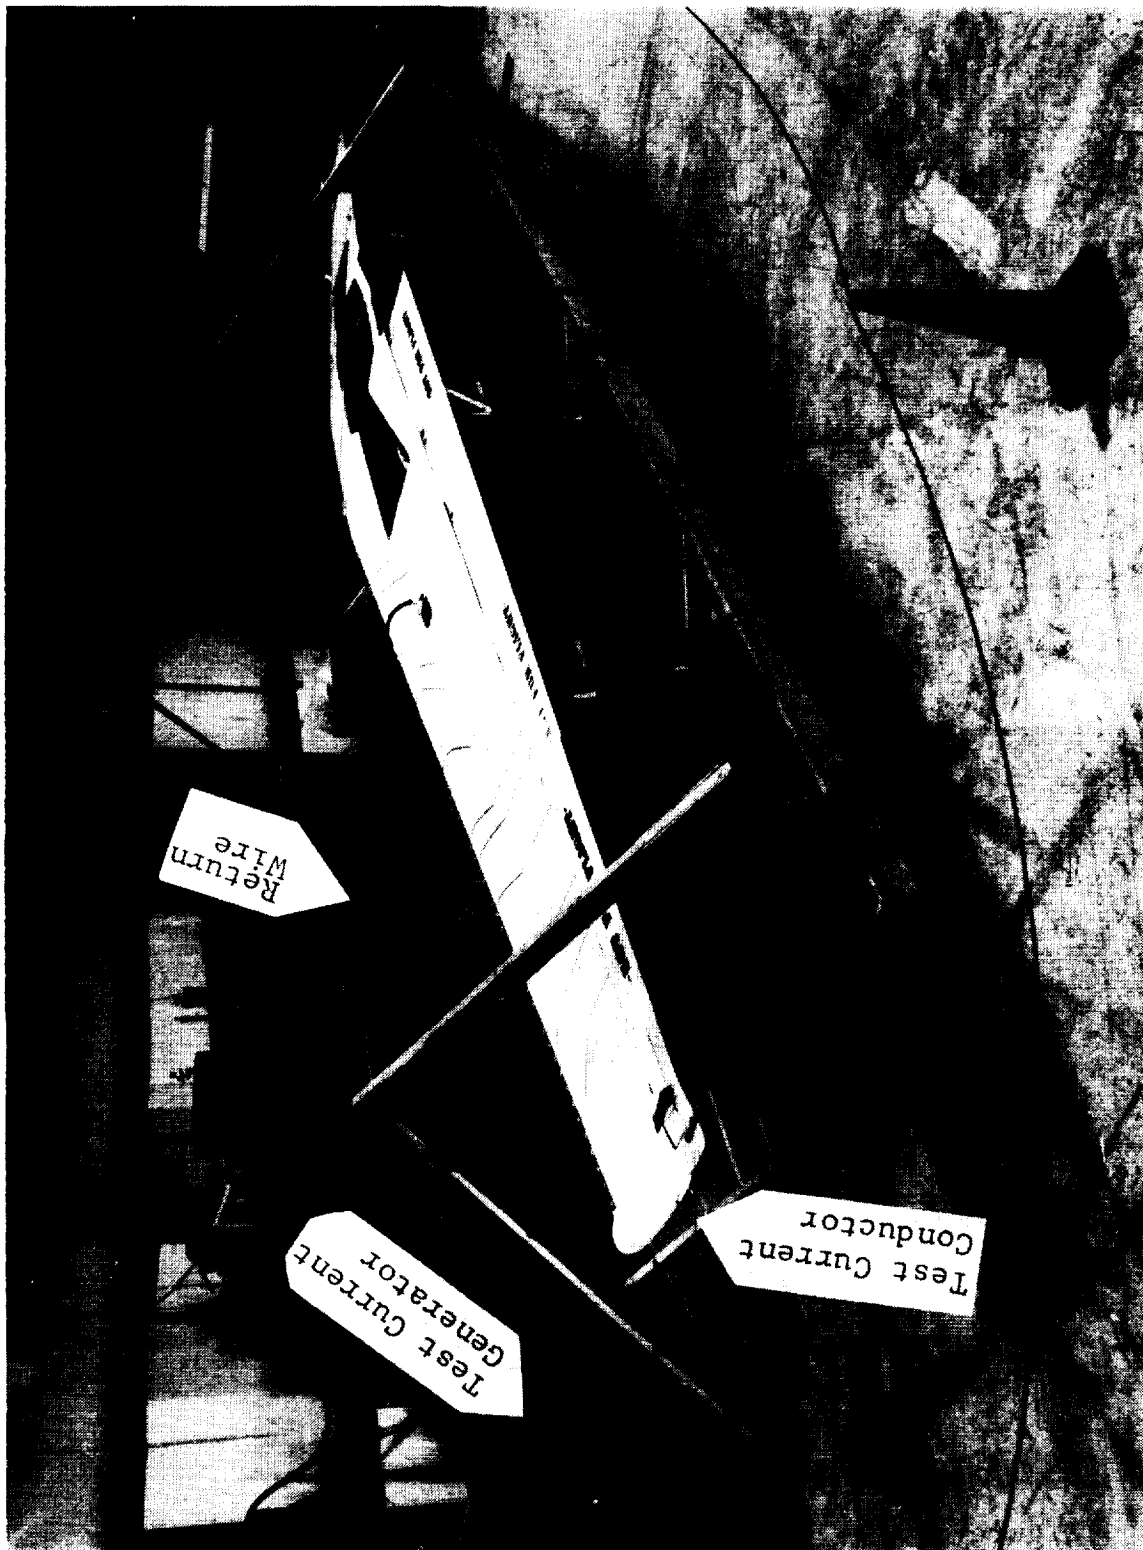
Figure 3.30 - gr/E Wing Test Setup.

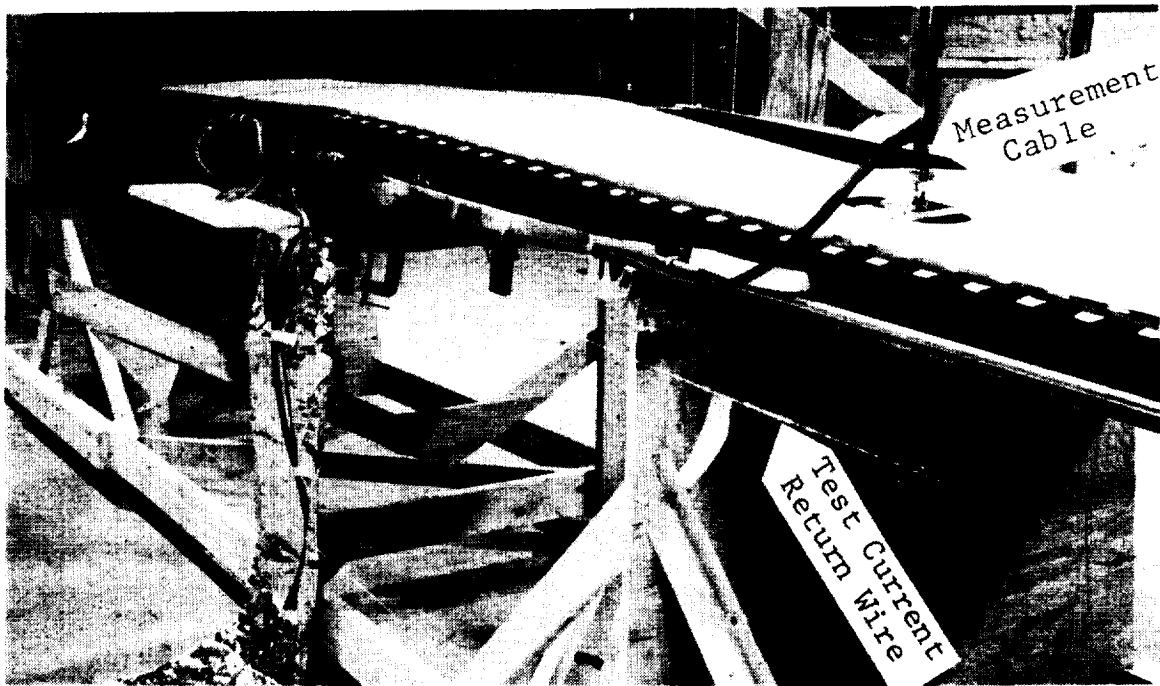
Figure 3.34 - Lab Setup for Bond Line and Fuel Probe
Voltage Measurements in gr/E Wing.
