**FLIGHT EXPERIENCE WITH SHOCK  
IMPINGEMENT AND INTERFERENCE HEATING  
ON THE X-15-2 RESEARCH AIRPLANE**

*by Joe D. Watts*

*Flight Research Center  
Edwards, Calif.*

NASA TM X-1669

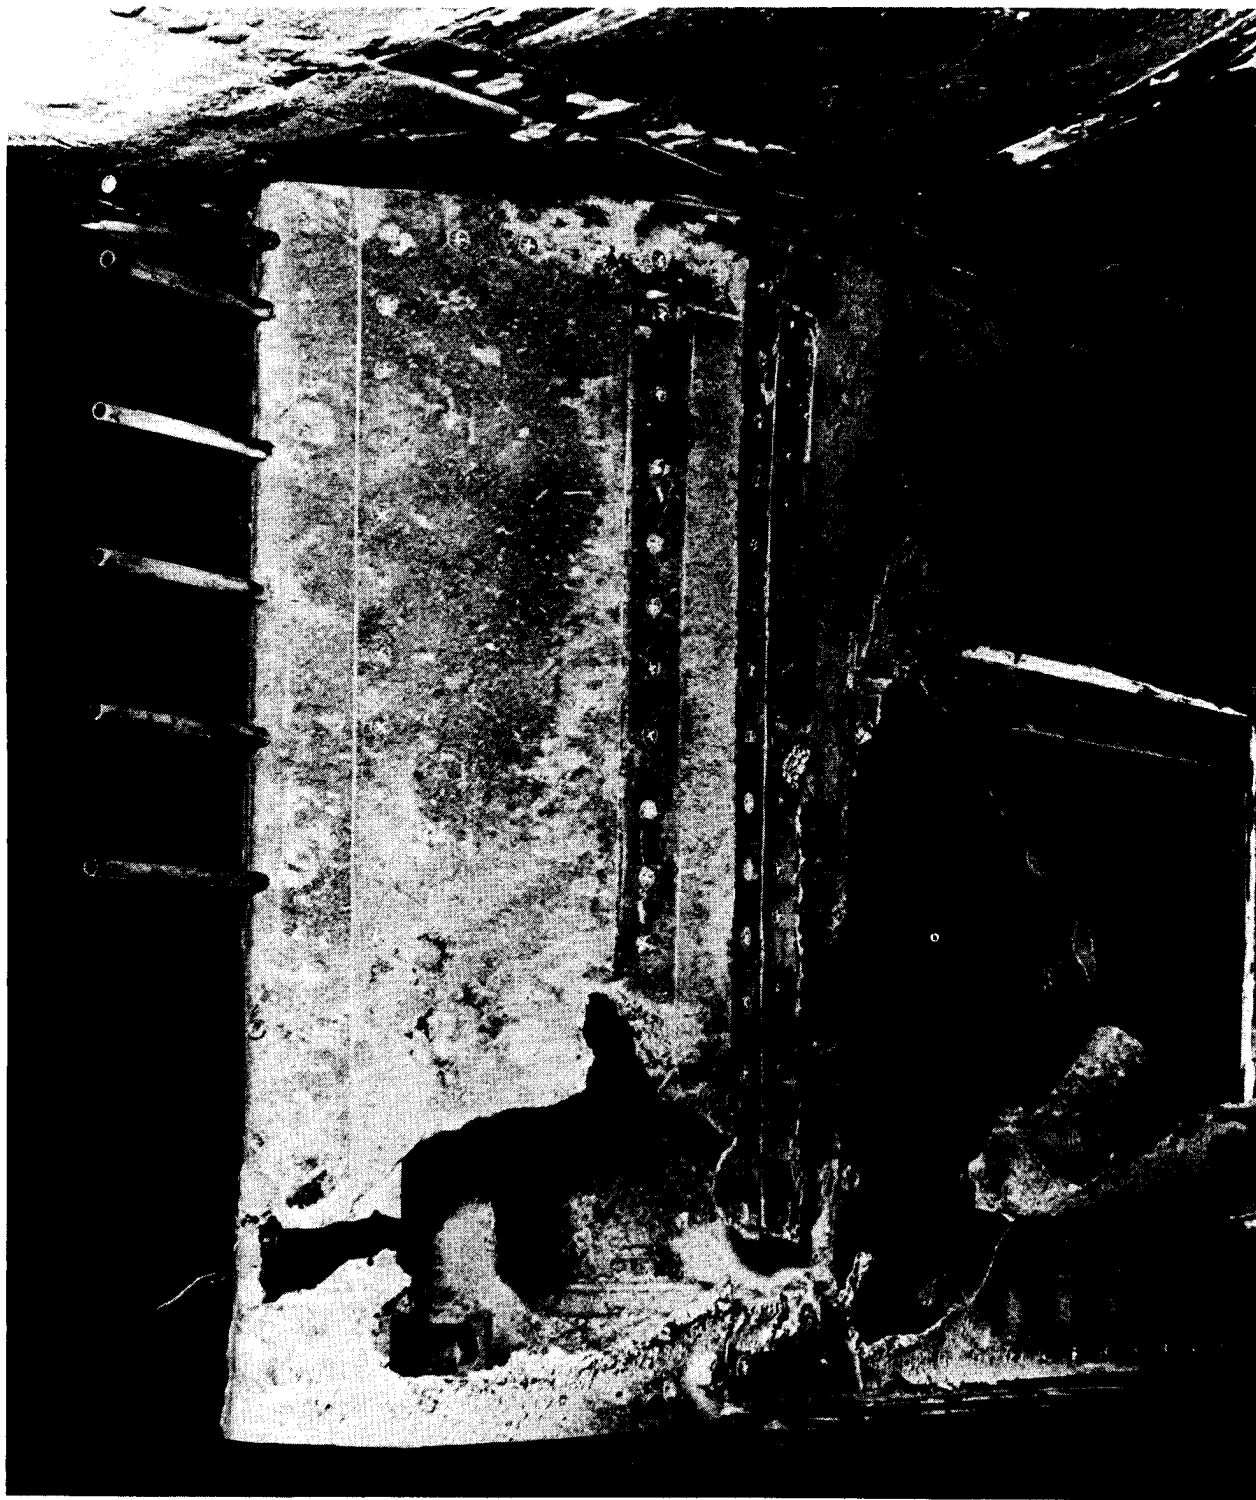
E-17526

The ablator was completely eroded away on the bottom of the fuselage around the pylon leading edge. The bare fuselage skin can be seen in figure 7. Some permanent skin deformation resulted.

(b) Left side view.

Figure 7. - Continued.
