USAARL 93-15

## Basic Principles of Helicopter Crashworthiness

Impact, Tolerance, and Protection Division

February 1993

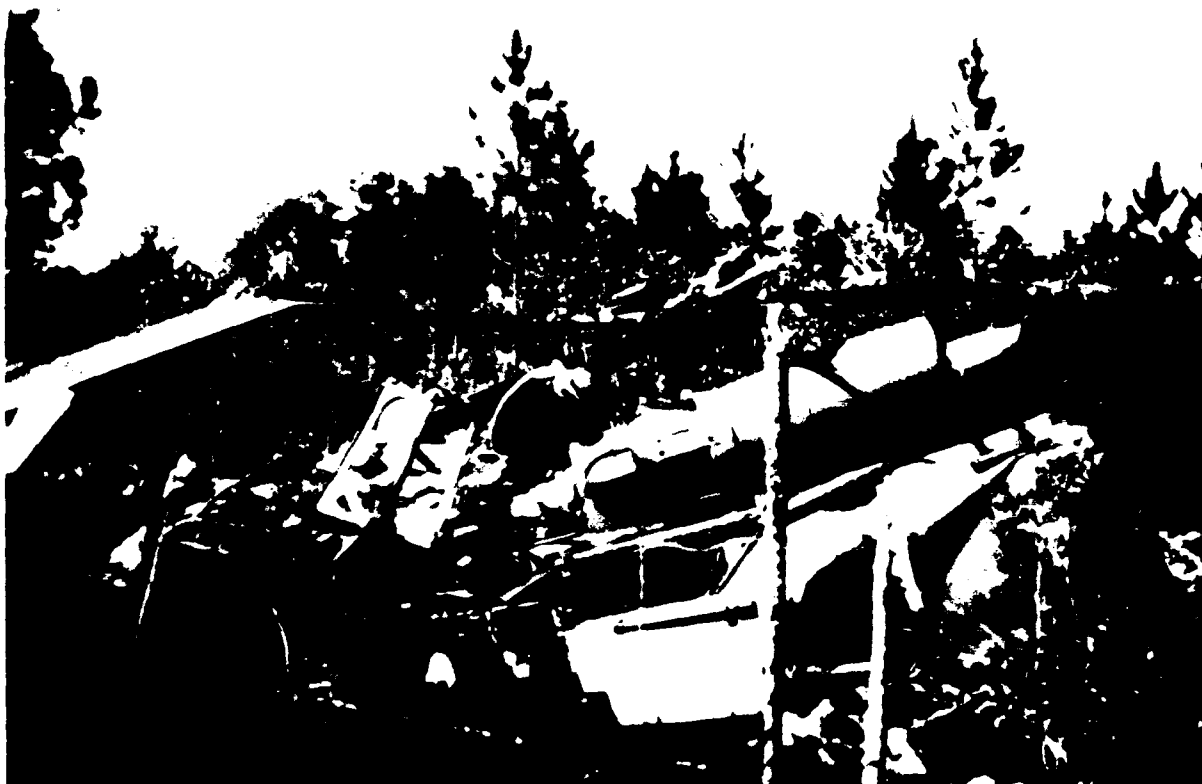
Figure 1. A crash where the roof completely collapsed, crushing the two rear cabin occupants. Surprisingly, one survived due to excellent restraint and a roof mounted, energy absorbing seat that collapsed with the roof.

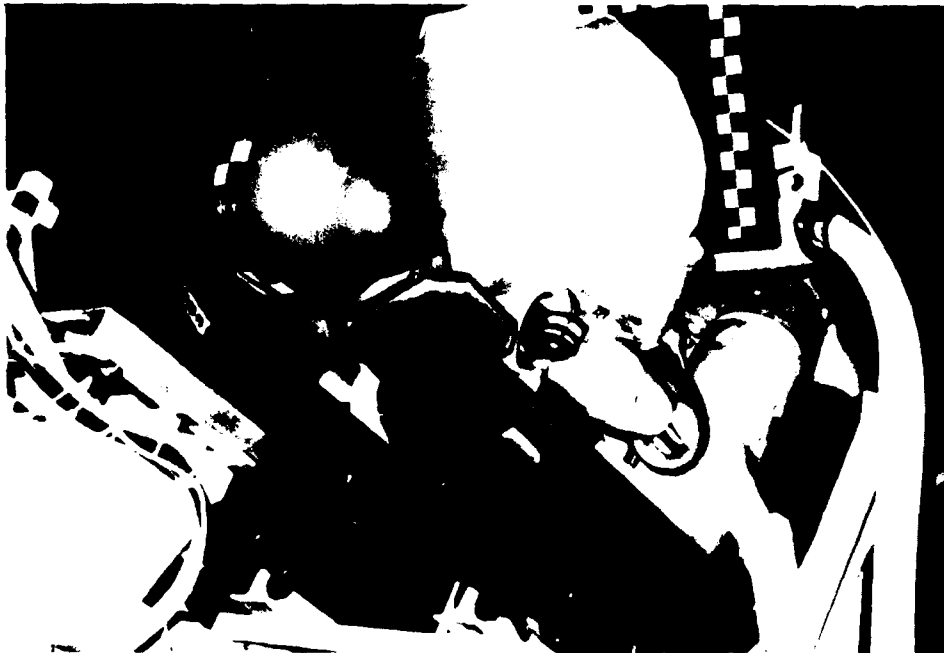
Figure 4. A U.S. Army experimental airbag system being tested in an attack helicopter cockpit mockup. The airbag is mounted on the lower portion of the gunsight.

As an adjunct to standard belt type restraint systems, the U.S. Army is currently developing multibag, airbag systems for use in some of its helicopters (Alem et al., 1991). As in the automobile, these systems have tremendous potential for reducing the incidence of flailing injuries and should be economically adaptable to civil applications (Figure 4).

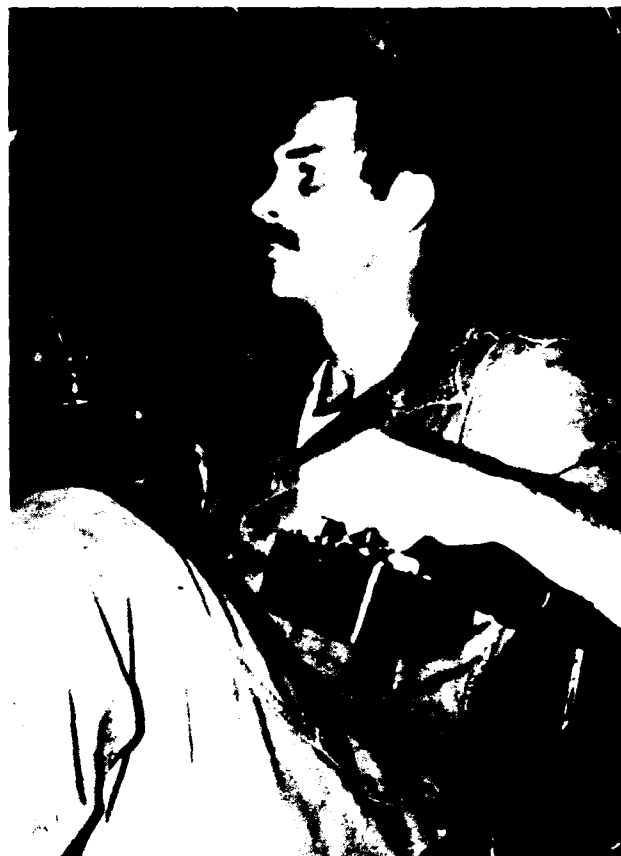
Figure 6. The proximity of the cyclic and collective controls to the pilot is accentuated in stroking (energy absorbing) seats as shown in this demonstration of a UH-60 pilot seat after a severe crash.

In designing an aircraft interior, it is extremely important to consider the local environment of the occupants at all potential seating locations (Figure 6). A person's local environment refers to the space that any portion of his body may occupy during dynamic crash conditions. Any object within that space

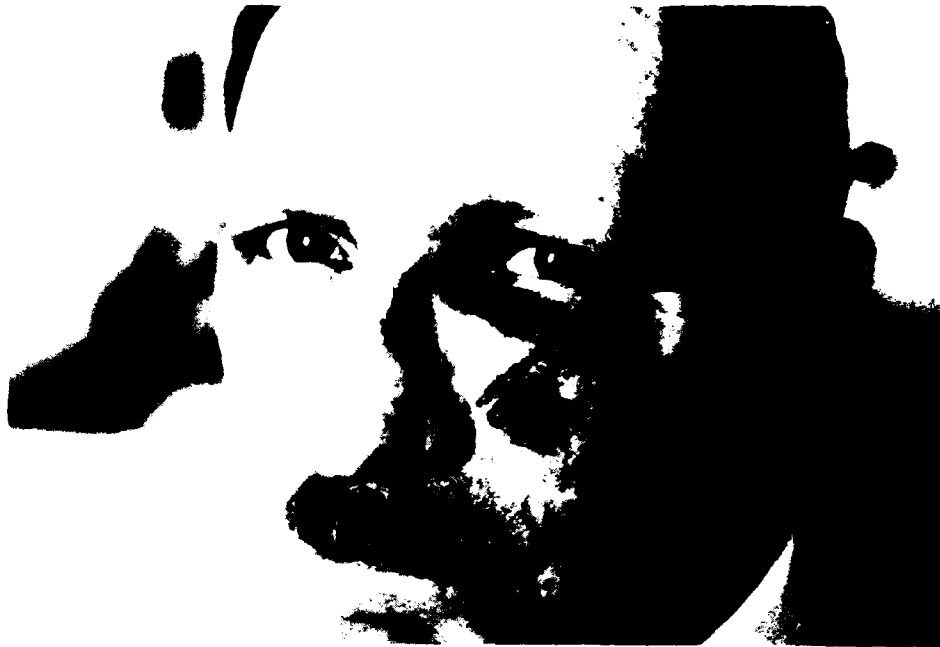
Figure 7a. Note the shapes and location of the abrasions and lacerations on the left side of the face of the pilot.

may be considered an injury hazard (Figures 7 and 8). As an example, the cyclic and collective controls can pose a significant injury hazard to pilots during a crash, particularly when the visor on the flight helmet is not worn in the down position. The volume of that space will vary depending on the type restraint system anticipated and, to a lesser extent, on the anthropometry of the expected occupants. The maximum head strike distance is reduced by about 50 percent when upper torso restraint is utilized. Clearly, the primary concern must be for hazards within the strike zone of the head and upper torso, but objects within the strike zone of the extremities also should be considered.

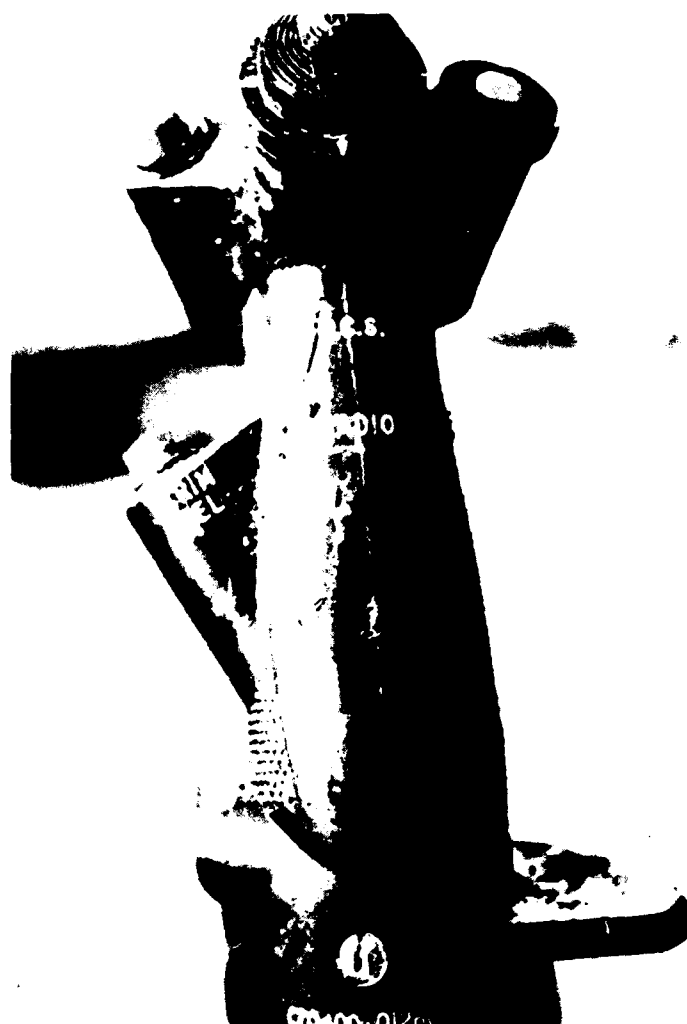
Figure 8. Cyclic control recovered from a UH-60 crash shows longitudinal gouges made by the pilot's teeth. The pilot lost several anterior teeth in the crash, but received no other serious injury.

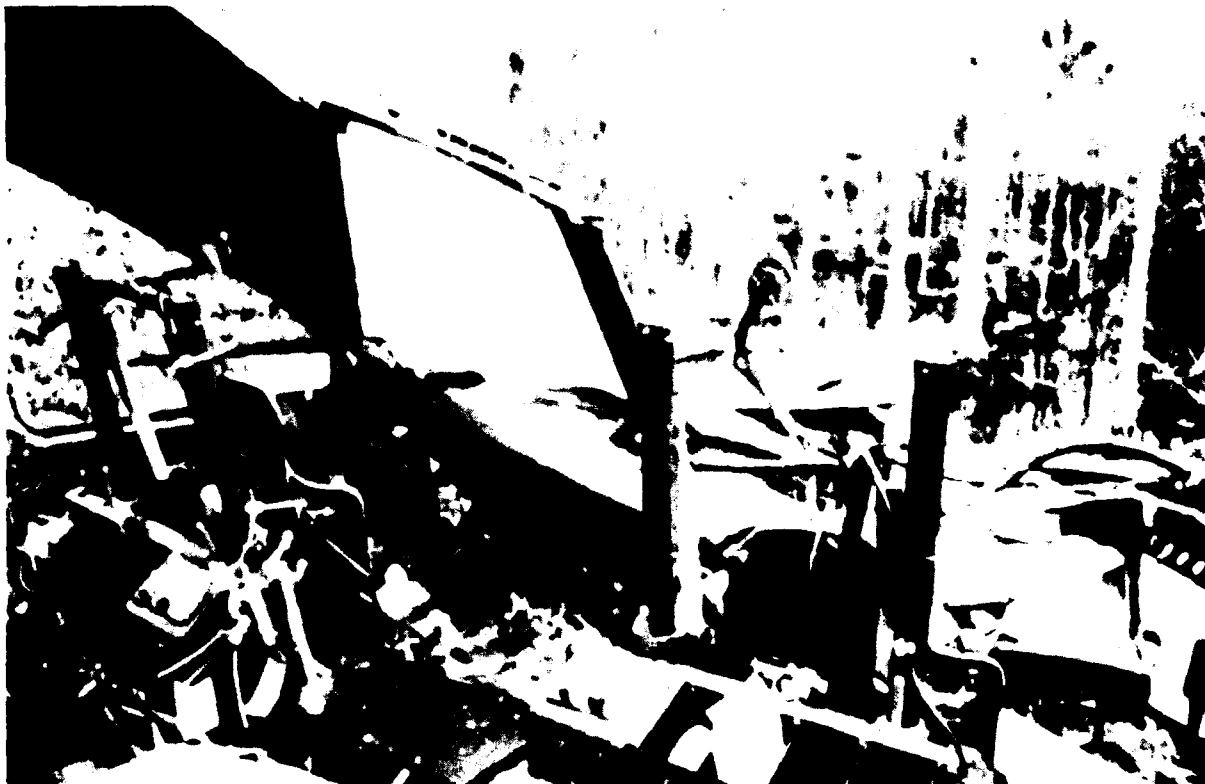
Figure 10. Both pilots survived a very severe UH-60 crash with serious injuries. Survival was due to pilots being restrained in their energy absorbing seats.
