January 1946 as
Advance Restricted Report E5L18a

SINGLE-CYLINDER ENGINE TESTS OF POROUS CHROME-PLATED

CYLINDER BARRELS WITH SPECIAL BORE COATINGS

FOR RADIAL AIR-COOLED ENGINES

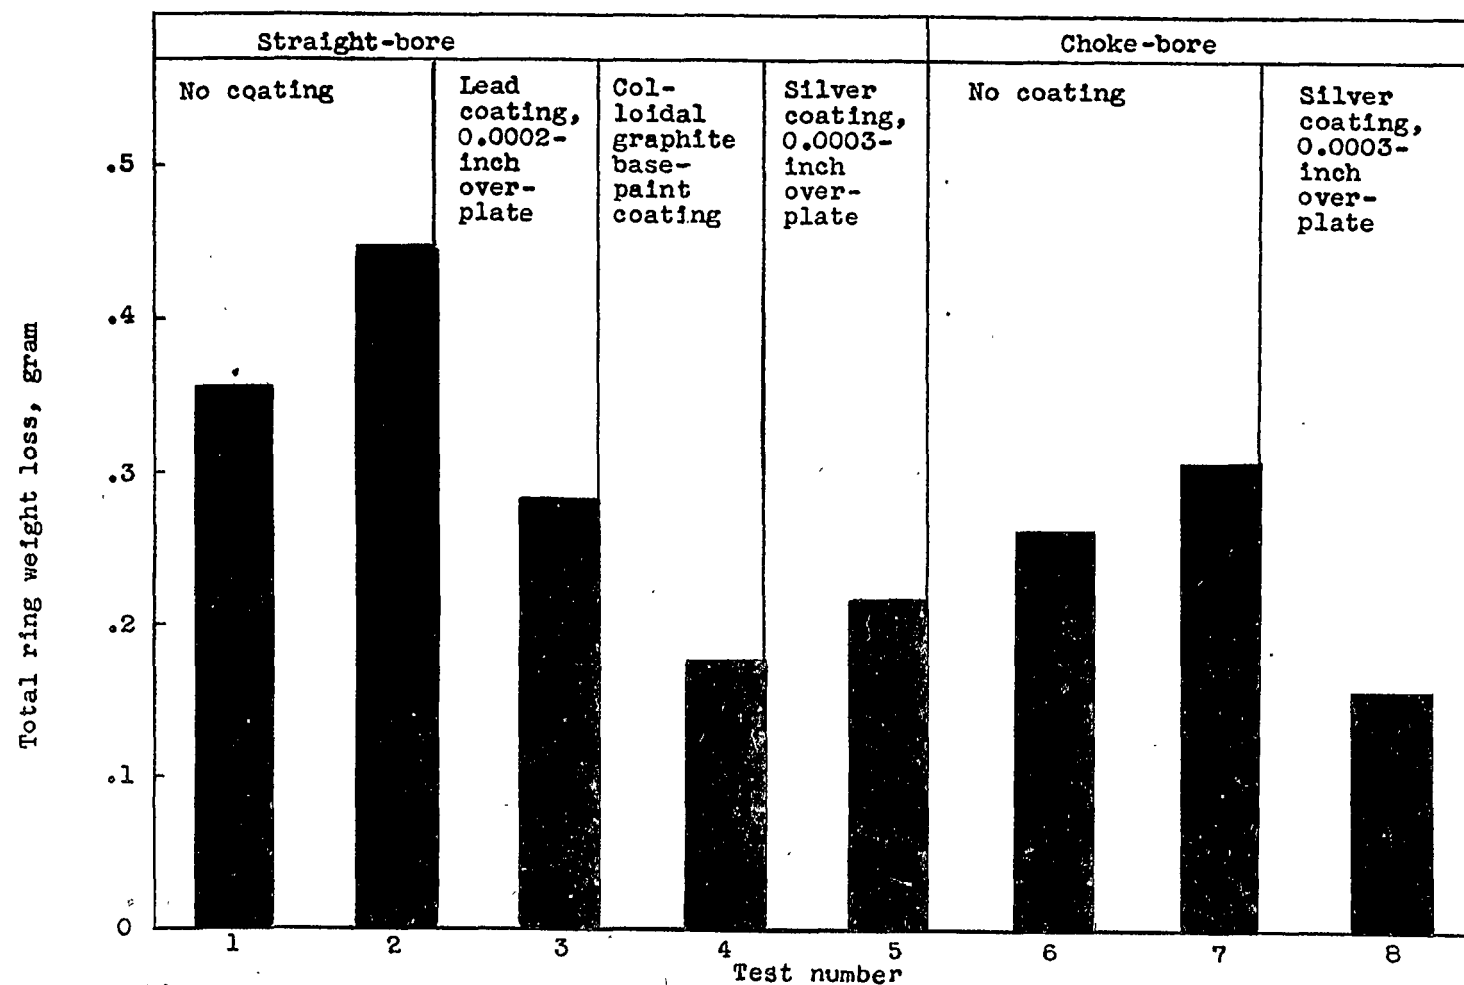
to replace a valve guide before testing.  Treating silver in this
manner will anneal it to a much less brittle condition and make it
more desirable for use as a bearing surface.  The silver had a suf-
ficiently high flow pressure or hardness so that this coating did
not have any apparent adverse effect on the run-in properties of
the piston rings.  Although it could not be accurately determined
with the test equipment used, it is possible that, inasmuch as the
coefficient of friction of silver against iron is the lowest found
for any metal combination (reference 3), engine friction may be
reduced somewhat by the use of a silver overplate as a bearing
material on the cylinder bore.  The possibility of decreased engine
friction is also indicated by the reduced ring wear obtained in the
tests of silver overplate.  (See fig. 5.)

Figure 5. - Ring weight loss in straight- and choke-bore porous chrome-plated cylinder barrels with different barrel coatings. Engine speed, 2400 rpm; brake mean effective pressure, 192 pounds per square inch.
