NASA Technical Memorandum 110267

Correlation of Structural Analysis and Test Results for the McDonnell Douglas Stitched/RFI All-Composite Wing Stub Box

July 1996

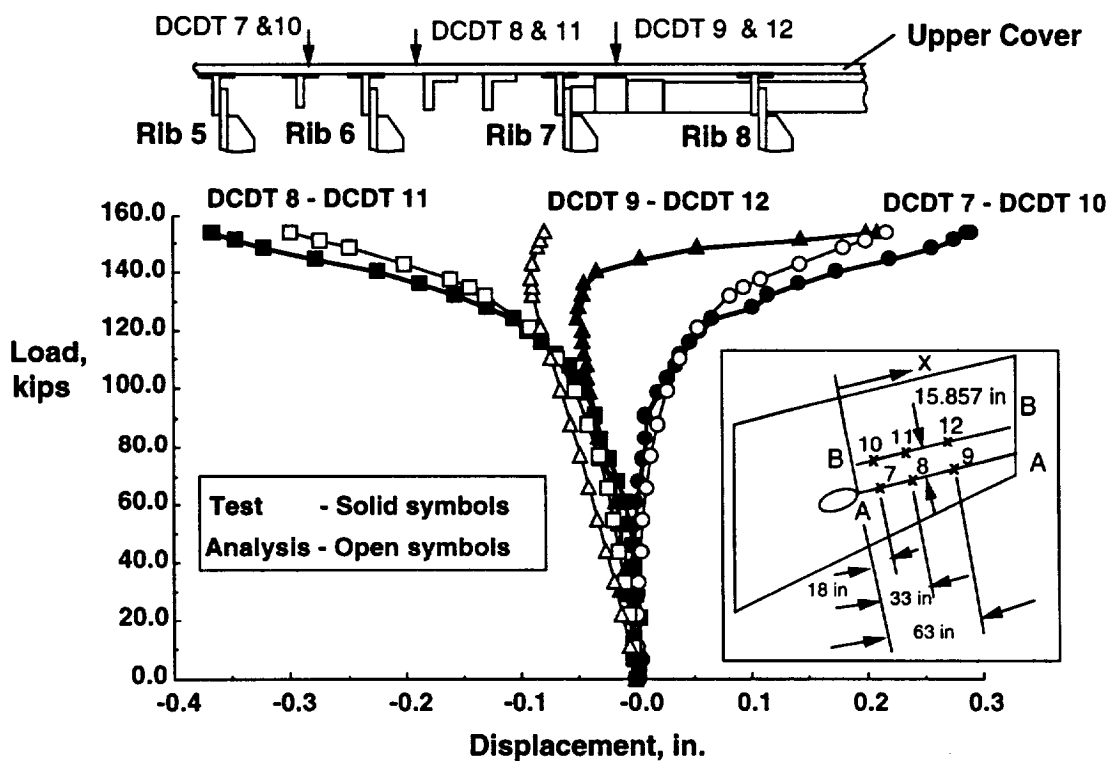
Figure 16. Relative out-of-plane displacements for DCDTs on the upper cover panel.

The experimental and analytical results correlate well for the locations 18 and 33 inches from the access-door cutout. However, the agreement between experimental and analytical results is not acceptable for the location 63 inches from the access-door cutout. An explanation of this discrepancy is presented in a subsequent section about failure.

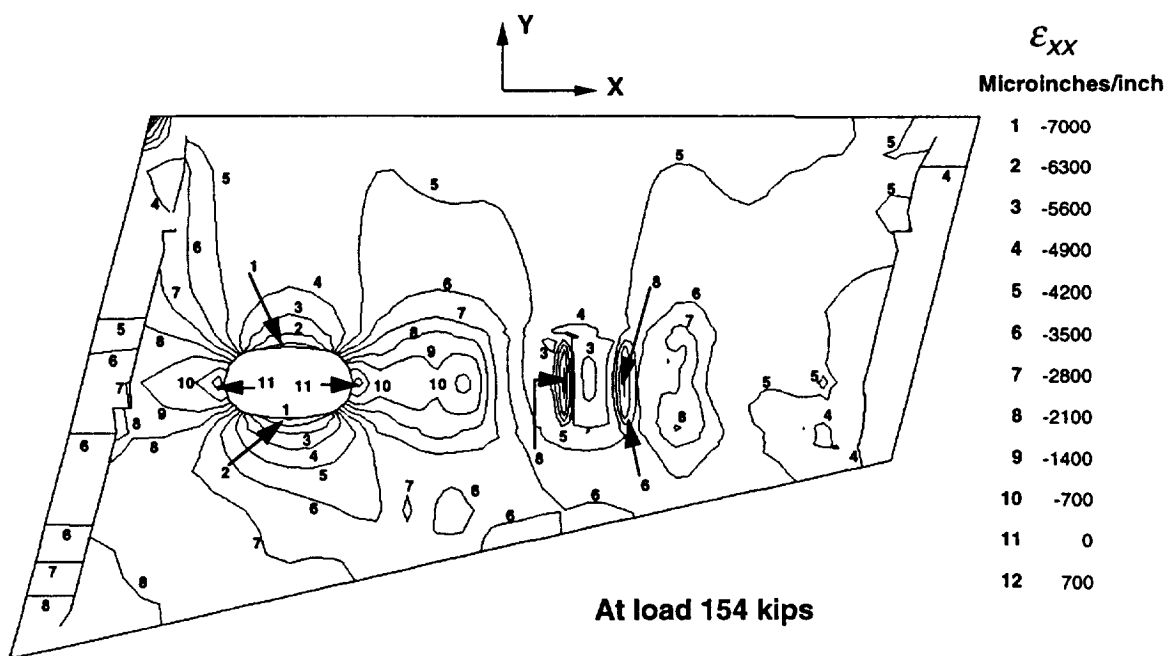
Figure 17. Axial strain contour plot for the exterior surface of the upper cover panel at the failure load.

Correlation of strain results - A contour plot of the predicted axial strains on the outer surface of the upper-cover-panel skin at an applied load of 154 kips is shown in figure 17. The axial x-direction is parallel to the rear edge of the panel. Analytical and experimental strains for strain gages 17, 20, 74, 84 and 602 are plotted in figures 18 through 22. These strain gages are located sufficiently far from the access-door cutout and the nonlinearly deformed region to be considered as far field results. In each of the figures, the hatched region in the sketch of the wing stub box is the mesh refinement region. These correlation plots indicate that the far field strains predicted by the analysis are quite accurate. High strains can be seen at the edge of the access-door cutout and in the region outboard of the access door where large nonlinear deformations occurred. Analytical and experimental strains at the strain gage locations in these regions and near the impact site are shown in figures 23-32.

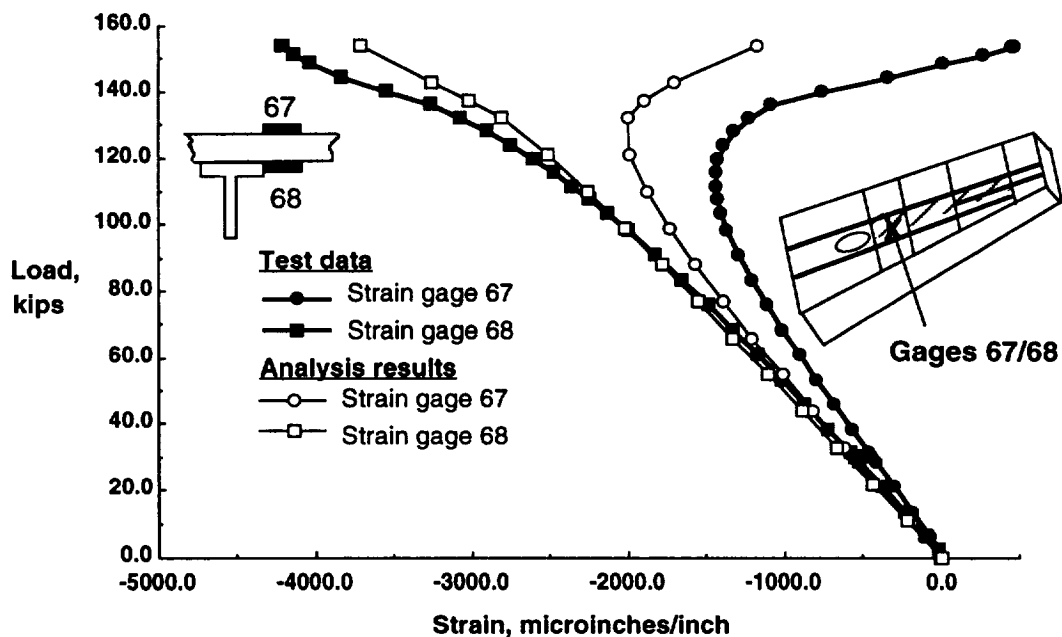
Figure 24. Correlation of strains for strain gages 67 and 68.

Predicted and measured strain results for the first and second bays outboard of the access-door cutout of the upper cover panel are shown in figures 24 through 28. The first and second bays are 18 inches wide, and they deformed nonlinearly due to the lack of longitudinal stiffeners. Results for strain gages 67 and 68 on the upper-cover-panel skin in the first bay, immediately outboard from the access door, are shown in figure 24. Results for strain gages 613 and 614 on the external skin at the edge of this bay are shown in figure 25. Results for strain gages 63 and 64 on the upper-cover-panel skin in the second bay outboard of the access door are shown in figure 26. Results for strain gages 22-24 , 607 and 608 at the edge of this bay are shown in figures 27 and 28. Results for strain gages 22- 24 at the aft edge of the nonlinearly deformed

Good correlation was obtained between experimental and analytical results in the skin and on the stiffeners for the first and second bays outboard of the access door, as shown in figures 24 to 28. The refined analysis accurately predicts strains in these two bays of the nonlinearly deformed region while the initial model did not accurately predict the nonlinear response in this region.

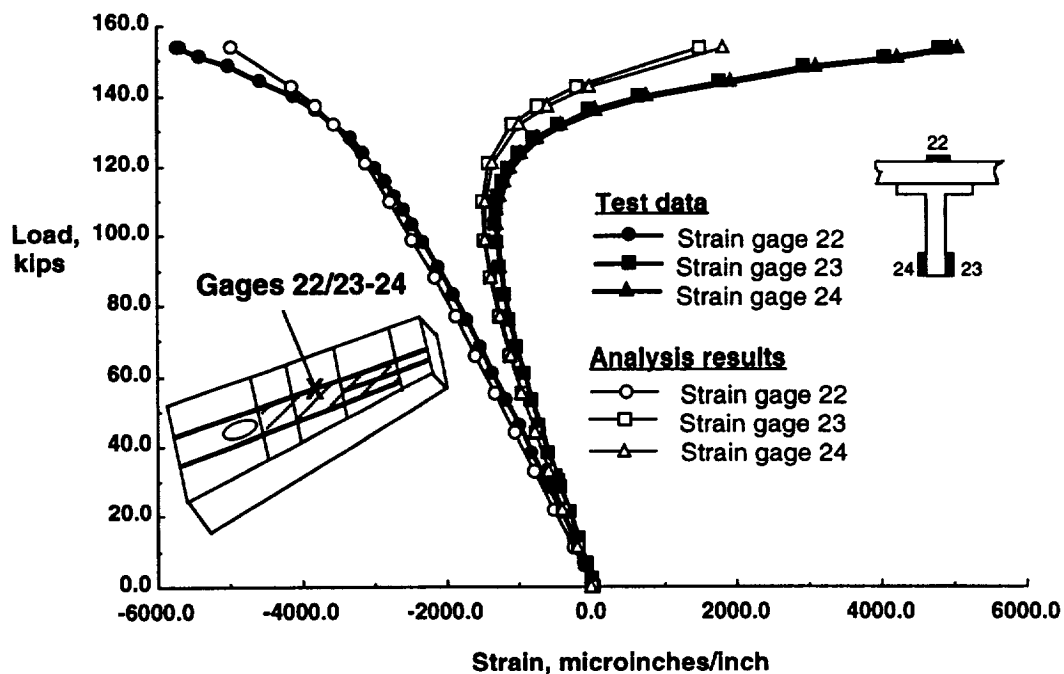
Figure 27. Correlation of strains for strain gages 22 , 23, and 24 at the aft edge of the highly nonlinearly deformed region.

region are shown in figure 27, while results for strain gages 607 and 608 at the forward edge of the nonlinearly deformed region are shown in figure 28.

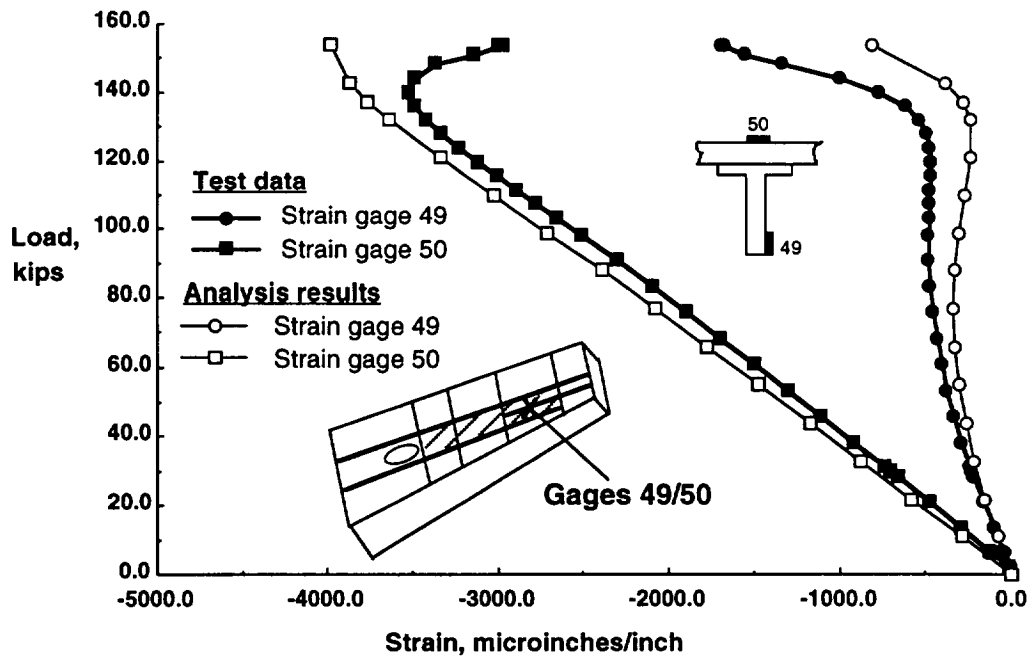
Figure 29. Correlation of strains for strain gages 49 and 50 on the runout stringer.

Predicted and measured strain results for the third bay outboard of the access door of the upper cover panel are shown in figures 29 through 32. The third bay has two stringer runouts and is also in the mesh refinement region. Results for strain gages 49 and 50, located at the center of the third bay outboard of the stringer Runout 3 (see figure 3), are shown in figure 29. Strain results for gages 51 and 54, located at the forward edge of the third bay inboard of the stringer Runout 2, are shown in figure 30. The correlation between experimental and analytical strain results shown in figures 29 and 30 is good.

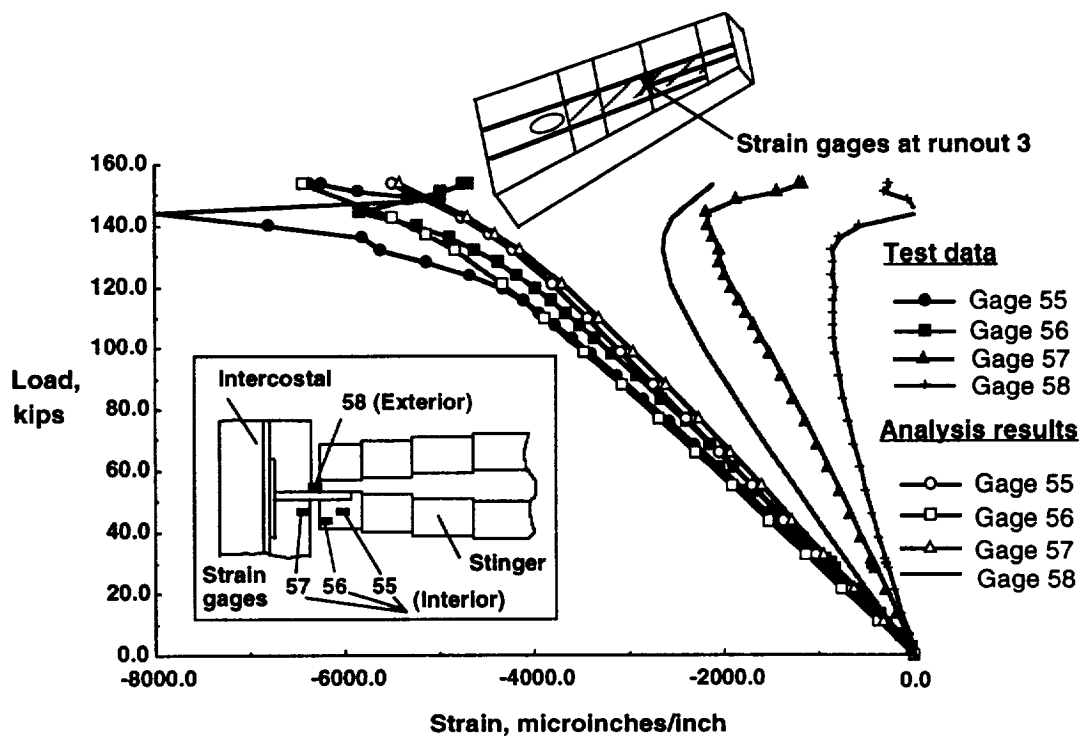
Figure 31. Correlation of strains for strain gages 55, 56, 57, and 58 at stringer runout 3.

Strain results for internal strain gages 55, 56 and 57 and external strain gage 58 near stringer Runout 3 are shown in figure 31. Strain gages 55 and 56 are located on the stringer flange. Good agreement can be seen between the analytical and experimental results for the stringer-flange strain gages for loads less than approximately 130 kips. The erratic strains recorded at loads above 130 kips by strain gages 55 and 56 indicate that a local failure has just occurred at this load level. The analysis predicts significantly more strain than was recorded by strain gage 57 on the intercostal flange, and by strain gage 58 on the external surface of the skin. The correct trend is predicted on the external surface, including the nonlinear behavior. However, for loads below 130 kips, the strain recorded by gage 57 on the intercostal flange is linear, but it is much less than the predicted strain. The discrepancy between analytical and experimental strain results from gage 57 may be attributed to that this gage was placed right next to edge of a intercostal flange (see insert in figure 31), and the discontinuity of thickness may cause the inaccurate strain predication at this location.

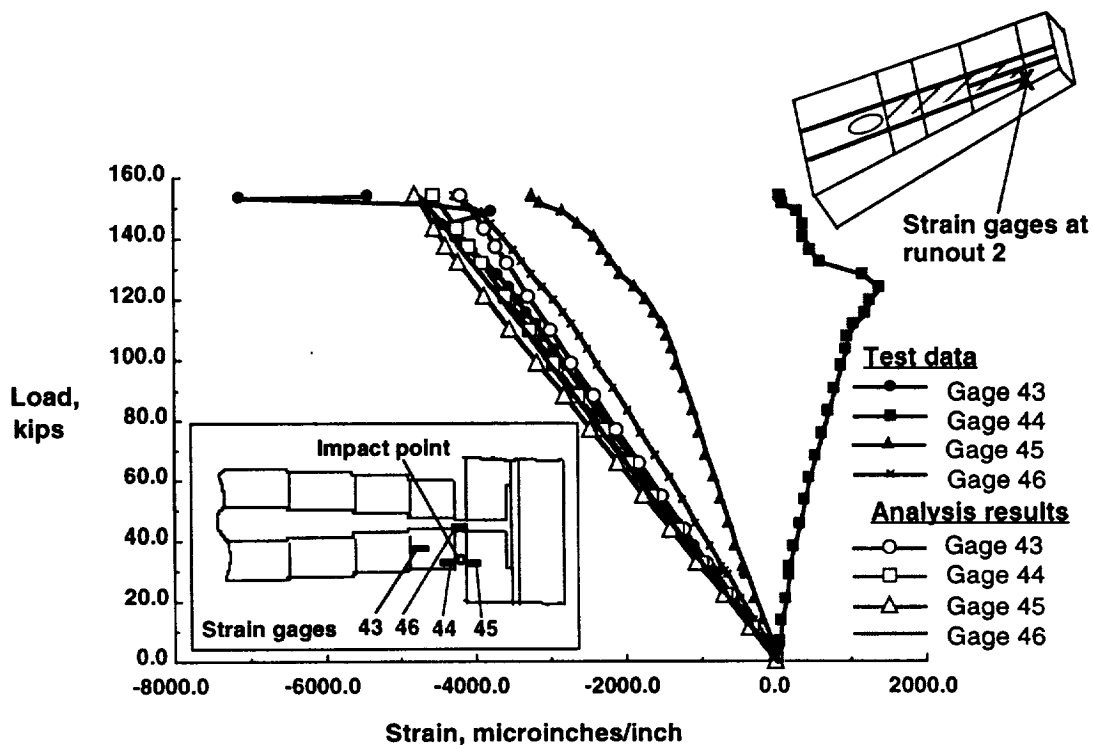
Figure 32. Correlation of strains for strain gages 43 through 46 at stringer runout 2.

Strain results for gages 43 through 46 on the upper cover panel in the stringer Runout 2 region are shown in figure 32. Poor correlation for strain gages 44 and 45 is very likely due to this location being subjected to a 100 ft-lb impact damage to the external skin prior to the final test. Strain gages 44 and 45 are located on interior flanges less then 0.4 inches from the impact site. The data recorded for these two strain gages from this final test are not the same as in previous

tests (as described in reference 3 for these previous tests involving no impact damage at stringer Runout 2). Since the analysis does not consider damage in this region, correlation between the final test results and analytical results should not be expected for strain gages 44 and 45. Strain gages 43 and 46 are approximately one inch from the impact site, where little damage would be expected. For loads below 120 kips, linear behavior is observed for strain gage 43, which is mounted on the flange of the runout stringer, and the experimental and analytical data correlate well. At higher loads, some nonlinear behavior is observed in the experimental results and significant discontinuities in the data can be seen at loads of approximately 140 kips and 145 kips, indicating local failures and load redistribution. However, no such discontinuities can be seen in the external strain gage, gage 46. Further discussion of this apparent interior local failure is presented in a subsequent section on failures.

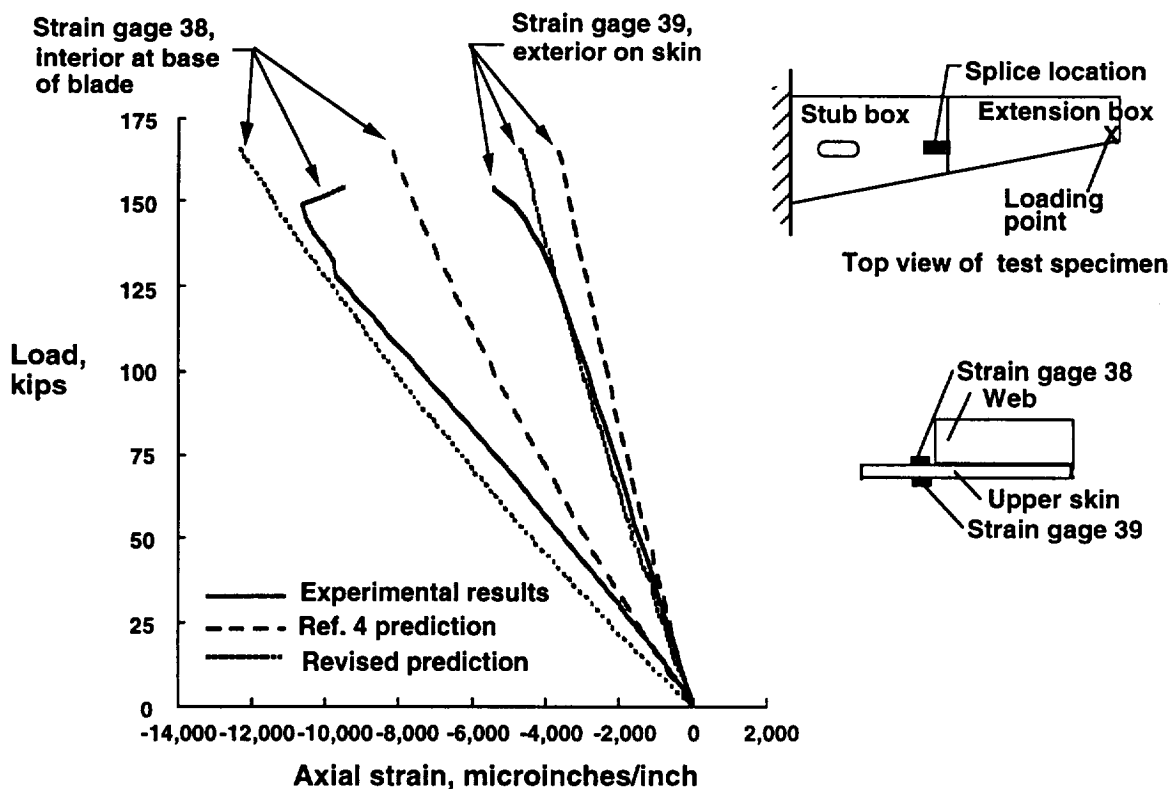
Results of the pre-test finite element local analysis in the vicinity of strain gages 38 and 39 are presented in reference 4. The initial finite element model was refined by increasing the number of elements of the skin at the base of the terminated stringer web (see figure 9). Details of the analysis procedure, which were reported in reference 4, were not changed for the new analysis and are not repeated here.

Strain gage 38, interior at base of blade

Strain gage 39, exterior on skin

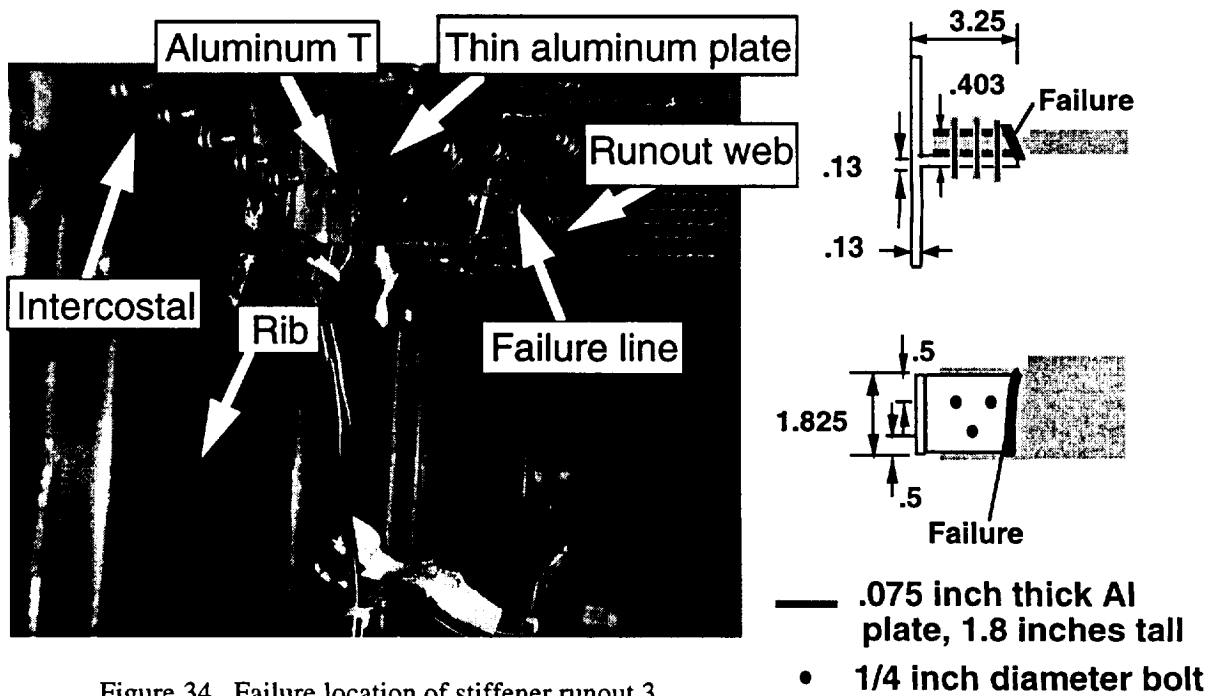
Figure 34. Failure location of stiffener runout 3.

Test results indicate that catastrophic failure of the stub box occurred when the upper-cover-panel skin failed through the impact site at stringer Runout 2. Post-test evaluation of the test article revealed local failures in both stringer Runouts 2 and 3 (see figure 8 for locations). These failures occurred in the thinnest portion of the web and flange of the stringer runout. The failure at stringer Runout 3 is shown in figure 34. While the stringer separated from the skin, no skin failure is evident at stringer Runout 3. Displacement and strain gage data at stringer Runout 3 indicate that an initial failure may have occurred at a load of approximately 135 kips as evidenced by discontinuities in the readings of strain gage 55 which is on the stringer runout flange, as shown in figure 31. However, no measured axial strain in this region is greater than the allowable strain. Shear strain in the stringer runout web was not measured experimentally, but analytical results indicate the presence of high shear strains in the thinnest portion of the stringer runout web, at the failure location. A contour plot of the shear strain at the failure load in the stringer runout web is shown in figure 35. The analytical results indicate that the shear strain alone would have been enough to induce failure prior to the maximum load of 154 kips applied to the test article.

The behavior of stringer Runout 2 is similar to the behavior of stringer Runout 3. The present model, which does not account for the reduction of stiffness in the impact damage zone near stringer Runout 2, predicted that the maximum shear strain at the failure load in the stringer web at stringer Runout 2 is 0.01069 which is about 15% below the shear allowable. However, when other factors, such as the axial strain in the stringer web and the increase of stringer web load due to the reduction of load carrying capability of the impact damage zone, are taken into consideration, failure of the stringer web at the stringer Runout 2 is likely. Indeed, the discontinuity of strain results from strain gage 43 indicate that a local failure occurred at 140 to 145 kips (see figure 32). An analysis that assumed the stiffener web at stringer Runout 2 had failed predicted an increase in the skin axial stress resultant of about 3.6% in the stringer runout region. The catastrophic failure of the box involving the skin failure at stringer Runout 2 occurred at a load of 154 kips, thereby implying that the stringer runout web failure did not immediately propagate into the skin. The test of an intermediate wing box, which has the same stringer runout design as the stringer runouts in the stub box, resulted in the same failure mode, as described in reference 10. A video camera inside the intermediate wing box confirmed this analytically-based failure scenario. It recorded the failure progression at that stringer runout and the failure of the thin web and flange occurring well before the failure of the skin. Strain gage

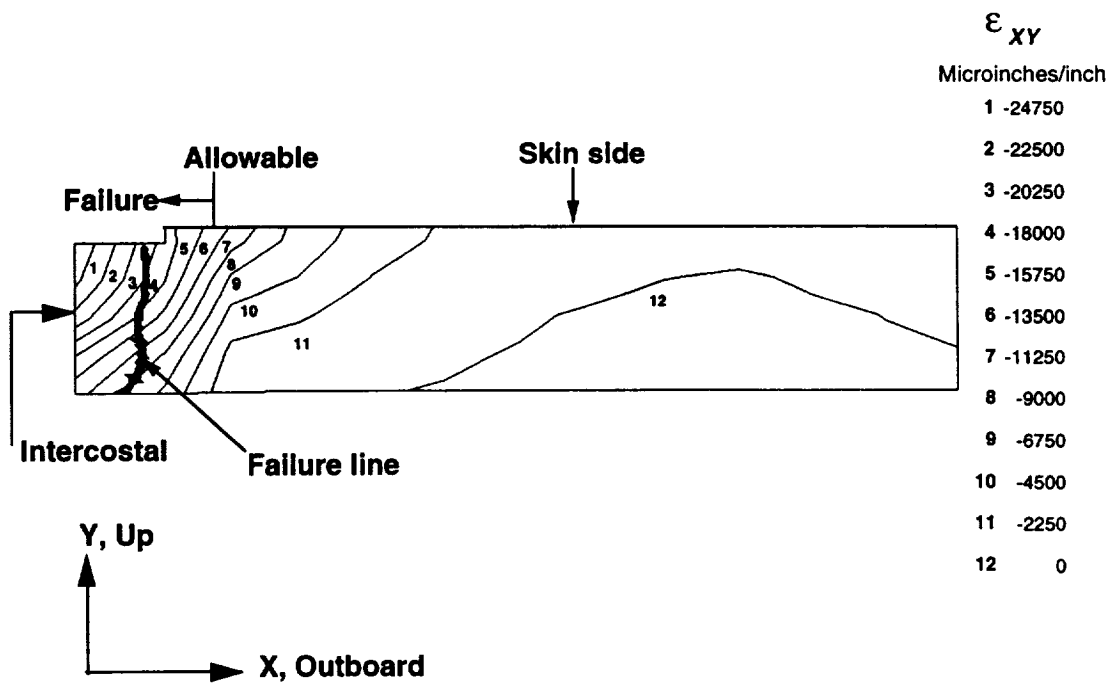
Figure 35. Shear strain contour plot for stringer runout 3 at the failure load.

The upper cover panel of the stub box contains two critical stringer runouts. One of these runouts is located outboard from the access-door cutout in the nonlinearly deformed region. The other critical stringer runout is located near the front spar. Only the runout near the front spar was impact damaged. The analysis indicates that the high shear strains in both these stringer runout webs exceeded the material allowable and led to local stringer web

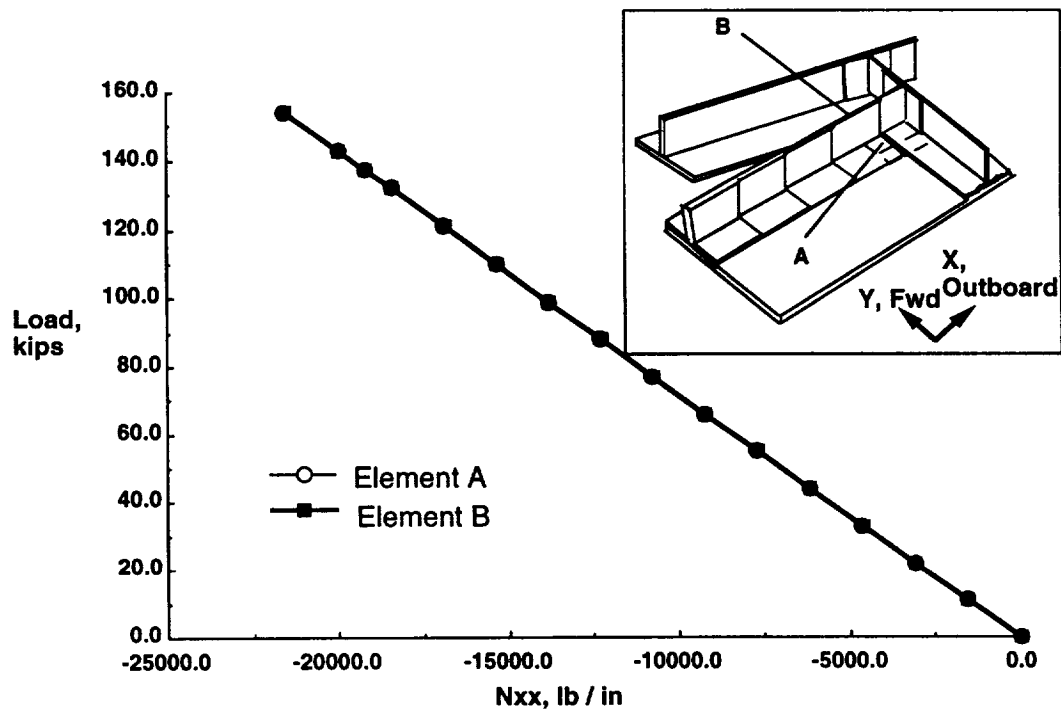
Figure 36. Axial stress resultants for elements on the stringer flange near stringer runout 2.

In order to determine whether the failure at stringer Runout 2 was activated prematurely by the large deformation in the upper-cover-panel skin and the failure in stringer Runout 3, axial stress resultants in the upper cover panel were computed by the analysis. Analytical results for axial stress resultants in the vicinity of stringer Runout 2 are presented in figures 36 through 38. The axial stress resultants, N_{xx}, for the elements in the thinnest section of the stringer runout flange, for the skin elements next to the intercostal flange, and for the elements in the intercostal flange are shown in the figures. Results for all of these elements indicate linear behavior for the complete load range. No evidence can be seen in these elements of any influence of the large nonlinear deformation elsewhere in the upper cover panel. Hence, the large nonlinear deformations in the upper cover panel appear to have no influence on the final failure.
