ASC-TR-2010-5002

**THREATS TO AIRCRAFT STRUCTURAL SAFETY,
INCLUDING A COMPENDIUM OF SELECTED
STRUCTURAL ACCIDENTS / INCIDENTS**

**Engineering Directorate (ASC/EN)
Aeronautical Systems Center**

**MARCH 2010
Final Report**

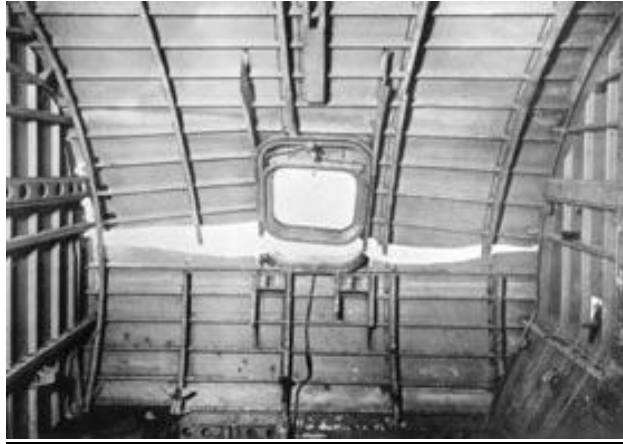
so as to achieve large critical crack sizes. If the structure had been designed to be fail-safe to today's standards initial manufacturing defects could have been tolerated without resulting in catastrophic failure. Figures illustrating this lack of crack containment capability of the fuselage structure (i.e., lack of fail-safety) and photographs taken as part of the failure investigation are shown in Figure A5.

Figure A.5: Uncontained Running Cracks Caused the Breakup of this Hydro Test of the Retired Comet 1 (G-ALYU). Cracks Propagating from Forward Escape Hatch on the Port Side. Note that No Straps or Shear Tied Frames were Used. No Crack Arrestment Capability was Provided by this Construction. [A2]

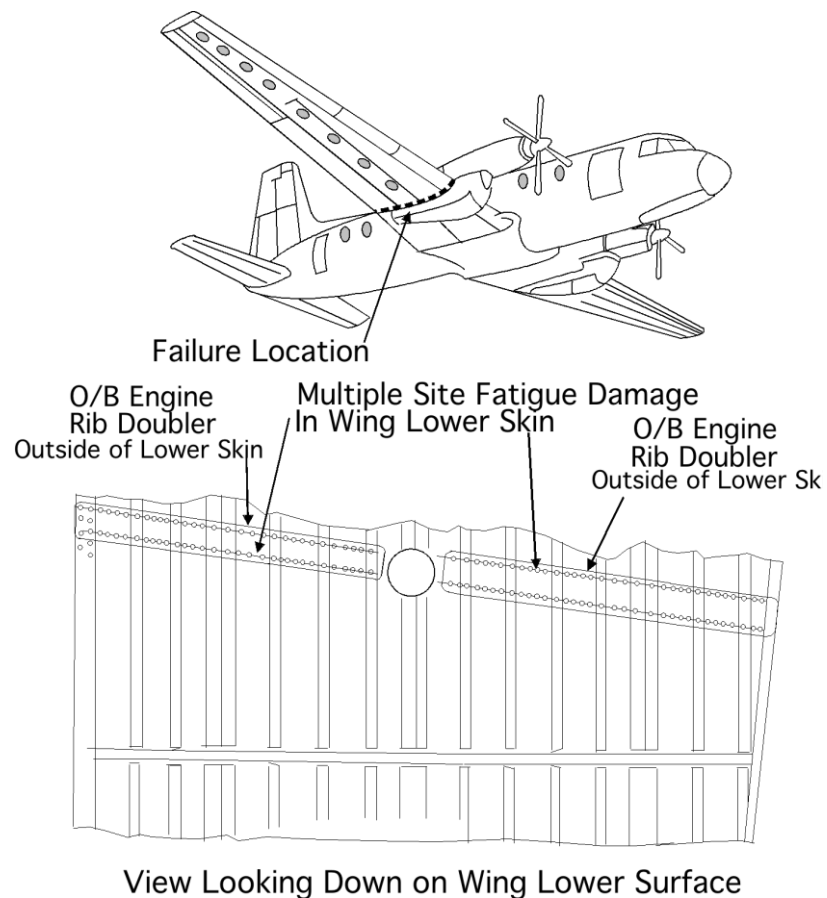
Figure A16: Sketch of AVRO 748 Aircraft Illustrating Failure Location

The Argentine state owned oil company, Yacimientos Petroliferos Fiscales (YPF), was making a domestic staff-transfer flight in its AVRO (Hawker Siddeley) 748 aircraft on April 14, 1976, when the right hand wing failed followed by the right hand tailplane. The airplane was flying at an altitude of 4,000 feet at the time of the structural failure causing the airplane to crash killing the 31 passengers and 3 crewmembers. The accident occurred 22 miles north of the Cutral airport in Argentina. The airplane had accumulated a total of 25,753 hours at the time of the accident. The cause of the failure was fatigue cracking in multiple rivet holes in the lower wing skin (between stringers 3 and 12) under external reinforcing doublers at the outboard engine rib. See Figure A16. The multiple site damage, MSD, was due to the local stress concentrations caused by fastener loads not accounted for in the original design. The fasteners attaching the external doublers to the skin were loaded in the spanwise direction as a result of strain compatibility between the skin and doublers.

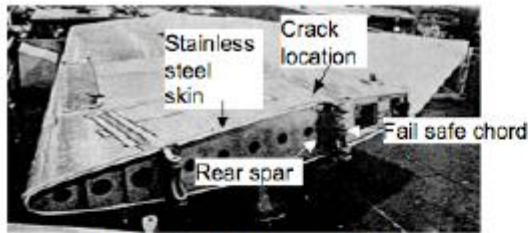
Figure A18: Photo of Right Horizontal Stabilizer that Separated from B-707-321C Aircraft and Details of “Fail-Safe” Structure Associated with the Accident

On May 14, 1977, a Boeing 707-300 operated by Dan-Air Services crashed on approach to Lusaka International Airport, located in Lusaka, Zambia. The accident was caused by the fatigue failure of the right horizontal stabilizer or tail-plane. This was followed by a loss of control and the crash killing all 6 occupants. While the aircraft had been certified as fail-safe per the 1956 CAR 4b.270 requirements, the upper rear spar chord failure (which occurred about 100 flights earlier) was not discovered prior to the failure of the fail-safe chord during this final landing approach. See a photograph and a sketch of the design in Figure A18 [A19].

Post accident flight tests revealed that deployment of the speed brakes during landing role produced a horizontal load spectrum, which was significantly more severe than assumed during the original design. Obviously, a good knowledge of both the external loads (and load spectrum) and the local internal loads are essential in predicting crack initiation, crack growth and fail-safe residual strength, which leads to this second lesson-learned:

It is essential that load surveys be performed to develop accurate loads and load spectra (including both ground and flight loads) for use in damage tolerance (i.e., crack growth) analyses, fatigue analyses and fail-safe residual strength and life analyses. These load spectra are also very important for the full-scale fatigue test.

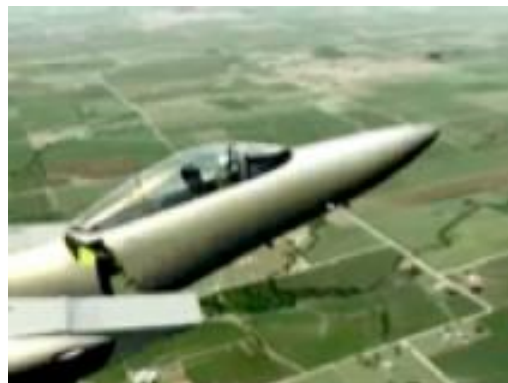
Figure A22: Artist's Rendition of F-15C Forward Fuselage Separation

On November 2, 2007, an F-15C flown by the Missouri National Guard broke apart in mid-air and crashed during a training exercise. An artist rendition of how the forward fuselage of this aircraft manufactured by McDonnell-Douglas separated just behind the cockpit is shown in Figure A22 [A23].

Both Boeing and the Air Force Research Laboratory's Materials Integrity Branch (AFRL/RXSA) conducted structures and materials investigations in support of the Air Force's Accident Investigation Board (AIB) [A24]. The Boeing failure analysis laboratory found a suspected fatigue crack in the upper right hand longeron near the center fuselage station (CFS) 377 splice joint that they thought could have caused the catastrophic failure (i.e., the longeron is a non fail-safe single load path structure). The location of this crack is shown in the structural diagram shown in Figure A23.

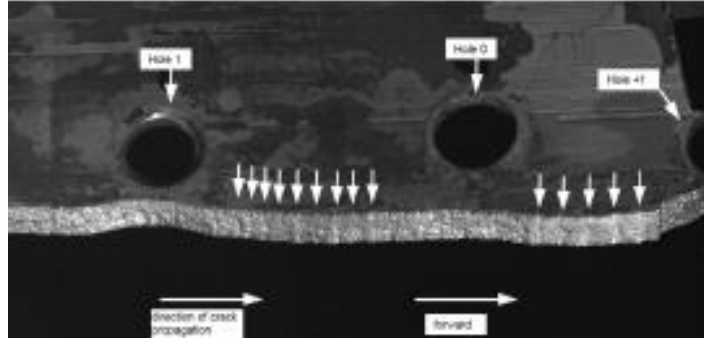
Figure C15 is a photograph of a portion of the fracture face showing bands of fatigue growth following increments of unstable crack growth and arrest (i.e., termed quasi stable growth by BMT). Each of the bands of fatigue growth represents a number pressurization cycles. Note that the crack location is outside the outer row of fastener holes, but still covered by the doubler.

Figure C15: Quasi-stable Crack Growth Identifying Numerous Starter Cracks (Prior to Final Fracture) [C9].

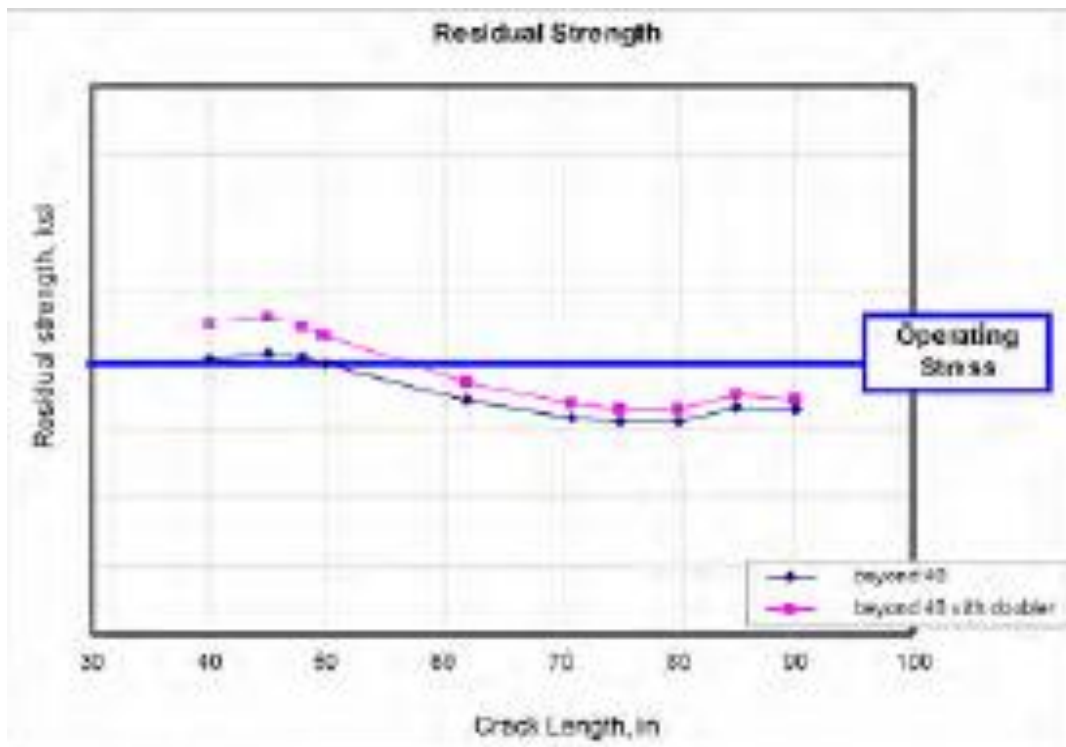
Boeing developed a non-linear finite element model to predict the effect of the doubler on the residual strength vs. crack length, when the skin was cracked in the observed location and not allowed to bulge because of the doubler. The analysis indicated that the doubler does increase the residual strength by a small amount and the crack length at failure was increased from about 50 inches to about 58 inches when the doubler was installed. This was attributed to the doubler allowing increased load redistribution around the cracking area and a small decrease in the crack tip stress intensity. This result is shown in Figure C16. It is noted that this prediction is conservative when compared to the previously mentioned 71 inch and 93 inch values. At any rate the structure has a very large damage capability in excess of a two bay crack length.

Figure C16: Predicted Residual Strength vs. Crack Length [C9]

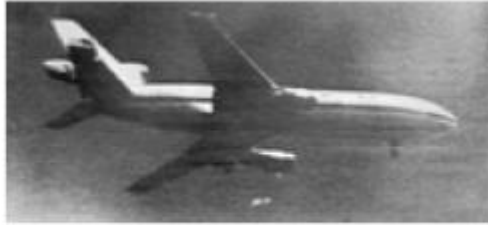
N1819U on its final descent. Note damage on the horizontal stabilizer and fuselage tailcone.

Figure F2: Photo of DC-10 Aircraft on Final Descent to Sioux City

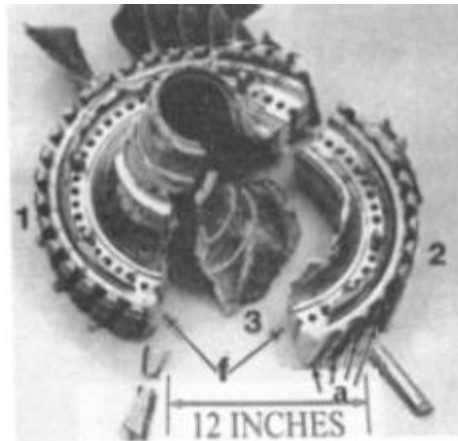
The National Transportation Safety Board determined that the probable cause of this accident was the fracture of the left engine's front compressor fan hub (i.e., disk) as shown in Figure F12, which resulted from the failure of Delta Air Lines' fluorescent penetrant inspection process to detect a detectable fatigue crack initiating from an area of altered microstructure (i.e., a manufacturing defect) that was created during the drilling process by Volvo for Pratt & Whitney and that the defect went undetected at the time of manufacture.

Figure F12. Photo of Fractured Pratt & Whitney Compressor Fan Disk

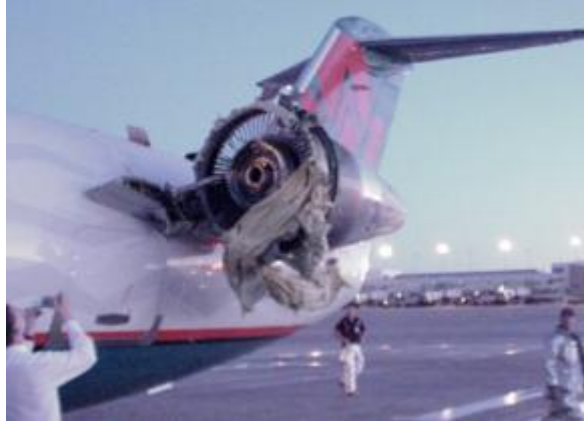
On January 25, 2007 a CRJ-200 aircraft operated by Mesa Airlines experienced an uncontained engine failure during a flight between Denver and Phoenix. The No. 1 engine, a GE CF34-3B1, threw a fan disk and blades during cruise. The debris took out the engine's forward cowling and punctured the fuselage as it departed the aircraft as shown in Figure F14 [F8].

While the No. 1 engine experienced a fan disk separation, it resulted in the separation of the inlet, fan rotor assembly, the fan containment case, and portions of the thrust reverser. The airplane reversed course and landed without further incident. Post incident examination revealed damage to the aft portion of the fuselage and empennage. An examination of the remaining airplane systems revealed no anomalies. Portions of the fan disk were recovered and examination of the fan disk revealed fatigue striations emanating from the aft bore corner of the fan disk. The striations came from an area that exhibited characteristics consistent with arc-out damage, which was the result of improper assembly and marking procedures during the electrochemical etching process. This damage was not detected during the manufacturer's quality assurance process used by the manufacturer. Further, the operator did not detect this damage while conducting the inspections prescribed through required airworthiness directives because the inspection procedures required were not detailed enough to detect the arc-out damage and the maintenance personnel did not receive appropriate training. Following the incident, the manufacturer issued alert service bulletins and the FAA issued an airworthiness directive to resolve these issues.

Figure F14: Photo of Damage Associated With Engine Failure

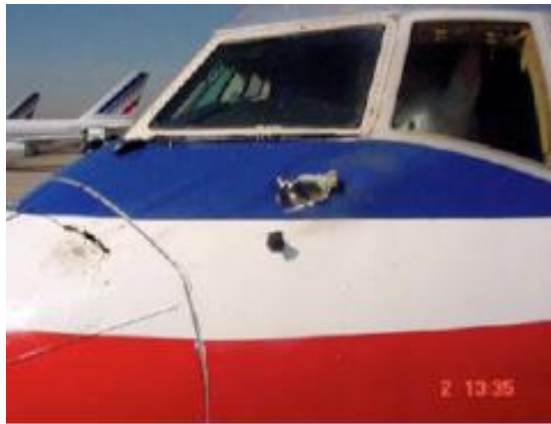
On April 2, 2001 an American Airline's 767-300 enroute from Paris to Miami encountered a flock of large birds while climbing through 12,000 feet. The radome, fuselage and wing leading edge all received extensive damage as shown in the photographs below. One of the large birds, believed to be cormorants, penetrated the cockpit area through the radome and forward pressure bulkhead. The aircraft depressurized and the crew landed the plane in Paris with no injuries [G2].

Figure G3: Photo of Bird Strike Damage to B767 Aircraft Just Below the Cockpit Windows

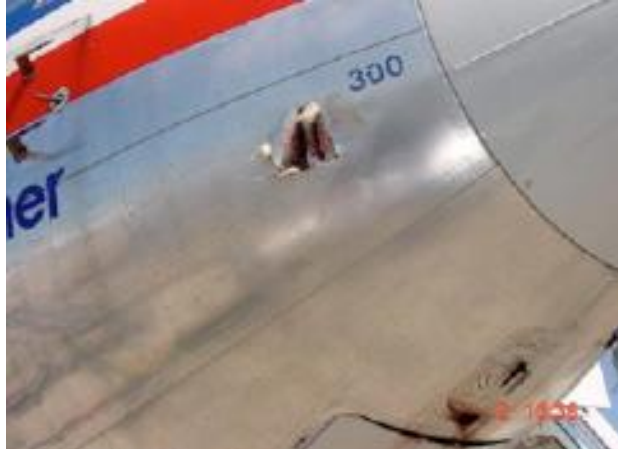
Figure G5. Photo of Bird-Strike Damage to Underside of B767 Fuselage Just Aft of the Radome

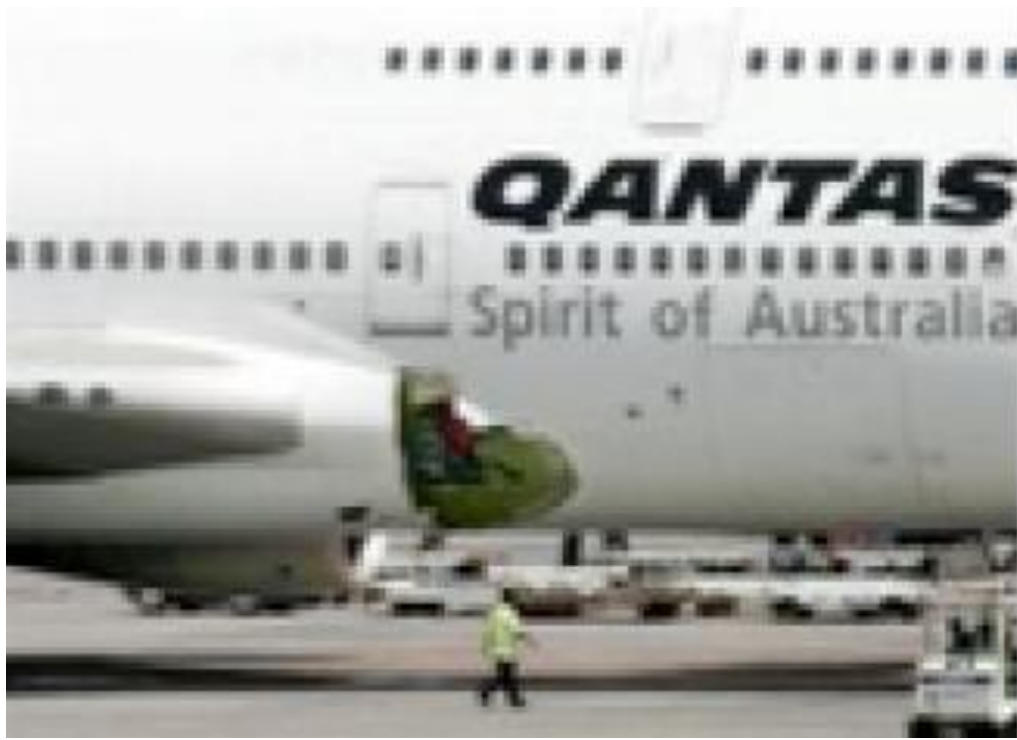
On July 25, 2008 a Qantas Airline Boeing 747 enroute to Melbourne, Australia from London was cruising at 29,000 feet when it experienced an explosive decompression of the fuselage. Per standard procedure the plane immediately descended to 10,000 feet and minutes later made an emergency landing at the Manila airport in the Philippines. There were 346 passengers onboard and there were no fatalities or injuries to any of the passengers or crew. Upon post flight examination a large hole was seen in the lower right side of the fuselage just forward of the wing. This is shown in the photographs in Figures I2 through I4 [I1].

Figure I2: Photo of Boeing 747 Fuselage after On-Board Explosion

On August 29, 2008, the Australian Transportation Safety Bureau (ASTB) confirmed that the incident was caused by the bursting of one of two oxygen bottles that were located in this area of the cargo compartment and has been found to be missing. Also, shards from the missing oxygen bottle and the oxygen regulator valve were found in the fuselage. This investigation the failure provides another strong testament to the importance of having fail-safe structures with large design damage sizes.

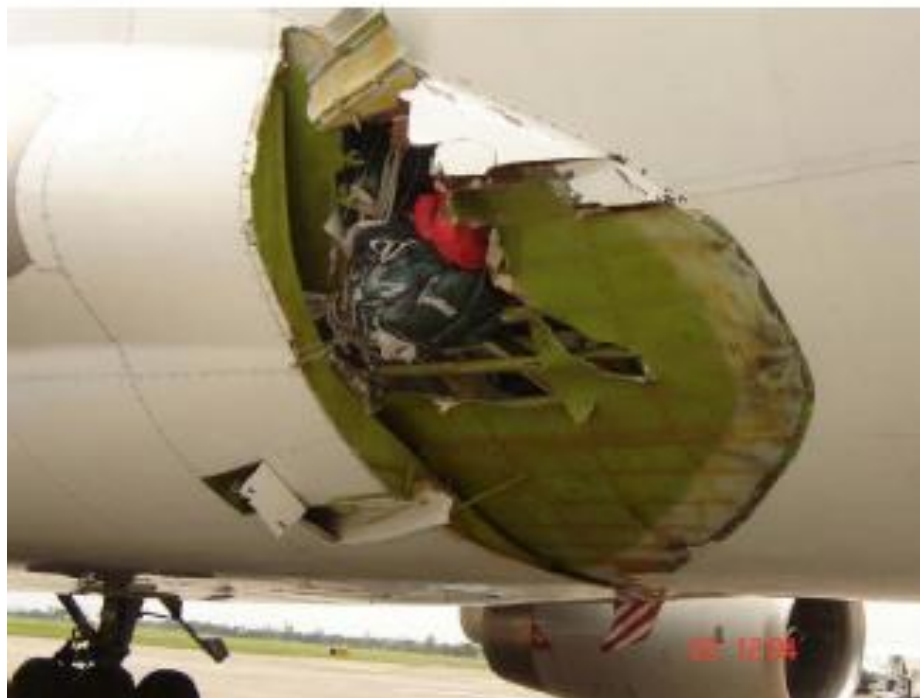
Figure I3: Close Up View of Boeing 747 Fuselage after On-Board Explosion

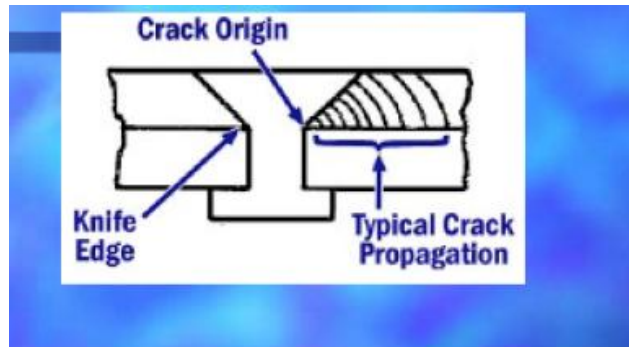
The investigation of the failure revealed that it initiated in the upper row of rivets in the stringer no. 10 (S-10) longitudinal lap splice that was a cold bonded and riveted joint. Boeing used this cold bonded design in the first 291 737 aircraft. However, it was later discovered that cold bonded joints can be subject to disbonding when moisture is present. When this occurs all of the pressure induced hoop load is transferred through the rivets rather than the bonded surface. This induces very high stress concentrations at the knife edge countersinks in the outer skin and fatigue cracks initiate. This is illustrated in the sketches shown in Figures J5. and J6.

Figure J5: Sketch Illustrating the Development of Small Fatigue Cracks in the Skin

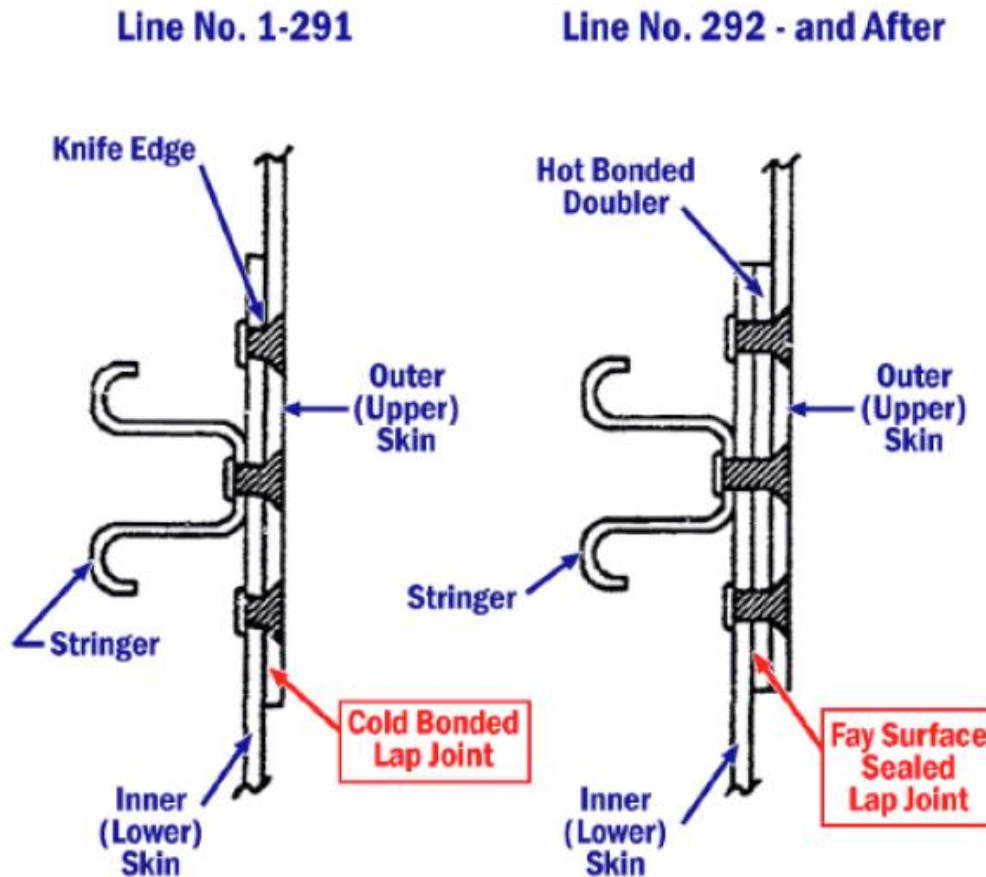
On Boeing 737 aircraft beyond the 291st aircraft manufactured, the lap splice joint design was improved with the incorporation of a moisture resistant hot bonded doubler, which was expected to substantially delay the onset of WFD. This improvement is compared to the original design in Figure J8.

Figure J8: Sketches Illustrating the Lap Splice Joint Designs of the B737 Aircraft

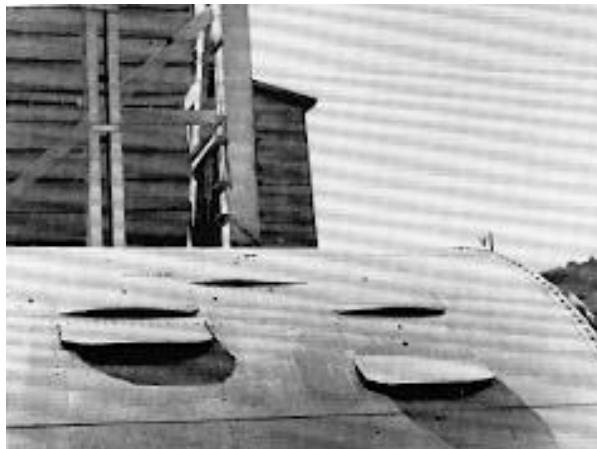
In the 1950s Boeing conducted about 30 guillotine tests on pressurized sections of the 707 fuselage (called Quonset huts), where blades were dropped through various structural configurations until crack arrest designs were achieved. Figure K1 is a photo of an early 707 Quonset hut showing several arrested blade penetrations [K1].

Figure K1: Boeing 707 Quonset Hut Test

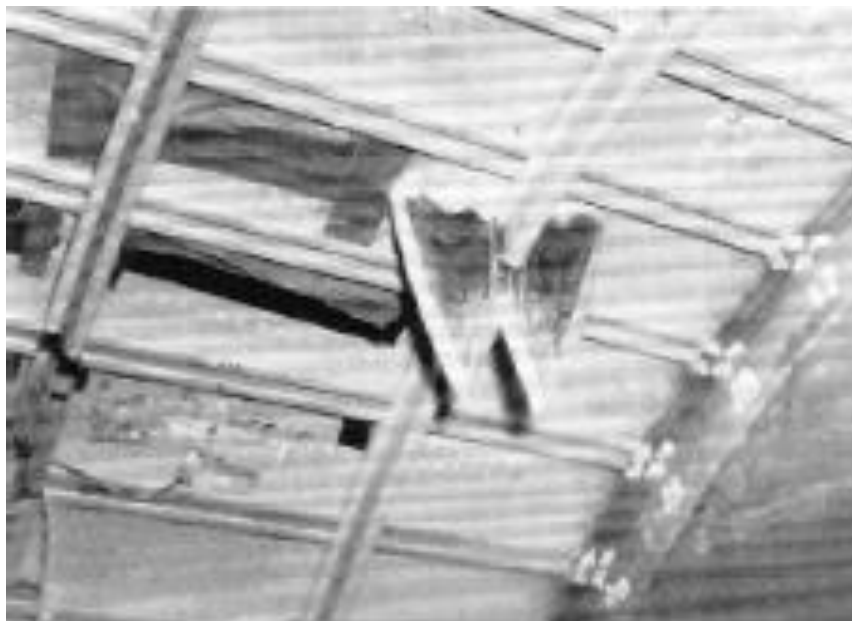
Fuselage fail-safe tests were continued with the development of the 737, but with a double bladed guillotine so as to sever the central frame as well as the skin. The test fixture is shown in Figure K2; the double bladed penetration is shown in Figure K3; and, the final two bay arrested crack with broken frame is shown in Figure K4.

Figure K3: Boeing 737 Blade Penetration

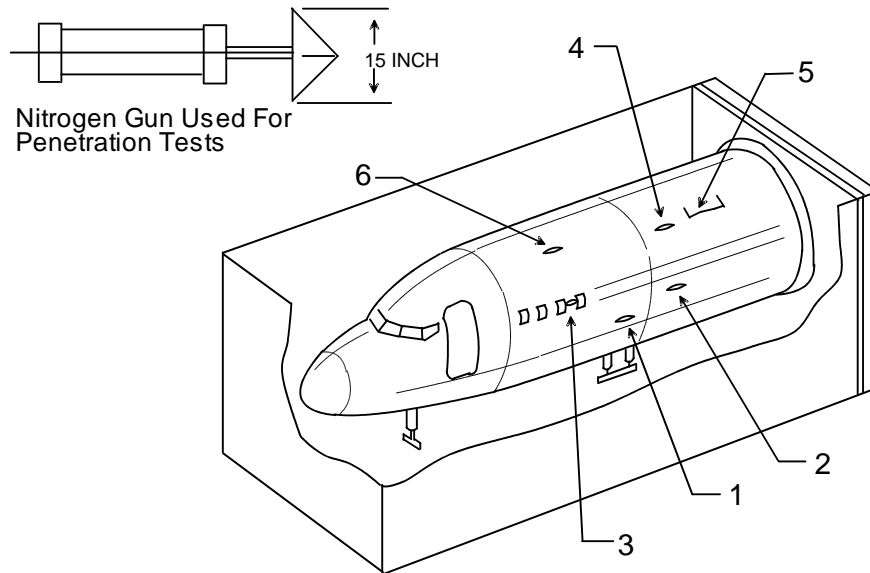
Like Boeing, Douglas Aircraft was developing their first high altitude jet transport (i.e., the DC-8) at the time of the Comet accidents. Also, like Boeing they embarked on development testing to ensure that their new airplane had crack arrest fail-safe capability. This development testing involved many fatigue test specimens, more than 30 large curved panel tests pressurized fatigue tests and, finally, wedge penetration tests on a full-scale pressurized fuselage, which also had inertial loads applied. A nitrogen pressure gun with a 15 inch wide blade was used to penetrate the fuselage shell and various stiffening elements. Penetrations were made at six different locations on the fuselage as shown in Figure K5 [K2].

Figure K5: DC-8 Wedge Penetration Tests

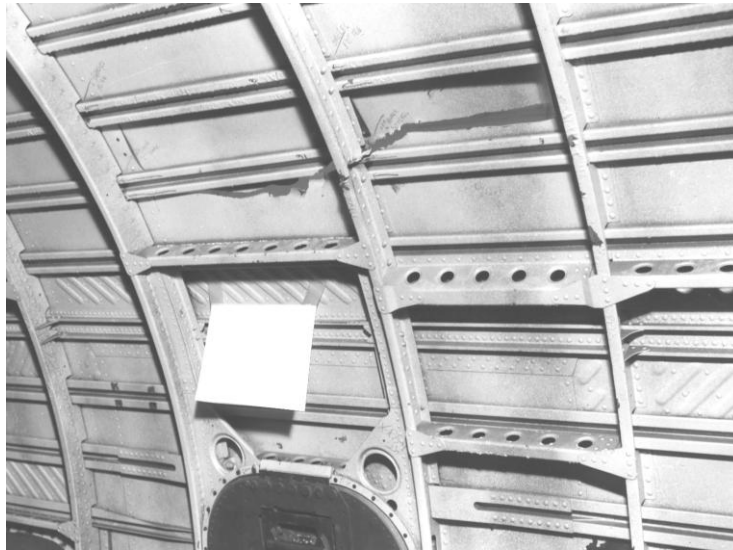
In Test number 5 the 15-inch blade penetrated the skin, the circumferential frame, the longitudinal stringer and the two bay crack flapped open and the fuselage safely depressurized. This is illustrated in the sketch in Figure K6 and shown in the photograph in Figure K7.

Figure K7: View Inside the DC-8 Fuselage
