AGARD Corrosion Handbook Volume-1 Aircraft Corrosion: Causes and Case Histories

AGARDograph No.278

## AIRCRAFT CORROSION: CAUSES AND CASE HISTORIES

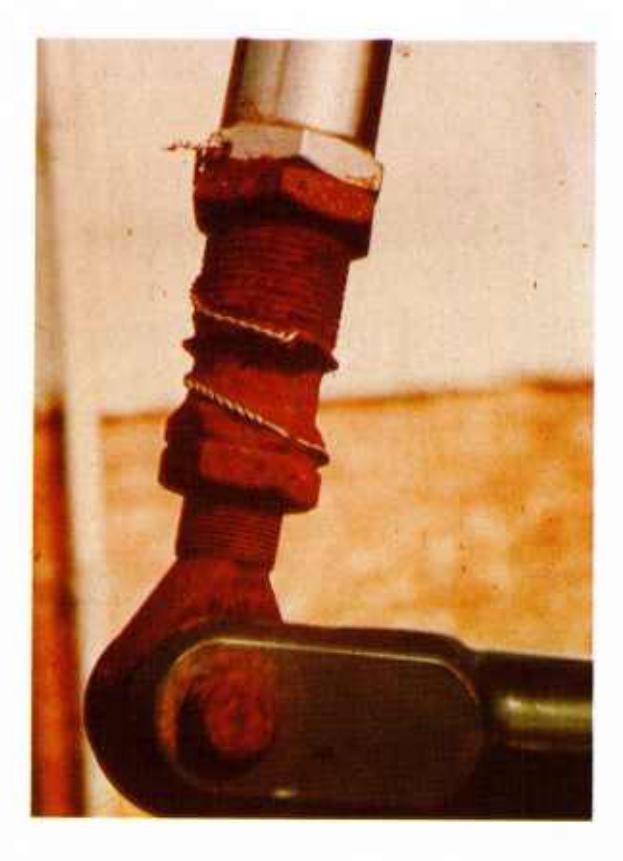
Most of the common engineering metals and alloys produce characteristic corrosion products which allow corrosion to be recognized fairly easily. Probably the best-known form of corrosion occurs on non-stainless iron and steel and is easily recognized by the familiar red iron rust (Figs. 7-1 and 7-2). Figure 7-1 shows rusting on a steel track rod adjuster and eye end, originally cadmium plated but operating in an exposed environment. The cadmium had presumably been totally sacrificed after loss on threads during assembly or maintenance. Use of a supplementary protective material should have prevented this. Figure 7-2 shows a steel jet pipe end cap liner which had been subjected to high temperature oxidation over a long period of time. In this figure the blistering and flaking of a surface protective coating is apparent, and the formation of red rust products in the underlying steel can be seen. The materials chosen for this application had simply proven unsuitable for the environment, though quite possibly they were the best available when the design was established. The fact that the aircraft life had been extended, and these components had been required to operate for much longer times than originally intended is also an important factor.

Fig. 7-1 Rusting on a steel track rod adjuster and eye after damage occurred to the protective cadmium plating

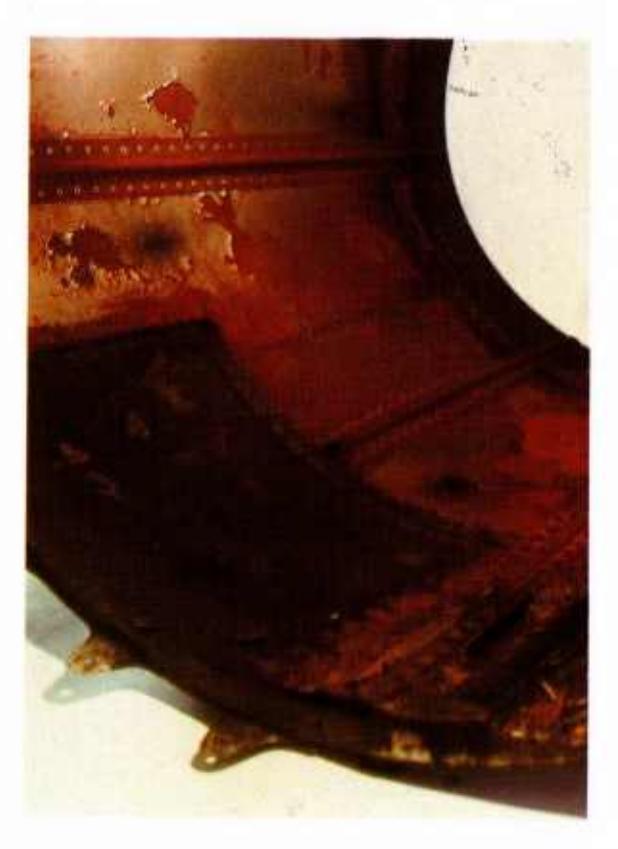
Fig. 7-2 Rusting in a jet pipe end cap liner following damage to its protective coating

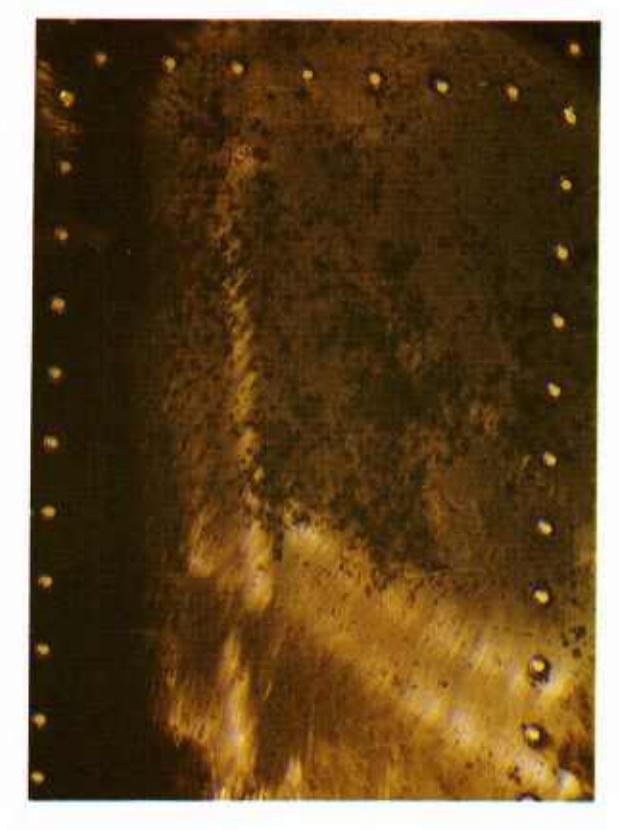
Fig. 7-4 Uniform corrosion in a magnesium alloy helicopter skin after damage to the chromate pre-treatment

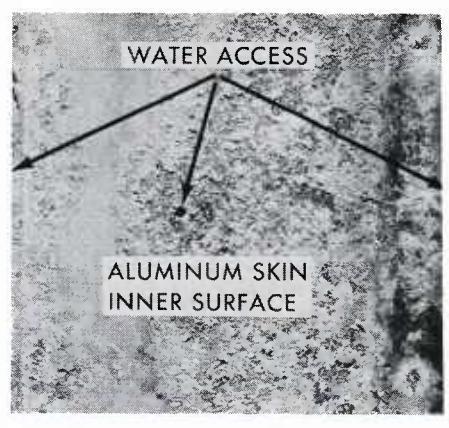
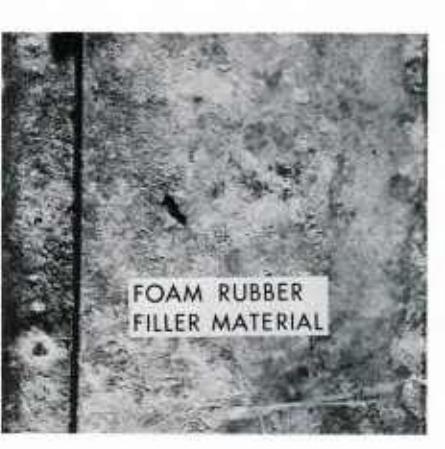
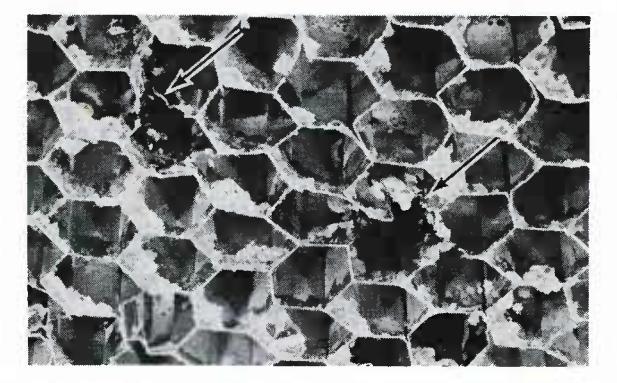
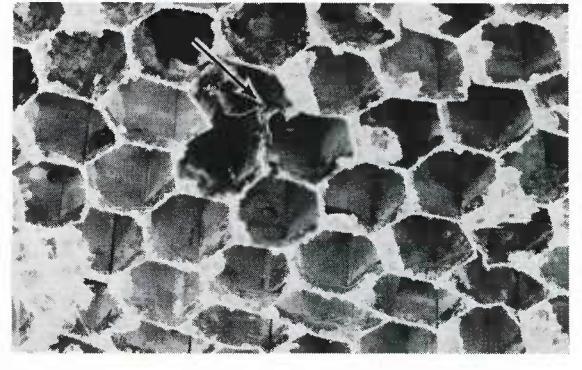
Fig. 7-5 Corrosion damage in an aluminium alloy honeycomb structure from a fighter aircraft

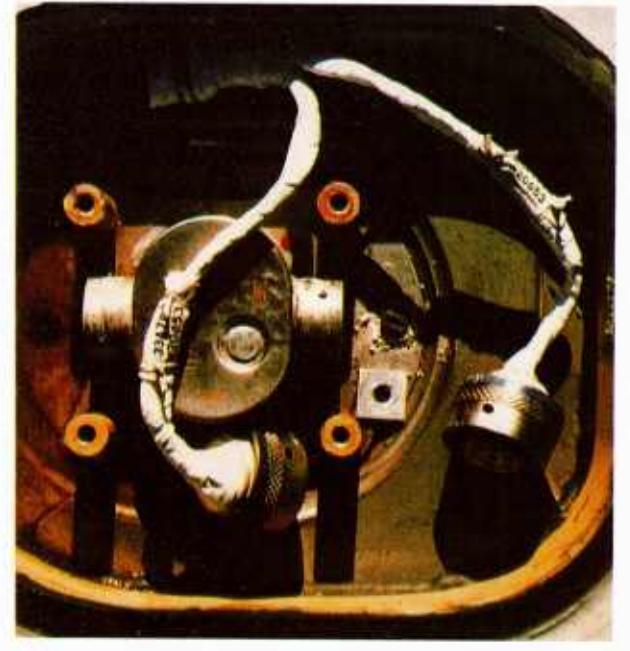
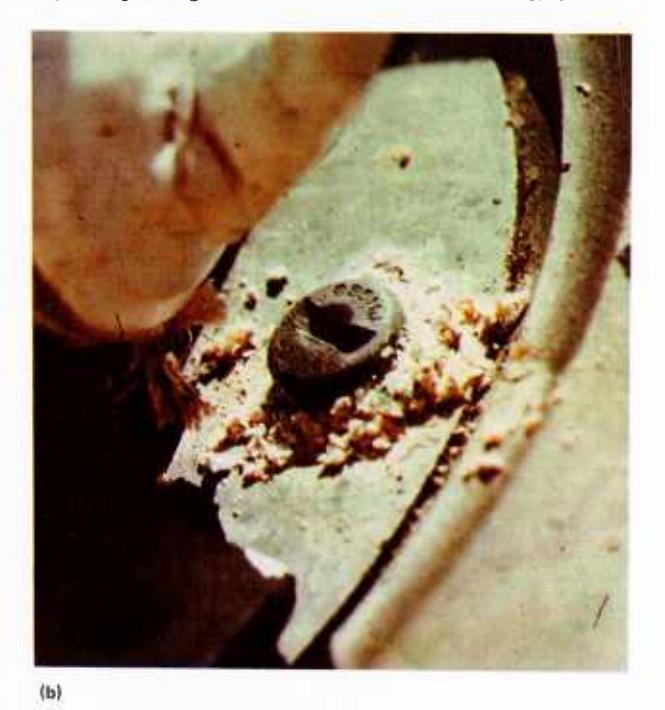
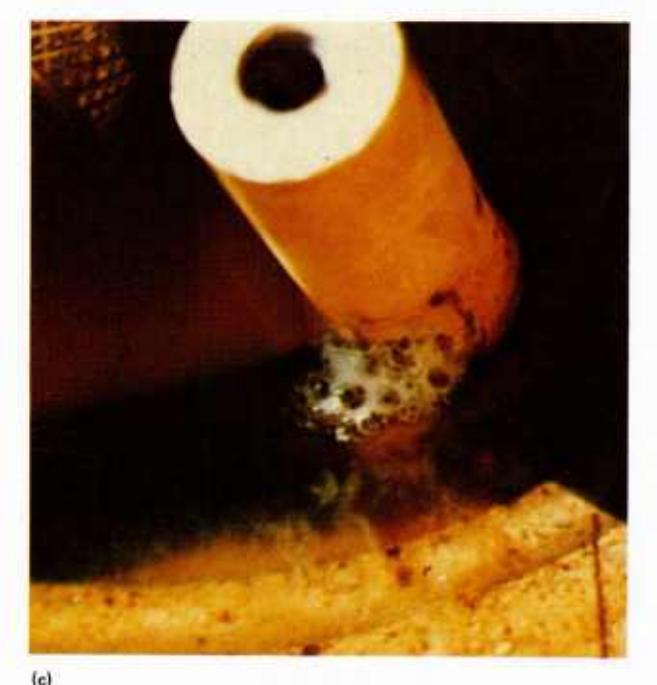
The need to prevent the ingress of water and other corrodents to internal structure and equipment is nowhere more important than with electrical and avionics equipment. In the interests of obtaining specific electrical characteristics, the materials used are often inferior in terms of corrosion resistance, and serious corrosion problems and often malfunction of equipment can occur if the equipment is not properly sealed. Figure 7-6(a-c) shows examples of corrosion of electrical equipment in a military aircraft due to water intrusion around the access door. The general reddish-orange discolouration of the compartment walls and floor, in Figure 7-6(a), indicates that uniform corrosion has occurred in these areas. The close-up photographs of Figure 7-6(b) and -6(c) show local eruptions of corrosion products around a screw and binding post, which are probably examples of galvanic corrosion and crevice corrosion.

Fig. 7-6 Corrosion in a container used to house electrical equipment

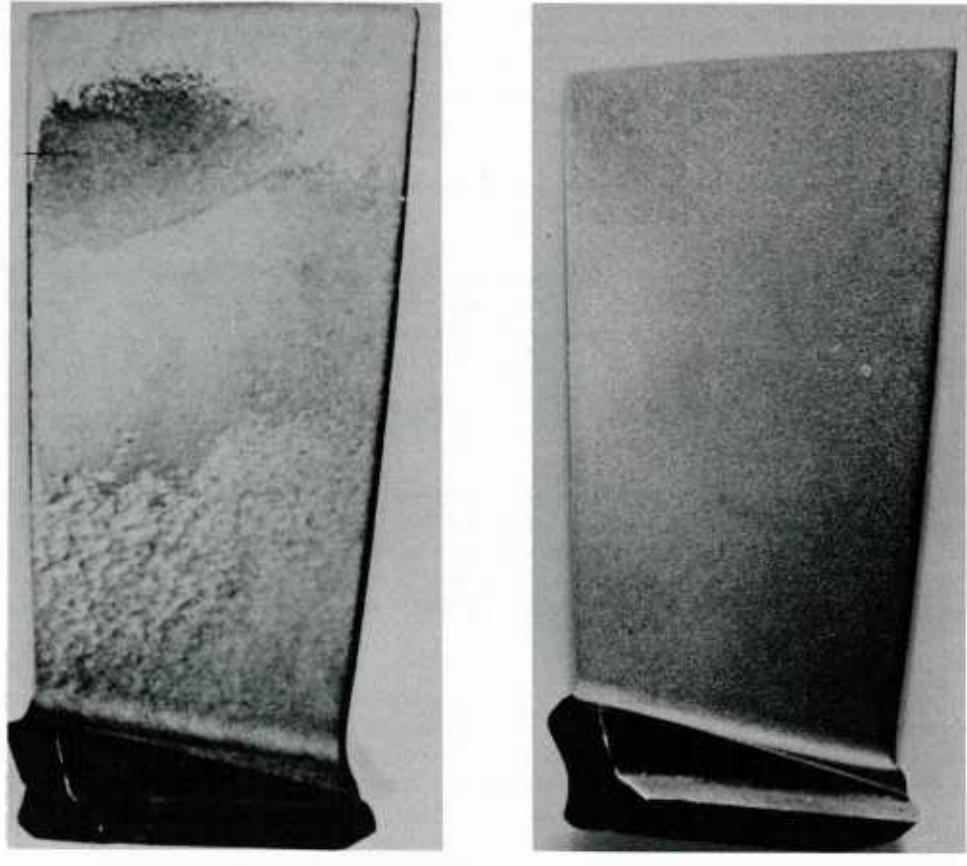
(a) VAPOUR DEPOSITED (b) BIAS SPUTTERED T-58 COMPRESSOR BLADES AFTER 16-1/2 HOURS EROSION TEST (CONCAVE SURFACE)

Fig. 7-8 Erosion-corrosion damage on the airfoil of a fighter aircraft compressor blade

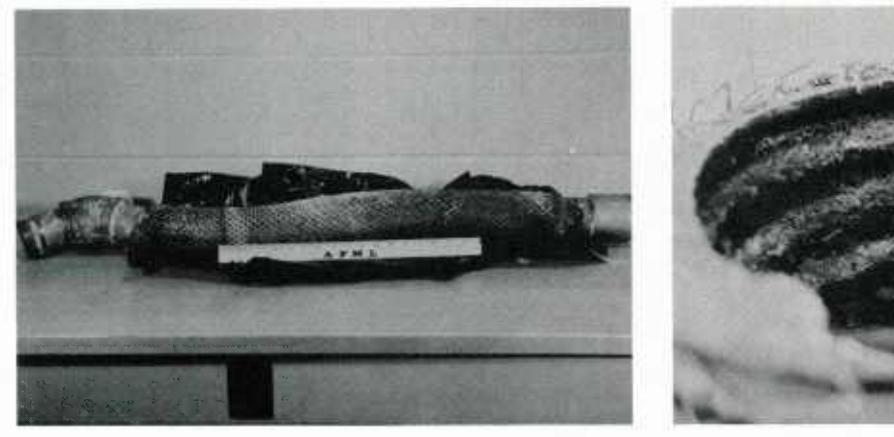
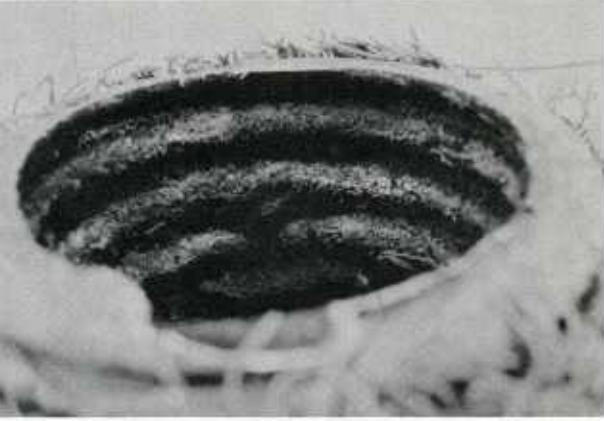
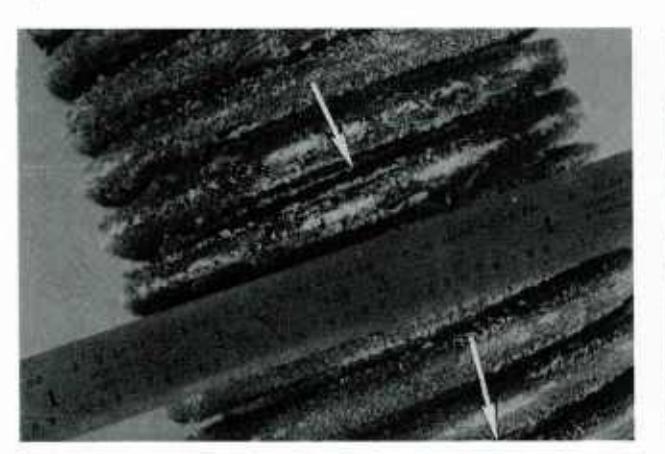
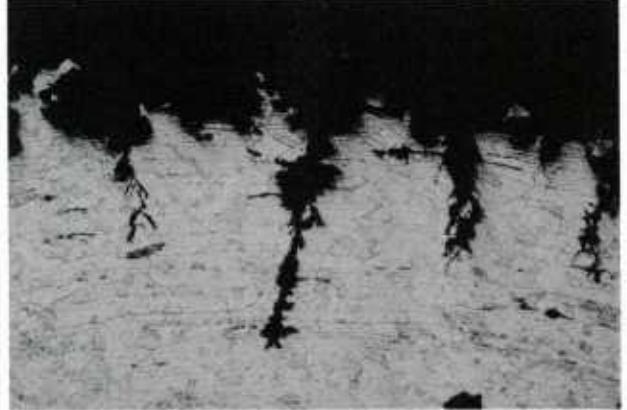
Visual examination of the flexible stainless steel pipe, Figure 7-11(a), revealed the outside surface to be covered with a light tan powdery residue or corrosion product. A dark brown residue was found on the inside surface when the pipe was sectioned (Fig. 7-11(b)). The wire mesh was stripped from the convoluted flexible pipe and large cracks were found running circumferentially around the inside or small radius bends of the convolutes (Fig. 7-11(c)).

Fig. 7-11 Hydrofluoric acid corrosion of an austenitic (316) stainless steel pipe

Microscopic examination of the convoluted pipe, Figure 7-11(d), showed that pitting had occurred beneath the corrosion products and that stress corrosion cracks had initiated at the base of the pits. The stress corrosion was observed only on the inside or small radius bends of the convolutes, while pitting was observed over the entire internal surface of the flexible pipe.

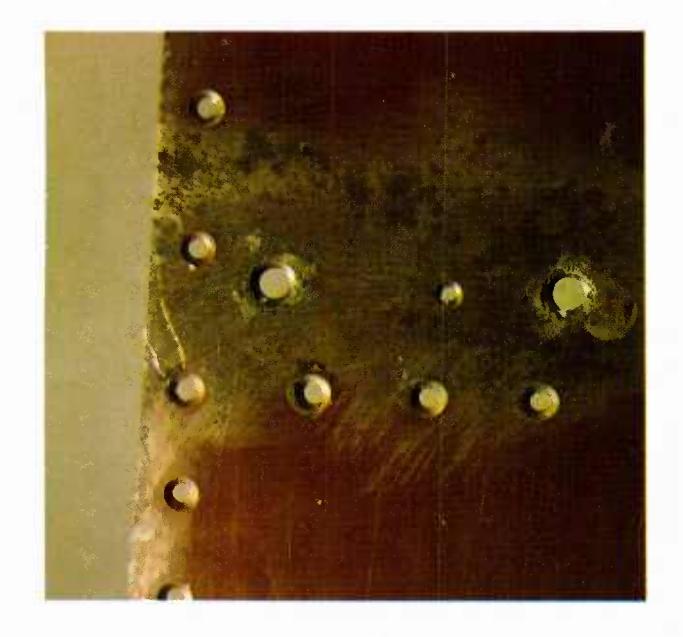
The example of Figure 8-2 shows dissimilar metal, or galvanic corrosion damage at fastener holes where steel bolts fastened through a magnesium alloy skin. The positions of these two materials in the electrochemical series, or galvanic series indicates that a high electrochemical potential would exist between them when in contact, and severe galvanic corrosion could be expected to occur.

Fig. 8-2 Galvanic corrosion around fastener holes used to locate steel fasteners in a magnesium alloy skin

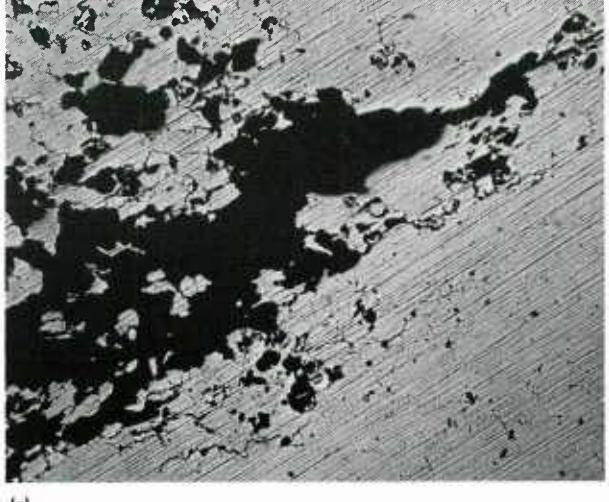
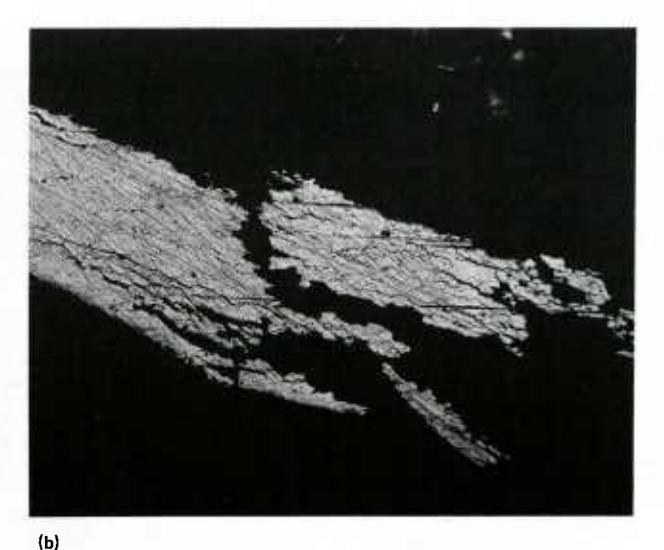
Metallographic specimens of the damaged aluminium skin showed areas of uniform corrosion on the outer exposed surface (Fig. 8-6(a)) and regions of deep intergranular corrosion (Fig. 8-6(b)), which had led to perforation of the skin panel. Areas of the tail and wings away from the de-icing cement were protected by Corogard 22 paint, and these areas were not damaged by corrosion.

Fig. 8-6 Metallographic sections through the aluminium skin shown in Figures 8-4 and 8-5

- (a) General surface corrosion leading to intergranular attack on the outer surface.(b) Deep intergranular attack and perforation of the skin.

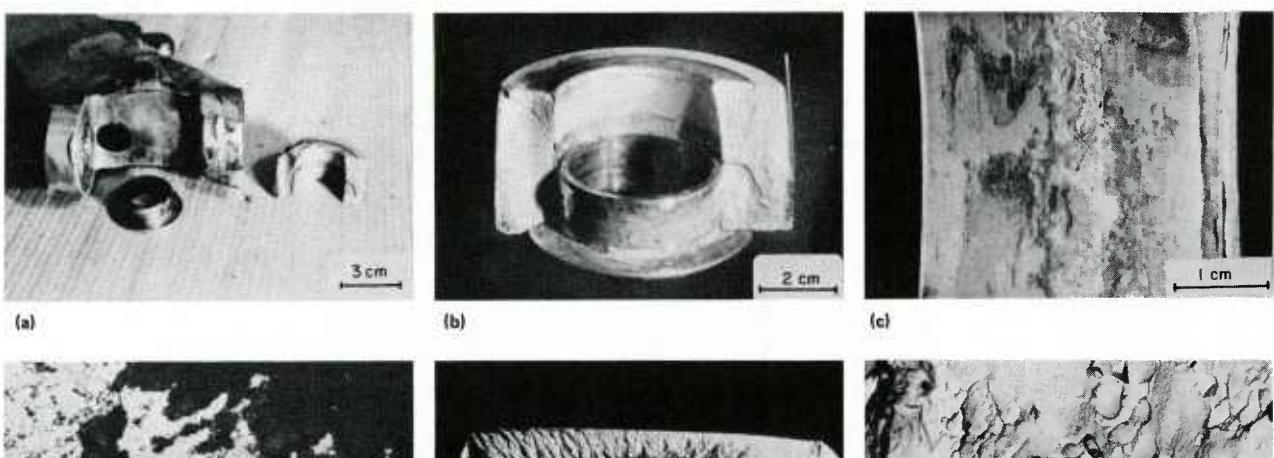
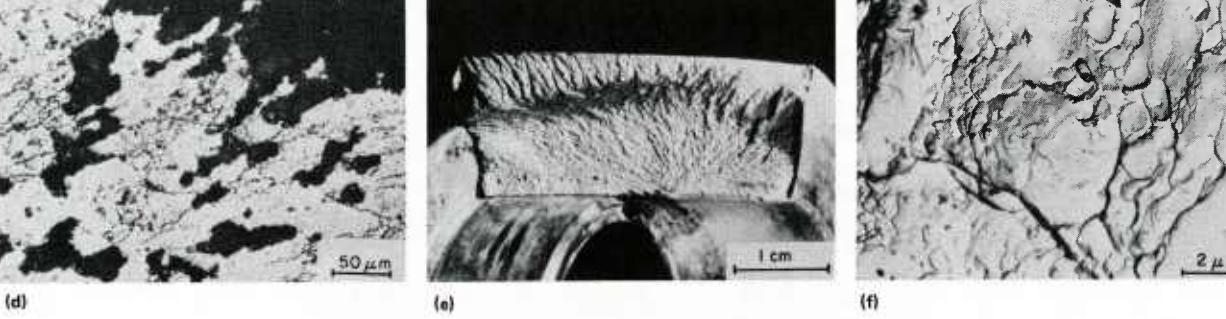
The lug was made from a 7075-T6 aluminium forging, and the holes used to mount the king pin were protected from mechanical damage and wear by steel bushings. The lug, steel bushings and fracture surfaces can be seen in Figures 8-7(a) and 8-7(b). Visual inspection of the lug revealed corrosion damage. This was restricted to the region between the two steel bushings, as indicated in Figure 8-7(c). This suggested that galvanic corrosion of the aluminium lug which was in contact with the steel bushings was the cause of the corrosion damage. The severity of the corrosion damage is indicated by the cross-section of the lug, shown in Figure 8-7(d).

Figures 8-7(e) and 8-7(f) show one of the fracture surfaces produced by the failure. Figure 8-7(e) shows that the fracture originated at the site of the corrosion damage. Electron fractography of the same fracture surface (Fig. 8-7(f)) revealed mainly ductile dimples indicative of ductile failure.

Fig. 8-7 Galvanic corrosion in a 7075-T6 king pin lug of a fighter aircraft main leg

General view of the failed lug. (Mag.  $\times$  0.3) (a)

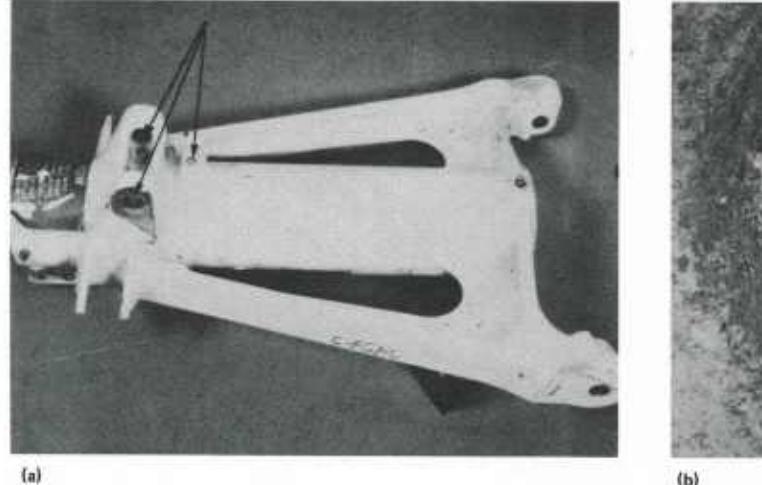
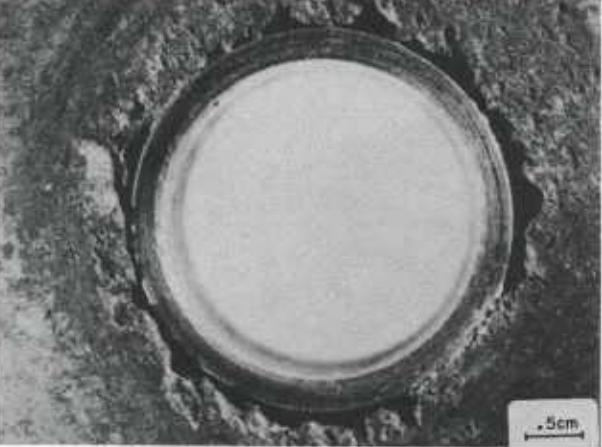
Visual inspection of the corroded lugs (Fig. 8-8(b)) showed that the steel bushings were undamaged while severe corrosion of the magnesium alloy which was in contact with the steel had occurred. The preferential corrosive attack of the magnesium at the magnesium/steel interface suggests that the damage was caused by galvanic corrosion, where the magnesium formed the anode of the electrolytic cell and the steel the cathode. The aircraft in question had been operated in a marine environment, and the moist salt laden atmosphere would have contributed to the problem. However even a milder environment would likely give rise to a similar problem given sufficient time.

Fig. 8-8 Galvanic corrosion between a steel bushing and a cast magnesium alloy nose gear strut

Both cadmium and zinc type coatings protect steel by anodic protection, which involves the sacrificial corrosion of the anodic coating to prevent or minimize corrosion in the cathodic steel. However in sea water magnesium alloys are strongly anodic with respect to both steel and cadmium, and therefore cadmium serves no useful purpose in this case other than to protect the bore of the steel bushing. It is doubtful whether magnesium alloy castings would be selected at the present time for a component such as this nose gear strut, which experiences severe conditions and aggressive environments in service. However, in other cases it is important to provide an insulating interface material between magnesium and any steel parts.

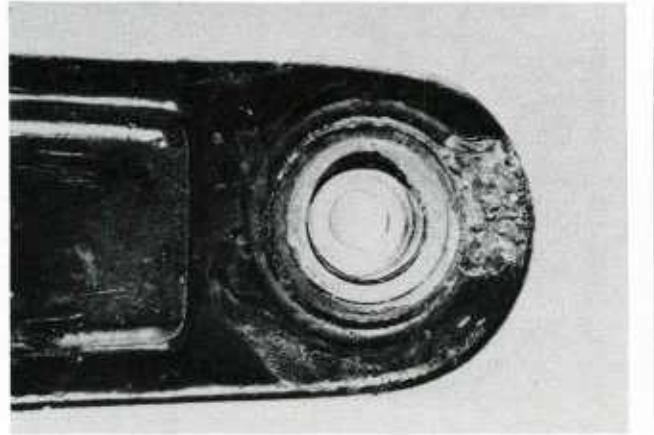
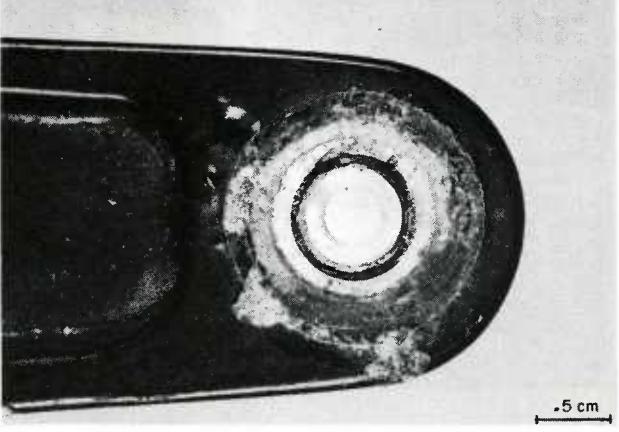
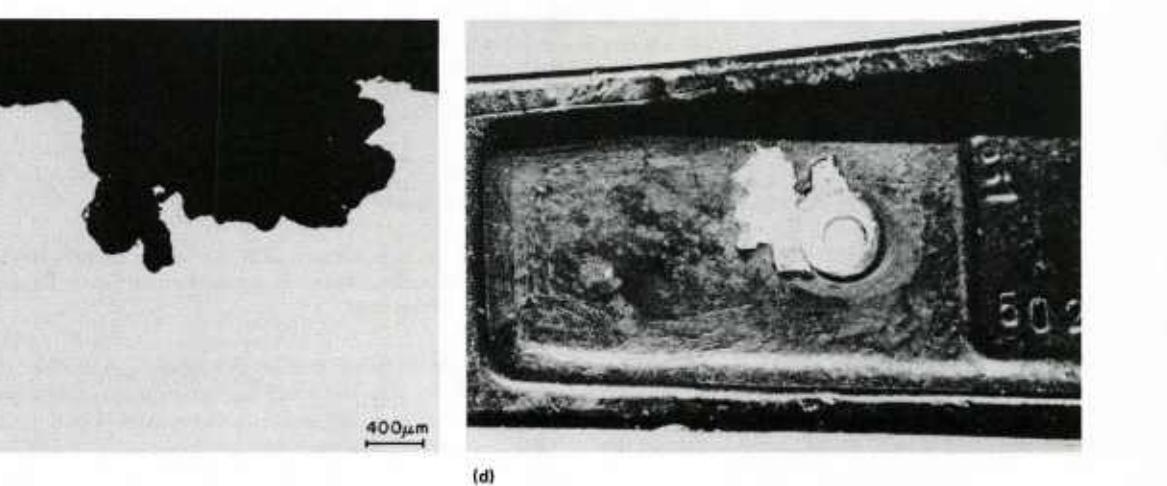
The control levers of a flap deflection mechanism of an aircraft were made from a magnesium casting alloy with a nominal composition Mg = 6%, Zn = 2%, Th = 0.75 Zr, similar to ZH62A. The levers were protected with a zinc-chromate primer and an epoxy top-coat. Galvanic corrosion was found in the levers in a socket where steel balls had been located. The ends of the lever arms are shown in Figures 8-10(a) and 8-10(b), which also show the corrosion damage. Figure 8-10(c) shows a cross-section through the lever arm in the corroded area and shows deep cavities due to this galvanic corrosion.

Fig. 8-10 Galvanic corrosion in a cast magnesium alloy flap control lever arm

- (a) and (b) End of the magnesium lever showing ball socket and corrosion. (Mag. × 2)
  (c) Cross-section through the corroded region of Figure 8-10(a), showing deep pitting. (Mag. × 25)
- (d) Galvanic corrosion in the magnesium lever around a press-fit aluminium bushing.

Other examples of galvanic corrosion were found in the same fittings. Figure 8-10(d) shows an area of galvanic corrosion around an aluminium bushing which was press fitted into the lever.

In both these cases the galvanic corrosion occurred because of the highly anodic behaviour of the magnesium with respect to the metals in contact, and the inability of the protection system to isolate the metals and to exclude moisture. In the case of the aluminium bushing, a sealant might have prevented ingress of moisture, while an elastic paint was considered as a means of delaying the galvanic corrosion in the steel ball bearing sockets. However, current aircraft designs tend to avoid use of magnesium alloys, and particularly when the components are in contact with moving parts of a dissimilar metal where damage will inevitably occur to protective coatings and allow galvanic corrosion to occur.

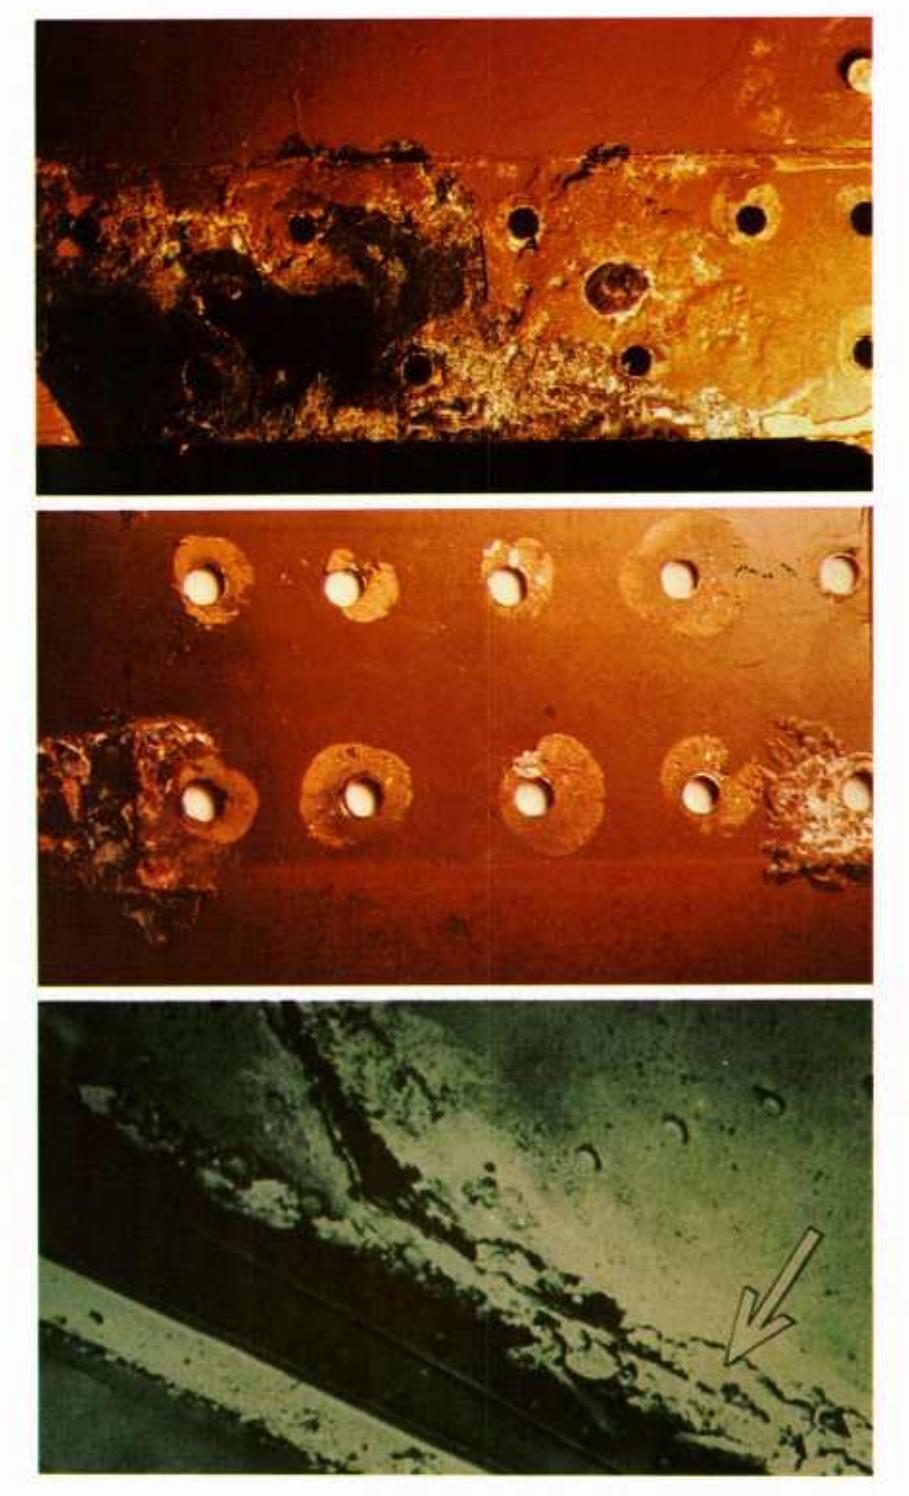
(a) Dismantled joint in a magnesium alloy panel.

(b) Crevice corrosion in a magnesium alloy skin joint due to inadequate sealing.

Fig. 9-2 Examples of crevice corrosion in aircraft structural parts

Some examples of crevice corrosion are shown in Figures 9-2(a), 9-2(b) and 9-2(c). Figure 9-2(a) shows a corroded and perforated magnesium panel in a dismantled joint area from a transport aircraft structure. The corrosion damage was due to inadequate sealing. Figure 9-2(b) presents a similar case of crevice corrosion at the interface of a magnesium alloy skin joint, which was also due to inadequate sealing. In both examples the most severe damage is away from the edges of the fastener holes which suggests that galvanic corrosion was not the major factor. Figure 9-2(c) shows a situation where both galvanic corrosion and crevice corrosion contributed to the damage. The corrosion damage has occurred at the junction between a magnesium alloy floor panel and aluminium alloy frames and angle plates. This problem was probably aggravated by poor drainage conditions, and inadequate sealing and surface protection.

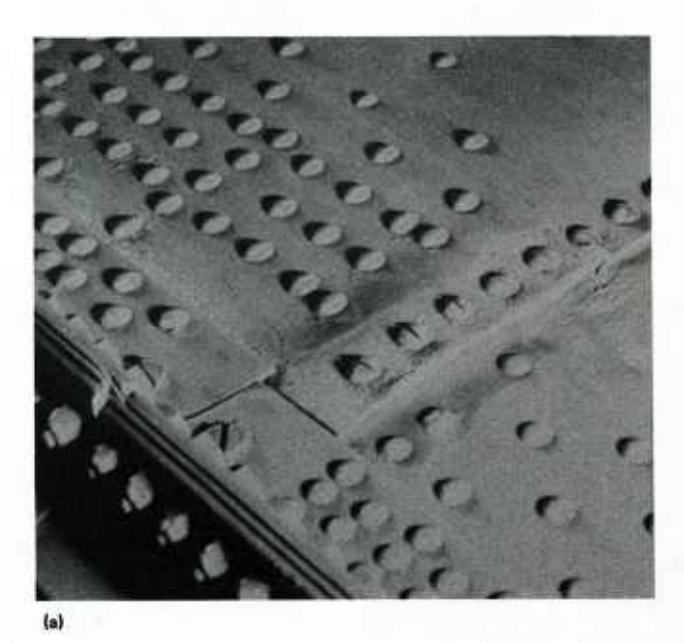
Fig. 9-3 Crevice corrosion in the outer wing coupling flange of a transport aircraft (a) Crevice corrosion in aluminium lap joint. (b) and (c) Corrosion around bolts and under nuts in the under wing structure.

Crevice corrosion may be particularly severe with magnesium alloys since they are the most anodic of the common airframe structural alloys, however similar problems also exist with aluminium alloys. Figures 9-3(a), 9-3(b) and 9-3(c) show examples of crevice corrosion in the outer wing coupling flange of an older type small transport aircraft which had been operating in the Mediterranean region. The damage was observed during routine visual inspection, and subsequently x-ray inspection was used to measure the depth of corrosion in the different areas of structure. The structure was predominantly aluminium alloy sheet and flanges, with steel fasteners, and the structure was protected by a titanium dioxide (TiO<sub>2</sub>) pigmented paint finish. Crevice corrosion is evident between the aluminium alloy flanges and sheet, and at the aluminium lap joints (Fig. 9-3(a)). Corrosion cavities were also observed under the bolts and nuts (Figs. 9-3(b) and 9-3(c)), and the corrosion can be seen to extend beyond the area of contact of the fasteners. Measurements of the depth of corrosion showed that this was greatest under the heads of the bolts and nuts, rather than at the immediate edges of the fastener holes. This suggests that the crevice effect was probably at least as significant as the galvanic effect in this case. The corrosion repair work led to this aircraft being out of commission for a reported "long period", although the precise details were not available. The repair work involved the use of a pigmented zinc chromate primer and top coat, in place of the TiO<sub>2</sub> finish used originally.

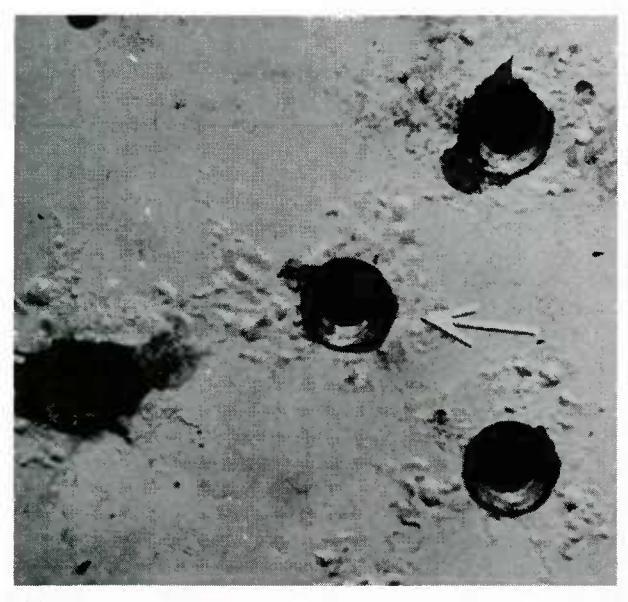
(a)

This form of corrosion may become quite severe before it is detected, since it will often be hidden by either cladding or paint, and in the latter case may be indicated by blistering. A typical example is shown in Figure 9-4(a), where the paint blistering is concentrated around the rivet holes in an aluminium alloy sheet. Figure 9-4(b) shows the same area after the paint has been removed, and the threadlike meanderings of the corrosion filaments can be seen. Filiform corrosion has been observed in magnesium, aluminium, steel and chromium-plated nickel.

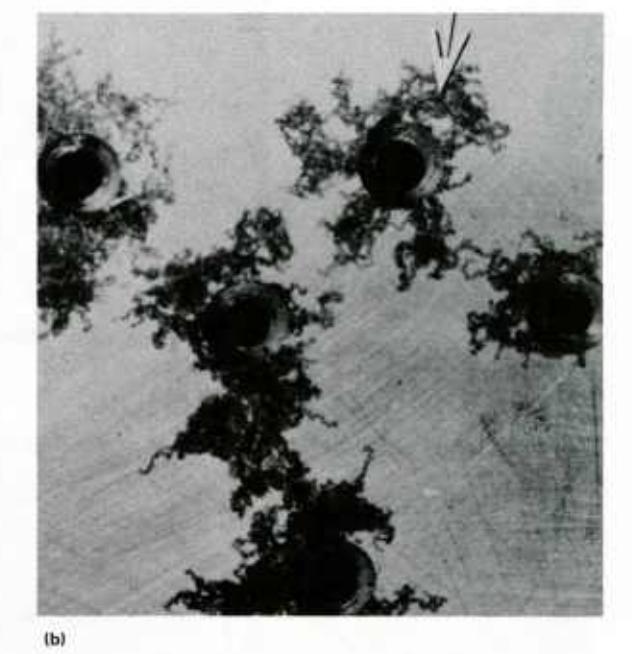
Fig. 9-4 Filiform corrosion in an aluminium alloy sheet structure (a) Blistering of paint due to underlying corrosion. (b) Filiform corrosion revealed by removing paint.

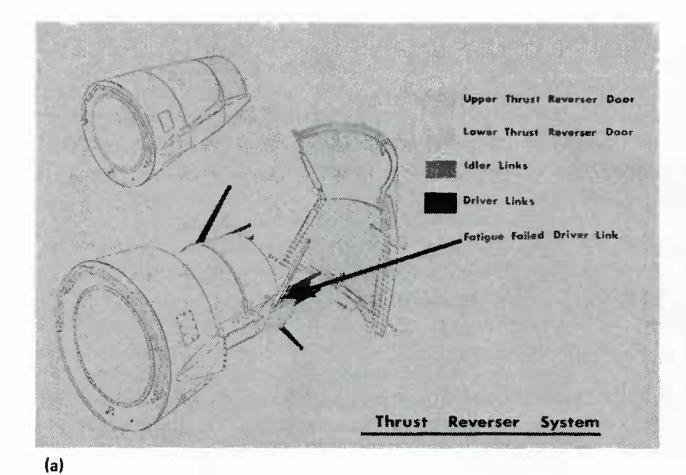
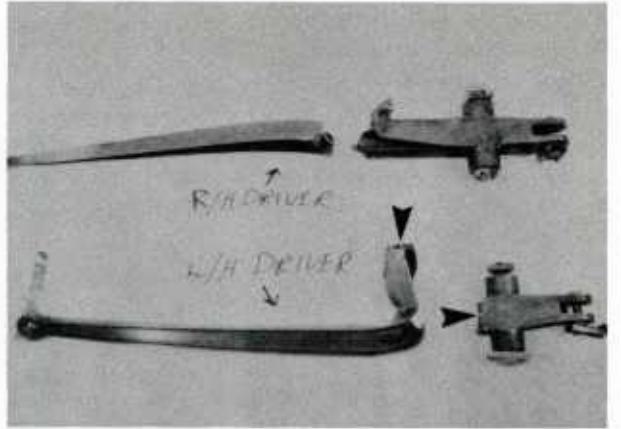
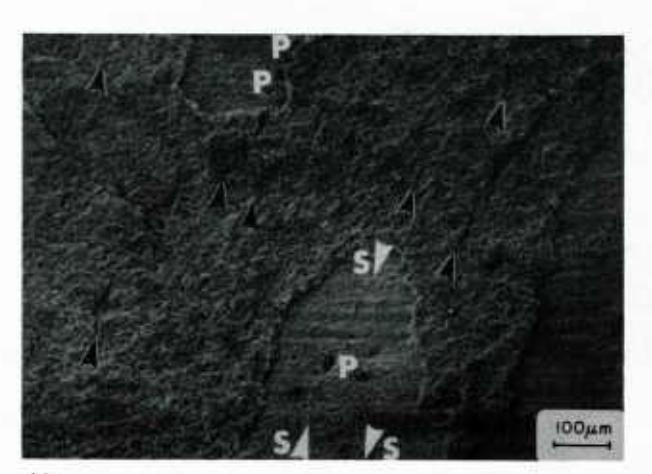
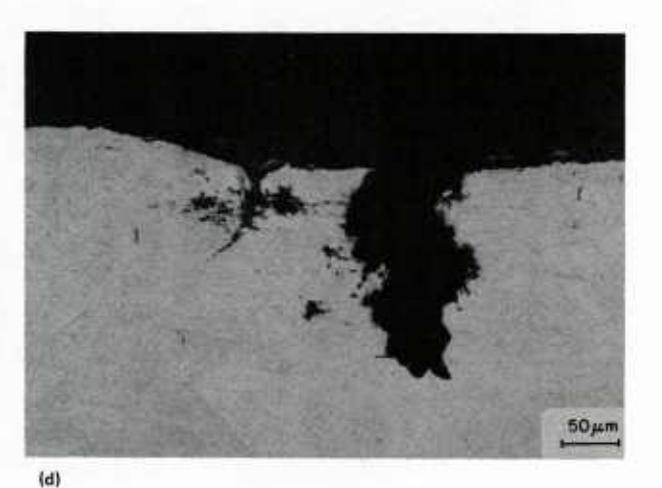
Fig. 9-5 Pitting corrosion and fatigue failure of a thrust reverser driver link

A large commercial jet lost the thrust reverser doors from one of its engines in cruise flight, but nevertheless landed safely. Subsequent investigation showed one thrust reverser door driver link had fractured, allowing the leading edge of the door to spring up into the 550 knot airstream. Figure 9-5(a) shows the general arrangement of the thrust reverser system with the failure location indicated by an arrow. The resulting air loads on the thrust reverser had torn the doors away from the aircraft. Closer inspection showed that the link failed in fatigue, but the fatigue crack initiated at pitting corrosion sites in the link surface. The latter was coated by a protective molybdenum disulphide type dry film lubricant. Figure 9-5(b) shows the broken driver links, with the primary fatigue fracture indicated by arrows.

(a) General arrangement of thrust reverser system showing location of failure.

- Broken driver links showing primary fatigue fractures (arrows). Scanning electron microscope photograph of link surface near fracture, showing (c) fissures in coating (black arrows). White arrows 'S' show cracks growing from pits 'P' in areas where coating has spalled off, Black arrows show fissures in coating. (Mag. × 100)
- Cross-section through a typical pit (P in Fig. 9-5(c)) showing depth of attack. Villela's etch. (Mag.  $\times$  200) (d)

Scanning electron microscopic (SEM) examination of the surface near the fracture showed that the coating was fissured, and that pits were being formed at the roots of these fissures. Small fatigue cracks were growing from almost every such pit, and all were parallel to the major fracture surface. These features are shown in Figure 9-5(c).

Since the operating cyclic stress was close to the yield stress for this 422 type stainless steel link, any pit represented a sufficient stress concentration site to rapidly initiate high stress, low cycle fatigue. Pitting was the result of entrapment of fuel combustion by-products and moisture, collecting in fissures in the coating and attacking the stainless steel. A cross-section through a typical pit is shown in Figure 9-5(d).

Prevention could be accomplished by lowering the very high stress level in the link, or by preventing the corrosion pitting of the link. However, the corrosive medium in this case could not be eliminated since combustion products will inevitably condense on the part. The most practical immediate approach to preventing further failures was to strip the coating from all existing links, inspect for corrosion or cracks, and recoat the sound links with an improved coating while maintaining an ongoing inspection programme to identify early signs of corrosion. In the longer term, a redesign of the link system to reduce the service stresses would also be beneficial.

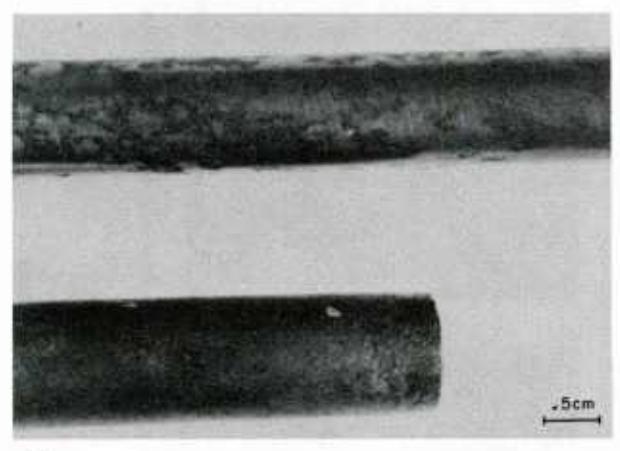
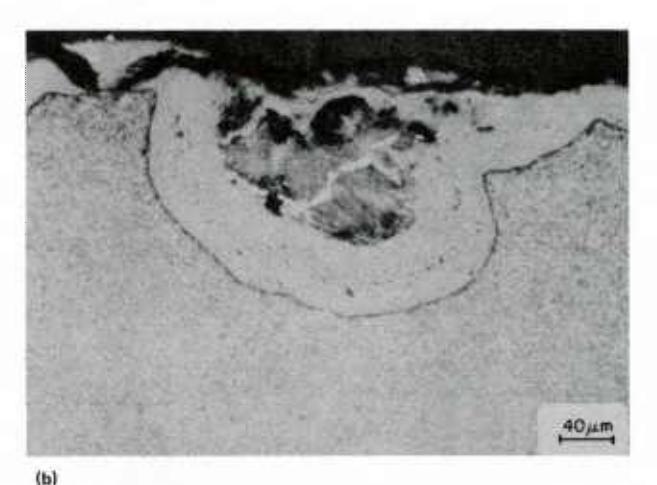
Fig. 9-8 Pitting induced failure of an engine exhaust valve

Figure 9-8(b) shows a typical pit in the valve stem, filled with a complex series of corrosion products containing iron, chromium and silicon oxides, and aluminium, copper, lead, sulphur and bromine compounds. Pitting near the fracture was so severe as to overlap the pits and reduce the section diameter by approximately 0.25 mm. Since this engine continued to run for some time after the valve head had separated and had fallen into the cylinder head, extensive secondary damage resulted from the valve head ingestion and eventually seized the engine.

Teardown revealed extensive pitting of several other valves and push rods. The engine was found to have been inactive for long periods, during which the engine oil was not drained and replaced by inhibiting oil. This improper maintenance resulted in pitting corrosion of the valves and push rods from acid compounds formed in the old engine oil.

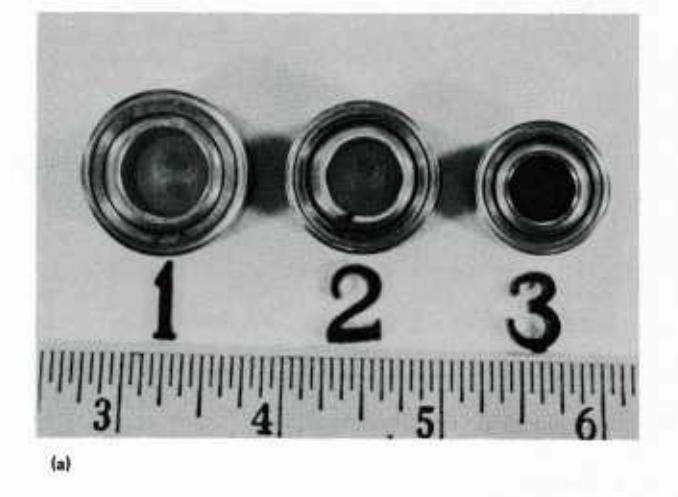
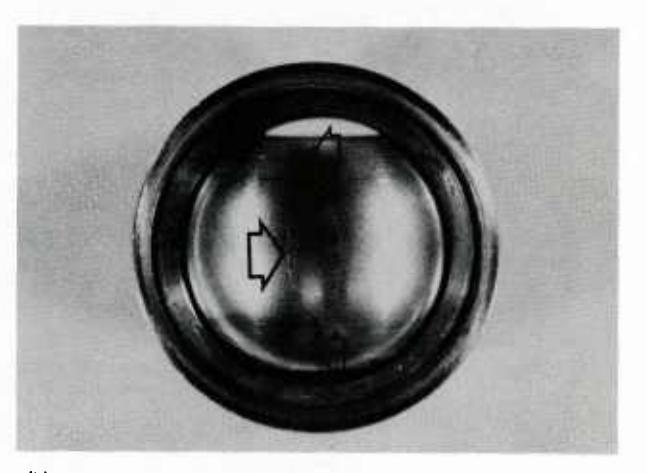
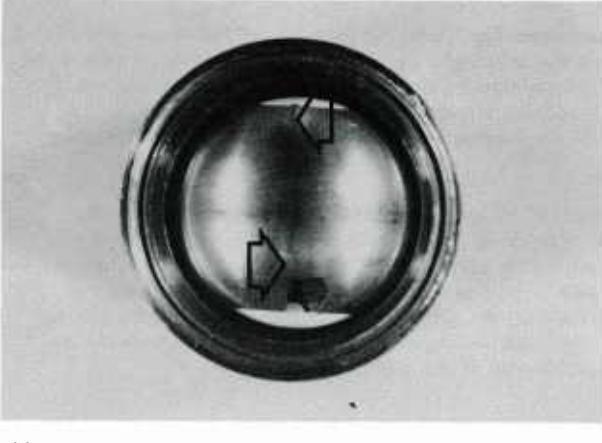
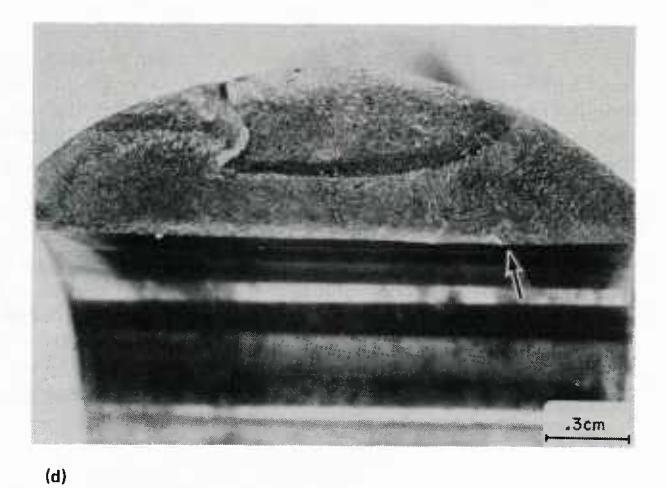
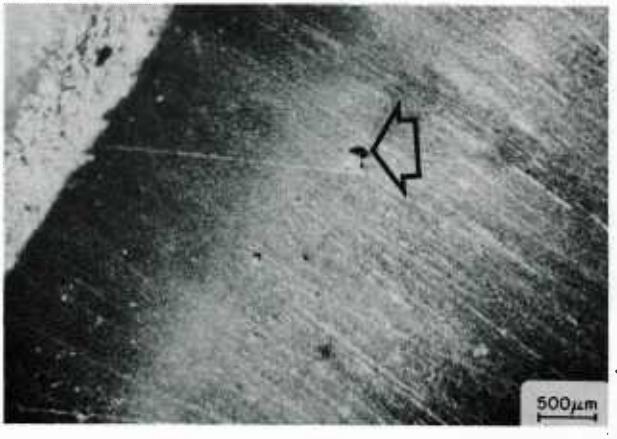
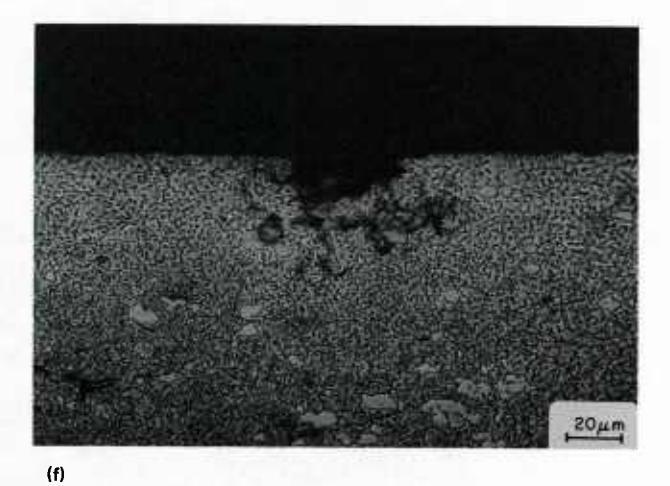
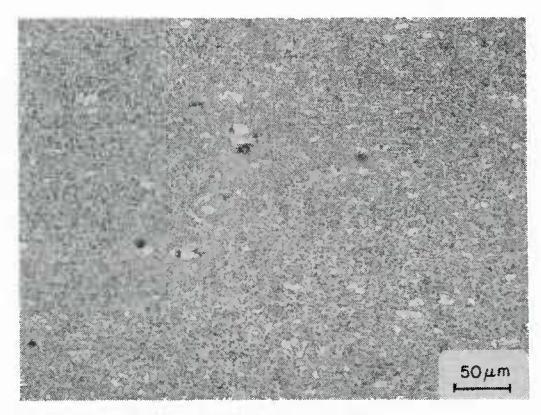
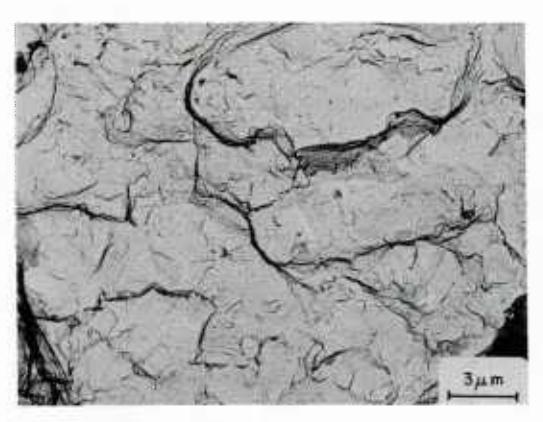
Fig. 9-9 Pitting induced failure of some 440C stainless steel hinge bearings

- (a) Three hinge bearings from a fighter aircraft.
  (b) Bearing number 1, showing crack configuration.
  (c) Bearing number 2, showing crack pattern and fragment missing at end of crack.
  (d) Fracture face of second crack in bearing number 1. Arrow shows probable crack initiation area. (Mag. × 5)
  (e) Corrosion pits on the inner diameter of a bearing which are typical of all three bearings submitted. (Mag. × 20)
  (f) Cross-section of corrosion pit found on bearing showing intergranular cracking at the base of the pit. Picric acid etch. (Mag. × 500)

The microstructure of the bearings is shown in Figure 9-9(g), and shows fine spheroidal chromium carbide together with larger carbide globules dispersed in the tempered martensitic matrix. The material had a hardness of  $R_c$  54-55, and both the microstructure and hardness were considered acceptable for this class of steel and the intended application. Figure 9-9(h) shows a replica transmission electron micrograph of the fracture surface of bearing No. 1, and indicates an intergranular mode of fracture. Similar observations were made for bearing No. 2, and both fracture surfaces showed indications of corrosion products on the intergranular facets.

It was concluded that the failures were caused by corrosion pitting which led to crack initiation and propagation either by stress corrosion cracking or hydrogen embrittlement. It was decided to carry out a fleet wide non-destructive examination to determine the extent of the flap hinge bearing cracking problem, and to inspect for pitting on the inner diameter. Since it is known that hydrogen cracking can occur during chromium plating of hardened 440C, it was decided to review the chromium plating and baking sequence to ensure that a source of hydrogen was not introduced during the plating operation. To counteract the pitting problem it was suggested that electroless nickel plating could be used on the entire bearing, since electroless nickel can be heated to 340°C for 1 hour subsequent to plating to provide wear resistance equivalent to that of chromium.
