AGARD Corrosion Handbook Volume-1 Aircraft Corrosion: Causes and Case Histories

AGARDograph No.278

## AIRCRAFT CORROSION: CAUSES AND CASE HISTORIES

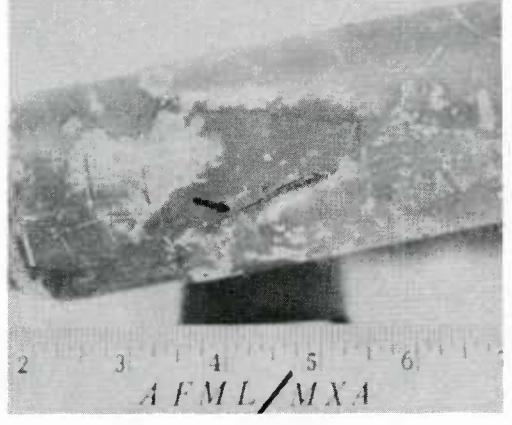
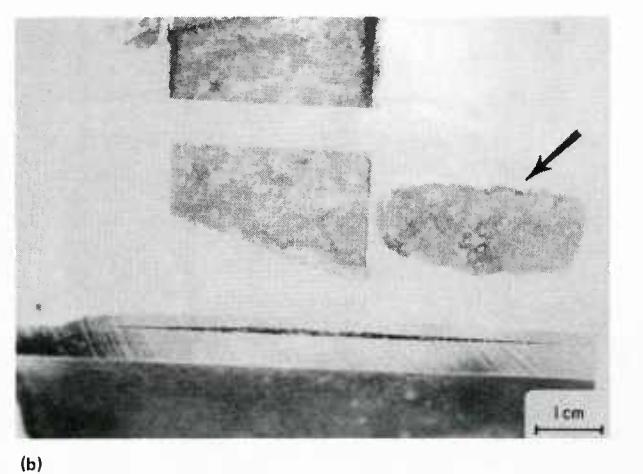
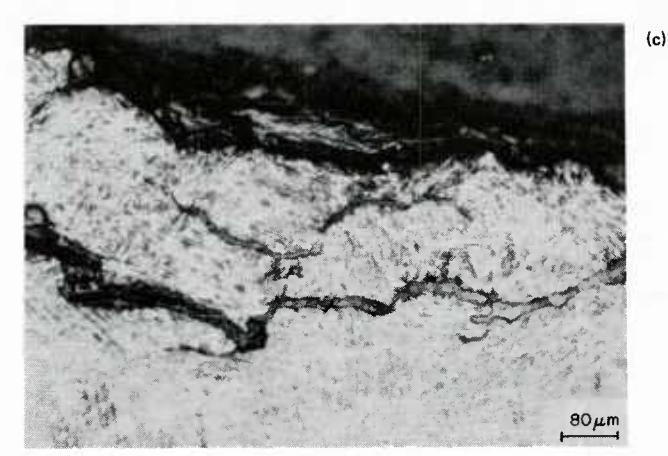
Fig. 9-10 Crevice corrosion in a welded steel joint

- (a) Appearance of the as-received torque tube showing the cracked weld.
- (b) Composite photograph showing corrosion deposit after the first cut (bottom) and second cut (top) of the tube section. Arrow indicates corrosion deposits found. (Mag. × 1.2)
- (c) Evidence of intergranular cracking in the weld bead. (Mag. × 125)

A crack was found in a weld bead in an elevator torque tube on a coast guard patrol aircraft. The torque tube serves as part of the elevator control linkage, and the crack which was found during a routine visual inspection is shown in Figure 9-10(a).

The torque tube was fabricated from two hollow telescoping steel tubes which were joined by welding. The geometry of the weld bead was not circumferential but rather followed the double trapezoidal cut out of the outer tube as shown in Figure 9-10(a). The weld bead appeared excellent in all respects except for one section which was cracked along the centre of the weld bead for a distance of about 46 mm. The outer tube appeared to be bulging outwards just at the crack defect.

The cracked area was sectioned whereupon a large amount of ferrous corrosion product was discovered (Fig. 9-10(b)). The volume of deposit was much greater than the displaced metal from which it had formed, with the result that the outer tube was bulged outward to develop stresses in the weldment. Evidence of intergranular fracture was found in the adjacent weldment, suggesting that stress corrosion cracking had occurred to relieve the internal pressure (Fig. 9-10(c)).

It was concluded that cracking was due to crevice corrosion occurring between the telescoping steel tubes. The corrosion product had built-up to a sufficient quantity and thickness to expand against and fracture the weld bead. Stress corrosion cracking was also suspected as playing a secondary role in the failure. The obvious recommendation was to employ proper corrosion control measures. It was observed that the torque tube was primed and painted on the outside, but was devoid of corrosion control coatings on the inside. It was also noticed that the tube was not sealed to prevent water access to the interior of the tube. In problems of this type, where welded joints are involved, proper design of the weld geometry is important to avoid crevices where corrosive fluids can collect. The joint should also be stress relieved after welding, and inspected by magnetic particle or dye penetrant to ensure a crack free weld.

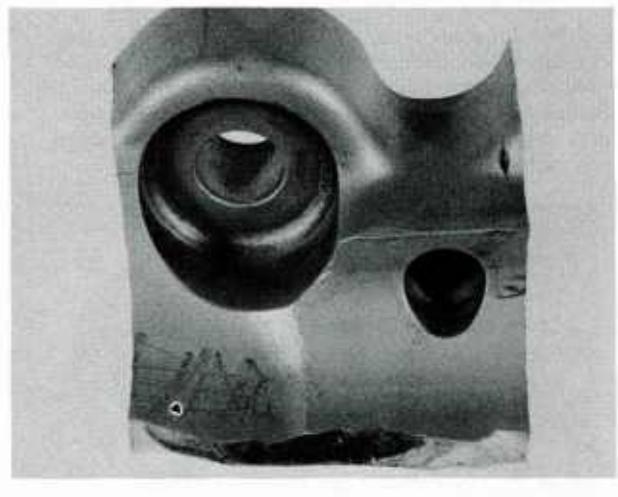
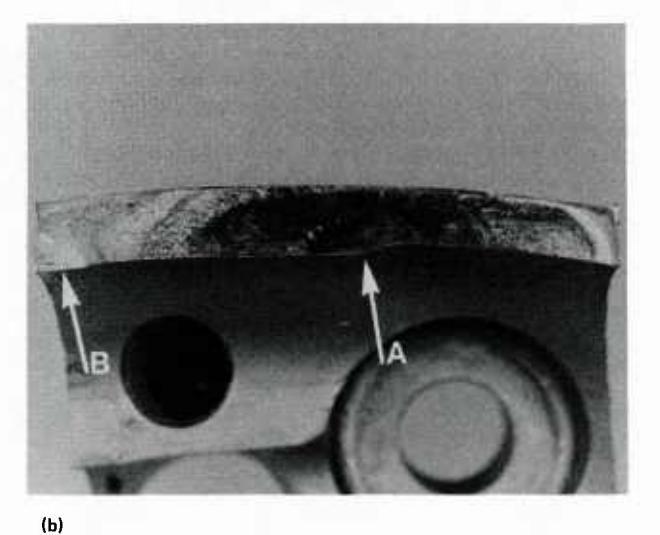
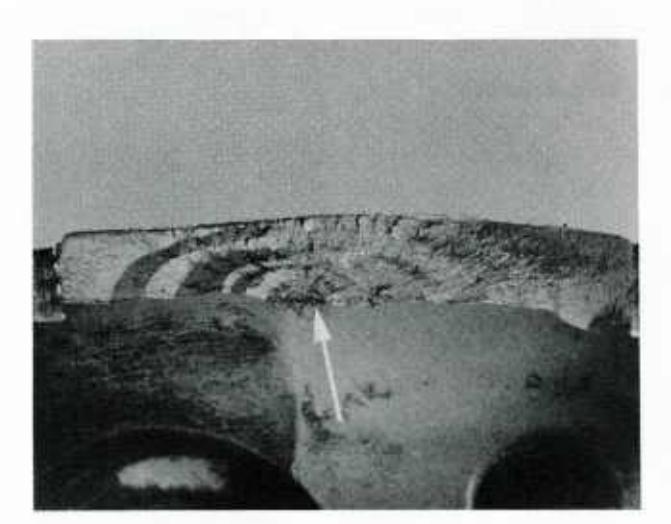
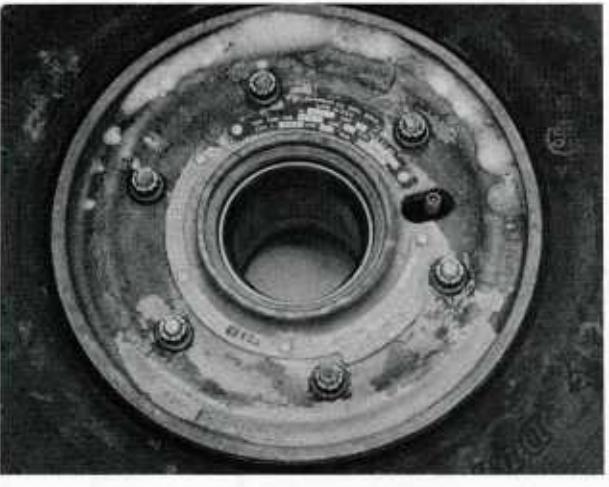
Fig. 9-11 Pitting corrosion and fatigue of a 2014-T6 aluminium alloy main landing gear wheel

Figure 9-11(a) shows a piece of an aluminium alloy main wheel, while Figure 9-11(b) is the same piece at higher magnification and shows a portion of the fracture surface involved. The fracture surface in this area showed beach marks, characteristic of fatigue, and the fatigue crack could be traced back to an initiation site at a corrosion pit, which is indicated by the arrow 'A'. The adjacent arrow 'B' points to a neighbouring fatigue crack which had also initiated at a corrosion pit. The total length of these two cracks was about 80 mm, and both had propagated through the wall of the wheel until air had escaped and the tyre deflated.

Figure 9-11(c) shows another example of a fatigue crack originating at a corrosion pit in a main wheel. In all these cases it was observed that the cracks initiated at corrosion pits, and in all cases the corrosion pits occurred in the same area where the wheel was in contact with a stainless steel heat shield. As explained in case history 9-2 above, aluminium alloy 2014 is normally a passive corrosion resistant metal, forming a protective anodic film on exposure to corrosive environments. However, in this case the repeated contact between the stainless steel heat shield and the wheel had resulted in the removal of both the paint finish on the wheel and the anodic film. The bare metal would then be in direct contact with the stainless steel, and in the presence of an electrolyte a corrosion cell would be set up in which the aluminium would be the anode and the stainless steel the cathode. The pitting situation was aggravated by the large cathodic surface area of the stainless steel and very small area of rubbed and unpassivated aluminium anode.

The problems in the magnesium nose wheels are illustrated in Figure 9-11(d), which shows bubbling in a soap solution which was applied to the wheel in the bead seat radius. In these cases the problems were attributed to excessive porosity due micro-shrinkage and intergranular corrosion in these magnesium alloy castings.

These problems led to more regular maintenance of the protective finishes, especially around the key boss areas where the heat shields contact the wheels. The problem also led to an investigation of adhesive tapes to provide insulation between the stainless steel and the aluminium wheel, and an aluminium foil tape which was thought would provide better heat dissipation properties and less likely to damage the wheel anodic coating. The heat shields could not be removed since high temperatures would occur in the wheels and lead to fuse plug release. A more rigorous programme of non-destructive inspection was also implemented, involving eddy current inspection about the bead seat radius and ultrasonic inspection for defects in the key boss radius-heat shield contact area.

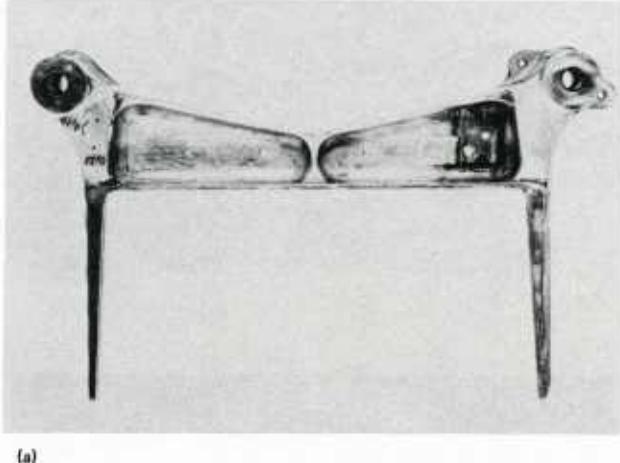
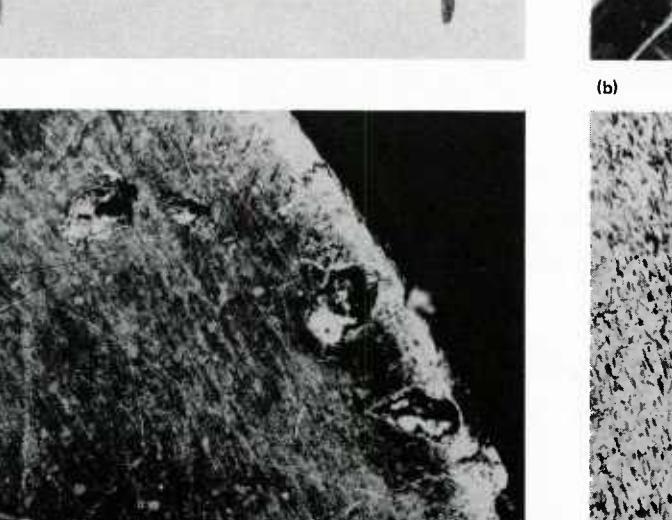
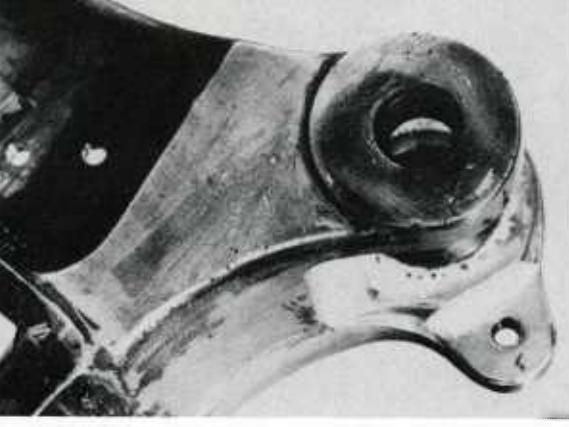
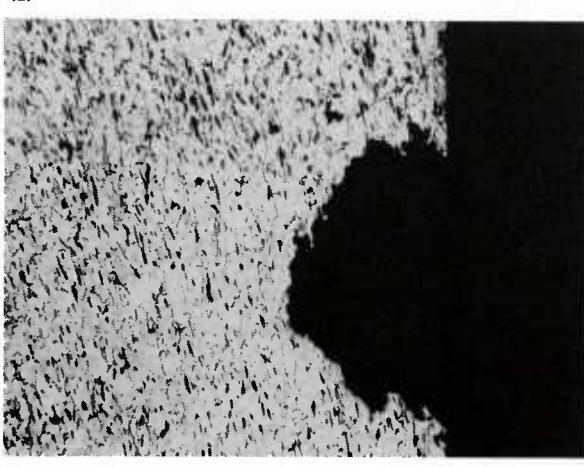
Fig. 9-12 Pitting corrosion of a 7075 aluminium tail cone fitting

Deep corrosion pits were found in the lug area of an aluminium alloy tail cone fitting during routine inspection. The fitting, shown in Figure 9-12(a), was determined to be made of 7075 aluminium alloy and the pitting was found around the outer perimeter of the lug, shown at higher magnification in Figure 9-12(b). Typical corrosion pits are shown in Figure 9-12(c), and a cross-section is shown in Figure 9-12(d). The corrosion pits were measured to be up to 1.5 mm in diameter and up to 0.65 mm in depth. These corrosion pits were found to contain corrosion deposits which were determined to consist of aluminium hydroxide  $Al(OH)_3$  containing sodium and chloride ions, suggesting that the pitting was due to salt water corrosion.

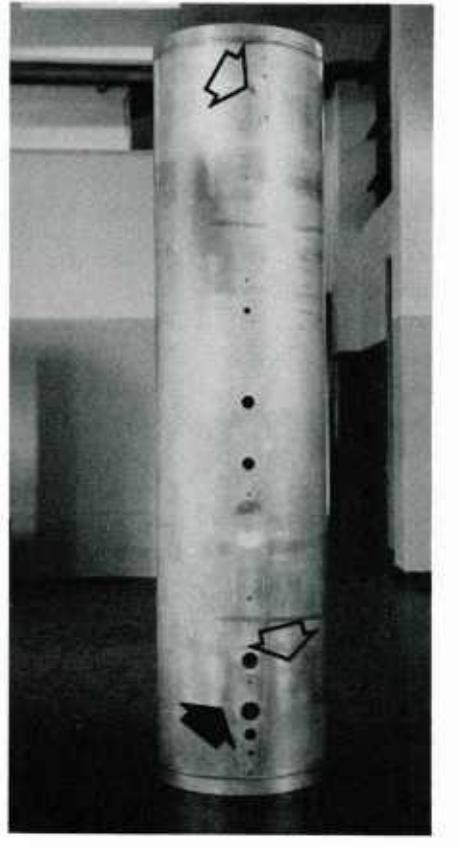
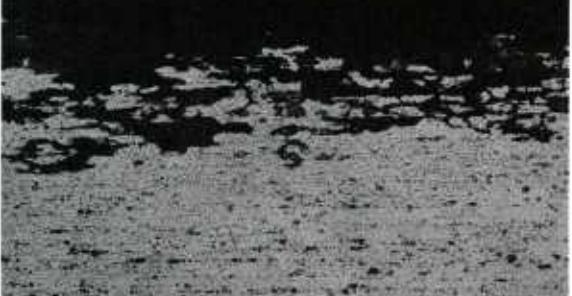
Fig. 9-13 Filiform corrosion in a fighter aircraft pylon tank

The aircraft in question had been operating in the Mediterranean region and the corrosion damage was detected during a routine visual inspection. The damage to the pylon tank was largely superficial affecting isolated areas over the full length of the tank, as indicated by open arrows in Figure 9-13(a). However at one point, penetration had occurred, as indicated by the solid arrow in Figure 9-13(a).

Closer surface examination showed that the corrosion followed the characteristic wandering path of filiform corrosion, as shown in Figure 9-13(b), while metallographic sections through the corrosion damage showed areas resembling broad pits and intergranular tunnelling (Fig. 9-13(c)). The alloy was found to be 6061 aluminium with a hardness of  $H_B$  52, suggesting the alloy was in a T6 temper condition. The protective coating on this part had been removed by the operator prior to laboratory inspection, and therefore is unknown, however modern epoxy primers and polyurethane paint finishes, if properly maintained, should be sufficient to prevent this type of problem from recurring.

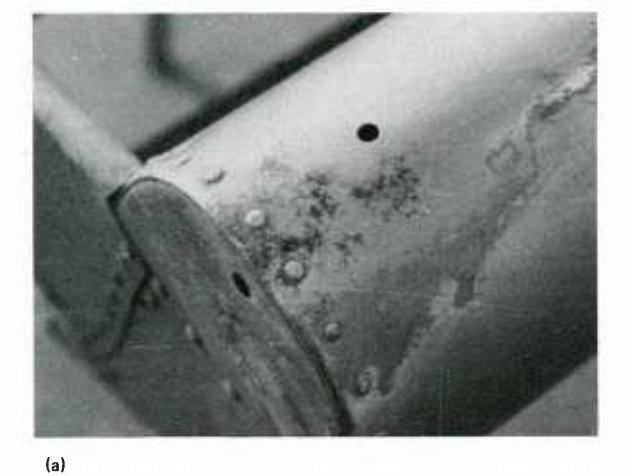
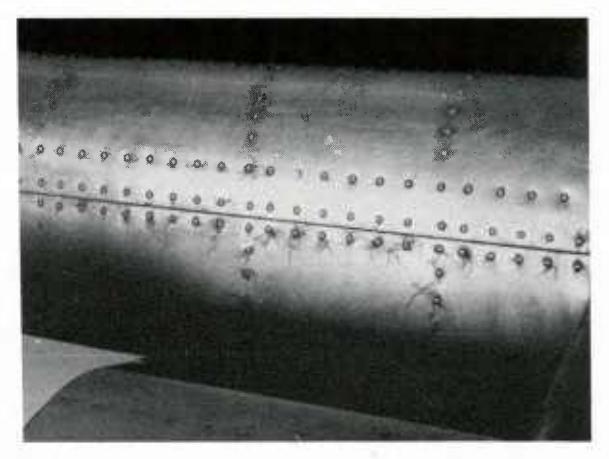
Fig. 9-14 Filiform corrosion in some 2024 ailerons and flaps

This aircraft had also been operating in the Mediterranean region, and the corrosion damage was again detected during visual inspection. The structure in this case was made from 2024 aluminium and had been protected by a nitro-alkyd resin paint system. Areas of corrosion damage are shown in Figure 9-14(a), and in Figure 9-14(b) after removal of the paint system. The corrosion was largely superficial, although penetration had occurred in one area. The surface corrosion showed the thread-like meanderings of filiform corrosion, and appeared to have originated in the fastener holes, as indicated in Figure 9-14(b).

A strontium chromate epoxy primer and polyurethane finish were recommended to replace the nitro-alkyd protection system used previously.

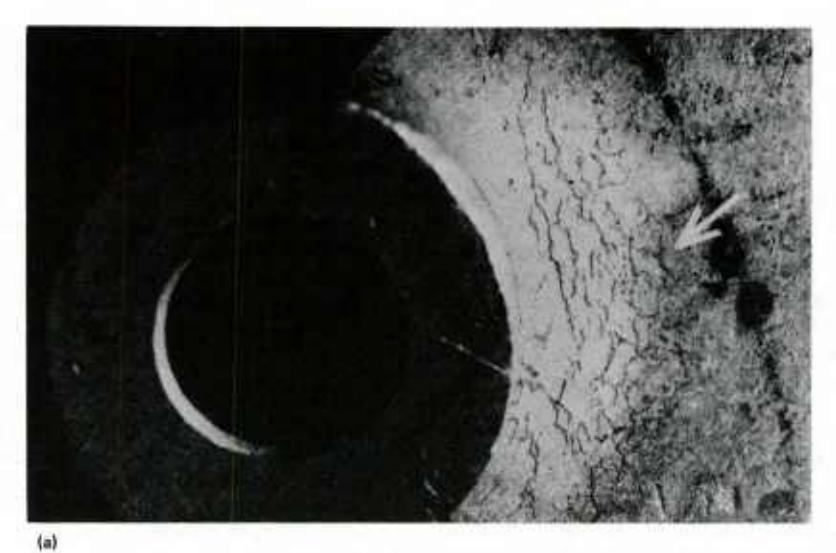
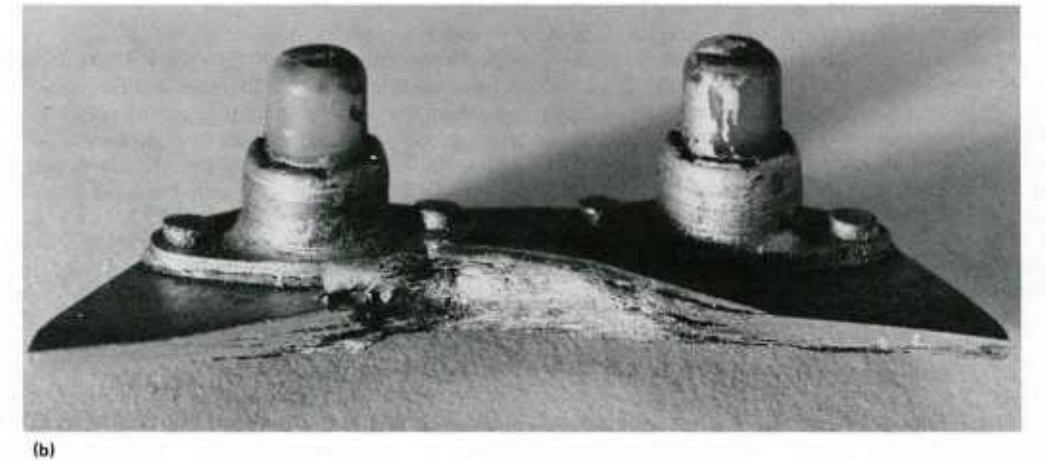
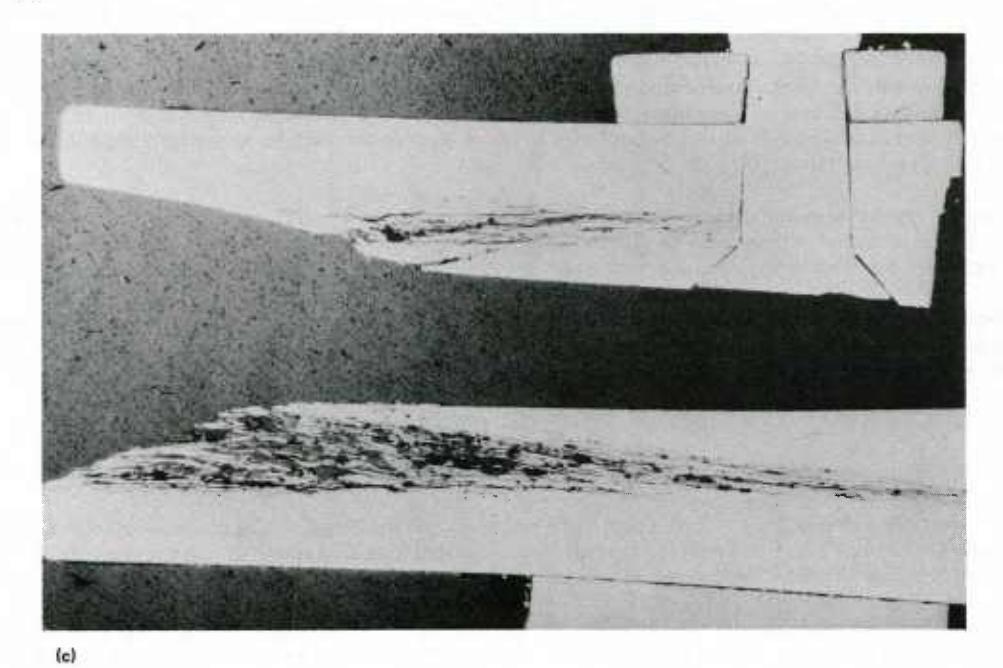
Fig. 10-1 Examples of intergranular and exfoliation corrosion in aircraft structure and components

Intergranular corrosion is a highly localized form of dissolution which affects the grain boundary regions in a polycrystalline metal. The corrosive attack can produce a network of corrosion or cracking on the metal surface, occasionally dislodging whole grains, or it may penetrate deeply into the metal leaving behind very little visible evidence of the damage. An example of a network of fine surface cracking is shown in Figure 10-1(a), where the part is a forged aluminium alloy hydraulic valve.

In heavily rolled or extruded products where the grains are flattened and elongated in the direction of working, the presence of intergranular corrosion can lead to layering and flaking, producing a delamination effect with surface grains being pushed out by the underlying corrosion products. This is known as exfoliation corrosion, and is essentially a severe form of intergranular corrosion occurring in the direction of grain flow. Examples of exfoliation are shown in Figures 10-1(b) and 10-1(c). Figure 10-1(b) shows a specimen cut from the edge of an access hole in a aluminium alloy skin panel, and reveals the severely destructive effect of exfoliation. This damage occurred due to the use of a susceptible rolled alloy with inadequate protection to the flat land of the access holes, combined with operations in a maritime environment. Figure 10-1(c) shows the voluminous dark corrosion products forming in the intergranular fissures and the substantial delamination occurring in the skin.

- (a) Intergranular surface cracking in a forged aluminium alloy valve.
  (b) Exfoliation corrosion in an aluminium alloy skin.
  (c) Cross-section through an aluminium alloy skin showing dark corrosion products and delamination due to exfoliation.

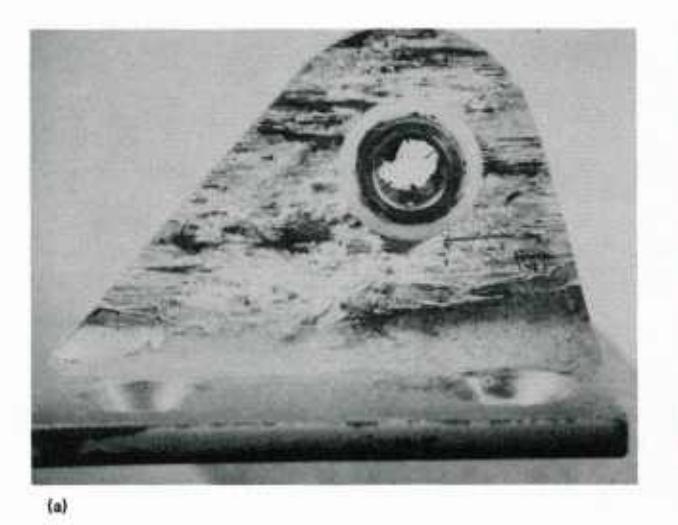
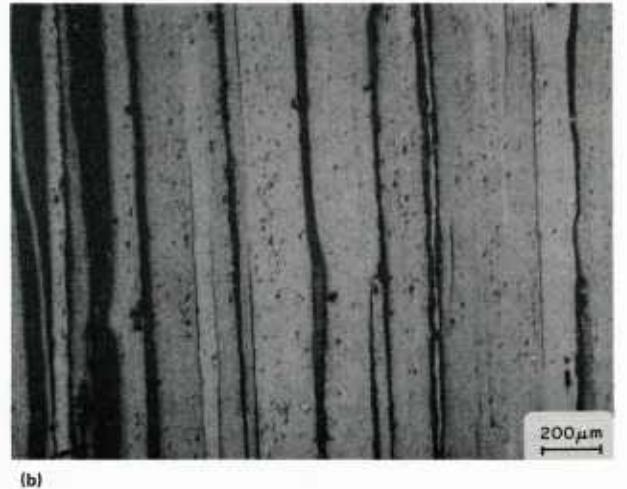
Fig. 10-2 Exfoliation corrosion in an aluminium alloy stabilizer bracket

- (a) Heavy surface corrosion of the stabilizer hinge bracket.
  (b) Cross-section through the bracket showing the corro
- Cross-section through the bracket showing the corroded surface grains at the right, and corrosion of elongated grain boundaries only. Keller's etch. (Mag. × 50)

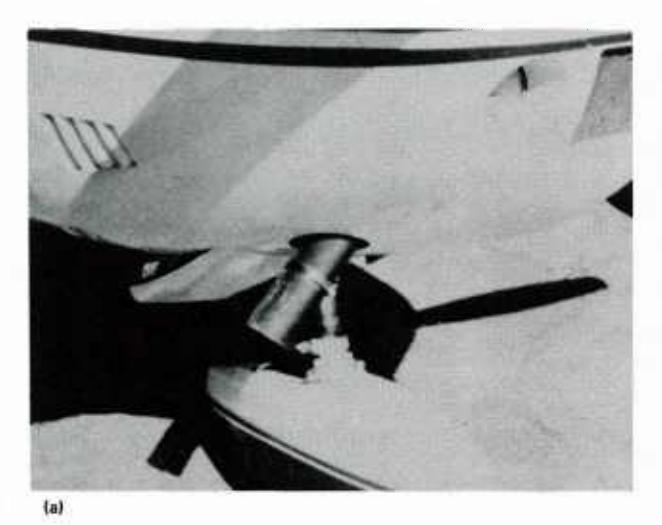
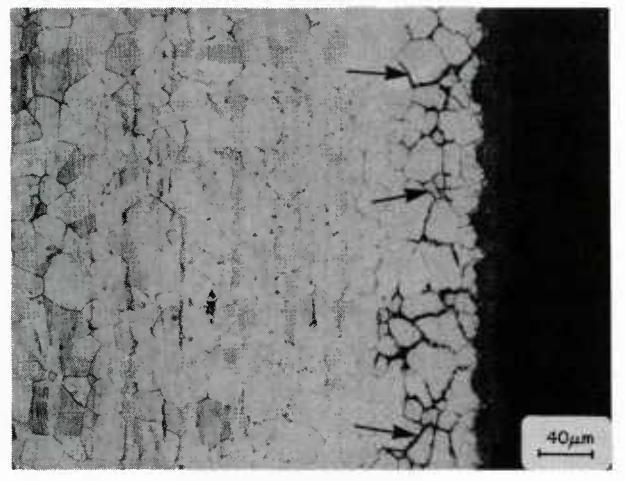
Fig. 10-3 Intergranular corrosion and fatigue of a light aircraft engine exhaust

A custom silencing muffler was added to a light aircraft engine exhaust, as shown in Figure 10-3(a). This muffler and most of the exhaust separated in flight, and the unrestrained hot exhaust gases caused an in-flight fire. The exhaust pipe broke near its flange support, the pipe and silencing muffler were otherwise unsupported. Examination revealed the austenitic stainless steel exhaust had suffered intergranular corrosion (Fig. 10-3(b)), and the corrosion cracks had served as stress concentration sites to initiate fatigue. The loading causing fatigue was due to vibration of the cantilevered pipe and muffler, which was excited by fluctuating air loads as well as engine induced vibration.

Intergranular corrosion of austenitic stainless steel exhaust pipes is common, since the cycles of hot and cold exposure to combustion by-products and condensates represents a severe corrosive environment. However, since the pipes are usually well supported and hence subject only to low loads, normally they will not fracture until virtually perforated. In this case, the heavy, cantilevered, unsupported muffler extension created high cyclic stresses. The problem was alleviated by adding an extra support for the muffler. The grade of austenitic stainless steel used in the exhaust was not disclosed in this investigation, and therefore the possibility of sensitizing occurring due to the high temperature of the exhaust gases cannot be ruled out. The oxidation resistance and corrosion resistance of these alloys generally increase with increasing chromium and nickel contents, while microstructural stability improves with lower carbon levels.

(b) Intergranular attack of the austenitic stainless steel pipe. Kalling's etch. (Mag.  $\times$  250)

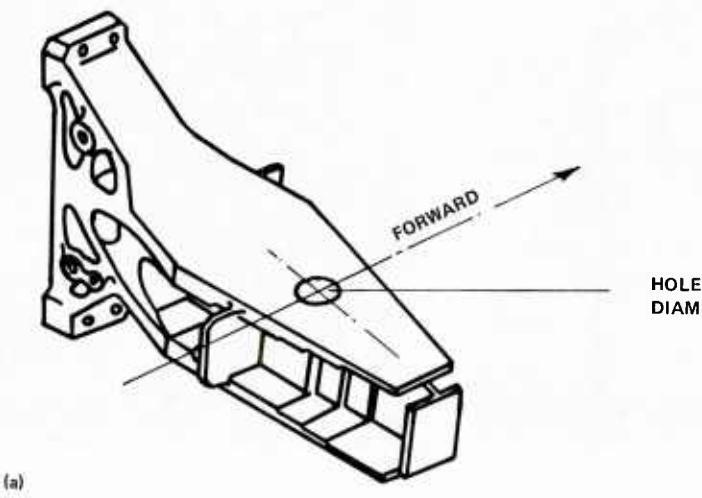
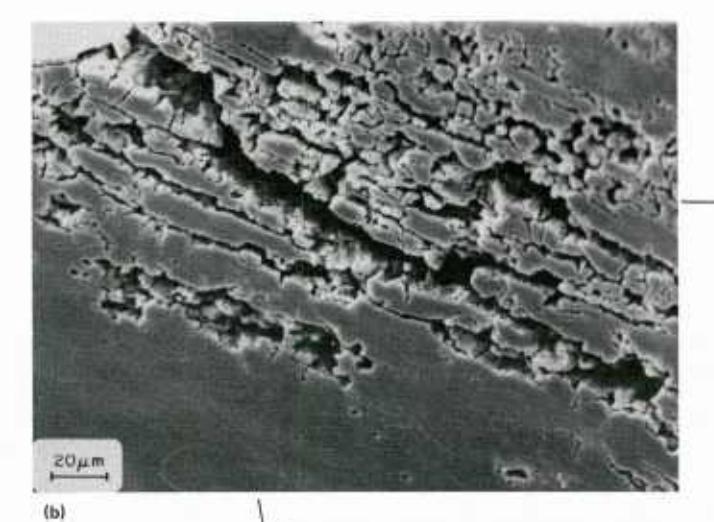
HOLE FOR HOIST PIN DIAMETER 25.4-25.5 mm

CORRODED GRAIN BOUNDARIES

SURFACE OF THE HOLE OF THE HOIST PIN

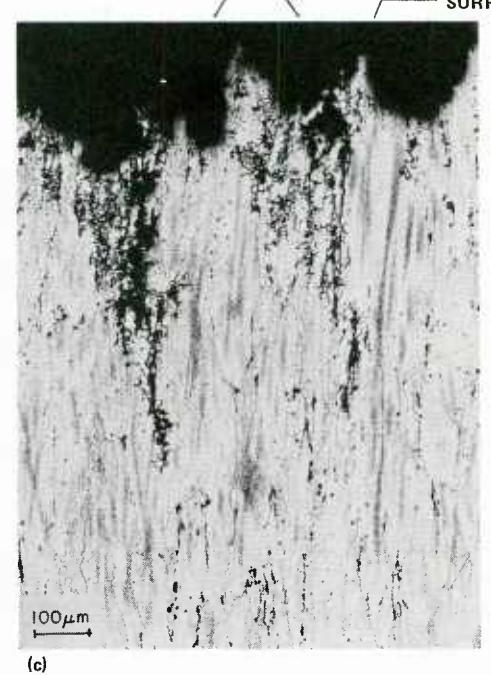
- Fig. 10-4 Intergranular corrosion of an Al-Zn-Mg-Cu alloy wing attachment forging

(a) Wing attachment fitting indicating the corroded hoist pin hole.
(b) Macroscopic view of the corroded area. (Mag. × 500)
(c) Representative microstructure showing intergranular corrosion. (Mag. × 100)

The surface preparation of the fitting included shot peening on all surfaces, including the hole of the hoist pin, together with chemical conversion coating using Alodine 1200 and a zinc chromate primer. Notwithstanding this treatment, corrosion occurred in service and this is shown in Figure 10-4(b) to have occurred preferentially along grain boundaries in the forging. This was confirmed by preparing metallographic cross-sections through material adjacent to the hoist hole, and a typical example is shown in Figure 10-4(c). This shows that the forging has an elongated grain structure with grains boundaries running normal to the axis of the hole. There was also evidence of fine recrystallized grains forming a necklace structure around the boundaries of the coarser grains. The intergranular nature of the corrosive attack is very clear in Figure 10-4(c).

Intergranular corrosion occurred in this component due to a combination of circumstances. Material of this type is susceptible to intergranular corrosion when aged to a peak strength 'T6' condition. Greater resistance to corrosion can generally be achieved by overaging to a T76 or T73 condition, although the response of this sepecific alloy to this type of treatment would need to be verified. Intergranular attack is clearly promoted when grain boundaries intersect a free surface. By drilling the hoist hole perpendicular to the direction of grain flow leads to many grain boundaries being exposed. And finally, the surface protection system was probably damaged during insertion of the hoist pin, and appears not to have been adequately repaired. Similar parts remaining in service were also inspected, and where corrosion damage was detected the holes were re-drilled and ground to remove the corrosion and the full protection system was re-applied.

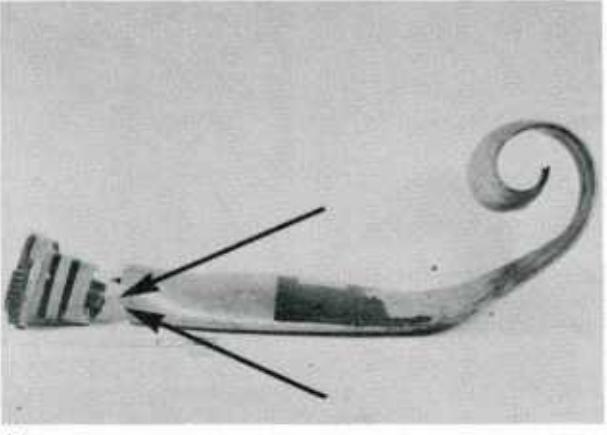
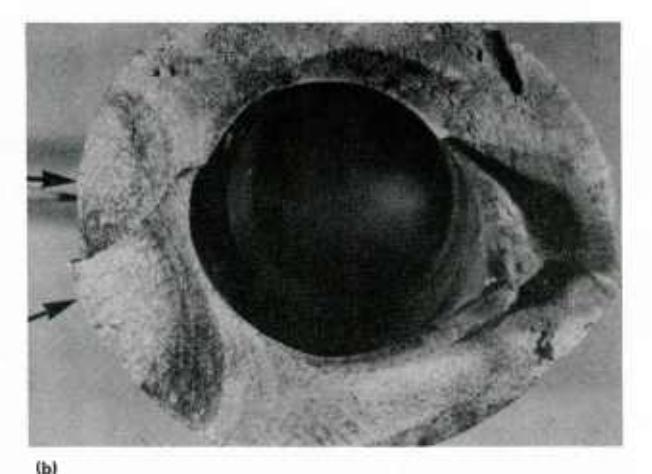
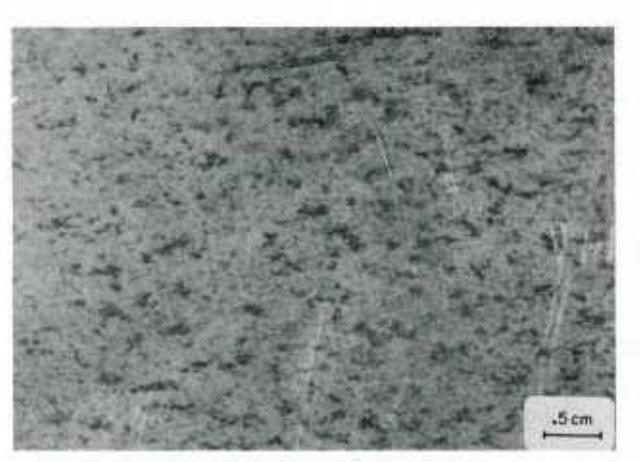
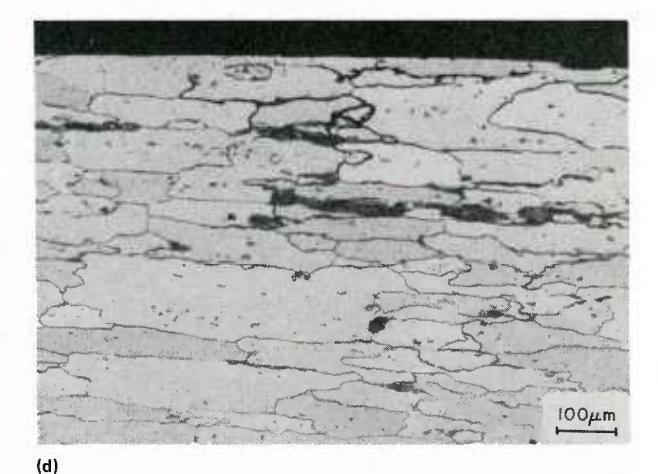
- Fig. 10-5 Intergranular corrosion and fatigue of an aluminium alloy propeller (a) Failed propeller showing the fatigue crack initiation sites near the leading edge root
- (arrows).(b) Fracture face showing two major fatigue cracks whose origins correspond to the arrows in Figure 10-5(a).
- (c) Surface of the propeller blade near the fatigue initiation sites showing a mottled appearance but no indications of widespread corrosion. (Mag. × 2)
- appearance but no indications of widespread corrosion. (Mag. × 2)
  (d) Section through the area seen in Figure 10-5(c) showing severe intergranular corrosion. Keller's etch. (Mag. × 100)

An aircraft used for crop dusting lost a propeller blade just after taking off. The resulting severe imbalance ripped the engine out of its mounts and the aircraft crashed and was destroyed by fire. Figure 10-5(a) shows the damaged propeller and the arrows indicate the crack initiation sites. Figure 10-5(b) shows the fracture surface, and scanning electron microscopy showed that crack growth occurred by fatigue through about 40% of the root section before catastrophic rupture occurred under centrifugal loading.

Two major fatigue crack initiation sites were apparent, as indicated by the arrows in Figure 10-5(b), but no obvious stress concentration sites were visually apparent at the origins. Figure 10-5(c) shows the surface of the blade around the fracture zone exhibited a slightly mottled effect, apparently due to mild surface corrosion. However, sections cut from this area showed that severe intergranular attack had occurred, as shown in Figure 10-5(d). This attack provided the stress concentration sites which had initiated fatigue cracking. The corrosive medium responsible was found to be the agricultural spray chemicals used in crop dusting.

No information was provided in this investigation of the alloy type or the inspection procedures used with this aircraft propeller. Most of the high strength aluminium alloys used for safety critical aircraft parts are susceptible to intergranular corrosion unless properly heat treated and protected. Satisfactory heat treatment generally involves rapid quenching, of the order of several hundred °C per second, to avoid grain boundary precipitation during the quench. Subsequent precipitation heat treatment must also be extensive enough to avoid introducing susceptibility to intergranular corrosion. It is possible that intergranular corrosion may occur even in correctly heat treated parts, if particularly aggressive corrodents are present in the atmosphere. Hence to avoid corrosion in a case such as this it would be recommended to carefully wash off all chemicals after each flight, and wax the surfaces to protect them.

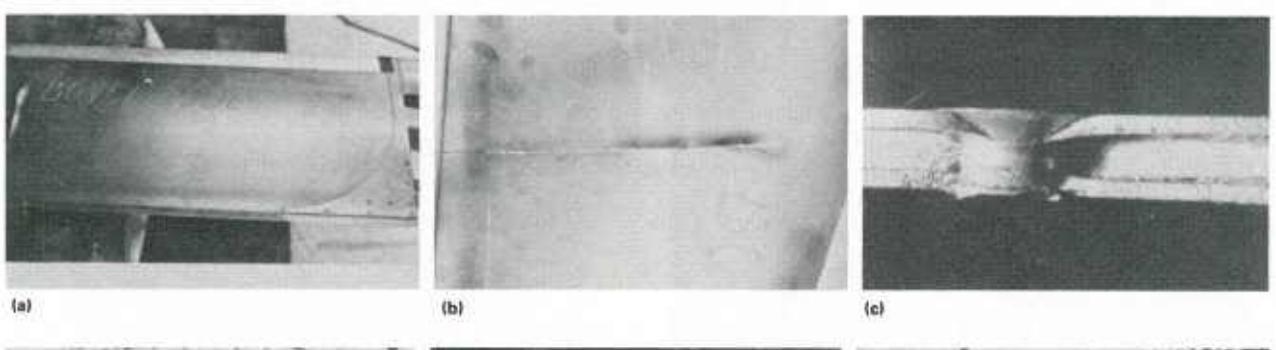
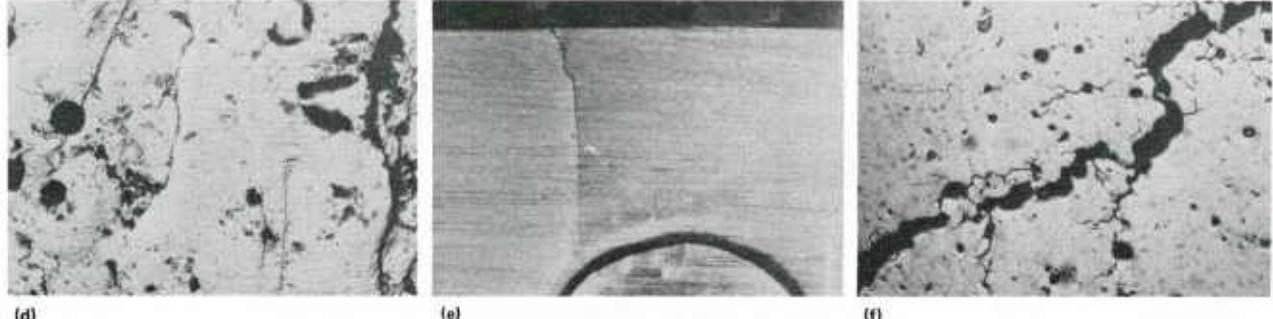
A long crack was found in a helicopter rotor blade. The crack had initiated at the trailing edge and had propagated across the blade in a chordwise direction to a length of 225 mm. The blade chord was 350 mm, and the crack was located 650 mm from the blade root. The rotor blade and crack are shown in Figures 10-6(a) and 10-6(b).

Fig. 10-6 Intergranular corrosion and fatigue in a helicopter main rotor blade

Trailing edge of the blade. (a)

- (b) 225 mm long crack growing from the trailing edge. Fracture surface on either side of a rivet.
- (c) (d) Fatigue striations on the crack face in the lower skin.
- A secondary crack adjacent to the main crack. Intergranular cracking in the trailing edge skin. (f)

Figure 10-6(c) shows the fracture surface after opening of the crack, and Figure 10-6(d) is an electron fractograph showing fatigue striations on the fracture surface of the bottom skin behind a rivet. Since the main crack ran through a rivet hole, further inspections were carried out involving removal of paint from the locations of all other rivets. Many other cracks were found, similar to that shown in Figure 10-6(e), and in all cases it was found that the cracks had grown into the rivet holes but had initiated elsewhere. Thus it was found that the stress concentration sites responsible for fatigue crack initiation were not associated with the rivet holes, but were due to intergranular corrosion in the skin in the trailing edge region.

Figure 10-6(f) shows the typical metallographic evidence of the intergranular corrosion in the trailing edge skin. Further examination showed that the bond line along the trailing edge was not completely sealed, so that moisture could penetrate and be absorbed by the foam filler. It was also found that the bottom skin had undergone a hot-dimpling operation. Reheating wrought aluminium alloys during such operations must be carried out with caution because of the danger of lowering the corrosion resistance of the metal. For example, 2024 aluminium in the T3 and T4 conditions should not be reheated to temperatures in the range 150-230°C, because of its harmful effect on corrosion resistance, while material in the more stable T81 or T86 conditions must be limited to exposure times varying from 20-40 hours at 150°C to 5 minutes at 230°C (Ref. 10-1).

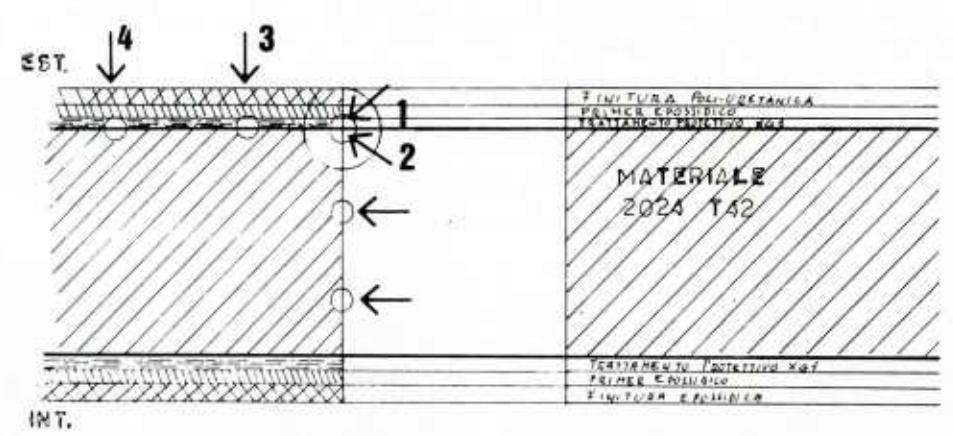
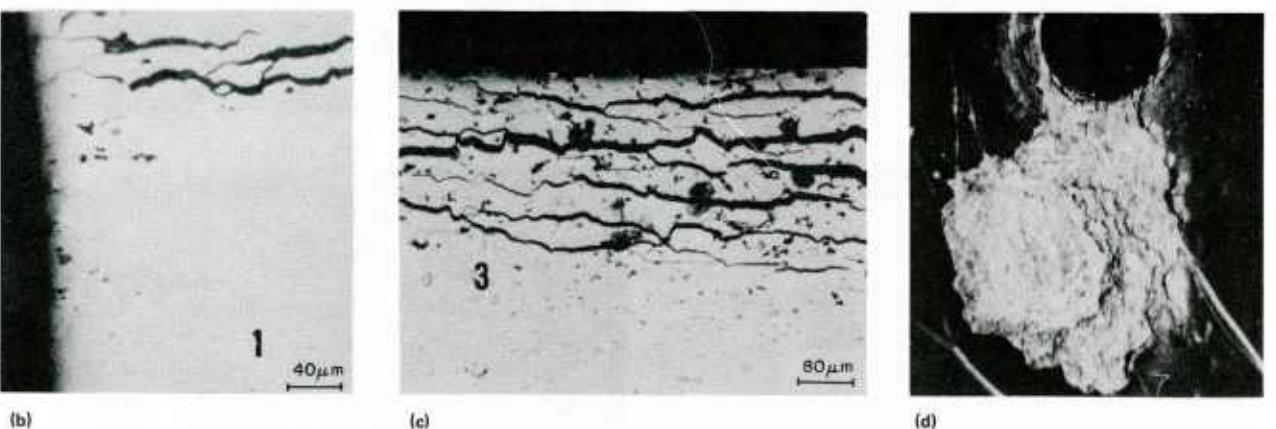
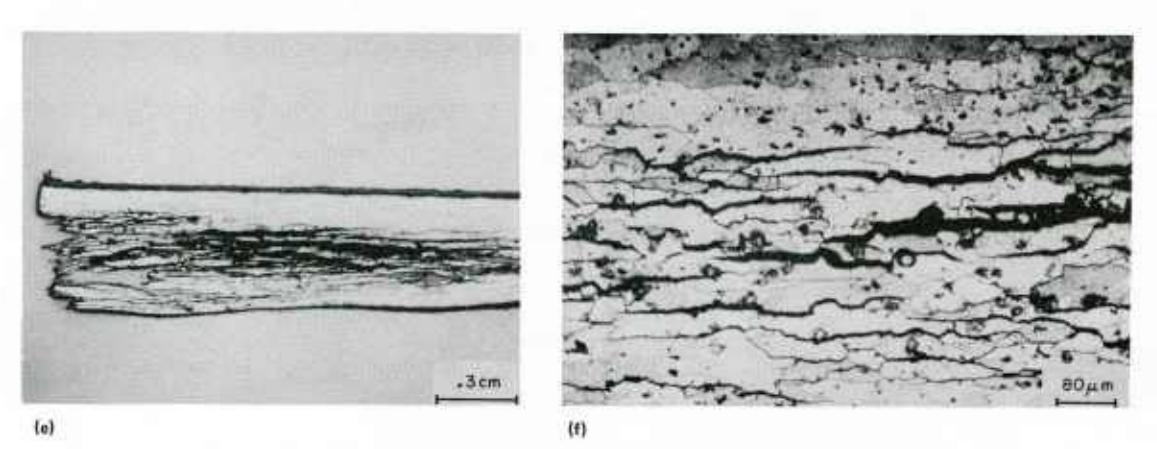
Fig. 10-7 Intergranular corrosion and exfoliation in a 2024-T42 vertical fin and horizontal stabilizer

- Diagram showing the aluminium skin and corrosion protection system.
- Intergranular corrosion observed at location 1 in a fastener hole, (Mag.  $\times$  250) Intergranular corrosion observed under the corrosion protection system at location 3 in (b) (c)
  - the skin outer surface. (Mag. × 130)
- (d) Corrosion products at a fastener hole
- Severe exfoliation and delamination. (Mag.  $\times$  5) (e)
- (f) Intergranular corrosion associated with delamination of Figure 10-7(e), (Mag.  $\times$  130)

Corrosion damage was detected during visual inspection of the vertical fin and horizontal stabilizer of a transport aircraft. The structure involved the extensive use of rivetted and bolted joints in 2024-T42 aluminium alloy. The surface skin was coated with the corrosion protection system shown schematically in Figure 10-7(a). All non-machined surfaces were protected by a layer of chromic acid anodizing and an epoxy primer. On the inside surface of the skin the top-coat was a layer of epoxy paint, while on the outside (exterior) surface a coating of polyurethane enamel was employed. The machined surfaces of the fastener holes were bare.

Corrosion damage was found to have initiated in the bores of the fastener holes. Since the fasteners were installed without the use of sealants, moisture could easily penetrate between the fastener and skin to cause corrosion damage in the bare metal. Figure 10-7(b) shows evidence of the corrosion damage in the bore of a fastener hole, and Figure 10-7(c) shows evidence of the intergranular attack in the skin immediately below the exterior coating away from the fastener hole. In areas of severe corrosion, for example at fastener holes, substantial build-up of corrosion products had occurred (Fig. 10-7(d)), while internal propagation exhibited the characteristic delamination effects of exfoliation corrosion (Figs. 10-7(e) and 10-7(f)).

Several forms of remedial action are possible in a case such as this. The optimum temper for 2024 aluminium alloy in terms of resistance to intergranular corrosion and exfoliation is not the T42 temper as used, but is the T81 (T851 or T861) temper (Refs. 10-2, 10-3). For thin sheet the T81 temper provides higher yield strength and ultimate tensile strength than the T42 temper for an equivalent section thickness. In the case of the T42 temper, the absence of a corrosion protection system in the fastener holes was a key factor leading to corrosion. By using wet assembly, with sealing compounds introduced to the holes during fastener installation, it would have been possible to exclude the corrosive solution and substantially reduce corrosion.

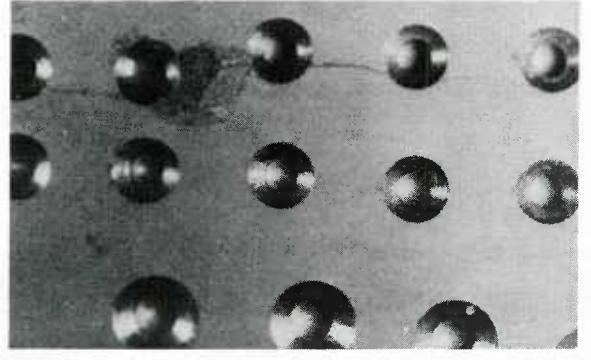
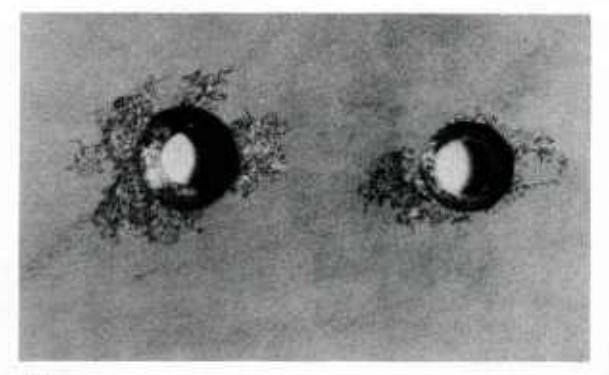
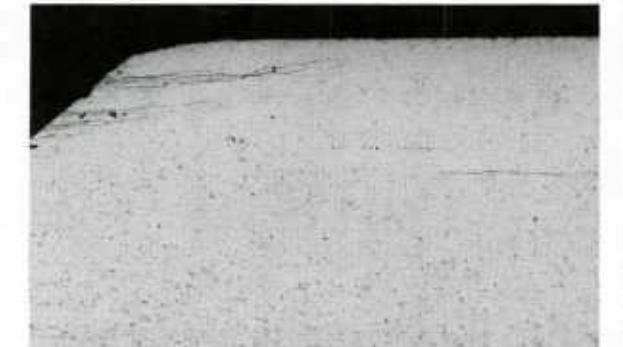
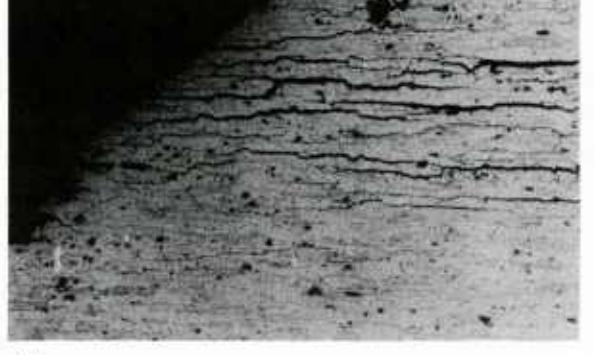
Deep corrosion between the fastener holes of the wing panel bolted joints.

(b) Localized corrosion around fastener holes.

- Traces of pitting and intergranular corrosion at the fastener countersink holes. (c)
- (d) Similar area to Figure 10-8(c) at higher magnification.
   (e) Intergranular corrosion extending from a fast ner hole and running out to the
  - free surface of the plate.
- (f) Cracking shown in Figure 10-8(e) at higher magnification.

Corrosion damage was located primarily around fastener holes, as shown in Figures 10-8(a) and 10-8(b), but damage was also found in areas away from fastener holes. The damage included pitting, areas of filiform type corrosion and extensive intergranular cracking. The predominant type of damage was pitting in the bores and countersink areas of the fastener holes, from which extensive intergranular cracking emanated (Figs. 10-8(c) and 10-8(d)). Several surface connected cracks can be seen running between fastener holes in Figure 10-8(a). Metallographic examinations showed that substantial intergranular cracking was associated with the surface connected cracking, as shown in Figs. 10-8(e) and 10-8(f).

Several courses of action are possible to resolve problems of this type, involving either enhanced corrosion protection of the existing structure, or change of either the alloy type or the heat treatment condition of the metal structure. For aircraft already inservice, major up-grading of the corrosion protection system was carried out involving touch-up of fastener hole bores and countersinks using a chemical conversion coating (Alodine 1200). This was followed by wet assembly of fasteners and the use of a strontium chromate primer and an acrylic finish. It was reported that similar treatments had also been applied to new aircraft in manufacture, resulting in marked improvements in their corrosion resistance.

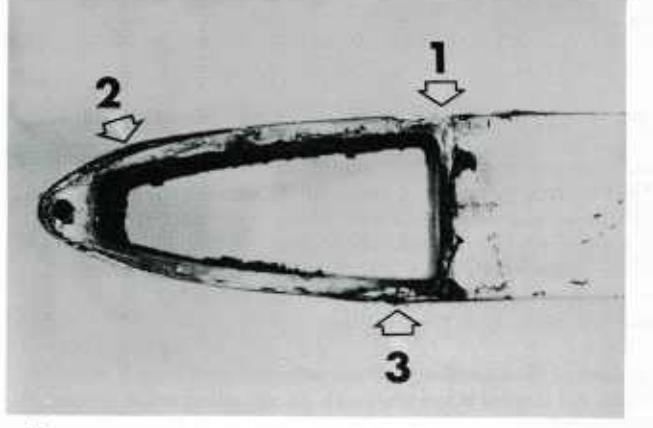
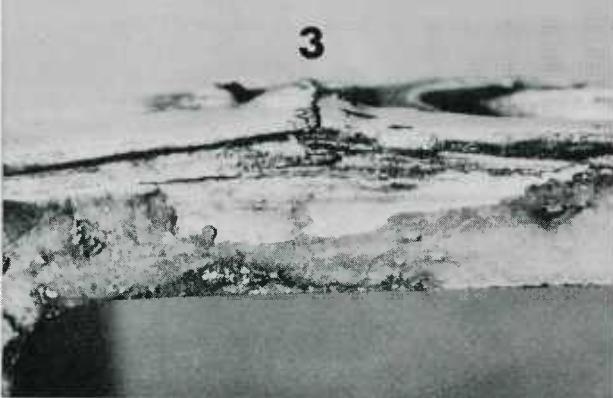
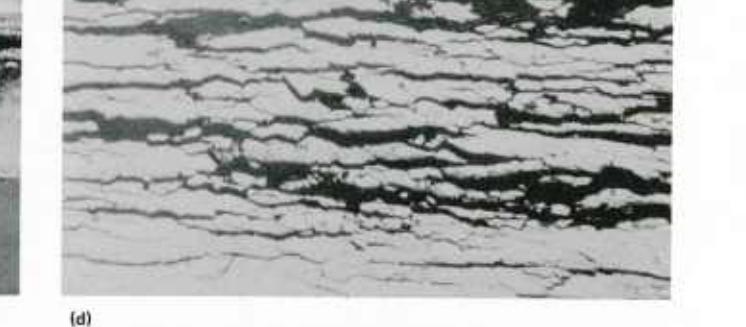
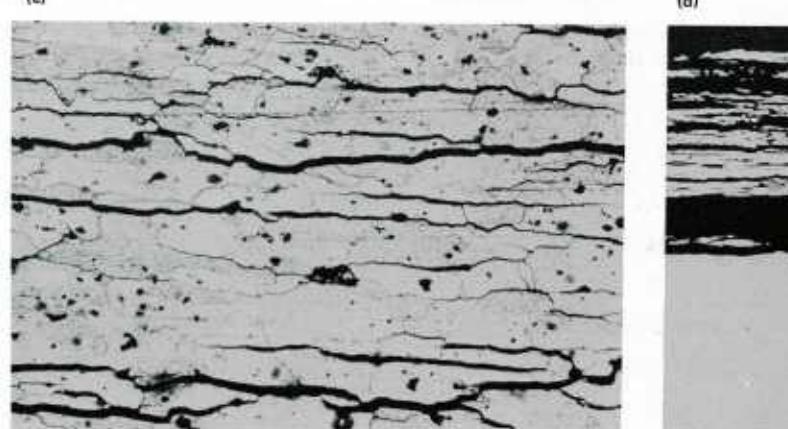
Fig. 10-9 Corrosion of a 2024 aluminium alloy helicopter rotor blade

- Leading edge at the blade tip showing three areas of severe corrosion. Corrosion in the aluminium alloy skin at location '1'. (a)
- (c)
- Rupture of the surface skin at location '3', due to the build-up of corrosion products in the underlying spar.
- (d) and (e) Evidence of intergranular corrosion in spar. (f) Exfoliation corrosion in the surface skin.

Severe corrosion was found in the tip region of a helicopter main rotor blade during routine inspection. Corrosion was found to be most severe in the leading edge and disassembly showed that the corrosion had occurred preferentially between the leading edge spar and the surface skin, as indicated in Figure 10-9(a). Three areas showing signs of particularly severe corrosion can be seen in Figure 10-9(a). Area '1' lay between the leading edge spar and the honeycomb filler material in the centre section of the blade. Corrosion in this area is shown in Figure 10-9(b). Area '2' was located towards the leading edge where the build-up of corrosion products between the skin and the spar had caused the skin to lift off the spar. Area '3' was located on the lower surface of the blade where severe corrosion of the spar had caused the skin to lift off and crack, as shown in Figure 10-9(c).

The leading edge spar was made of 2024 aluminium and analysis of the corrosion products indicated aluminium hydroxide containing approximately 1.3% chlorine. Cross-sections through the spar and outer skin showed that both had intergranular corrosion (Figs. 10-9(d) and 10-9(c)), leading to exfoliation in local regions (Fig. 10-9(f)).

The corrosion protection system used in this component was not revealed in this investigation, although this would clearly be important in view of the very aggressive environments that such blades would be exposed to. Also, the nature of the adhesives used to bond the skin to the spar and to the honeycomb core was not revealed, nor was it possible to determine its role in the corrosion process discussed. However, an investigation of the alloy microstructure and mechanical properties in the spar indicated an incorrect heat treatment which had led to the formation of coarse Cu  $Al_2$  precipitates in grain boundaries. As indicated in Section 10-1, and Chapter 4, the correct heat treatment of 2024 aluminium is essential to avoid sensitivity to intergranular corrosive attack.

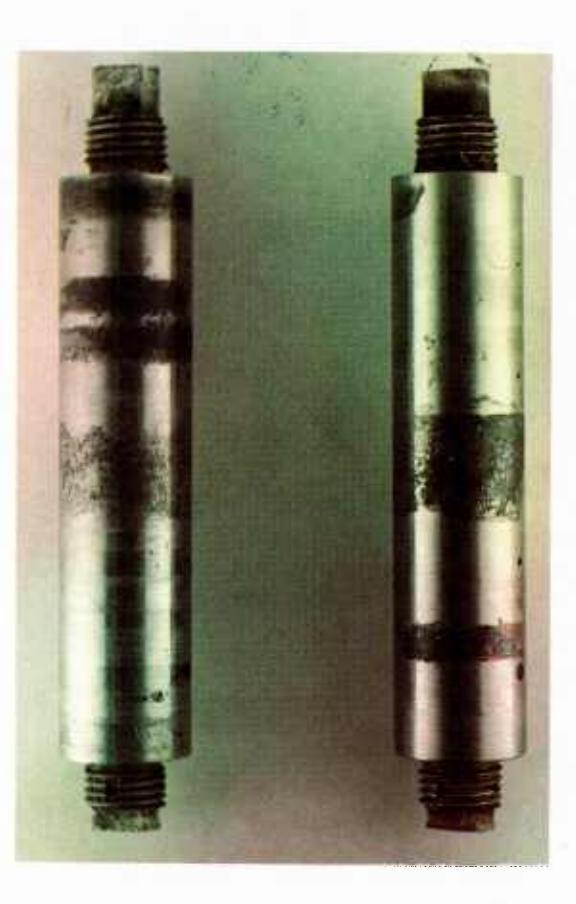
Figure 11-1 shows fretting damage in two flying control hinge pins, in the form of broad bands of deep pitting with associated accumulations of corrosion products. In service these pins would experience a combination of large amplitude displacements associated with deliberate movements of the control surfaces, and small amplitude displacements associated with normal aircraft vibrations in steady-state flight. Thus the damage observed may be due to a combination of wear and fretting corrosion. These problems are probably due to lack of adequate lubrication to alleviate the rubbing action.

Fig. 11-1 Fretting damage in two flying control hinge pins
