AGARD Corrosion Handbook Volume-1 Aircraft Corrosion: Causes and Case Histories

AGARDograph No.278

## AIRCRAFT CORROSION: CAUSES AND CASE HISTORIES

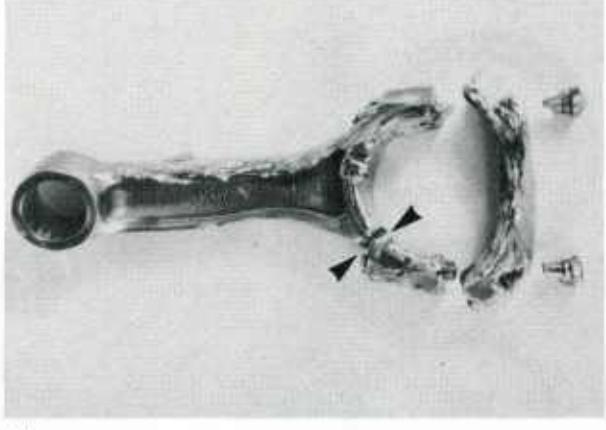
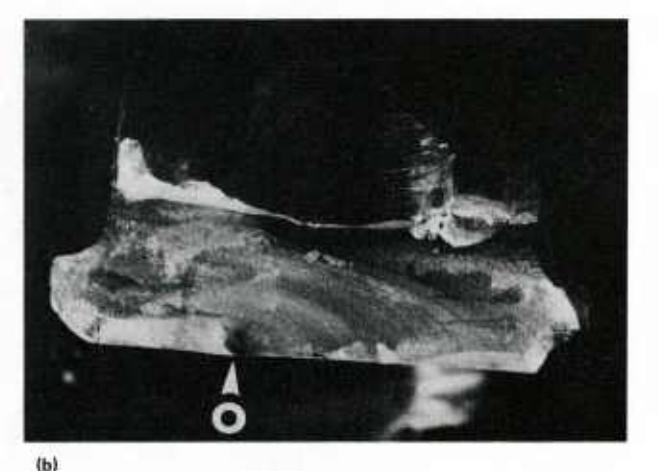
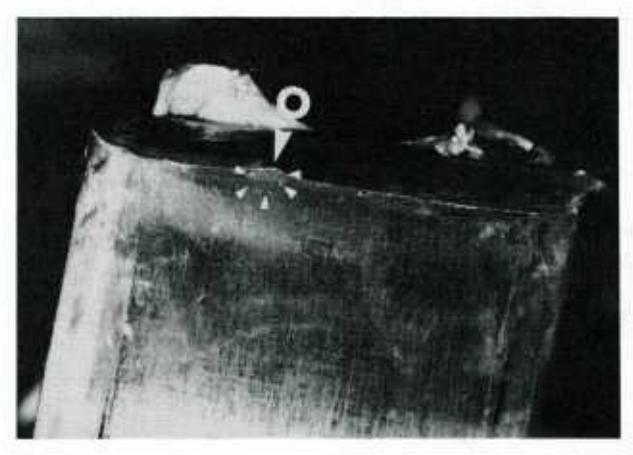
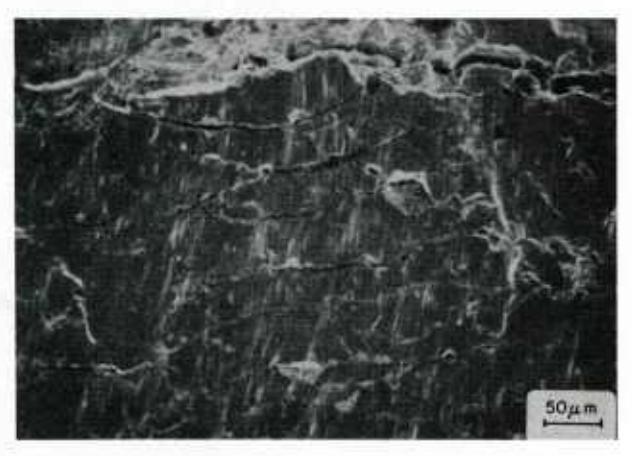
A piston engined helicopter crashed due to in-flight engine failure after a connecting rod broke. The shattered connecting rod is shown in Figure 11-3(a). The primary fracture is shown by an arrow in Figure 11-3(a), and is shown in plan view in Figure 11-3(b). The origin of this fatigue failure is on the bore wall, and this coincides with a small region of fretting damage which can be seen in Figure 11-3(c).

Scanning electron microscopic examination of the fretting zone clearly shows the surface damage and the initiation of a multitude of small fatigue cracks parallel to the major fracture (Fig. 11-3(d)). Fretting occurred because of the rotational oscillatory motion of the shell bearing within the connecting rod big end bore.

### Fig. 11-3 Fretting corrosion and fatigue of a helicopter engine connecting rod

This and other similar failures were the result of inadequate restraint of the bearing shells. By increasing the "crush" of the shell, that is by increasing the circumference of the shells relative to the bore of the connecting rods, and by increasing the bolt loadings, the high crush shells were effectively restrained and prevented from initiating such fretting damage.

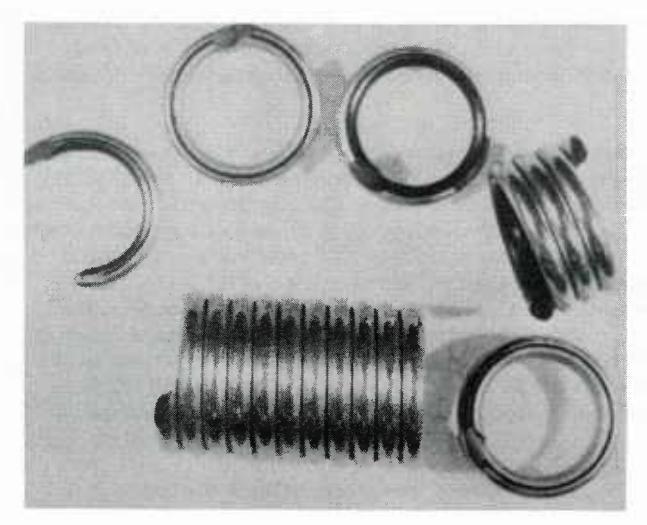
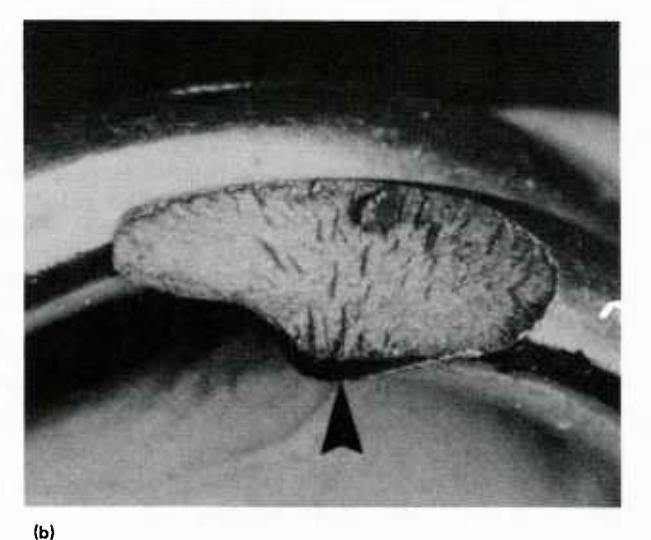
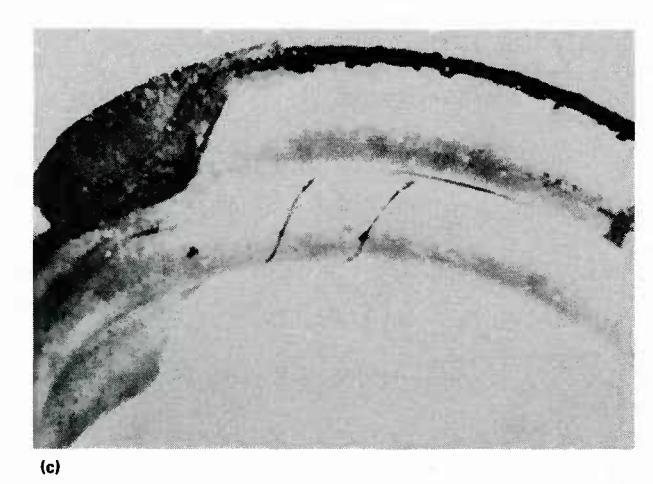
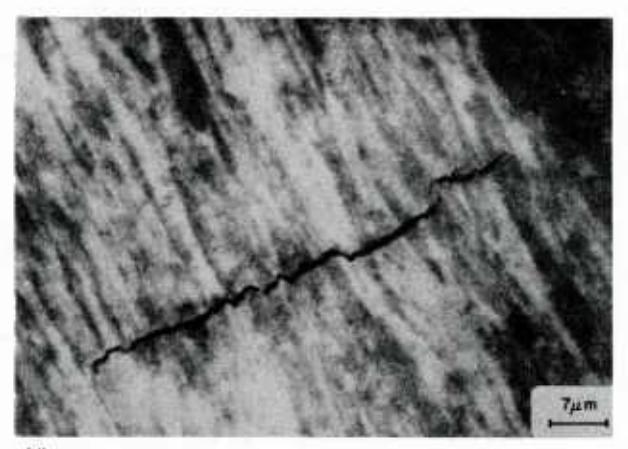
During a pre-flight inspection of a light aircraft the pilot lowered the flaps, heard a loud noise and found the flaps jammed down. The flap control return spring was found to be shattered into many pieces (Fig. 12-7(a)). All the fracture faces revealed similar small, dark, crescent shaped areas radial to the wire axis on the inside surface of the coil. These areas followed a  $45^{\circ}$  helical path with respect to the wire centre line (Figs. 12-7(b) and 12-7(c)). The remaining portion of each fracture face was characteristic of sudden overload rupture, confirmed as mixed ductile dimpling and cleavage mode by scanning electron microscopy. The pre-cracked helical zones were all damaged by corrosion.

Magnetic particle inspection (MPI) revealed many other helical cracks on the spring coil's inner surface (Fig. 12-7(c)). The spring was found to be cold wound carbon steel of about 1900 MPa strength. Axial sections cut through the cracks revealed by MPI showed them to be corroded, however some subsurface cracks were also found (Fig. 12-7(d)). The large number of simultaneous fractures at failure, and the multitude of surface and subsurface cracking indicated that this was an unusual failure.

Figure 12-7(d), showing an entirely internal crack, is indicative of hydrogen embrittlement. The conditions for hydrogen assisted cracking were all present; (1) the material and its strength level were appropriate, (2) the material was subjected to high sustained stresses in service (207 MPa initial tension set, plus residual coiling stresses, plus elongation stresses in service) all of which were concentrated at the coil inner surface where all the cracking was located, (3) the spring was exposed to a source of hydrogen during cadmium electroplating.

Fig. 12-7 Hydrogen embrittlement of a carbon steel flap control return spring

As discussed in Section 12-3, hydrogen absorbed during pickling and electroplating can be removed by baking after each stage of processing. In this case there was no record of any baking after cadmium plating. The spring was replaced and precautions taken to ensure that the springs were baked for 24 hours at  $190^{\circ}$ C, and that this baking was performed immediately after the plating.

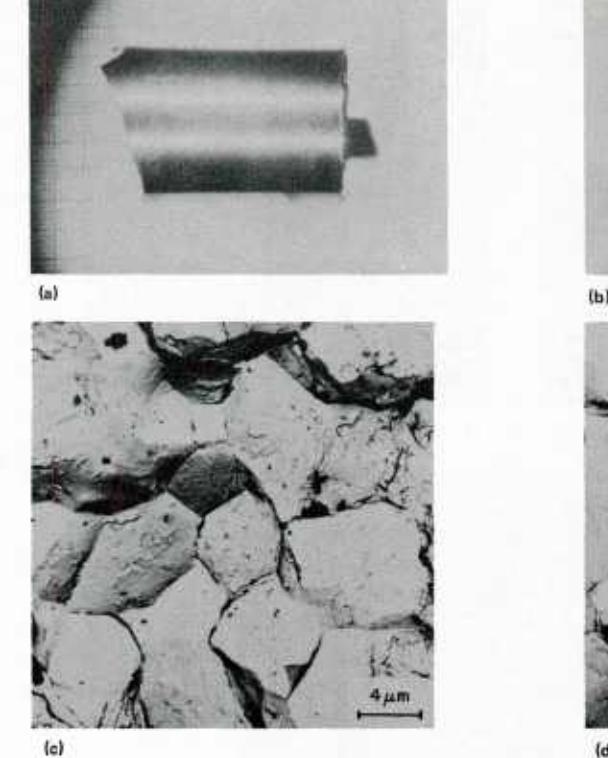
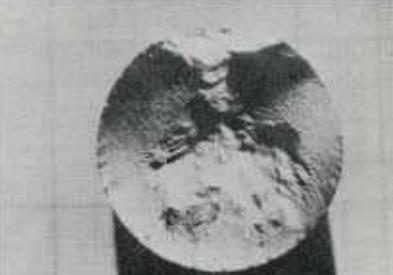
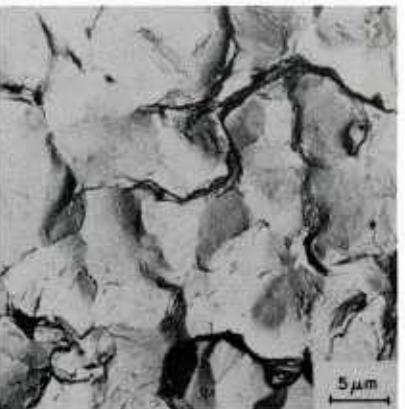
Fig. 12-8 Hydrogen delayed cracking in a 4340 main landing gear pivot pin

Intergranular fracture in a high strength low alloy steel, in the absence of temper discolouration or discolouration due to corrosion and pitting, is strongly indicative of hydrogen embrittlement. In order to test the hypothesis that the failures were due to hydrogen embrittlement, some sustained load tests were performed. All specimens failed within a fairly short time, and the replicas of the fracture surfaces showed the same clean intergranular features as the service failures. An example of the sustained load fracture surfaces is given in Figure 12-8(d).

It was concluded that the failures were due to hydrogen embrittlement, and the source of hydrogen was most probably the galvanic chromium plating process. The baking treatment used for the relief of hydrogen embrittlement was evaluated and modifications made to the process.

- (a) Central portion of the broken pivot pin.
  (b) One of two fracture surfaces on the piece shown in Figure 12-8(a).
  (c) Replica transmission electron microscope picture of an area from Figure 12-8(b). (Mag. × 2800)
  (d) Fracture surface of a specimen which failed during a sustained load for a former of the picce of the
- test. (Mag. × 2200)

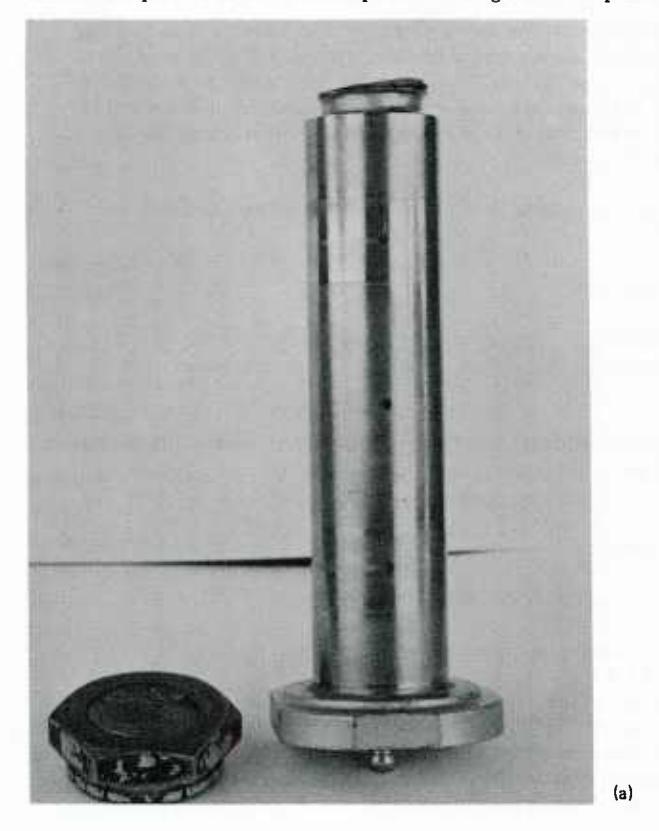
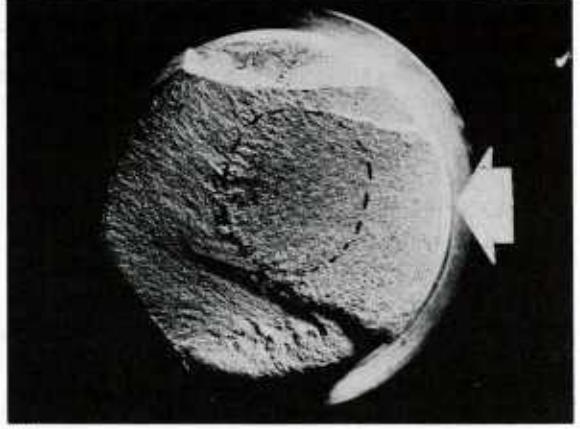
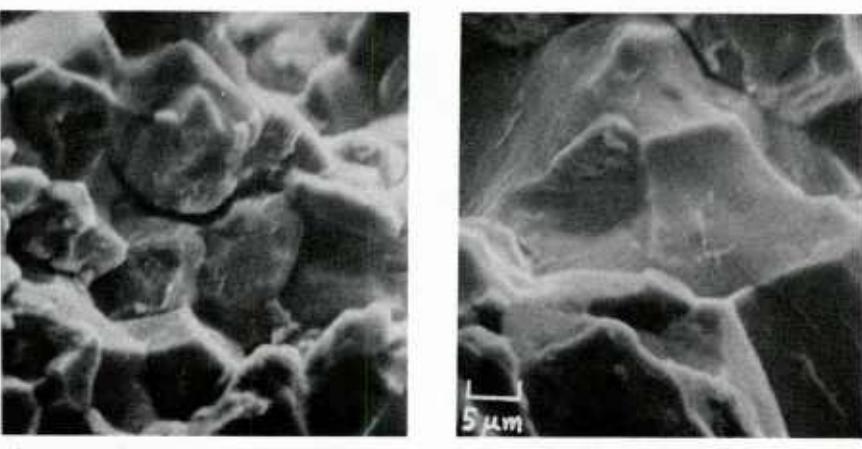
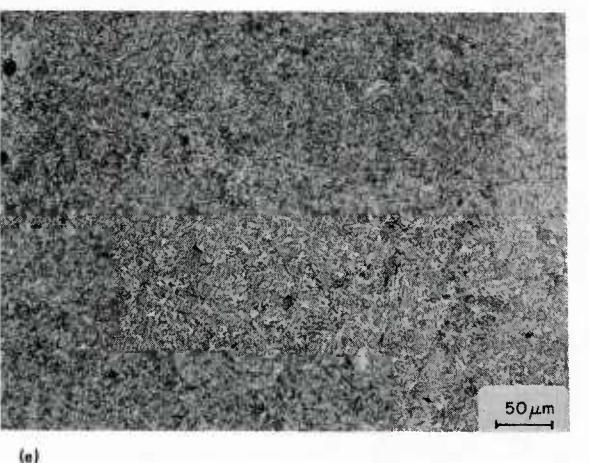
Fig. 12-9 Hydrogen embrittlement of a 4340 steel bolt from a main landing gear drag link

A cadmium plated 4340 steel bolt from a fighter aircraft main landing gear drag link was found to be fractured during a visual inspection of the aircraft. The part is shown in Figure 12-9(a), and it can be seen that the fracture occurred in the root of the first engaged thread, under a nut. The fracture appeared to have initiated in the region of the arrow, in Figure 12-9(b), and the fracture surface was quite clean and flat except for two ledges at the top and bottom edges as viewed in Figure 12-9(b).

(a) General view of the failed bolt.(b) Fracture surface of the failed bolt.

- (c) and (d) SEM pictures of the fracture surface shown in Figure 12-9(b) showing intergranular fracture.
- Figure 12-9(b) showing intergranular fracture. (e) Microstructure of the 4340 steel. (Mag.  $\times$  200)

Scanning electron microscopy revealed a predominantly intergranular fracture topography (Fig. 12-9(c)), with fine hair lines on the equiaxed grain faces (Fig. 12-9(d)). The material was found to have a fine martensitic structure (Fig. 12-9(e)), with a hardness  $R_c = 52$ . This suggests the material was tempered in the range 200-260°C, and would have a tensile strength of 1800-1950 MPa. The bright and clean intergranular fracture in a steel of this strength level strongly suggests that failure was due to hydrogen embrittlement. As indicated in Figure 12-4, sustained load cracking will occur in hydrogen embrittled steels of this type in times as short as 1 hour when stresses of about 75% of the yield stress are applied.

The source of hydrogen was believed to be the cadmium plating process, and a more rigorous baking treatment was recommended.

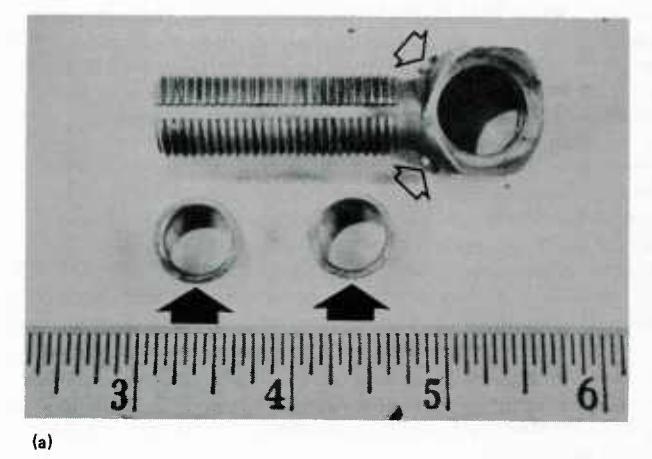
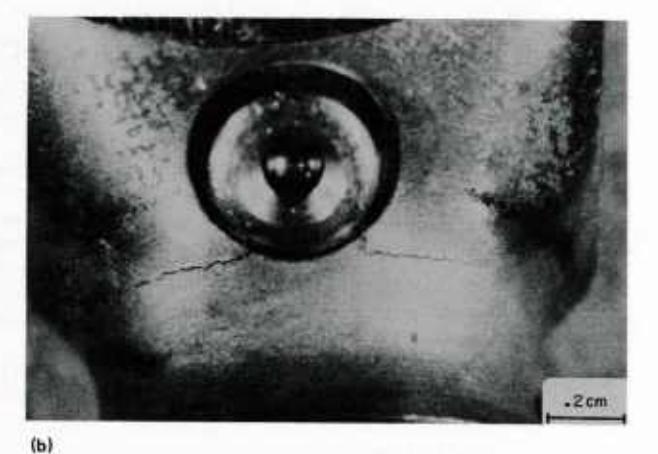
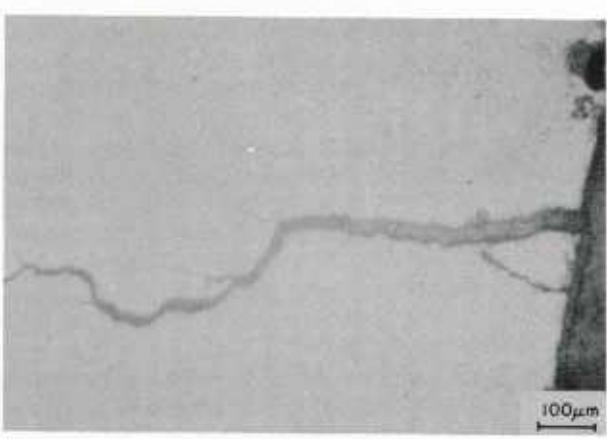
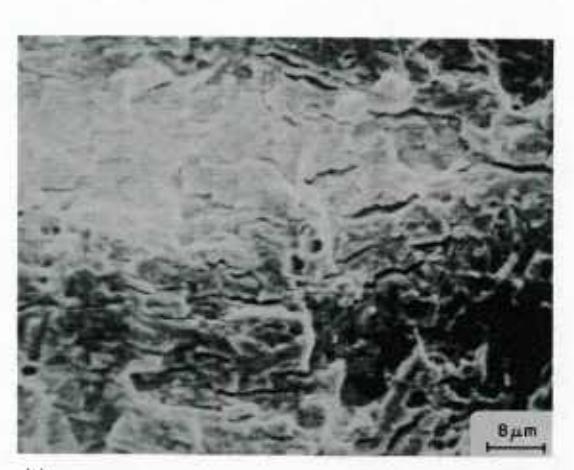
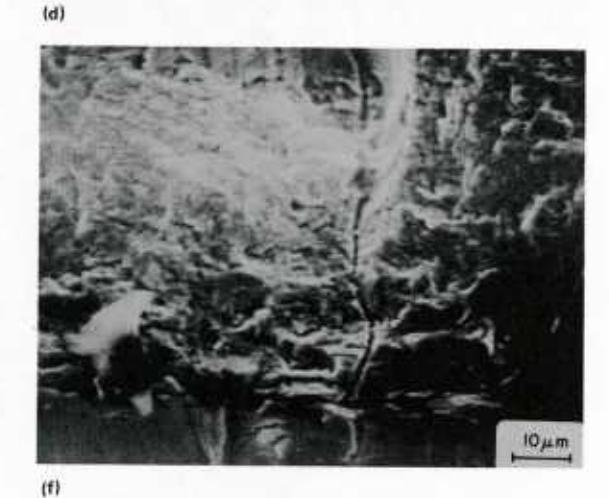
#### Fig. 12-10 Failure of a 4340 steel tie rod end

On inspection two cracks were found in the part shown in Figure 12-10(a). The first crack was clearly visible with the naked eye, and was found on the outside of the rod end emanating from the grease fitting hole, as shown in Figure 12-10(b). The second crack was not readily apparent until the two bushings shown in Figure 12-10(a) were removed from the eye of the tie rod end. The crack was located on the inside of the eye opposite the threaded rod section. The appearance of this crack is shown in Figure 12-10(c) as a separated fracture face. It can be seen that the crack was quite extensive and had propagated from several initiation sites. In both cases the cracks appeared to be driven by stresses arising from pressed inserts, and in both cases the inserts were cadmium plated steel. The rod end was analyzed and found to meet specifications for 4340 steel in the 1250-1400 MPa condition.

The cracks were examined metallographically and by scanning electron microscopy. The cracks were found to be multiple in nature, with numerous initiation sites and extensive branching, as shown in Figure 12-10(d). The fracture path was mainly transgranular, and no oxide scale or corrosion deposits were evident. No decarburization was observed and there was no evidence of cadmium within the crack formations. Figures 12-10(e) and 12-10(f) are scanning electron photographs of the fracture surface exposed by breaking open the crack in the tie rod eye. The direction of crack propagation is from bottom to top in both photographs, and the fracture characteristics are primarily of brittle transgranular fracture, with little or no evidence of integranular fracture or ductile dimples. The appearance of the fracture surface most closely resembled mechanical fatigue except for the absence of striations and the presence of multiple

secondary cracks running both transverse to the direction of primary crack propagation (axial cracks), Figure 12-10(e), and parallel to this direction (radial cracks), Figure 12-10(f). The absence of corrosion products and intergranular cracking would seem to rule out stress corrosion cracking, while the absence of ductile dimples would rule out overload cracking.

It was thought that hydrogen assisted delayed failure was the most likely explanation for this unusual fracture behaviour, although this was not unequivocally established. The driving stresses were thought to arise from the interference fit bushings and grease fittings, rather than from service loading. The source of the hydrogen was conjectured to be from the cadmium plated bushings and fittings, and/or from the cadmium plated tie rod threads. It was recommended to remove the cadmium from the bushings and grease fittings, and the surfaces that they are in contact with, and to reinstall using wet assembly techniques with an epoxy primer for corrosion control. It was also recommended that the cadmium plated threaded ends of the tie rod be examined to insure that no hydrogen assisted delayed cracking was occurring in those regions.

- (a) As received tie rod end showing (open arrows) cadmium plated grease fittings and (solid arrows) cadmium plated steel bearing inserts. Both are press fitted.
- Cracks propagating from the grease fitting hole,  $(Mag, \times 7)$ Fracture surface of the crack in the eye section. The surface was prepared by bending the section to (c) open and expose the crack. The dark area is the crack formation, the lighter area is overloaded sound metal. (Mag. × 7)

(d) Metallographic section through a typical crack. (Mag. × 100)
(e) SEM picture of the fracture face showing secondary transverse tearing. (Mag. × 1250)
(f) SEM picture of the crack initiation surface showing cracking in the direction of crack propagation. Same orientation as Figure 12-10(e). (Mag. × 1000)

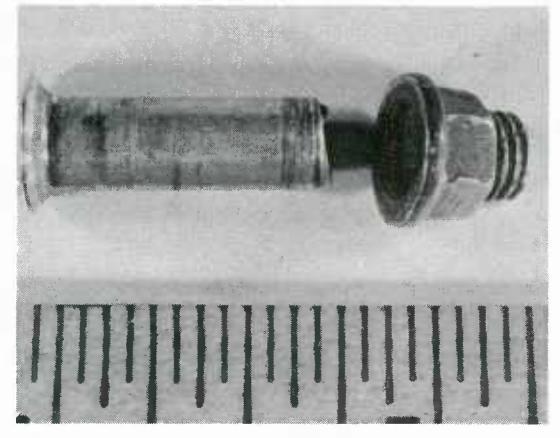
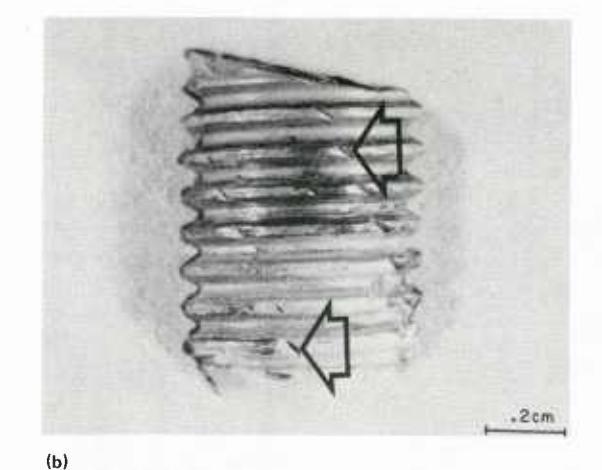
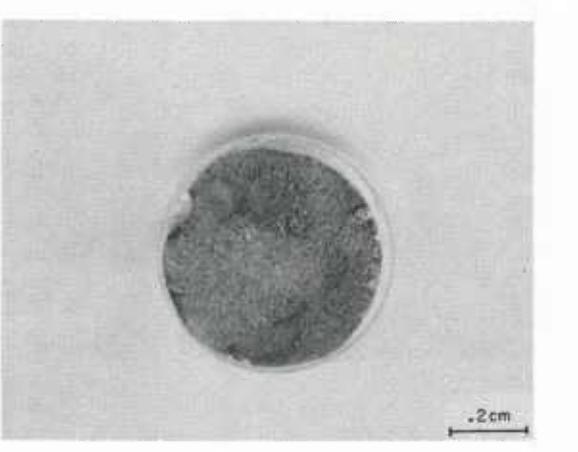
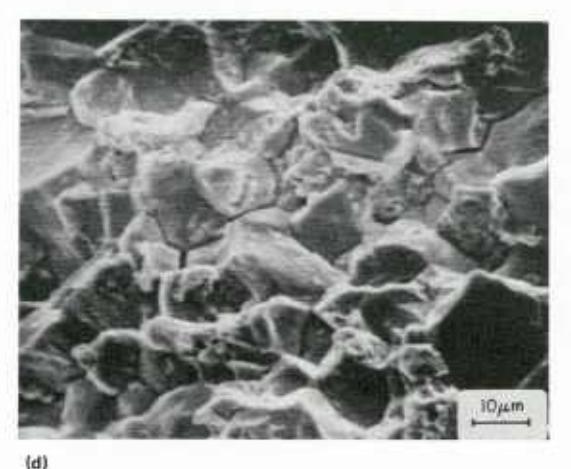
Fig. 12-11 Failure of a low alloy steel bolt

The failed bolt shown in Figure 12-11(a) was found during a training exercise of a fighter aircraft rudder assembly. The inspection was not scheduled maintenance. Of eight bolts securing the rudder post, two were discovered to have separated. One of the two bolts was examined in the laboratory.

The fracture surface of the bolt, shown in Figure 12-11(c), was studied by optical and scanning electron microscopy. It was observed that the fracture originated at multiple sites in the upper thread root and also at the notches shown in Figure 12-11(b). The cracks propagated radially towards the centre of the bolt. The fracture surface of the bolt was free of corrosion deposit, and no prominent beach marks or arrest pattern were apparent. The intergranular crack propagation shown in Figure 12-11(d) suggests that stress corrosion or hydrogen embrittlement failure mechanism was active during the initial crack propagation. However low alloy steels of this type have poor corrosion resistance and signs of rust might be expected in the case of aqueous stress corrosion cracking. Hydrogen embrittlement might therefore be the more likely explanation. Ductile dimples indicating overload failure were apparent toward the centre of the bolt.

- (a) General view of the failed bolt and nut.
- (b) Threaded end of the failed bolt removed from the nut. (Mag.  $\times$  7)
- (c) Fracture face of the head end of the bolt. Multiple initiation sites are present. (Mag.  $\times$  7)
- (d) SEM picture of the fracture surface showing intergranular topography. (Mag.  $\times$  1000)

It was concluded that the rudder assembly bolt failed by hydrogen embrittlement. Several factors may have contributed to the failure, including excessive torque on the bolt and the presence of notches on the thread crowns. The source of hydrogen was not established, although this may have been from the cadmium plating. The dry film lubricant was also considered to be a potential corrodent, but this was not established.

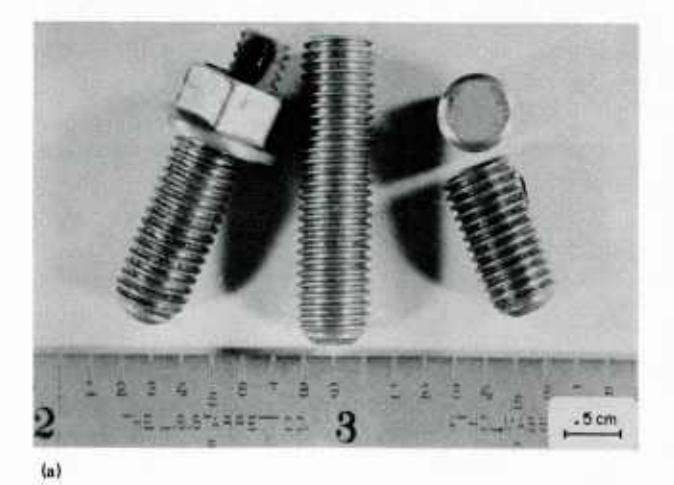
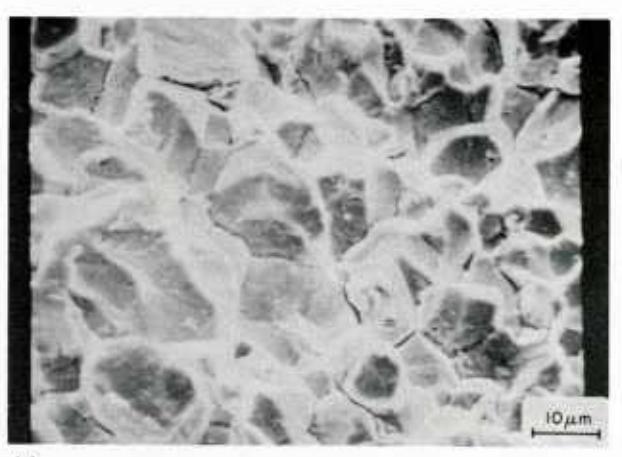
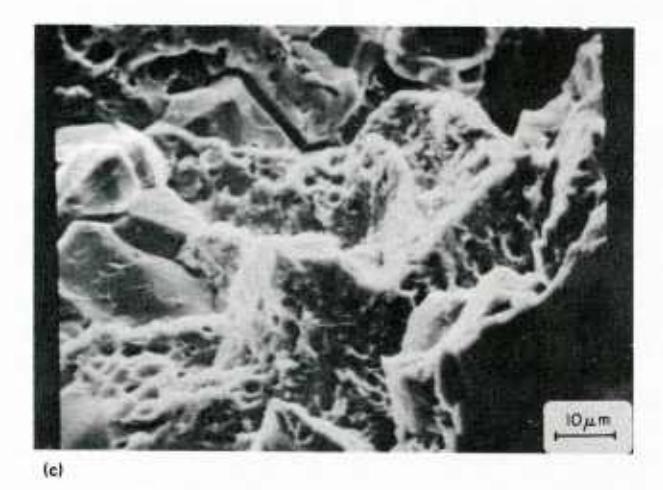
Fig. 12-12 Hydrogen induced failure of some 4037 steel setscrews

The fracture surface of a failed setscrew exhibited predominantly intergranular fracture (Fig. 12-12(b)), but some areas of ductile dimples and secondary cracking were evident (Fig. 12-12(c)). These features suggested that hydrogen embrittlement may be involved. An unused setscrew was loaded in tension until failure occurred at 23.14 KN. Another setscrew was loaded to 19.58 KN, or 85% of the ultimate load, and held under sustained static load. The setscrew failed in 51 hours, the fracture face again exhibiting a mixed mode brittle intergranular and ductile dimpled appearance. This behaviour confirmed hydrogen embrittlement.

(a) General view of some new and unused, and used and failed setscrews. (Mag.  $\times$  2)

(b) SEM picture showing intergranular fracture and secondary cracking of setscrew fracture face. (Mag. × 1200)

The subject batch of setscrews was recalled from service to preclude future embrittlement failures. It was thought that the hardness of the setscrews was excessively high for the specific application even though allowed by the specifications. It was recommended to lower the hardness of the setscrews in order to improve their toughness and resistance to service induced embrittlement.

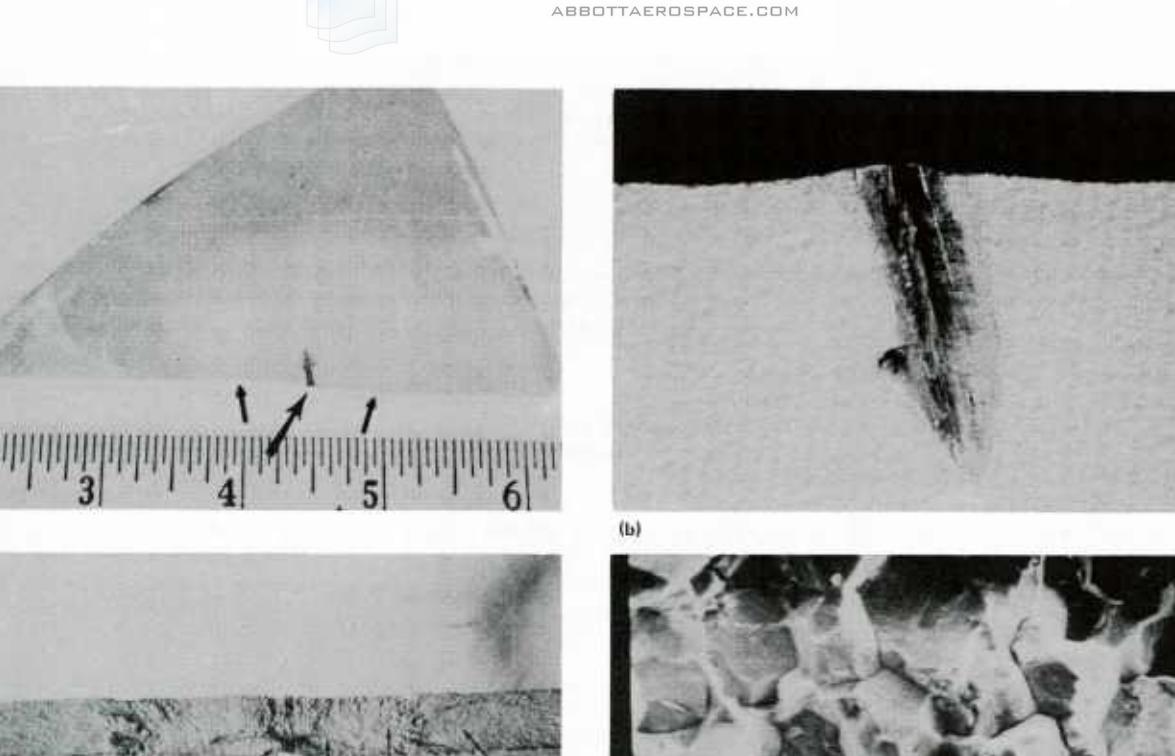
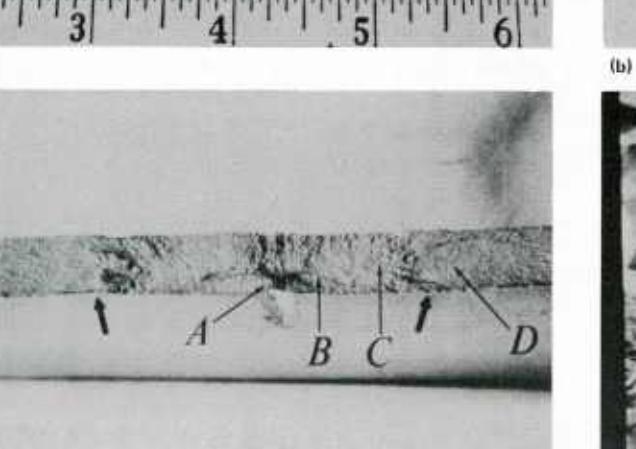
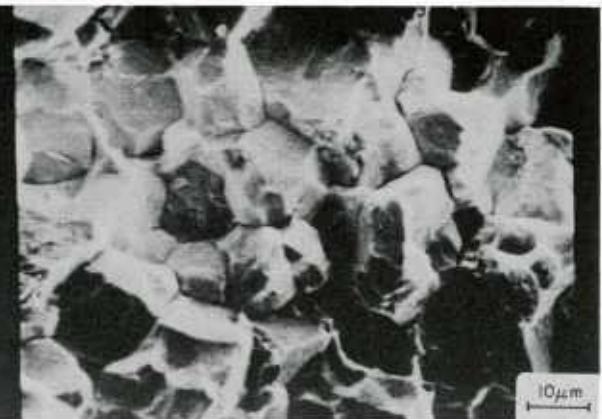
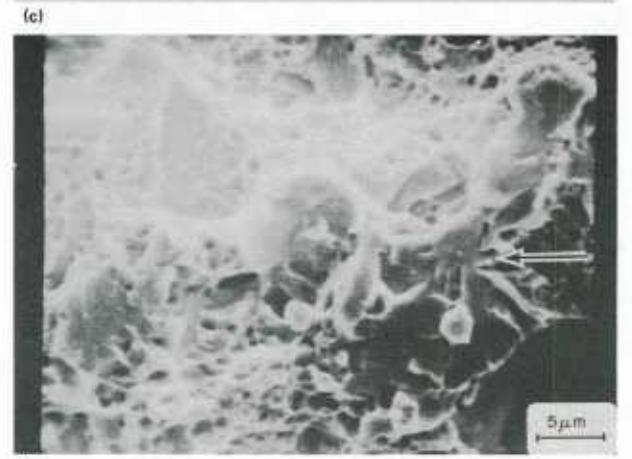
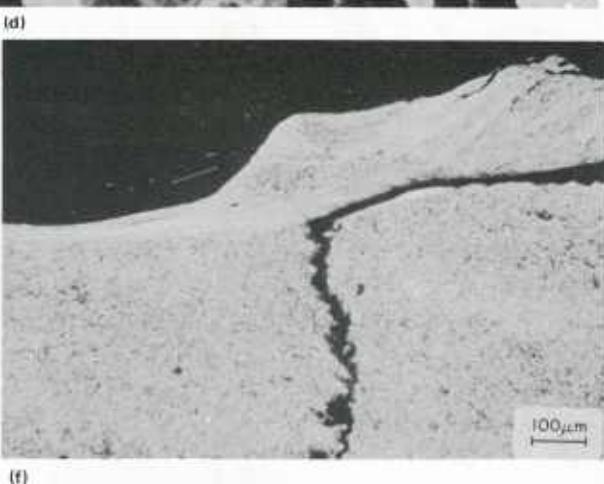
#### Fig. 12-13 Failure of a 4340 steel landing gear cylinder

- (a) Piece of cylinder with paint removed. Large arrow indicates gouge which initiated fracture. The fracture surface between the small arrows is free of a shear lip.

- (b) Close-up of the gouge with a build-up of material to the left. The gouge was free of corrosion products and bare steel was exposed in some areas with residual cadmium plating in others. (c) Fracture surface at the gouge, Small arrows indicate the start of shear lip formation, Long arrows A and D

- indicate the locations of SEM pictures shown in Figure 12-13(d) and Figure 12-13(e).
- (d) SEM picture of Area A showing clean and unpitted integranular fracture facets. (Mag. × 1100)

A piece of the outer cylinder, shown in Figure 12-13(a), was submitted for laboratory examination and was found to contain a gouge which extended from the fracture surface. Closer examination revealed no evidence of paint or primer in the gouge (Fig. 12-13(b)), although there were signs of solvent contact with the outer surface in the vicinity of the gouge. The walls of the gouge were bright in some areas and dark in others, but exhibited no obvious signs of general corrosion.

Inspection of the fracture surface showed that the outer surface gouge was centred in a roughly clamshell-shaped area whose boundaries were not well defined but could be generally discerned by the texture of the chevron marks, as indicated in Figure 12-13(c). There was no shear lip on the outer surface for a length of about 12 mm on either side of the gouge, but the rest of the fracture edges, including the entire inner wall surface, had well formed shear lips. There was no rust or other evidence of corrosion to be seen anywhere on the fracture surface. Rather, it appeared clean and bright, even near the gouge.

Scanning electron microscopy of the fracture surface revealed a predominantly intergranular cracking mode near the initiation site at the gouge, with small patches of transgranular dimpling. The grain facets were very clean and not pitted (Fig. 12-13(d)). Moving progressively farther from the initiation zone, the fracture surface revealed an increasing proportion of transgranular tearing, still mixed with clean intergranular cracking and little or no quasi-cleavage. Estimates of the proportion of intergranular cracking occurring at sites A, B, C and D (in Fig. 12-13(c)) indicated values of 90%, 60%, 50% and less than 10% respectively. The fracture surface at location D is shown in Figure 12-13(e), and consists of a mixture of ductile dimples and quasi-cleavage, producing a predominantly transgranular fracture. No definite transition from intergranular cracking to ductile transgranular tearing was seen. Such a transition is commonly found in slow, stable-growth cracks, such as stress corrosion cracks, which may progress to instantaneous failure.

A metallographic cross-section was taken parallel to and approximately 5 mm below the fracture surface. This section traversed the lower portion of the gouge and is shown, polished and etched, in Figure 12-13(f). The microstructure of the steel away from the gouge was that of a normal tempered martensite, but in the immediate vicinity of the gouge light bands of untempered martensite were observed. A secondary crack, running perpendicular to the main fracture surface, had followed one of the light bands under the gouge burr, and then turned toward the cyclinder inner surface and progressed intergranularly. Micro-hardness tests, performed to compare the hardness of the light bands to that of the tempered matrix confirmed that the bands were untempered martensite with a hardness of  $R_c$  61.5.

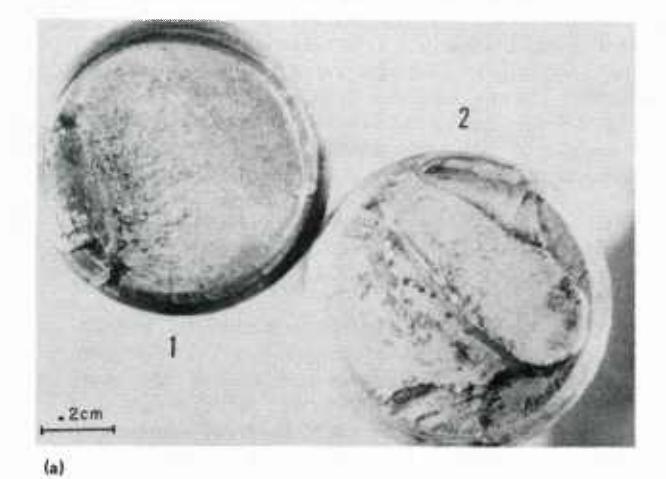
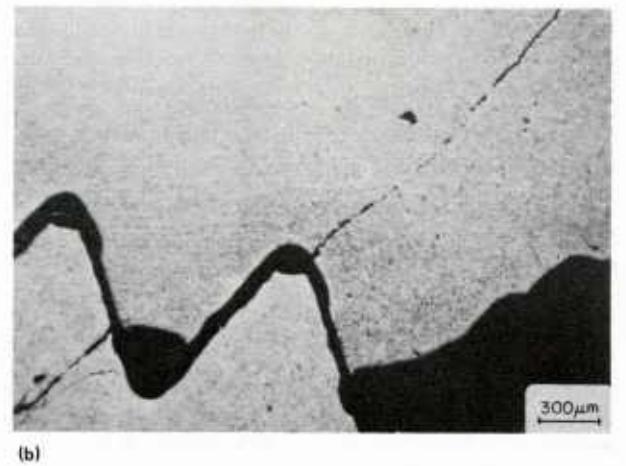
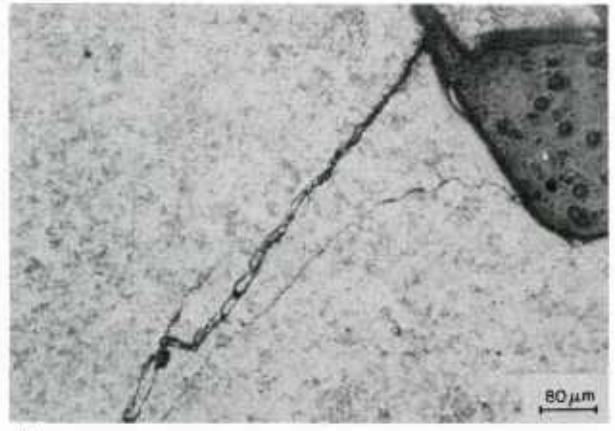
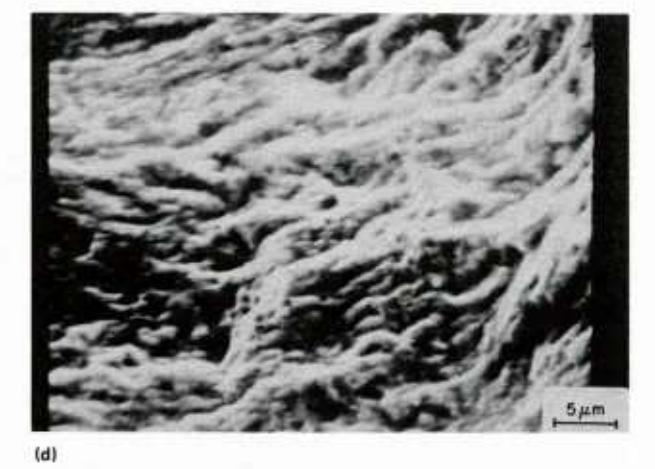
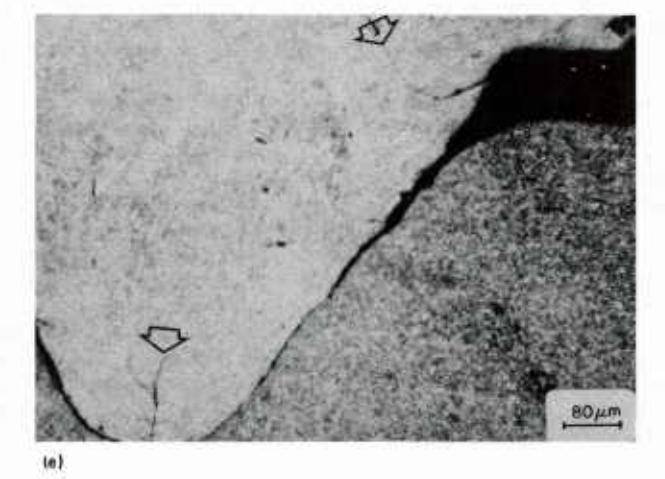
# Fig. 12-14 Failure of two low alloy steel bolts

A problem involving the failure of securing studs from a helicopter filter bowl persisted for several years. Two failed studs, as shown in Figure 12-14(a), were submitted for laboratory examination. Stud No. 1 was determined to be a 41XX steel with a hardness of  $R_c$  26, while stud No. 2 was found to be a 43XX type steel with a hardness of  $R_c$  38. The carbon contents were found to be 0.36% and 0.46% respectively and the alloys were assumed to be 4130 and 4340 with 0.03% carbon in excess. No significance was attached to the high carbon values since many other similar failures had been examined where the compositions were within specification.

The fracture surface of the lower strength stud, No. 1, closely resembled a fatigue fracture surface. It was relatively flat and had an unusually small final overload area. The fracture surface of the higher strength stud was not typical of mechanical fatigue. The numerous crack propagation planes, multiple initiation sites and different inclinations of the various fracture facets were thought to be indicative of an environmentally enhanced fracture mode. However, cross-sectional examination of stud No. 1 also revealed multiple sub-surface cracking on planes parallel to the main fracture plane. A similar examination of stud No. 2, and its mating nut showed that the nut also contained cracks, one of which is shown in Figure 12-14(b). Again the condition is not typical of mechanical fatigue. Further evidence of environmentally enhanced fracture was found in the form of a multiple jagged crack in stud No. 2, which had propagated almost all the way across the section without causing complete failure. This crack is shown in Figure 12-14(c).

Examination of the fracture surfaces in a scanning electron microscope failed to provide conclusive information. The fracture surface on stud No. 1, resembled fatigue but fatigue striations could not be discerned (Fig. 12-14(d)). The fracture surface of stud No. 2 was found to have a rough topography, having a slight rock candy appearance but indisputable intergranular fracture could not be found. No corrosion deposit or evidence of cadmium was detected on the fracture surfaces by dispersive x-ray analysis. The absence of a corrosion deposit indicated that the active corrodent or embrittling agent was hydrogen.

The two studs differed not only in chemistry and strength level but also in the type of threading. The higher strength stud (No. 2) exhibited machine cut threads, while the lower strength stud (No. 1) had rolled threads. Thread rolling is usually to improve fatigue resistance of the stud. Figure 12-14(e) shows a cross-section of a rolled thread stud where cracking has occurred in both the root and the crown of the thread. It would appear that folds and laps generated in the rolling operation act as stress raisers from which cracks initiate. It could not be determined whether the rolled threads, designed to prevent mechanical fatigue were better or worse than the machined threads when delayed static failure was involved. The cracking in the thread crown was puzzling, but the observations suggest that thread rolling does not necessarily prevent delayed static failure.

- (a) Fracture surfaces of the failed bolts. (Mag.  $\times$  6.5)
- (a) Fracture surfaces of the failed bolts. (Mag. × 5.5)
  (b) Secondary cracking in the nut (top) and the high strength R<sub>c</sub> 38 bolt (bottom). (Mag. × 37.5)
  (c) Longitudinal section through bolt No. 2, showing additional secondary cracking. (Mag. × 125)
  (d) SEM picture of the fracture surface on bolt No. 1. (Mag. × 2200)
  (e) Cracking in the root and crown of the rolled thread in bolt No. 1. (Mag. × 125)

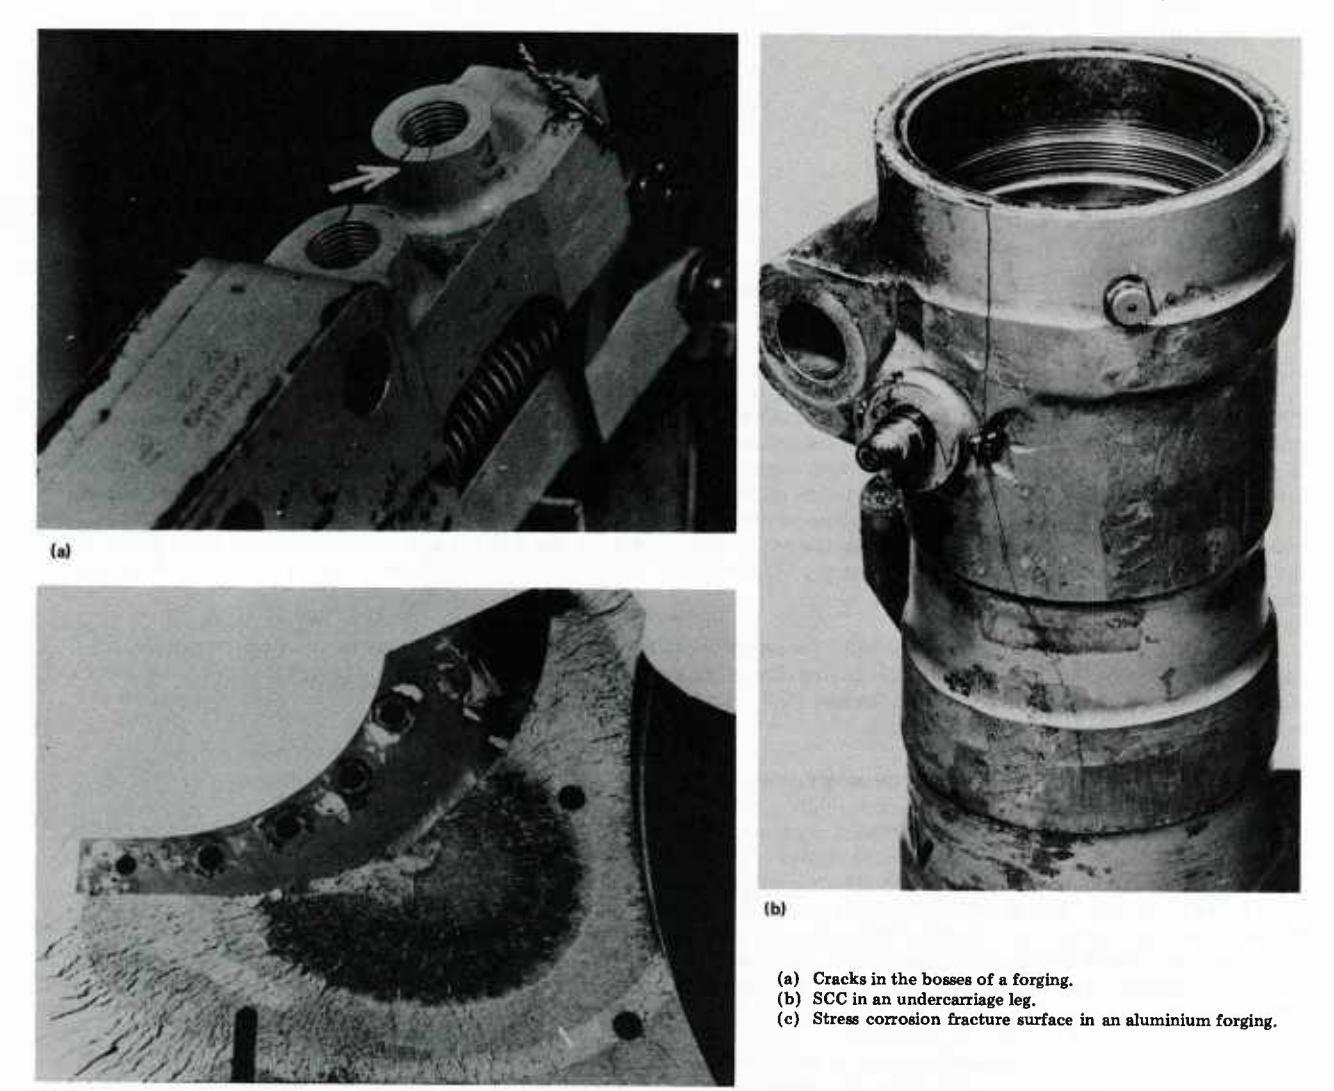
Fig. 13-1 Examples of stress corrosion cracking in aluminium alloy components

Stress corrosion is a particularly insidious form of corrosion since it will often occur with little or no visual evidence of surface corrosion such as discolouration or the build up of noticeable corrosion products. This is illustrated in Figure 13-1(a), which shows stress corrosion cracking in the bosses of a forged aluminium alloy component. The cracks can travel over long distances with time, as indicated in Figure 13-1(b), and as they propagate they lower the residual strength of the affected part. Figure 13-1(b) shows stress corrosion cracking which initiated at corrosion pits in the flat lower surface of an undercarriage leg, the corrosion pits having served as local stress raisers. Stress corrosion cracks may propagate deeply into thick section parts, as indicated in Figure 13-1(c), while the visible surface crack length may often be quite small. The banded appearance of the fracture surface in Figure 13-1(c) is an indication that crack growth occurred in a slow, time dependent manner, and macroscopically the fracture surface may resemble

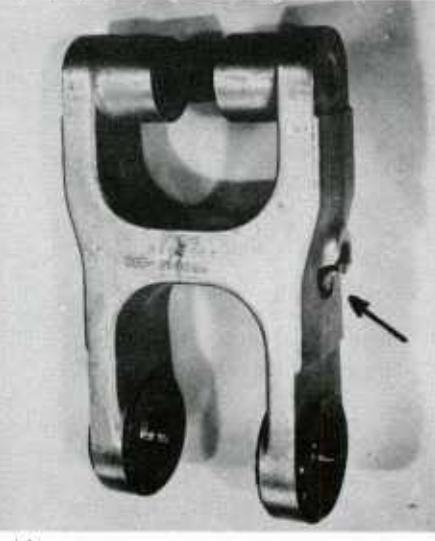
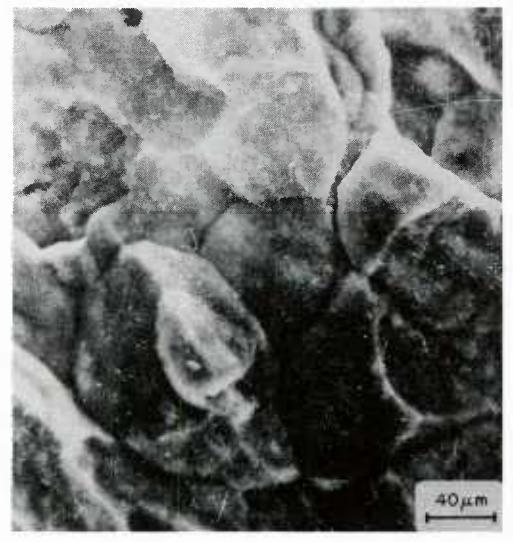
Fig. 13-7 Stress corrosion cracking occurring from corrosion pits and intergranular corrosion cracking in the parting plane of a 7079-T6 H-link.

A particular sensitivity to stress corrosion cracking occurs at the parting plane of forgings. Cracking of this type is shown in Figure 13-7(a) where the component is a 7079-T6 H-link of a main landing gear assembly. This problem has been explained in Reference 13-11 to be due to the directionality of grain flow in forgings and the tendency for end grain boundaries to be exposed at the surface at the parting plane, as indicated in Figure 13-8. In the case of the H-link of Figure 13-7(a), examination showed that SCC was preceded by pitting and intergranular corrosion (Fig. 13-7(b)), and areas of intergranular separation evident on the fracture surface showed a distinctly equiaxed grain structure (Fig. 13-7(c)).

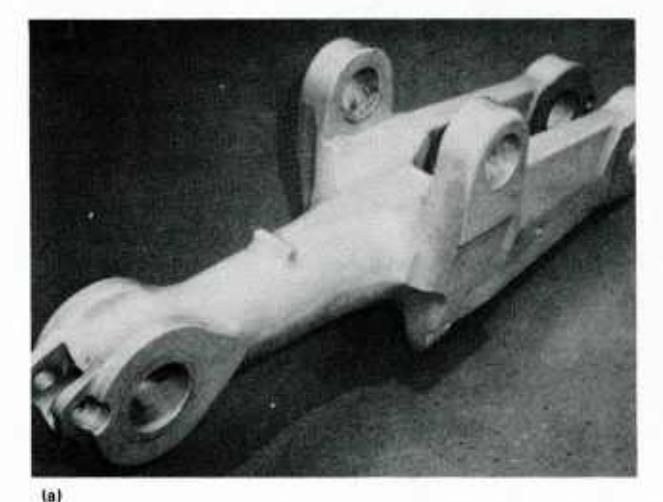
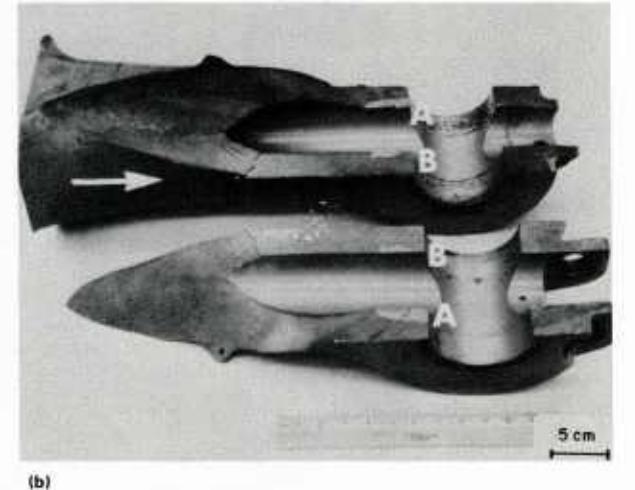
Fig. 13-30 Stress corrosion cracking in a 7075-T6 main landing gear bogie, case history 13-4.

- (a) New and unused bogie.
- (b) Failed bogie beam showing the crack initiation sites (A and B) underneath the shrunk-in steel bushings for the main axle bearings. The arrow tip indicates the maximum extent of the crack in the parting plane.

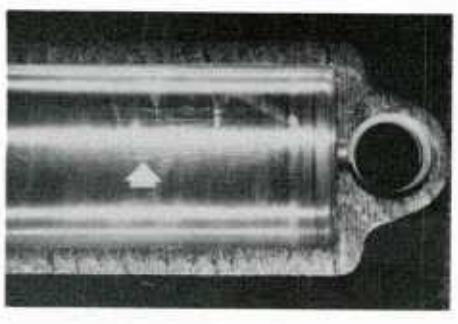
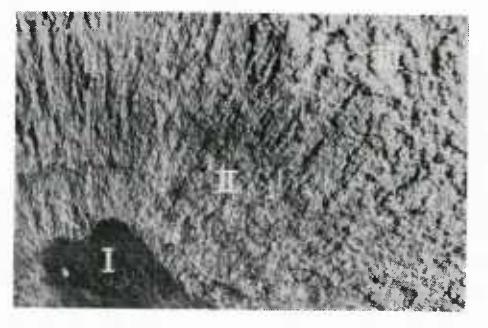
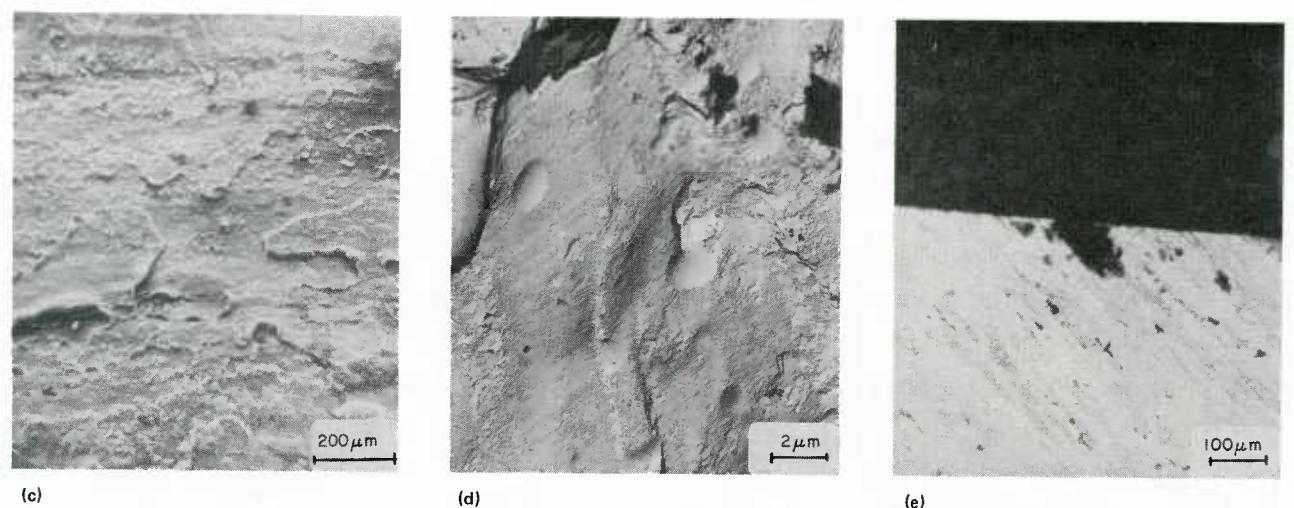
Three main landing gear door actuating cylinders were found to contain cracks at, or near the parting planes of the as-forged 7075-T6 cylinders. Two of the cylinders were examined metallographically and fractographically, while the third was sectioned and its interior surface was inspected using fluorescent penetrants to reveal the cracks indicated in Figure 13-31(a).

Fractography on one cylinder revealed the presence of three distinct regions of fracture as indicated in Figure 13-31(b). Region I consisted of layered intergranular fracture, as shown in Figure 13-31(c); region II was found to contain fatigue striations as shown in Figure 13-31(d), while region III was the overload fracture region produced when the cylinder was broken open for examination.

Metallography revealed corrosion pits on the inside surfaces of the cylinders, as shown in Figure 13-31(e) where the pits can be seen to be aligned at about 45° to the surface in the direction of the grain boundaries. Since the cylinders in service were filled with hydraulic fluid which was not expected to cause pitting corrosion, it was thought that the pitting had occurred during storage prior to service use. However, Reference 13-11 has shown that stress corrosion cracking can occur in 7075-T651 when exposed to hydraulic fluids such as Aerosafe 2300W and Skydrol 500A. It was thought therefore that region I of the fracture surfaces of these cylinders was due to stress corrosion, and that this was the primary failure mode leading eventually to crack propagation by fatigue.

Fig. 13-31 Stress corrosion cracking of a 7075-T6 hydraulic cylinder, case history 13-5.

This problem may have been avoided if the inside surfaces of the cylinders had been protected during storage to prevent the initial pitting attack. However, to be safe a stress corrosion resistant material such as 7075-T73 should be used, subject to satisfactory static and fatigue design margins.
