AGARD Corrosion Handbook Volume-1 Aircraft Corrosion: Causes and Case Histories

AGARDograph No.278

## AIRCRAFT CORROSION: CAUSES AND CASE HISTORIES

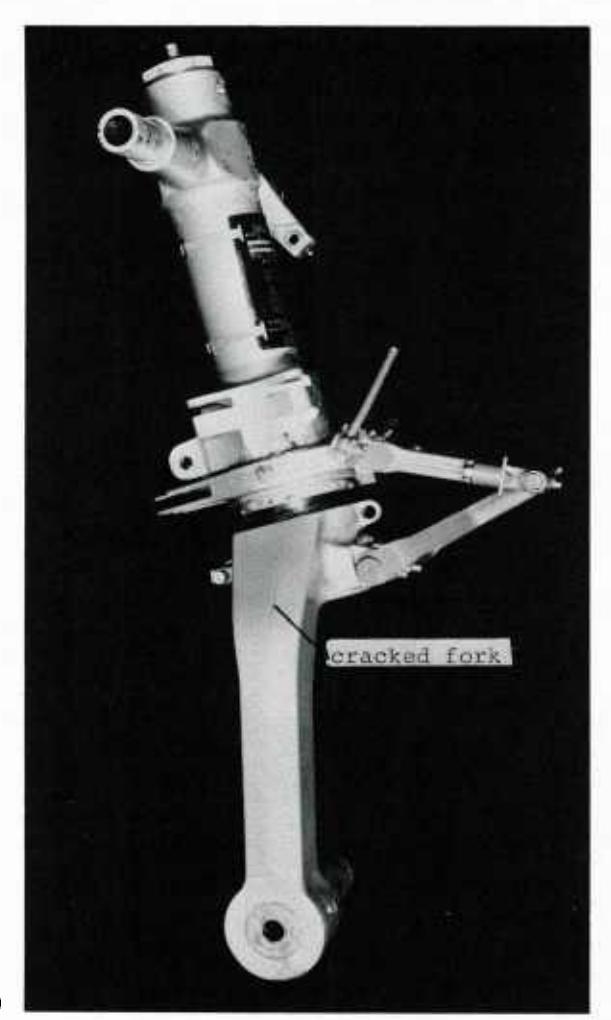
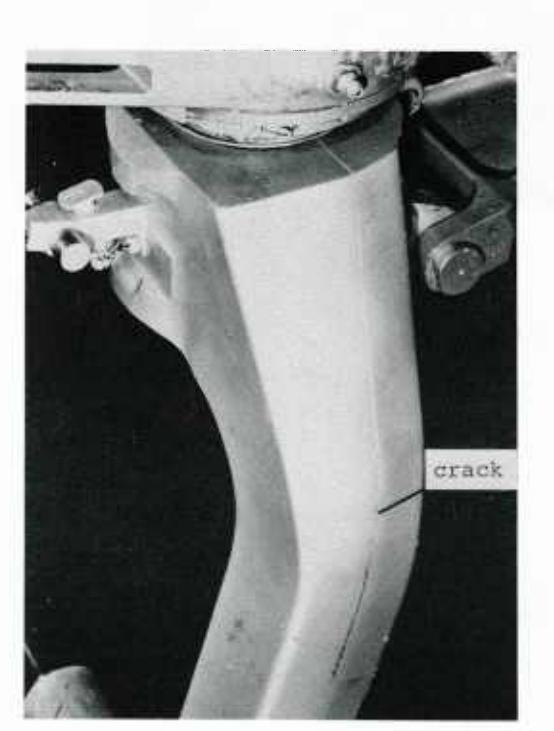
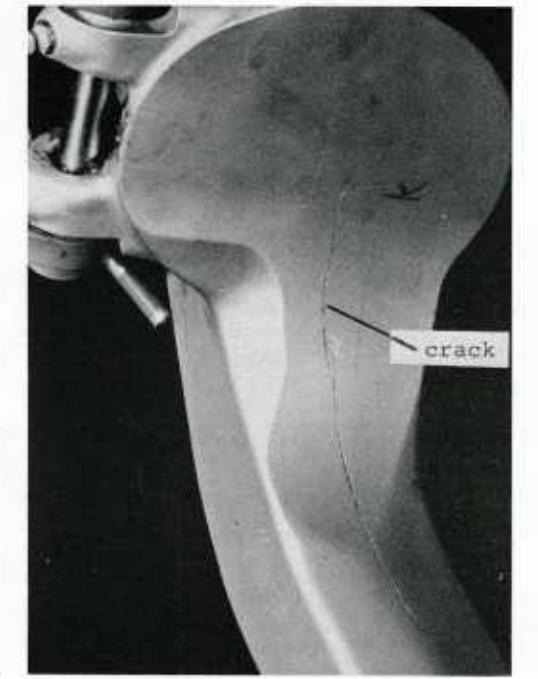
During a post-flight visual inspection of a fighter aircraft a long crack was found in the nose landing gear fork. The part is shown in Figure 13-32, and the crack which can be seen in this figure was found to lie in the parting plane of the aluminium alloy forging. The forging was made from 7075-T6 and its surfaces were treated with a single coat of wash primer plus two coats of acrylic paint.

Fig. 13-32 Stress corrosion cracking in a 7075-T6 nose landing gear fork, case history 13-6.

(a) Complete landing gear assembly.(b) Close-up of the fork outer surface showing the crack.(c) Close-up of the fork inner surface showing the crack.

The crack was found to extend through the thickness of the fork, as indicated in Figures 13-32(b) and 13-32(c), and when the crack was opened up it was found to extend over about three quarters of the longitudinal cross section of the fork, as indicated in Figure 13-33. Figure 13-34(a) shows the fracture surface and reveals a dull fibrous fracture typical of stress corrosion cracking, where the crack appears to have started in the upper bore for the nose-landing gear leg attachment and the adjacent bore hole, which was introduced as a weight saving measure. However while the bores may have been effective in respect to weight savings, they provided natural traps for moisture. Figure 13-34(a) also reveals a narrow ribbon of material along both external surfaces which appear to have a lighter appearance than the area affected by SCC, and this suggests that the stress corrosion crack may have propagated over a substantial distance through the NLG-fork before breaking through to the external surfaces. Thus the crack may have been hidden for a substantial period of time prior to visual detection. Figure 13-34(b) shows a metallographic section through the crack tip and demonstrates quite clearly that the crack had propagated along grain boundaries, as expected for SCC in this type of alloy. The intergranular fracture mode was confirmed by scanning electron microscopy.

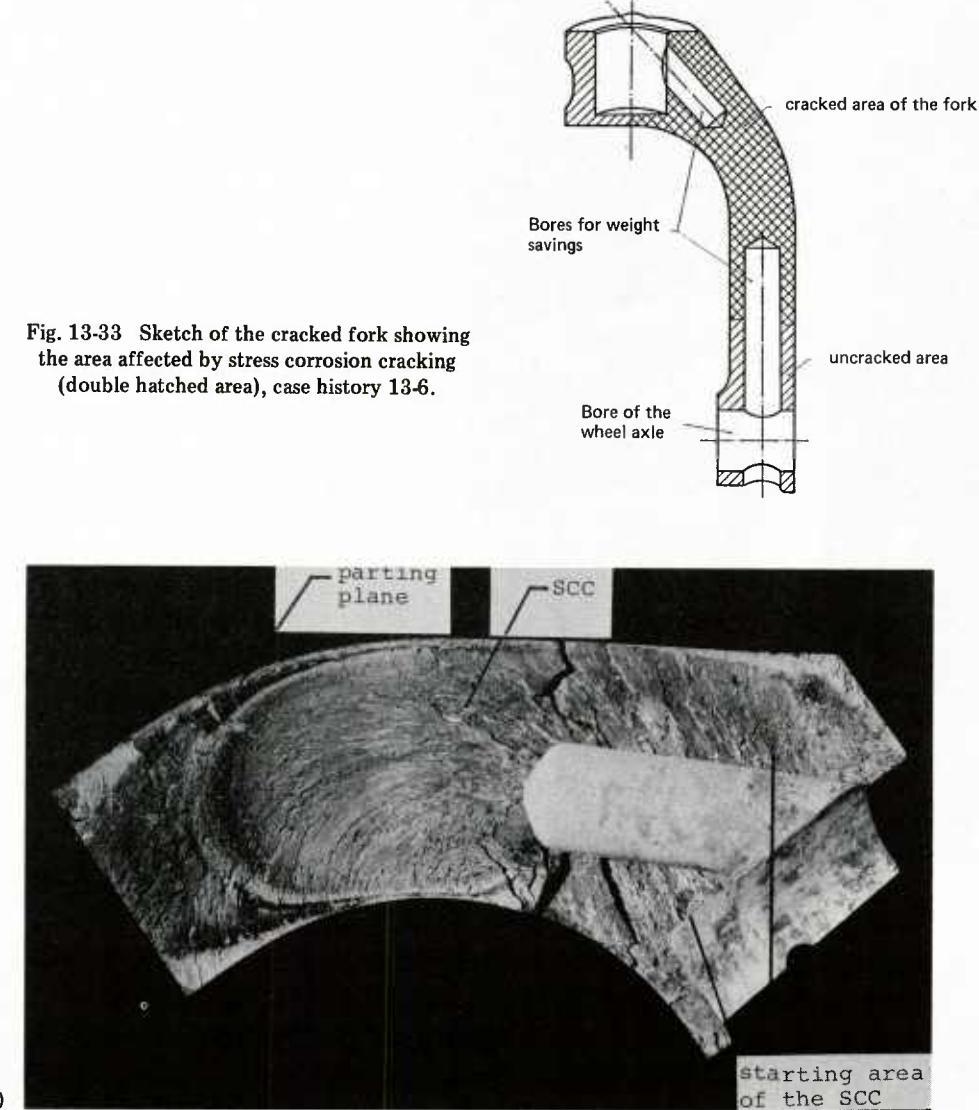
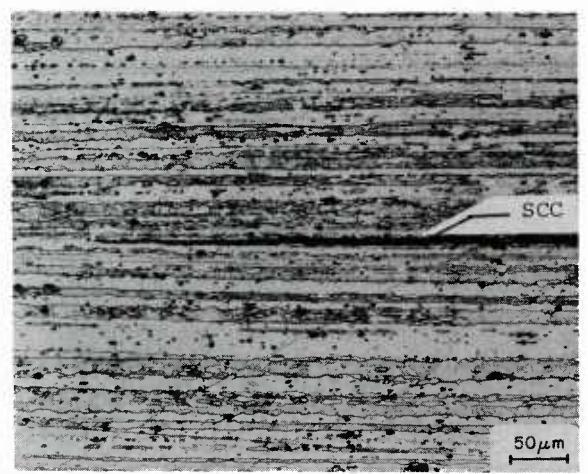
Fig. 13-34 Stress corrosion cracking in a 7075-T6 NLG fork, case history 13-6.

(a) Macroscopic view of the SC crack in the fork.

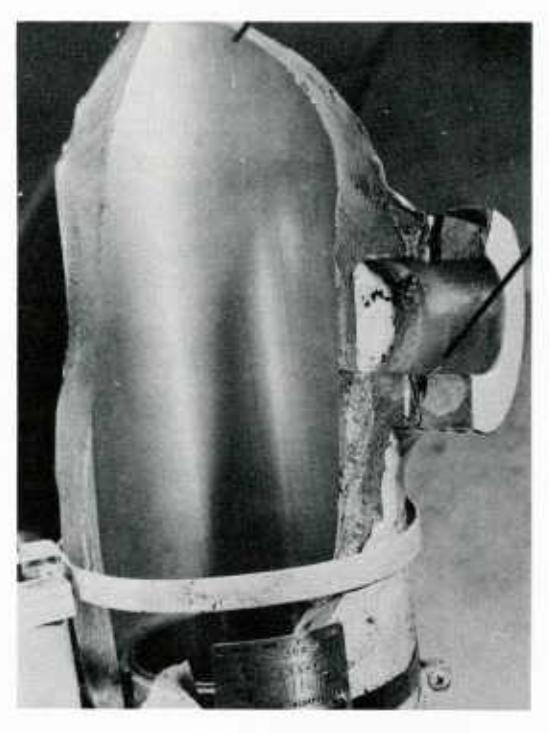
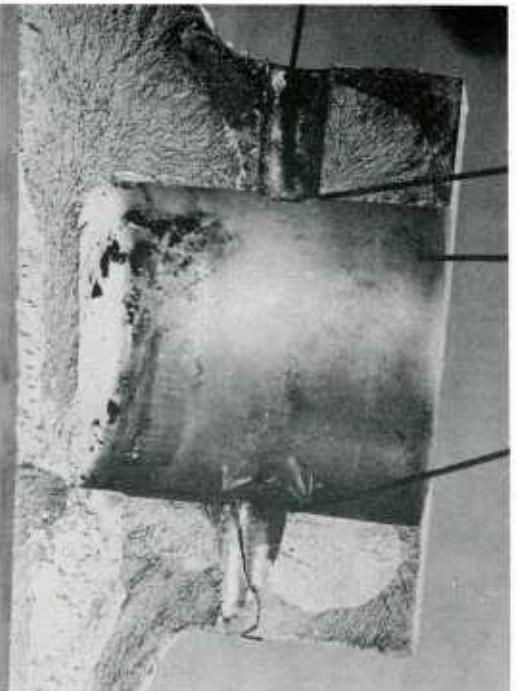
The nose landing gear strut of a fighter aircraft failed during a normal landing procedure after only 30 hours of flight had been accumulated. The failed part is shown in Figure 13-35, and closer examination of the fracture surfaces evident in the failed part revealed that pre-existing cracks had been present prior to the final failure. The fracture surfaces due to these pre-existing cracks are shown in Figure 13-36, and it can be seen that these had initiated at the corners of the bore holes used to locate the clamping attachment bolts for the retraction cylinder.

Fig. 13-35 Stress corrosion cracking in a 7075-T6 nose landing gear strut, case history 13-7.

The failure was a classical stress corrosion cracking problem and was influenced by the use of a susceptible material, the bored holes exposing end grain boundaries, assembly stresses due to interference fit bushings, and superimposed stress concentrations due to the intersecting bores. It was likely that high residual stresses were also present as a result of the T6 heat treatment.

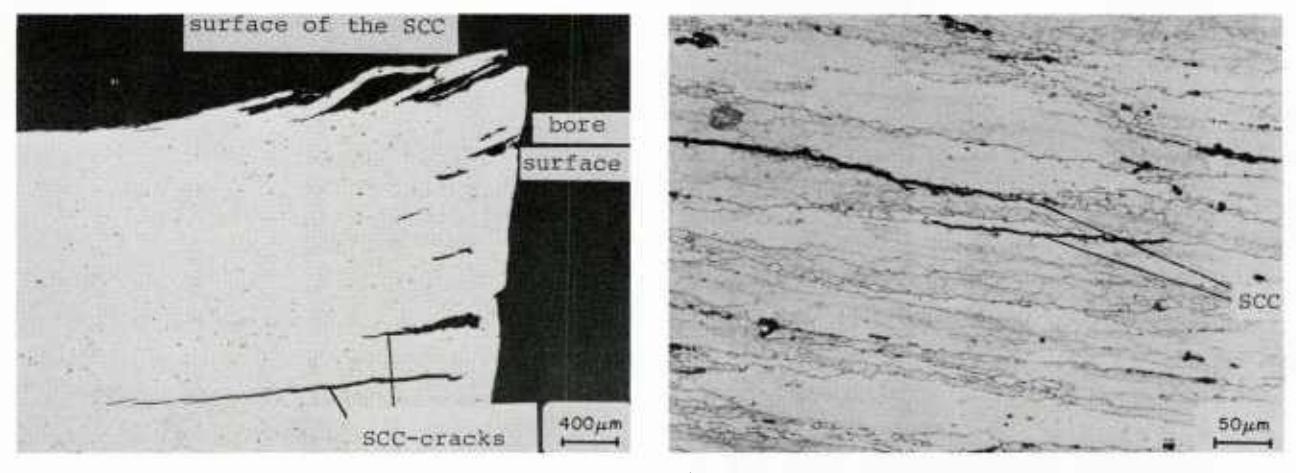
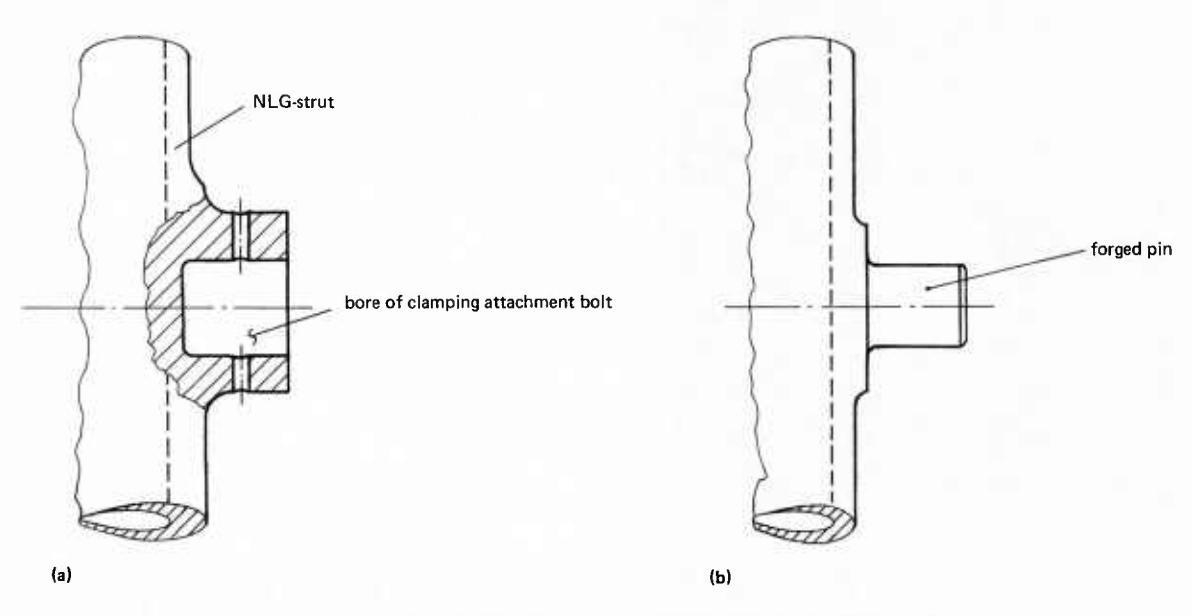
Fig. 13-38 Design details of the nose landing gear strut, case history 13-7.

(a) Original design.(b) Modified design.

A number of alternative designs were considered to resolve this problem including the use of one of the newer high strength, stress corrosion resistant forging alloys such as 7050-T73. However, it was decided to change to a high strength low alloy steel, AMS-6427 (0.3% C, 0.9% Cr, 0.2% Cu, 0.9% Mn, 0.42% Mo, 1.9% Ni) which provides higher strength together with good stress corrosion resistance. The design was also changed, replacing the clamping attachment bore with a forged steel pin, as indicated in Figure 13-38. The steel forging was protected by a vacuum deposited layer of cadmium plating followed by a layer of epoxy primer and a single coat of polyurethane paint.

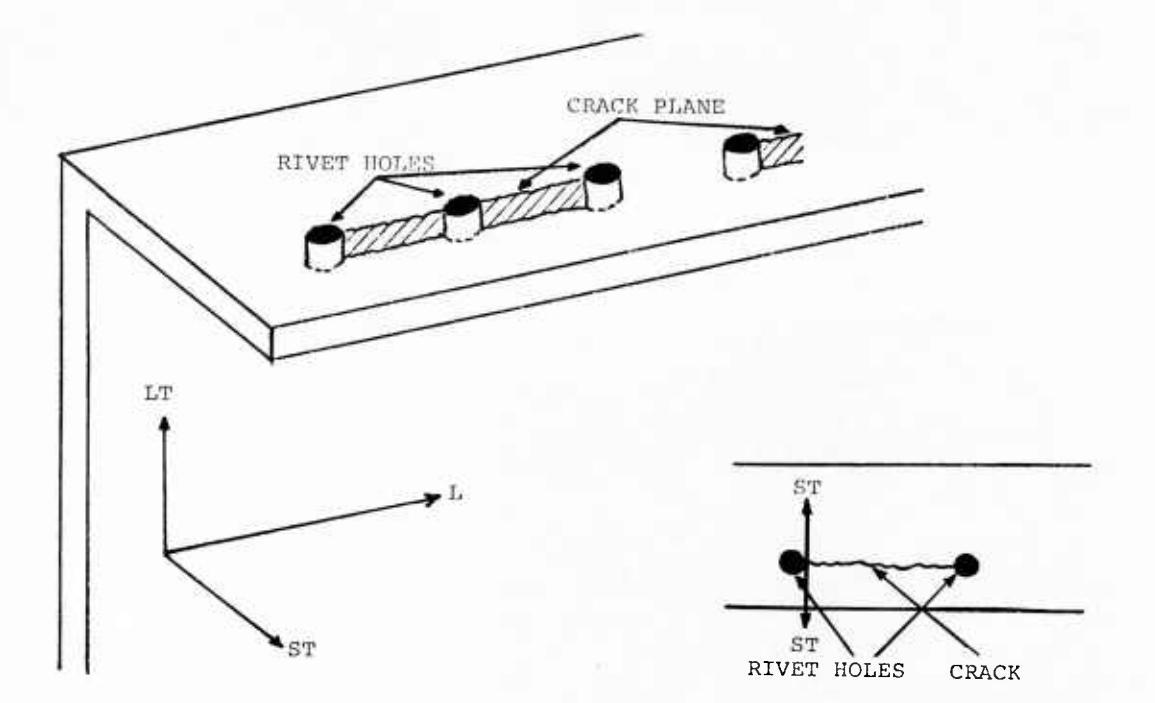
A spectrographic analysis showed the alloy contained 3% Mg, 5.1% Zn, 1.8% Cu, 0.18% Cr and lesser amounts of Fe, Si and Mn. The alloy concentrations were consistent with specifications for 7075 and the alloy hardness indicated the material was in a T6 strength condition. A microstructural evaluation of the grain structure showed a heavily wrought structure of pancake shaped grains, where the crack plane was coincident with the plane containing the longitudinal-long transverse directions, and the short transverse direction was normal to the crack plane as indicated in Figure 13-40.

Fig. 13-40 Orientation of the crack plane with respect to the principal directions in the fuselage frame, case history 13-8.

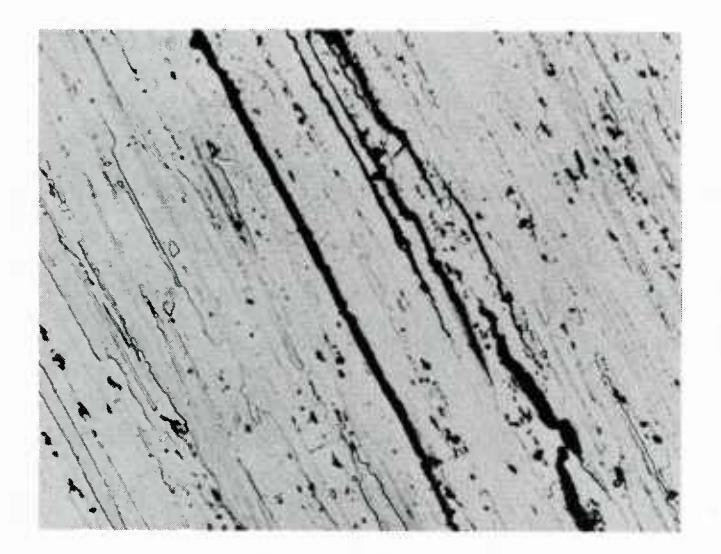
Figure 13-41 shows a metallographic section normal to the LT direction and cracks can be seen running in the longitudinal direction along grain boundaries. The fracture surfaces were corroded, and in most cases they showed no recognizable feature other than flat grain boundary surface facets, as shown in Figures 13-42(a) and 13-42(b), and secondary cracking (Fig. 13-43). In a few cases striation like markings were present immediately adjacent to the fastener holes and in most cases the surfaces of the fastener holes contained corrosion pits. The failure analysis report made no mention of sealants or other forms of corrosion protection in the fastener holes and no information was given on the fastener materials used. However it was concluded that cracking was due to stress corrosion, initiating at corrosion pits in the bore of the fastener holes. The stresses were believed to be due to assembly and operating loads and a stress analysis showed that stresses in the ST direction in the region of the fastener holes were in excess of the threshold values for stress corrosion cracking given in Reference 13-1, Table 13-1.

Fig. 13-41 Metallographic section indicating the intergranular crack path in the fuselage frame, case history 13-8.

It was recommended to replace these fuselage frames with 7075-T73 to prevent SCC. However, since there was evidence of fatigue in some areas and since threshold stress intensities for fatigue in 7075-T73 are slightly lower than for 7075-T6 it might be preferable to replace this alloy completely with a higher strength stress corrosion resistant alloy such as 7050-T73. Wet assembly of fasteners should also assist by excluding moisture from the fastener holes.

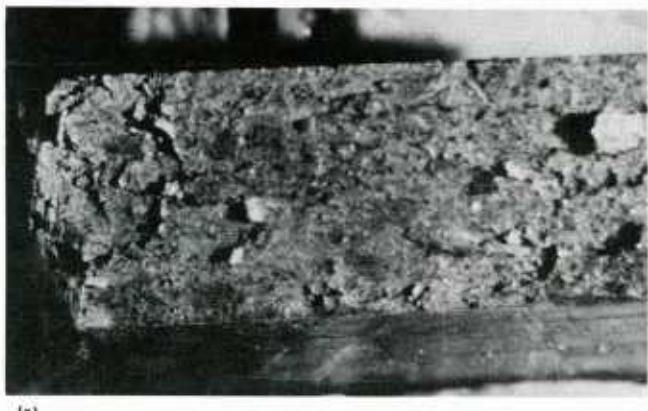
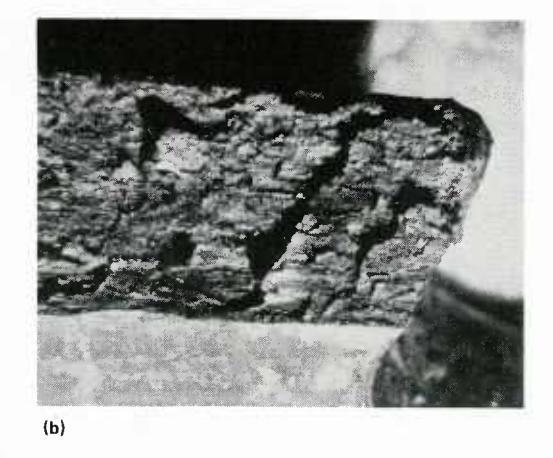
Fig. 13-42 Fracture surface topography extending between two adjacent fastener holes, case history 13-8.

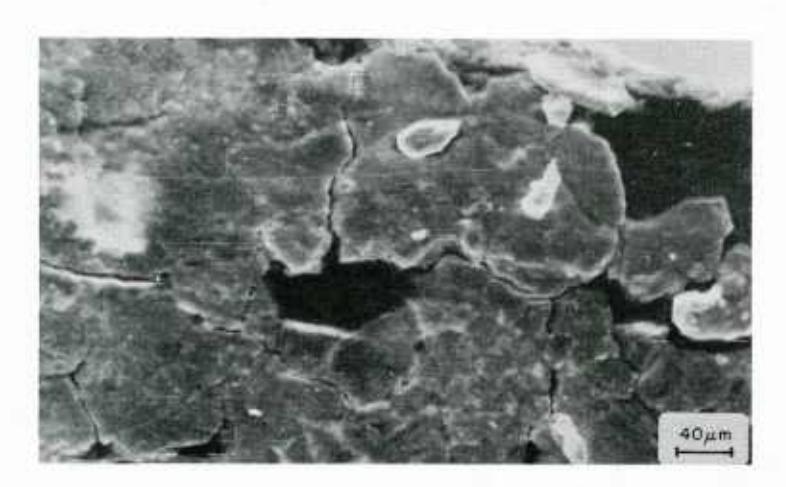
Fig. 13-43 Scanning electron micrograph of a fracture surface from case history 13-8, showing secondary intergranular cracking.

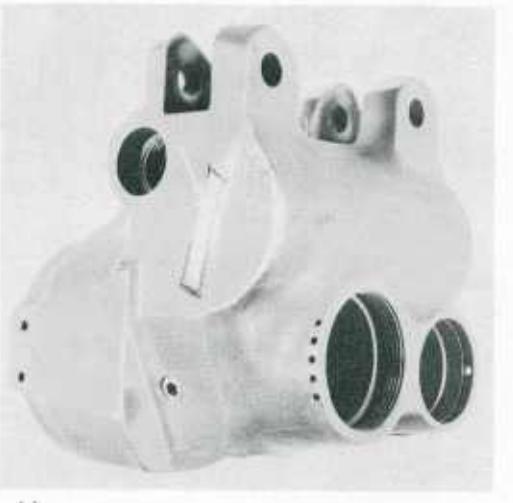
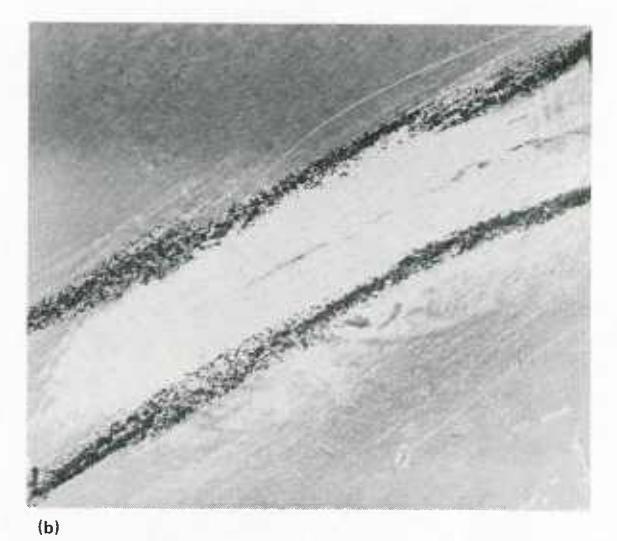
During a visual inspection of a fighter aircraft, a crack was found in the body of the nose wheel steering damper. The component is shown in Figure 13-44(a), where the location of the crack on the outside body is indicated by the arrow. The protective coating and metal in the region of the crack had been scraped away prior to delivery to the laboratory for examination, and a number of impact marks were noticed in this region. A section perpendicular to the crack front was prepared for metallographic examination, and this showed that the crack had propagated over two-thirds of the way through the thickness of the part, which was identified as being 2014 aluminium alloy. The crack was intergranular in nature over most of its length, as indicated in Figure 13-44(c), and it had propagated at about 45° to the external surface following the grain flow in the component. Figure 13-44(d) shows the crack path at higher magnification and reveals both intergranular facets, indicated by solid arrows, and transgranular facets, indicated by open arrows. The remainder of the crack was opened up for examination and the fracture surface exhibited a flat brittle appearance (Fig. 13-44(e)), although the finer features of the fracture surface were obliterated by heavy corrosion.

It was concluded that stress corrosion was the most probable cause of failure, and as noted in Section 13-5, 2014 aluminium is one of the most susceptible 2000 series alloys to SCC in the T4 or T6 conditions. It was impossible to determine how, or where the crack had initiated since the initiation site had been obliterated. However the tool marks visible near the crack indicate that the protective surface anodizing had been removed in these areas, exposing end grains to the corrosive environment. The service operating stresses in this part were not unduly high, and it is likely that residual stresses contributed to the SCC process. Also the surface indentations would have created a stress concentration effect and it is possible that the SCC cracks initiated at these locations.

Fig. 13-44 Cracking in a 2014 aluminium nose wheel steering damper, case history 13-9.

- Arrow indicates the location of cracking.
- Close-up of the surface crack. (b)
- (c) Microstructure near the surface of the part showing the grain structure and crack path. Arrow indicates location of Figure 13-44(d). (d)
- Crack path showing intergranular facets (solid arrows) and transgranular facets (open arrows).
- (e) Fracture surface topography.

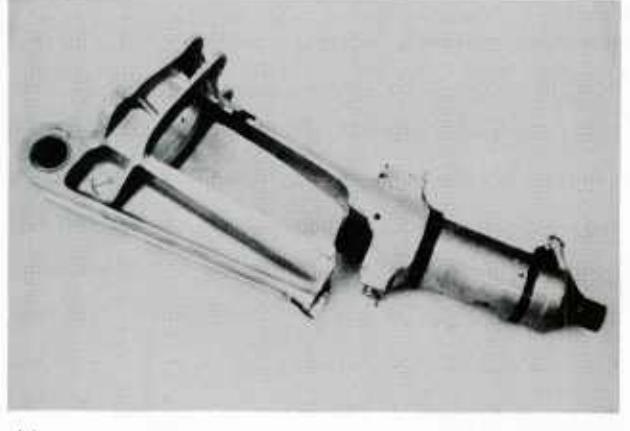
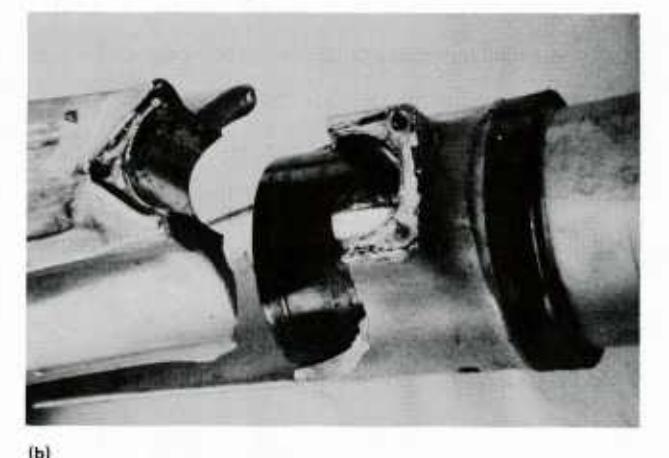
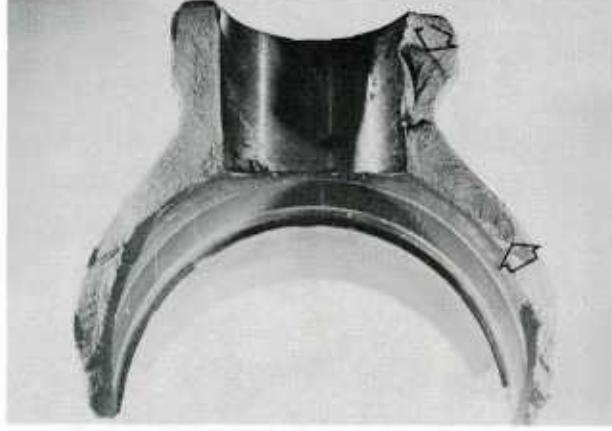
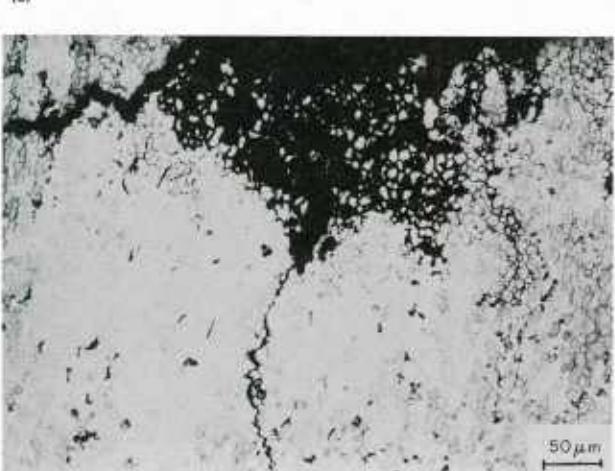
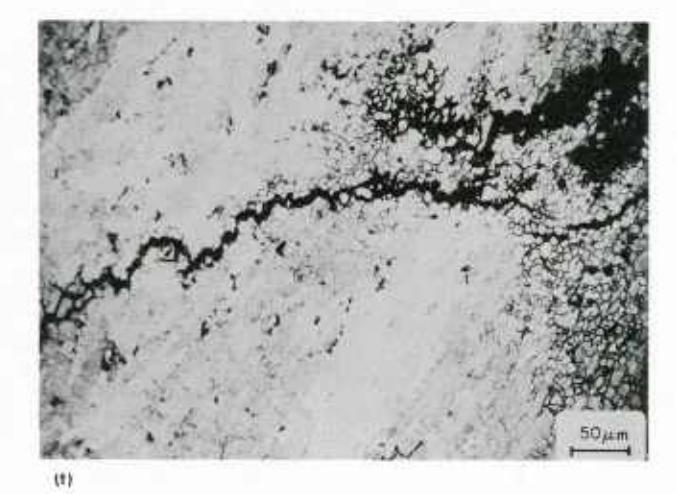
A landing gear forging of an aircraft, Figures 13-45(a) and 13-45(b) failed during ground operations. The crack initiated on an interior surface at the junction of an axial bore and a radial bore, Figures 13-45(c) and 13-45(d). The fracture surface to the right of the radial bore, see Figure 13-45(c), contained a dark corroded area, which had propagated to a considerable length as indicated by the open arrows. This was surrounded by a light, non-corroded, overload region which formed a narrow band between the dark corroded region and the outer surface of the part. This indicates that the growing crack had not broken through to the outside until the final overload failure had occurred, and therefore the pre-crack had remained hidden until this final failure. The presence of the narrow band of overload fracture suggests that growth of the pre-crack had been suppressed by compressive residual stresses in the surface layers, which presumably did not exist, or had been removed by machining on the interior surfaces. Figures 13-45(c) and 13-45(d) show that severe corrosion and pitting occurred on the interior surface of the radial bore, and deep corrosion pits were present in the crack initiation regions.

Fig. 13-45 Failure of an Al-Cu main landing gear part, case history 13-10.

- Fracture component. (a)
- (b) Close-up of the fracture area.
- (c) Arrows indicate the extent of corrosion induced cracking
- Crack initiation sites at the junction of the axial and radial bores. (d) (e) Sub-surface intergranular cracking adjacent to the radial bore.
- (f) Sub-surface intergranular cracking adjacent to the axial bore.

The component was made from an AlCuSiMn alloy, conforming to the German specification WLB 3.1254. This alloy contains about 4.3% Cu, and is similar to 2017 aluminium. Metallographic examination showed that the material had a very fine recrystallized grain structure, with a grain size of about 10-20  $\mu$ m. Cross sections prepared through the component adjacent to the radial and axial bores showed severe intergranular corrosion immediately adjacent to the machined internal surfaces as shown in Figures 13:45(e) and 13:45(f) respectively. In both figures long cracks can be seen growing out of the regions of intergranular cracking to penetrate deeply into the wall thickness. These cracks resemble stress corrosion cracks, propagating intergranularly and exhibiting signs of crack branching.

It was concluded that the failure occurred by stress corrosion cracking and this produced the dark pre-crack shown in Figures 13-45(c) and 13-45(d). Although the strength of the alloy was not given in this failure report, it is known that alloys of this type are sensitive to intergranular corrosion and stress corrosion cracking, particularly when heat treatment leads to the formation of solute-depleted regions adjacent to grain boundaries which are anodic with respect to the grain boundaries and grain interiors. Little specific data appears to be available on 2017 aluminium, but Reference 13-45 indicates that stress corrosion service failures can be expected in 2017-T4 or 2017-T451 when sustained tensile stress acts in the short transverse direction relative to the grain structure. In this particular component there was very little directionality in grain structure, but as indicated in Section 13-5 equiaxed structures of the type observed might represent a worst-case condition with respect to SCC.

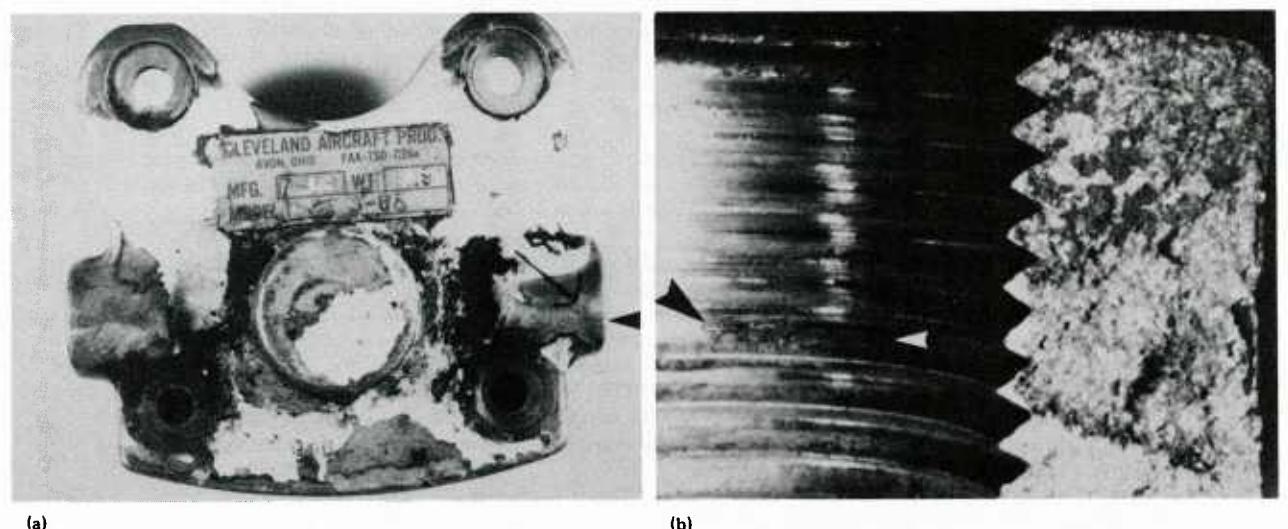
The brake housing castings of a popular light aircraft were frequently being found cracked and leaking at the brake line union, leading to brake failure. A typical cracked casting is shown in Figure 13-46(a).

On breaking open the crack in the laboratory it was found that the crack had grown only as far as the line union had been threaded into the casting (Fig. 1346(b)). The required driving stress was the hoop stress caused by a tight fitting union. The crack stopped growing when it reached a zone where the local hoop stress fell below the threshold required for stress corrosion cracking. It was thought that as the crack leaked fluid, the operator had tightened the union further, thus raising the local hoop stress and causing the crack to propagate further.

Fig. 13-46 Stress corrosion cracking of a magnesium alloy brake housing, case history 13-11.

- (a) General view of the as-received brake cylinder housing, indicating location of crack (arrow).
  (b) Fracture surface and internal thread. Bright area of fracture is overload region. Note dark area of
- fracture stops at same depth as union (see Loctite remains and chip arrowed in thread root).

The problem was solved by increasing the section thickness in the casting around the brake line union so that the hoop stress caused by insertion of the union was lowered below the SCC threshold stress, and hence SCC could not occur.

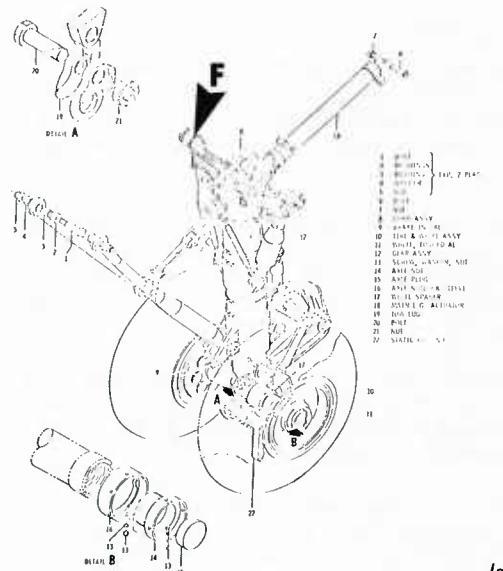
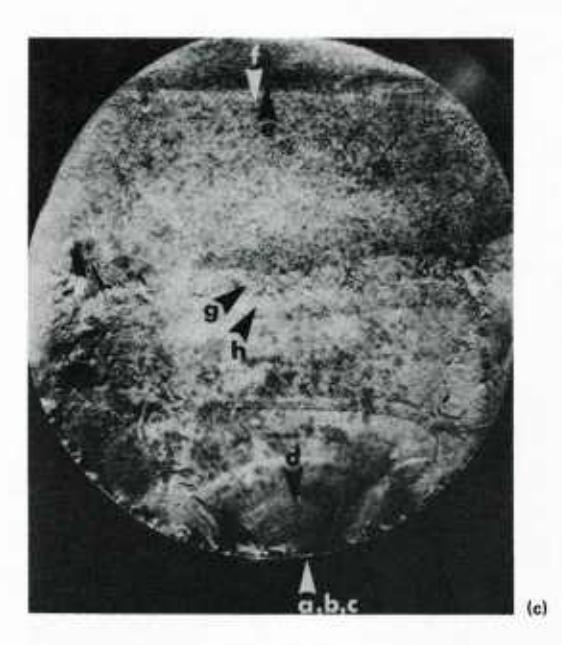
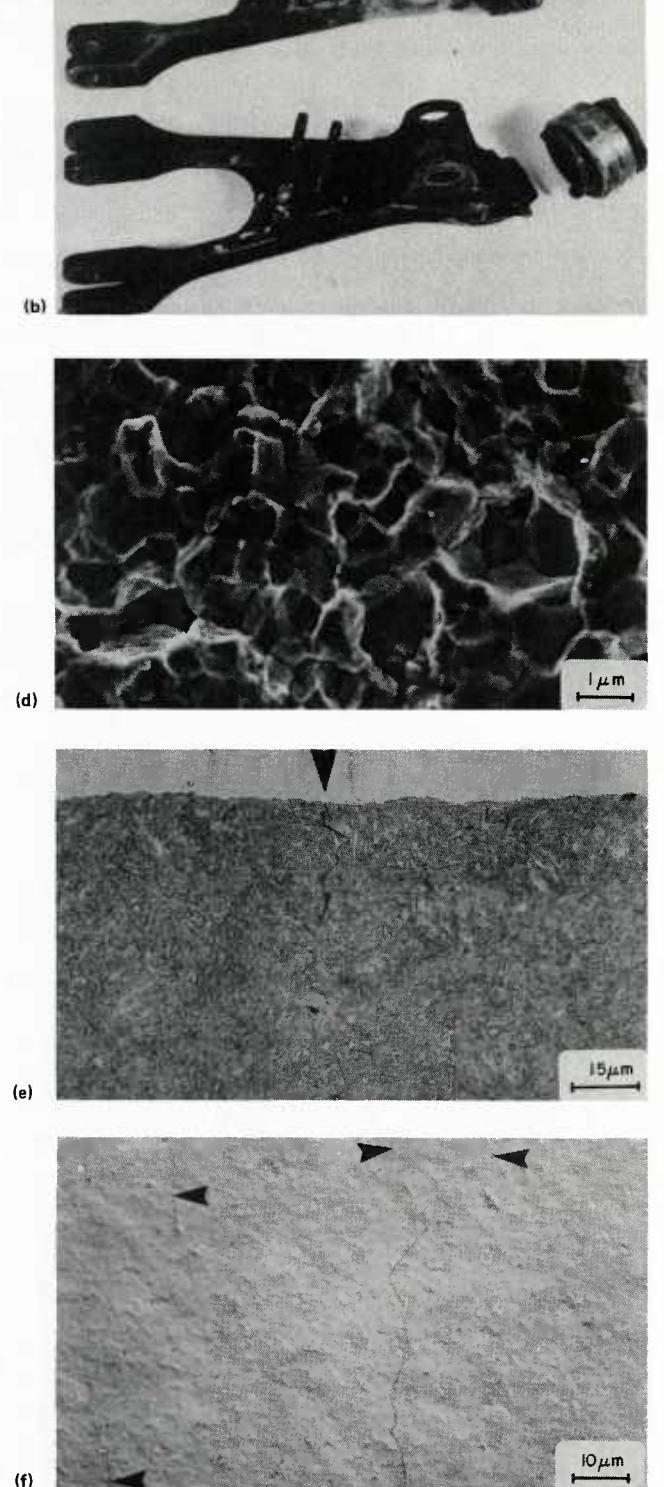
A large commercial turboprop aircraft suffered collapse of its left main undercarriage shortly after touchdown while landing. The aircraft settled onto the left wingtip, slewed off the runway and was extensively damaged by the subsequent fire. It was found that the right hand trunnion shaft, which acts as the hinge pivot for the gear assembly, had fractured as indicated in Figures 13-48(a) and 13-48(b).

Fractographic analysis of the shaft fracture surface (Fig. 13.48(c)), showed that about 90% of the cross-section had cracked progressively. Crack initiation had occurred in the region of the white arrow, marked 'a,b,c' in Figure 13.48(c), and stable slow crack propagation had occurred across the fracture surface to the location marked 'f', except for a band of overload rupture at 'g'. This overload band extended across the diameter of the shaft and consisted of mixed cleavage and ductile dimpling. It was ascribed to a previous heavy landing. The bulk of the fracture surface, including areas marked 'a, b, c, d, h and f' in Figure 13.48(c), exhibited well defined intergranular facets as indicated in Figure 13.48(d). The final overload rupture occurred as the crack reached the location marked 'e' in Figure 13.48(c).

### Fig. 13-48 Environmentally enhanced fracture of a steel landing gear trunnion, case history 13-13.

- MLG assembly showing trunnion failure location F. (a)
- (b) Fractured right hand trunnion arm shaft, and unfailed left hand trunnion.
- Fracture surface showing origin at a, b, c. Intergranular fracture as observed at sites a, b, c, d, h and f. (c)
- (d)
- (e) (f) Axial section near fracture shows cracking under chromium plating. Surface of shaft after stripping of plating, showing circumferential grinding cracks (arrowed).

The presence of intergranular fracture and the clear evidence of stable slow crack propagation led to the view that an environmentally enhanced fracture process was involved. Stress corrosion was suspected, although it was found that the threshold stress level for stress corrosion cracking in this particular steel was 620 MPa while the design maximum surface tensile stress was 276 MPa. Further investigation showed that crack initiation was due to the presence of surface grinding cracks, which were produced on the shaft during rework to repair prior corrosion damage. These pre-cracks were hidden by the subsequent hard chromium plating used to rebuild the shaft to size, but they were revealed by post-fracture sectioning, as indicated in Figure 13-48(e), and later confirmed by stripping the plating and viewing the original steel surface as indicated in Figure 13-48(f).

The conditions for stress corrosion cracking were not met unless the grinding cracks were present under the chromium plating, since although the steel was known to be susceptible to SCC, and the natural crack network in the chromium plating would allow a corrosive medium to reach the steel, normal stresses were far below the threshold level for SCC. However the stress concentration effect of the pre-existing grinding cracks provided the necessary stress levels at the crack tips to cause crack propagation to occur. The authorized rework procedure required post-grinding inspection for such cracks, this was not performed in this particular case. This failure would have been avoided had the authorized overhaul procedure been strictly followed.

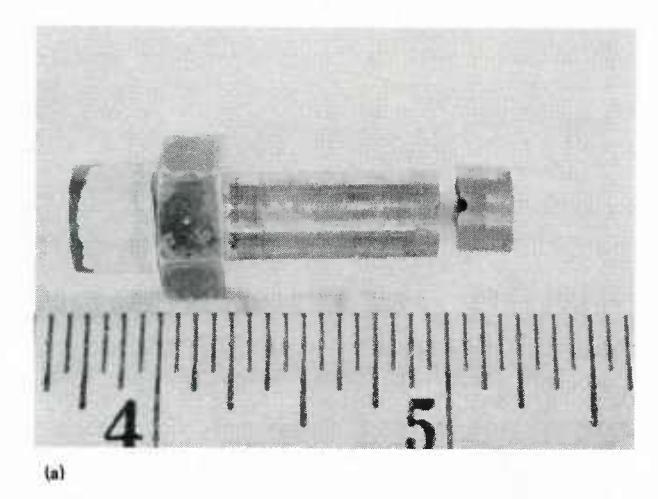
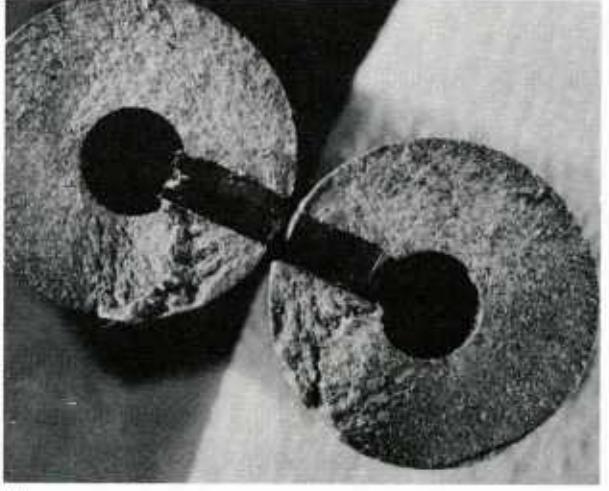
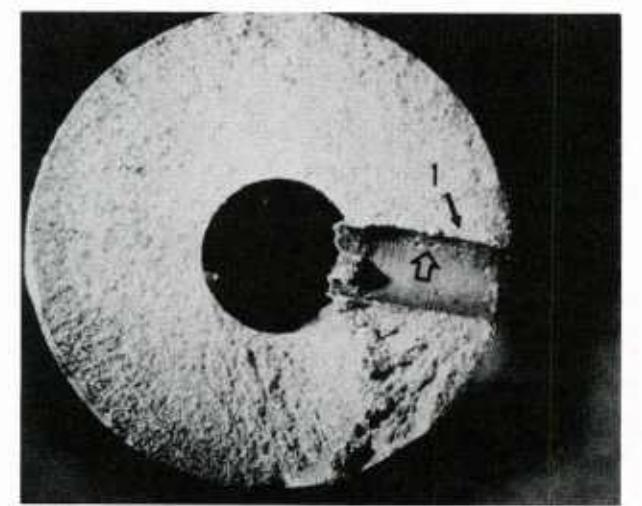
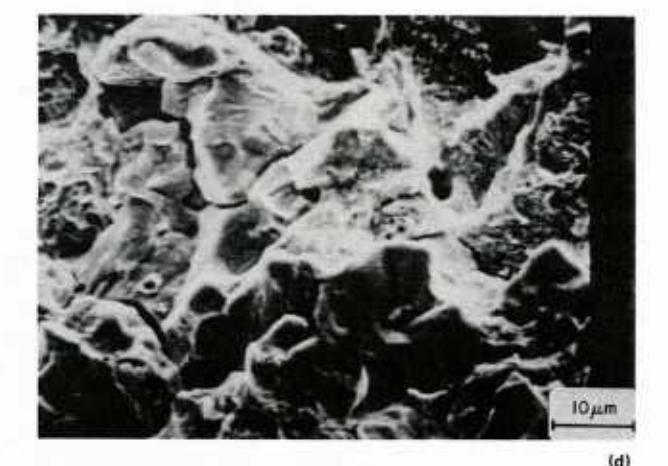
Optical examination showed that corrosion pits were present on the bolt shank and on the inside surface of the lubrication hole, as indicated in Figure 13-49(a) and Figure 13-49(c). The fracture had occurred on a plane through the lubrication hole, as indicated in these figures. Further fractographic analysis showed that the failure had initiated at the upper edge of the hole shown in Figure 13-49(c), and had progressed in a counter-clockwise direction. The fracture surface on the opposite side of the lubrication hole exhibited a rougher, more fibrous fracture appearance, and appeared to have formed as a result of final overload rupture.

Scanning electron fractographic examination of the failed bolt revealed an intergranular fracture in the initiation region (region 1 in Figure 13-49(c)), and both secondary cracking and corrosion pitting were evident on the fracture surface, as indicated in Figure 13-49(d). Chemical analysis of the steel showed that it satisfied the requirements AMS 6428B, for  $4335V \mod$ . steel, and hardness was in the specified range indicating an ultimate tensile strength in the range 1517 to 1655 MPa.

The presence of corrosion pits in the crack initiation area, and on the fracture surface, together with intergranular cracking suggested an environmentally enhanced fracture process, and a stress corrosion cracking/hydrogen embrittlement mechanism was considered. Hydrogen embrittlement might have occurred as a result of the original cadmium plating process, if the bolt had not been adequately baked after plating. However it was felt that failure would then have occurred in a relatively short time under the action of sustained tensile stresses in service. However, as noted previously, the bolt had performed satisfactorily for several years. It was concluded therefore that stress corrosion cracking was the most probable cause of cracking, where sustained service stresses and the corrosive nature of the operating environment contributed to failure by a process possibly involving hydrogen evolution, embrittlement of the steel and cracking.

(a) Cracked MLG hinge bolt.

- (b) Mating fracture surfaces showing flat fracture.
- (c) Corrosion pits in the lubricating hole.
  (d) Intergranular fracture observed in the initiation region (area 1 in Fig. 13-49(c)).

Since this bolt was one of several that had been in service for a long period of time, it was considered likely that the remaining bolts may also be affected by corrosion. All of the hinge bolts were removed and replaced with new bolts protected with a low embrittlement cadmium plating. However, since service induced corrosion was the major source of damage, as opposed to plating induced embrittlement, a program of regular inspections was implemented.

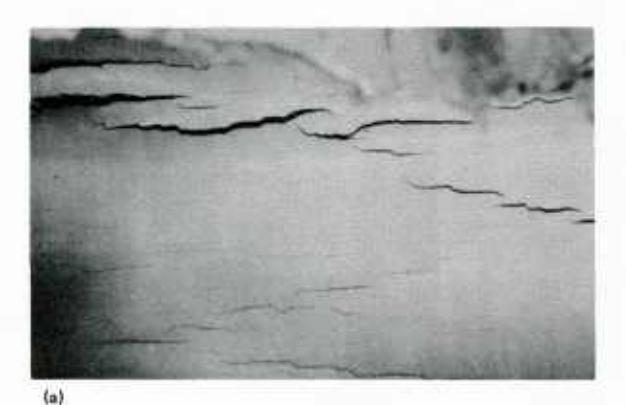
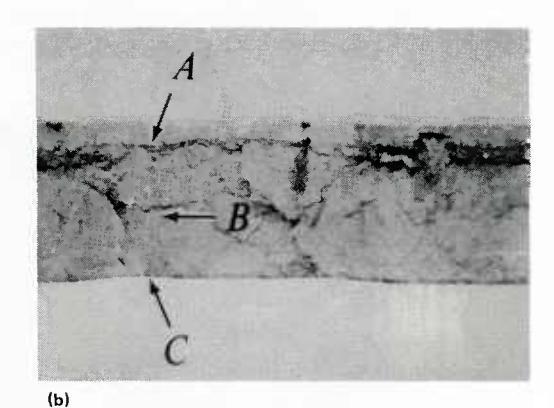
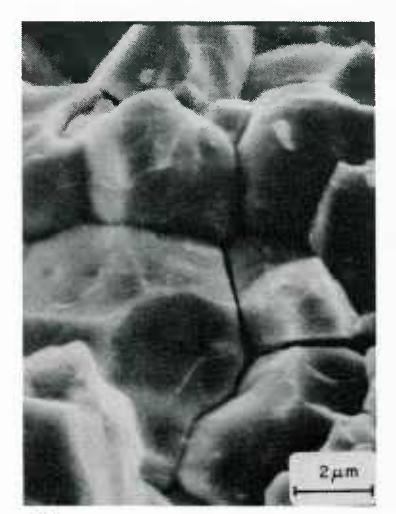
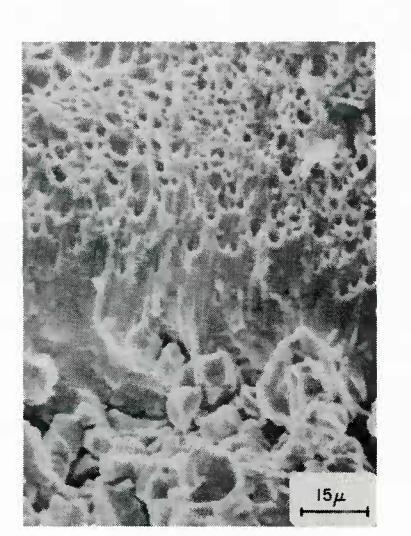
Visual examination of the cylinder inner wall showed numerous cracks running along the length of the cylinder, and there was no evidence of deformation associated with the crack sites, as indicated in Figure 13-50(a). Further examination of the open fracture faces showed that crack initiation had occurred on the inner surface of the cylinder, and indicated that before final overload fracture occurred the crack fronts were establishing a stable, slow crack growth configuration. The cracks had propagated through about 80% of the wall thickness before final overload rupture occurred, as indicated in Figure 13-50(b). In this figure, the symbols 'A', 'B' and 'C' indicate the overload fracture region, the region of slow crack growth, and the initiation region respectively.

Fractographic examination showed that the fracture mode in the initiation region and the region of slow crack growth was intergranular, and heavy corrosion products partly obscured the grain facets in the initiation region. Figure 13-50(c) shows the fracture topography in region B, while Figure 13-50(d) shows the transition zone between the region of slow crack growth (B) and the overload region A. This latter region showed ductile dimples, characteristic of overload rupture. Metallographic cross-sections through the wall of the cylinder showed extensive intergranular cracking with multiple crack paths, as indicated in Figure 13-50(e).

The presence of corrosion products and intergranular fracture in the region of slow crack growth suggested that an environmentally induced fracture mode was operating. The inner surface of the cylinder was found to be covered by a thin film of oil which was analysed and found to be an established hydraulic fluid. Because of the small amount of oil available for analysis it was not possible to determine whether any contaminants were present that might cause corrosion. However, as noted in Section 13-6, it is known that many light oils and hydraulic fluids contain small amounts of water which are sufficient to cause stress corrosion cracking in some susceptible alloys. No other source of corrosion was identified, and in the absence of alternative explanations the failure was attributed to stress corrosion cracking.

Fig. 13-50 Failure of a 18-Ni maraging steel pressure vessel, case history 13-15.

(a) View of the cylinder inner surface showing longitudinal cracks.

- (b) Macrograph of a fracture surface showing inner wall (C), region of stable crack growth (B), and overload region (A).
- c) Intergranular fracture in region B.
- (d) Transition from intergranular to transgranular dimpled fracture, region  $B \rightarrow A$ .
- (e) Metallographic section across wall showing extensive intergranular attack.

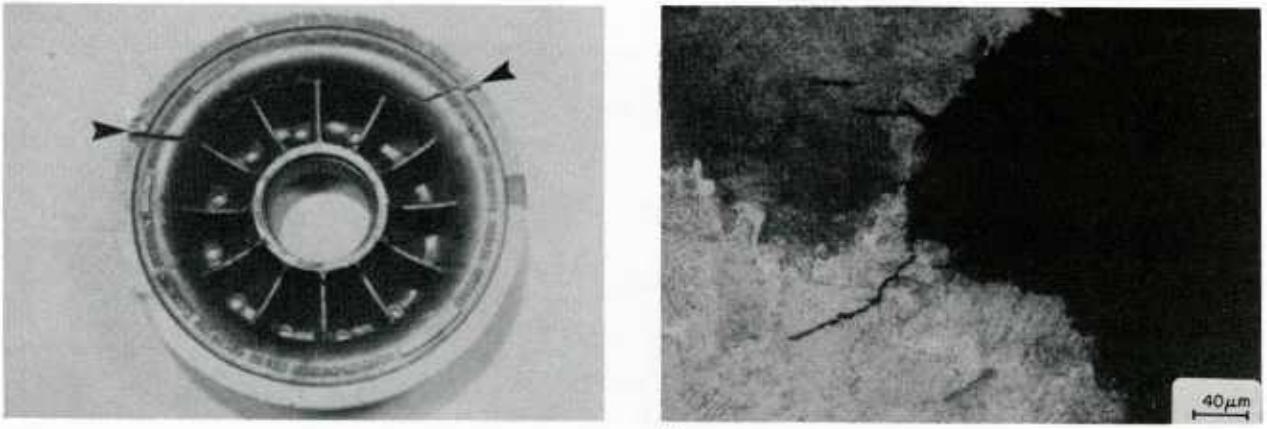
A large rim section was found broken from the rim of a STOL transport aircraft main wheel after landing (Fig. 14-8(a)). The cause of fracture was found to be corrosion fatigue cracking which had grown completely through the rim section. Cracking initiated from the tyre bead seat radius, and the corrosion products were typical of a marine environment.

Fig. 14-8 Corrosion fatigue of a magnesium alloy (AZ-91C) main landing gear wheel

- (a) General view of the failed wheel and the crack indicated by arrows.
- (b) Section through a typical pit showing multiple corrosion fatigue cracks.
  - Nital etch. (Mag. × 250)

These experimental low pressure tyre wheels allowed salt moisture to penetrate the tyre bead seat area between tyre and rim, aided by frequent tyre changes. The wheel was a magnesium alloy casting (AZ-91C) and fatigue crack initiation occurred at the base of deep corrosion pits. Figure 14-8(b) shows a typical pit with multiple crack origins.

Such failures are not likely to occur until the cracking is substantial and then only when side loaded during taxiing, since tyre pressure loads are small. Dye penetrant or eddy current inspection to detect cracking during tyre changes would prevent in-service failures. In this case the frequent experimental tyre changes increased the availability of the corrosive media to the growing undetected cracks.

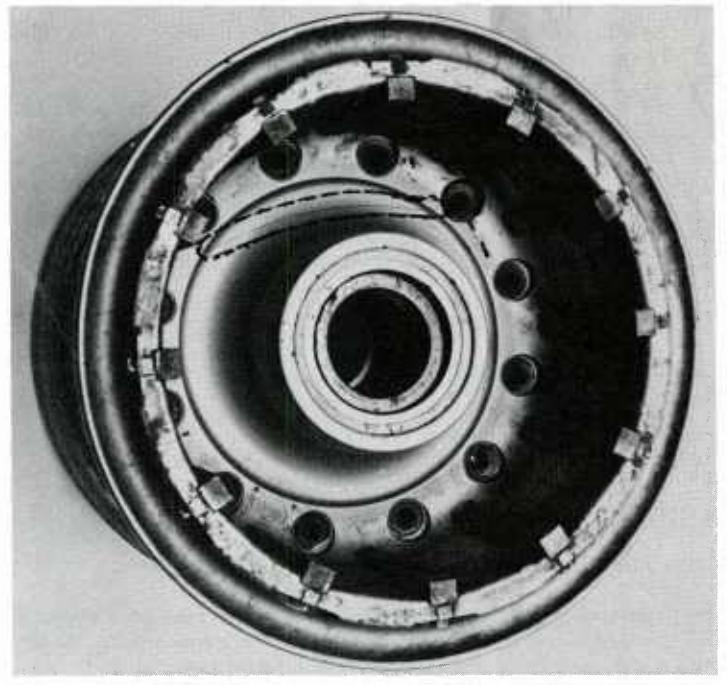
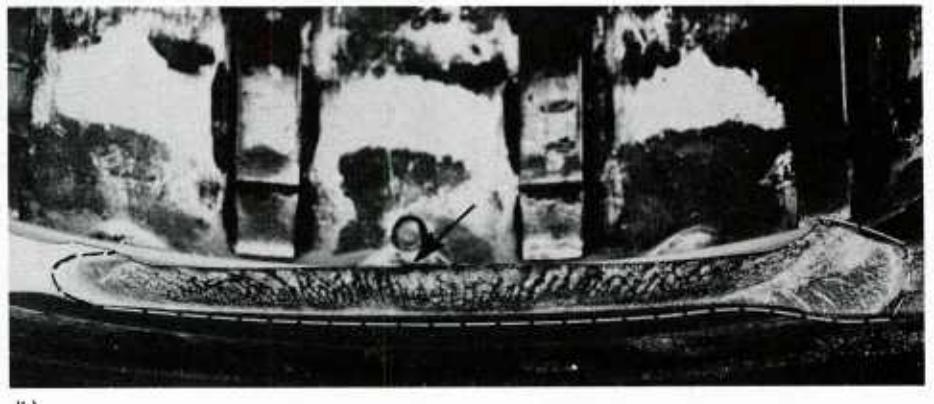
Long cracks were found during visual inspection of a fighter aircraft main landing gear wheel. The cracks were approximately 125 mm long and were found to run between the rim of the wheel and a bolt hole, as shown in Figure 14-9(a). The crack initiation site is indicated by the arrow in Figure 14-9(b).

Fig. 14-9 Corrosion fatigue of a magnesium alloy (QE-22A) main landing gear wheel

(a) General view of the wheel showing the crack.
(b) Fracture surface showing the crack initiation site indicated by arrows.

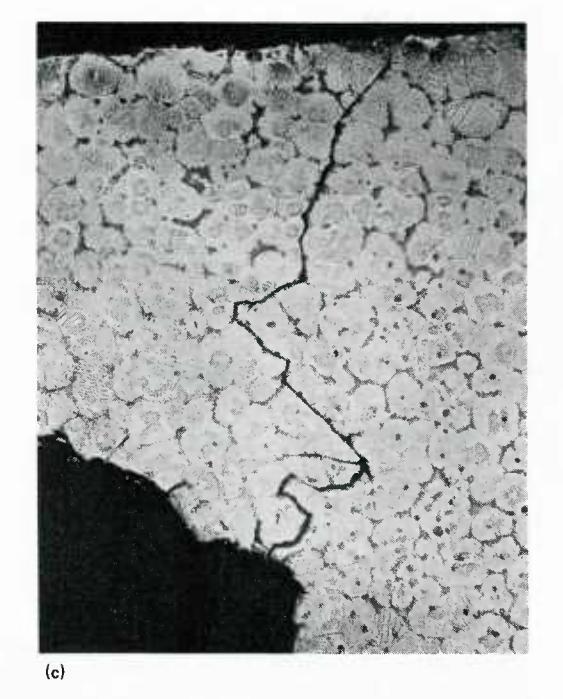
Heavy surface corrosion was observed over most of the wheel and polished sections, such as that shown in Figure 14-9(c), showed several through cracks and partial cracks initiating from corrosion pits. The cracks were found to propagate in a predominantly intergranular mode, as indicated in Figure 14-9(c).

- (c) Secondary cracking initiating from corrosion pits.
- (d) Area showing intergranular fracture on the heavily corroded fracture face. (Mag. × 220)
- (e) Heavy corrosion products largely obscuring fatigue striations running normal to the direction of crack propagation indicated by the arrow.
