AGARD Corrosion Handbook Volume-1 Aircraft Corrosion: Causes and Case Histories

AGARDograph No.278

## AIRCRAFT CORROSION: CAUSES AND CASE HISTORIES

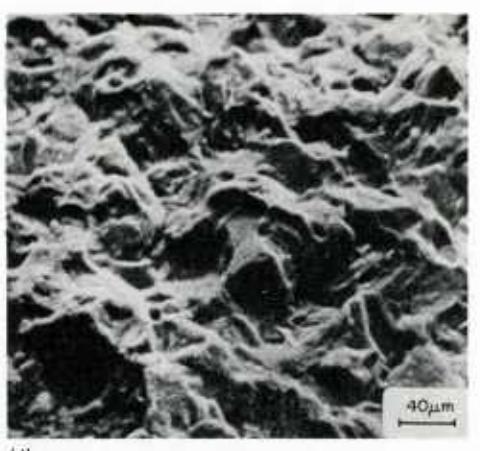
- (c) Secondary cracking initiating from corrosion pits.
- (d) Area showing intergranular fracture on the heavily corroded fracture face. (Mag. × 220)
- (e) Heavy corrosion products largely obscuring fatigue striations running normal to the direction of crack propagation indicated by the arrow.

Scanning electron microscopy showed that the fracture surface was covered by thick corrosion products, but the intergranular nature of the fracture was still clearly evident in many areas (Fig. 14-9(d)). The fine features of the fracture surface were largely obscured by the corrosion products, but isolated areas could be found which showed what appeared to be fatigue striations (Fig. 14-9(e)).

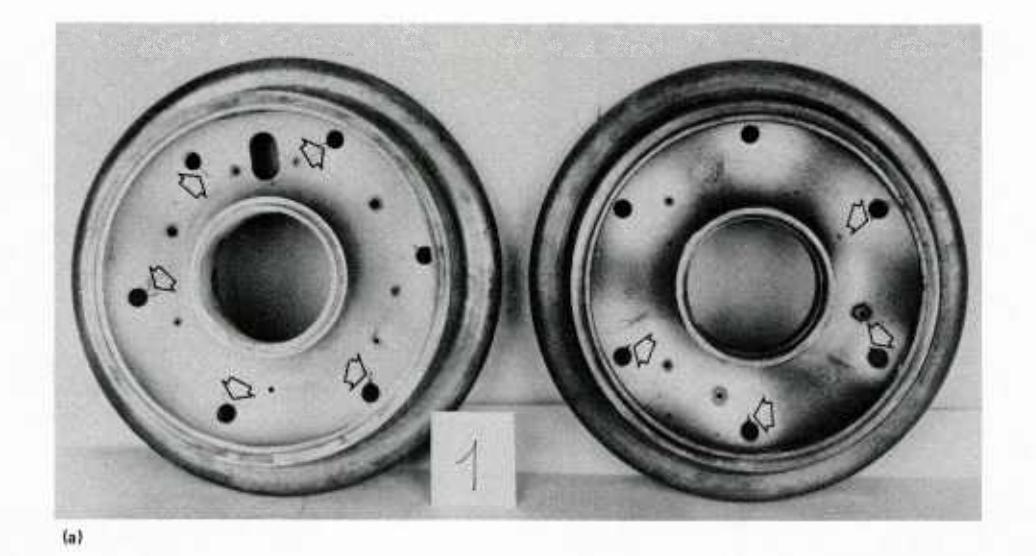
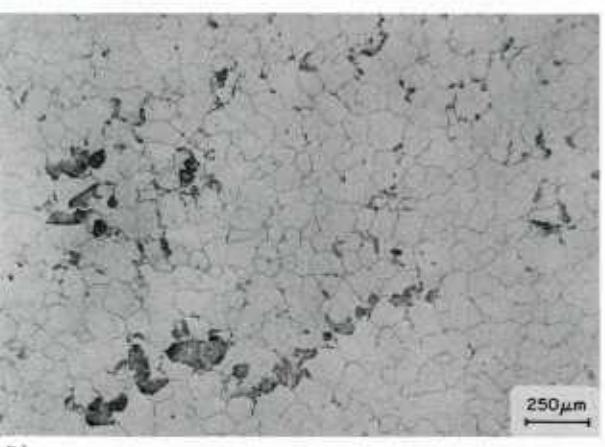
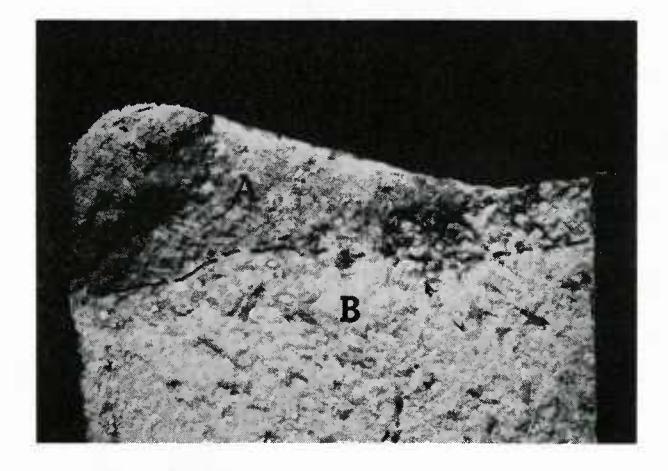
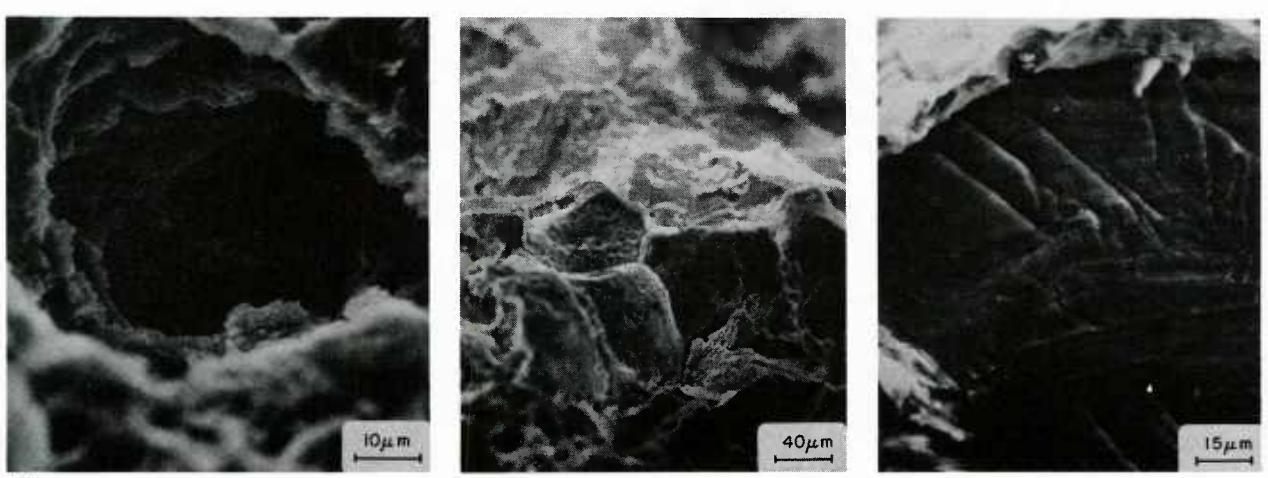
### Fig. 14-10 Corrosion fatigue of a magnesium alloy (AZ-91C) nose wheel

Multiple cracks were found propagating out of bolt housings during a visual and liquid penetrant inspection of the nose wheels of a fleet of fighter aircraft. Many wheels were found to be affected, and typical cracks are indicated by the arrows shown in Figure 14-10(a).

Several cracks were opened in the laboratory, and these showed a dark zone, covered by corrosion products, which extended up to the bright overload zone produced during opening (Fig. 14-10(c)). The inner surfaces of the bolt holes were also examined. These were found to contain deep corrosion pits of the type shown in Figure 14-10(d). Examination of the fracture surfaces using a scanning electron microscope showed that intergranular cracking had occurred in the initiation regions (Fig. 14-10(e)), while transgranular fracture had occurred at longer crack lengths (Fig. 14-10(f)). Both the intergranular and transgranular zones were badly corroded, but fatigue striations were clearly visible in the transgranular areas (Fig. 14-10(f)).

Pitting attack in the bolt holes may have been influenced by galvanic effects, or by crevice conditions existing between the wheel and the steel bolts. However, the presence of heavy corrosion across the fracture faces and the clear evidence of striations suggests that corrosion fatigue was responsible for at least the later stages of crack propagation. This aircraft had operated in the Mediterranean region which is also a significant factor. This, and the two preceding case histories, suggest that magnesium alloy castings are not good choices for aircraft wheels.

- (a) General view of two wheels showing cracks (arrows) growing out of bolt holes.
  (b) Microstructure of the AZ-91C magnesium alloy. (Mag. × 45)
  (c) Fracture surface showing the corroded (dark) pre-cracked area 'A', and the bright final fracture zone 'B'.
  (d) Inner surface of a bolt hole showing a deep corrosion pit. (Mag. × 1200)
  (e) Intergranular cracking in the initiation zone. (Mag. × 260)
  (f) Fatigue striations in a transgranular portion of the fracture surface. (Mag.× 650)

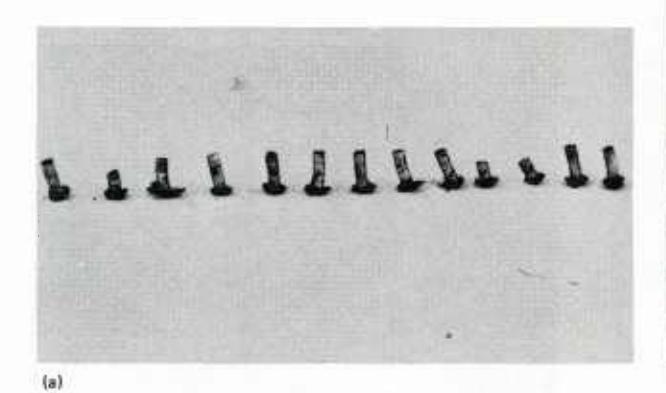
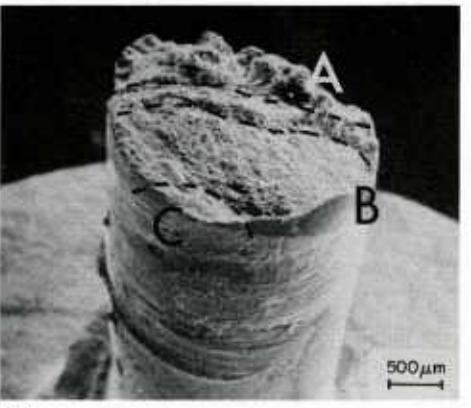
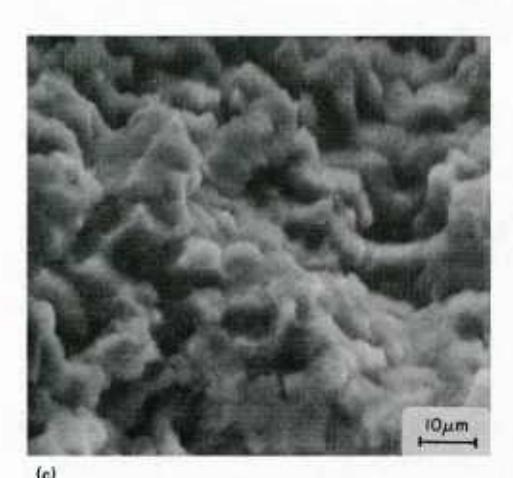
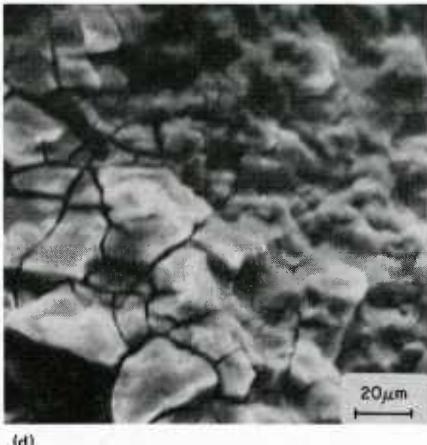
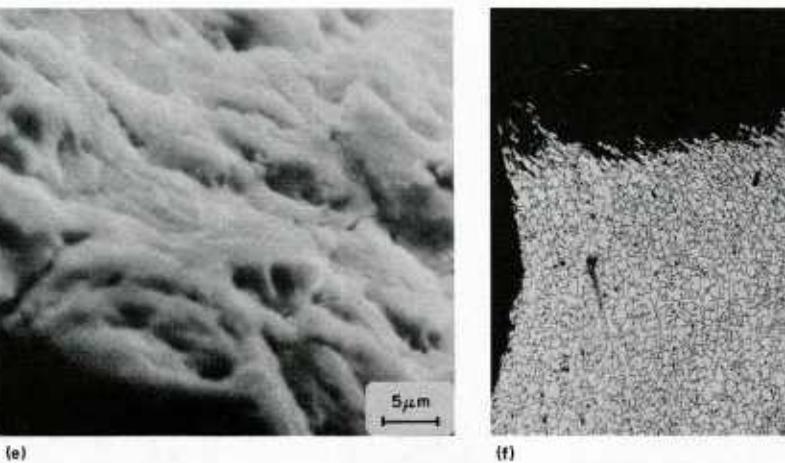
Fig. 14-12 Corrosion fatigue of 5052 aluminium alloy rivets

- (a) Rivets removed from the structure for examination. (b)
  - Fracture surface of a rivet showing three zones of fracture. (Mag. × 20)

- (Mag. X 20)
  (c) Intergranular fracture observed in zone 'A'. (Mag. X 1000)
  (d) Mud-crack pattern observed in fracture zone 'A'. (Mag. X 500)
  (e) Fracture surface appearance in fracture zone 'B'. (Mag. X 2000)
  (f) Grain structure in the rivets. The deformation is due to tearing
- in an overload region, (Mag. × 500)
#### Case history 14-5. Corrosion fatigue of 5052 aluminium alloy rivets.

Visual inspection of a set of rivets, used to hold a filter housing in a helicopter, showed that several were fractured. The rivets were removed and inspected. Many of the rivets (Fig. 14-12(a)), were badly deformed and they were all badly corroded. Closer examination in a scanning electron microscope showed that the sides of the rivets were badly scored and pitted, while the fracture surfaces typically showed three or four distinct zones of fracture as indicated in Figure 14-12(b).

Zone A in Figure 14-12(b) was found to contain predominantly intergranular fracture (Fig. 14-12(c)), but large areas were covered by corrosion deposits having a mud-crack appearance as shown in Figure 14-12(d). Zone B in Figure 14-12(b) was found to be fairly smooth and was also covered by heavy corrosion products. However some areas were found which had a striated appearance, as shown in Figure 14-12(e), suggesting the presence of underlying fatigue striations. The fact that the rivets failed in an essentially brittle manner, with little evidence of necking or other signs of ductility in the fracture process suggests that fatigue was involved. The absence of clearly defined fatigue striations is not uncommon in corrosion fatigue and this often complicates the interpretation of service induced fracture surfaces. Zone C in Figure 14-12(b), and the intermediate zone between zones B and A, were rougher in texture suggesting that these may have formed by tearing during the final stages of fracture of the rivets. These zones were also covered by thick layers of corrosion debris.

Microstructural analysis of these rivets showed they were made from wrought aluminium alloy 5052 (Al-2.5% Mg-0.25% Cr), with a very small equiaxed grain structure (Fig. 14-12(f)). The material had a Vickers hardness,  $Hv = 112 \pm 8$ . This alloy is generally resistant to corrosion in normal marine and industrial atmospheres, and to salt water in the tempers normally used for rivets. The presence of corroded fracture surfaces and the macroscopic and microscopic aspects of the fracture surfaces indicate that corrosion fatigue was the primary cause of failure.

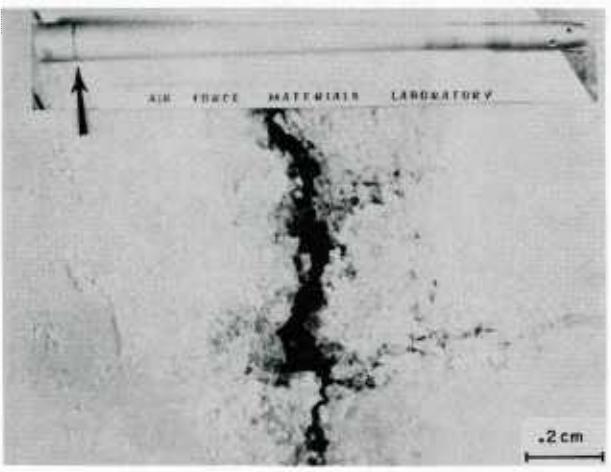
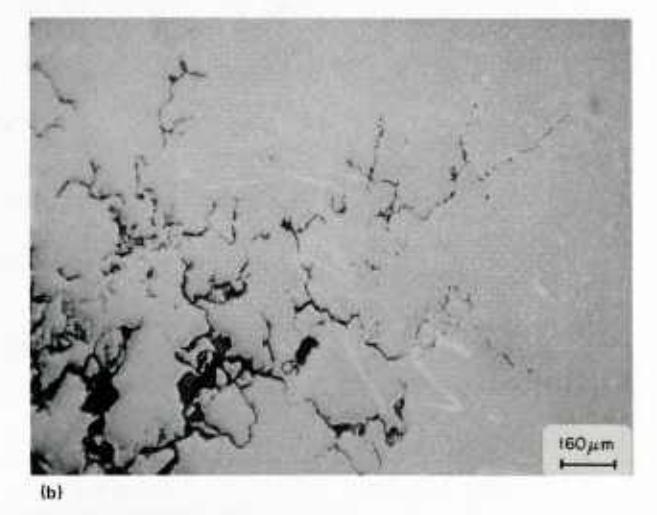
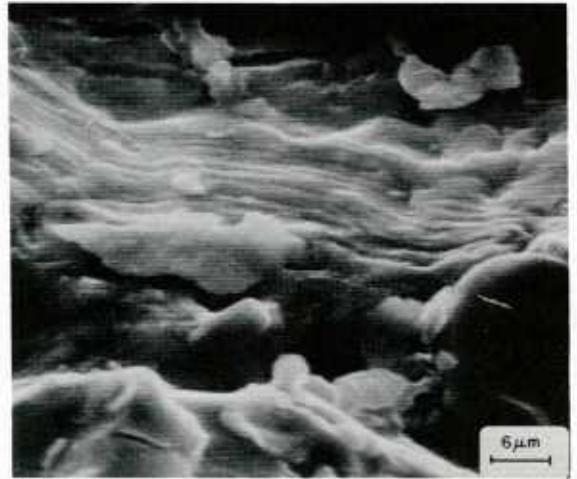
A pitot support tube (Fig. 14-13(a)), on a military aircraft was found to be cracked during a routine visual inspection. The crack encircled the tube more than  $300^{\circ}$  and had existed for a considerable period of time. The tube did not separate from the pitot boom because it contained air hoses and electrical wiring which hold it in place to some degree. The appearance of the magnified crack (Fig. 14-13(a)), suggested that extensive corrosion of an old fracture had occurred. The intergranular nature of the corrosive attack is shown in the metallographic cross-section of Figure 14-13(b). The crack was carefully broken open so that the most recent portion which was not so severely corroded could be studied by scanning electron microscopy. The fracture surface was found to contain fatigue striations amid the corrosion debris and secondary cracking (Fig. 14-13(c)).

(a) Corroded crack encircling the tube (arrow inset). (Mag.  $\times$  7)

b) Cross-section showing intergranular corrosion attack. (Mag.  $\times$  62.5)

The failure of the pitot support tube was therefore attributed to corrosion fatigue, although the corrosive medium could not be specifically identified and aerodynamic loading was the only significant source of stress. No material or design deficiency could be identified, other than the vibrational loading situation.

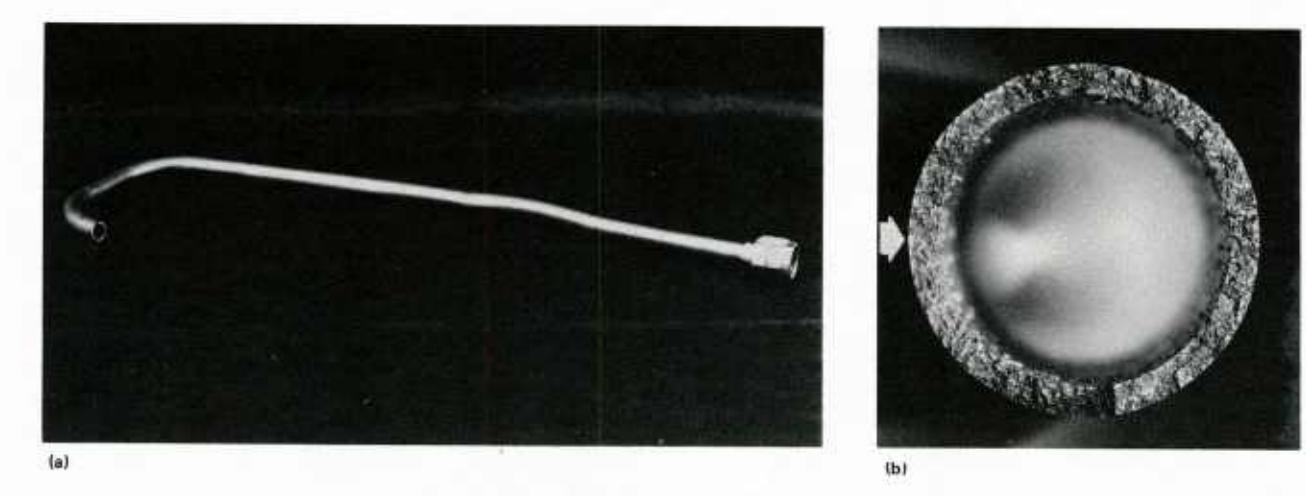
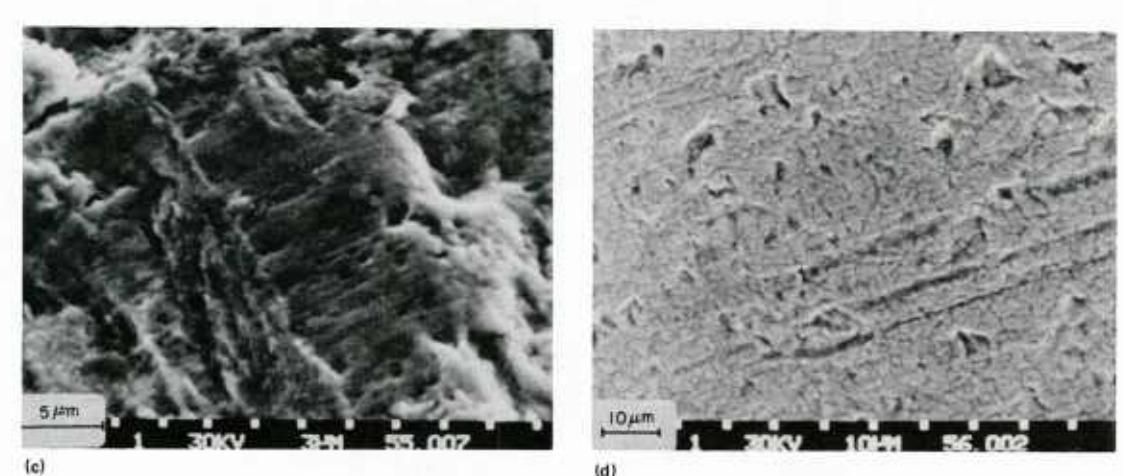
Fig. 14-14 Corrosion fatigue of a 321 stainless steel hose assembly

A visual inspection was carried out on a turbojet engine from a fighter aircraft after a flame-out. A hose assembly, shown in Figure 14-14(a), was found to be completely fractured, the fracture occurring towards one end of the tube close to a weld. Prior to failure the engine had been in service in the Mediterranean region where it would be exposed to warm and humid salt atmospheres.

The fracture appeared to have initiated in the region indicated by the arrow in Figure 14-14(b), and examination of the fracture surface in this region revealed the presence of fatigue striations (Fig. 14-14(c)), partially covered by corrosion products. Examination of the outer surface of the tubing adjacent to the fracture surface revealed the presence of surface pits, longitudinal scratches, and superficial intergranular cracking (Fig. 14-14(d)).

- (a) General view of the tube showing fractured end (left).
- (b) Fracture surface and the crack initiation site indicated by arrow.
- (c) Fatigue striations on the corroded and pitted fracture surface close to the initiation zone. (Mag.  $\times$  3300)
- (d) Surface of the tube close to the fracture face showing corrosion pits and intergranular crevices. (Mag. × 1050)

The presence of pitting (Fig. 14-14(d)) and fatigue (Fig. 14-14(c)) in a stabilized, corrosion resistant stainless steel suggests that fatigue, or corrosion fatigue was the primary mode of failure. There is little information on the corrosion fatigue behaviour of stainless steels, but the fact that stress corrosion cracking may occur in salt laden atmospheres under static loading conditions suggests that an environmental contribution to fatigue crack growth might also occur under certain conditions of cyclic loading. Zinc and aluminium rich coatings are effective in preventing or retarding stress corrosion and pitting in salt laden atmosphers (Ref. 14-13).

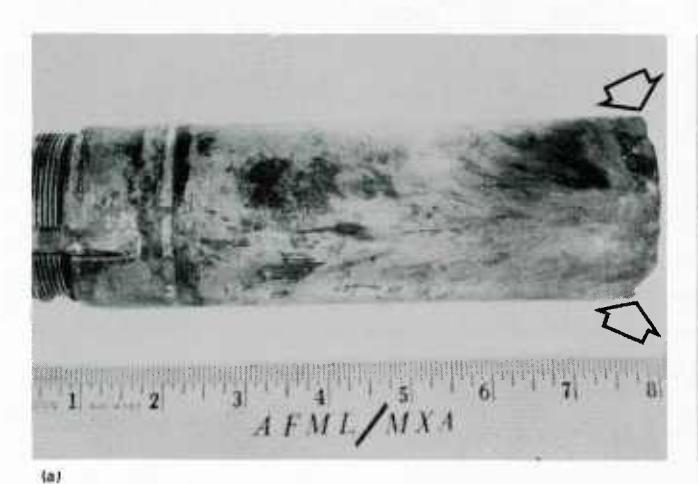
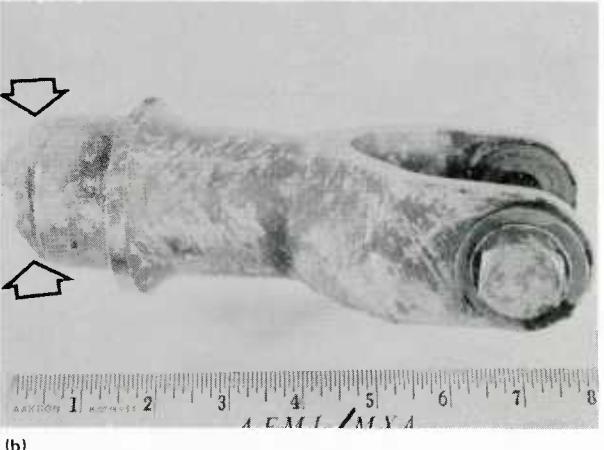
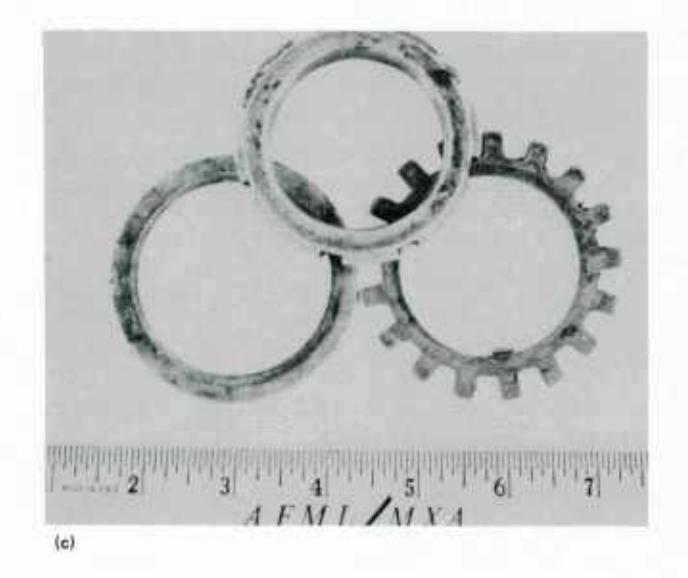
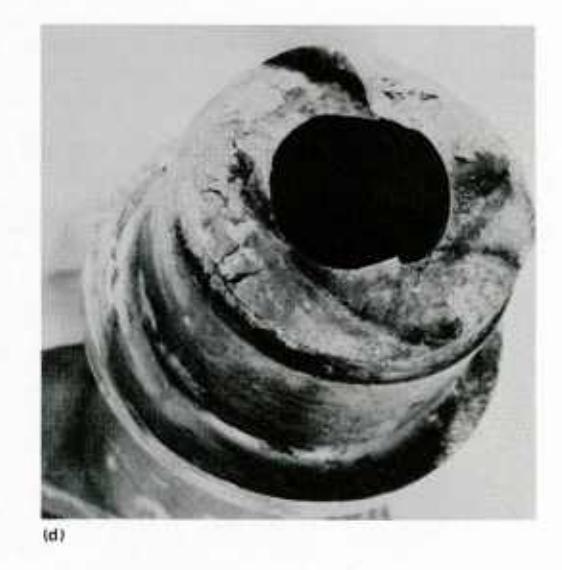
Fig. 14-15 Corrosion fatigue of a 4340 steel rotor attachment assembly

A military helicopter lost a rotor blade in flight and crashed. Several parts from the rotor blade attachment assembly and the blade were recovered from the crash site and were submitted for laboratory examination. These parts included the horizontal hinge pin and the associated nut and locking washer, which are shown in Figures 14-15(a)-(c).

Visual examination revealed that the hinge pin was broken, and the fracture face showed a flat beach mark indicating the presence of a pre-existing crack. The fracture surface and beach mark are shown in Figures 14-15(d) and 14-15(e) respectively. Also noteworthy was a dent on one side of the threaded area of the hinge pin (Fig. 14-15(f)). The threaded area was examined carefully to determine whether the nut was on the pin at the time of the crash. The nut was not recovered.

- (a) Threaded end of the horizontal hinge pin with arrows indicating fracture
- location. Mating part of the hinge pin with arrows indicating fracture location.
- (c) Nut and locking washer from the failed pin.(d) Fracture face of the pin before cleaning.

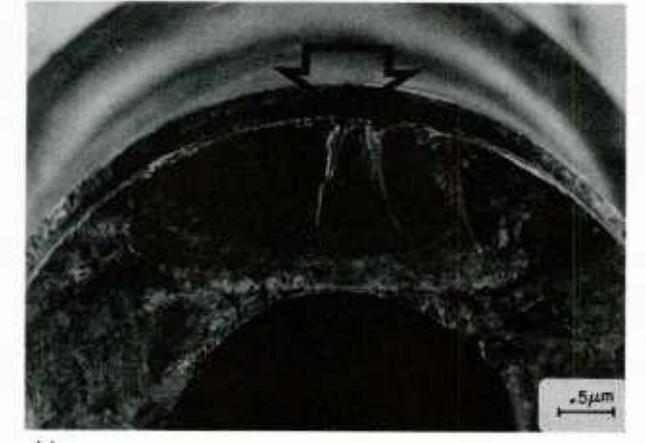
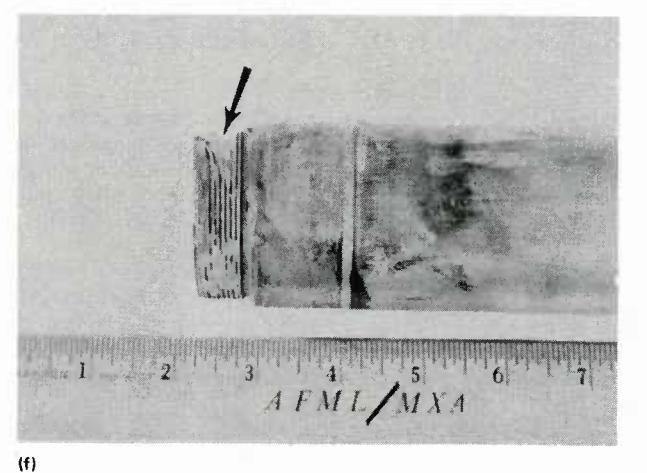
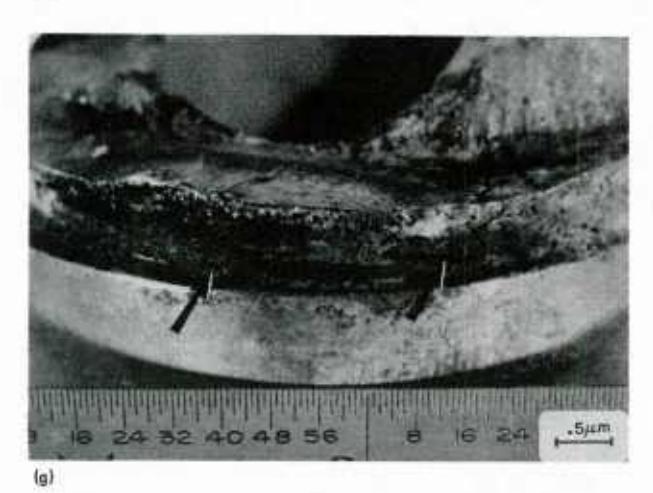
#### Fig. 14-15 Corrosion fatigue of a 4340 steel rotor attachment assembly

- (e) Fracture face after cleaning, showing beach marks and crack plateaus in the
- initiation region. (Mag. × 2)
  (f) Threaded end of the pin showing damaged threads.
  (g) Outer circumference of the pin at the fracture showing secondary cracks and
- pits indicated by arrows. (Mag.  $\times 2$ ) (h) Close-up of threads showing embedded thread at arrow. (Mag.  $\times 2$ )

Optical examination of the hinge pin showed the beach mark or pre-crack had progressed across about one quarter of the total cylinder cross-sectional area. Further examination of the hinge pin close to the fracture initiation site revealed the presence of corrosion pits and secondary cracking on the outer circumference of the pin adjacent to the primary fracture face. The cracks ran parallel to the primary fracture and seemed to be propagating from small pits (Fig. 14-15(g)).

Examination of the threaded portion of the pin revealed an embedded thread which did not appear to come from the pin (Fig. 14-15(h)). Chemical analyses were performed on the hinge pin, an associated attachment nut, and the embedded thread. The results, shown in Table 14-1, indicated that the hinge pin was made from 4340 alloy steel, while the locking nut and the thread were made from the same 4130 low alloy steel. This suggests the embedded thread was from a nut, and that the nut had been in contact with the pin just before the sequence of events occurred that caused the crash.

The failure of the horizontal hinge pin was attributed to corrosion fatigue. The failure initiated in areas of localized corrosion pits, and propagated by fatigue to the depth indicated in Figure 14-15(e). The 4340 steel was found to have a hardness of  $R_c$  41, which was within the specified range of  $R_c$  39-43 for this part, and the part was found to be cadmium plated. As noted in Chapter 9, 4340 steel has poor corrosion resistance and corrosion protection is required in most normal operating environments. The presence of pitting in the hinge pin suggests that the cadmium plating had deteriorated to expose the underlying steel.
